SITE NUMBER AND NAME: S014 Bellevue Mine Sinkholes		HIGHWAY & KM: 3:02, 27.203	PREVIOUS INSPECTION DATE: June 15, 2016	INSPECTION DATE: June 1, 2017
LEGAL DESCRIPTION: 04-21-007-03 W5M and 13-16-007-03 W5M	NAD 83 COORDINATES: UTM Northing Easting 11 5659724 614296		RISK ASSESMENT: PF: 1 CF: 1 TOTAL: 1 PF: 2 CF: 3 TOTAL: 6	
AVERAGE ANNUAL DAILY TRAFFIC (AADT): 8020 (west), 6320 (east) (Ref. No. 70000008)			CONTRACTOR MAINTENANCE AREA (CMA): 26

SUMMARY OF SITE INSTRUMENTATION: None LAST READING DATE: n/a	INSPECTED BY: Chris Gräpel (KCB) Peter Roy (KCB) Ross Dickson (AT) Roger Skirrow (AT) Ammar Zaidi (AT)
PRIMARY SITE ISSUE: Sinkholes formed after heavy rainfall in 2002 due to collapse of old coal mine workings.	
APPROXIMATE DIMENSIONS: Sinkholes formed in a line approximately 280 m long along highway and were located between 5 and 35 m from west edge of pavement. Sinkholes varied in depth from 9 to 25 m.	
DATE OF ANY REMEDIAL ACTION: Sinkholes were excavated to 9 m depth and backfilled with rock fill in 2002, a few days after the sinkholes developed.

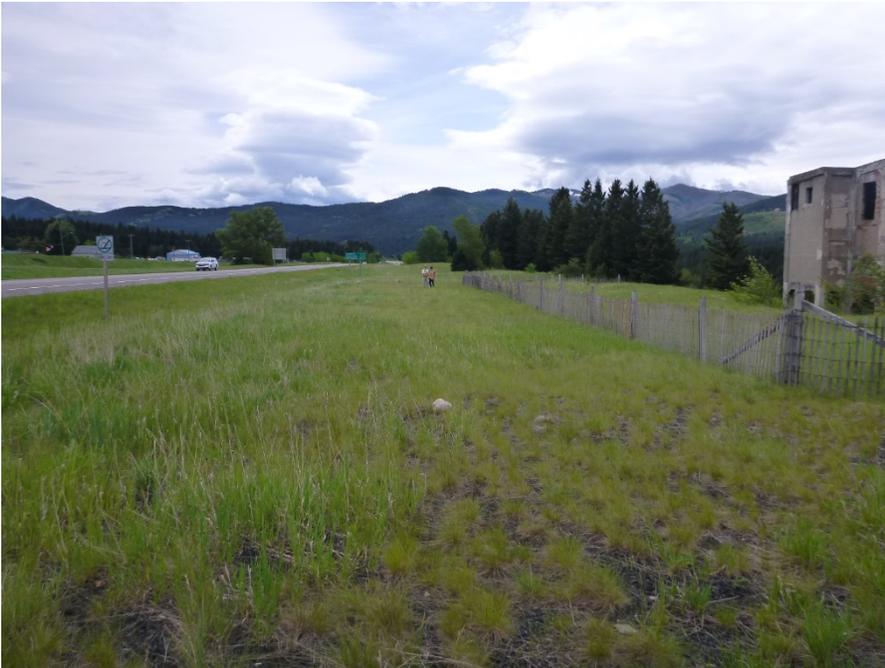
Photo 1 Area of 2002 sinkhole formation after intense rainfall event. Sinkholes were filled with rock fill and are now grown over and obscured. Photo taken facing east on June 1, 2017.

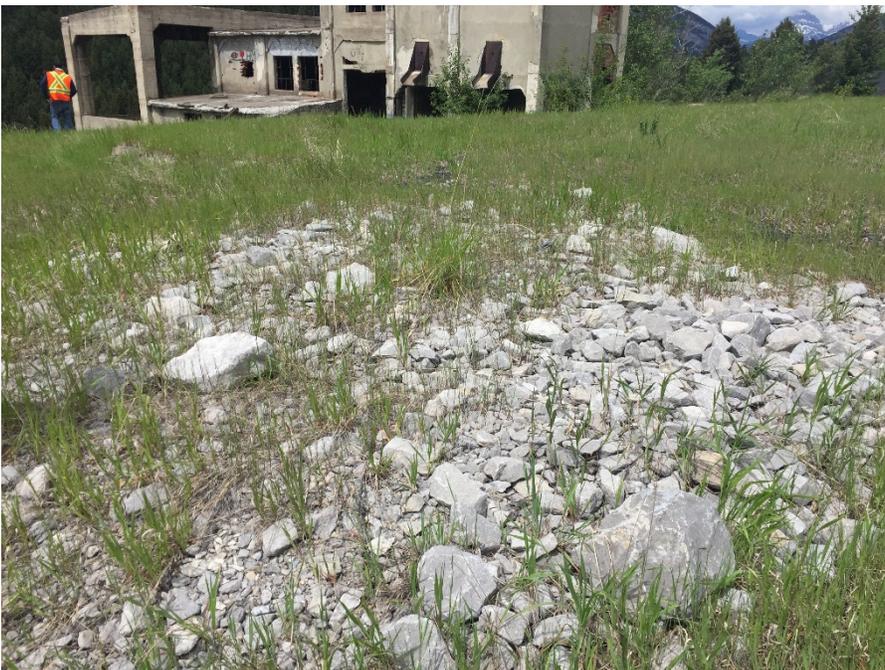
Photo 2 Sinkhole filled in due to collapse of old coal mine workings with old coal mining building in background. Photo taken facing west on June 1, 2017.

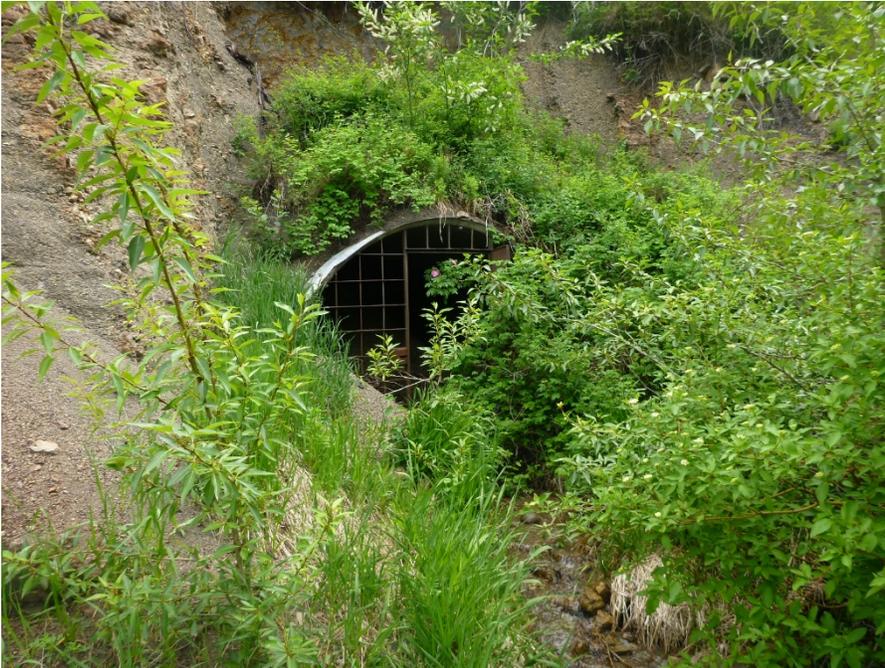
Photo 3 Coal-mine portal to west old mine building, above train tracks at waypoint 341. Initial formation of sinkholes in 2002 was accompanied by discharge of water and soil/rock debris onto tracks from the shaft. Photo taken facing north on June 1, 2017.

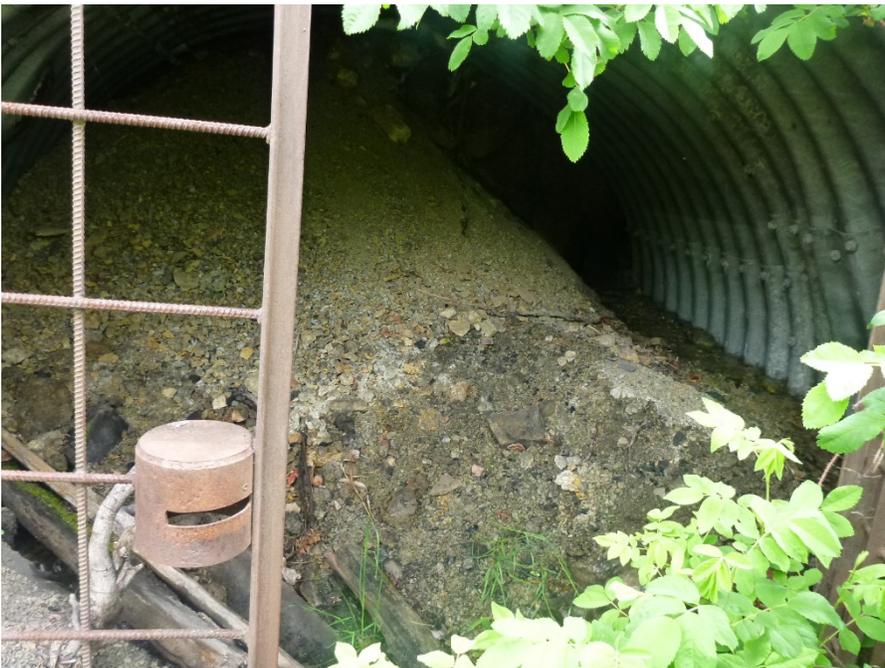
Photo 4 Mine-collapse debris inside old mine shaft. Ground water seepage exiting shaft. Photo taken facing north on June 1, 2017.
