SITE NUMBER AND NAME: <b>S070-II and -III Eyrie Gap and Fir Creek Geohazard Sites</b>		HIGHWAY & KM: 541:02, km 4.488 to km 4.794	PREVIOUS INSPECTION DATE: May 9, 2023	INSPECTION DATE: <b>May 28, 2024</b>
LEGAL DESCRIPTION:	NAD 83 COORDINATES: UTM Northing Easting		RISK ASSESMENT:	
S070-II: NW-35-16-05 M5	11	5585241 671123	S070-II: PF: 11 CF: 1 TOTAL: 11	
S070-III: NW-35-16-05 M5	11	5585007 671335	S070-III: PF: 11 CF: 1 TOTAL: 11	
AVERAGE ANNUAL DAILY TRAFFIC: 171 (west) & 175 (east) (Reference No. 55410220)			CONTRACTOR MAINTENANCE AREA (CMA): 27

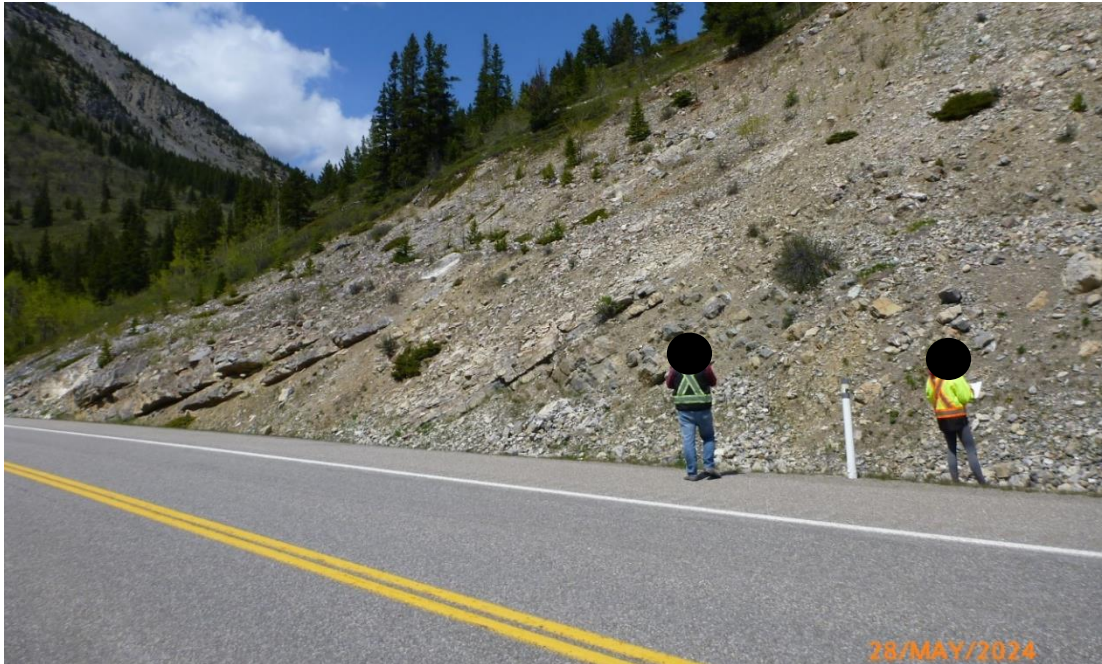
**Photo 1**      **S070-II: Northern portion of back slope adjacent to the highway. Photo taken facing northwest on May 28, 2024.**

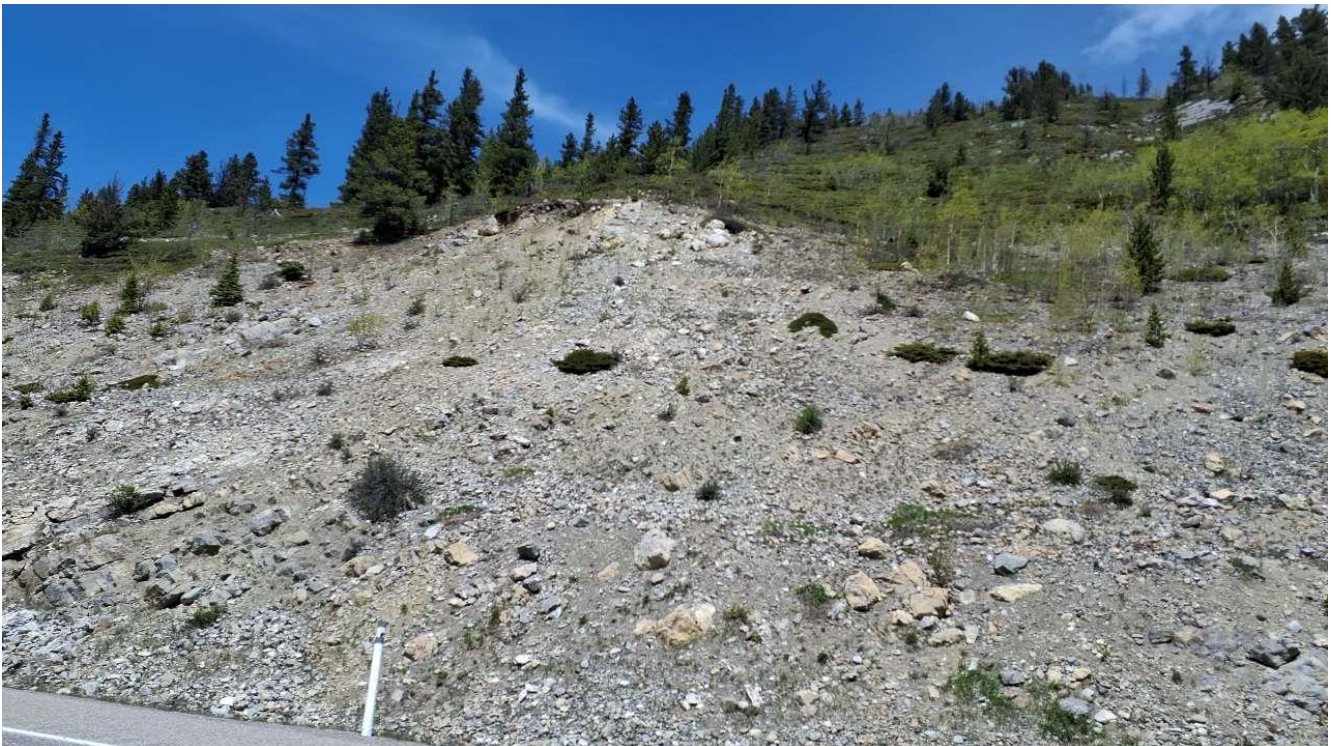
**Photo 2**      **S070-II: Central portion of back slope adjacent to the highway. Photo was taken facing north on May 28, 2024.**

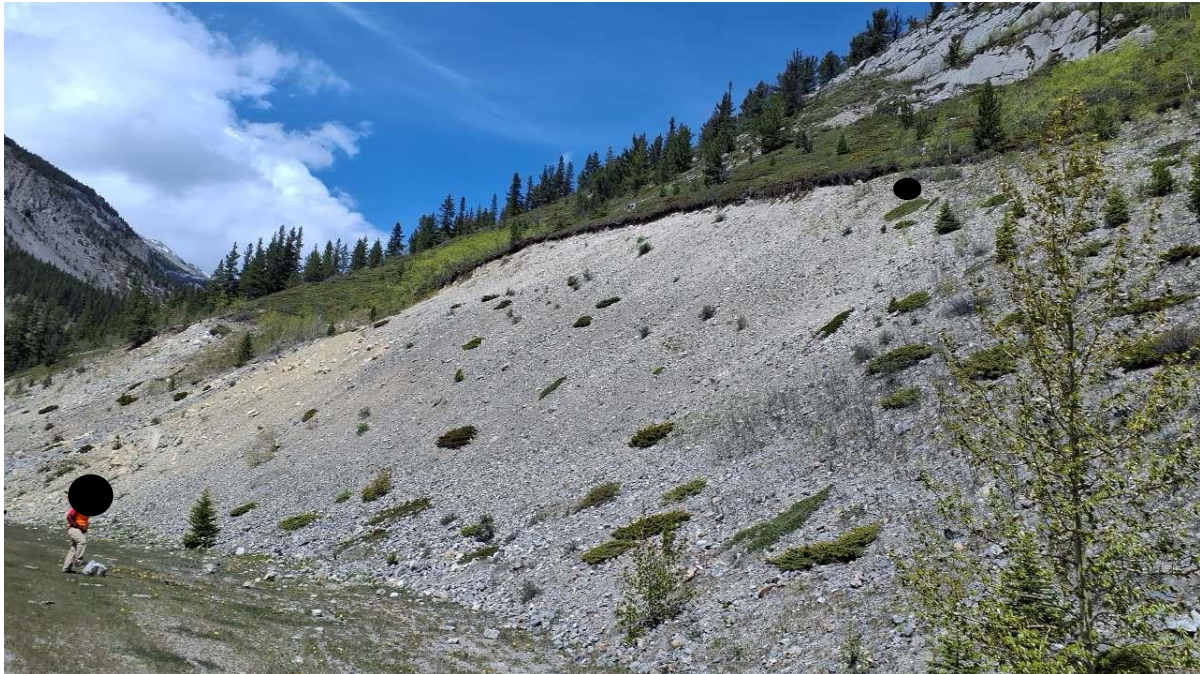
**Photo 3**      **S070-II: Southern portion of back slope adjacent to the highway. Photo was taken facing northwest on May 28, 2024.**

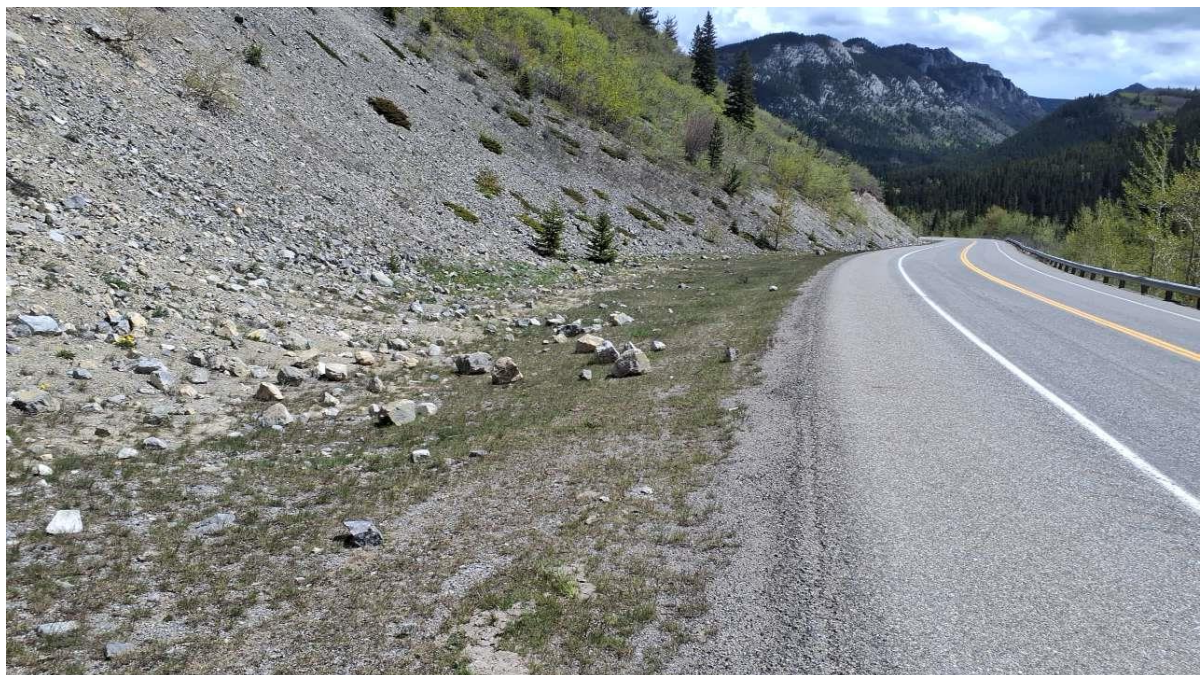
- The height of the bedrock backslope north of the highway is approximately 20 m. The upper portion of the backslope consists of granular soil and the lower portion of intact bedrock. The natural ground upslope of the backslope is well vegetated with grass and trees.
- The bedrock bedding plane is approximately 30° from horizontal and has a strike perpendicular to the road.
- Erosion at the brow of the rock slope is leading to an overhanging topsoil root mat.
- The ditch is clearly defined and provides good catchment. The ditch is approximately 6 m wide and 1 m deep. Rockfalls are active and fresh rockfall debris up to 1 m in width was noted in the ditch during the 2024 inspection. The majority of the debris was approximately 0.3 m in diameter. Rockfall debris observed

was primarily blocky with some rounded particles.

**Photo 4**      **S070-II: Rockfall debris close to the road. Photo taken facing southeast on May 28, 2024.**

- The sites should be regularly inspected by TEC's MCI and inspected as part of the Southern Region GRMP Section B inspections.
- The ditches at S070-II and -III should be regularly cleaned out to maintain rockfall capacity.

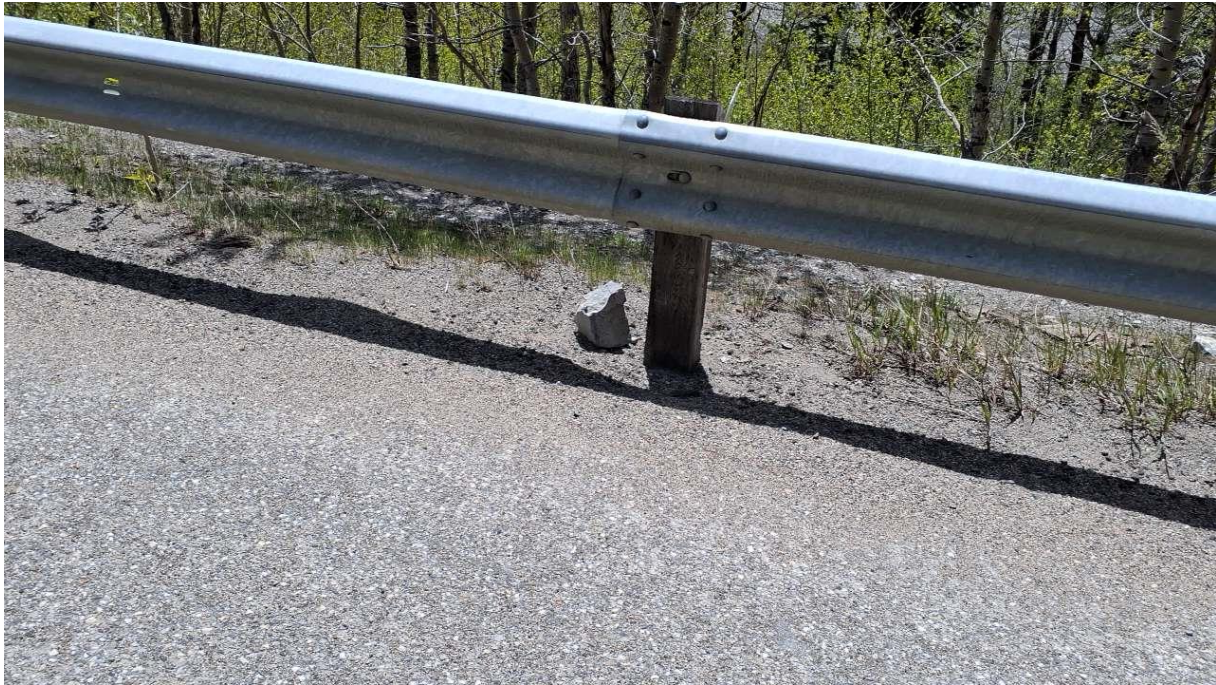
- Rock fall debris noted on the south side of the highway which could have travelled across the highway. Approximately 0.3 m in diameter.

**Photo 5**      **S070-II: Rockfall debris on south side of highway which may have travelled across the highway. Photo taken facing south on May 28, 2024.**

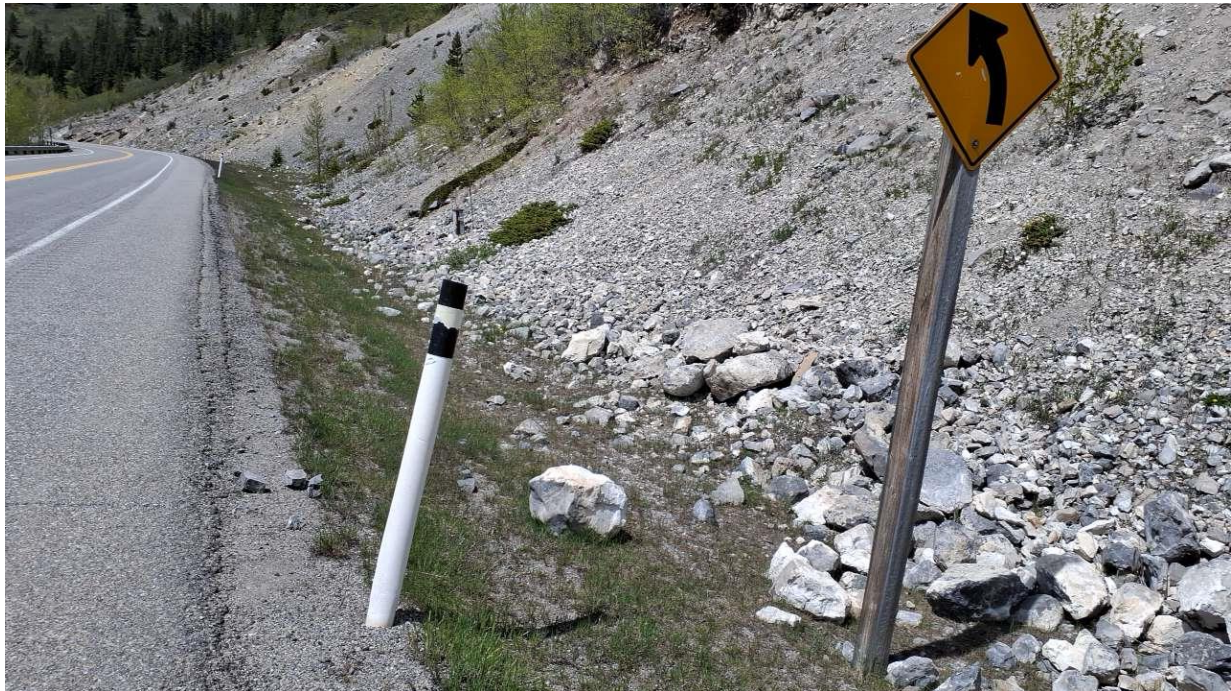
- Rockfalls are active and fresh rockfall debris up to 1.45 m x 0.65 m x 0.70 m was observed in the ditch during the 2024 inspection. The large debris noted was at the same location as what was observed during the 2022 inspection, indicating that the debris has not been cleared out of the ditch. Rockfall debris is primarily subrounded to angular. Material that has accumulated in the ditch and should be cleared out.

**Photo 6**      **S070-III: Rockfall debris at the toe of the slope in northbound ditch. Photo taken facing northwest on May 28, 2024.**

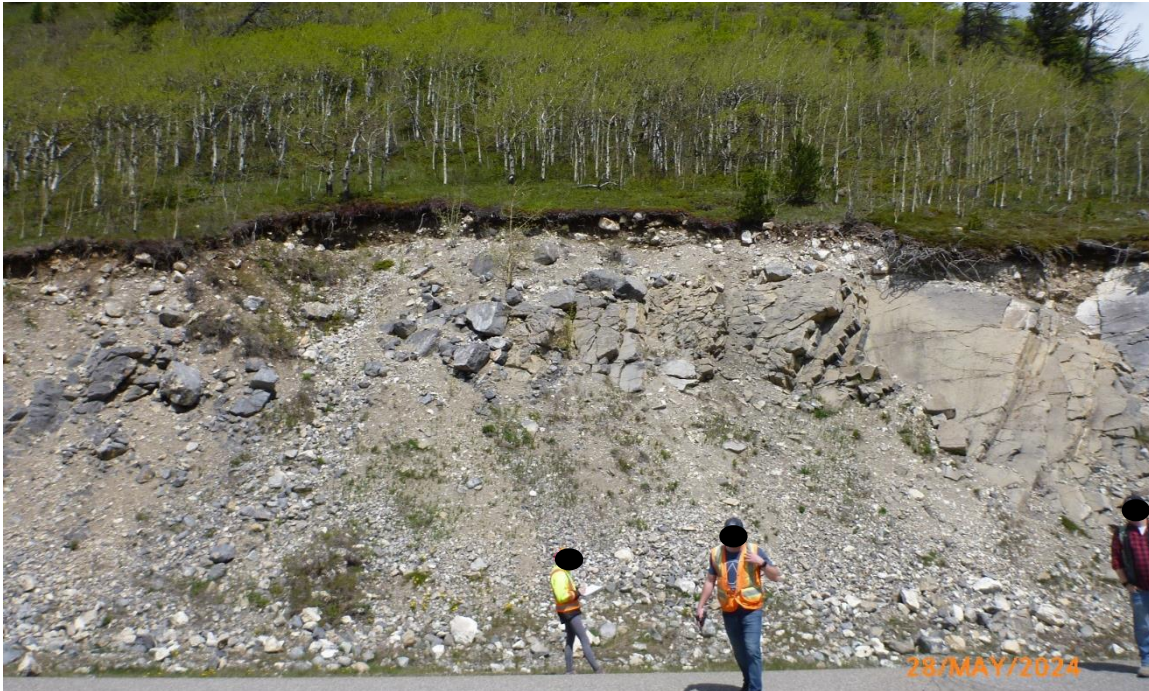
- The ditch is approximately 0.7 m deep and provides good catchment for rockfall debris.

**Photo 7**      **S070-III: Northbound ditch and bedrock fracturing. Photo taken facing north on May 28, 2024.**

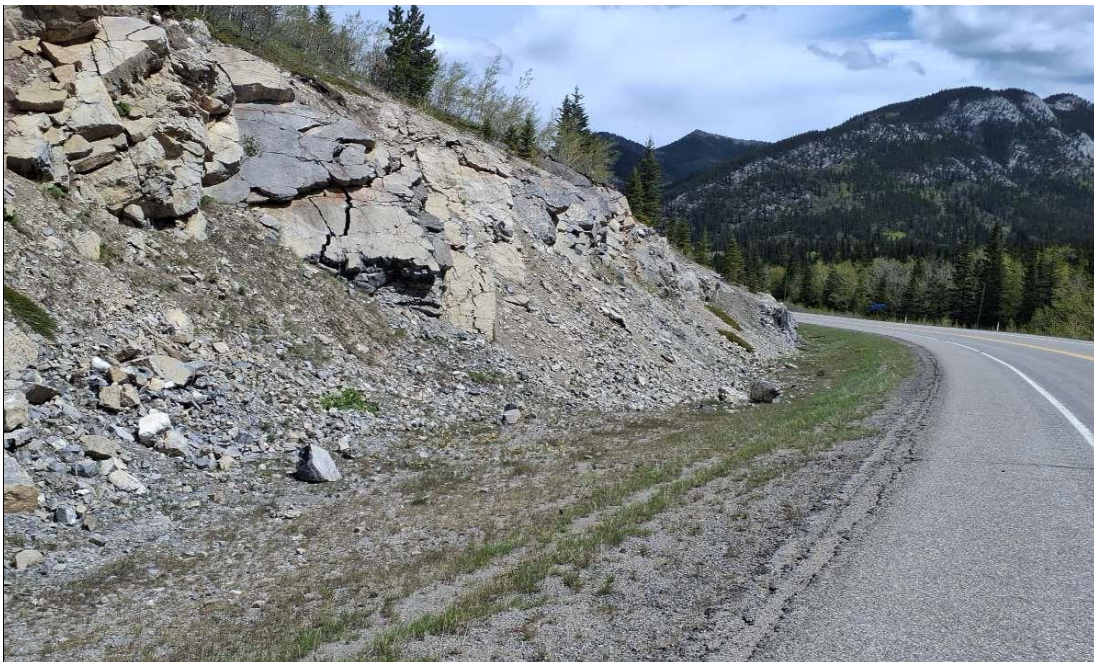
**Photo 8**      **S070-III: Bedrock fracturing leading to future rockfall blocks. Large rock noted in ditch was there during the 2022 inspection. Photo taken facing southeast on May 28, 2024.**
