SITE NUMBER AND NAME: S070-2 and -3 Eyrie Gap and Fir Creek Geohazard Sites		HIGHWAY & KM: 541:02, km 4.488 to km 4.794	PREVIOUS INSPECTION DATE: May 28, 2024	INSPECTION DATE: May 27, 2025
LEGAL DESCRIPTION: S070-2: NW-35-16-05 M5 S070-3: NW-35-16-05 M5	NAD 83 COORDINATES: UTM Northing Easting 11 5585241 671123 11 5585007 671335		RISK ASSESSMENT: Rockfall: S070-2: PF: 11 CF: 1 TOTAL: 11 S070-3: PF: 11 CF: 1 TOTAL: 11	
AVERAGE ANNUAL DAILY TRAFFIC: 171 (west) & 175 (east) (Reference No. 55410220)			CONTRACTOR MAINTENANCE AREA (CMA): 520

PRIMARY SITE ISSUE: S070-2: rockfalls from colluvium and undeveloped rock outcrop on the backslope north of the highway. S070-3: rockfalls from the rock outcrop on the backslope north of the highway. Large rock outcrop further upslope of the highway backslope.
APPROXIMATE DIMENSIONS: S070-2: Approximately 460 m long, 11 m to 38 m in height, with a slope angle 0.8H:1V to 1.0H:1V. S070-3: Approximately 395 m long and up to 11 m high.
DATE OF ANY REMEDIAL ACTION: None.

SOUTHERN REGION GEOHAZARD RISK MANAGEMENT PROGRAM

Site Plan
S070-2, -3 - Eyrie Gap and Fir Creek Geohazard Sites
Hwy 541:02, km 4.794-4.488

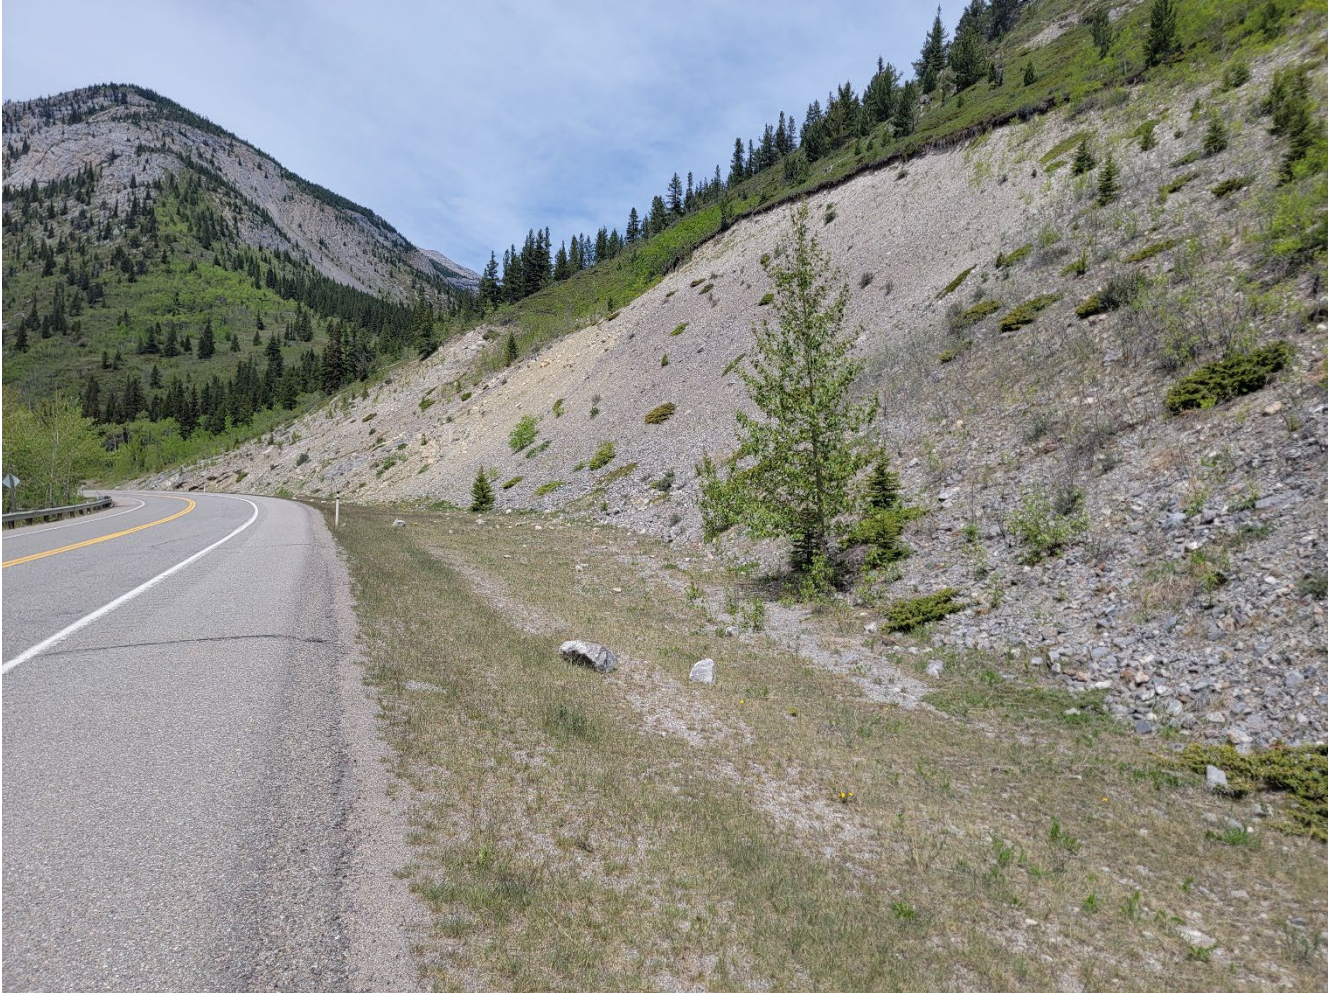
- Erosion at the brow of the rock slope is leading to an overhanging topsoil root mat.
- Rockfalls are active, and fresh rockfall debris up to 1 m in width was noted in the ditch during the 2025 inspection, similar to the 2024 inspection. The majority of the debris was approximately 0.3 m in diameter. Rockfall debris observed was primarily blocky with some rounded particles. No ditch cleaning was noticed or reported to KCB.

Photo 1 **S070-2: Northern portion of back slope adjacent to the highway.**
Photo taken facing northwest on May 27, 2025.

- The sites should be regularly inspected by TEC's MCI and inspected as part of the Southern Region GRMP Section B inspections.
- The ditches at S070-II and -III should be regularly cleaned out to maintain rockfall capacity.

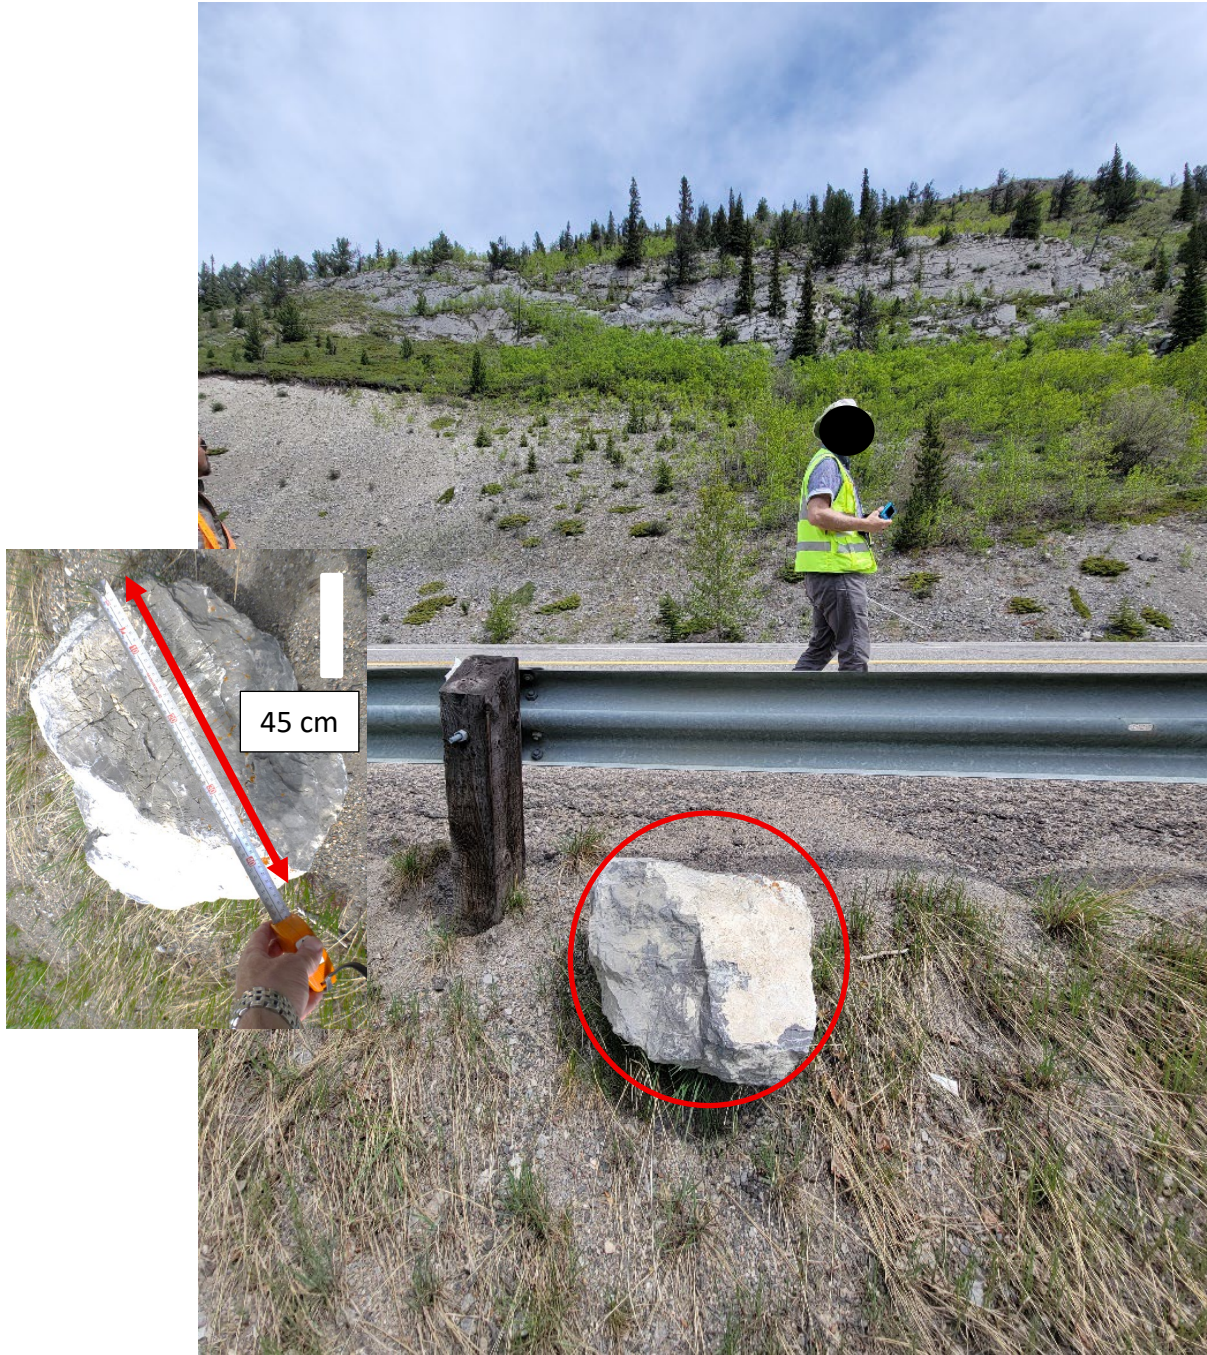
- The ditch is 3.0 m to 8.0 m wide and 0.5 m deep and provides good catchment for rockfall debris. However, rockfall debris was noted on the south side of the highway, which could have travelled across the highway. Approximately 0.3 m in diameter.

Photo 2 **S070-2: Rockfall debris (red circle) on south side of highway which may have travelled across the highway. Photo taken facing northeast on May 27, 2025.**

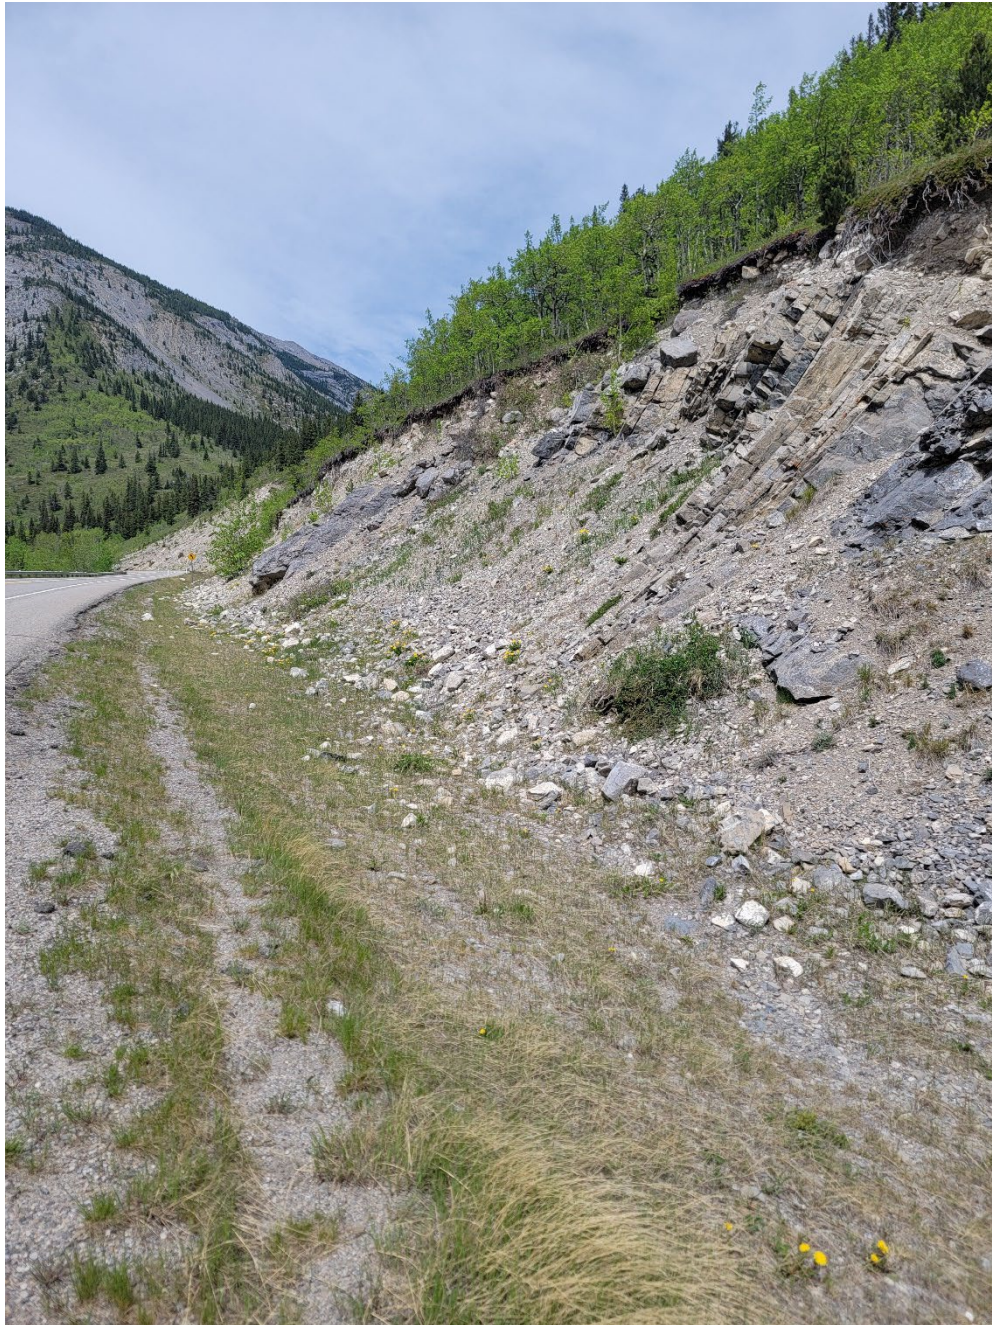
- Erosion from the brow is leading to an overhanging of topsoil root mats.
- Rockfalls are active, and rockfall debris of up to 1.45 m x 0.65 m x 0.70 m was noted in the ditch during the 2025 inspection, similar to the 2024 inspection. The large debris noted was at the same location as observed during the 2022 inspection, indicating that the debris has not been cleared out of the ditch. Rockfall debris is primarily subrounded to angular.

Photo 3 **S070-3: Rockfall debris at the toe of the slope in northbound ditch.**
Photo taken facing northwest on May 27, 2025.

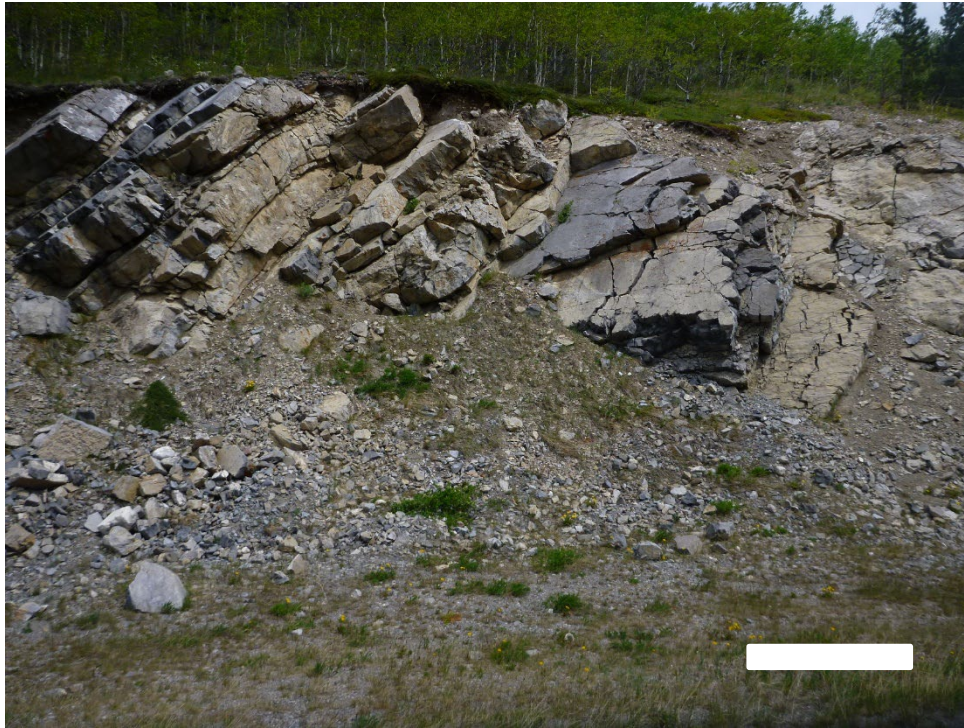
- The ditch is approximately 6.0 m wide and 0.9 m deep and provides good catchment for rockfall debris.

Photo 4 **S070-3: Northbound ditch and bedrock fracturing.**
Photo taken facing north on May 27, 2025.

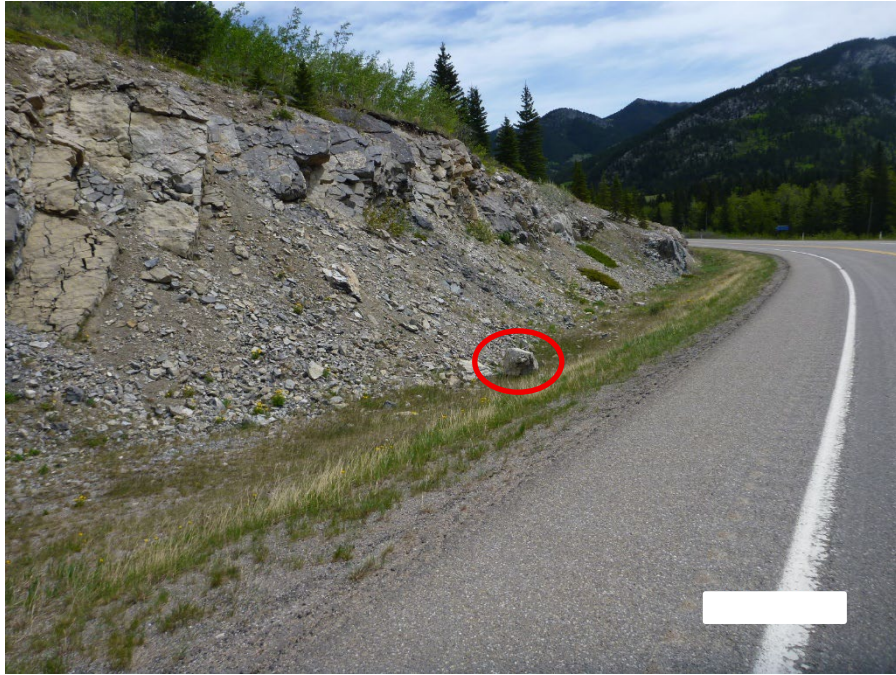
Photo 5 **S070-3: Bedrock fracturing leading to future rockfall blocks. Large rock noted in ditch was since the 2022 inspection (red circle). Photo taken facing southeast on May 27, 2025.**
