SITE NUMBER AND NAME: S070-6 Eyrie Gap and Fir Creek Geohazard Site		HIGHWAY & KM: 541:02 7.023	PREVIOUS INSPECTION DATE: May 17, 2022	INSPECTION DATE: May 9, 2023
LEGAL DESCRIPTION: SE-01-17-05 M5	NAD 83 COORDINATES: UTM Northing Easting 11 5585666 673290		RISK ASSESMENT: PF: 12 CF: 2 TOTAL: 24	
AVERAGE ANNUAL DAILY TRAFFIC: 153 (west) & 158 (east) (Reference No. 55410220)			CONTRACTOR MAINTENANCE AREA (CMA): 27

SOUTHERN REGION GEOHAZARD RISK MANAGEMENT PROGRAM

Site Plan
 S070-6 - Eyrie Gap and Fir Creek Geohazard Sites
 Hwy 541:02, km 7.023

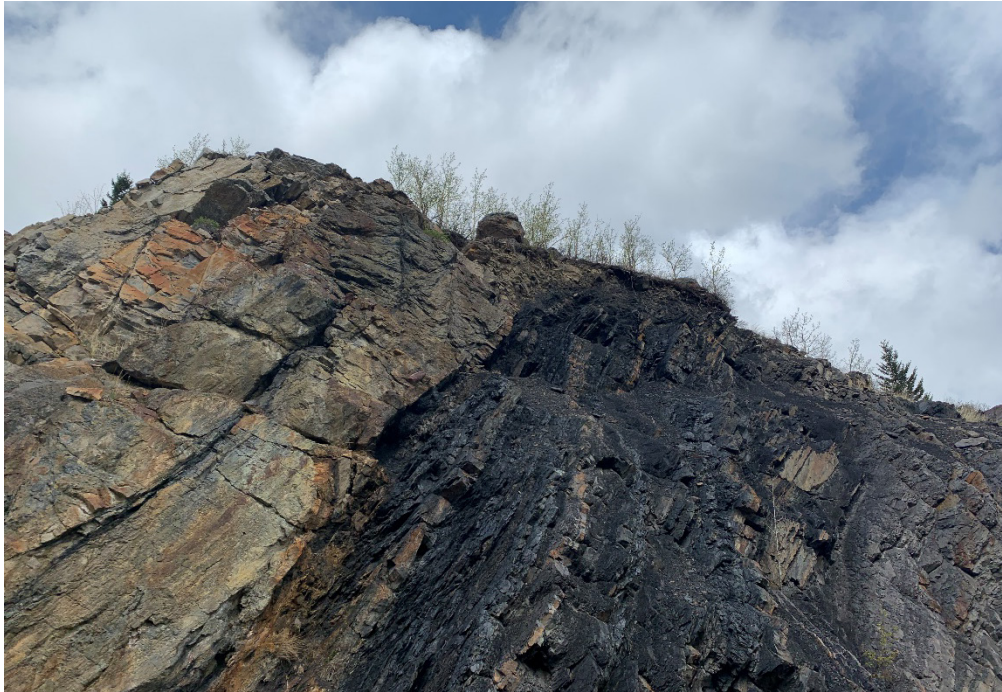
Photo 1 **Bedrock cutting on the north side of the highway estimated as up to 20 m high.**
Photo taken May 9, 2023, facing north.

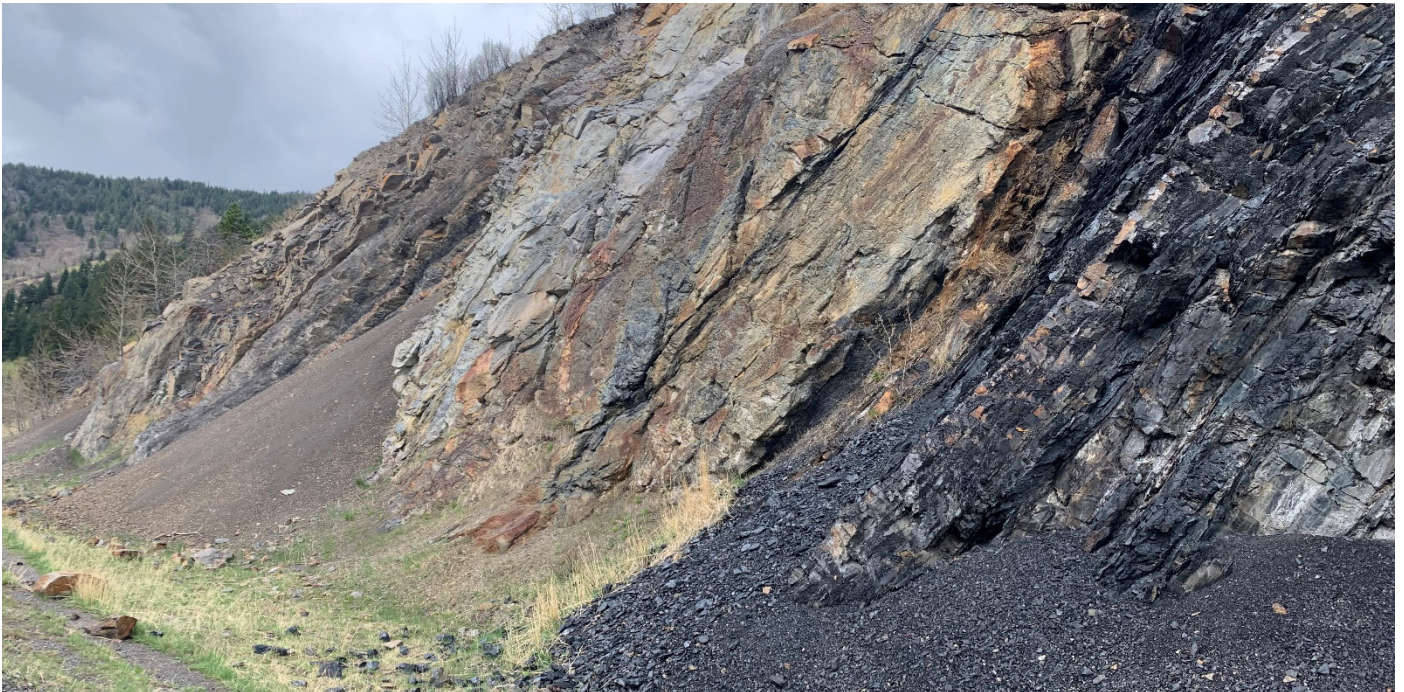
Photo 2 **Rockfall material in the ditch and debris fan on the lower portion of the back slope.**
Photo taken May 9, 2023, facing northwest.

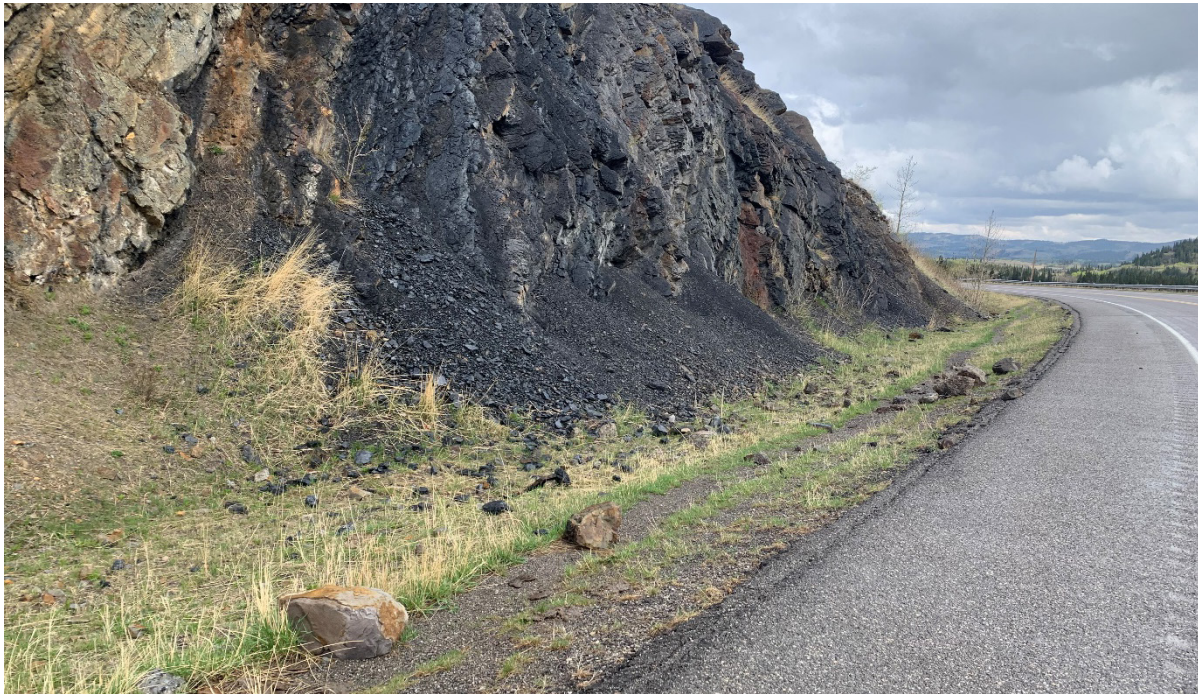
Photo 3 **Rockfall material in the ditch and mini debris fans on the lower portion of the back slope. Photo taken May 9, 2023, facing east.**

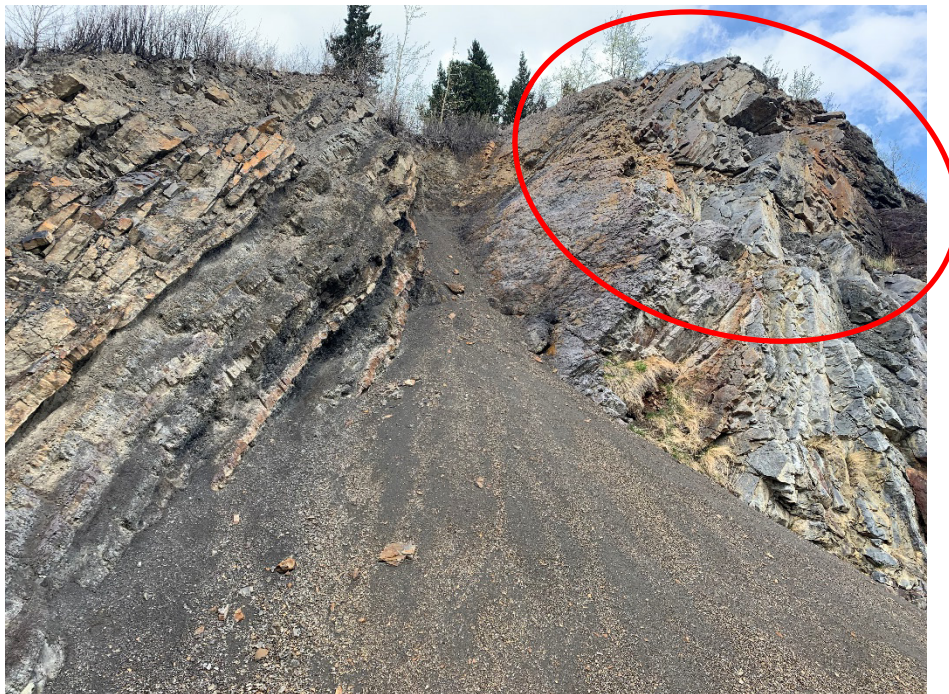
A large block adjacent to the debris fan is at risk of detaching and falling into the north (westbound) ditch and rebounding into the highway (Photo 4).

Photo 4 **Large debris fan in central portion of the slope. Block adjacent to debris fan (indicated by red circle) is at risk of detaching. Photo taken May 9, 2023, facing north.**

- The large block of material shown in Photo 4 should be assessed for stability and if needed, anchored to limit deformation/dilation and toppling.
- A lock block wall or HTCBB could be considered but the impact in wildlife movement and road safety would need to be evaluated.
