### SOUTHERN REGION GRMP SITE INSPECTION FORM

SITE NUMBER AND NAME:		HIGHWAY & KM:	PREVIOUS	INSPECTION DATE:	
S070-6 Eyrie Gap and Fir Creek		541:02 7.023	INSPECTION DATE:	May 28, 2024	
Geohazard Site			May 9, 2023	ay 20, 202 :	
LEGAL DESCRIPTION:	NAD 83 COO	RDINATES:	RISK ASSESMENT:		
SE-01-17-05 M5	UTM North	ning Easting	PF: 12 CF: 5	ΓΟΤAL: 60	
	11 5585	666 673290			
AVERAGE ANNUAL DAILY	TRAFFIC:	CONTRACTOR MAINTENANCE AREA (CMA):			
171 (west) & 175 (east) (Refe	erence No. 554	27

Plan Site S070-6 Eyrie Gap and Fir Creek Geohazard Site Hwy 541:02, km 7.023

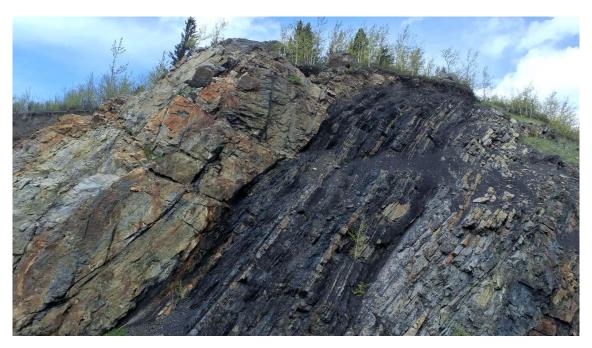
Photo 1 Bedrock cutting on the north side of the highway estimated as up to 20 m high. Photo taken May 28, 2024, facing north.

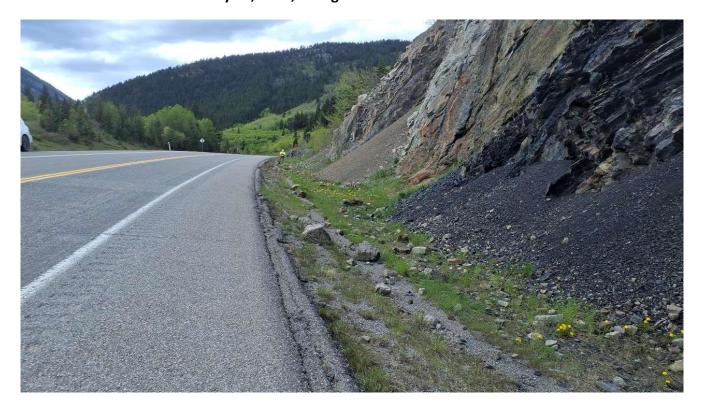
Rockfalls are active and unweathered rockfall debris (up to  $0.7 \text{ m} \times 0.3 \text{ m} \times 0.35 \text{ m}$ ) was noted in the north (westbound) ditch. The site is active with small rockfalls observed during the 2024 inspection. The larger debris noted during the 2022 inspection was present during the 2024 inspection indicating that the ditch was not cleared in the past two years.

Photo 2 Rockfall material in the ditch and debris fan on the lower portion of the back slope. Photo taken May 28, 2024, facing west.

- The site should be regularly inspected by TEC's MCI and annually as part of the Southern Region GRMP Section B inspections.
- Excavation of rockfall catchment ditches adjacent to the highway and spot bolting of blocks which appear unstable or pose a wedge failure risk.

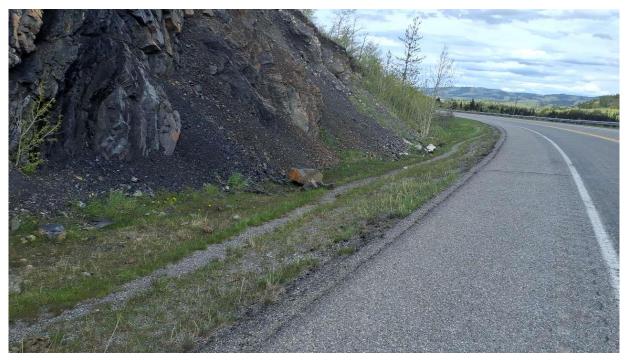
Photo 3 Rockfall material in the ditch and mini debris fans on the lower portion of the back slope. Photo taken facing east on May 28, 2024.

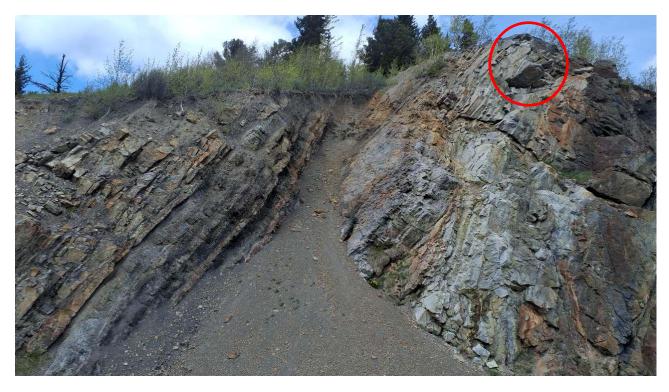
A large block adjacent to the debris fan is at risk of detaching and falling into the north (westbound) ditch and rebounding into the highway (Photo 4).

Photo 4 Large debris fan in central portion of the slope. Block adjacent to debris fan (indicated by red circle) is at risk of detaching. Photo taken May 9, 2023, facing north.

- The large block of material shown in Photo 4 should be assessed for stability and if needed, anchored to limit deformation/dilation and toppling.
- A temporary lock block/jersey barrier wall should be installed at the edge of the highway to help limit the
  rockfall hazard to vehicles. A detailed rockfall assessment and mitigation design should be completed at
  this site.
