November 26, 2025

Alberta Transportation and Economic Corridors  
2<sup>nd</sup> Floor, 803 Manning Road N.E.  
Calgary, Alberta  
T2E 7M8

**CON0022161 Southern Region GRMP Instrumentation Monitoring**  
**Site S004; H02:08, km 6.284 Willow Creek**  
**Section C – 2025 Fall Readings**

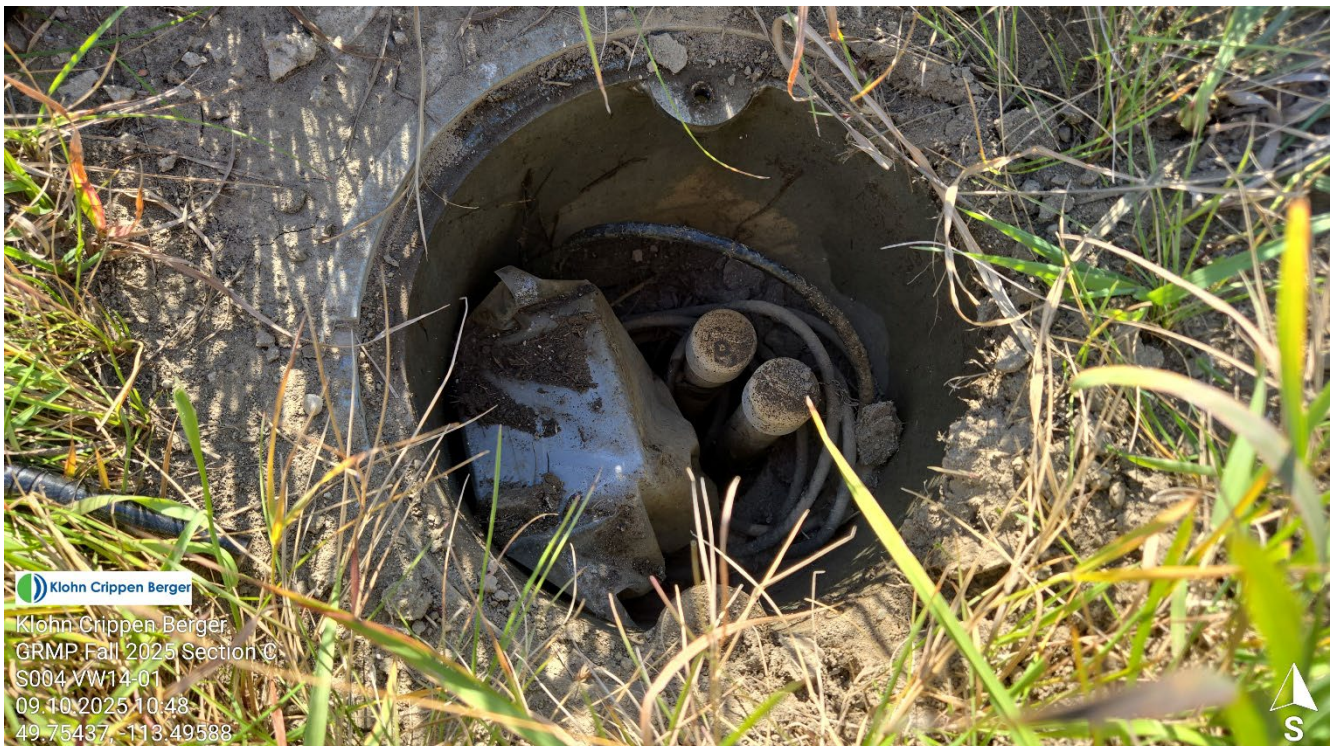
**Photo 3.1** Bagged data logger at the VW14-01 inside the flash-mount installation.

The dataloggers VW14-01 and VW14-03 have a flash-mount installation and exhibit signs of internal water damage that impacted the battery. Battery problems at BH14-01A have disrupted data collection from fall 2024 to spring 2025. Similarly, at BH14-03, readings have been missing since fall 2024 due to a datalogger battery issue. The batteries for VW14-01 and VW14-03, which were replaced during spring 2025, were found dead in fall 2025. Another battery replacement was performed during the fall 2025 readings, and the daily reading was taken. The loggers have been placed in a new, sealed bag to ensure waterproof protection. If the water problem with the dataloggers persists, we recommend installing them above ground using an anchored post.

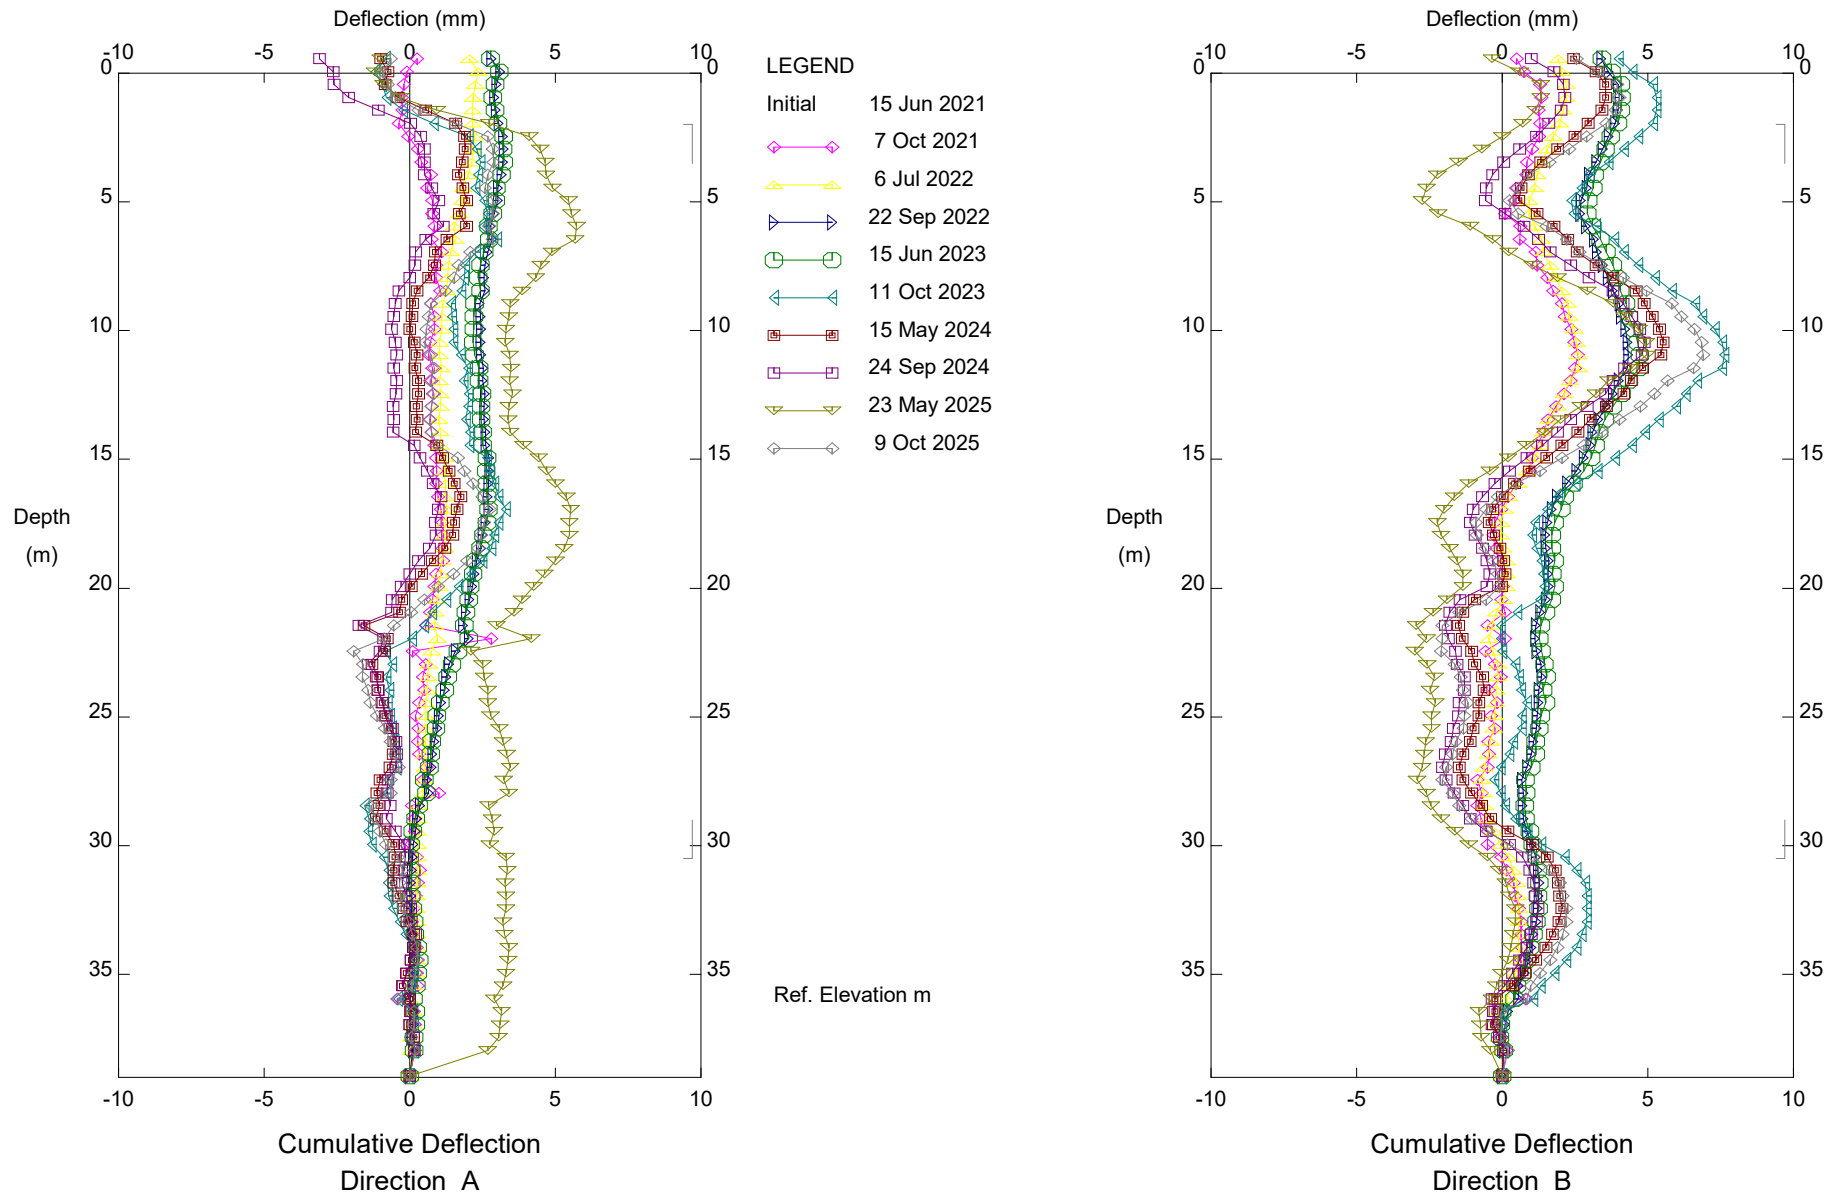
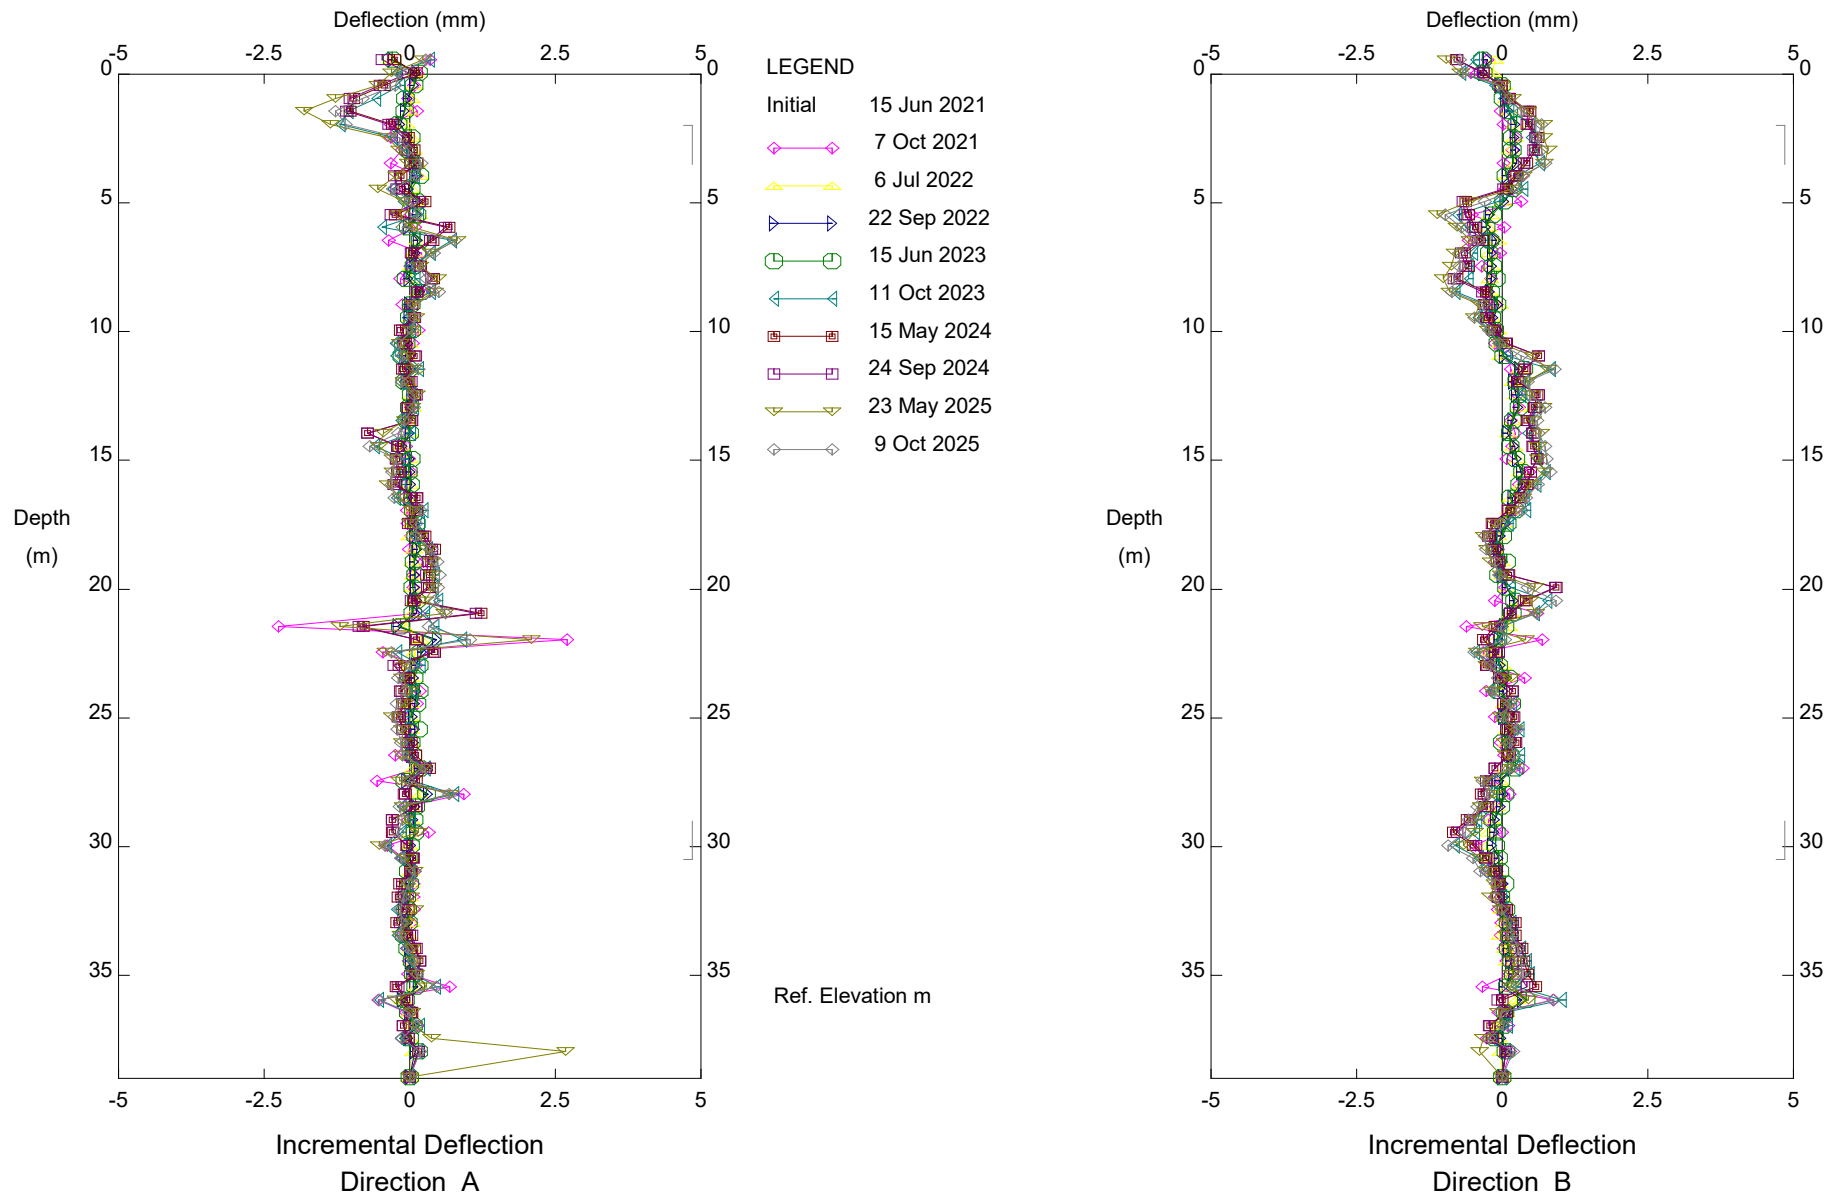
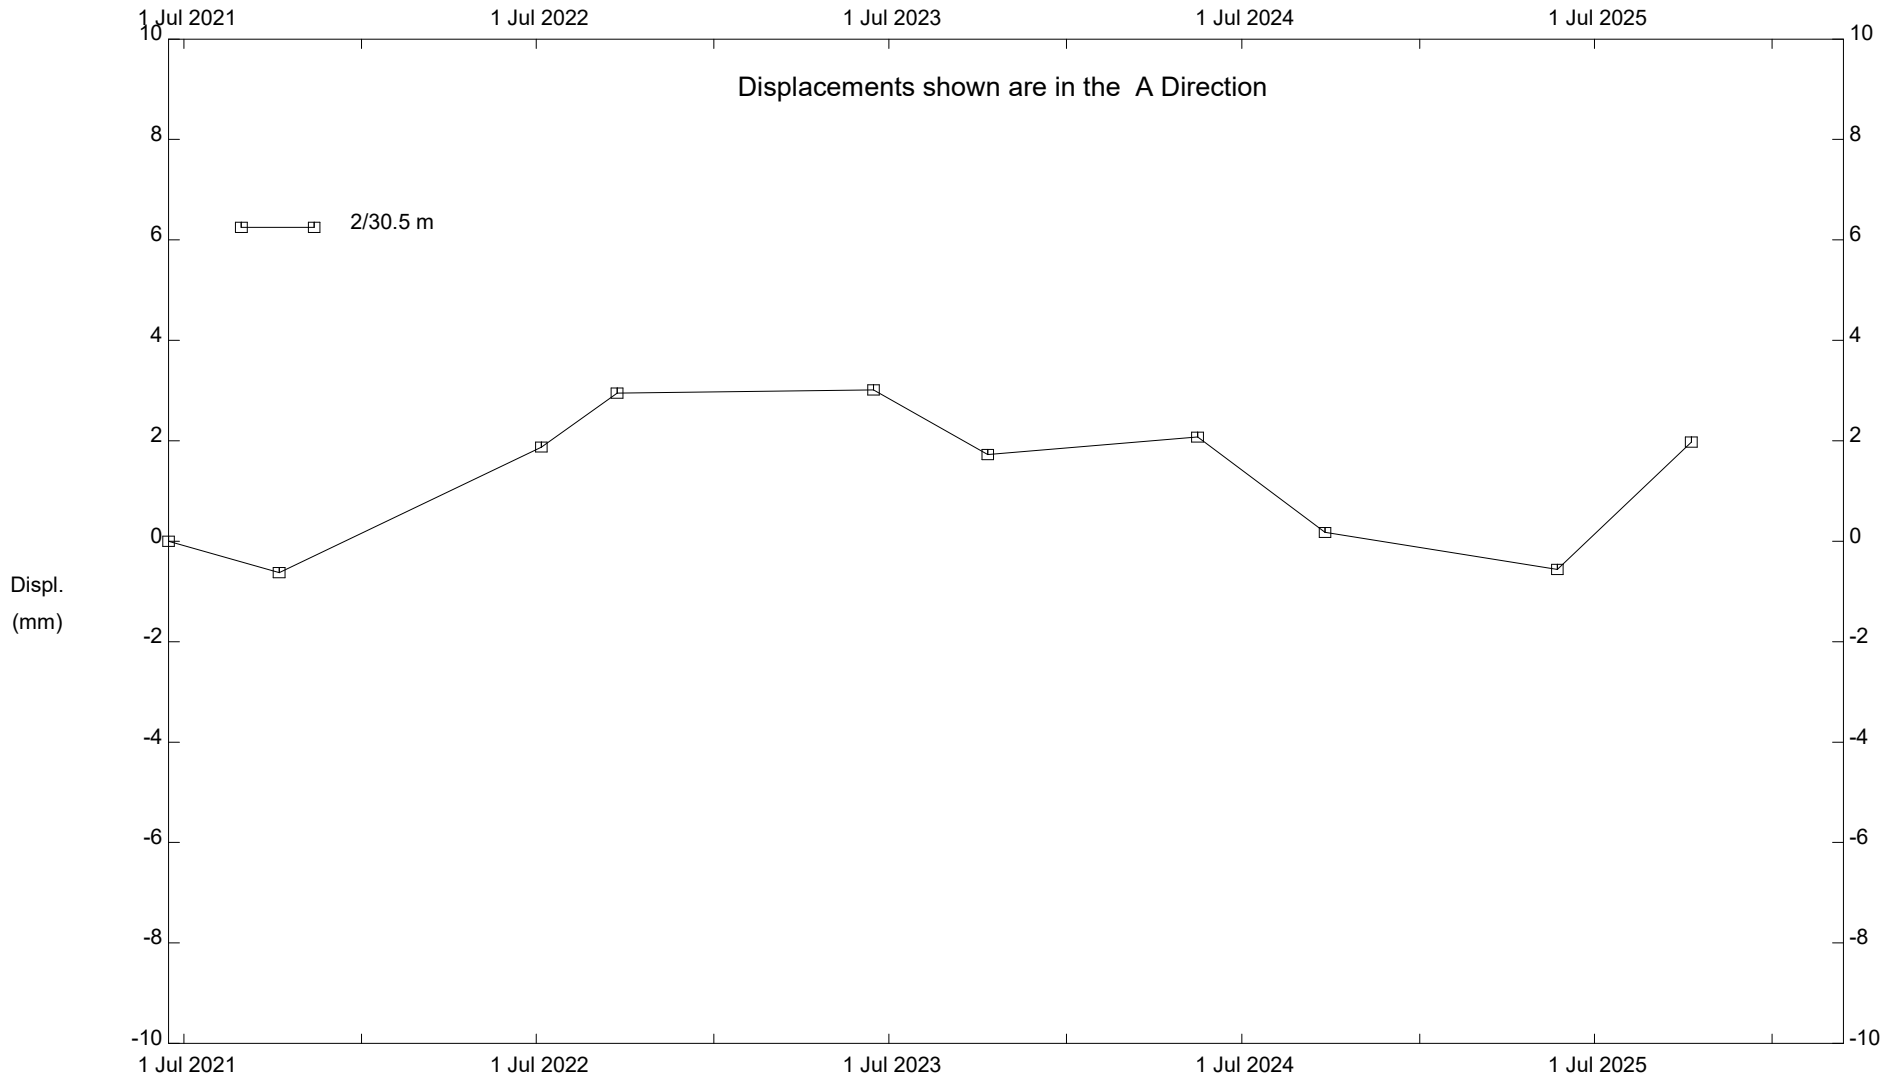
S004; H02:08, Willow Creek, Inclinator SI-1A  
 Alberta Transportation

- SI-1A is “wavy” with kinks at approximately 22 m, 28 m, 30 m and 36 m below the ground surface.
- SI-5A is tilted approximately 1.0 m in the A-direction and 1.7 m in the B-direction, and there is also a kink in the casing at approximately 22 m below the ground surface.
- SI-9A is “wavy” with kinks at approximately 5 m, 11 m, and 25 m below the ground surface.
- SI-10A is “wavy” with kinks at approximately 6 m and 25 m below the ground surface.

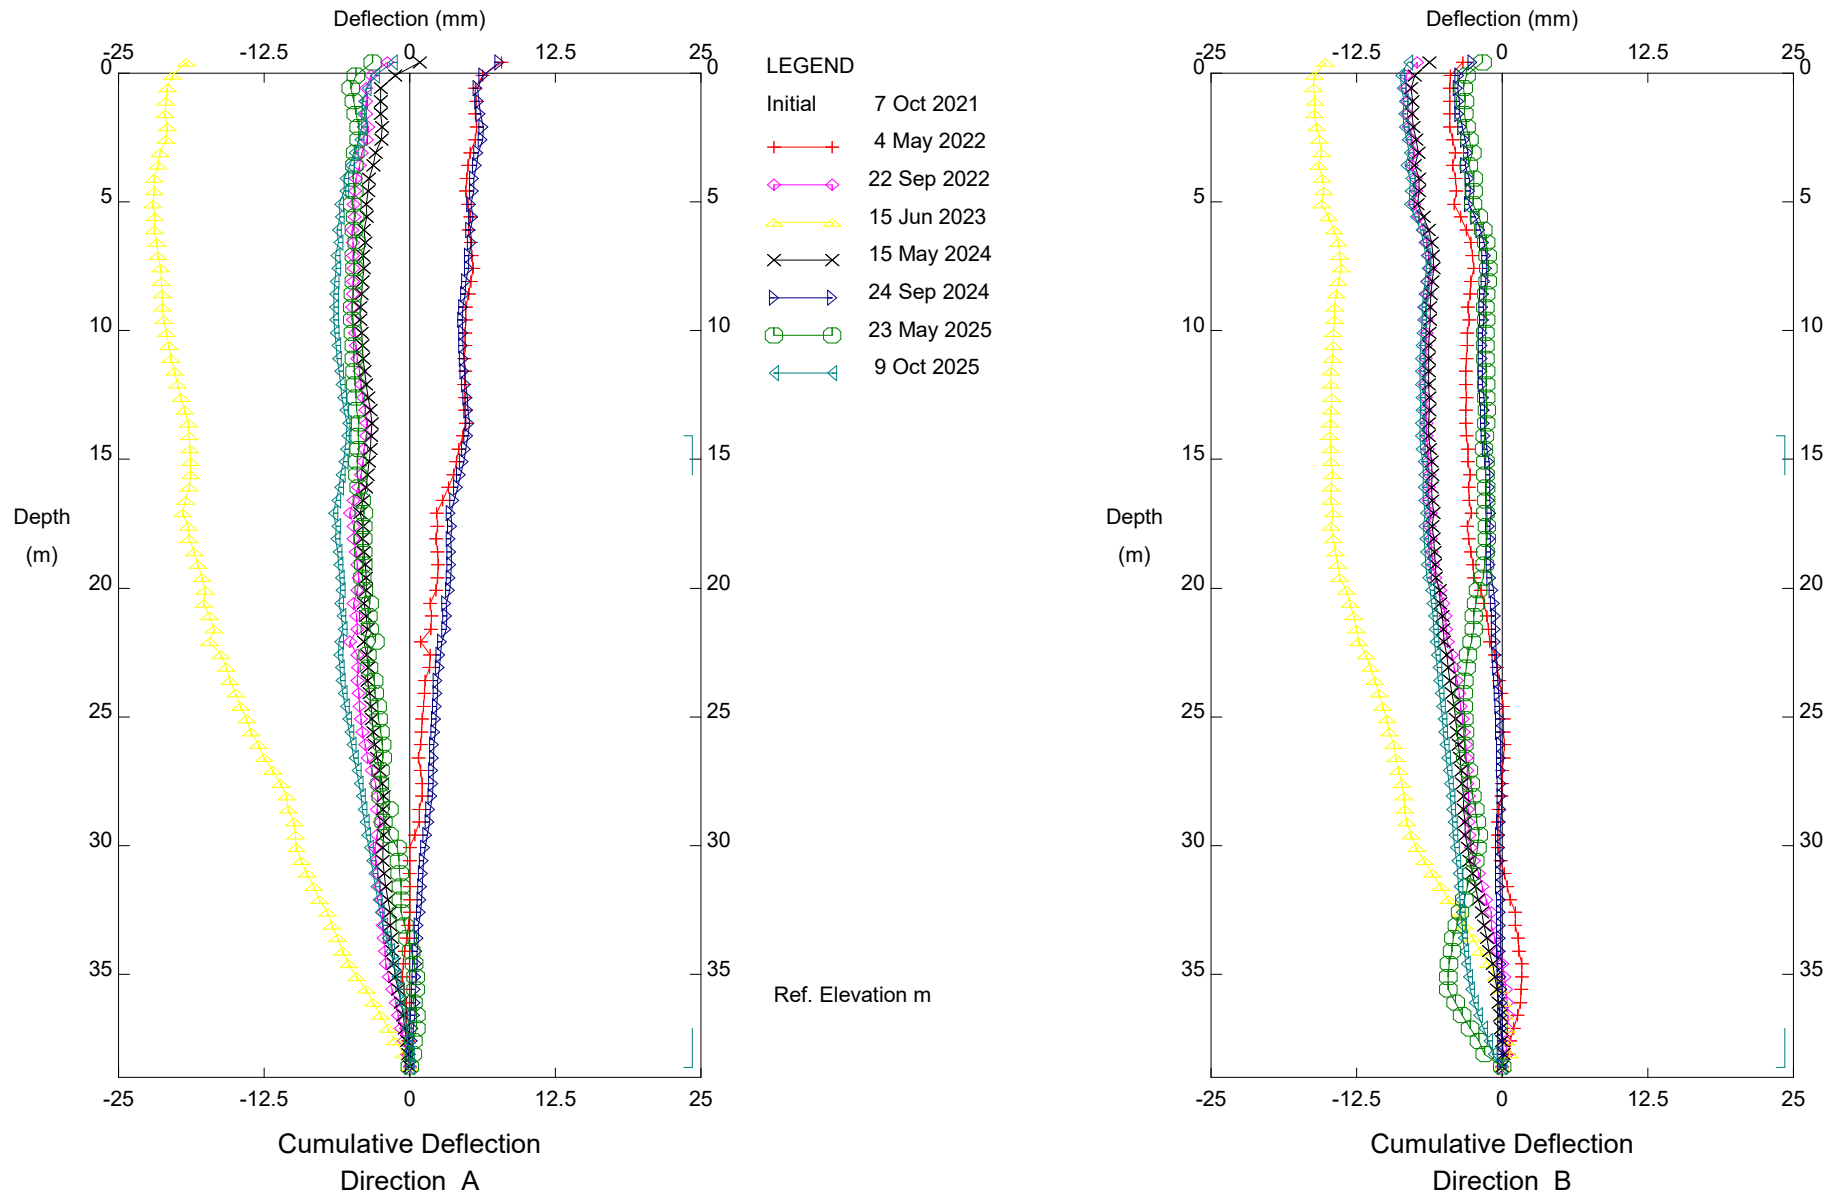
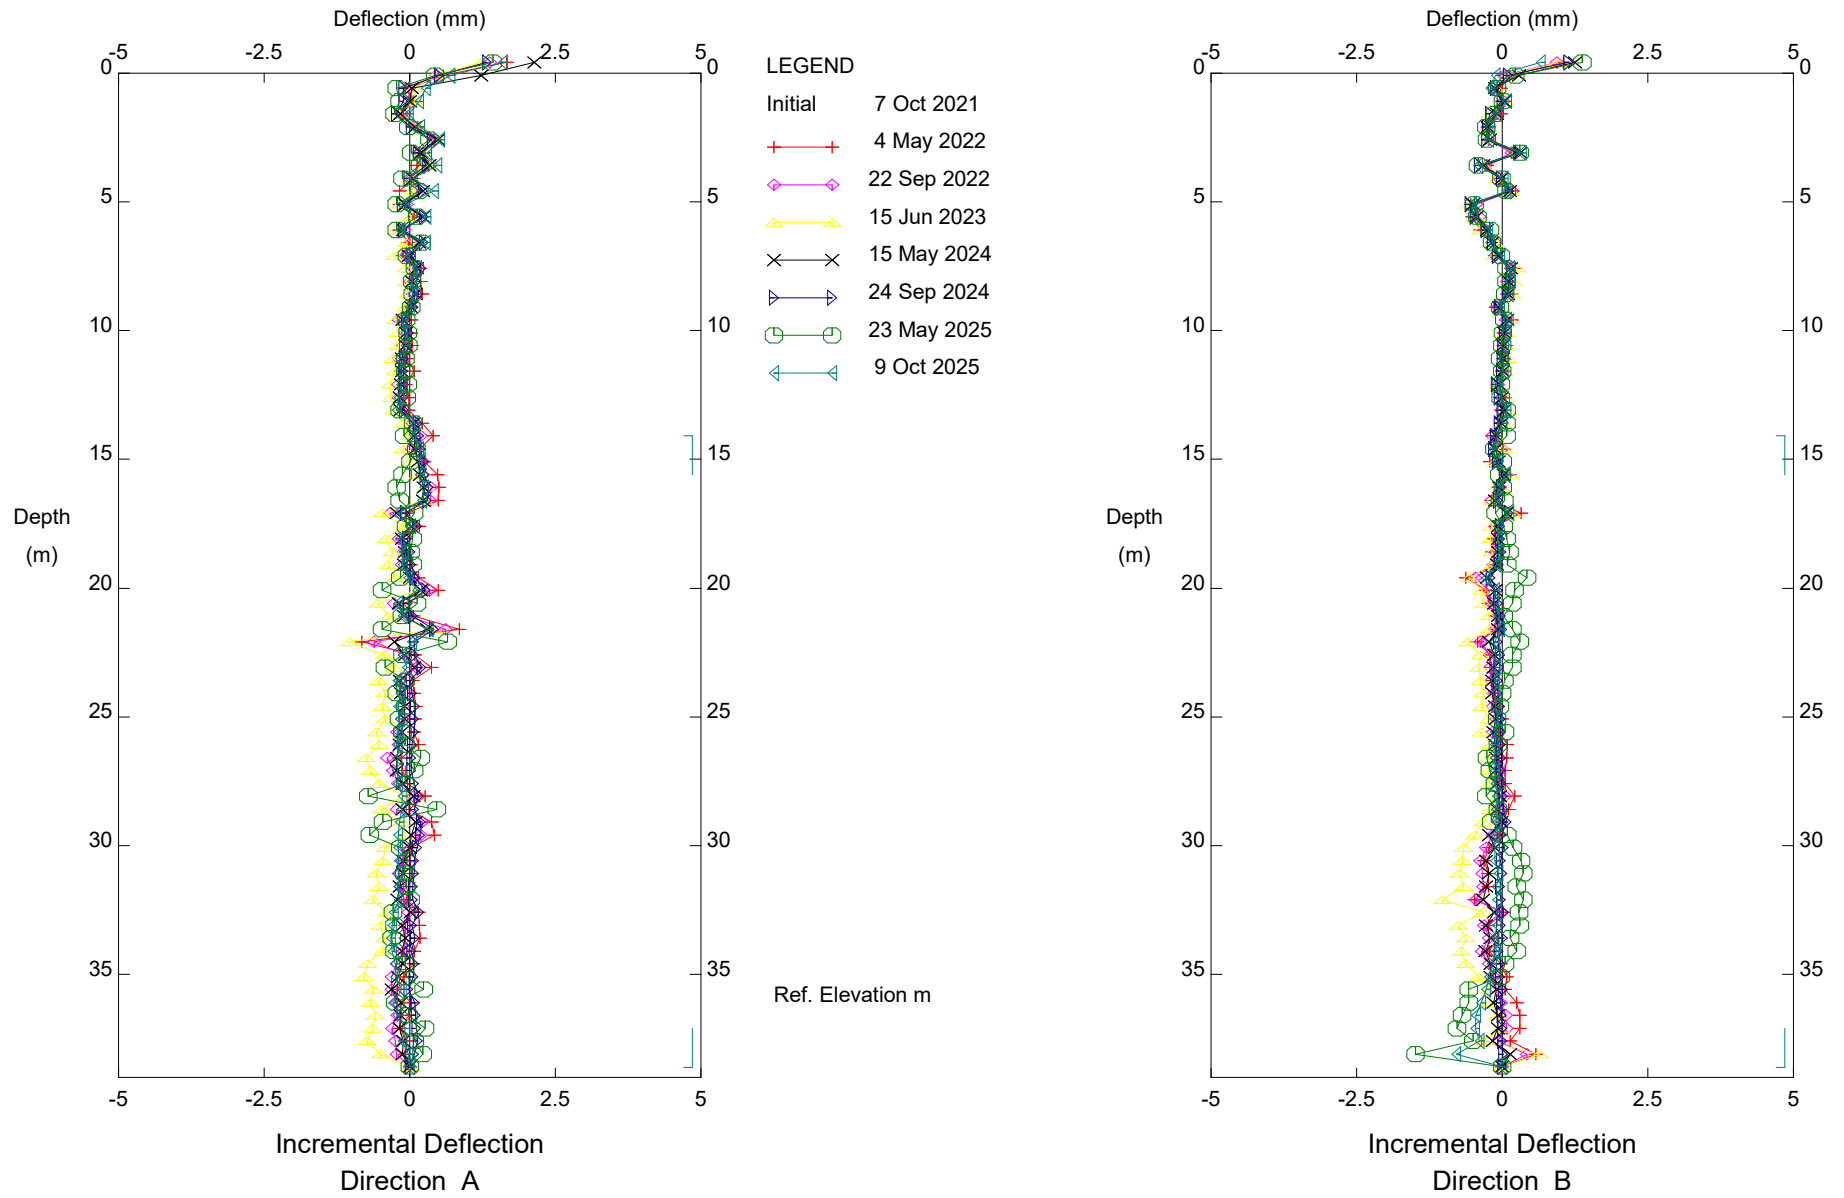
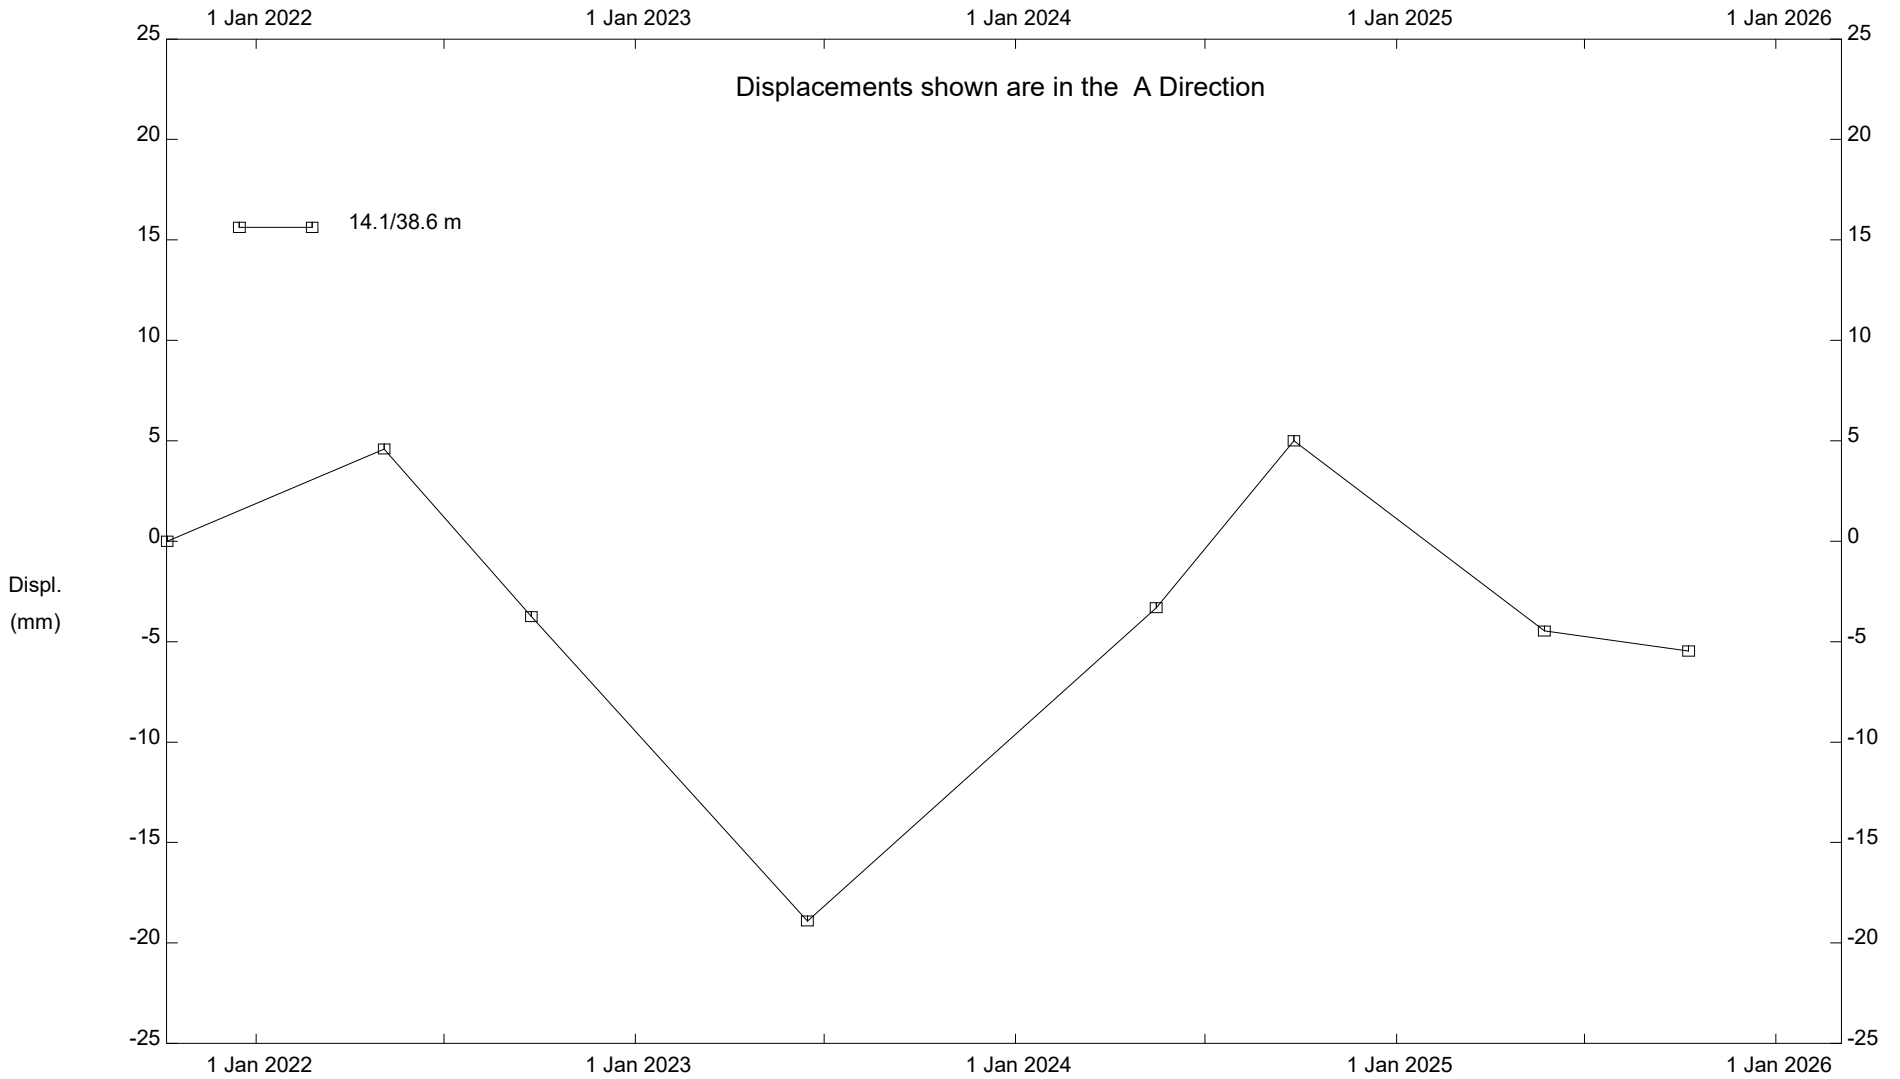
S004; H02:08, Willow Creek, Inclinator SI-5A  
 Alberta Transportation

The SI data plots presented herein include readings from both our new and old SI reading equipment. However, SI-5A was reinitialized to October 7, 2021, to improve movement interpretations, as previous readings were very noisy. No data for the SIs were available between 1994 and 2020. Data collected in the future should be reviewed to assess whether the instruments need to be re-initialized or to monitor movement trends.
