November 26, 2025

Alberta Transportation and Economic Corridors  
2<sup>nd</sup> Floor, 803 Manning Road N.E.  
Calgary, Alberta  
T2E 7M8

**CON0022161 Southern Region GRMP Instrumentation Monitoring**  
**Site S004; H02:08, km 6.284 Willow Creek**  
**Section C – 2025 Fall Readings**

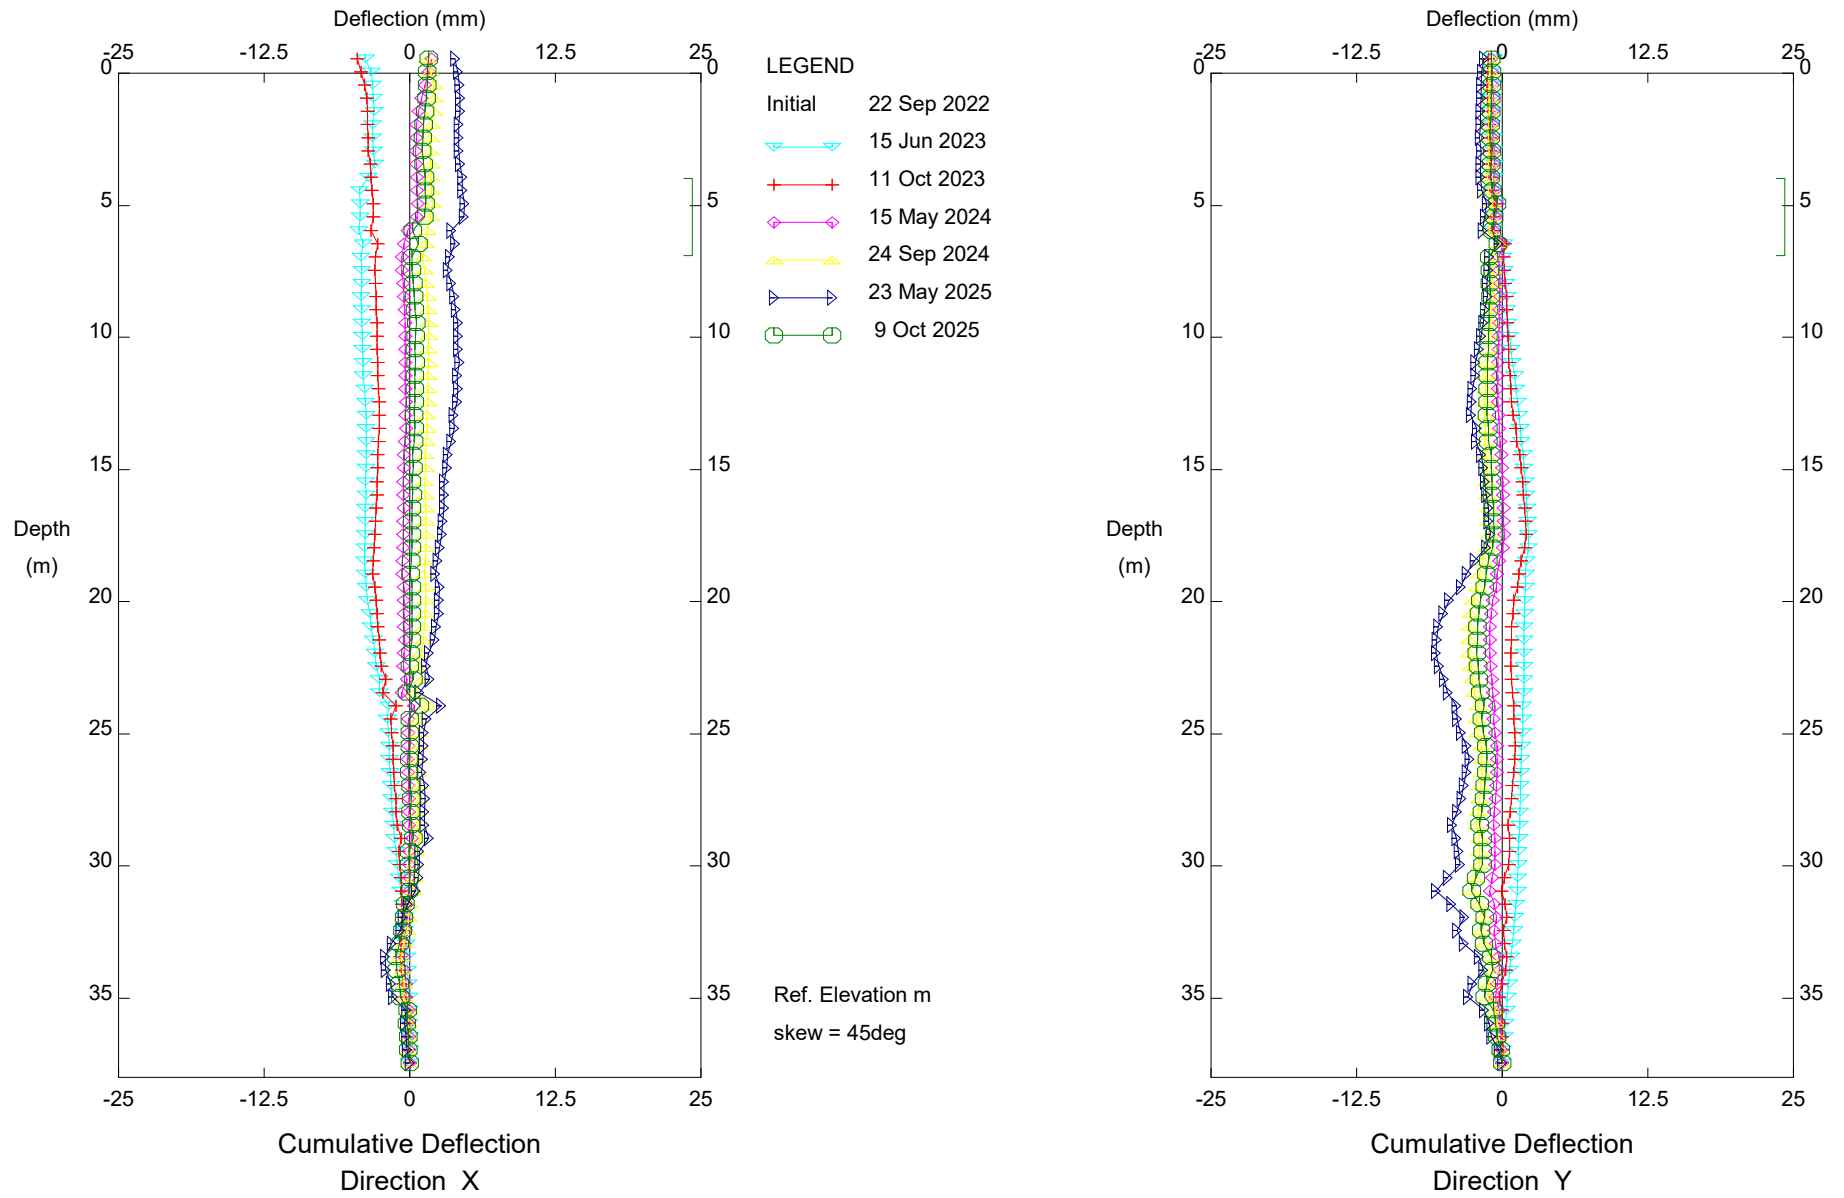
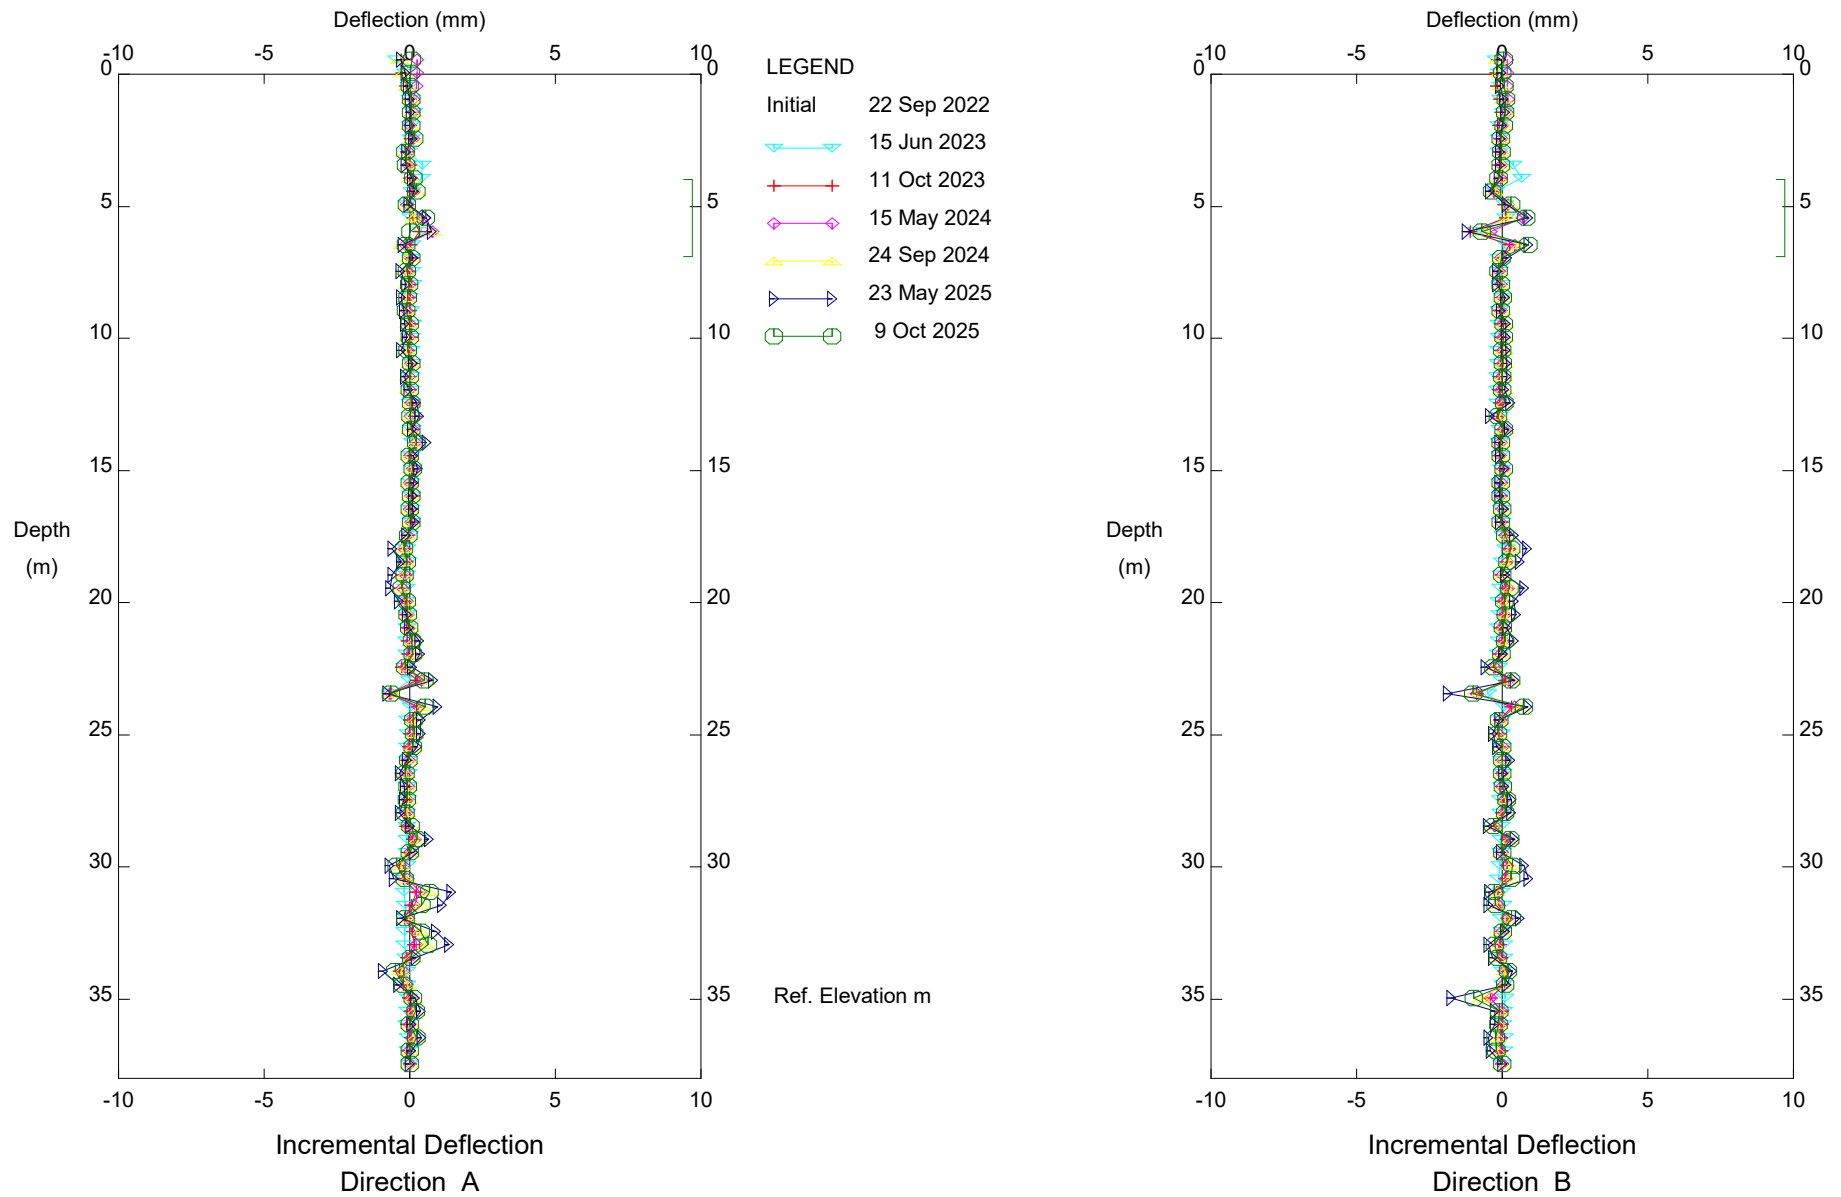
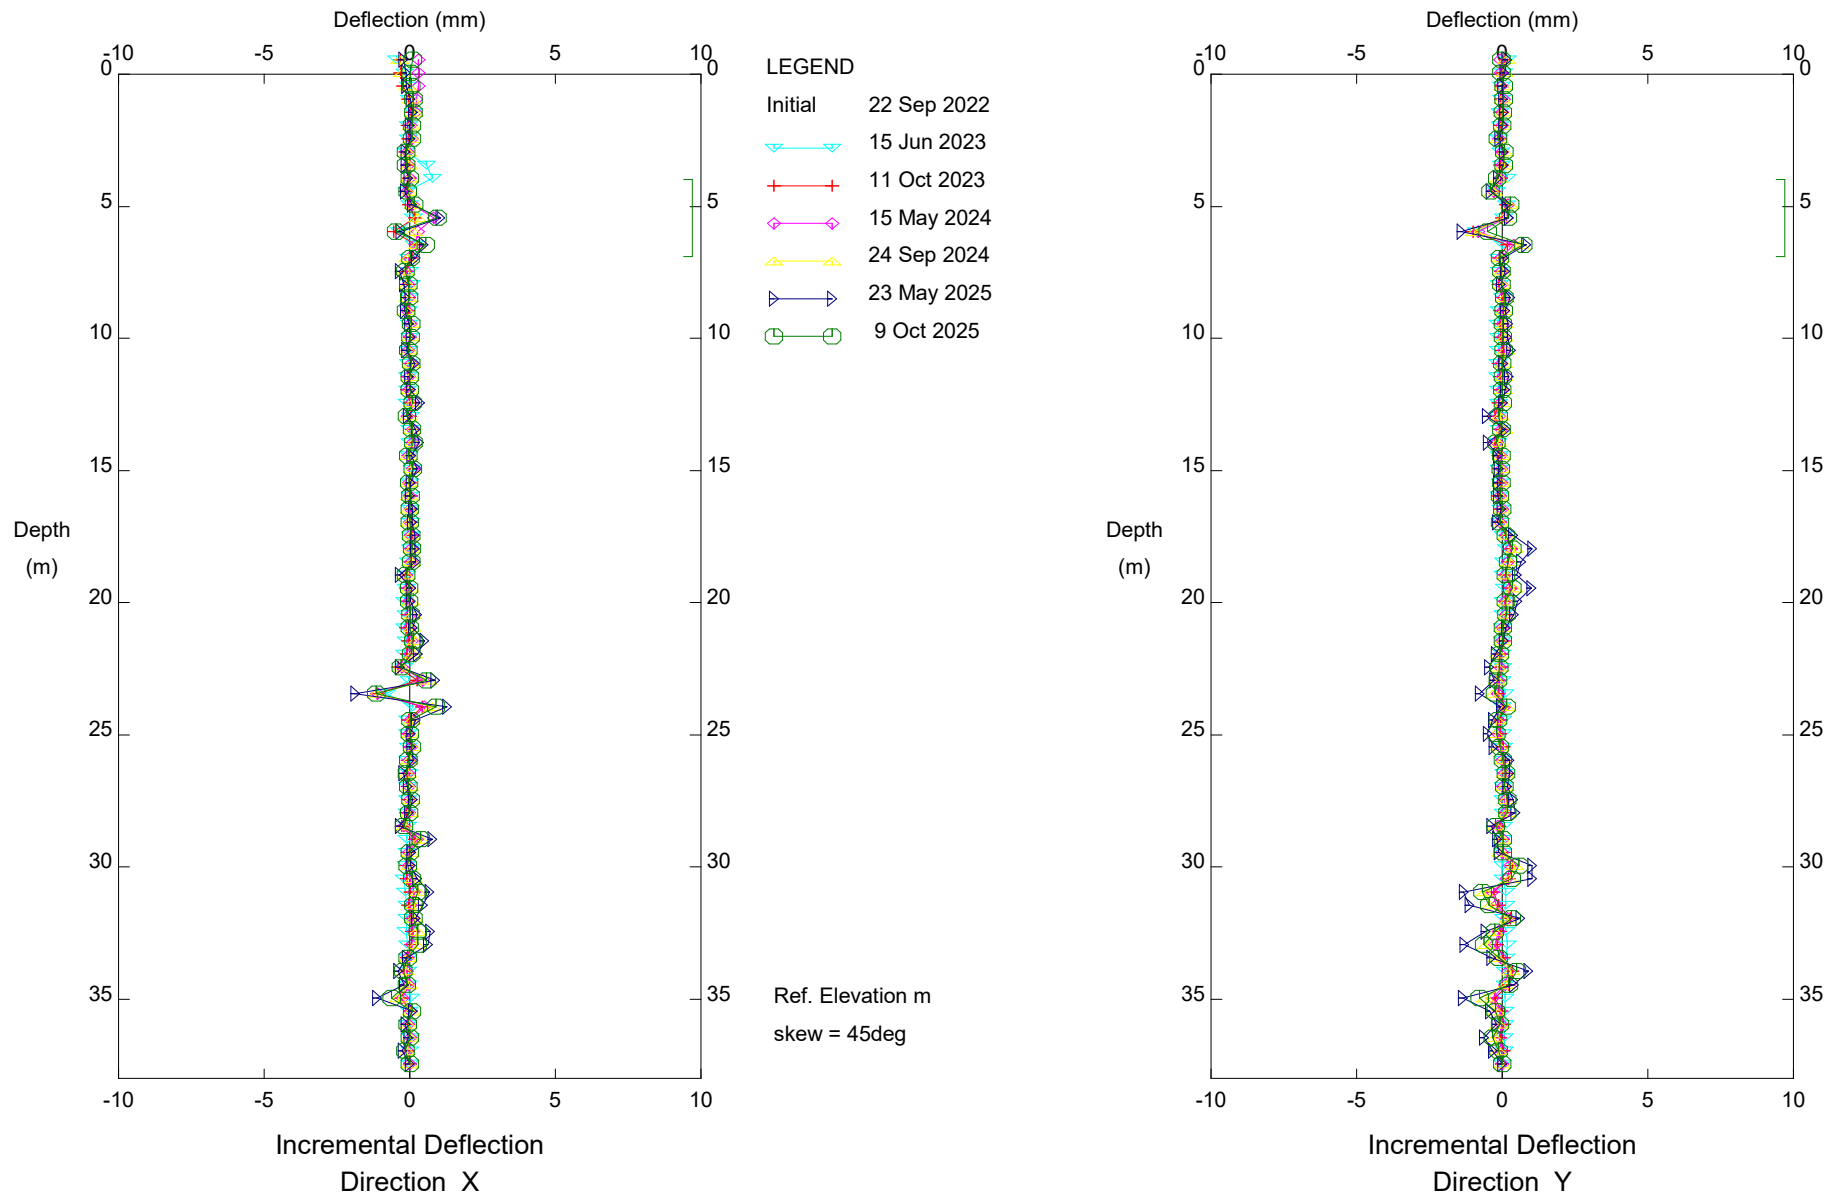
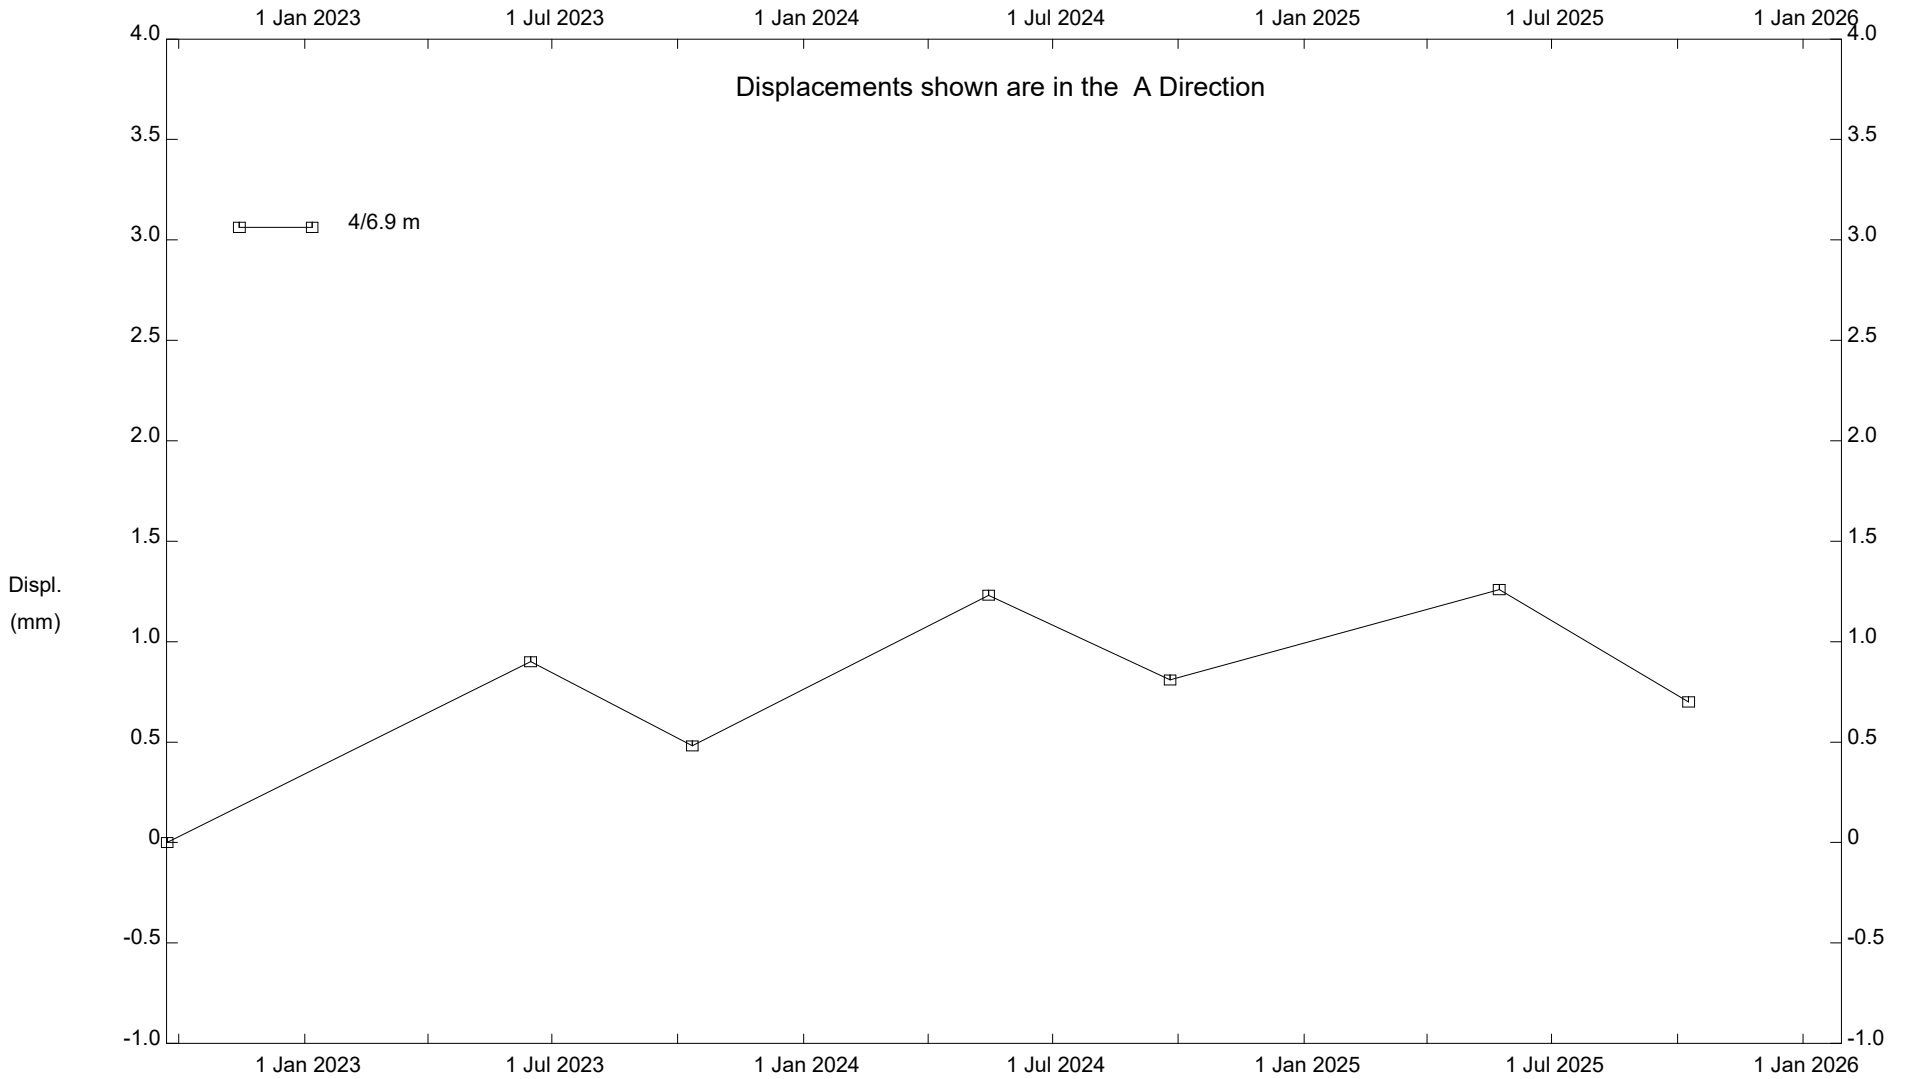
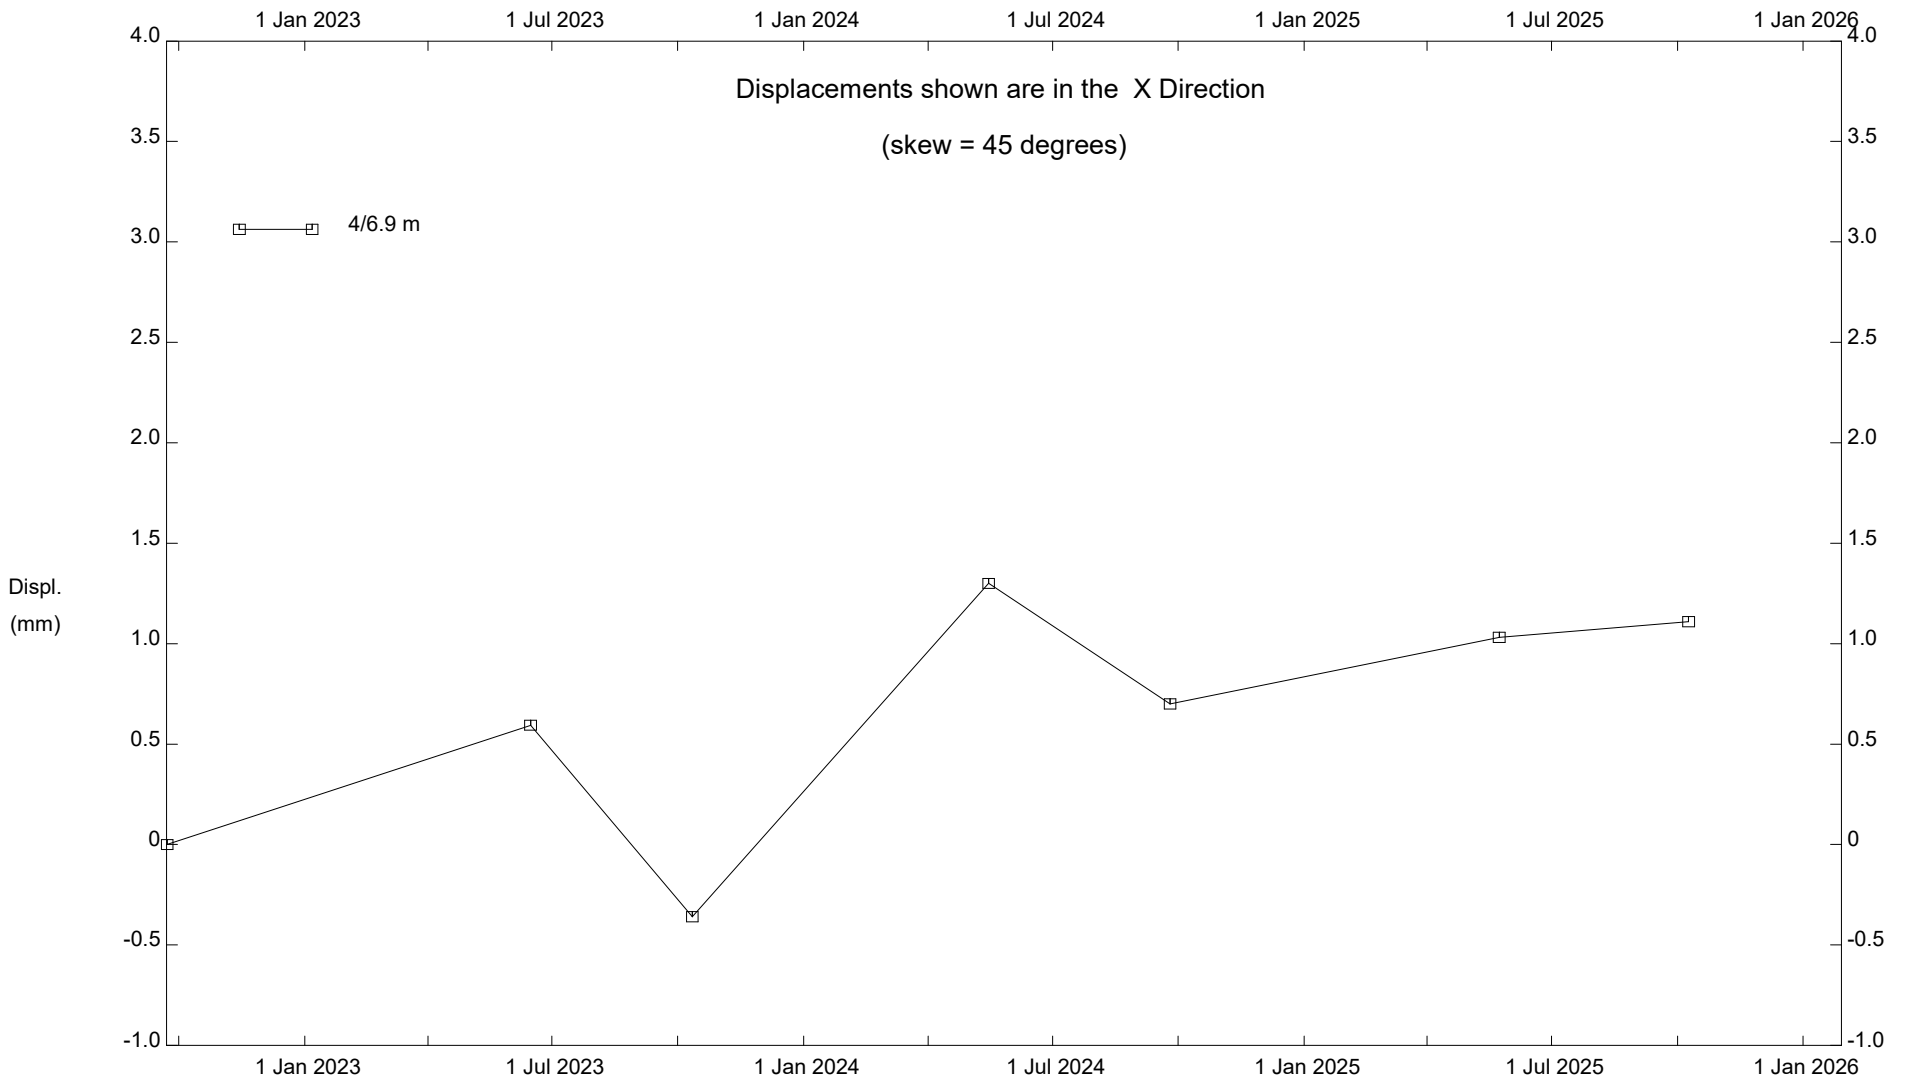
Alberta Southern Region, Inclinator S04 SI-10A

Since these SIs are located outside the slide mass, such stability is not unexpected. Since KCB re-initialized the readings in September 2020 baseline—coinciding with changes to the SI equipment—no apparent movement has been observed in SI-5A, and SI-9A. However, readings at SI-10A, including for fall 2025, suggests a possible shear plane about 6 meters below the ground surface, which could be another slow failure retrogression near the prairie elevation, or a kinked casing. Additional information is still needed to evaluate the movement trends of this instrument.

- SI-1A is “wavy” with kinks at approximately 22 m, 28 m, 30 m and 36 m below the ground surface.
- SI-5A is tilted approximately 1.0 m in the A-direction and 1.7 m in the B-direction, and there is also a kink in the casing at approximately 22 m below the ground surface.
- SI-9A is “wavy” with kinks at approximately 5 m, 11 m, and 25 m below the ground surface.
- SI-10A is “wavy” with kinks at approximately 6 m and 25 m below the ground surface.

SI-10A	1994 (Sep. 22, 2022) <sup>4</sup>	May 15, 2024	May 23, 2025	October 9, 2025	971.0	4 m – 6 m	X-Direction 45°	N/A	N/A	1.1	0.1	1.1	-2.9	0.2	-0.3

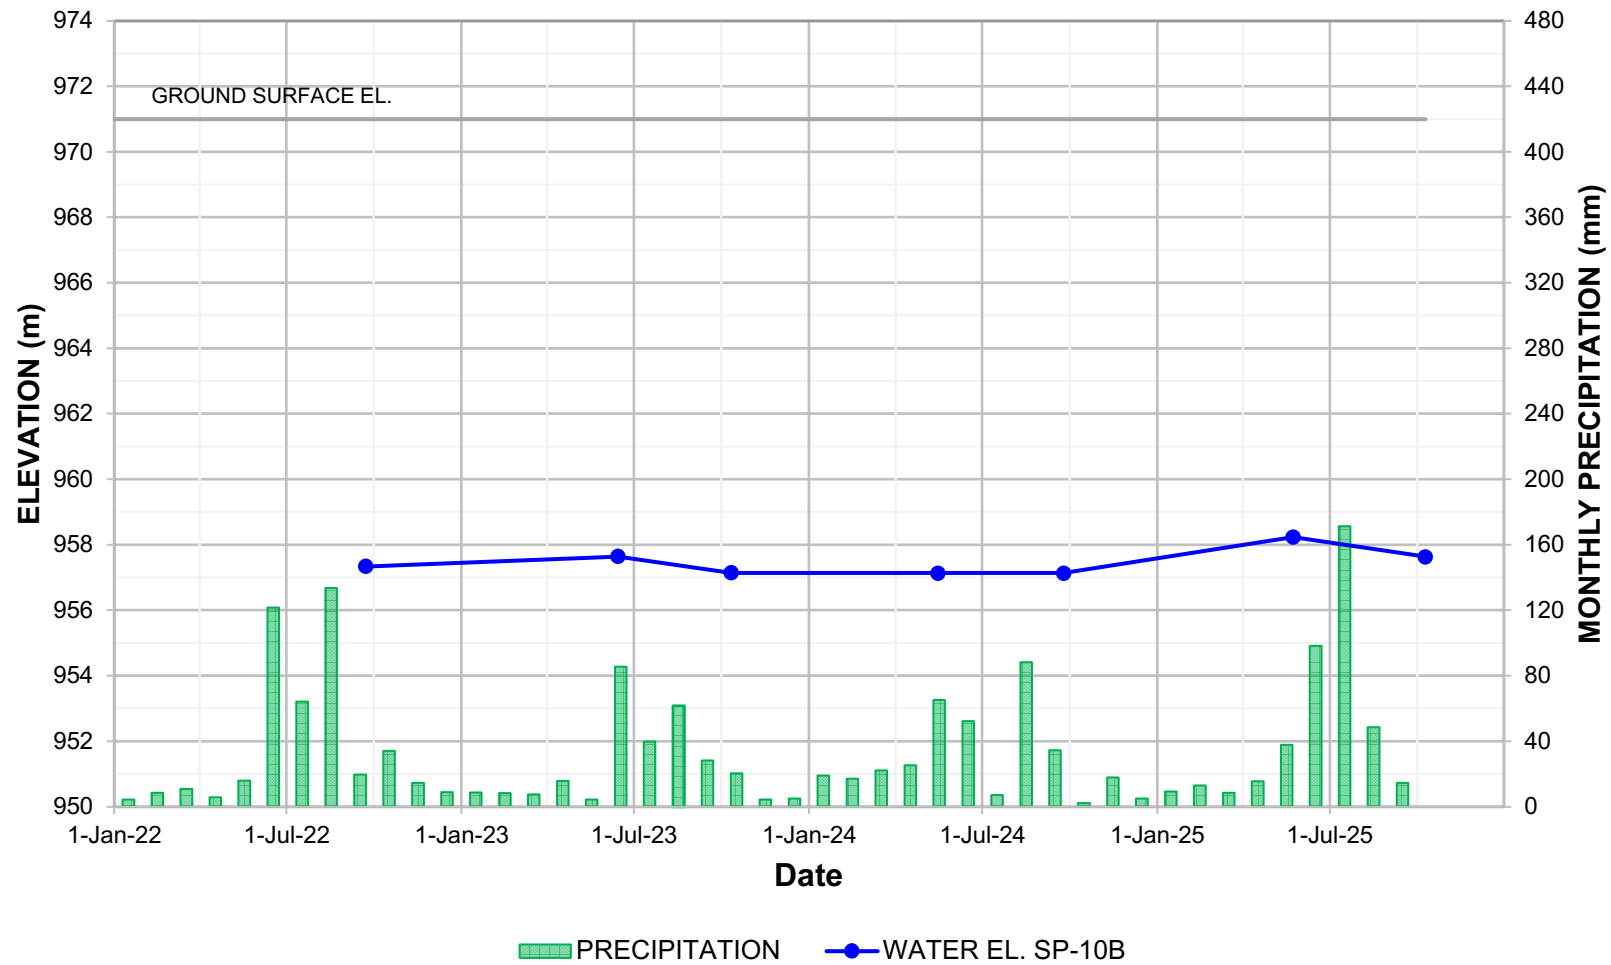
## SP-10B

Since KCB began reading the SP in 2020, water levels have fluctuated slightly in most piezometers by  $\pm 40$  cm. The fall 2025 SP readings show a drop in water level between 20 cm and 60 cm, except for SP-1C, which shows a 40 cm increase. The highest increase of 1.1 m was recorded in the Spring of 2025 on SP-10B, and the most significant drop of 1.2 m was recorded in the fall of 2023 at SP-1C. Overall, the SP data shows consistent fluctuations between recharge and discharge periods. This cycle appears to be yearly, with an increase in water level occurring in the fall and spring of subsequent years, followed by a lower water level in the next fall and spring. The data trend in the piezometers should be reviewed during wet years to assess the impact of increased precipitation.

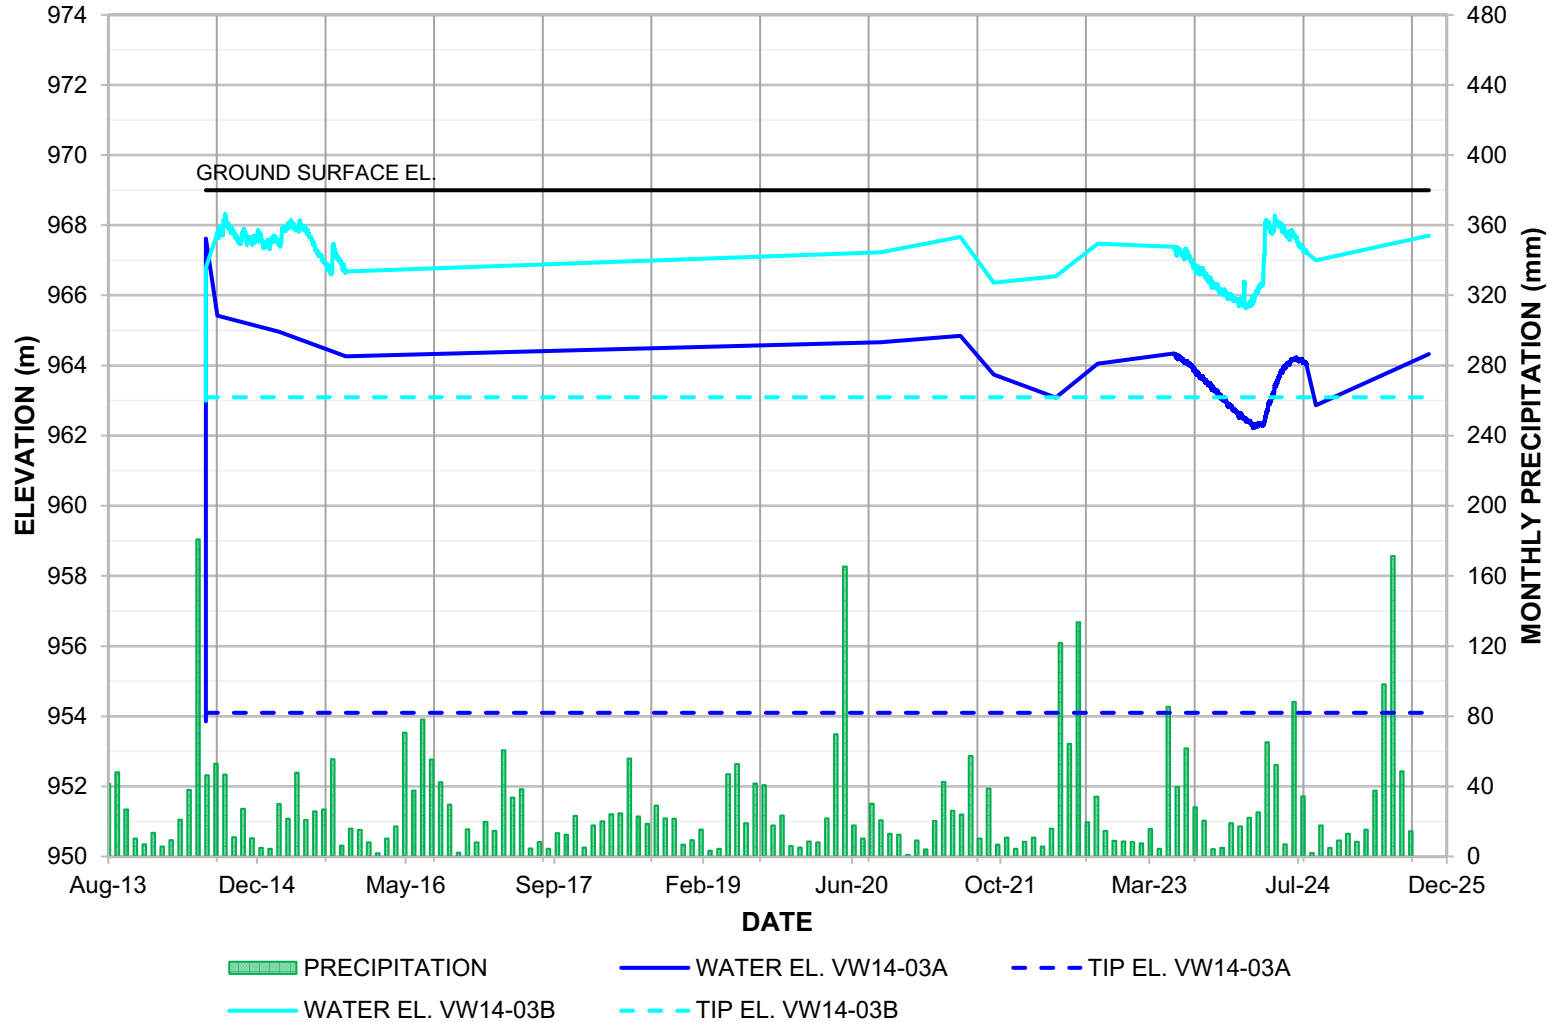
## VW14-03A AND VW-03B

Water levels recorded in the nested VWP's installed in the median ditch of Hwy 02:08 (VW14-03A/B) were at approximate depths of 1.3 m and 4.7 m below ground surface in the upper "B" tip and the lower "A" tip, respectively, as of the most recent readings.

The dataloggers VW14-01 and VW14-03 have a flash-mount installation and exhibit signs of internal water damage that impacted the battery. Battery problems at BH14-01A have disrupted data collection from fall 2024 to spring 2025. Similarly, at BH14-03, readings have been missing since fall 2024 due to a datalogger battery issue. The batteries for VW14-01 and VW14-03, which were replaced during spring 2025, were found dead in fall 2025. Another battery replacement was performed during the fall 2025 readings, and the daily reading was taken. The loggers have been placed in a new, sealed bag to ensure waterproof protection. If the water problem with the dataloggers persists, we recommend installing them above ground using an anchored post.
