SITE NUMBER AND NAME: S004 Willow Creek (North of Fort Macleod)	HIGHWAY & KM: 2:08, 6.284	PREVIOUS INSPECTION DATE: May 29, 2024	INSPECTION DATE: May 28, 2025
LEGAL DESCRIPTION: 13/14-20-09-26-W4M	NAD 83 COORDINATES: UTM Northing Easting 12 5514351 320169	RISK ASSESSMENT: PF: 9 CF: 4 TOTAL: 36	
Average Annual Daily Traffic (AADT): 5000 (north) & 5720 (south) (Reference No. 92080)		CONTRACTOR MAINTENANCE AREA (CMA): 522

SOUTHERN REGION GEOHAZARD RISK MANAGEMENT PROGRAM

Site Plan
S004 - Willow Creek (North of Ft. Macleod)
Hwy 2:08, km 6.284

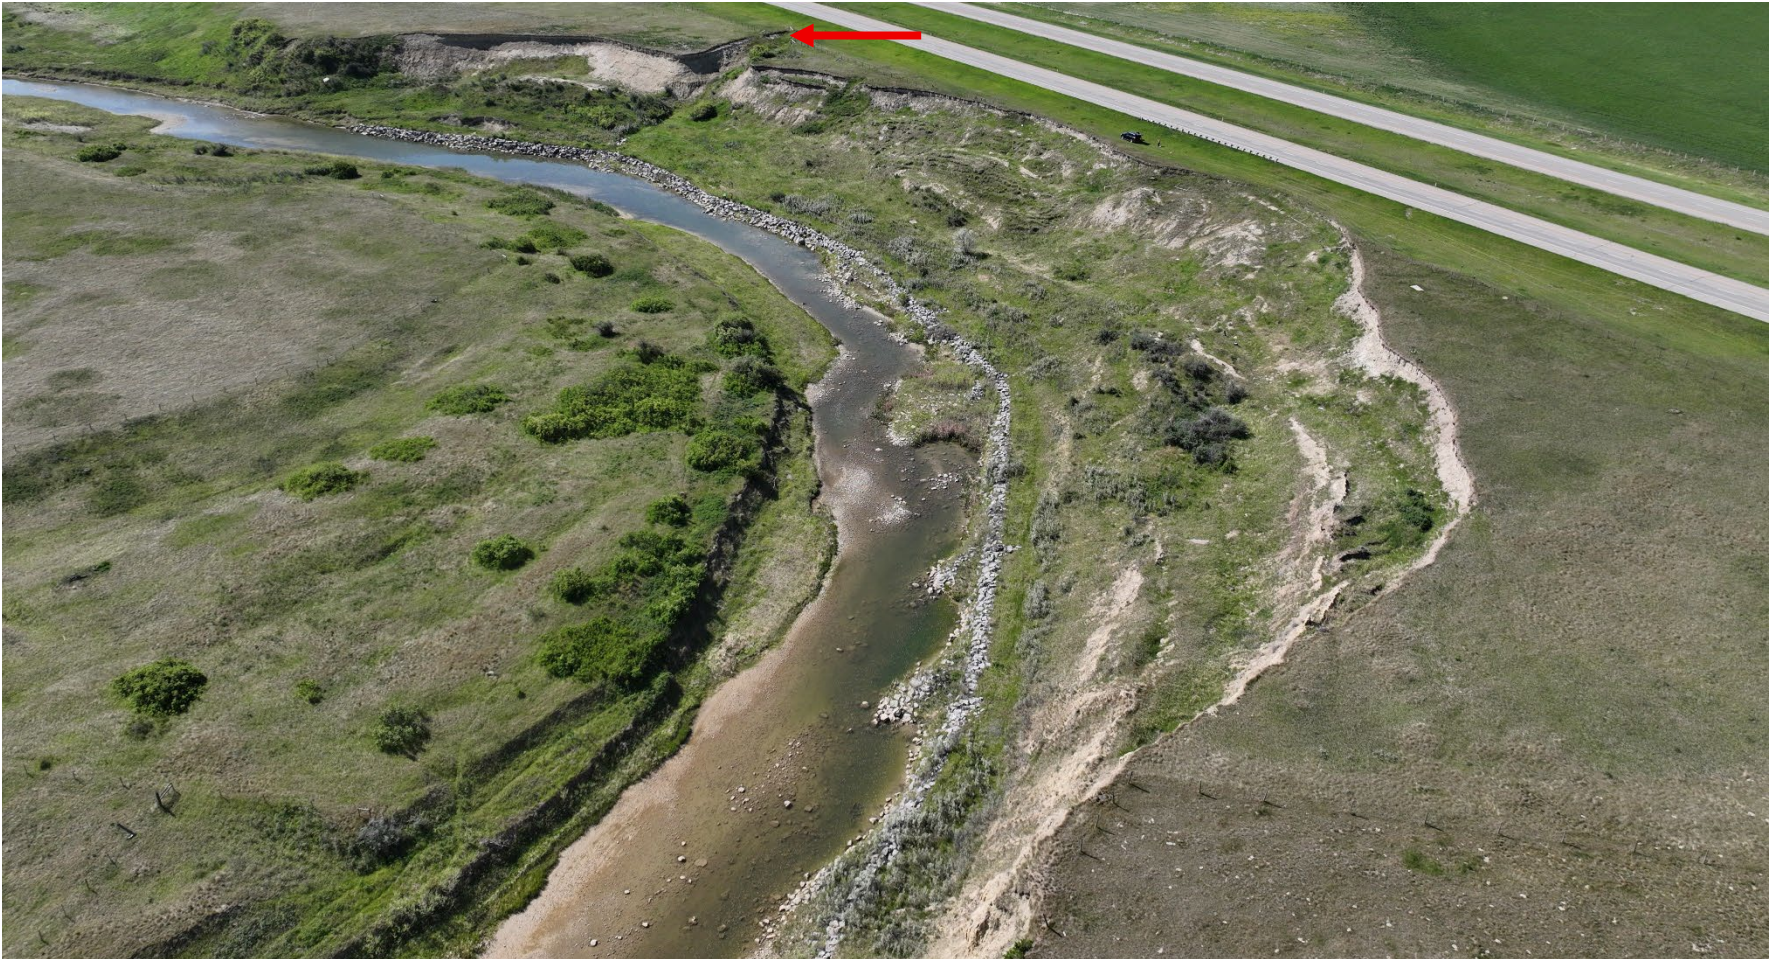
- In general, the site is well vegetated (Photos 1 through 6). However, bare patches of soil were observed near the top of the slide zone where the slope is steep (Photos 2, 3 and 4).

- The creek armouring completed in 2008 is in good condition (Photos 1 through 4, and 7). However, continued slope movement is displacing the armouring eastward across creek, straightening a former curved zone of creek bank. The riprap is exposed due to low water levels and needs maintenance to the vanes.

Photo 1 Aerial photo of the S004 site showing the slide extents, riprap armouring along the west shoreline of Willow Creek, and culvert outlet location (indicated by red arrow). Photo taken May 28, 2025, facing southwest.

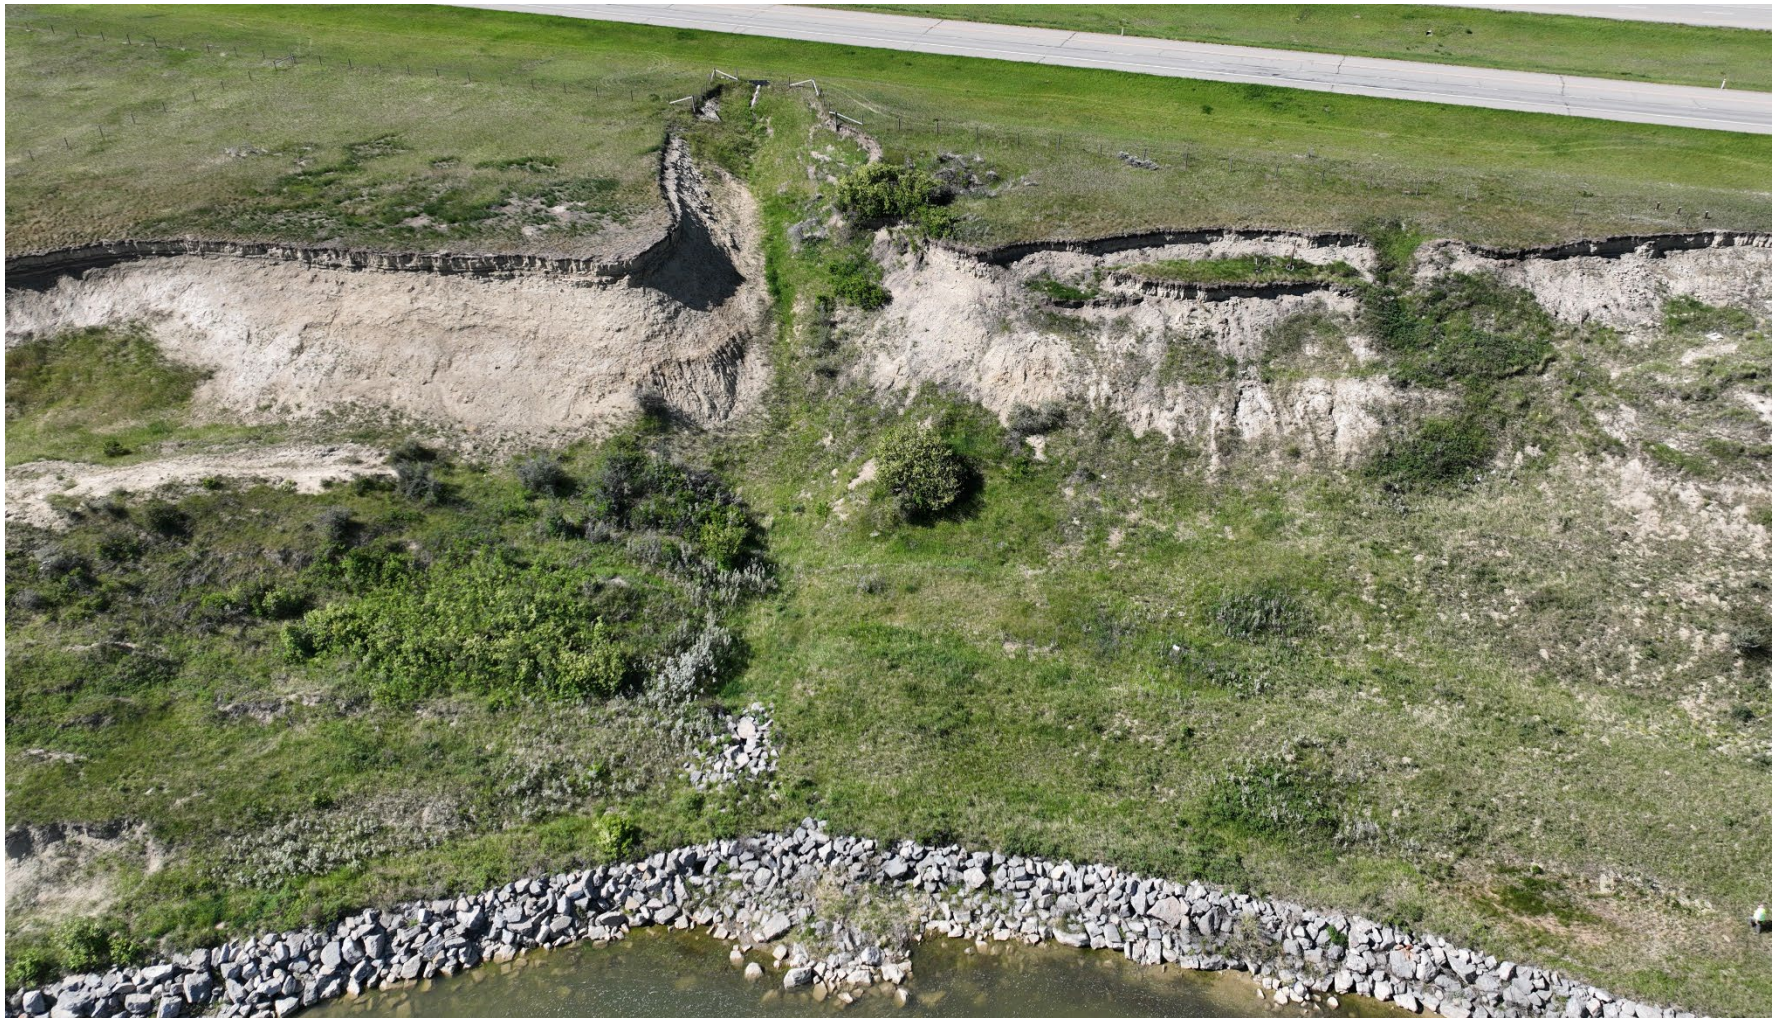
Photo 2 **Aerial photo of the site showing the culvert outlet, natural draw, steep poorly vegetated slopes, and riprap armouring along the west shoreline of Willow Creek. Photo taken May 28, 2025, facing west-southwest.**

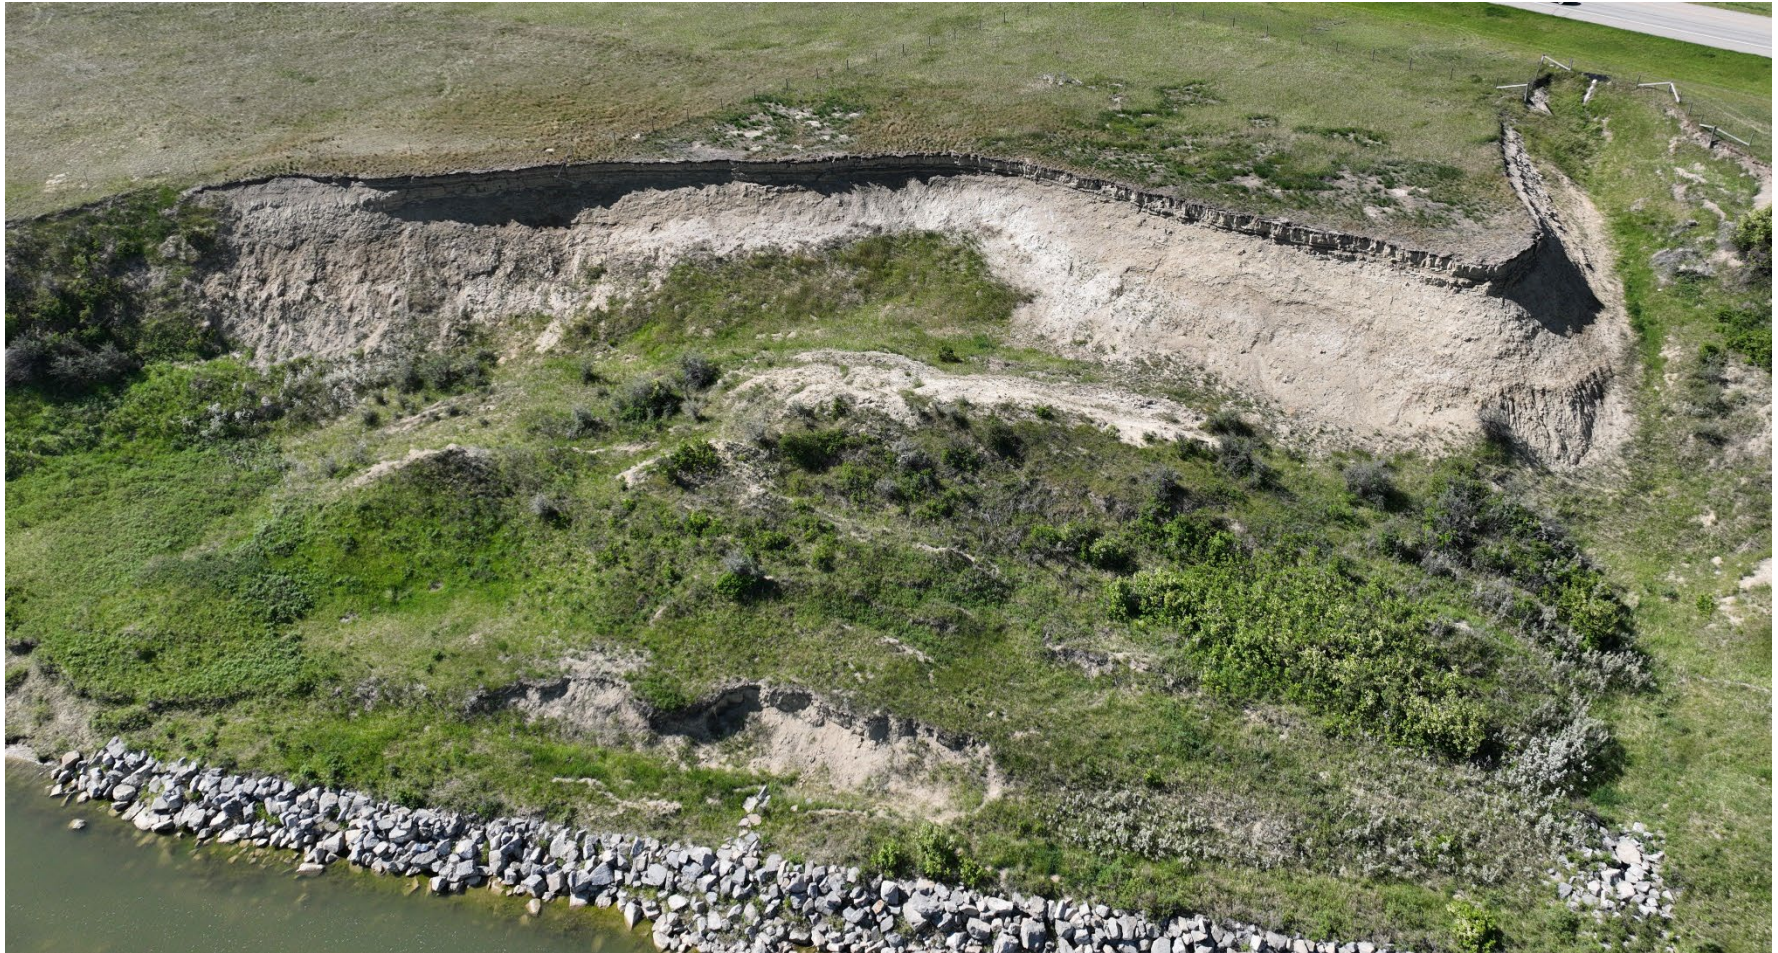
Photo 3 Aerial photo of the south extent of the site showing the steep unvegetated slope, culvert outlet, natural draw, and armoured shoreline. Photo taken May 28, 2025, facing southwest.

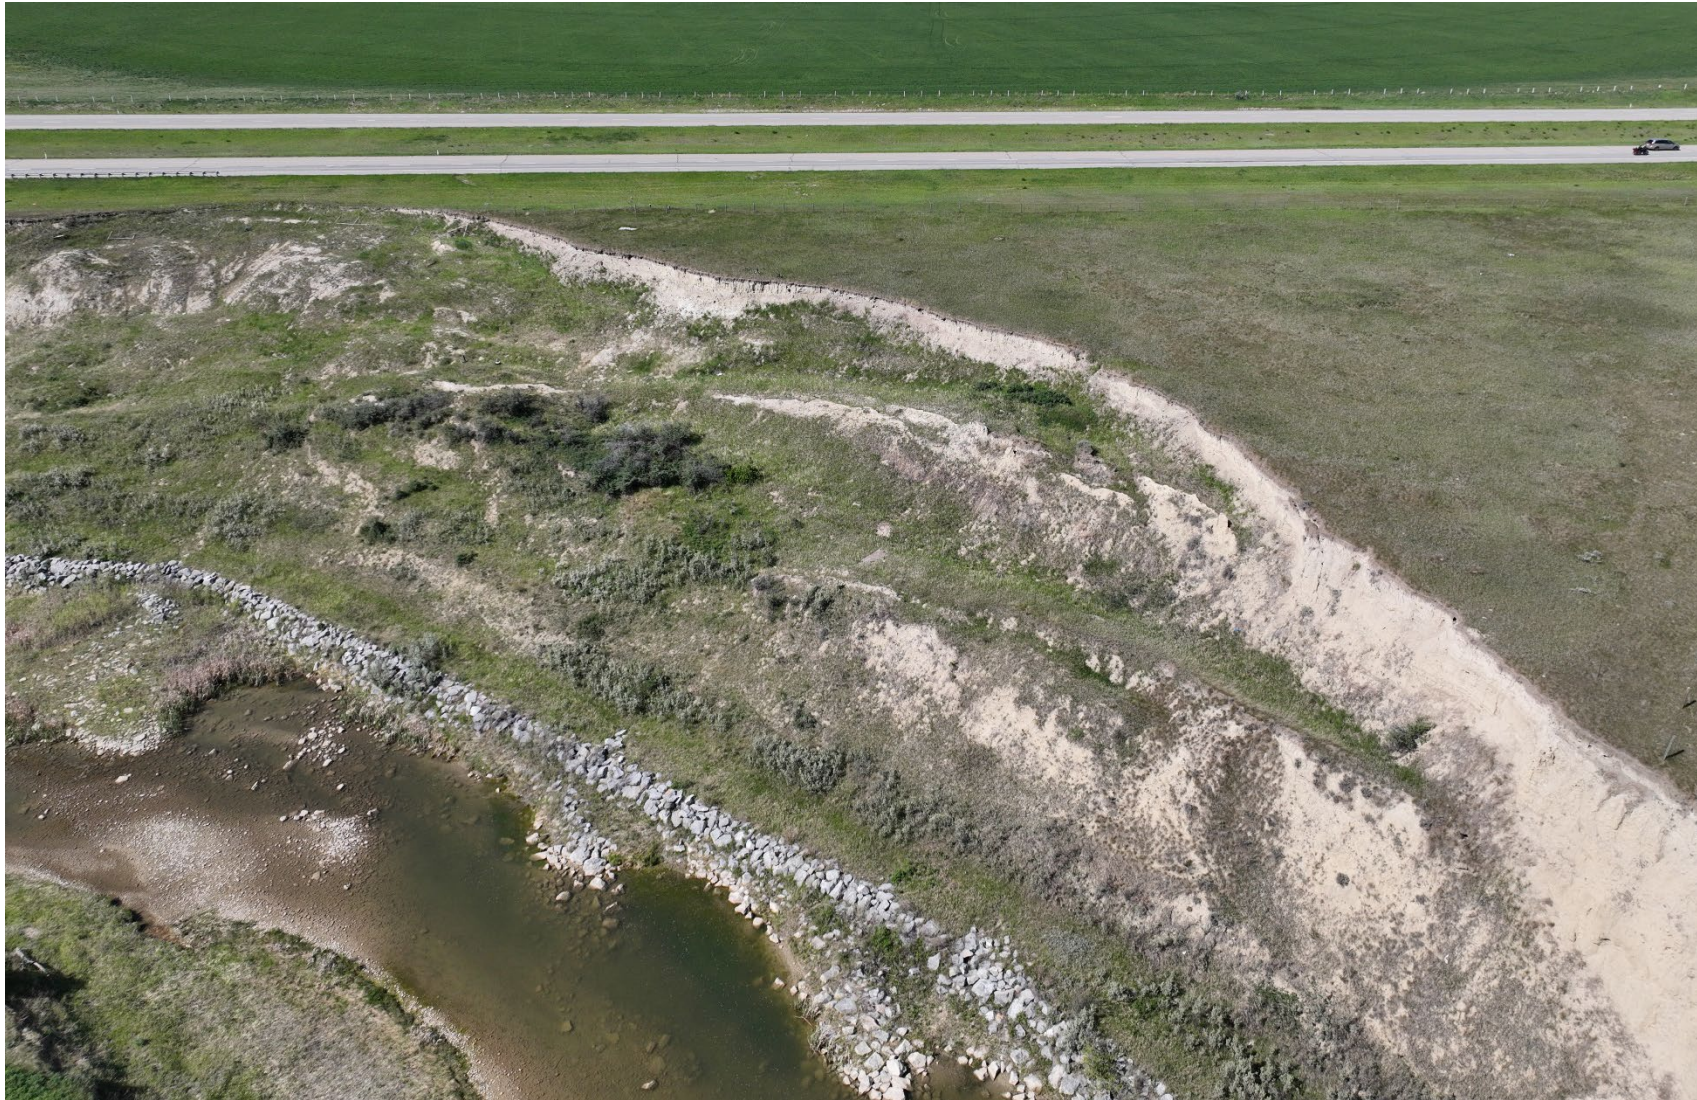
Photo 4 Aerial photo of the north extent of the site showing the steep unvegetated slope, natural draw, and armoured shoreline. Photo taken May 28, 2025, facing southwest.

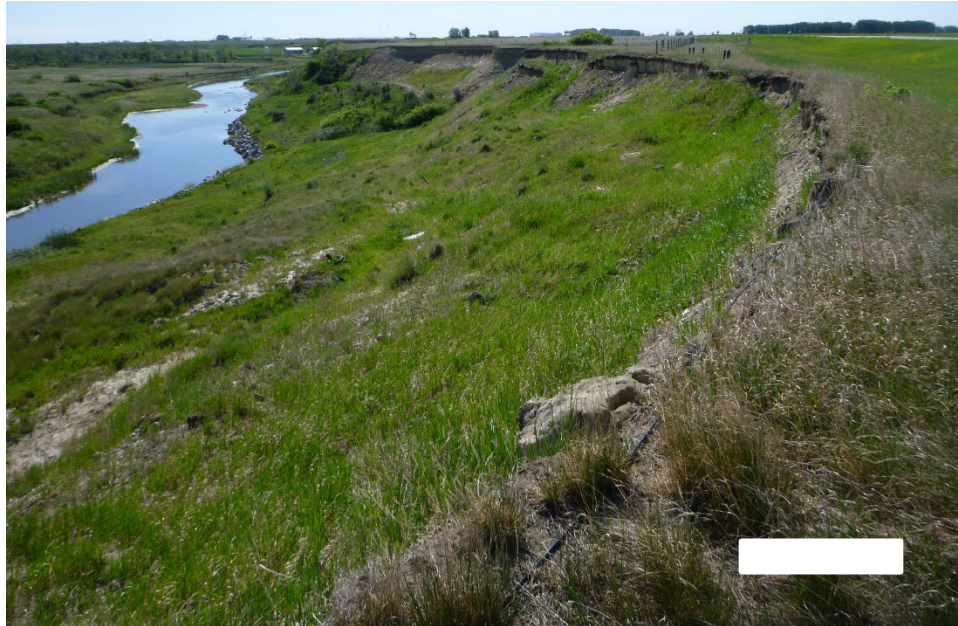
Photo 5 North extent of the slide. Photo taken May 28, 2025, facing south.

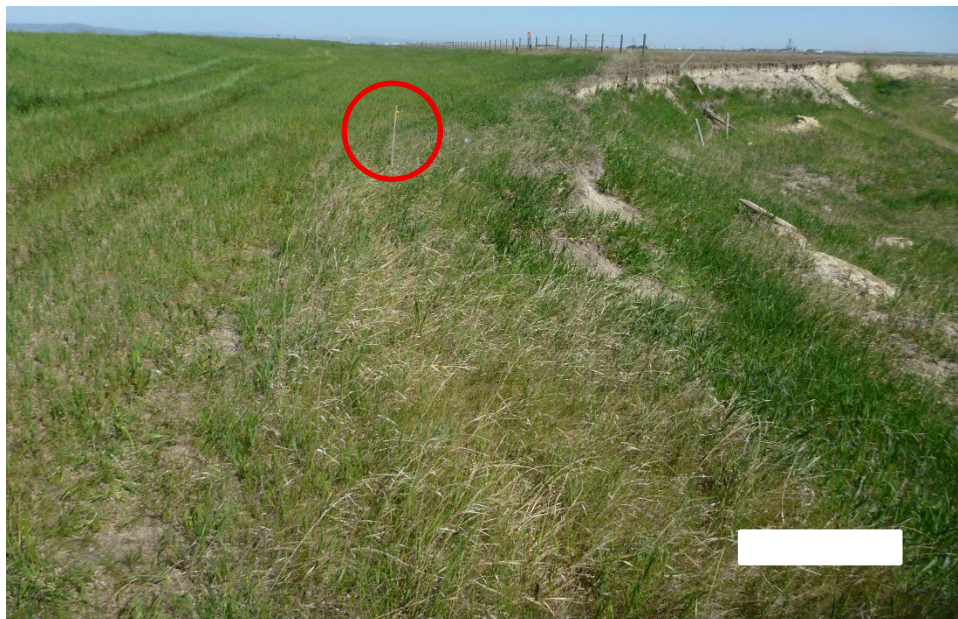
- There are three wooden stakes present at the head scarp that are used to estimate the rate of slide retrogression (middle stake is shown in Photo 6). During the 2024 inspection, the south stake was 1.3 m to the scarp, north stake was 0.75 m to the scarp, and the middle stake, where the scarp furthest closest to the highway, was 1.0 m to the scarp (measured during 2025 inspection, Photo 6). There was no change measured at the middle stake between the 2024 and 2025 inspections.

Photo 6 Wooden stake installed upslope of the slide (indicated by red circle) is approximately 1 m from the head scarp during the 2025 inspection. Photo taken May 28, 2025, facing north.

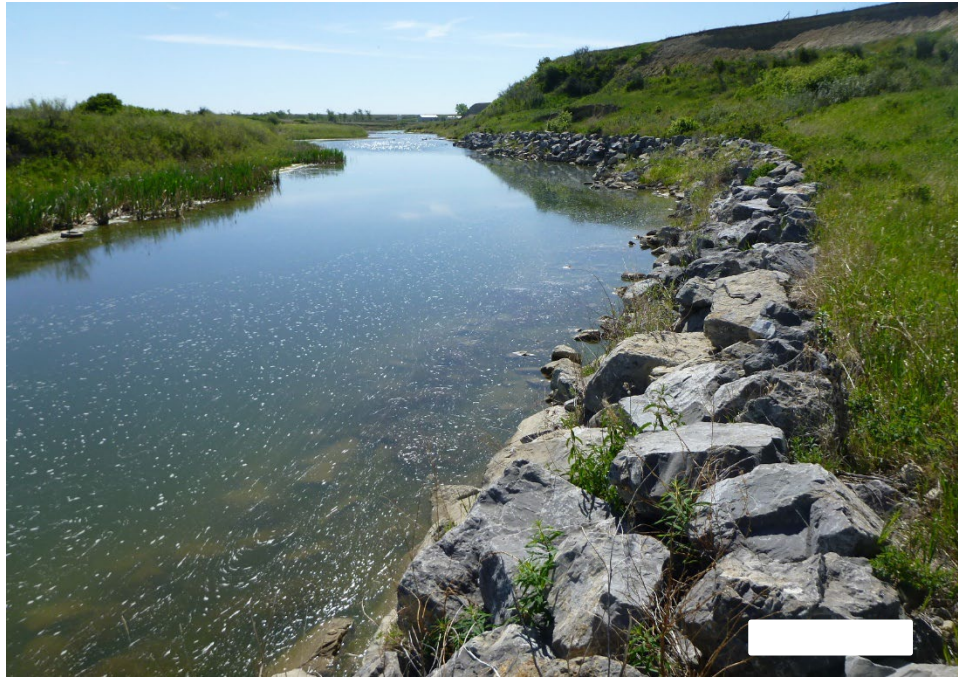
Photo 7 **Riprap armouring along the west shoreline of Willow Creek and downslope of the toe of the side. Photo taken May 28, 2025, facing south.**

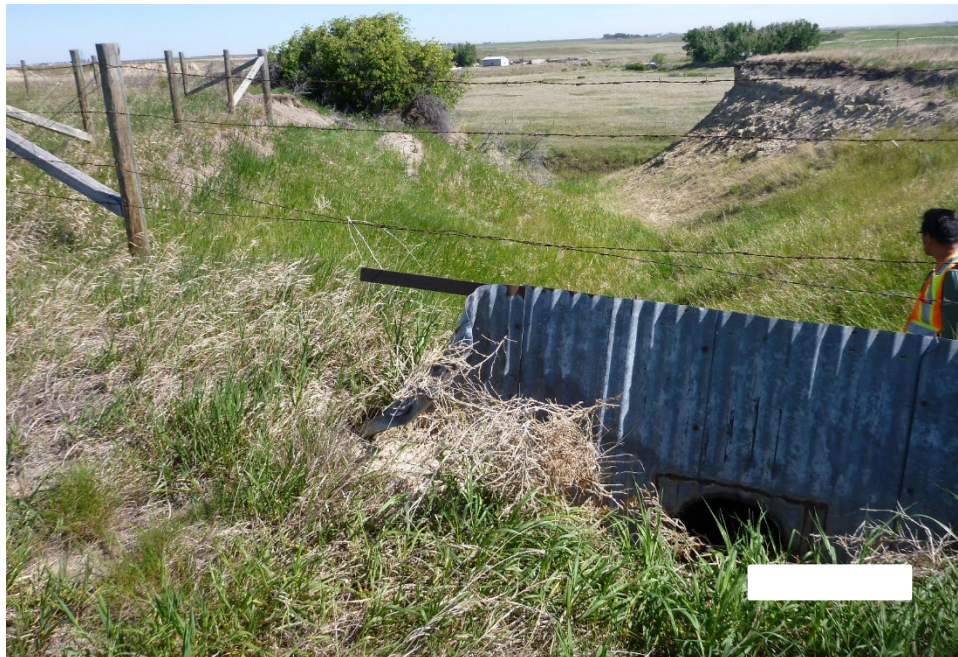
- There is a CSP culvert underlying Hwy 2:08. KCB estimated the diameter of the CSP culvert is 500 mm. At the culvert outlet, there is a CSP headwall and the culvert drains into a draw that drains towards Willow Creek (Photo 8). The head wall and culvert appeared to be in good condition during the 2025 inspection.

Photo 8 **Head wall, culvert outlet, and natural draw. Photo taken May 28, 2025, facing east.**
