July 15, 2025

CON0022161 Southern Region GRMP Instrumentation Monitoring
Site S004; H02:08, km 6.284 Willow Creek
Section C – 2025 Spring Readings

TITLE
Site Plan
S004 - Willow Creek (North of Ft. Macleod)
Hwy 2:08, km 6.284

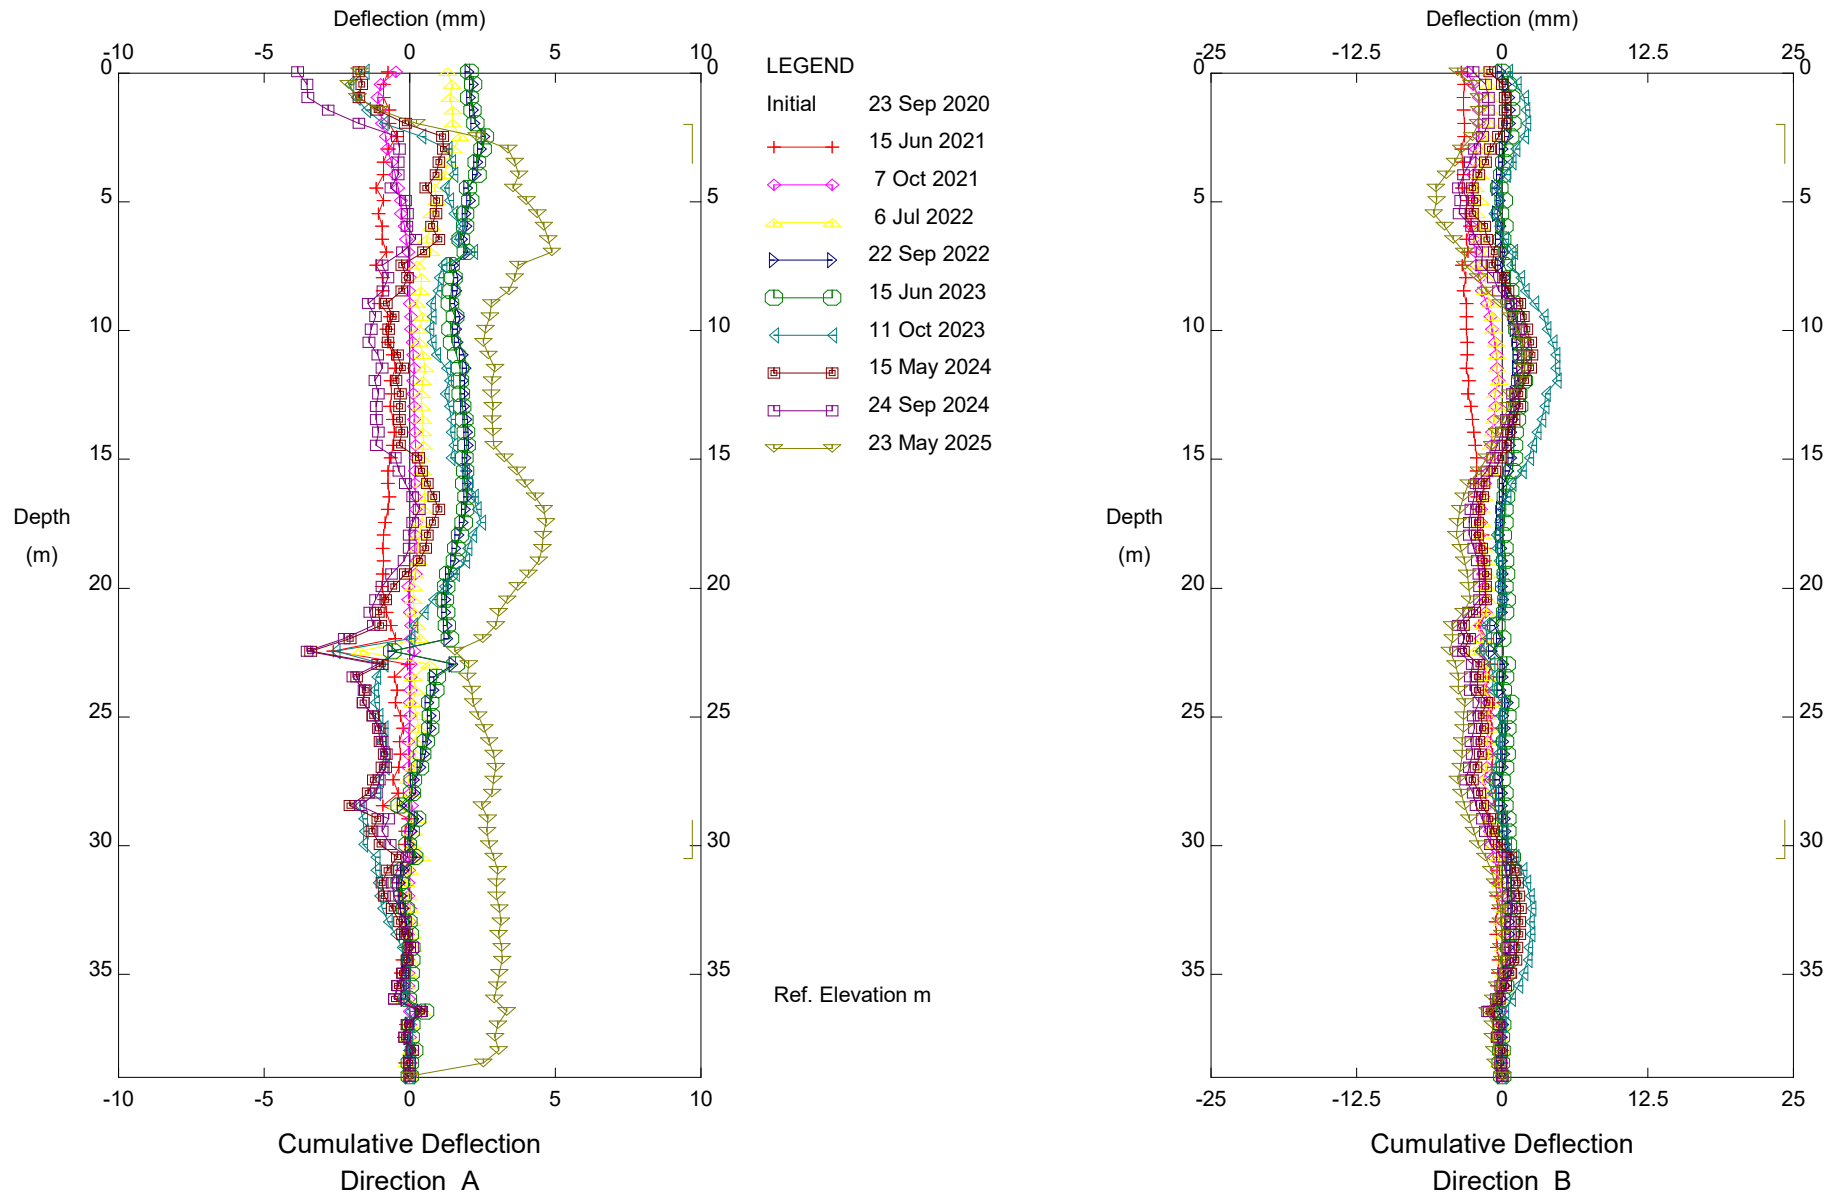
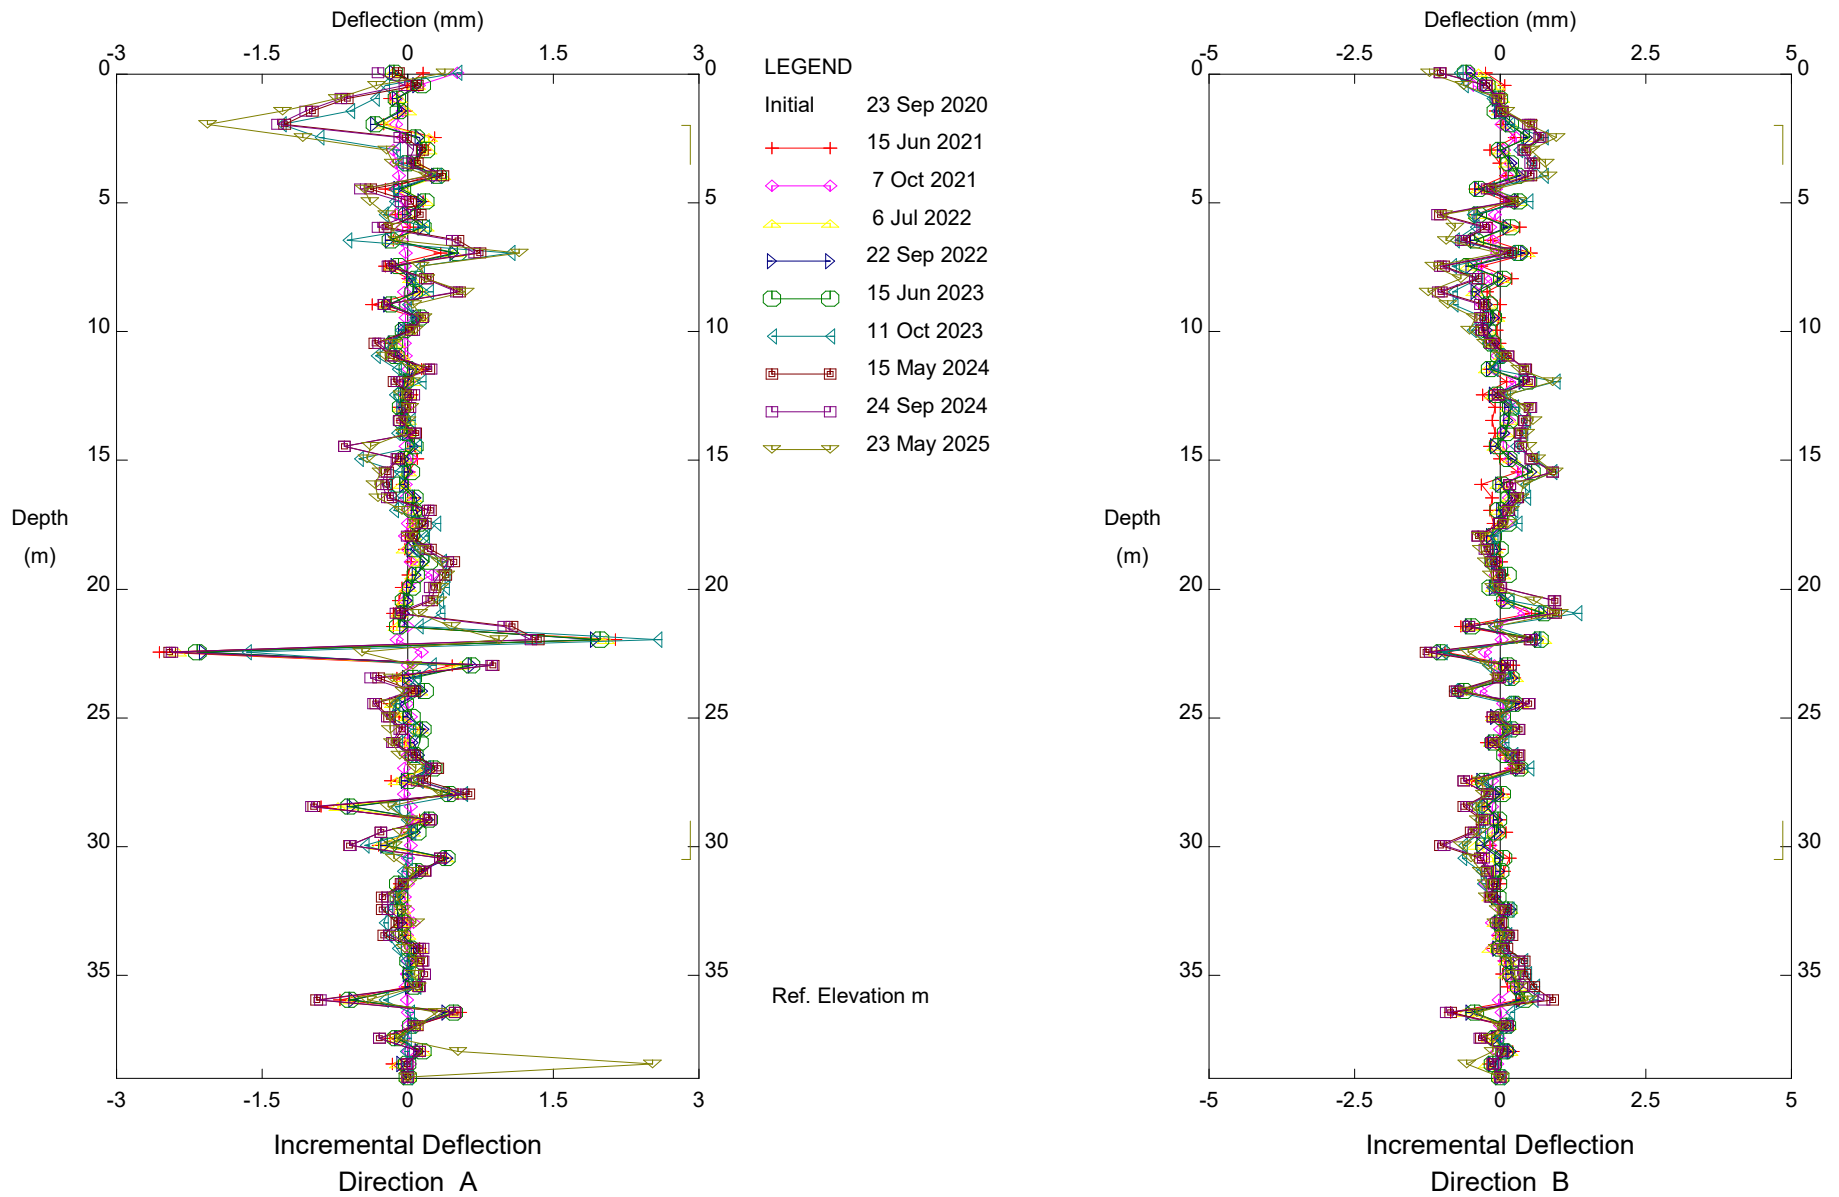
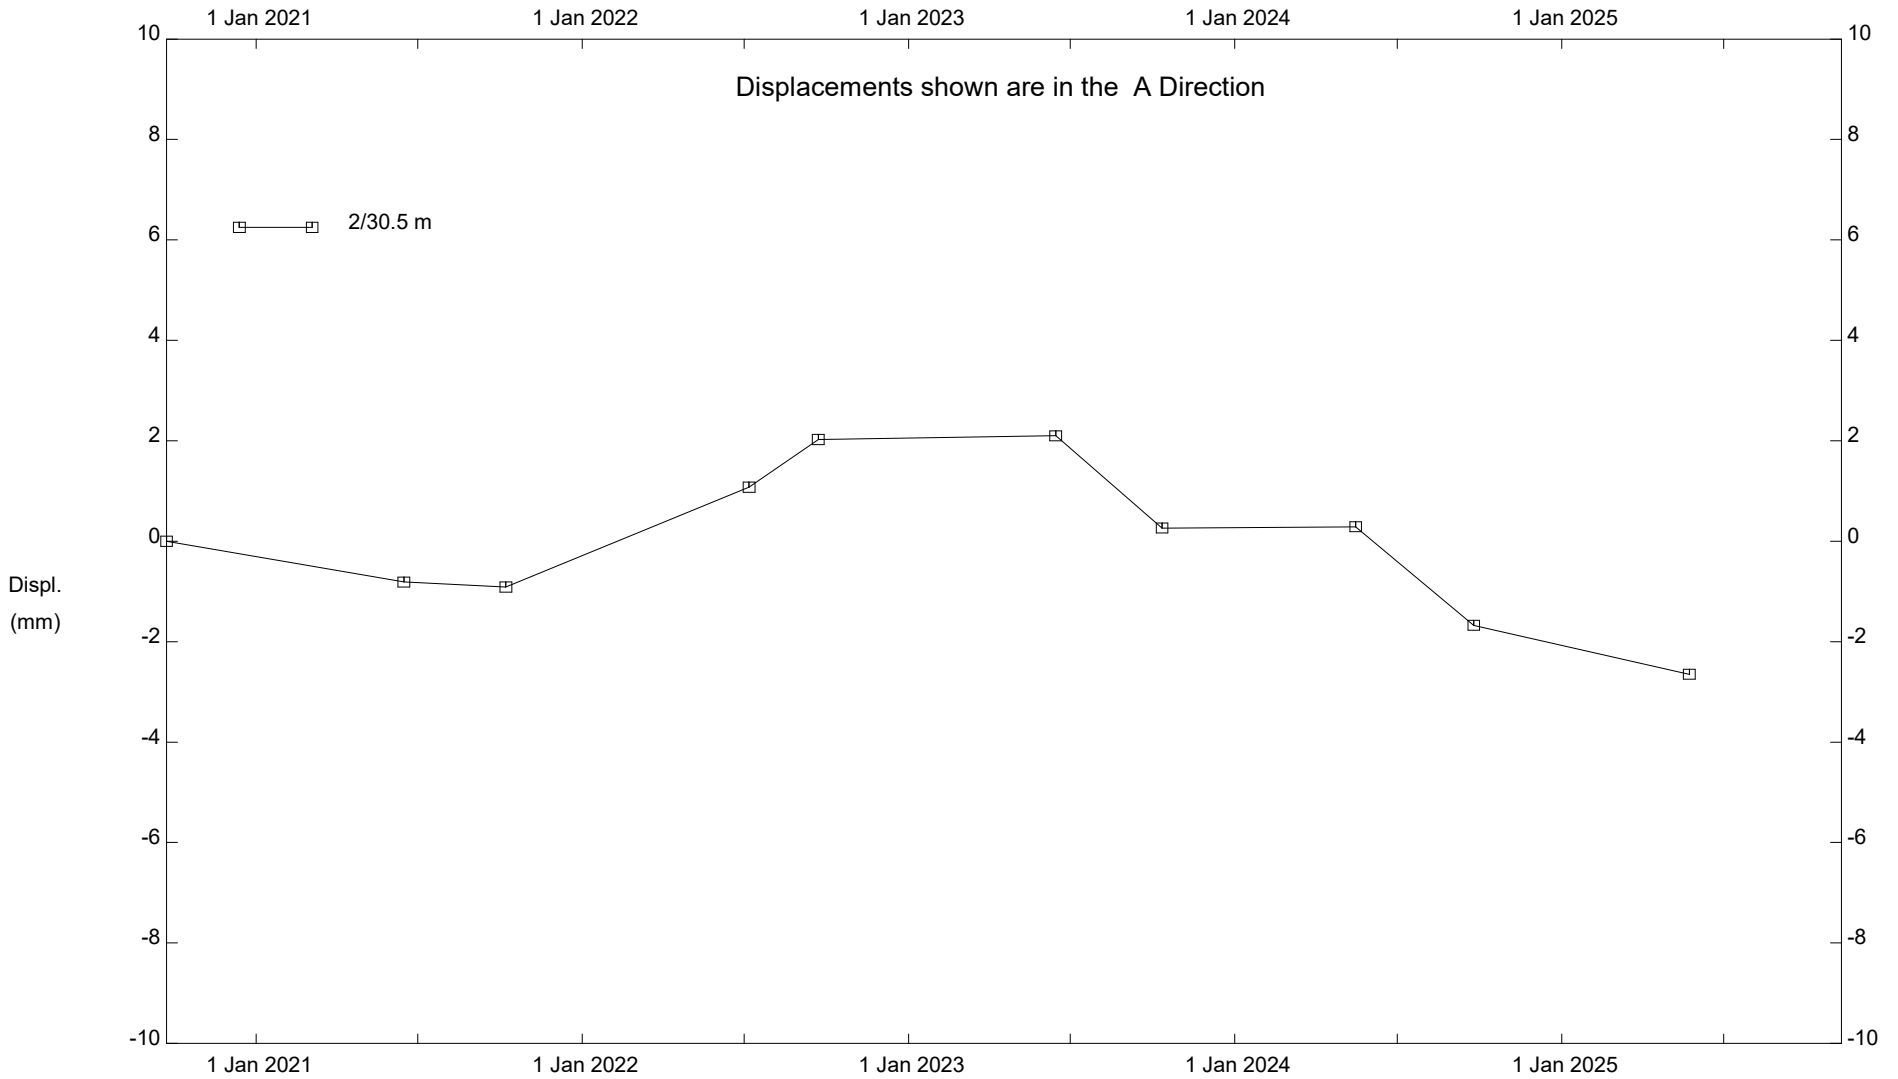
S004; H02:08, Willow Creek, Inclinator SI-1A
 Alberta Transportation

- SI-1A is "wavy" with kinks at approximately 22 m, 28 m, 30 m and 36 m below the ground surface.
- SI-5A is tilted approximately 1.0 m in the A-direction and 1.7 m in the B-direction, and there is also a kink in the casing at approximately 22 m below the ground surface.
- SI-9A is "wavy" with kinks at approximately 5 m, 11 m, and 25 m below the ground surface.
- SI-10A is "wavy" with kinks at approximately 6 m and 25 m below the ground surface.

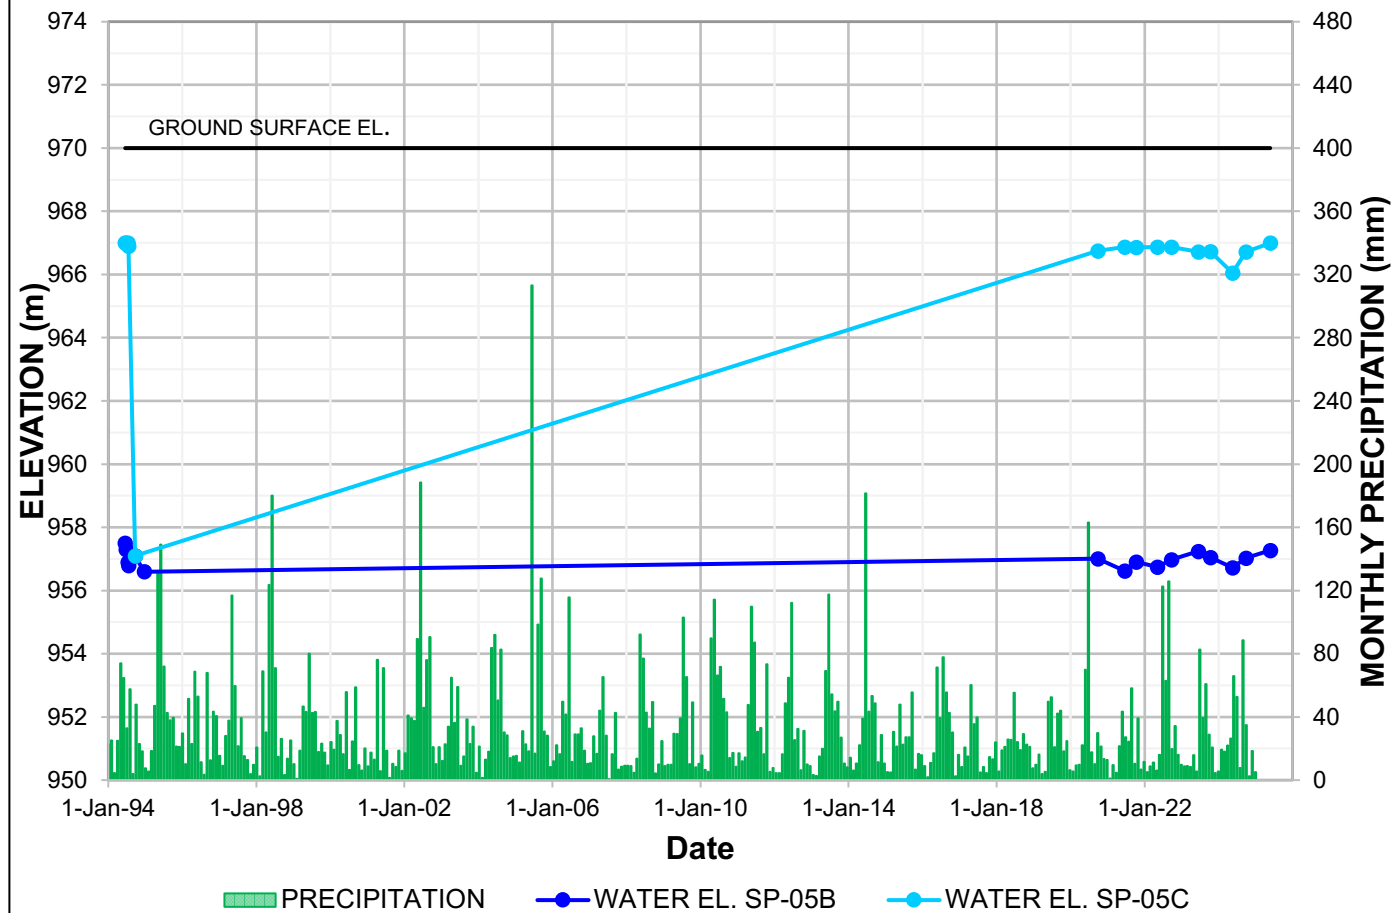
SP-05B AND SP-05C

The highest recorded water level increase is from the 1994 reading for SP-05C; however, this was most likely inaccurate, as it is approximately 10 m lower than the previous and current readings.

1. MONTHLY PRECIPITATION DATA OBTAINED FROM THE ALBERTA CLIMATE INFORMATION SERVICE (ACIS) DATABASE, REFERENCING LEGAL SUBDIVISION TWP009-26-W4.
2. THE 1994 READING FOR SP-05C APPEARS TO BE BAD DATA.
3. THE INSTRUMENTS WERE NOT READ BETWEEN OCTOBER 2015 AND SEPTEMBER 2020.

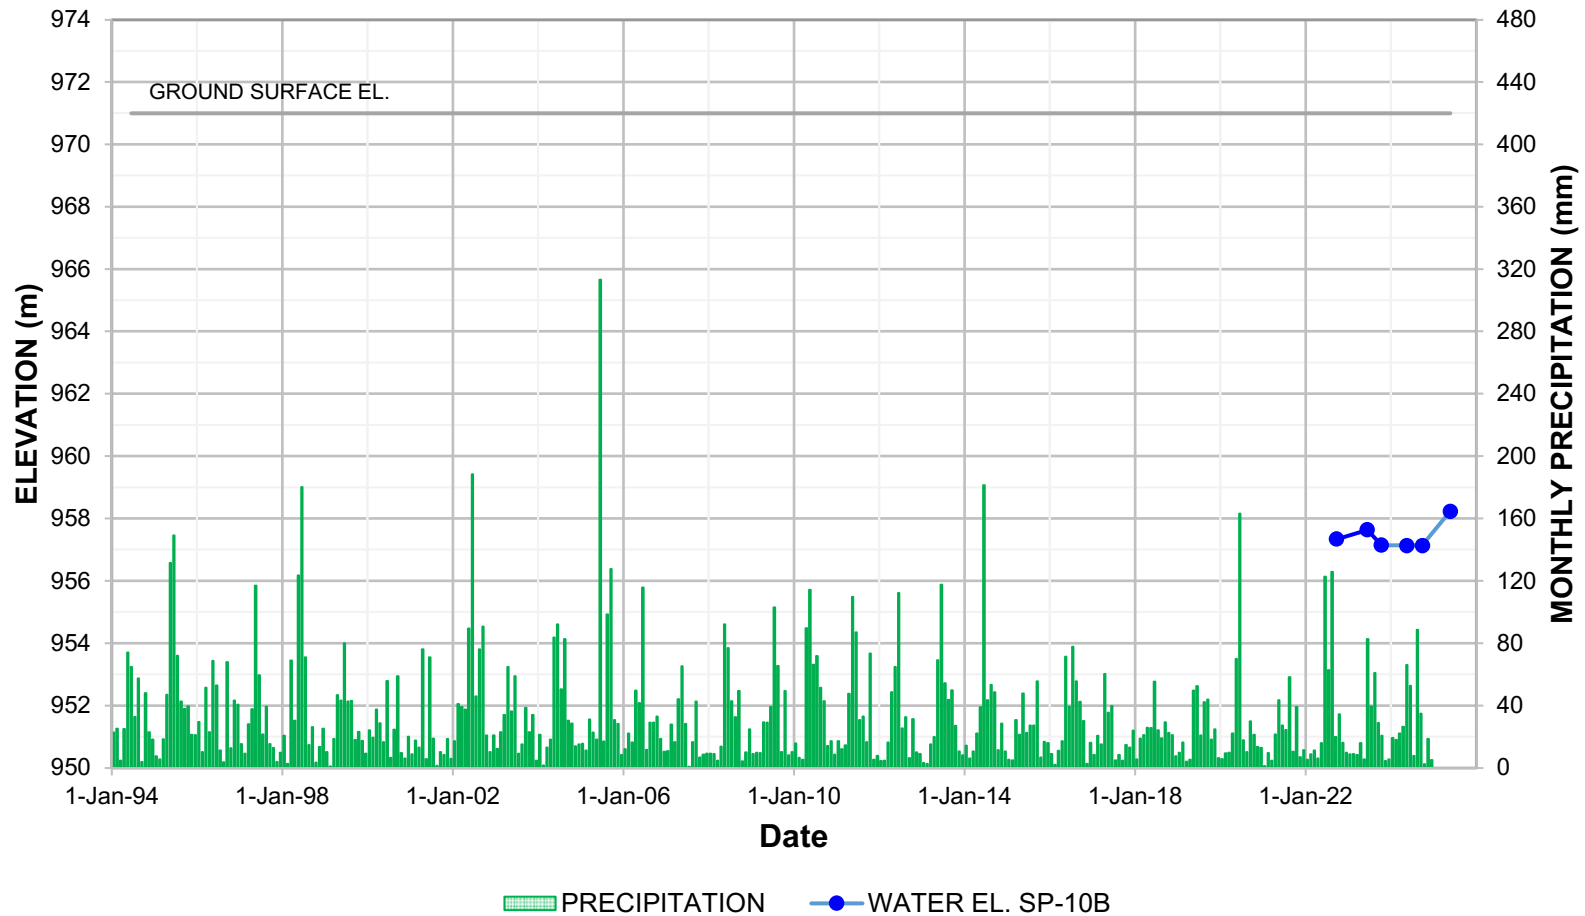
SP-10B

Since KCB took over reading the instruments in 2020, decreasing water levels have generally been recorded in most of the piezometers. The spring 2025 SP readings show a general trend of consistent water levels, other than SP-10B, which increased by 1 m. The VWP's show a decrease in water levels in the Spring 2024 readings compared to the Fall 2024 readings.

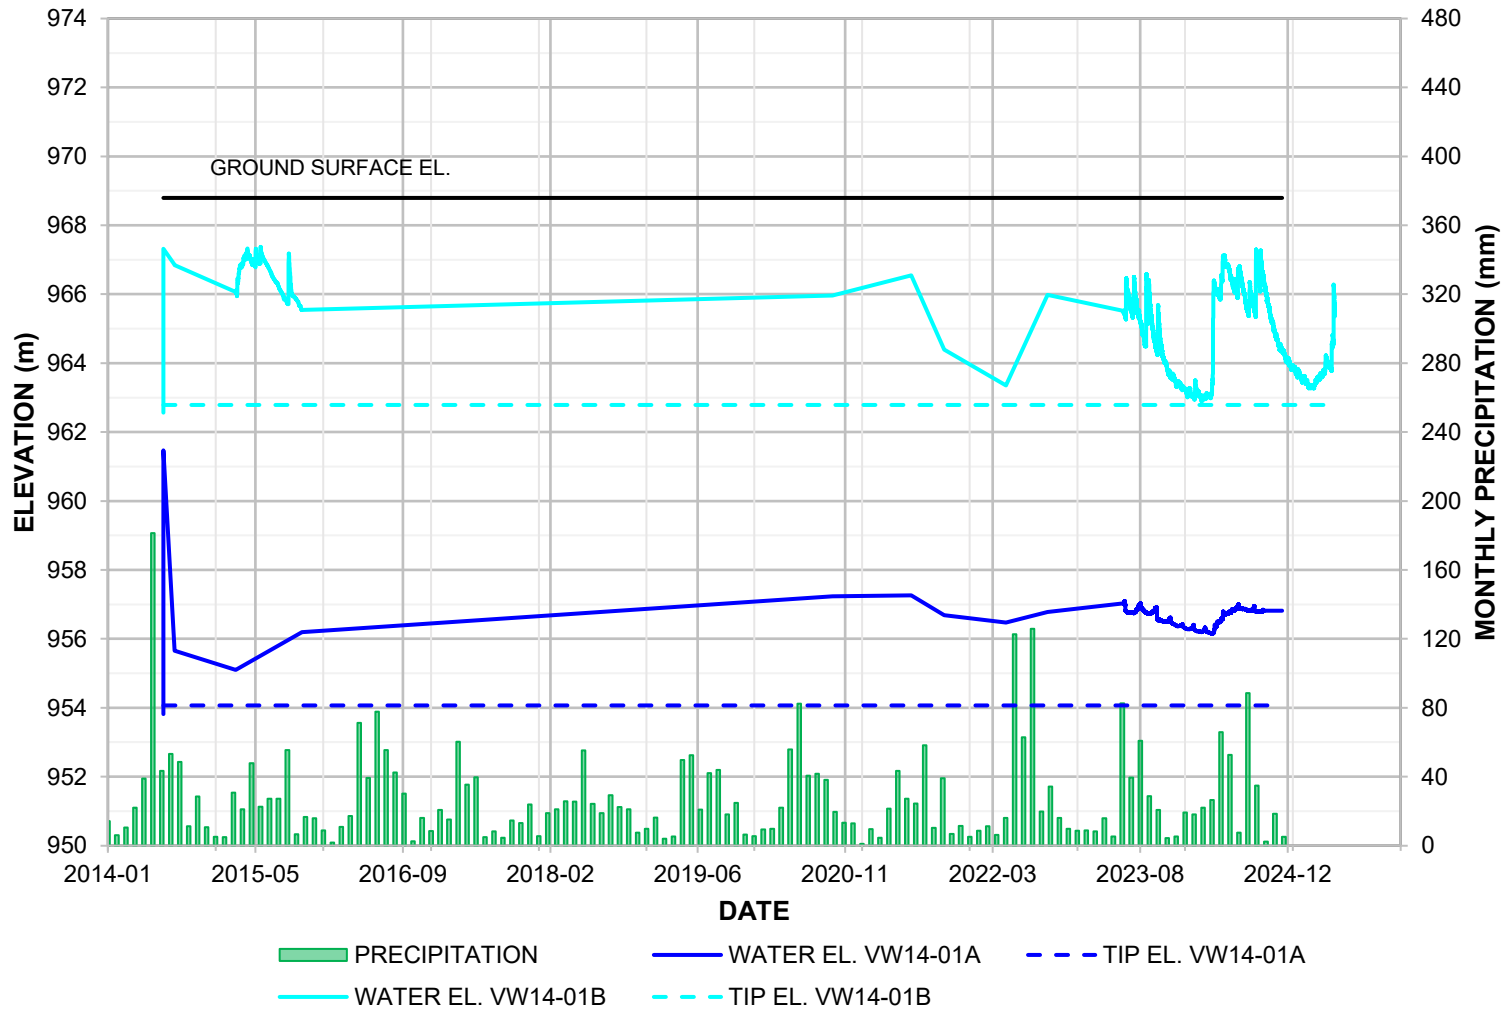
VW14-01A AND VW14-01B

Overall, measured groundwater levels from the VWP's declined from fall 2024 to spring 2025, with the largest drop of 1.0 m recorded at VWP14-01B. Rainfall data from station T009R26W4 only covers up to December 31, 2024, at the time this report was written. The available data suggest that rainfall and snowmelt contribute to rising water levels in the VWP's, although levels generally decrease during the summer season. VWP14-01B is the most responsive to precipitation, showing sharp increases in water level following rainfall events.

Water levels recorded in the nested VWPs installed between the highway and crest of the slide (VW14-01A/B and VW14-02A/B) varied from an approximate depth of 1.3 m to 3.4 m below ground surface in the upper “B” tips and 7.0 m to 12.1 m below ground surface in the lower “A” tips. Both the upper “A” tips have a similar elevation (El. 962.8 m and El. 963.1 m, respectively), and both the lower “B” tips have a similar tip elevation (El. 954.1 m and El. 954.4 m, respectively).

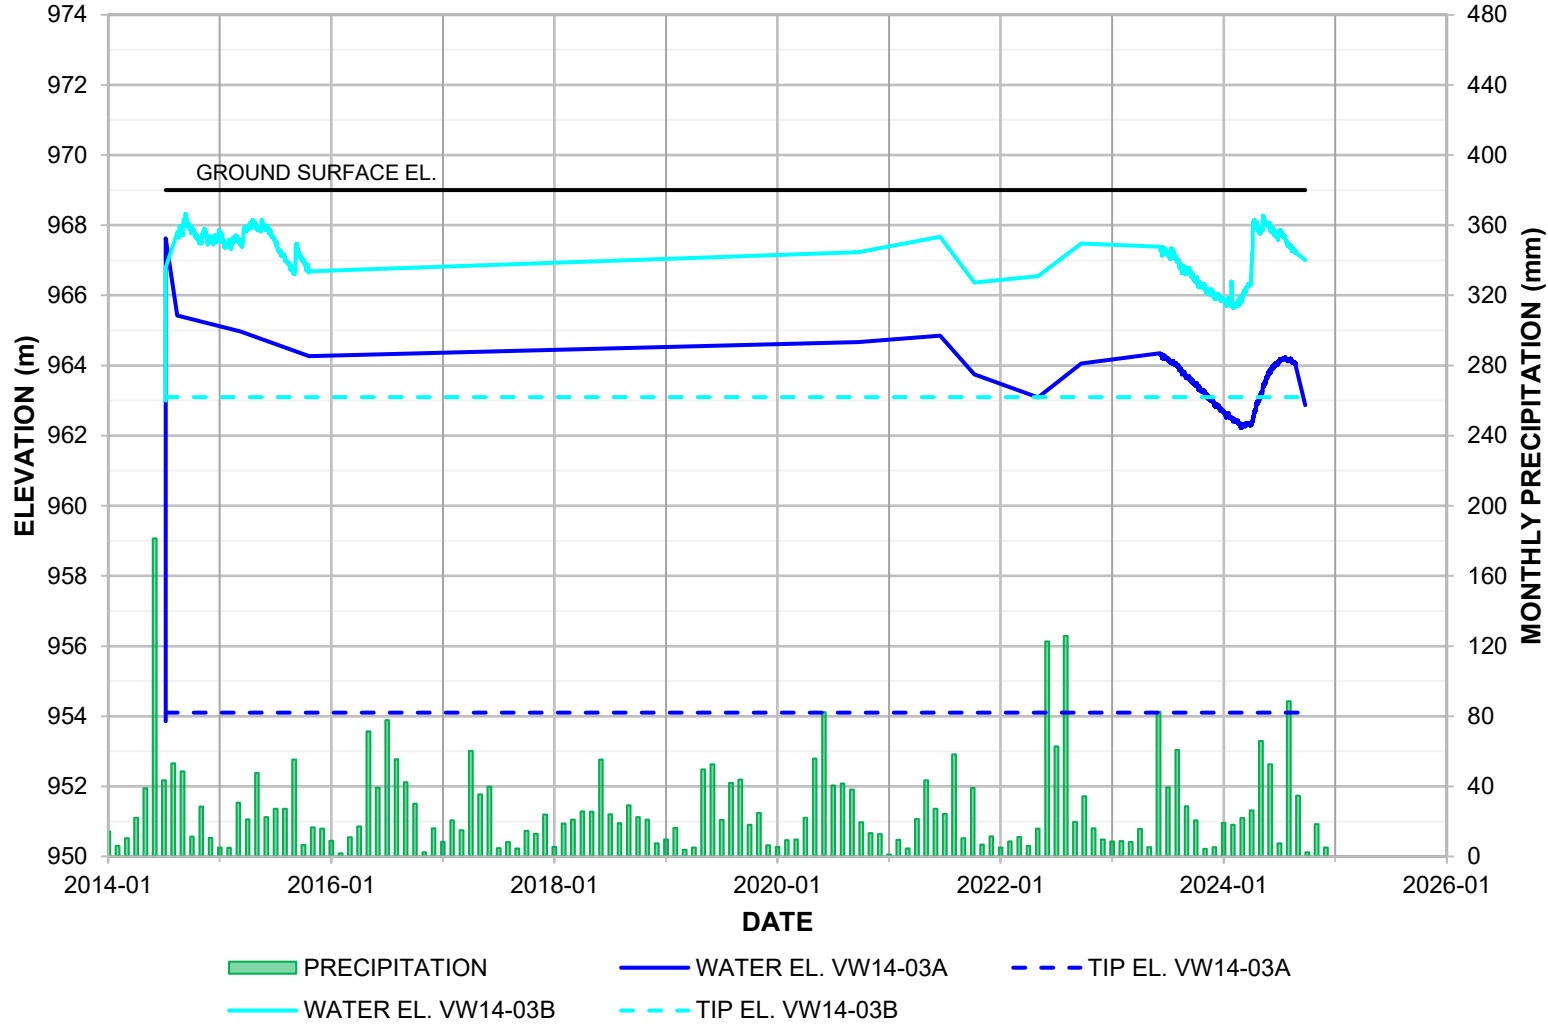
VW14-03A AND VW-03B

Water levels recorded in the nested VWPs installed in the median ditch of Hwy 02:08 (VW14-03A/B) were at approximate depths of 0.9 m and 5.5 m below ground surface in the upper “B” tip and the lower “A” tip, respectively, as of the most recent readings.

The VW14-03 Datalogger battery was replaced during the most recent readings. Some troubleshooting was necessary to connect the datalogger to the computer and download data; no new data has been added since the previous reading in September 2024. The inside of the datalogger also showed signs of possible water damage. It is unclear whether the datalogger is not collecting new readings because of water damage or a dead battery.
