SITE NUMBER AND NAME: S048 Castle Back Slope Failures	HIGHWAY & KM: 3:04, 23.708	PREVIOUS INSPECTION DATE: May 8, 2023	INSPECTION DATE: May 28, 2025
LEGAL DESCRIPTION: 15/06-12-007-01 W5M	NAD 83 COORDINATES: UTM Northing Easting 11 5492157 715695	RISK ASSESSMENT: PF: 9 CF: 2 TOTAL: 18	
AVERAGE ANNUAL DAILY TRAFFIC (AADT): 4,100 (west), 4,340 (east), (Ref. No. 78050)		CONTRACTOR MAINTENANCE AREA (CMA): 522

SOUTHERN REGION GEOHAZARD RISK MANAGEMENT PROGRAM

Site Plan
S048 - Castle Back Slope Failures
Hwy 3:04, km 23.708

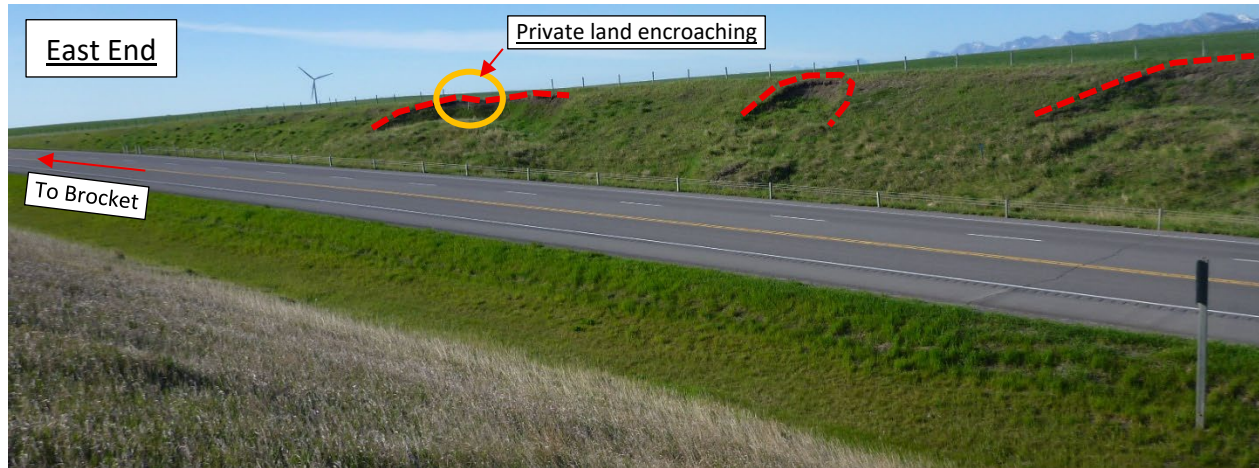
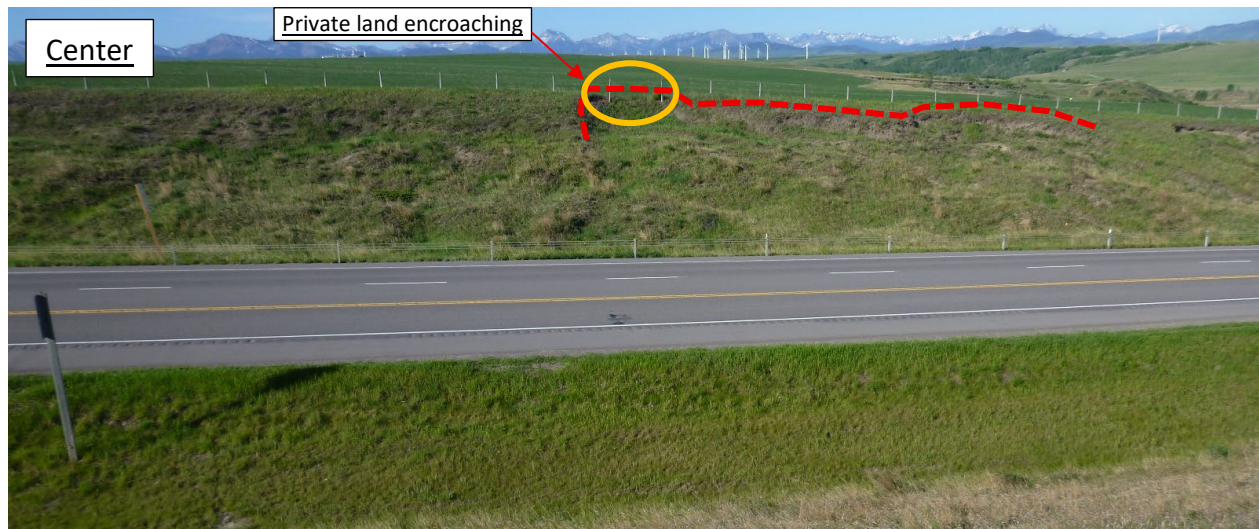
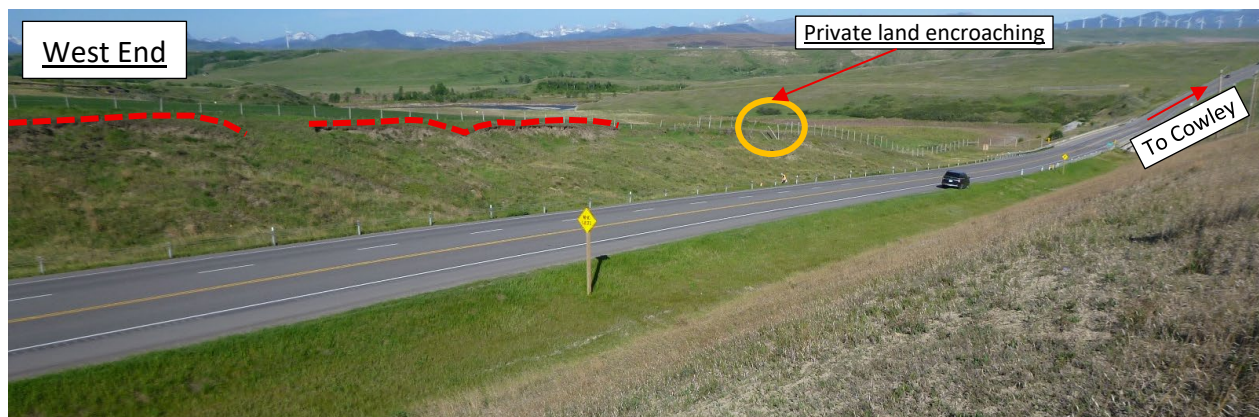
ITEM	CONDITION EXISTS		DESCRIPTION AND LOCATION	NOTICABLE CHANGE FROM LAST INSPECTION	
	YES	NO		YES	NO
Pavement Distress		X	N/A – none observed during the 2025 inspection.		X
Slope Movement	X		Slope instability in the south (eastbound) highway back slope (Photo 1). Head scarps retrogressing into private land and undermining the fence at multiple locations. Toe rolls are partially blocking the south (eastbound) ditch.	X	
Erosion	X		There has been some erosion of the failed material in the ditch.		X
Seepage	X		Wet areas have been observed within the slide mass. During the 2025 inspection, the ground was soft and dry.		X
Culvert Distress		X	N/A – none observed during the 2025 inspection.		X

- The zone of instability in the south (eastbound) highway back slope is approximately 200 m long. There is a series of slides along the back slope that will coalesce over time (Photo 1).

- The south (eastbound) highway back slope (north facing) is between approximately 6 m to 10 m high (increasing in height along the site from east to west) and sloped at approximately 3H:1V. In general, the instability is observed where the embankment height is greater than approximately 6 m (Photo 1).

- At some locations, the head scarp is up to approximately 2 m high and is near-vertical (Photo 1). There may be more activity at the east and west flanks of the site with material slumping from the head scarp. In general, there were no significant changes between the 2023 and 2025 inspections, except at the west end of backslope.

Photo 1 Panoramic view of multiple slides and head scarp (red dashed line) on the south backslope of the highway. Landslides encroaching private land (orange circle). Photos taken May 28, 2025, facing southwest.

- The stability of the south (eastbound) highway back slopes should be improved by flattening the slope from approximately 3H:1V to 4H:1V or 5H:1V. This would require purchasing additional right-of-way and moving the fence further south. Excavated material could potentially be stockpiled in the low area southwest of the site. This area could be levelled in the future for possible use by the private landowner as long as it does not impact the stability of the east Oldman River riverbank (south of the Hwy 3 bridge). TEC should conduct a site investigation (2-3 boreholes) to characterize the back slope materials of the

south slope and conduct a hydrogeological analysis to assess the impact of the groundwater and evaluate potential repair options, including drainage improvement.

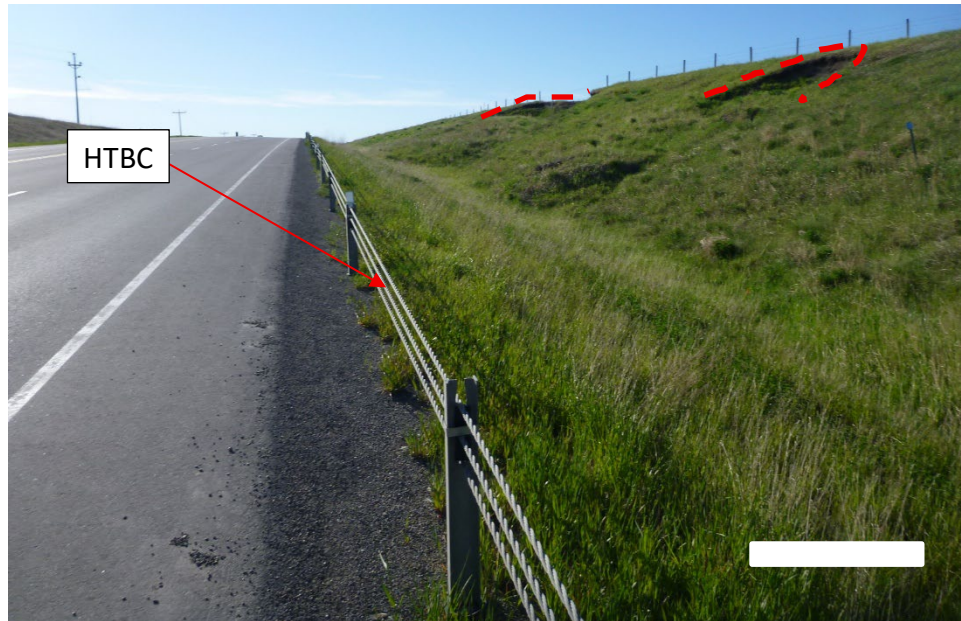
- A high-tension cable barrier (HTCB) was installed along the edge of the south (eastbound) lane between the 2023 and 2025 inspections (Photo 2).
- No pavement distress (cracking or settlement) was observed during the 2025 inspection (Photo 2).

- Failed material is partially blocking the south (eastbound) ditch and is impacting the ditch's flow capacity (Photos 2 to 3). There was no significant change between the 2023 and 2025 inspections.

Photo 2 HTCB installed between the 2023 and 2025 inspections, south (eastbound) ditch, and head scarp (red dashed line). Ditch and back slope are well vegetated. Photo taken May 28, 2025, facing east.

- The site should be regularly inspected by the Maintenance Contract Inspector (MCI).
- The site should be inspected every year as part of the Southern Region GRMP Section B inspections.
- Drainage for the south (eastbound) ditch should be improved by removing failed material partially blocking the ditch. Removed material should be kept to a minimum to re-establish flow capacity in the ditch without further destabilizing the slope.

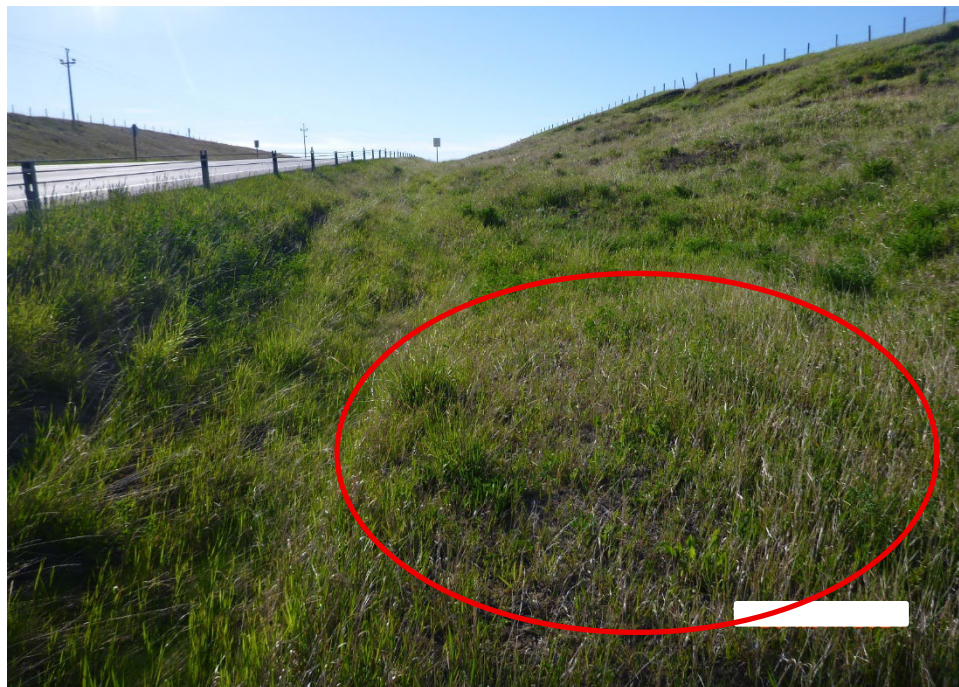
Photo 3 Failed material (red line) partially blocking south (eastbound) ditch. Photo taken May 28, 2025, facing east.

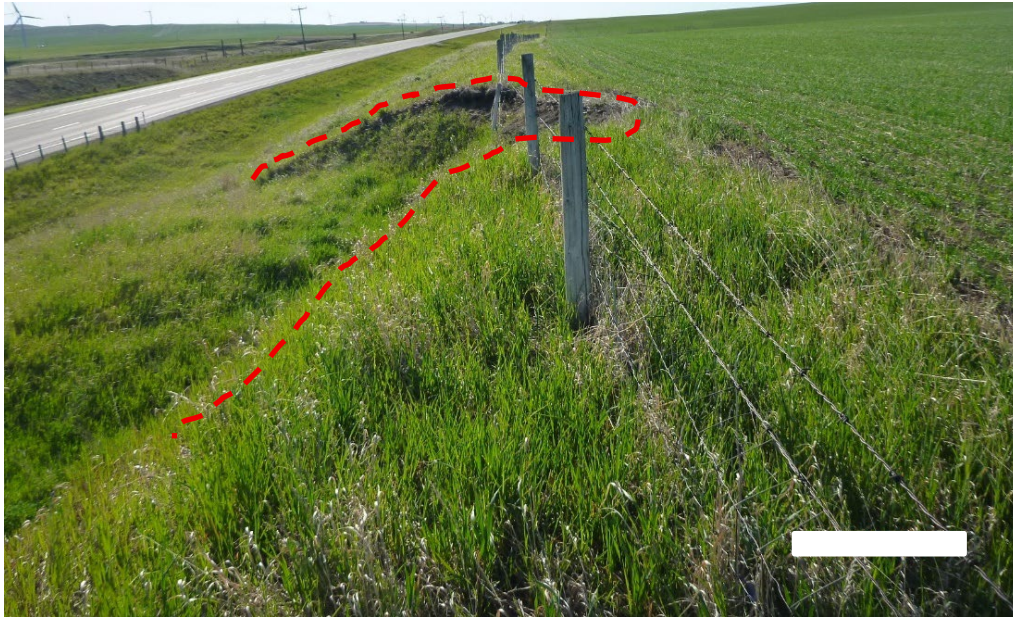
- Due to erosion, the head scarp has retreated onto private land, affecting the fence line along the slope's crest in three areas (Photos 4 to 6). The westernmost area, shown in Photo 6, seems to have happened between the 2023 and 2025 site inspections. The head scarp has moved past the fence line by about 2.5 m near the site's eastern end and has undermined one fence post. The centred scarp is roughly 10 m wide (Photo 5), and the new scarp near the western end is approximately 12 m long (Photo 6).

Photo 4 Head scarp (red dashed line) and private fence along the crest of the slope. Head scarp extends approximately 2.5 m south of the fence line. Photo taken May 28, 2025, facing east.

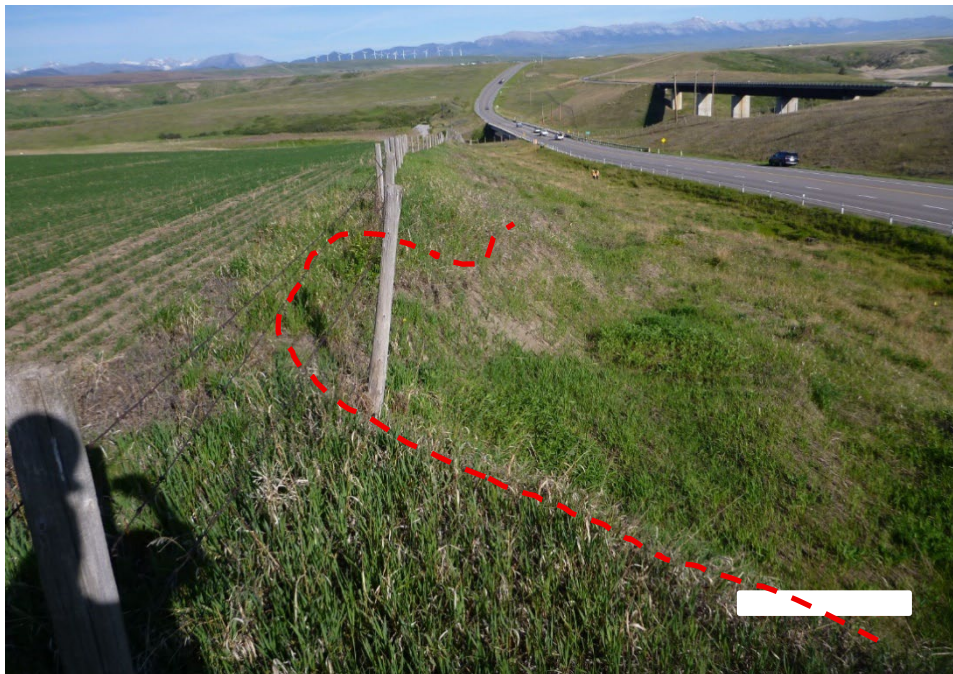
Photo 5 Head scarp (red dashed line) and private fence along the crest of the slope near the west end of the site. Photo taken May 28, 2025, facing west.

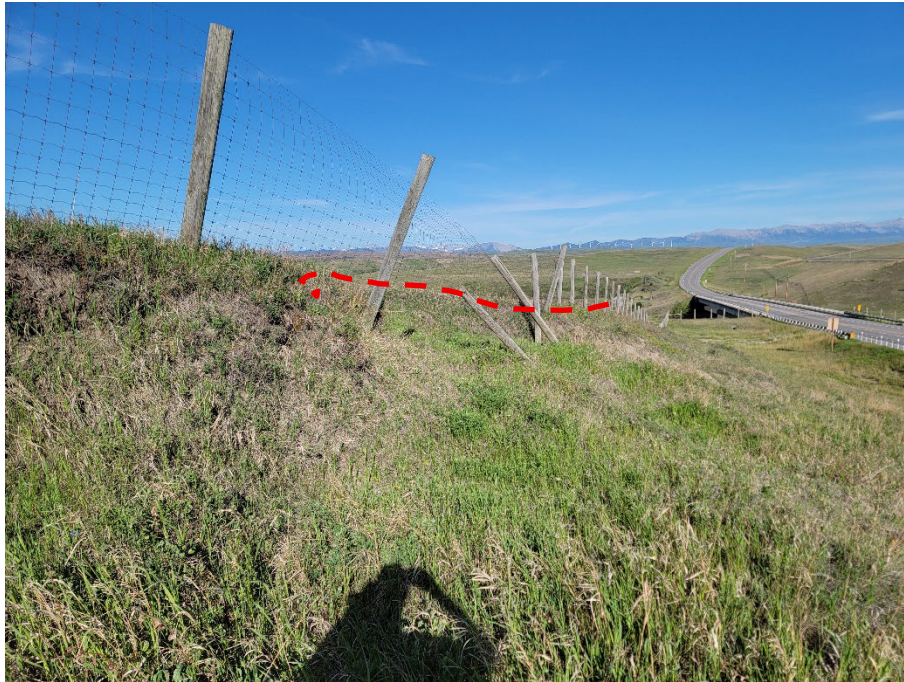
Photo 6 Head scarp (red dashed line) and private fence along the crest of the slope near the west end of the site. Photo taken May 28, 2025, facing west.

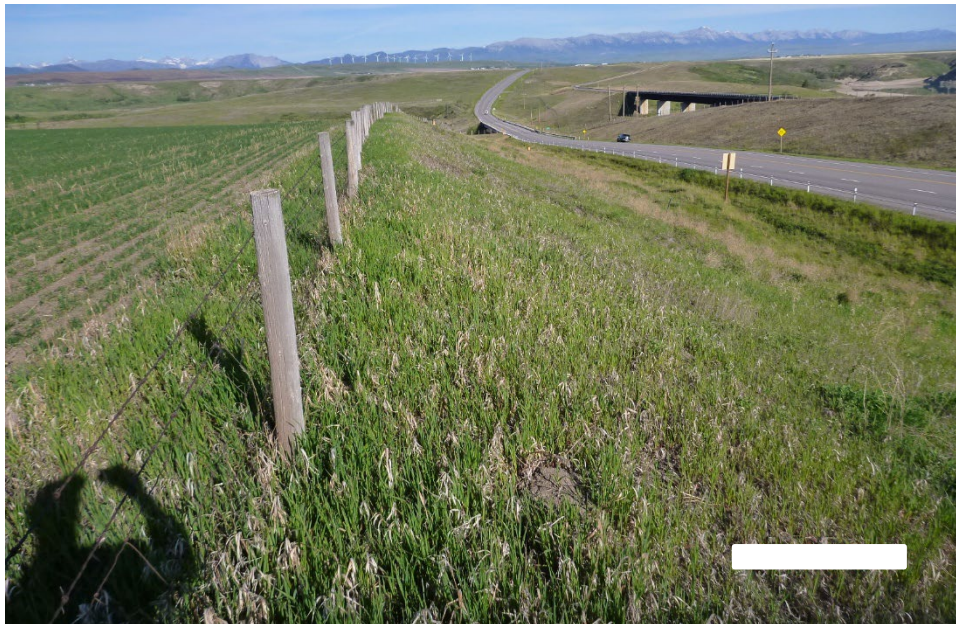
- The slope outside of the site limits is even, well-vegetated, and is performing well; furthermore, the area of instability does not appear to be impacting the private land along the western length of the site, but the head scarp is within approximately 1.5 m of the fence (Photo 7).

Photo 7 The slope outside of the site limits is even, well-vegetated, and is performing well. Photo taken May 28, 2025, facing west.
