November 26, 2025

Alberta Transportation and Economic Corridors  
2<sup>nd</sup> Floor, 803 Manning Road N.E.  
Calgary, Alberta  
T2E 7M8

**CON0022161 Southern Region GRMP Instrumentation Monitoring**  
**Site S039-I; H03:06, km 12.952 West Bocket Slide**  
**Section C – 2025 Fall Readings**

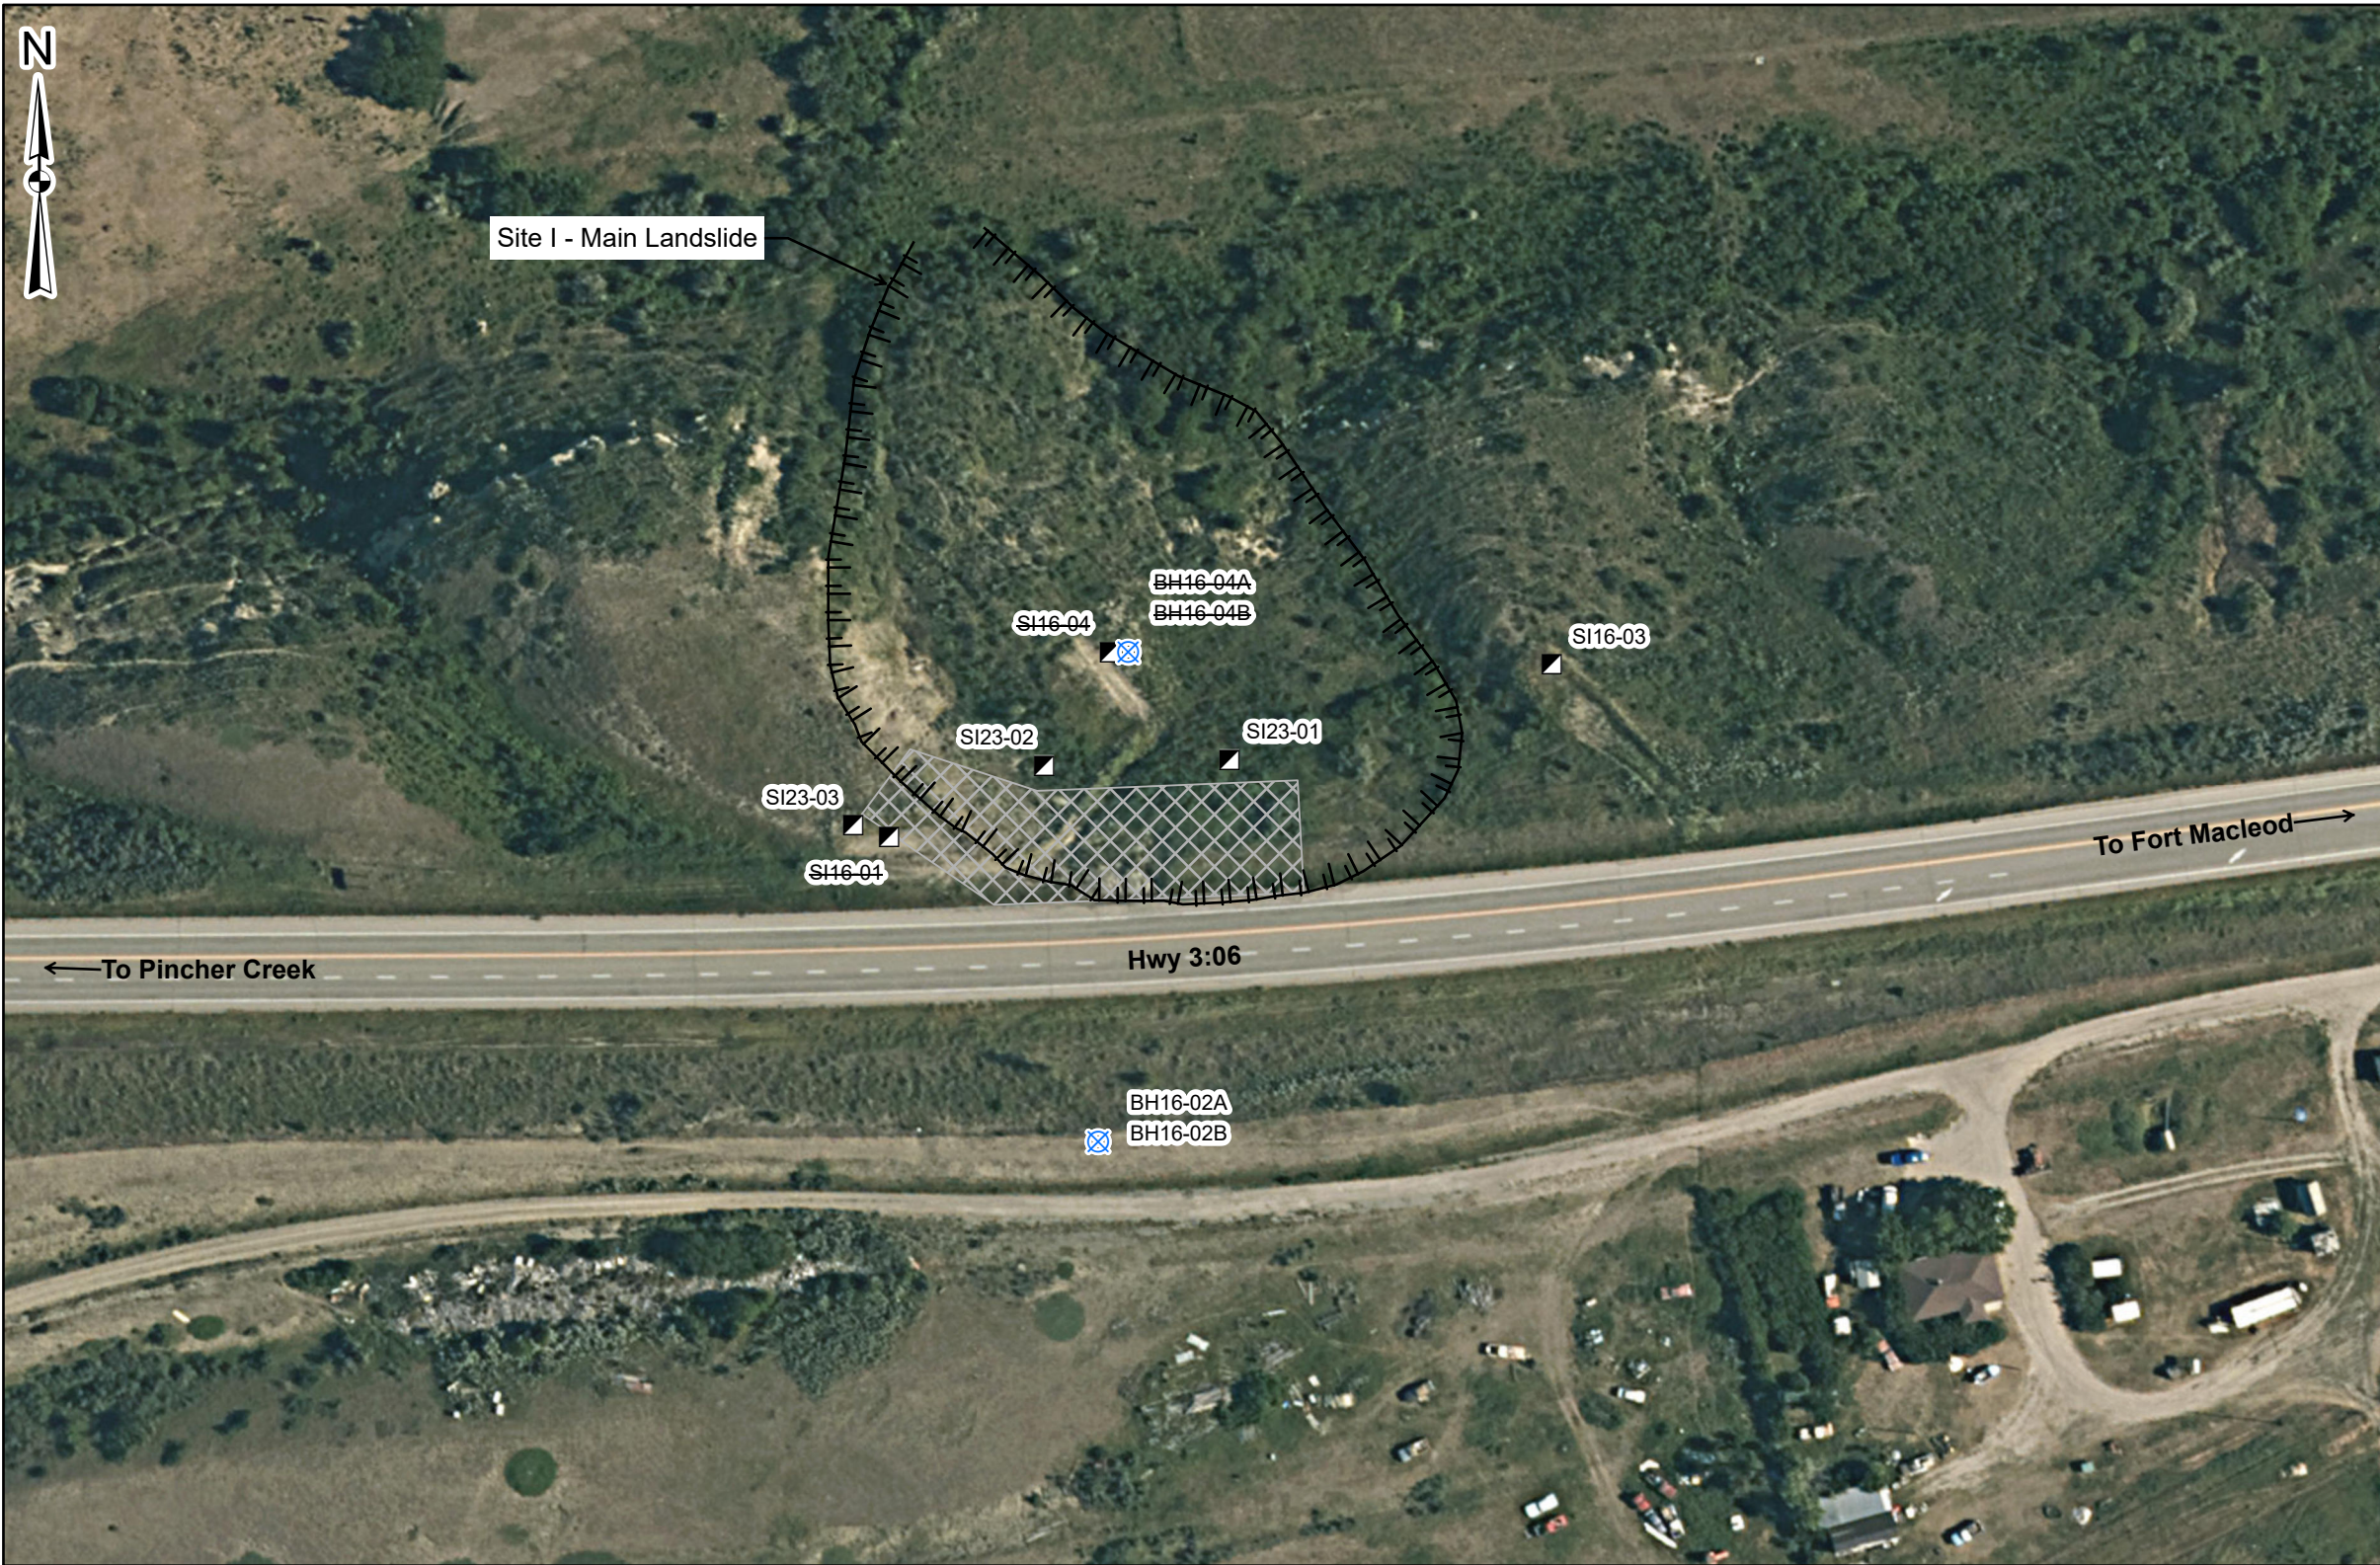
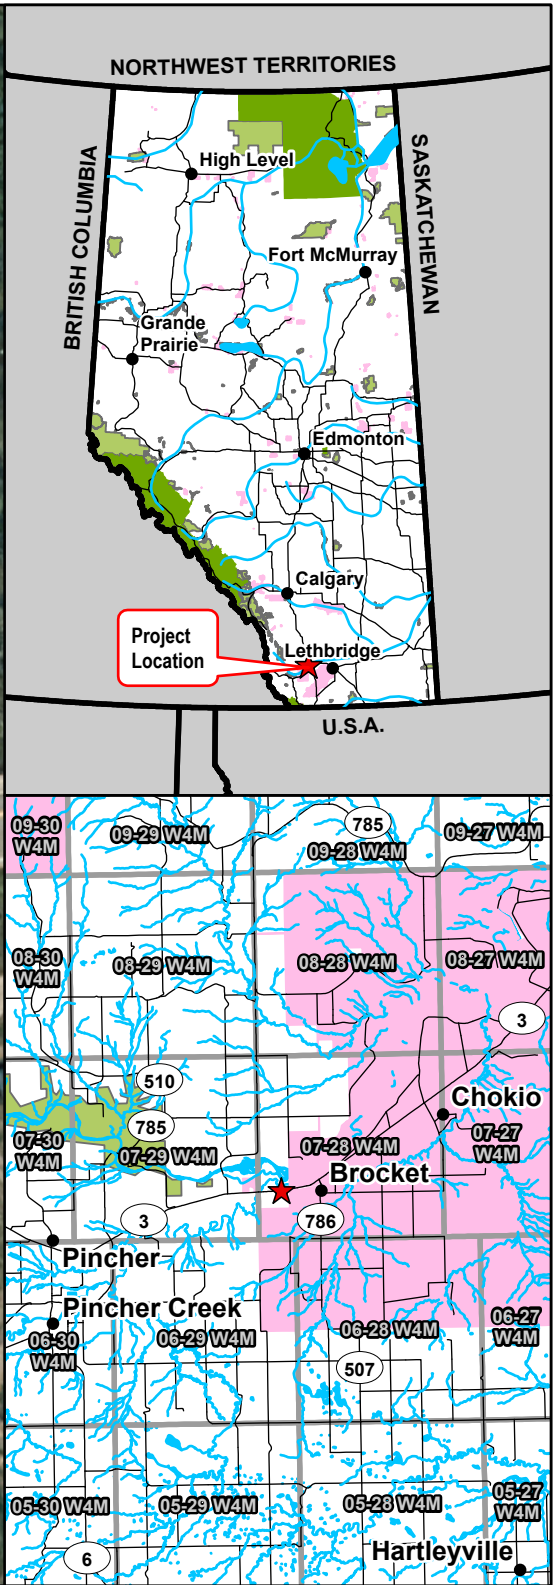
PROJECT SOUTHERN REGION GEOHAZARD RISK MANAGEMENT PROGRAM		
TITLE Site Plan S039 - Bocket Slides Hwy 3.06, km 12.952		
SCALE 1:1,250	PROJECT No. A05116A03	FIG No. 1

The geohazard at the S039 site consists of a range of instabilities over a total length of approximately 600 m along Hwy 03:06. Two subsites have been identified: S039-I at the west end of the site and S039-II at the east end of the site. Instrumentation is only installed at the S039-I site.

Since completion of the repair, a wet zone on the east limit of the anchored backscarp slope at the upper  $\frac{3}{4}$  mark was first observed during the May 2023 Section B inspection. This wet zone was not observed or encountered during the 2017 drilling investigation, during any Section B inspections prior to 2023, or during construction. A small, shallow zone of movement developed in 2023 approximately 30 m by 6 m at the east extent of the repair. During the spring 2024 Section B inspection additional slope movement and sloughing was observed across the repair slope. Additionally, erosion from runoff from the highway surface has created rills on the slope face, some of which have undermined the soil nail anchor plates. Instrumentation is not in place to monitor the performance of the anchored back slope or the zone of movement associated with an isolated wet area on the upper east part of the anchored slope.

If the designed slope repairs continue to be delayed, surveys (e.g., ground-based Light Detection and Ranging, LiDAR, or Unmanned Aerial Vehicle, UAV, photogrammetry) should be conducted to complete change detection analysis to monitor movement on the repair slope because there is no instrumentation currently installed that can monitor movement of the soil-nail repaired slope.

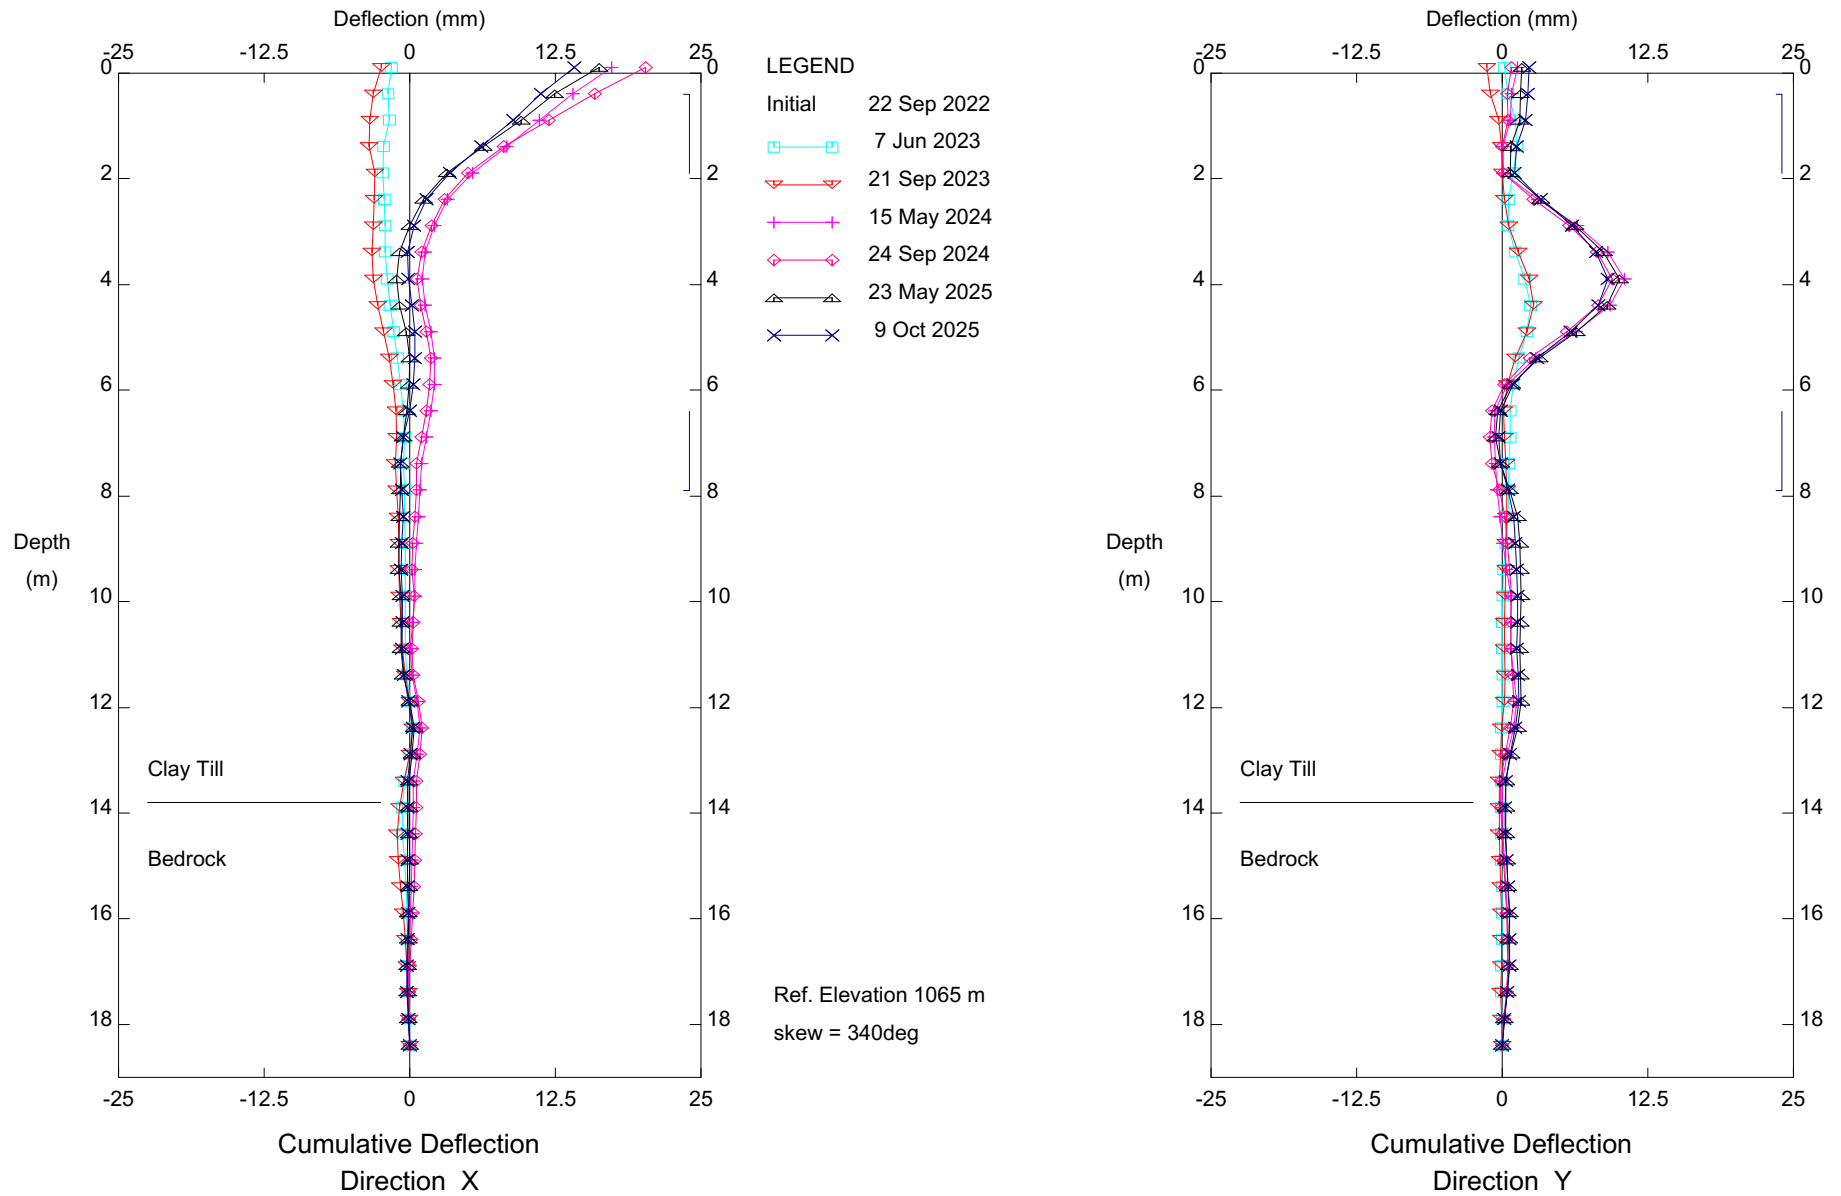
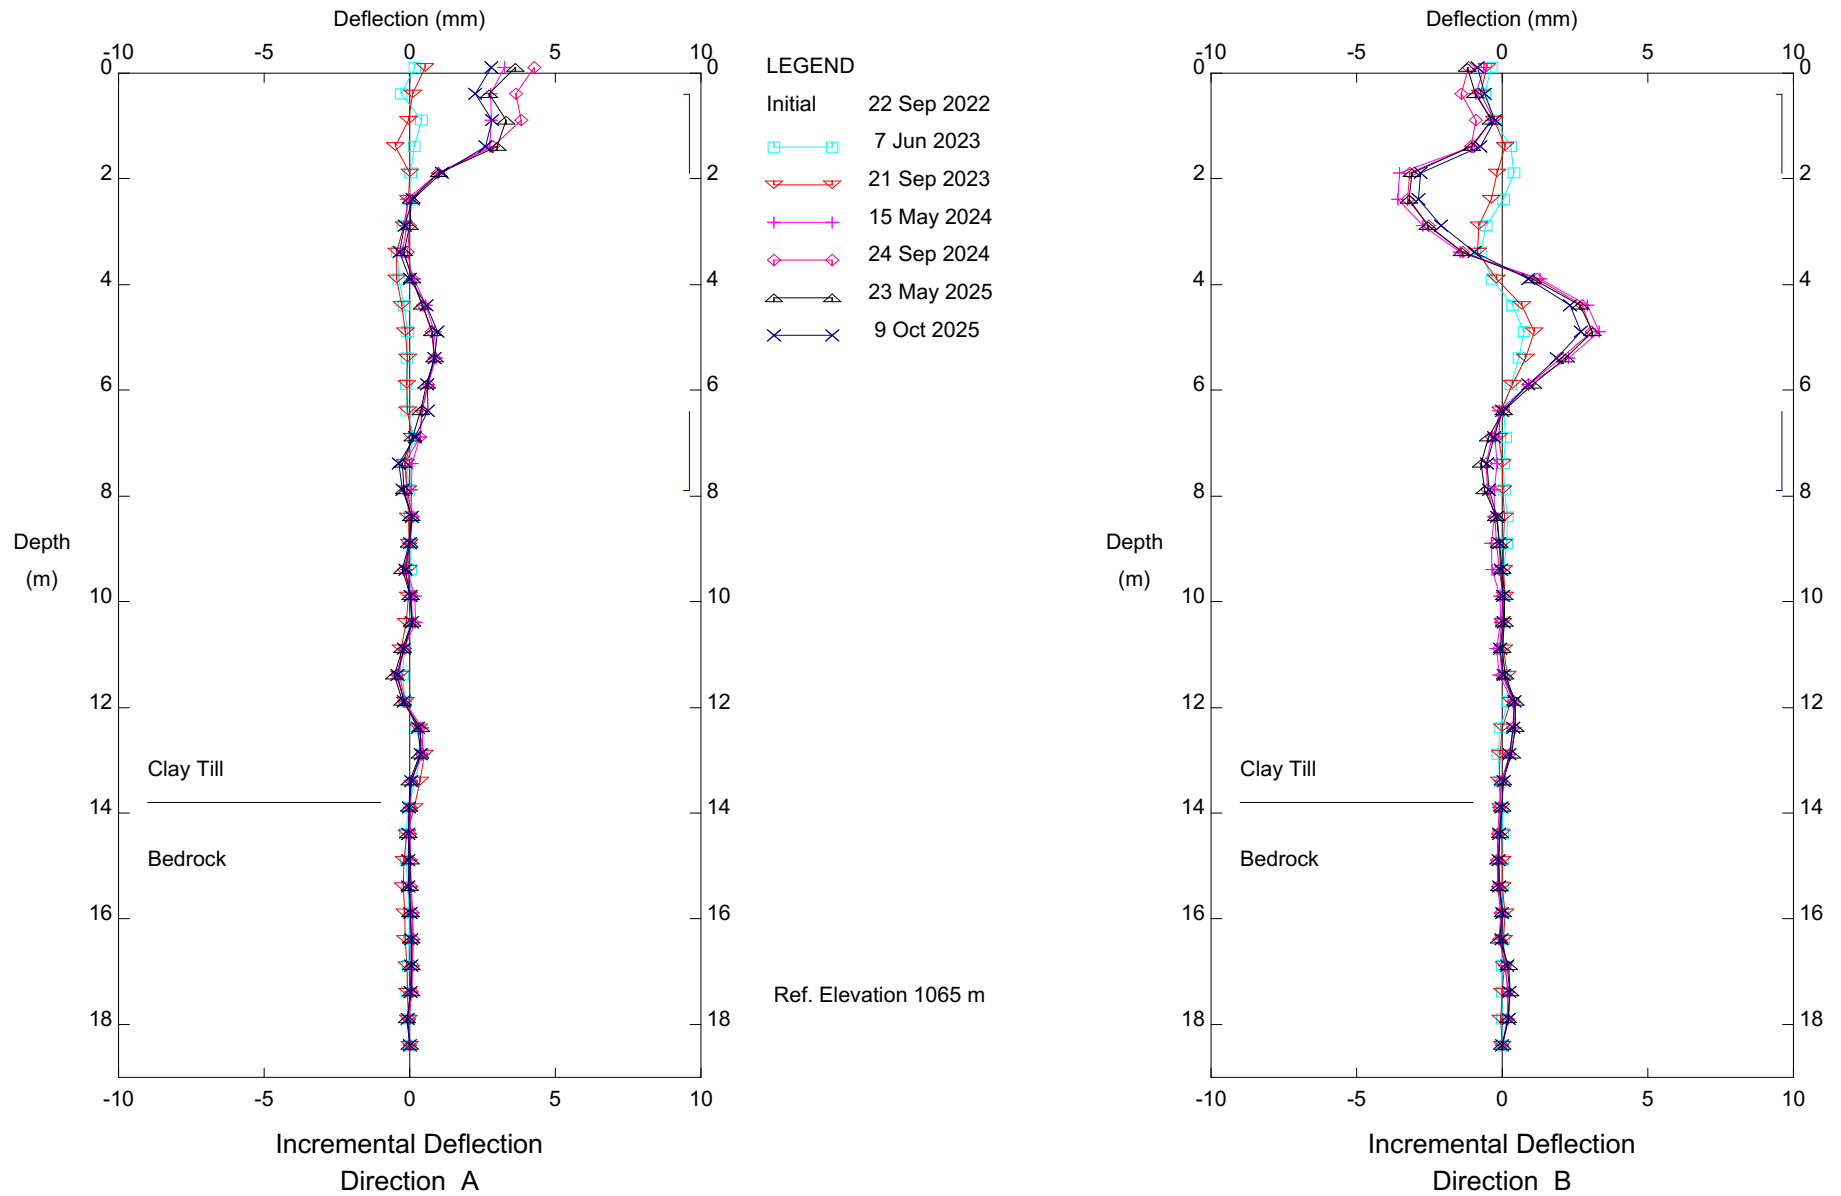
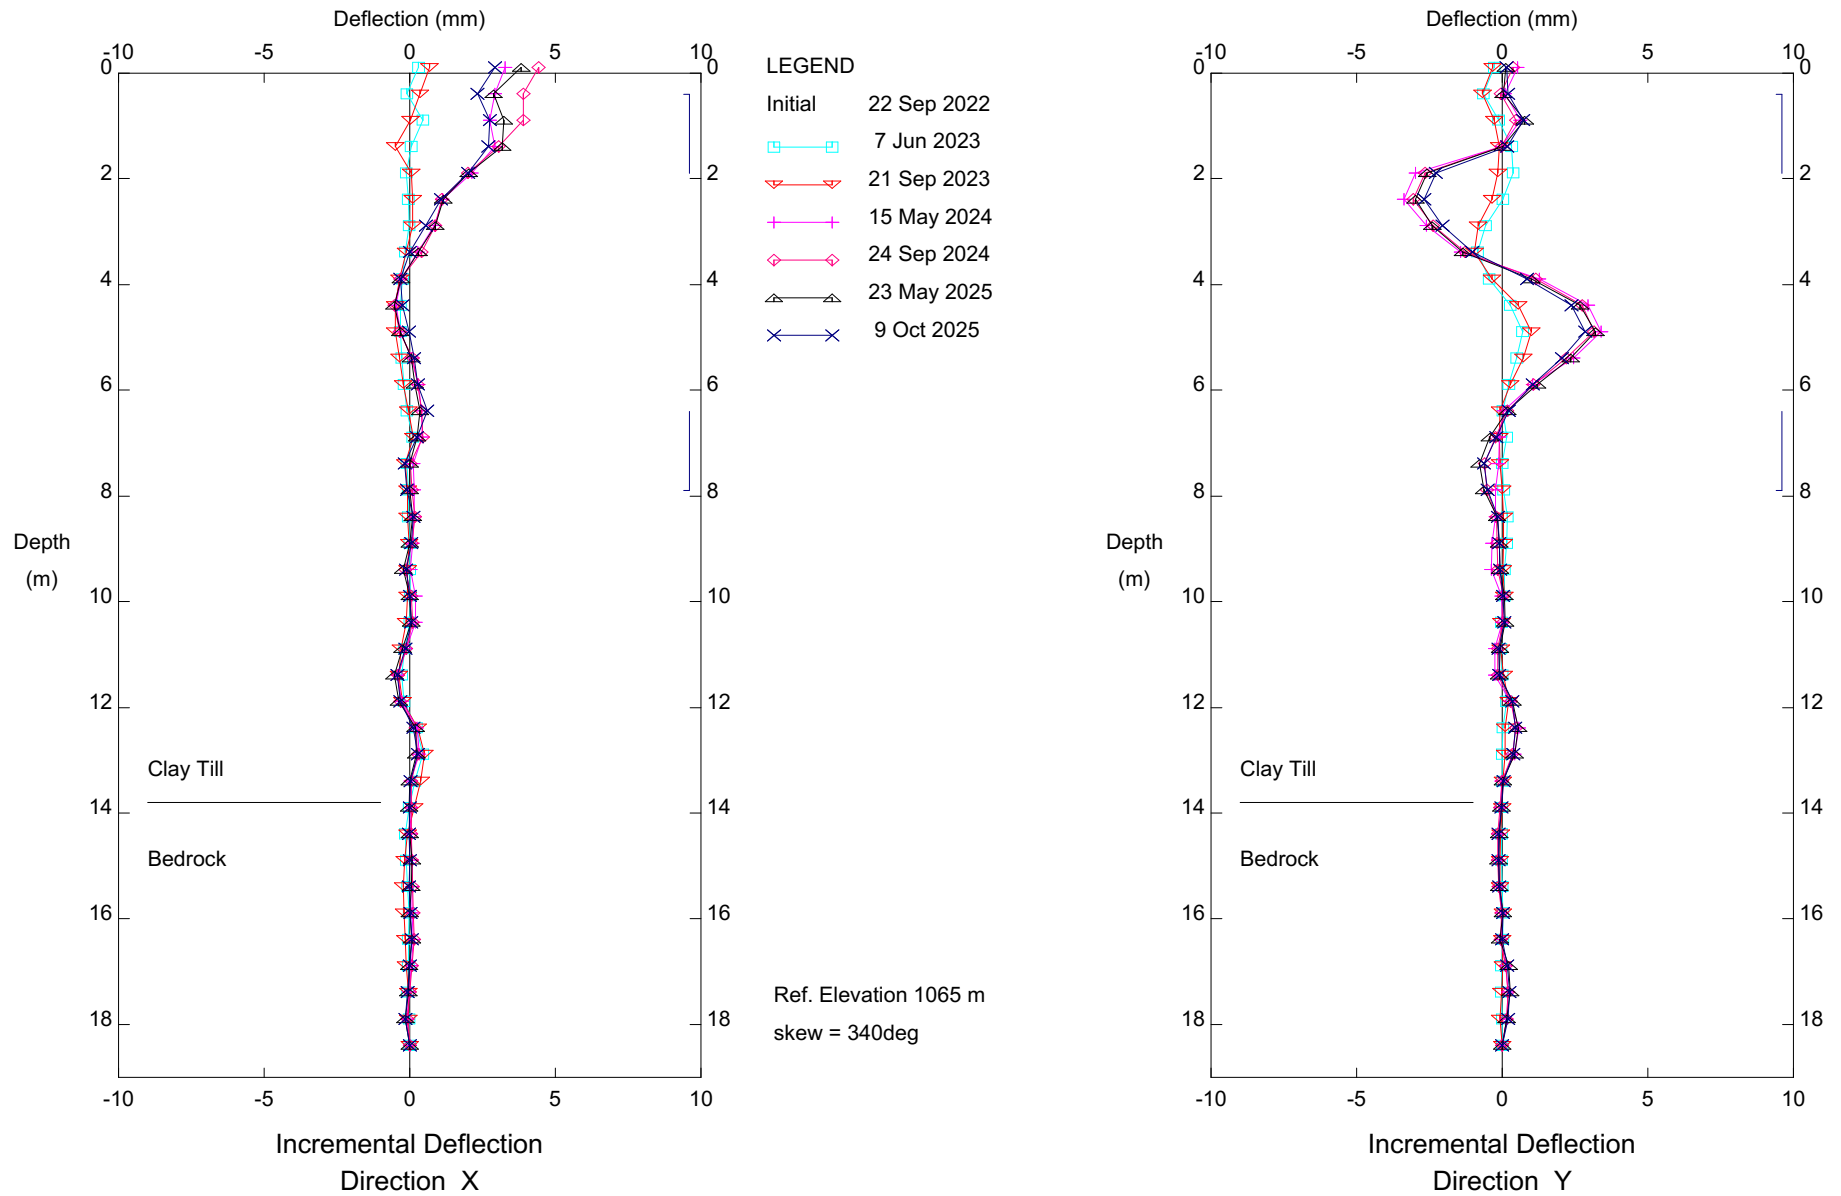
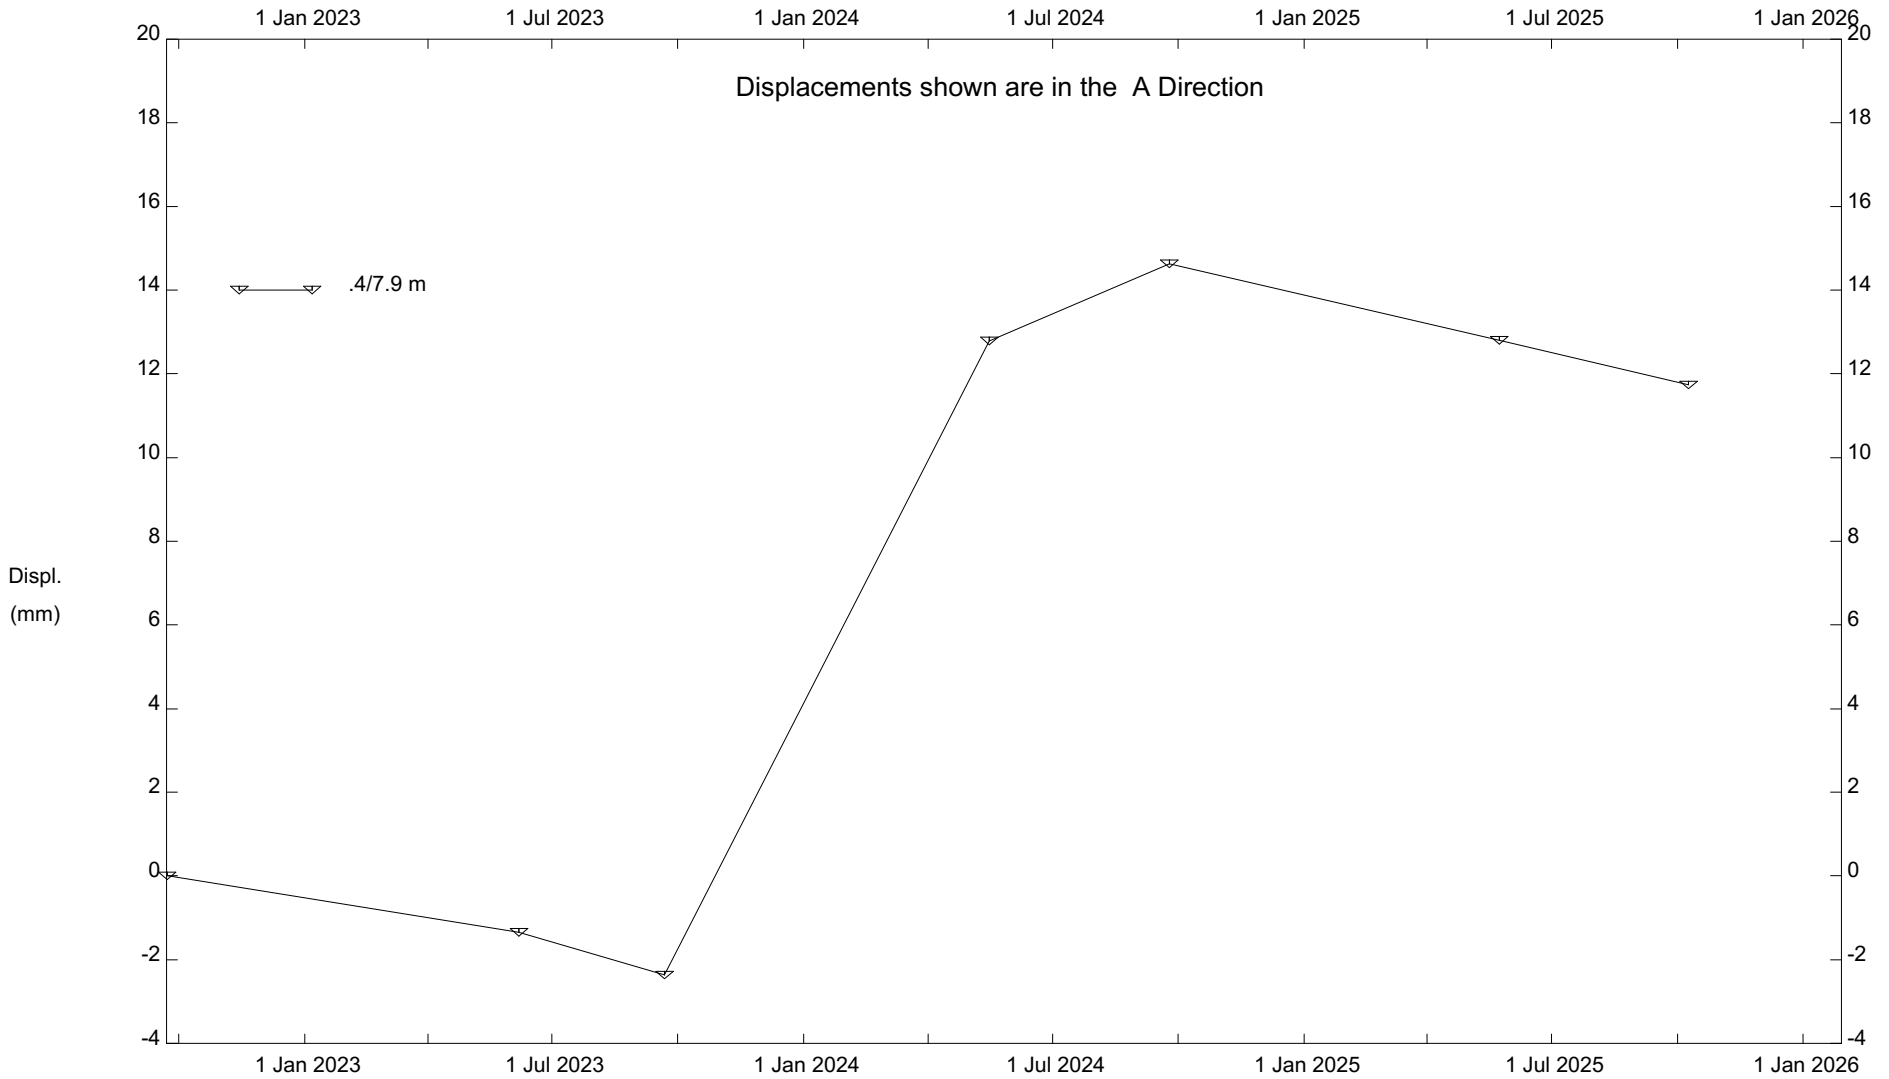
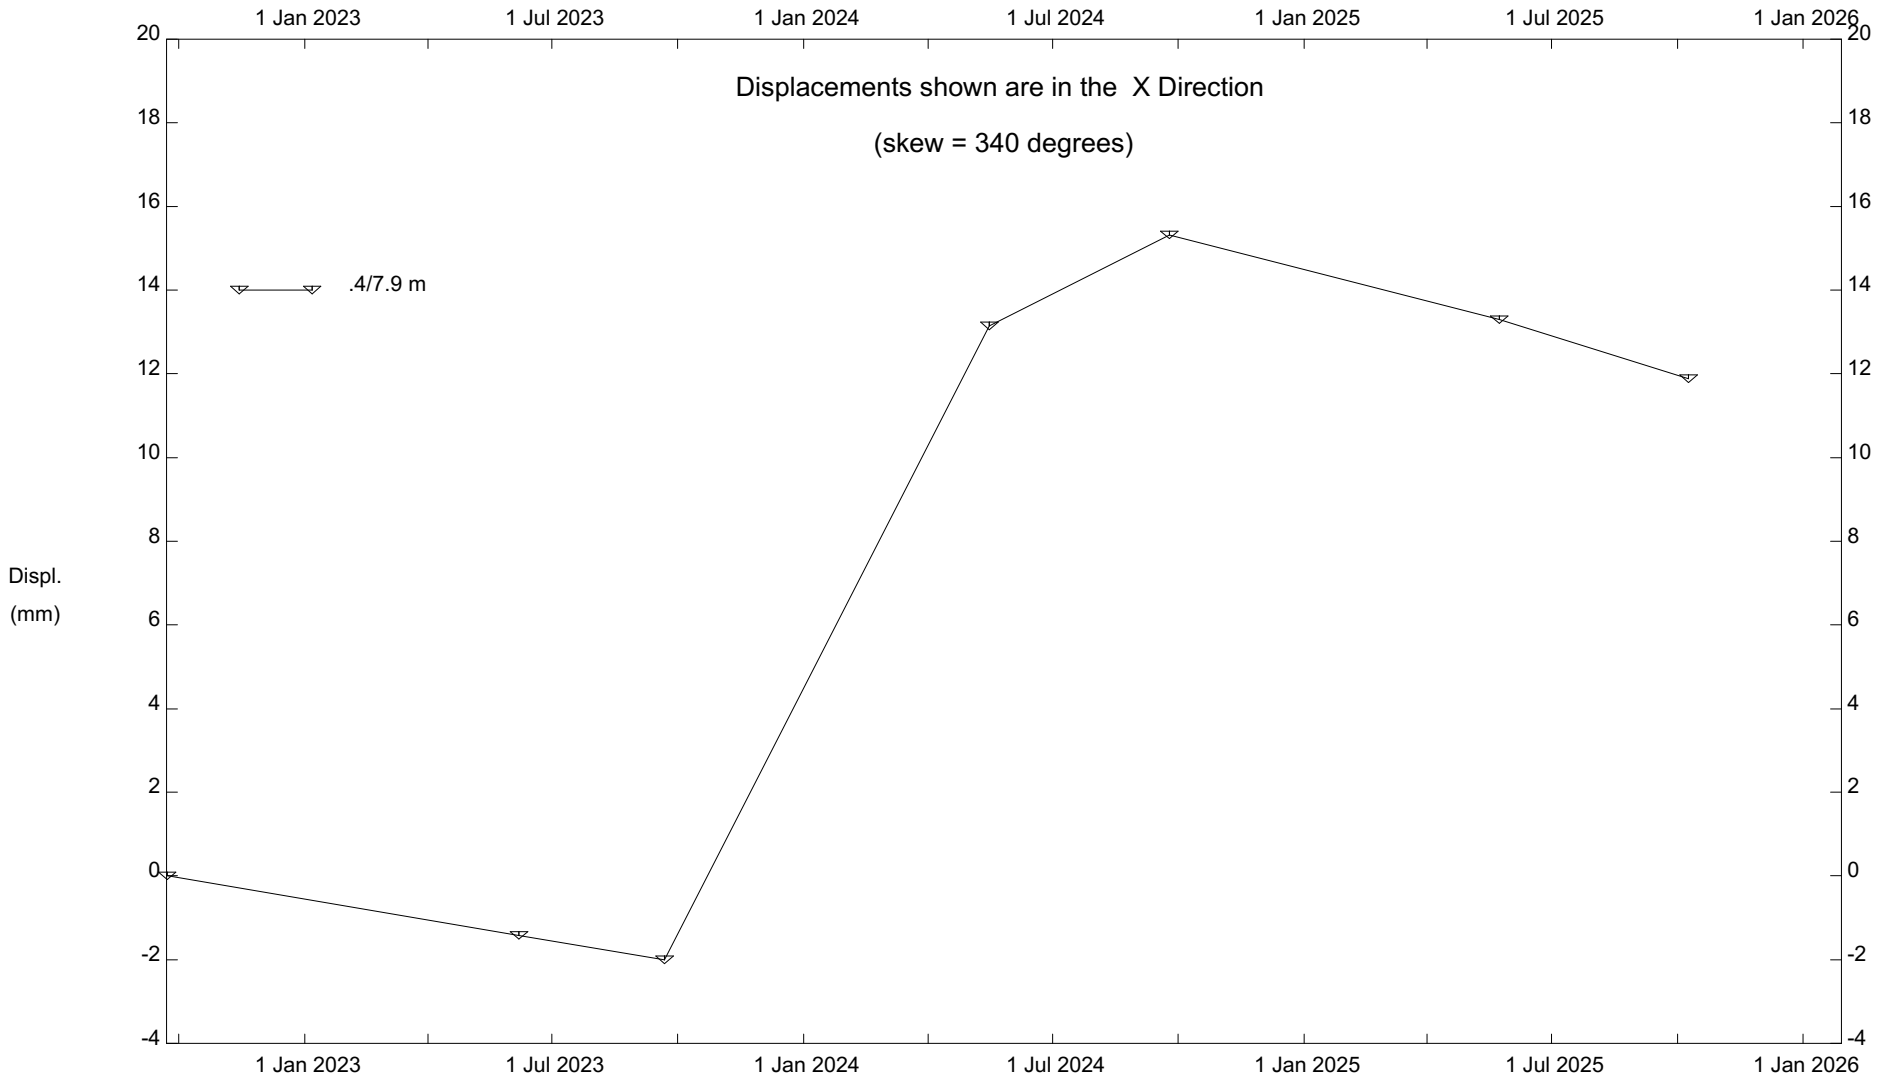
S039; H03:06, West Brocket Slide, Inclinometer SI16-03

Most of the movement recorded in SI16-03 (located east of the slide mass) occurred immediately after installation and could be due to post-installation SI casing flexure. Since late 2018, the rate of movement recorded in SI16-03 has been slow (less than 5 mm/year). Readings since spring 2024 have recorded approximately 9 mm of movement in the top 1.5 m of the SI, suggesting the slide is expanding laterally to the east. Although the data collected spring and fall 2025 readings have shown little decrease in movement, the total movement remains above 12 mm. Additional readings could help confirm the current interpretation of the data and determine whether this is a long-term trend.
