November 26, 2025

Alberta Transportation and Economic Corridors  
2<sup>nd</sup> Floor, 803 Manning Road N.E.  
Calgary, Alberta  
T2E 7M8

**CON0022161 Southern Region GRMP Instrumentation Monitoring**  
**Site S039-I; H03:06, km 12.952 West Bocket Slide**  
**Section C – 2025 Fall Readings**

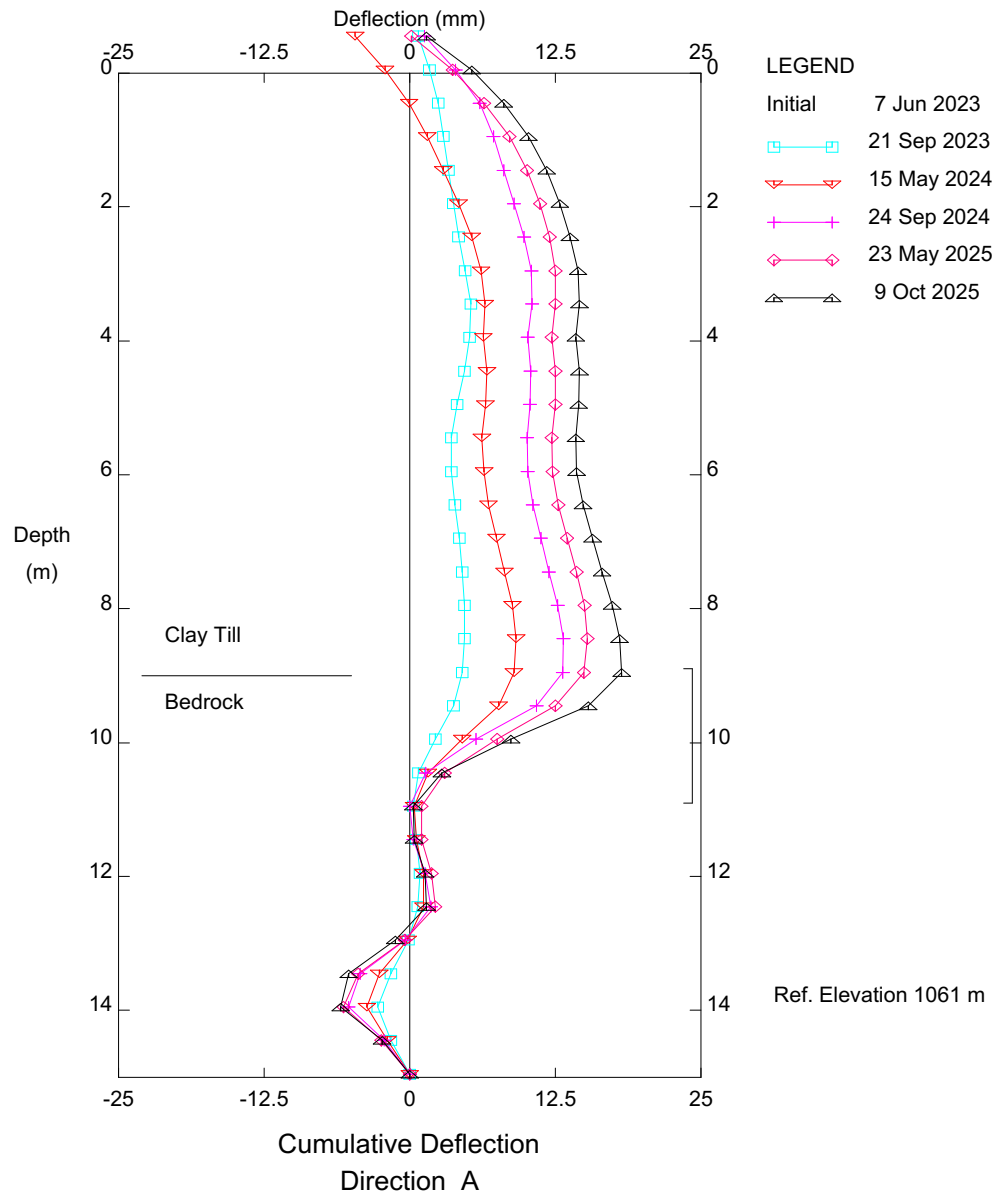
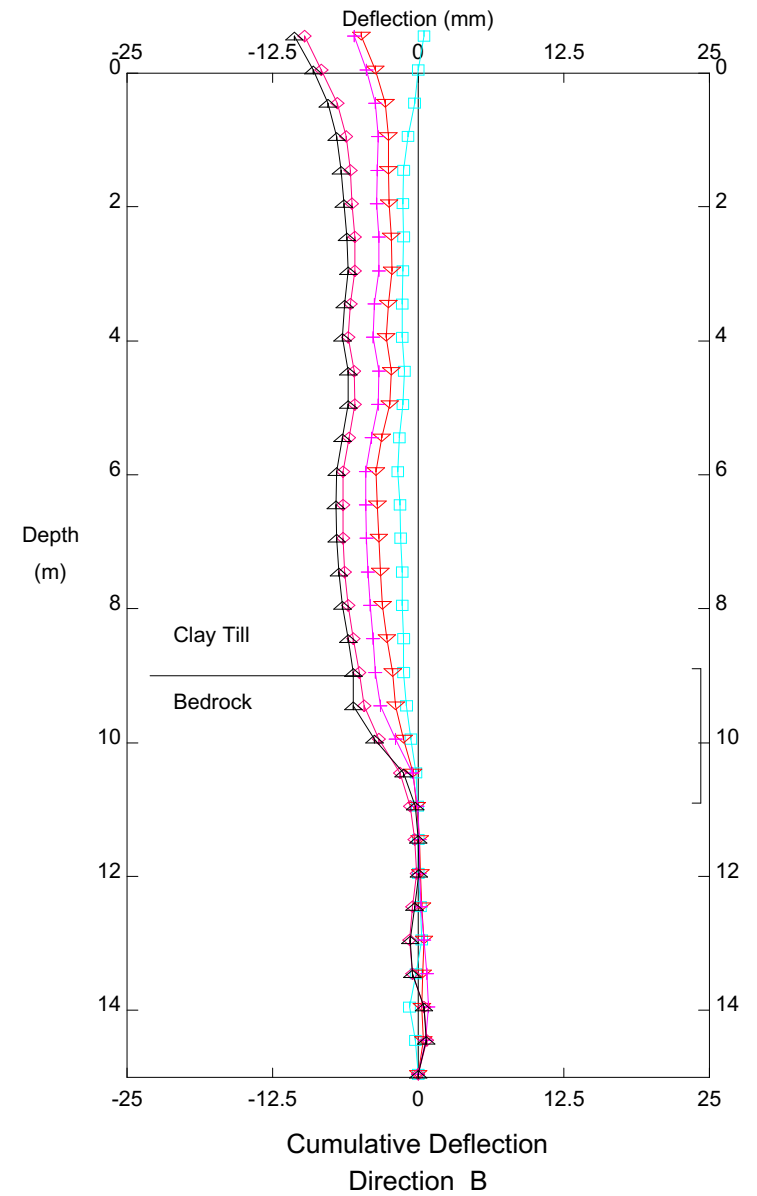
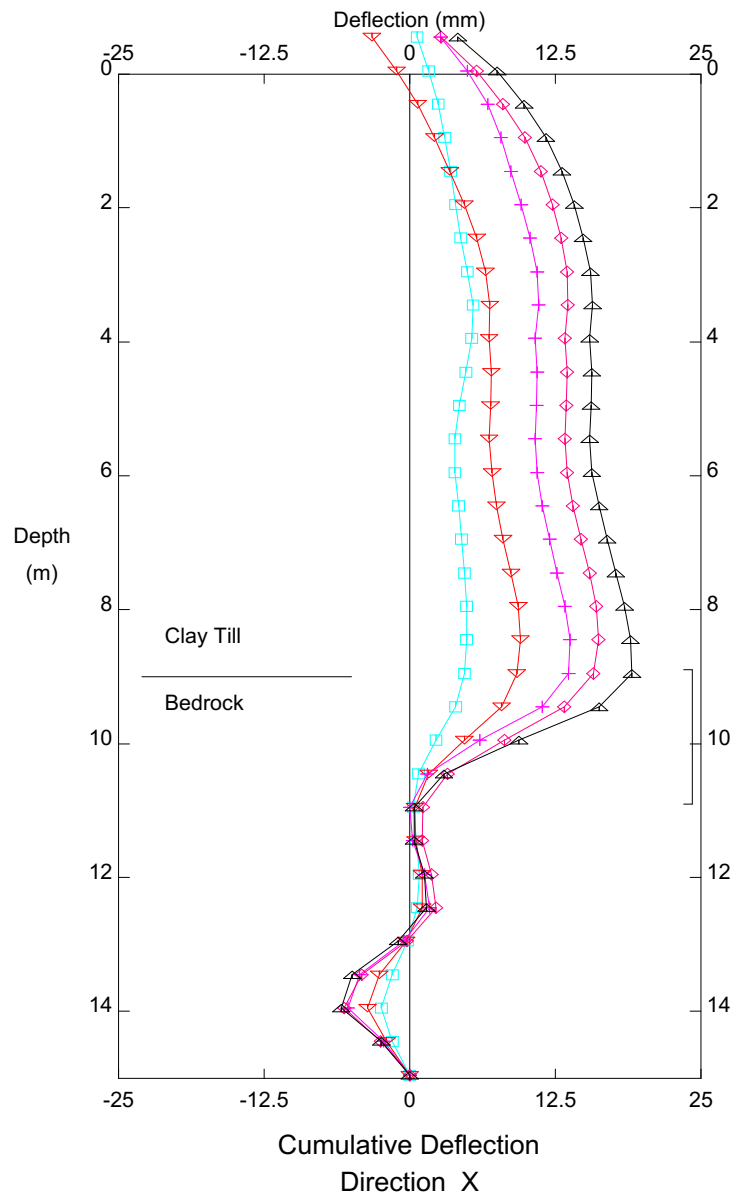
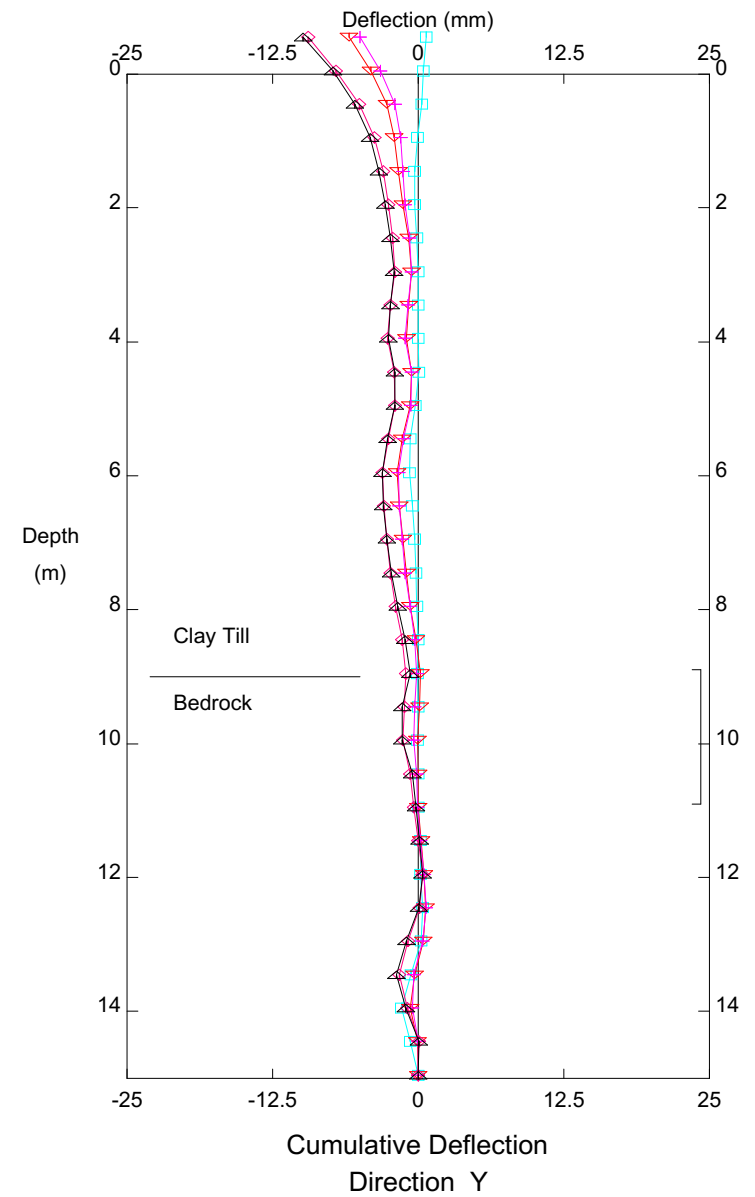
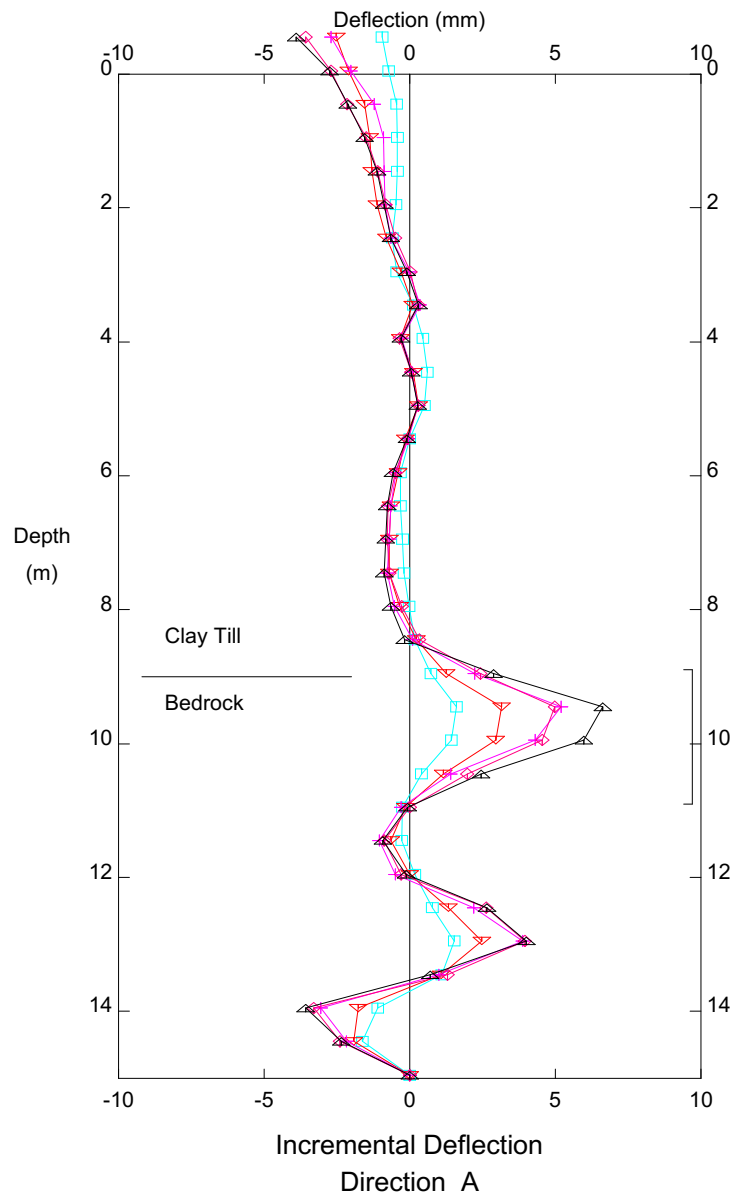
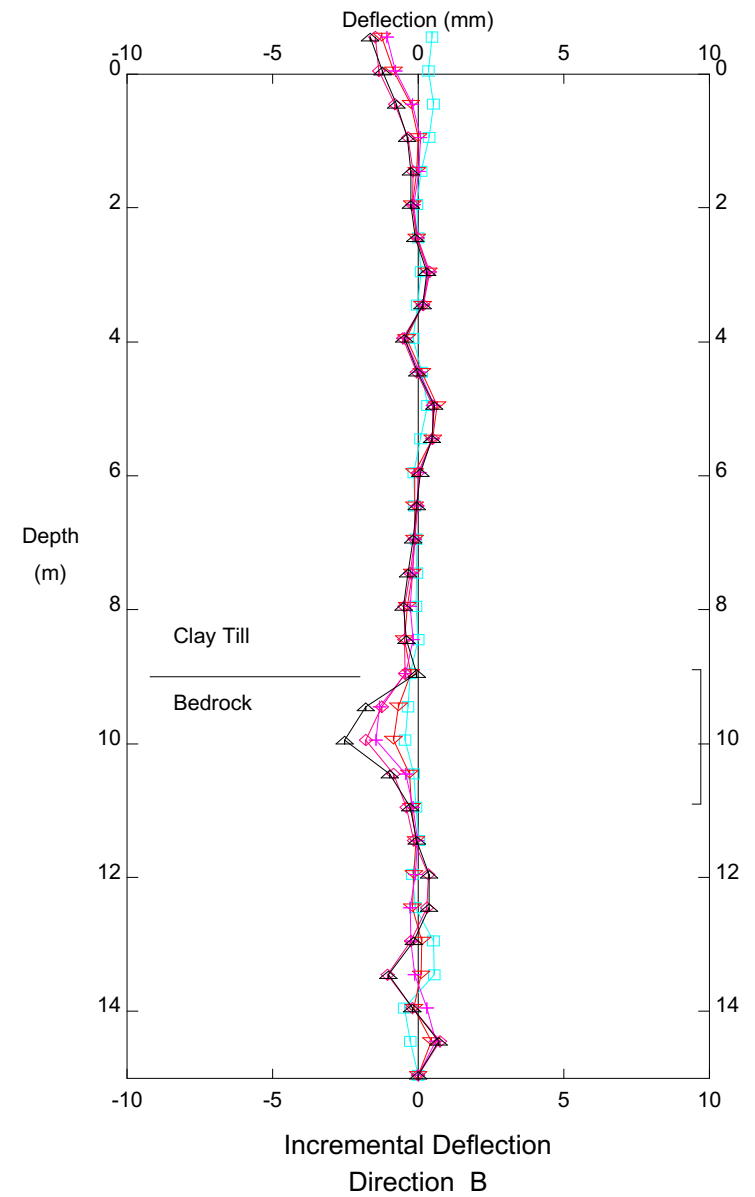
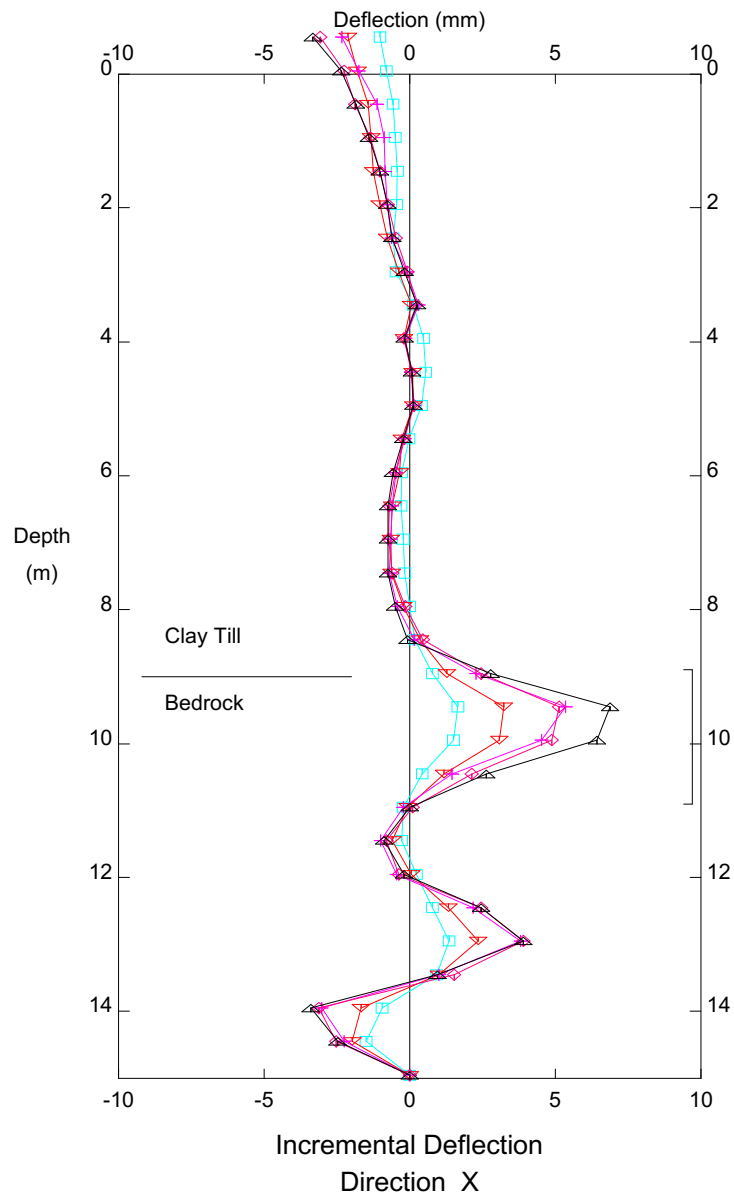
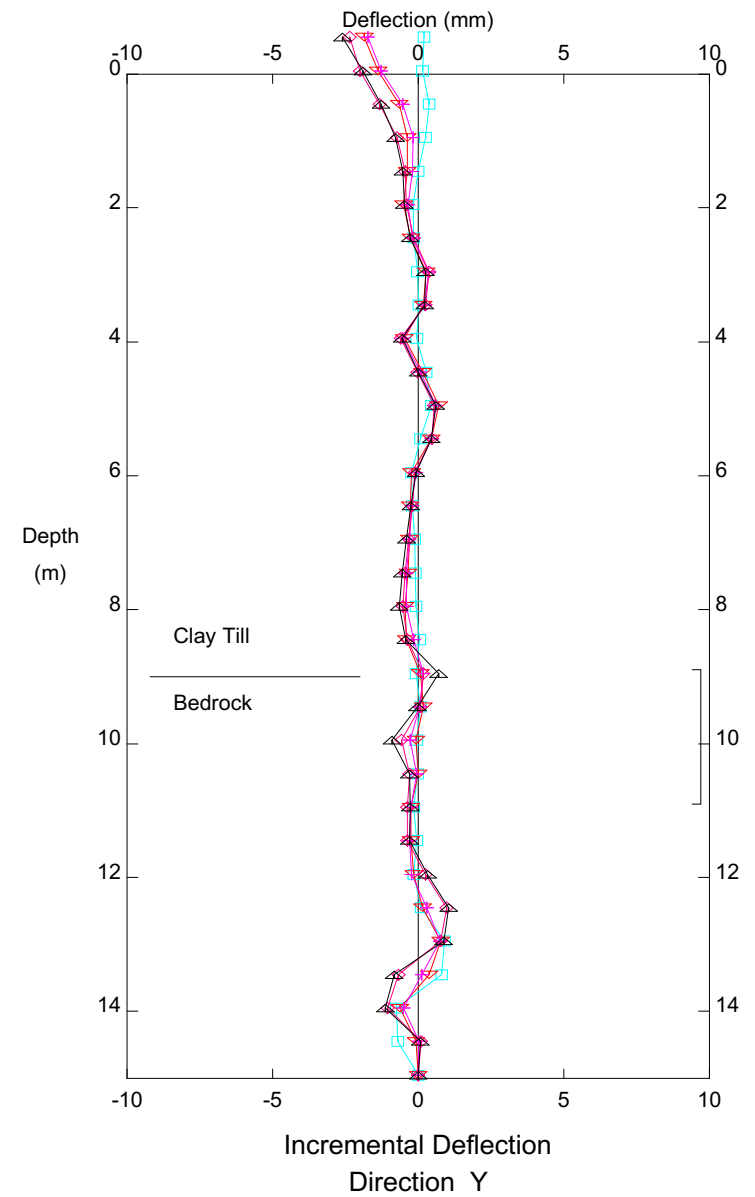
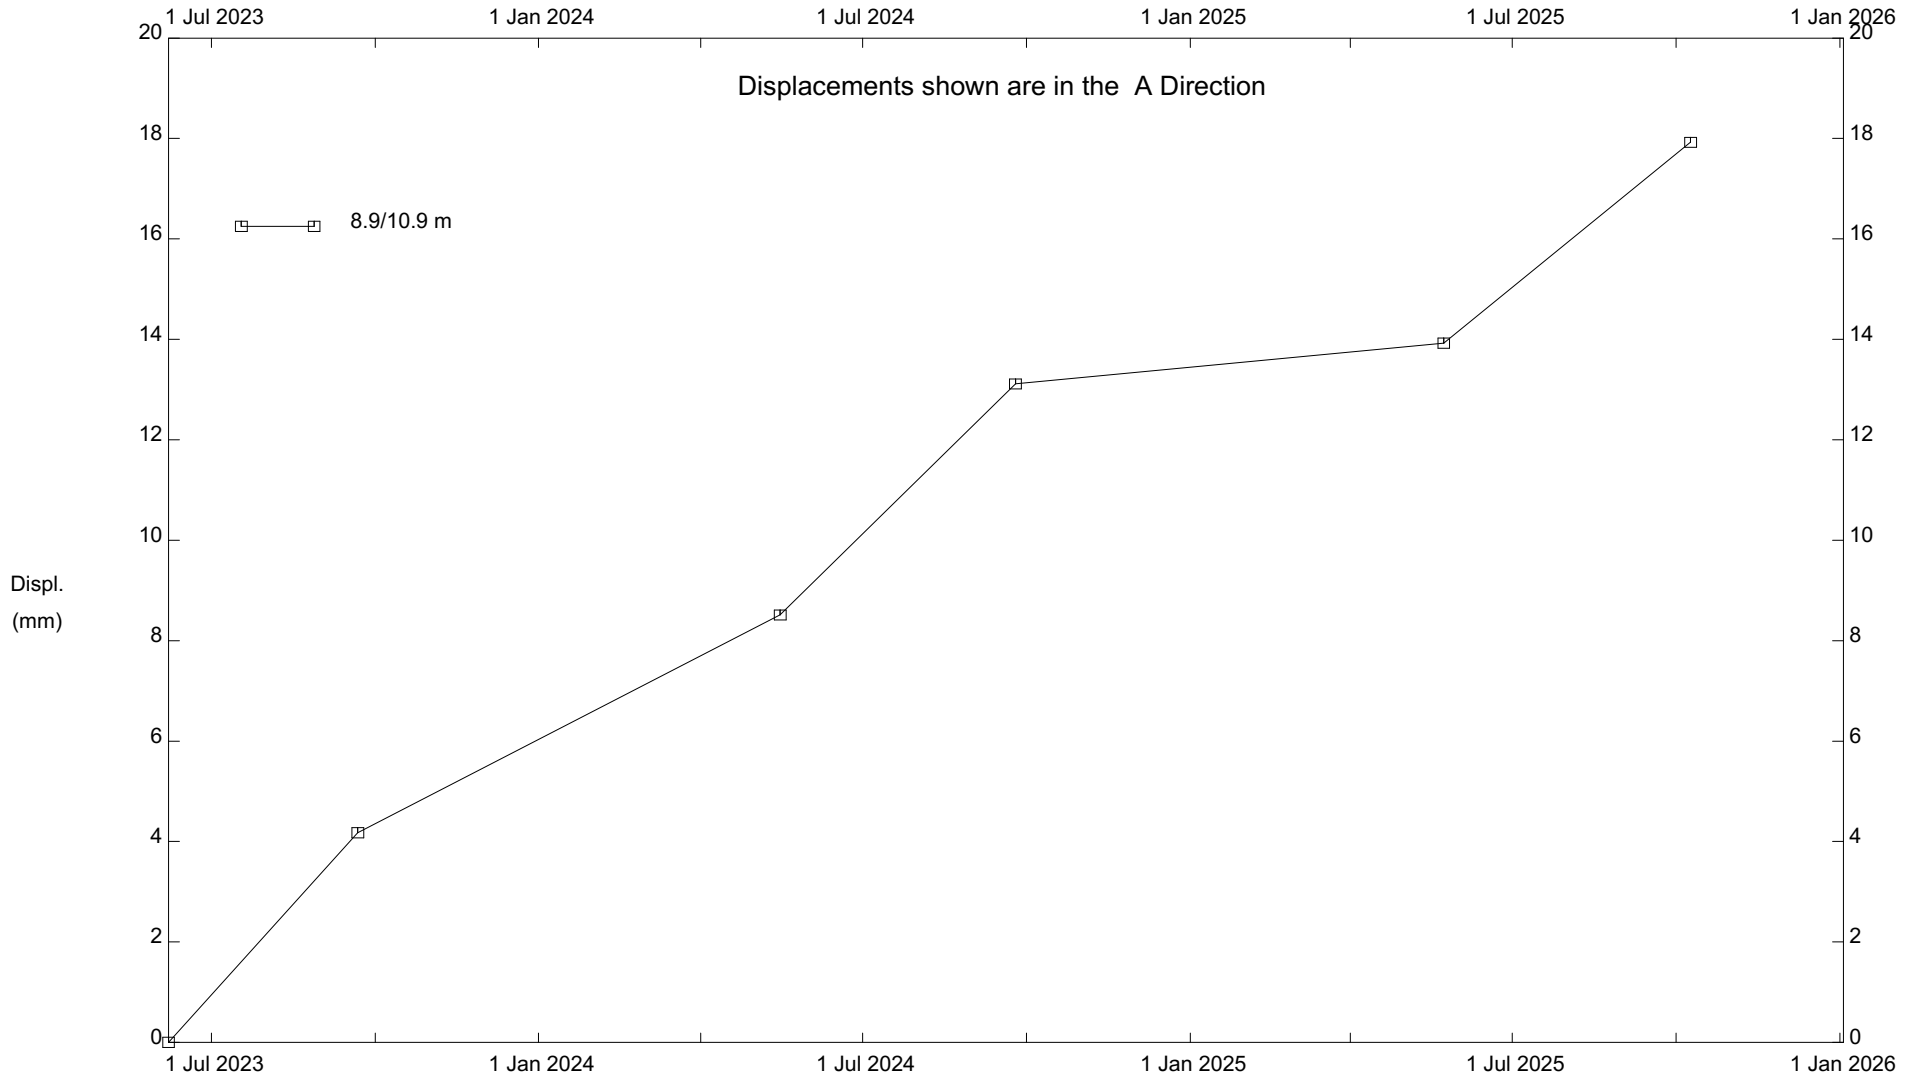
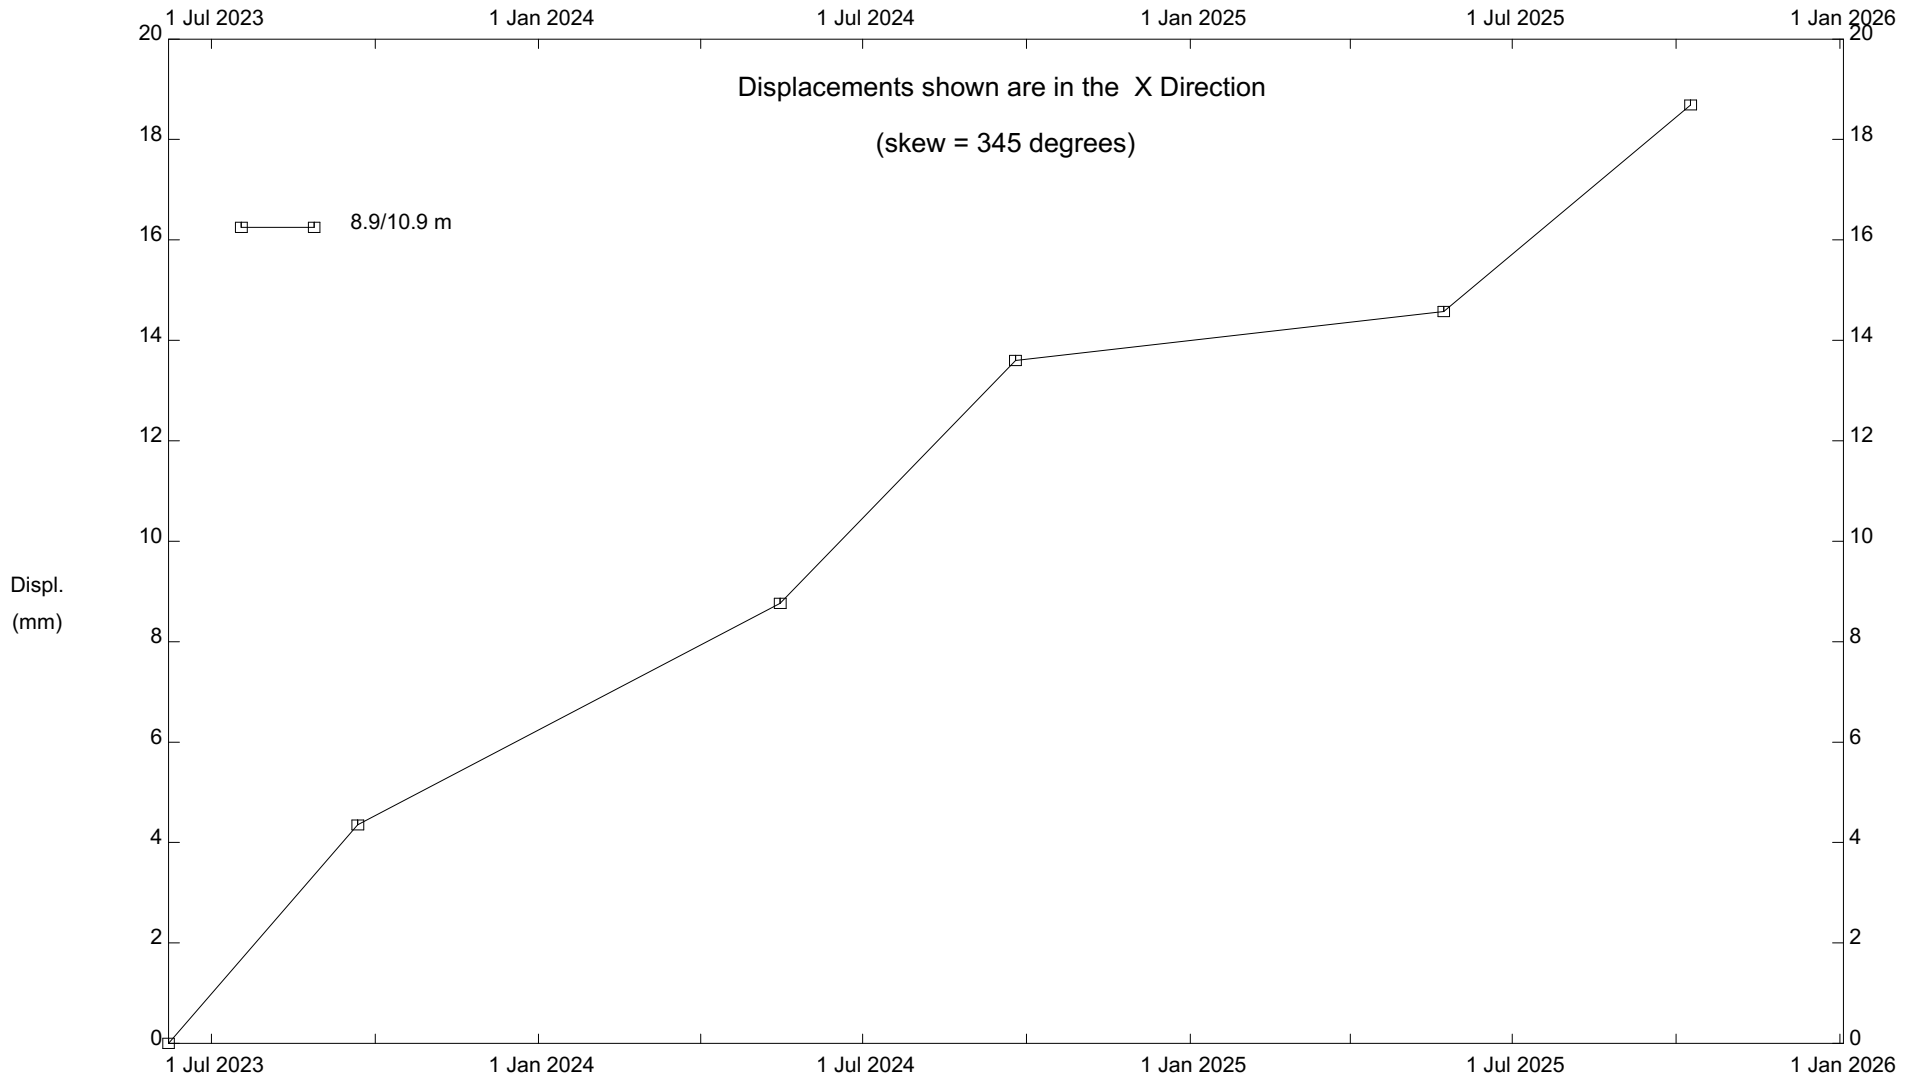
S039; H03:06, West Brocket Slide, Inclinator SI23-02

The SI23-02, located on the west side of the bench at the toe of the repaired section, has shown zones of distributed movement starting at the transition zone of bedrock, approximately at depths of 9 m to 11 m below ground surface (approximately El. 1052.1 m to El. 1050.1 m).

SI23-02 shows that movement has progressively increased since installation, with a total movement reaching 18 mm in the fall of 2025. The magnitude of the movement rates appears to be seasonally correlated with higher rates during the spring and summer. Future readings would confirm the seasonal increase in movement rates for SI23-02.

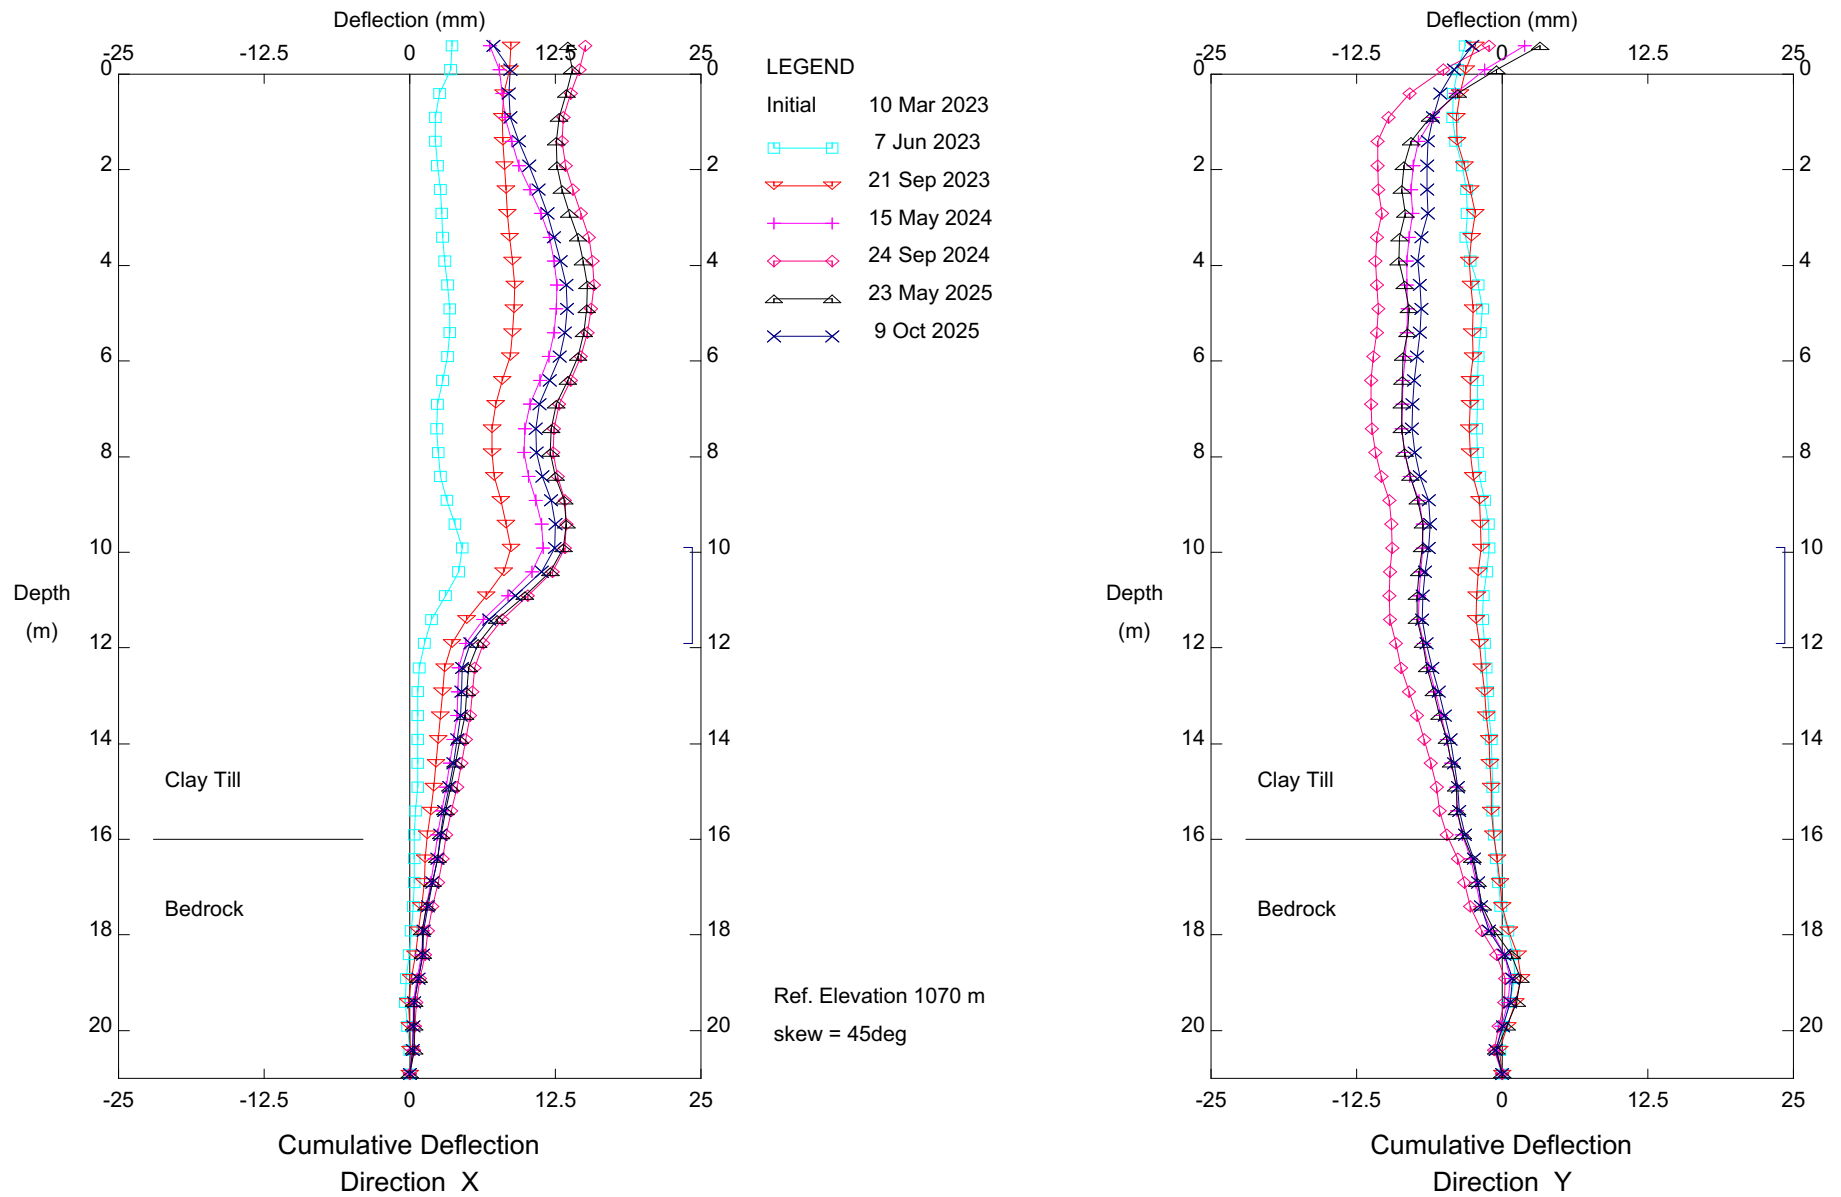
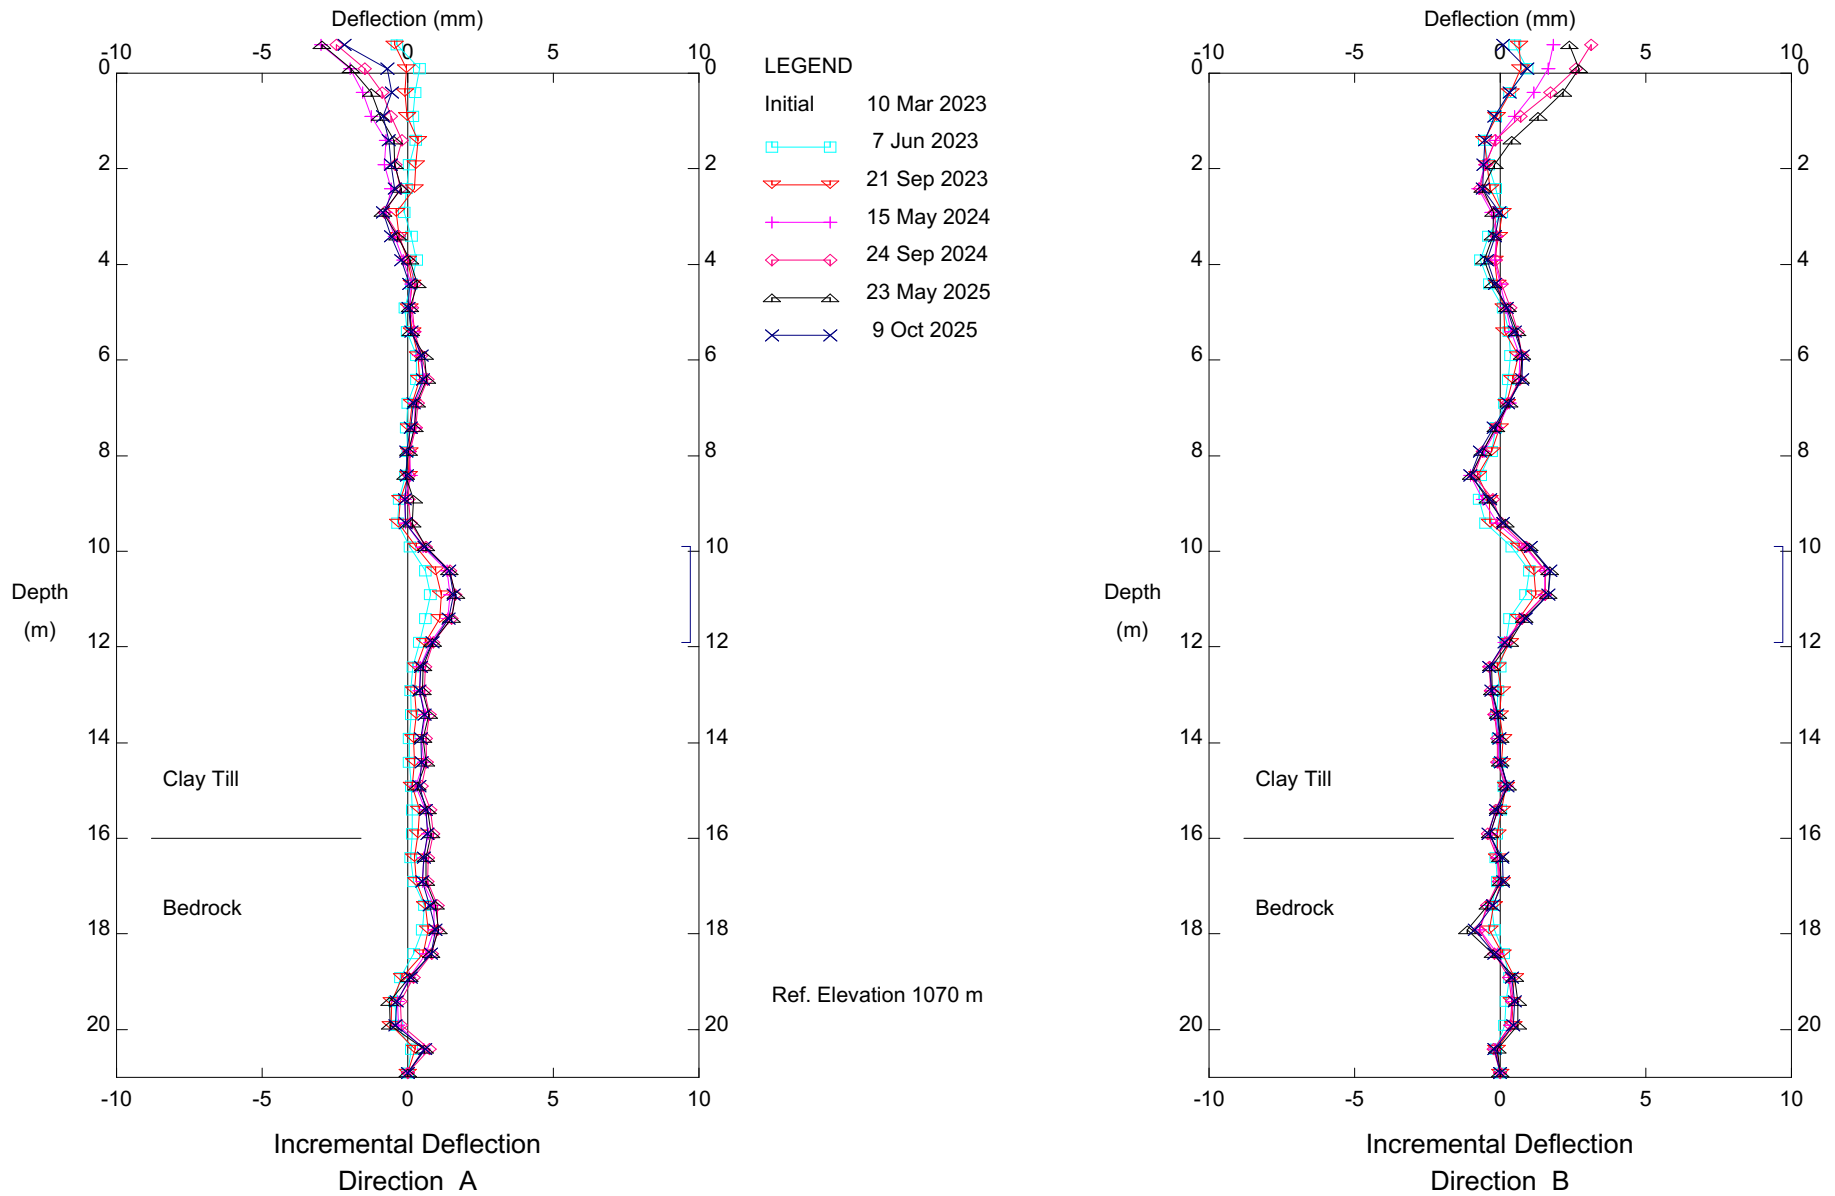
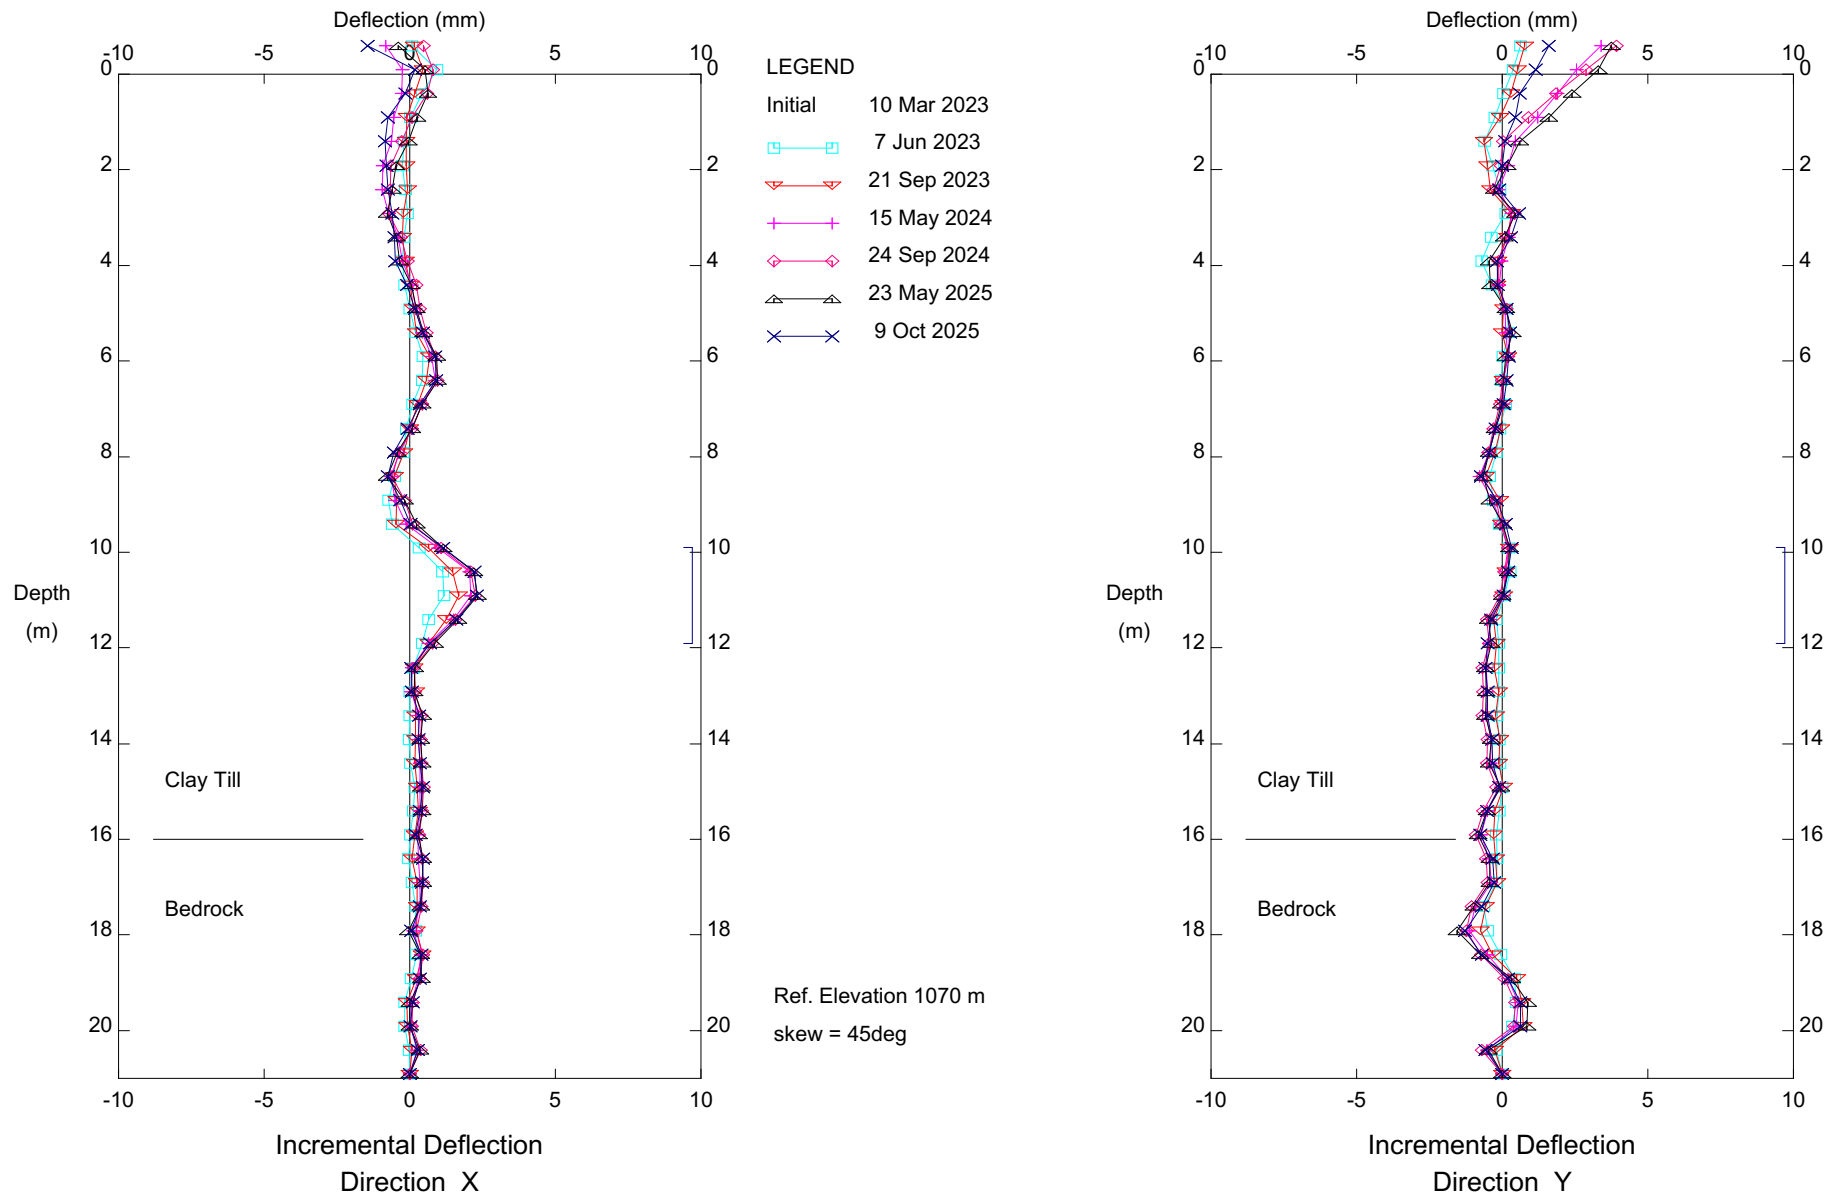
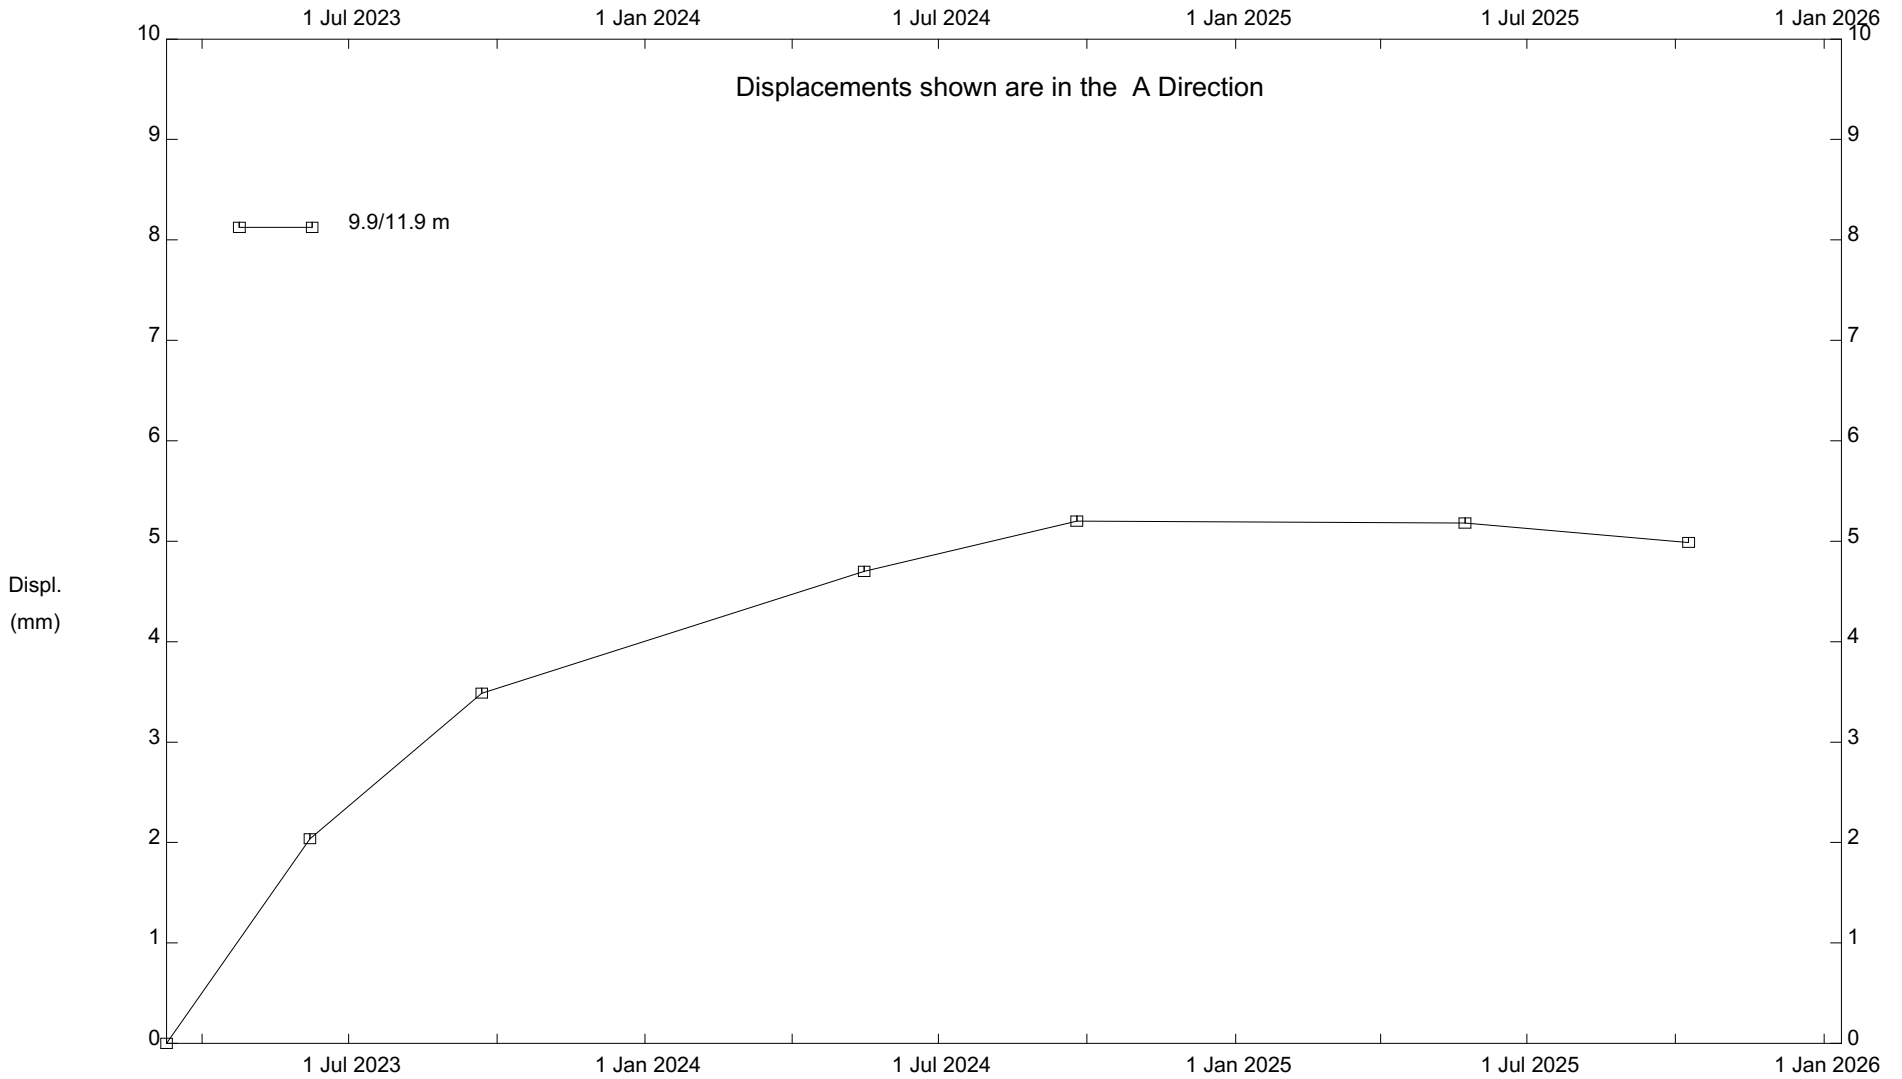
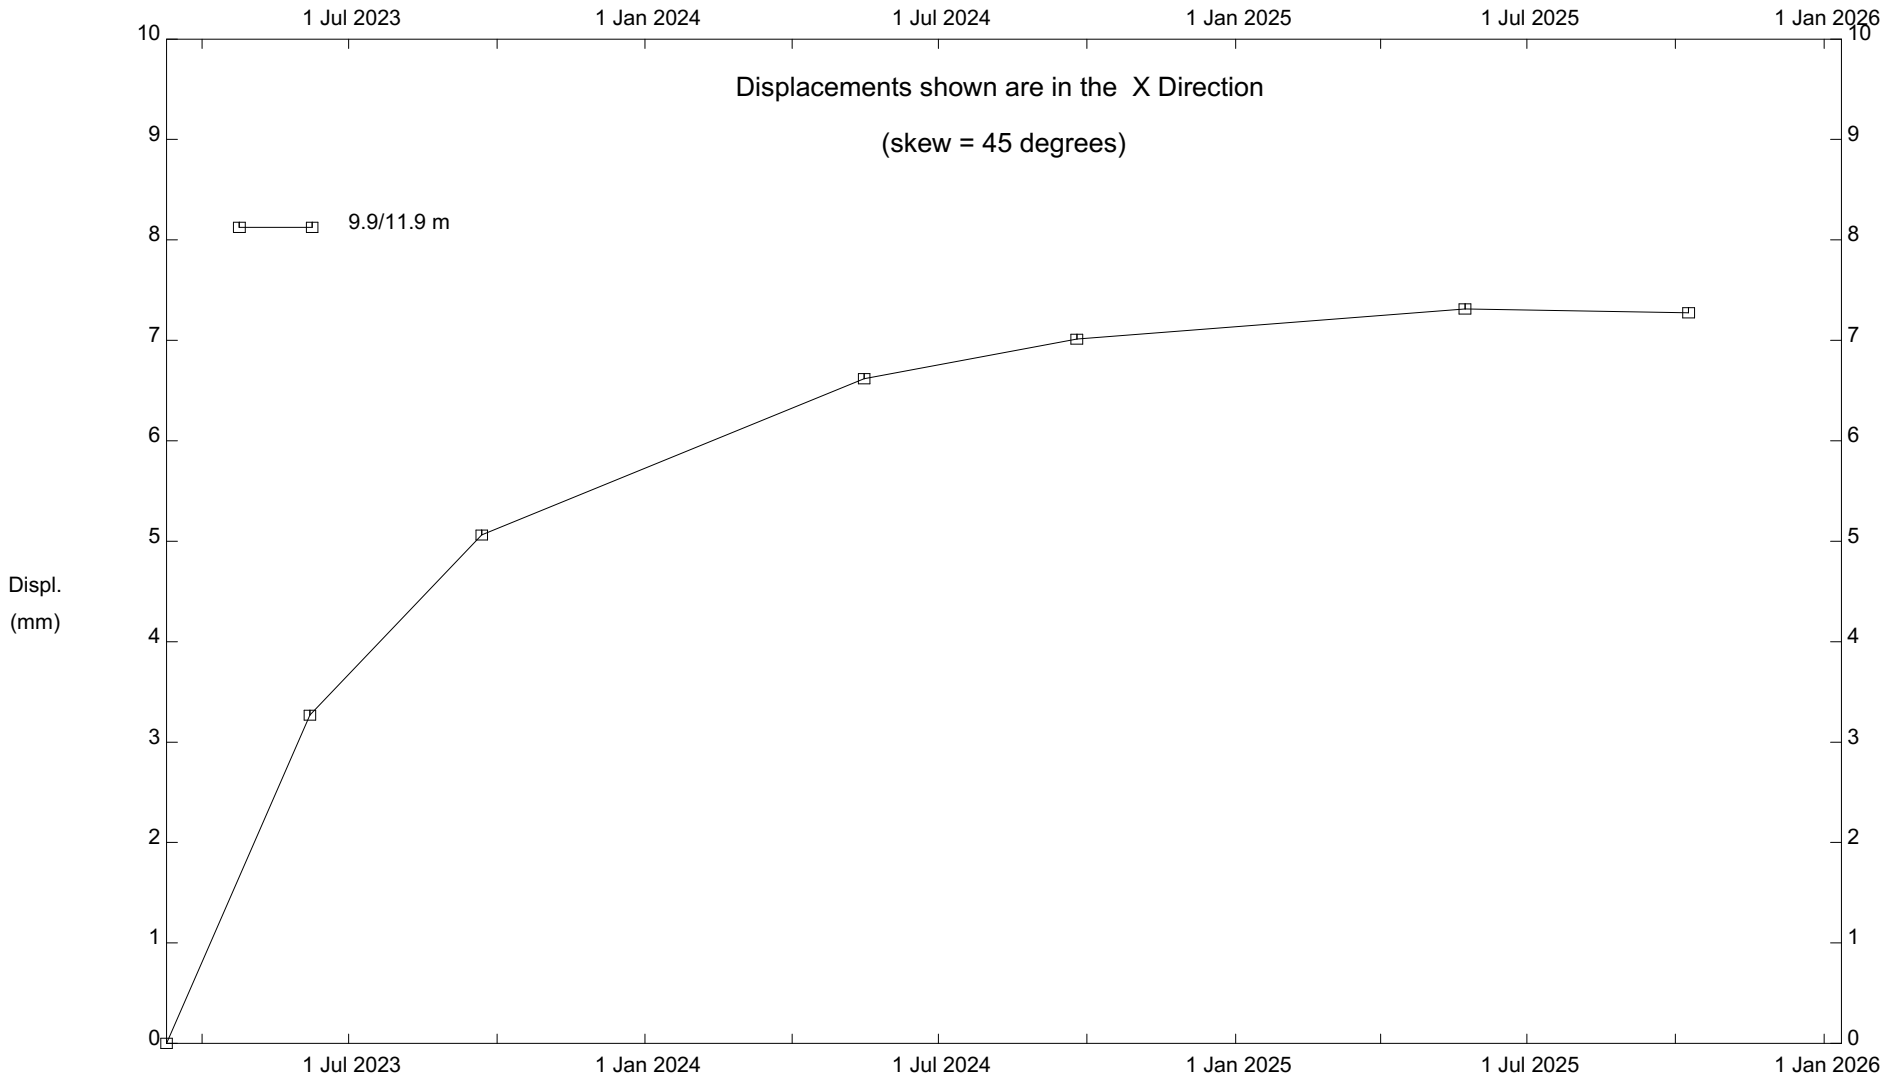
S039 West Brocket Slide, Inclinometer SI 23-03  
Alberta Transportation

SI23-03, located on the west flank of the slide near the crest of the slope, was tilted approximately 1 m over its 21 m depth from installation. The SI23-03 shows a possible zone of distributed movement approximately at 10 m to 12 m below ground surface (approximately El. 1062 m to El. 1057 m) in the clay till and possibly some casing settlement above this depth.

Distributed movement has been recorded in SI23-03 (located west of slide mass) between depths of approximately 10 m to 12 m below ground level at a skew angle of 45 degrees (northeast) from the down slope direction (perpendicular to the highway). Movement at similar depths was previously recorded in SI16-01 (replaced by SI23-03) before it was damaged. This elevation is approximately the same as the bench at the base of the slope. Movement has continued to slow, with only 0.7 mm noted since May 2024.
