November 26, 2025

Alberta Transportation and Economic Corridors  
2<sup>nd</sup> Floor, 803 Manning Road N.E.  
Calgary, Alberta  
T2E 7M8

**CON0022161 Southern Region GRMP Instrumentation Monitoring**  
**Site S039-I; H03:06, km 12.952 West Bocket Slide**  
**Section C – 2025 Fall Readings**

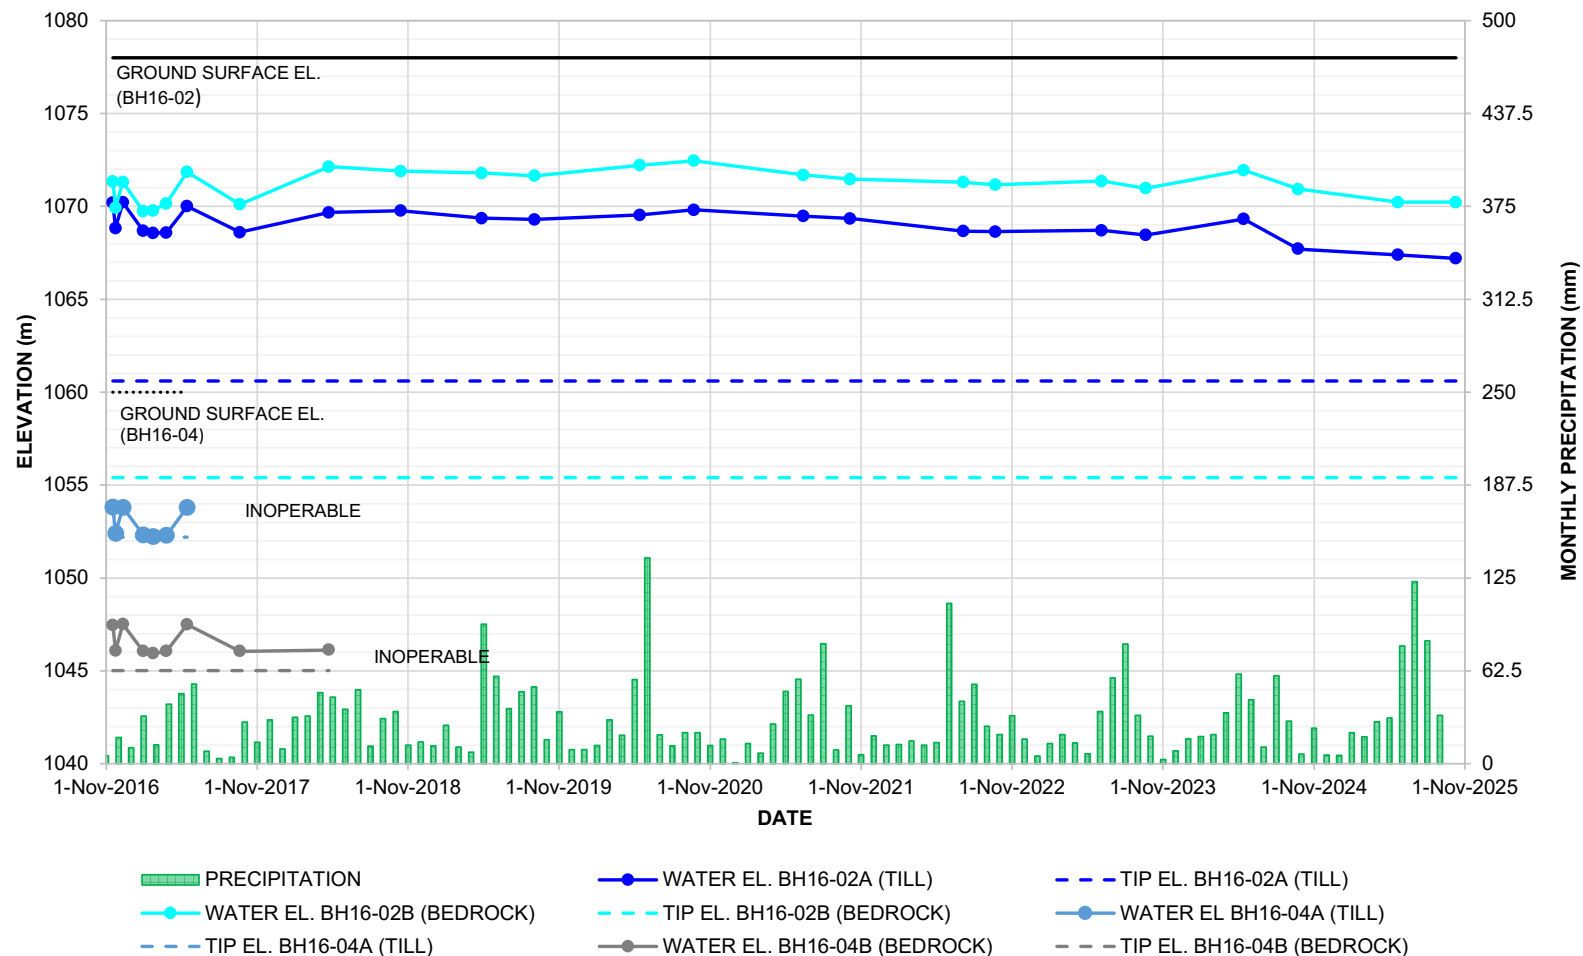
Piezometer Data  
S039 - West Brocket Slide  
Hwy 03:06 km 12.952

Since fall 2017, the water levels recorded in the two VWPs installed in BH16-02A (clay till) and BH16-02B (bedrock) have been relatively steady (up to  $\pm 1.0$  m), except for an approximate 1.9 m to 1.7 m decrease recorded in these instruments, respectively, since the spring 2024 readings. The last three readings of these instruments are the lowest recorded since installation (up to 0.7 m and 0.8 m lower, respectively).

In May 2023, during the Section B inspection, a wet area was noted at the eastern extent of the repair slope, which did not relate to the water levels recorded in the VWPs read in June 2023. During the 2024 fall readings in September, no wet areas were observed on the slope. During the 2025 spring readings, some wet areas were observed at the toe of the slope, but they were minor and may have been due to rainfall earlier that day. No wet spots noted during the 2025 fall readings in October. Still, wet areas on the slope may be associated with perched water tables in more permeable seams, as previously reported by KCB and Thurber. Data loggers should be installed on the VWPs to obtain more information on how groundwater levels fluctuate in relation to snowmelt and precipitation events.

A data logger should be installed on the functioning VWP's upslope of the repair section to monitor groundwater fluctuations throughout the year.
