SITE NUMBER AND NAME: S039-1 Brocket Slides	HIGHWAY & KM: 3:06, 12.952	PREVIOUS INSPECTION DATE: May 29, 2024	INSPECTION DATE: May 28, 2025
LEGAL DESCRIPTION: 09/10-07-007-28 W4M	NAD 83 COORDINATES: UTM Northing Easting 12 5491976 298990	RISK ASSESSMENT: PF: 13 CF: 3 TOTAL: 39	
AVERAGE ANNUAL DAILY TRAFFIC (AADT): 5240 (west) & 5260 (east) (Reference No. 84050)		CONTRACTOR MAINTENANCE AREA (CMA): 522

PRIMARY SITE ISSUE: Landslide in the north highway embankment/valley slope likely attributed to weak fine-grained soils and elevated groundwater table.
APPROXIMATE DIMENSIONS: The landslide is approximately 45 m wide at edge of westbound lane (undermining edge of pavement). The approximate height of the river valley slope is 50 m with an average slope of 2.0H:1.0V. The overall width of the unstable zone is approximately 135 m. The repaired section has an approximate height of 13 m with a slope of 1.5H:1V to the midslope bench.
DATE OF ANY REMEDIAL ACTION: 2023 – the slope above the bench was graded, and 215 soil nails 16 m long were installed. Over the soil nail section of the repair, a steel grid wire mesh was installed, and the slope surface was seeded.

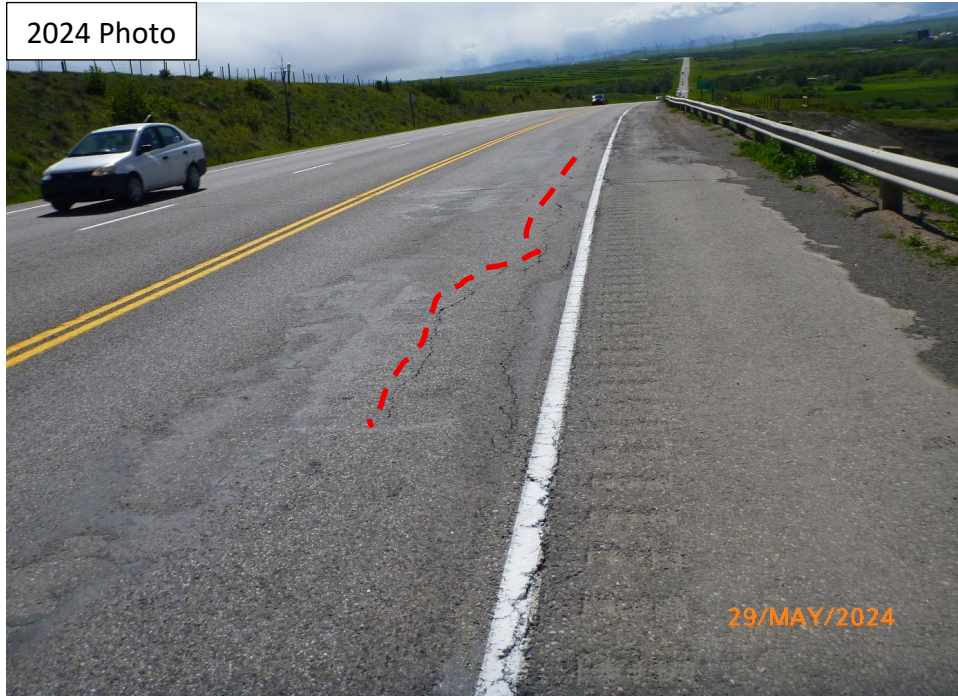
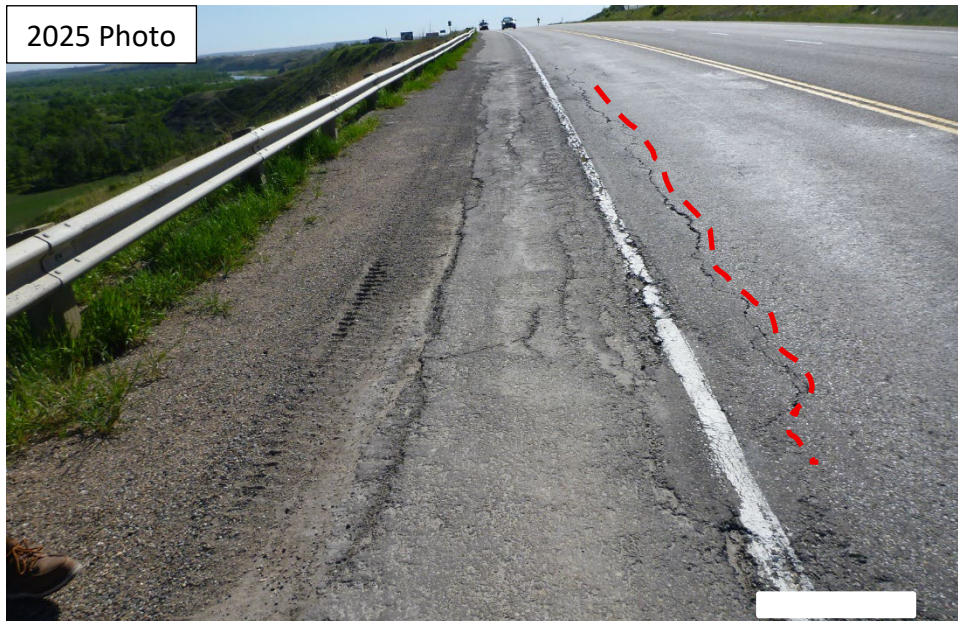
- The longitudinal pavement cracking along the crest of the slope does not appear to have changed between the 2024 and 2025 inspections (Photo 1). The cracking is along approximately a 20-m length of the highway above the slope.

- The guardrail along the crest of the slope appears to be in good condition, and no obvious deflection was observed during the 2025 inspection (Photos 1 and 2).

Photo 1 Comparison of pavement distress (cracking and settlement) along the crest of the slope between the 2024 and 2025 inspections (red dashed line). Distress appears similar between the consecutive inspections. Photos taken May 29, 2024, facing west, and May 28, 2025, facing east.

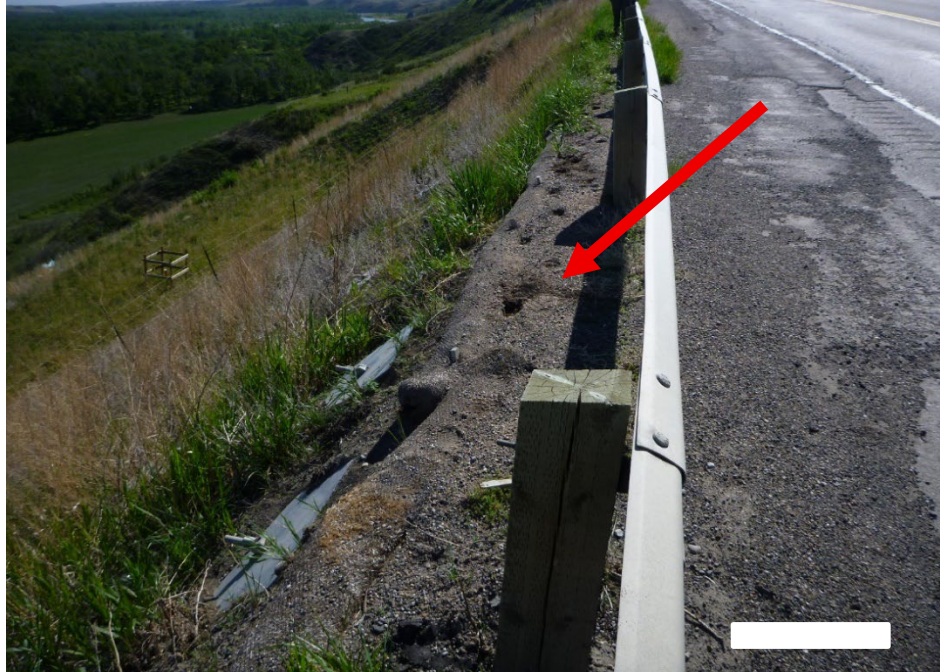
- The granular fill berm installed at the crest of the slope in October 2023, to direct surface water flow from the highway further downslope (east), is eroding and is almost gone (Photo 2). It appears the gravel berm was constructed on top of straw wattles, which have now settled and shifted downslope. During the 2025 inspection, there was no evidence of recent erosion. KCB suspects the berm may be completely washed out after a large rainfall event.

Photo 2 Sand and gravel berm at the crest of the slope is being eroded from surface water runoff from the highway surface. Straw wattle is almost buried. Photo taken May 28, 2025, facing east.

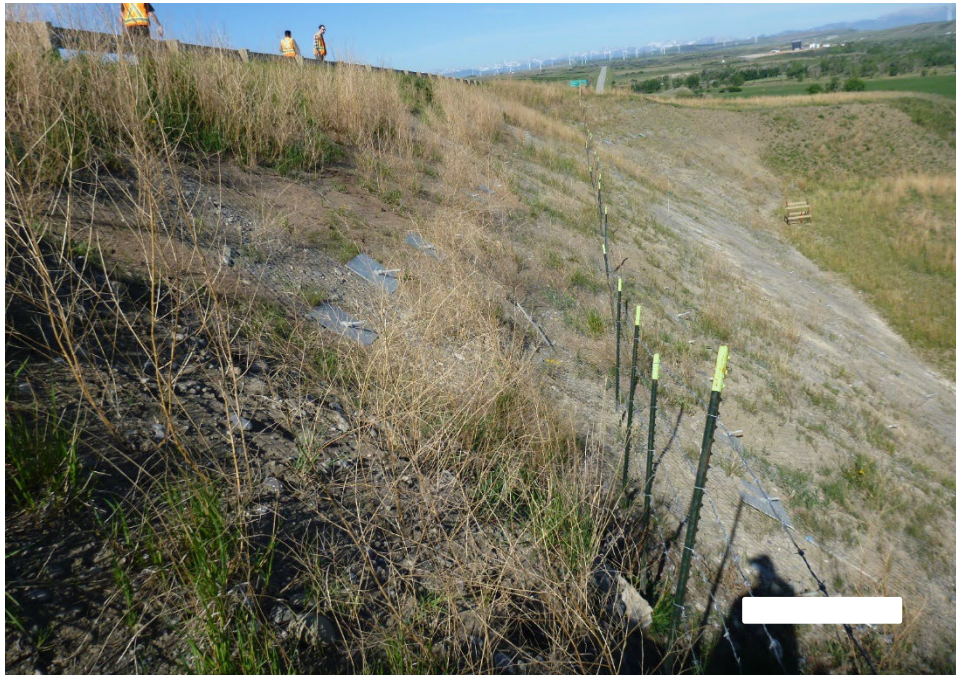
- In the upper third of the slope, the vegetative cover on the slope has improved between the 2024 and 2025 inspections (Photos 3 and 5). However, the vegetation appears to be mostly from weeds and the seed spread during construction appears to have not rooted. In the lower half of the repaired slope, there is little to no vegetative cover (Photos 4 and 5). The bench downslope of the repair has good vegetative

Photo 3 The slope is poorly vegetated, especially in the lower third of the slope. Photo taken May 28, 2025, facing west.

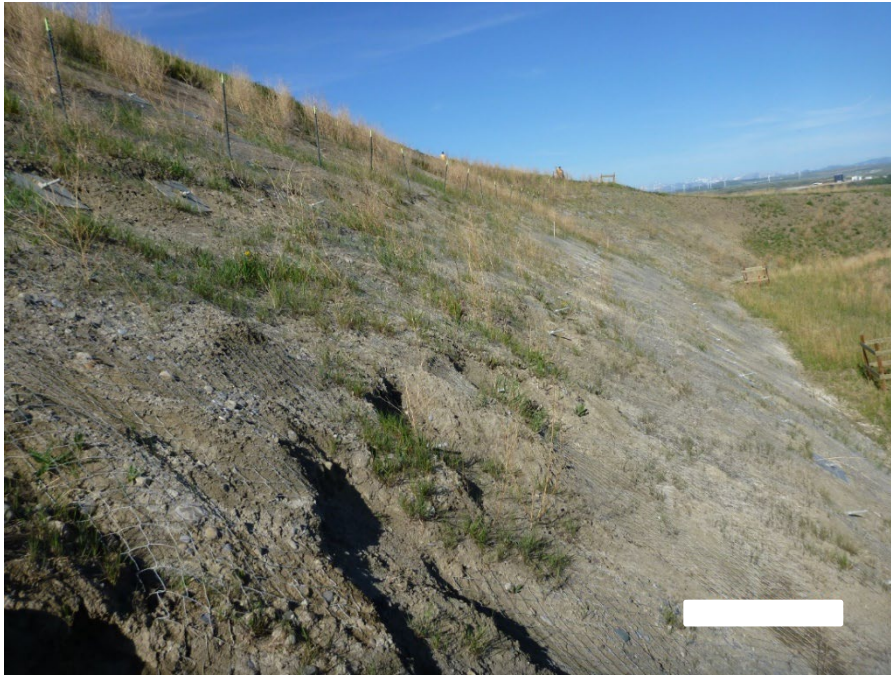
Photo 4 Erosion was observed on the slope surface below the wire mesh facing. Photo taken May 28, 2025, facing west.

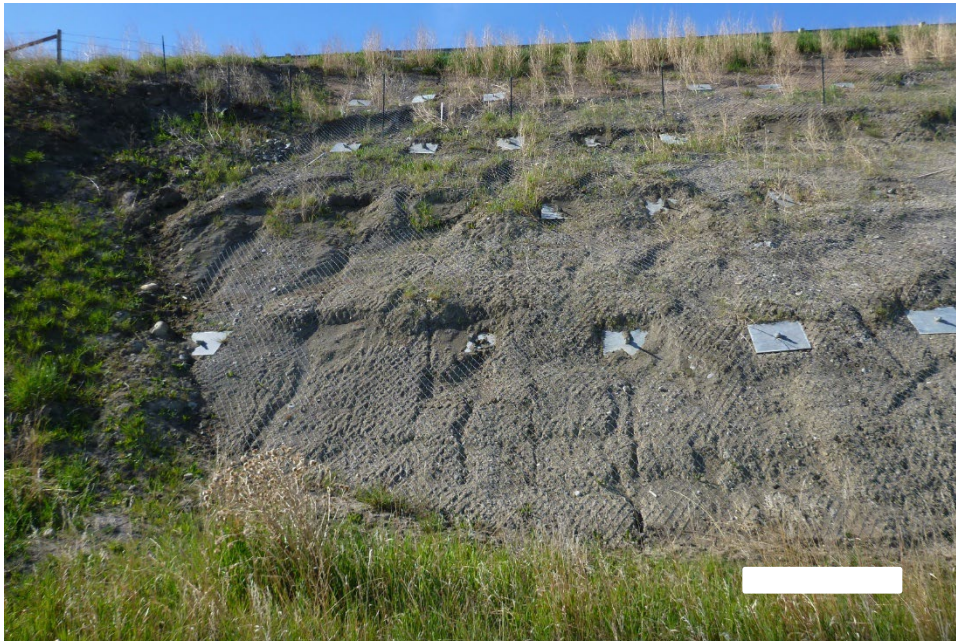
- During the 2025 inspection, the slope appeared drier than previous inspections, despite recent rainfall at the site.
- Ground cracks and rill erosion observed during previous inspections appear to have been backfilled by material being eroded from the upper portion of the slope (Photo 5 and 6).

- The bulging around the anchor plates does not appear to have worsened between the 2024 and 2025 inspections (Photo 5 and 6). Some of the anchor plates are almost completely buried by sediment being transported from further up the slope.

Photo 5 Rill erosion and sloughing on the slope surface near the east extent of the site. Some of the anchor plates have been covered by sediment. Photo taken May 28, 2025, facing south.

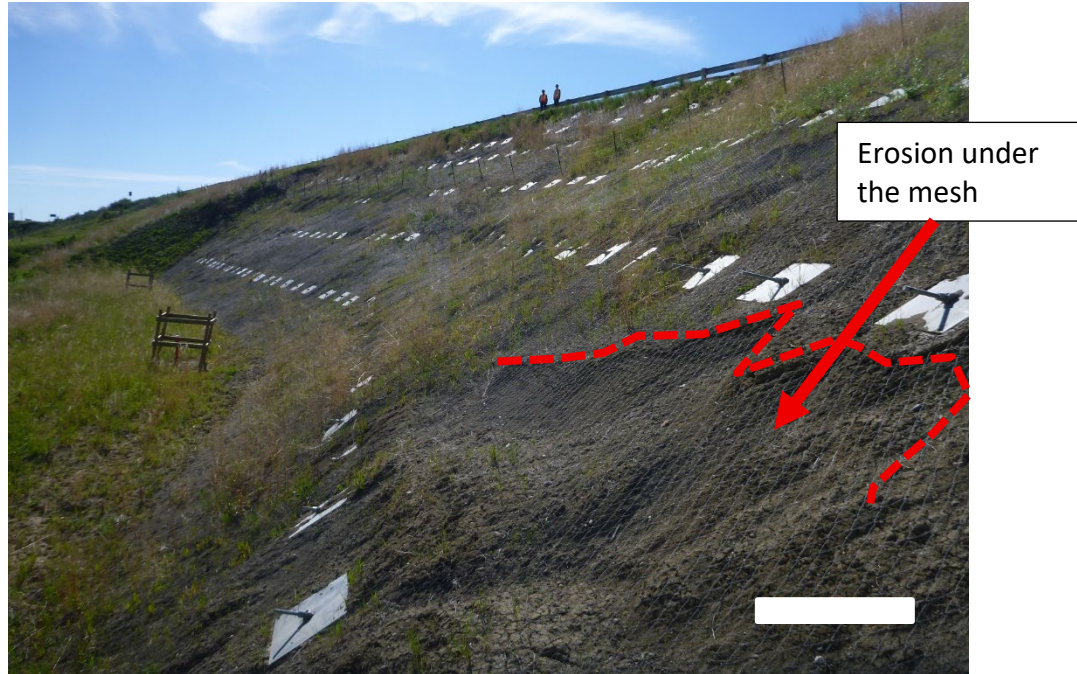
Photo 6 Erosion on the slope surface (red dashed line) near the east extent of the site. Some of the anchor plates have been covered by sediment. Photo taken May 28, 2025, facing southeast.
