SITE NUMBER AND NAME: S059 Siddons Slide	HIGHWAY & KM: 22:10, 27.530	PREVIOUS INSPECTION DATE: May 9, 2023	INSPECTION DATE: May 27, 2025
LEGAL DESCRIPTION: 01-20-17-02 W5M	NAD 83 COORDINATES: UTM Northing Easting 11 5591352 696456	RISK ASSESSMENT: PF: 9 CF: 2 TOTAL: 18	
AVERAGE ANNUAL DAILY TRAFFIC: 1400 (north), 1720 (south), (Ref. No. 71130)		CONTRACTOR MAINTENANCE AREA (CMA): 521

SOUTHERN REGION GEOHAZARD RISK MANAGEMENT PROGRAM

Site Plan
S059 - Siddons Slide
Hwy 22:10, km 27.50

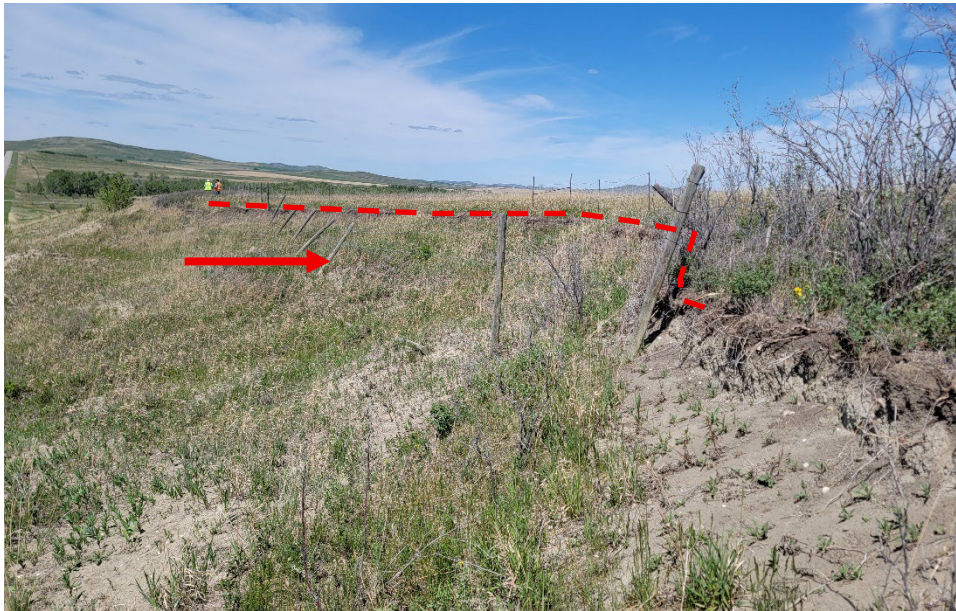
PRIMARY SITE ISSUE: Slope instability of the east highway backslope. The failure has undermined a length of private fence approximately 36 m long (along the highway). The slide is retrogressing onto adjacent private property.
APPROXIMATE DIMENSIONS: The slide is approximately 170 m long. The slope is approximately 12 m to 14 m high. The slope is approximately 3H:1V.
DATE OF ANY REMEDIAL ACTION: June 2021 – The highway was resurfaced, and the work included installation of a corrugated-steel-pipe (CSP) culvert in the east (northbound) ditch at the south end of the slide area, where the toe roll had previously blocked ditch flow. The bottom portion of the slope was flattened during the work.

- Photo 1** Head scarp (red dashed line) behind the private fence along the crest of the slope. Fence is being impacted for approximately 35 m along the slide (red arrow). Photo taken May 27, 2025, facing north.

- Since the slide is impacting private land, the slope could be flattened to maintain land use (which would require purchasing private land) or the slope could be rebuilt with geogrid-reinforced granular fill (including drainage improvements).

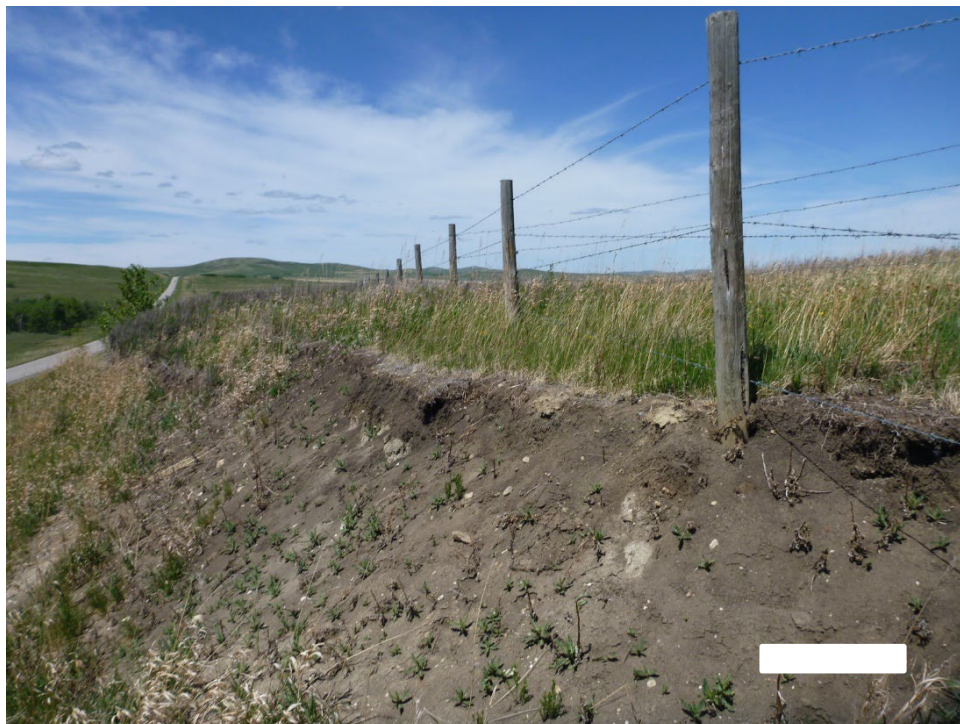
- Photo 2** Head scarp of the slide intersecting the private fence. Head scarp is near vertical and poorly vegetated. Photo taken May 27, 2025, facing north.

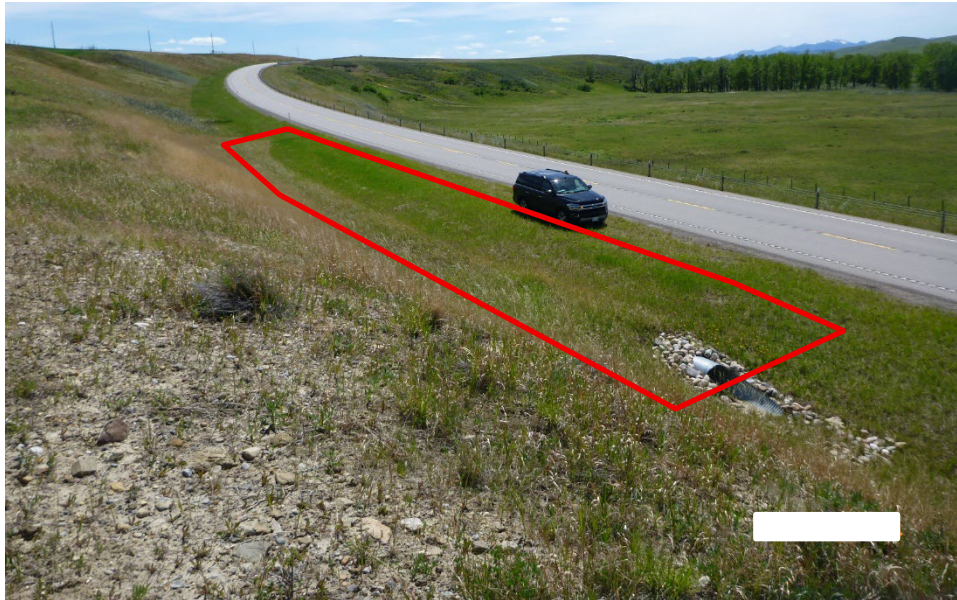
- TEC's Maintenance Contract Inspector (MCI) advised KCB that there's been recent activity at the north and south ends of the slide. However, the slide doesn't appear to have changed significantly between the 2023 and 2025 inspections.
- The back scarp is undermining an approximate 36-m-length of a private fence along the crest of the east highway backslope (Photos 1 and 2). The back scarp extends approximately 7.5 m into private land. The landowner installed a new fence around the failure zone sometime after 2019.
- The back scarp is up to approximately 1.5 m high and generally poorly vegetated (Photo 2).
- The ditch is open, and the culvert appears to be in good condition (Photos 3 and 4).
- The surface of the slide mass appears to be dry.

Photo 3 Lower portion of the repaired slope, culvert outlet, and ditch backfill (red line). Repair work performed in June 2021. Photo taken May 27, 2025, facing south.

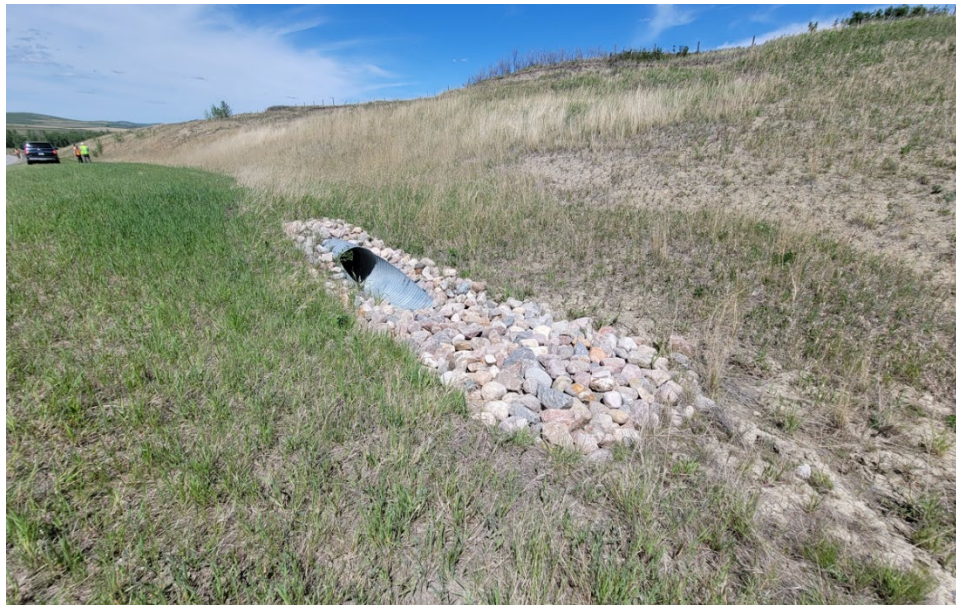
Photo 4 Culvert inlet and riprap apron installed in June 2021. Photo taken May 27, 2025, facing north.
