July 10, 2024

CON0022161 Southern Region GRMP Instrumentation Monitoring
Site S002; H22:14, km 12.95 Priddis
Section C – 2024 Spring Readings

Site Plan
S002 - Priddis
Hwy 22:14, km 12.95

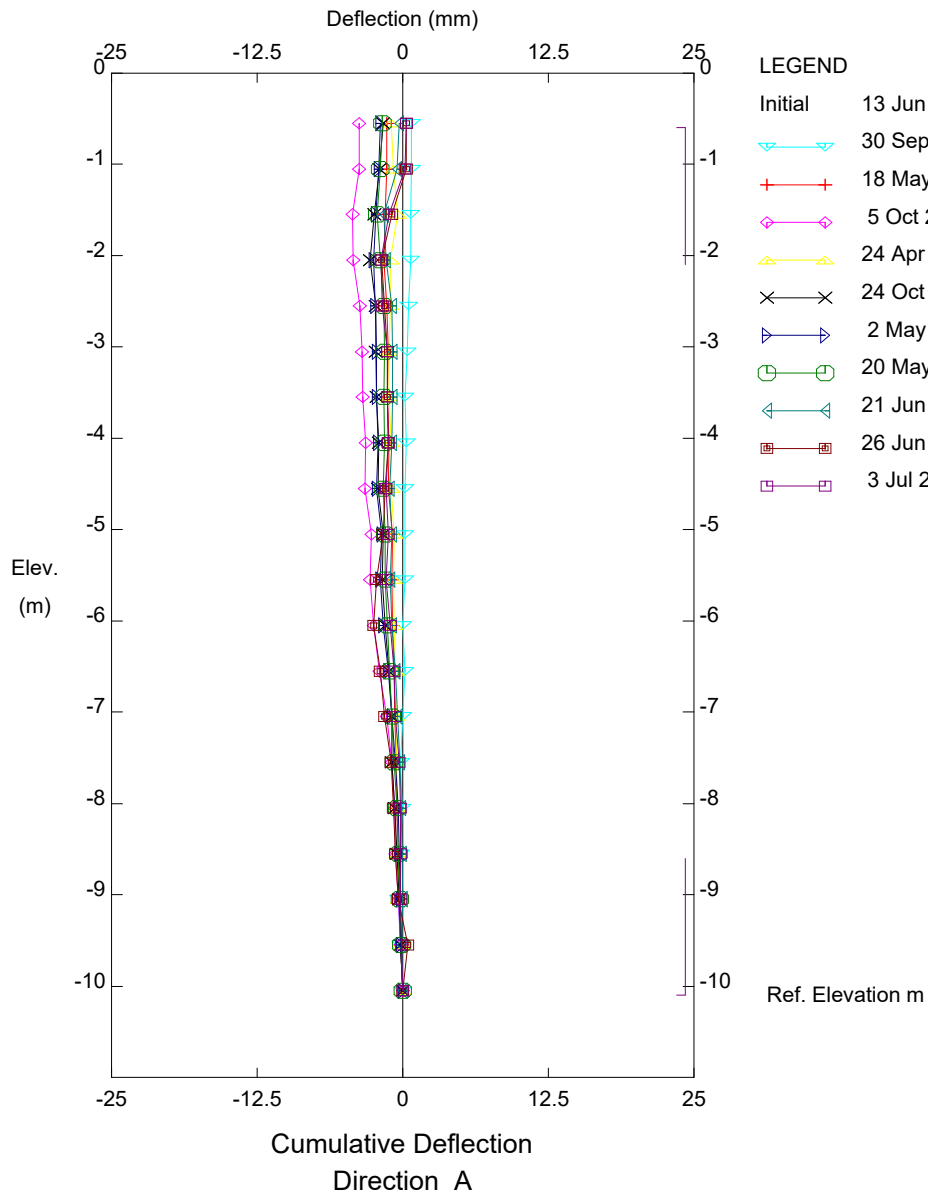
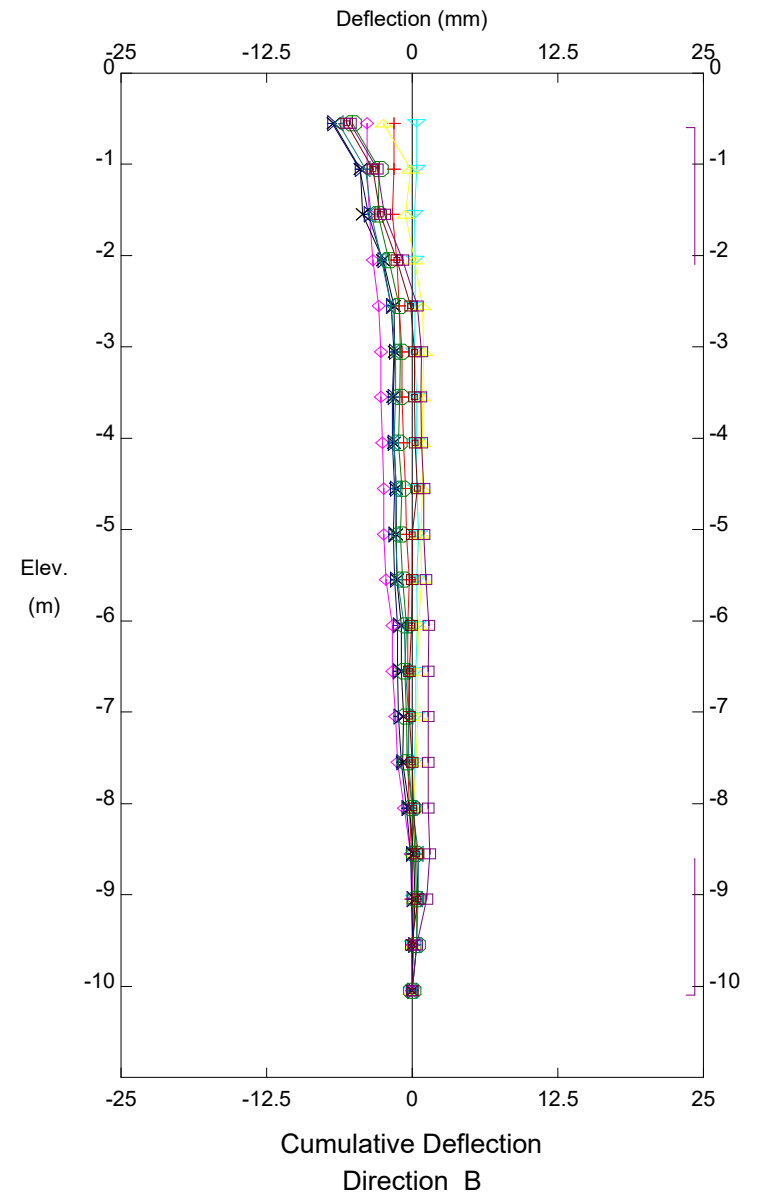
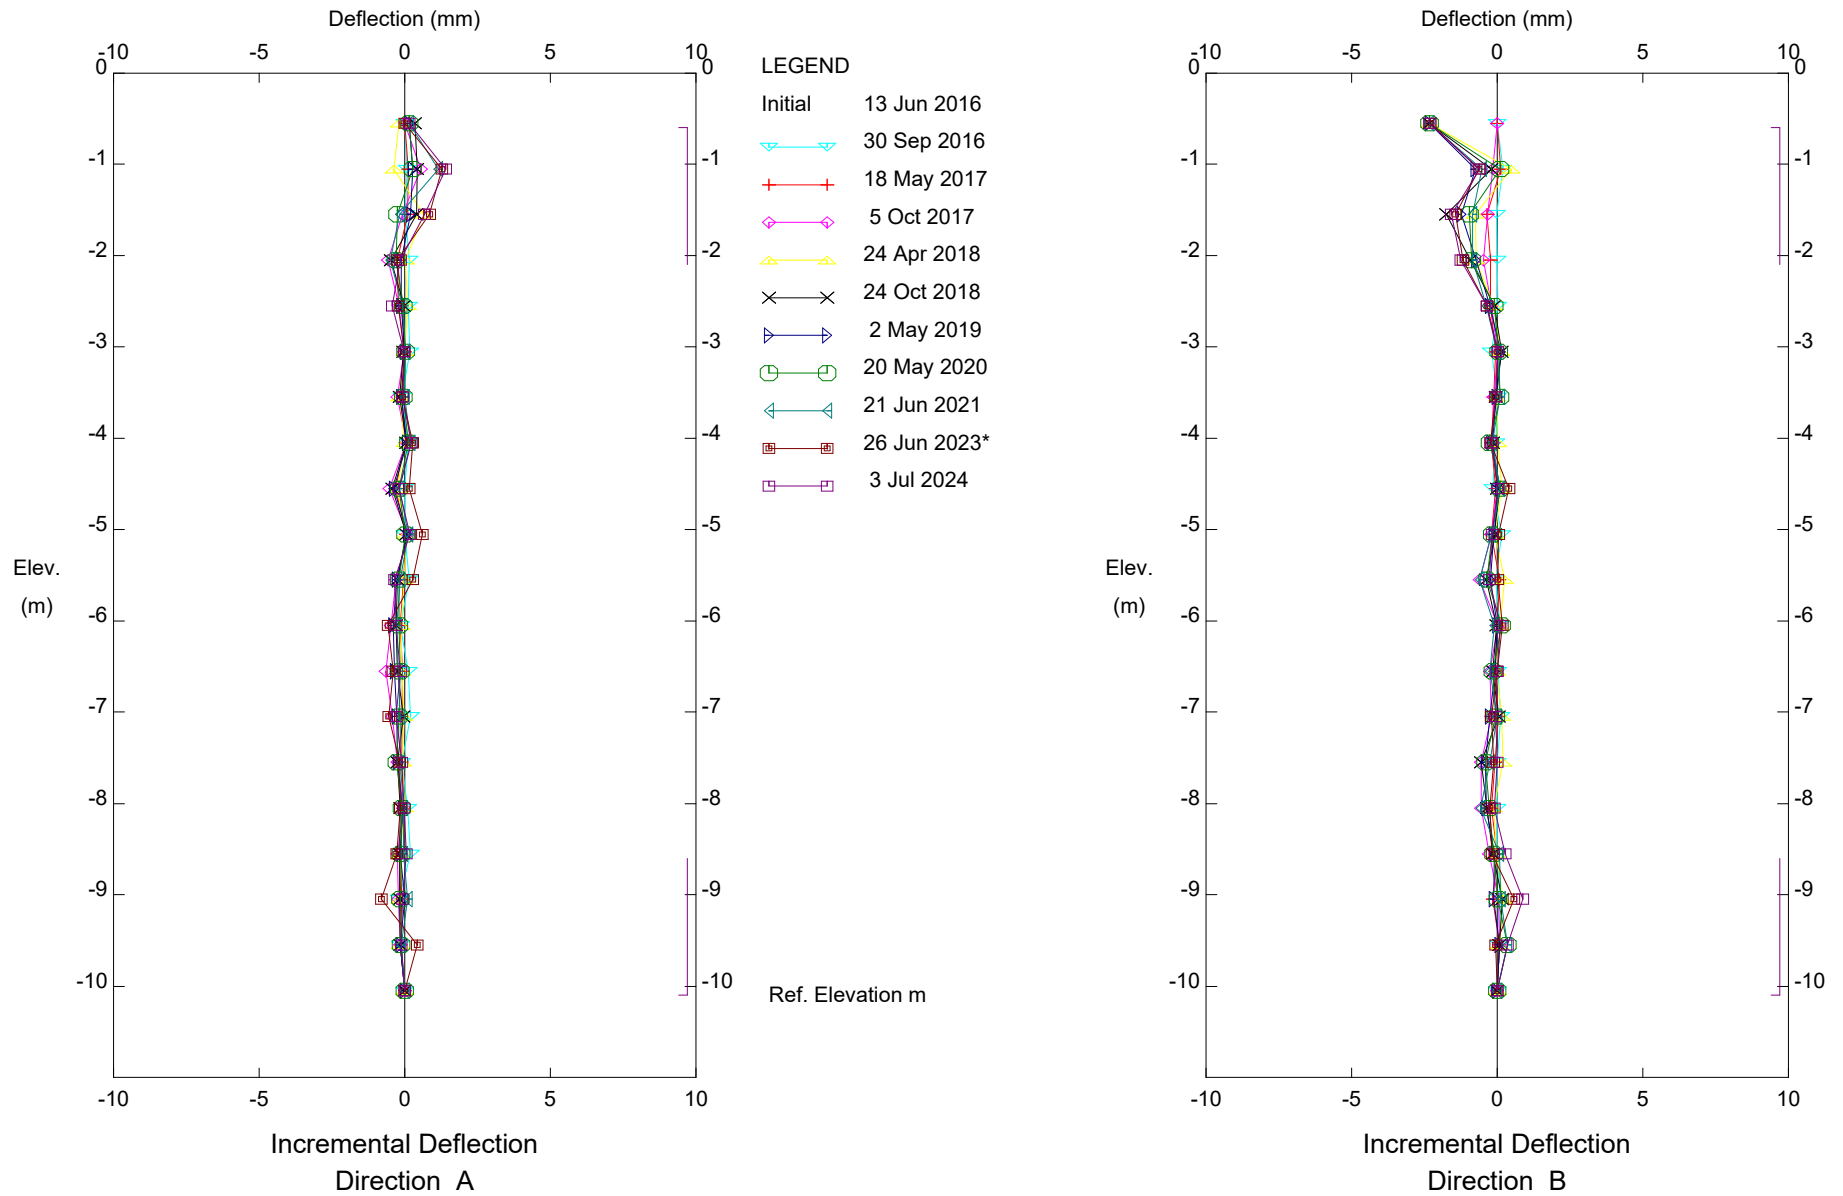
S002; H22:14, Priddis, Inclinator SI#9

Distributed movement was reported by the previous consultant near surface in SI#9 from approximately 0 m to 2 m below ground surface (approximately El. 1300 m to El. 1298 m) and in SI#11 from approximately 0 m to 3 m below ground surface (approximately El. 1300 m to El. 1297 m).

No discernible movement has been recorded in SI#9 and SI#11 since KCB began reading the instruments in 2016. Both SIs are located above (upslope of) the concrete pile wall.

SI#9 and SI#11 are recessed below the pavement surface in the westbound lane of Hwy 22:14. Fine-grained material (e.g., silt and sand) is regularly observed inside the flush-mounted casing protectors and the material must be removed to facilitate the instrument readings. Some of the material has entered the SI casing. Previous efforts of plugging the casing protector caps and sleeving the top of the SI casing with larger-diameter pipe to reduce the material migration have been moderately successful.

KCB should investigate alternative methods to reduce the amount of material entering the flush-mounted casing protectors (e.g., plugging the holes in the caps or replacing the casing protectors entirely, which has been recently completed successfully in the Central Region) and the SI casing, which could impact future reading. If necessary, the SIs should be cleaned out by injecting the SI casing with water and flushing out any sediment that has accumulated.

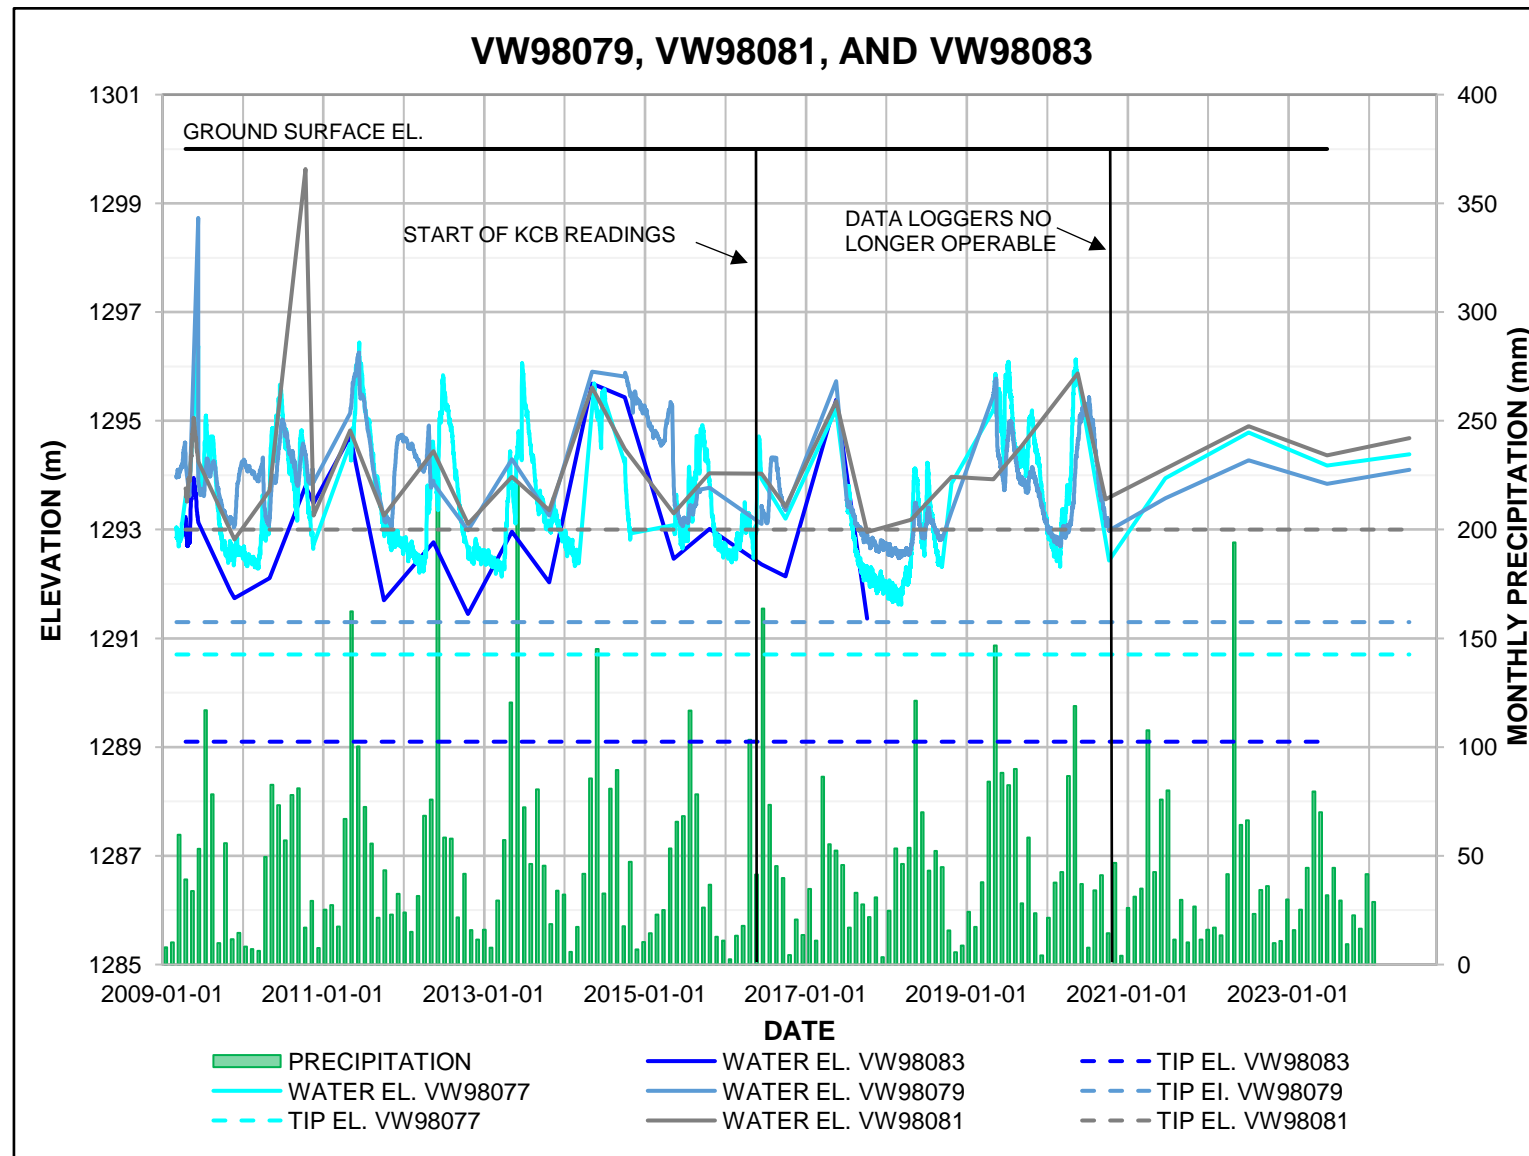
Piezometer Data
S002 - Priddis
Hwy 22:14, km 12.95

Since June 2023, water levels have been recorded to have increased between 0.2 m and 0.3 m in the three operable VWPs (VW98077, VW98079, and VW98081). Water levels recorded in the VWPs appear to fluctuate seasonally, with the spring readings typically being higher than fall readings.

1. MONTHLY PRECIPITATION DATA OBTAINED FROM THE ALBERTA CLIMATE INFORMATION SERVICE (ACIS) DATABASE, REFERENCING LEGAL SUBDIVISION T022R04W5.
2. VW98083 BECAME INOPERABLE BETWEEN THE FALL 2017 AND SPRING 2018 READINGS.
