July 15, 2025

CON0022161 Southern Region GRMP Instrumentation Monitoring
Site S002; H22:14, km 12.95 Priddis
Section C – 2025 Spring Readings

KLOHN CRIPPEN BERGER LTD.

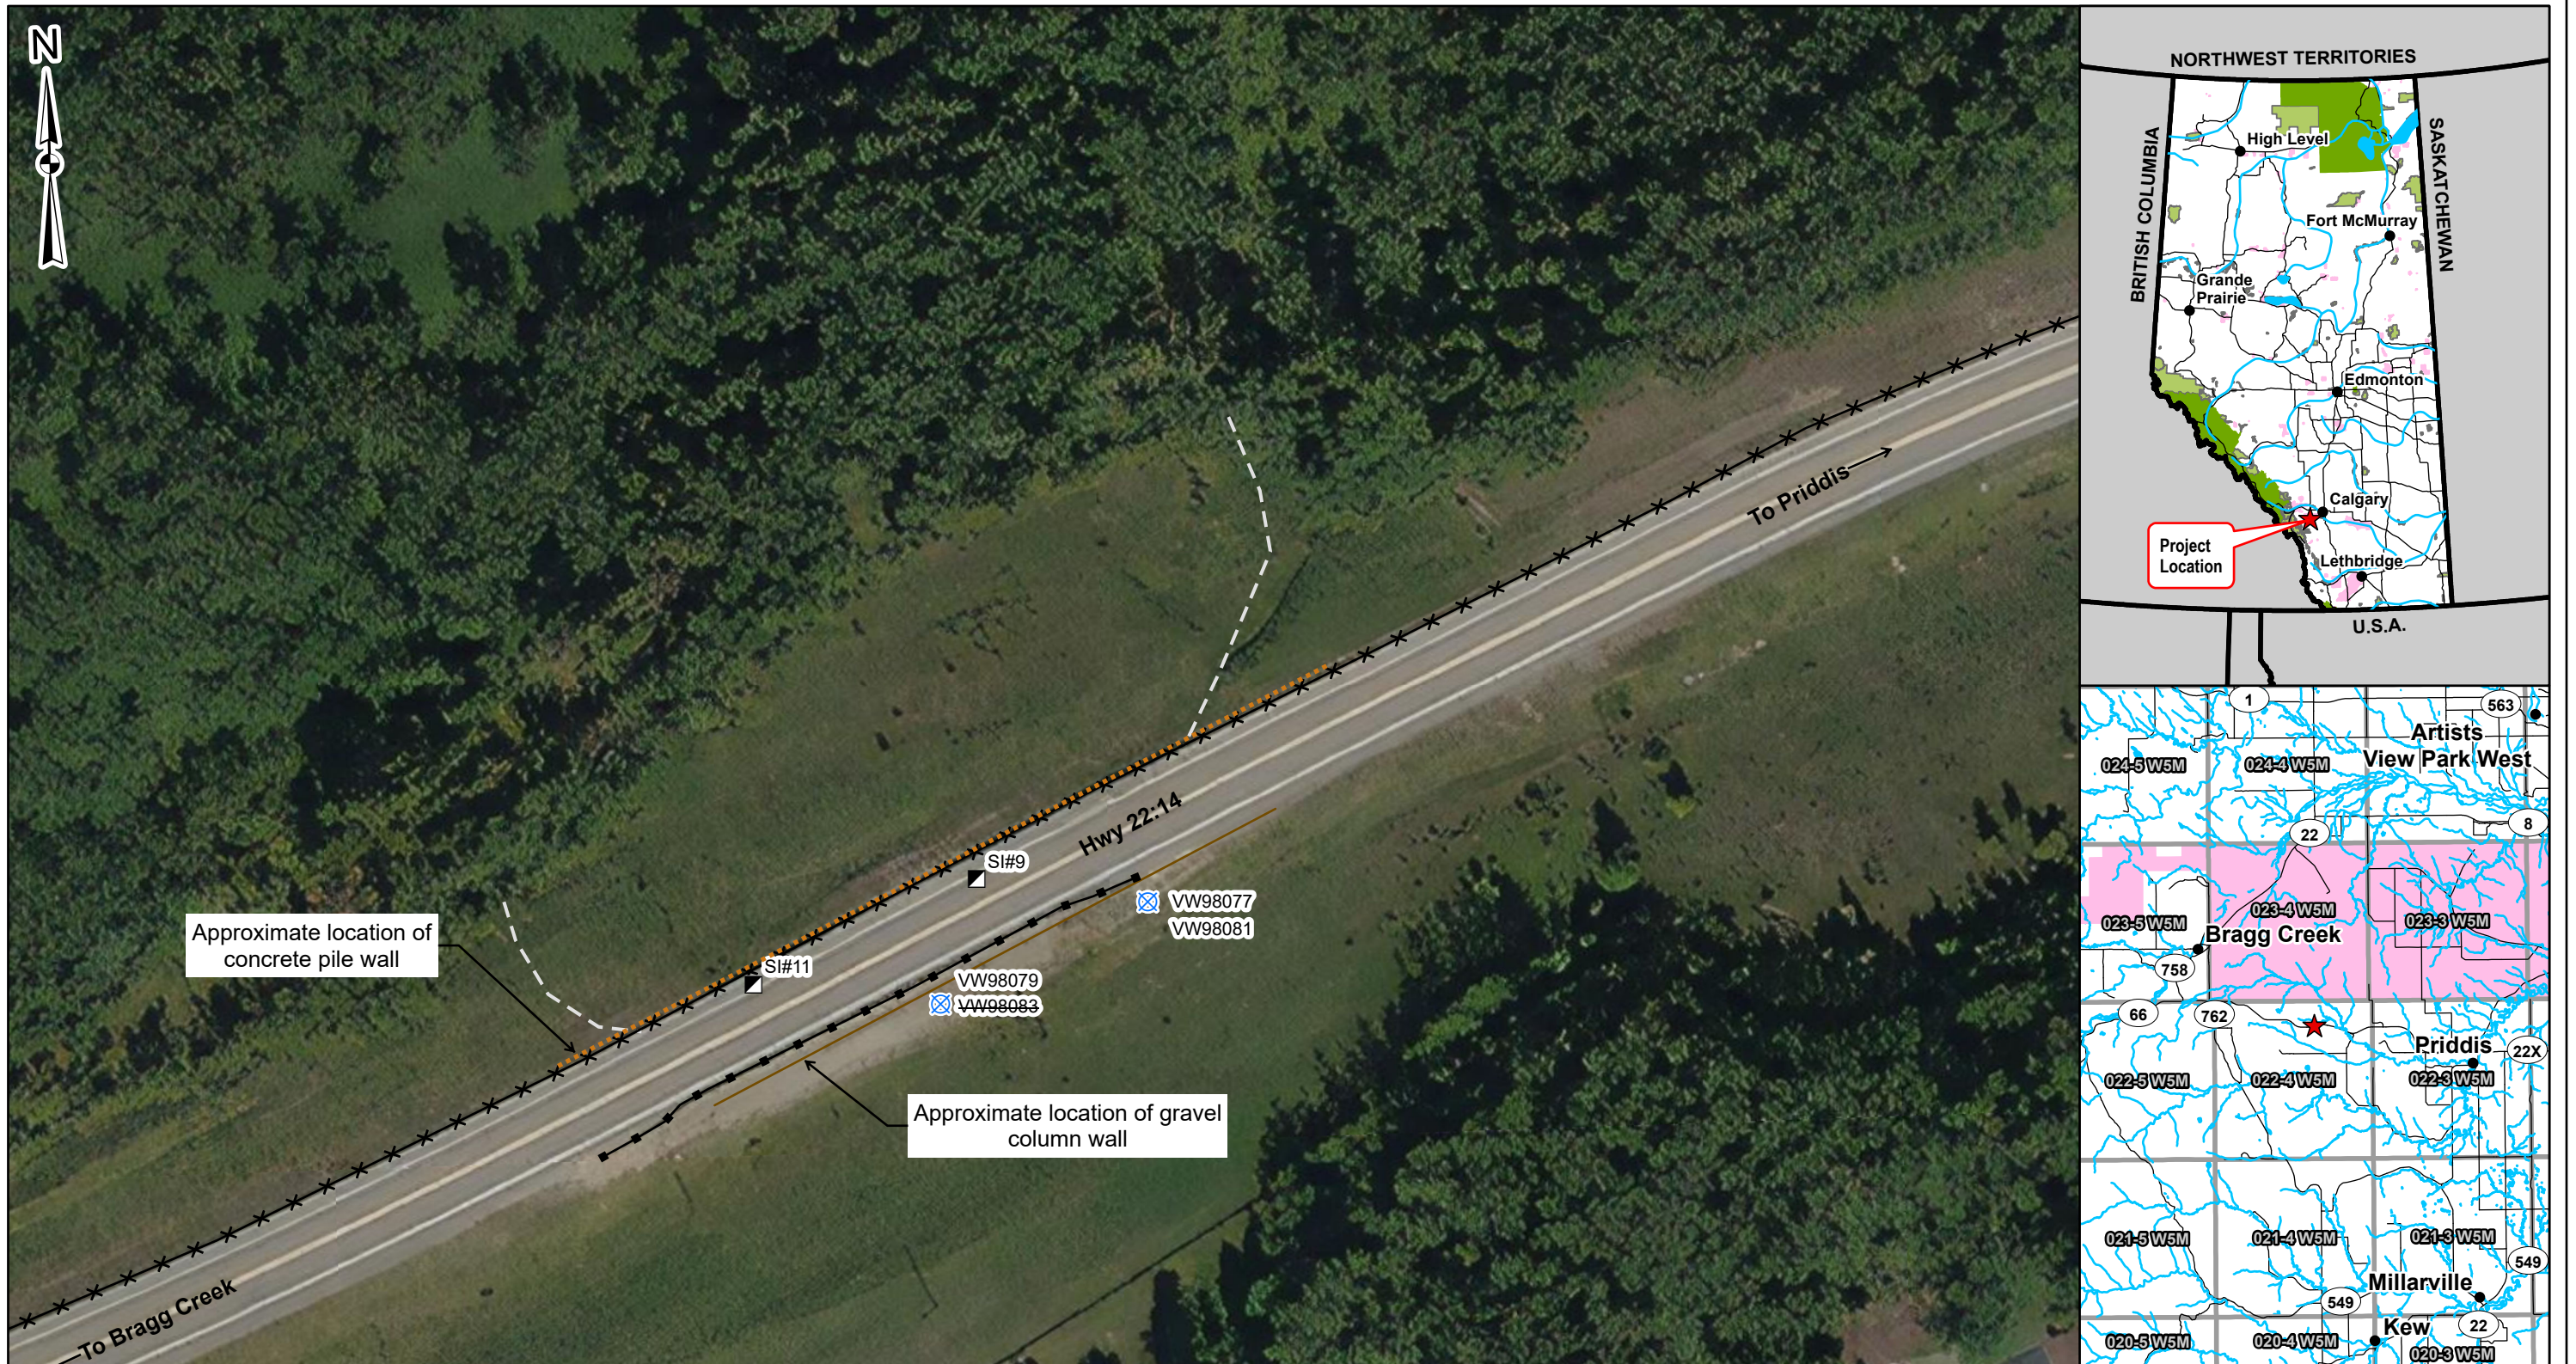
PROJECT SOUTHERN REGION GEOHAZARD RISK MANAGEMENT PROGRAM		
TITLE Site Plan S002 - Priddis Hwy 22:14, km 12.95		
SCALE 1:800	PROJECT No. A05116A03	FIG No. 1

The geohazard at the S002 site consists of a slope failure on the north side of the highway, which is impacting the westbound lane and north shoulder. Previous remedial actions at this site include installing a concrete pile wall in 1992, along the north shoulder (westbound lane) of Hwy 22:14 in an effort to stabilize the highway. Additionally, a row of gravel columns was installed on the upslope (south) side of the highway. Pumps were installed in two of the columns with water level activated switches. The pumps are operable but are turned off during the winter months. Regular pavement patching has also been completed at the site.

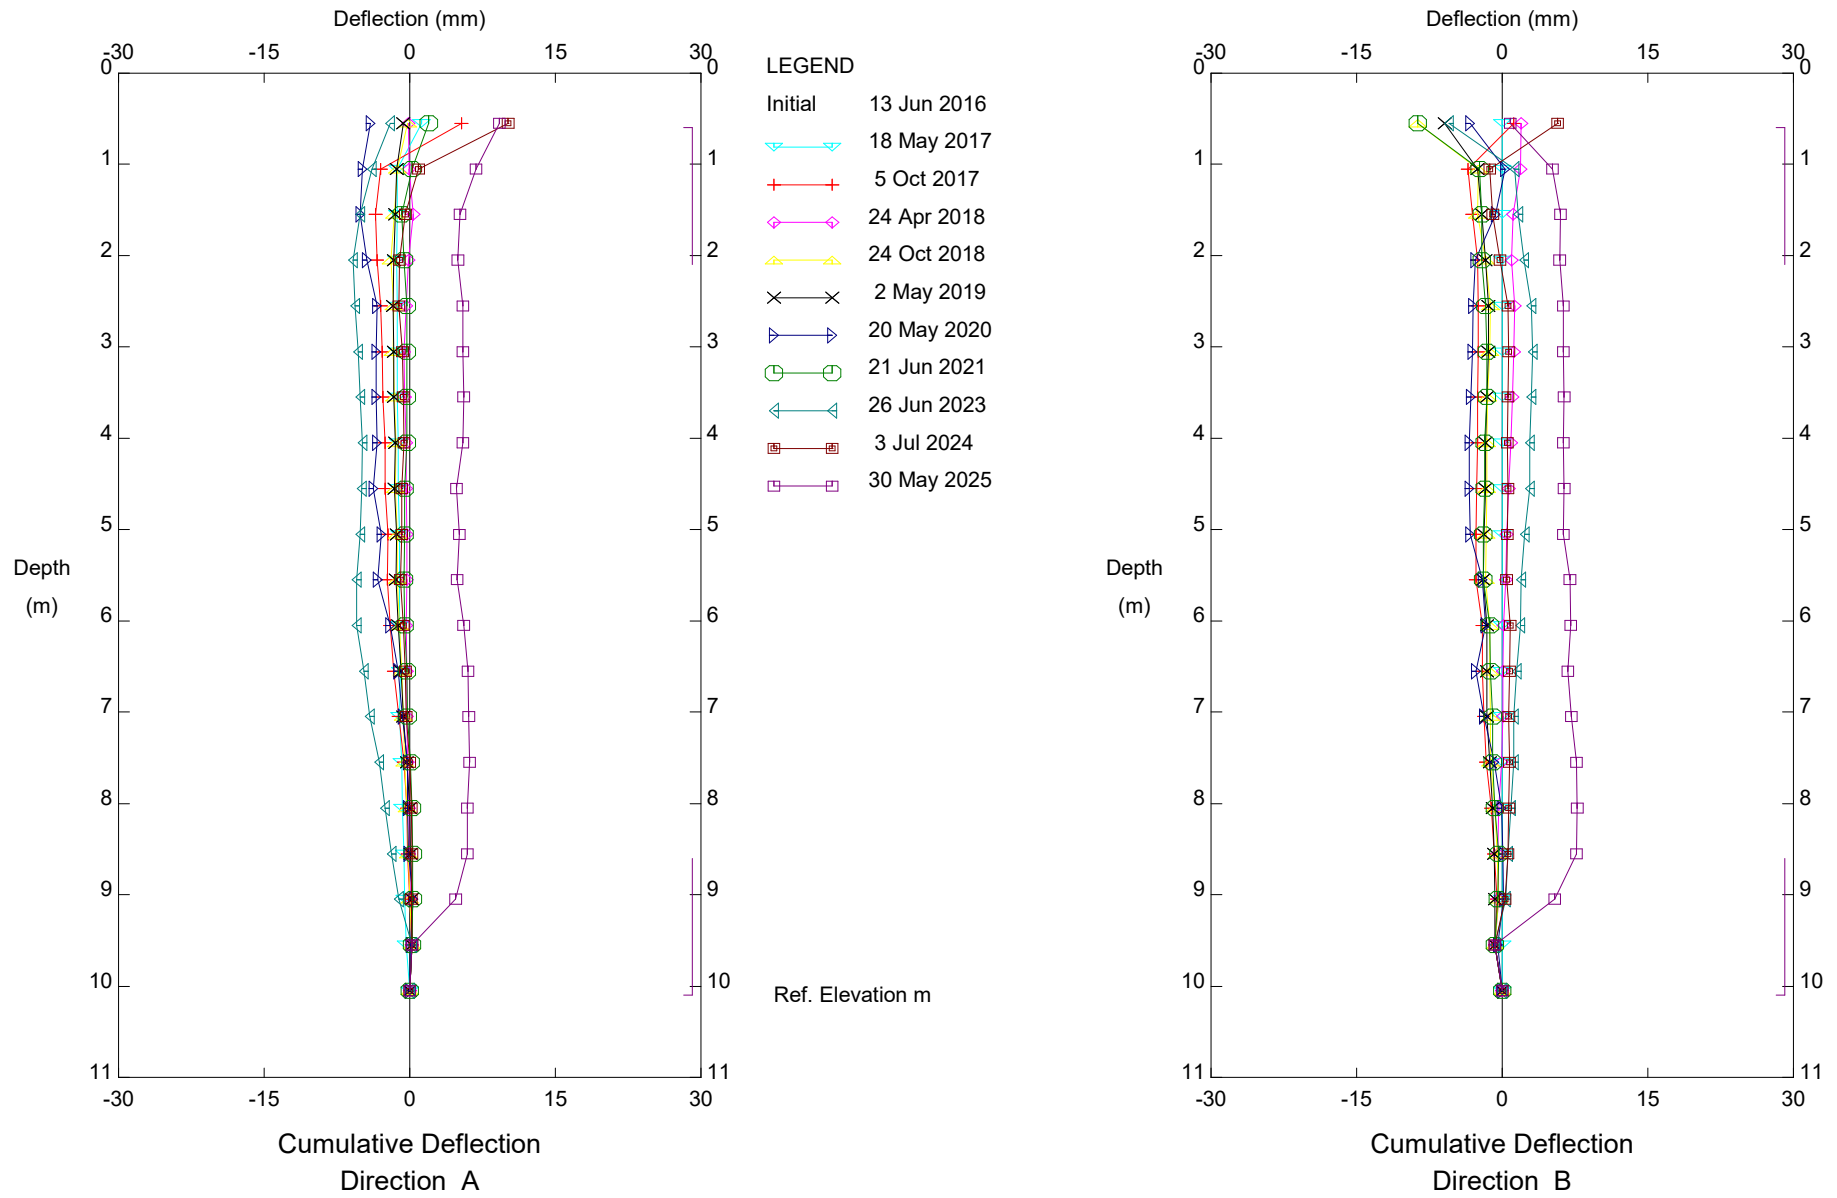
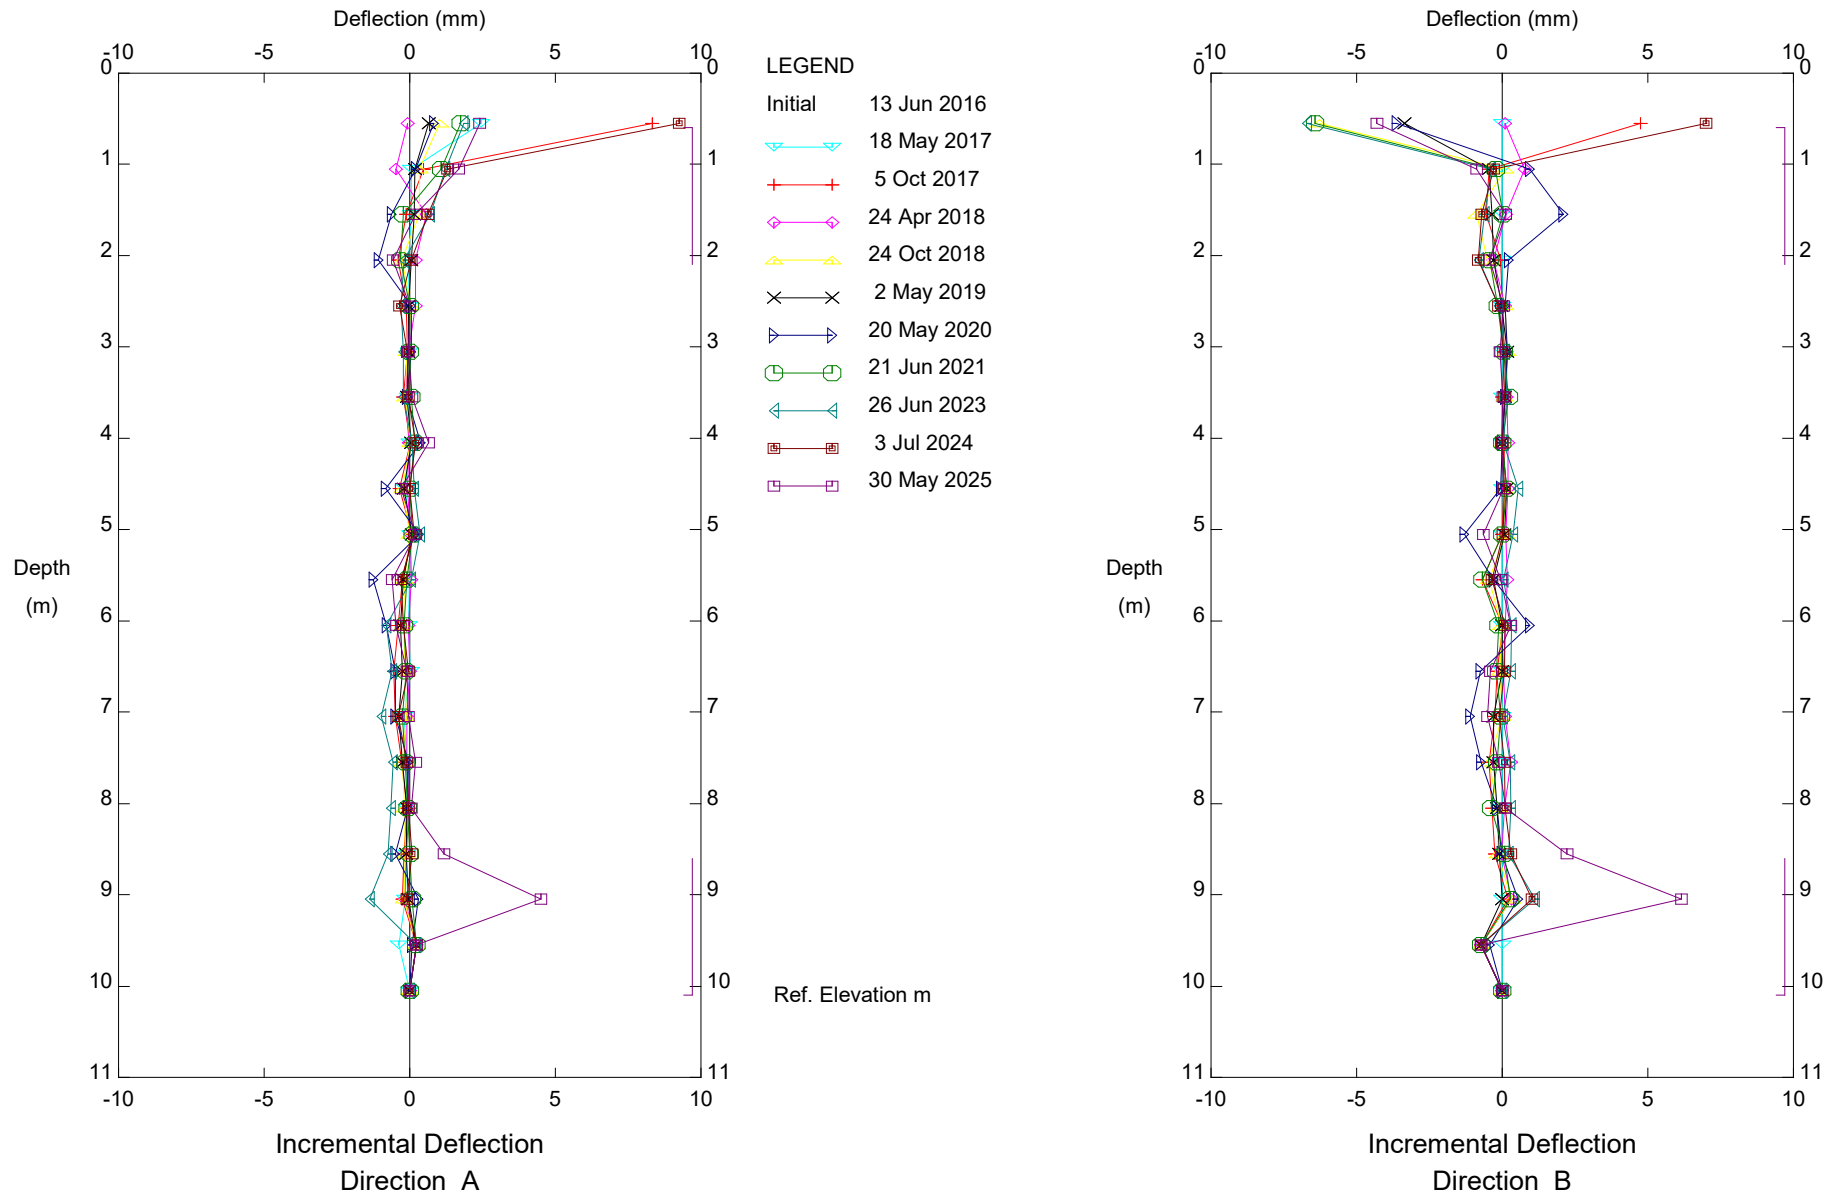
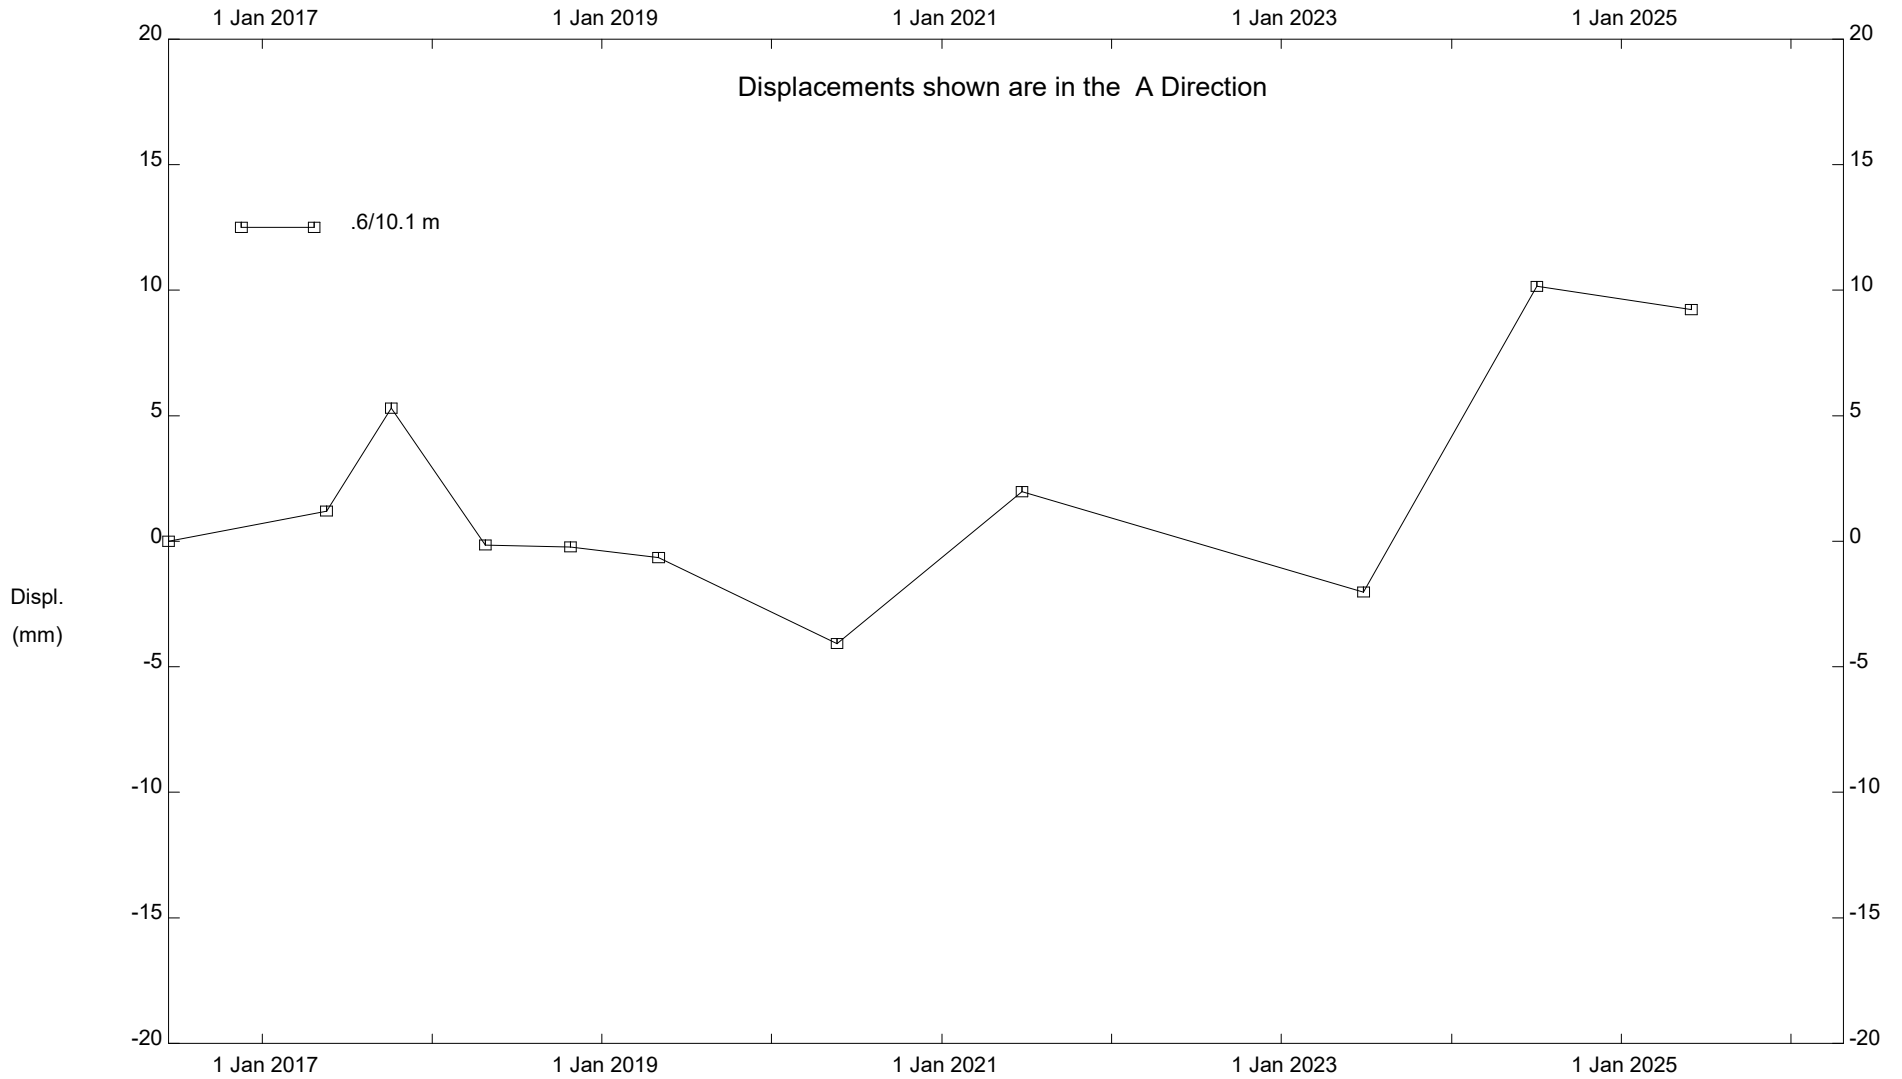
S002; H22:14, Priddis, Inclinator SI#9

No clear discernible movements have been observed after the reinitialization in 2016; however, SI#9 and SI#11 might be starting to show some signs of movement since 2023. Both SIs are located above (upslope of) the concrete pile wall.

Previous reports have indicated that the majority of the movement in the SIs was recorded before 2014. This has been interpreted as though the concrete pile wall has picked up load, stabilizing the sliding mass and reducing the rate of movement. Nevertheless, both SI#9 and SI#11 have begun to exhibit an increase in displacement since 2023 both in the A and B direction. The movement observed might be noise in the recorded data and will need to be confirmed with subsequent readings.

SI#9 and SI#11 are recessed below the pavement surface in the westbound lane of Hwy 22:14. Fine-grained material (e.g., silt and sand) continues to be observed inside the flush-mounted casing protectors, and the material must be removed to facilitate the instrument readings and avoid depth corrections of the data. Currently, the material has filled approximately 1 m of the SI casing. Previous efforts to plug the casing protector caps and sleeve the top of the SI casing with larger-diameter pipe to reduce material migration have been moderately successful.

Alternative methods should be explored to minimize the material entering the flush-mounted casing protectors and the SI casing. Examples include plugging the holes in the caps or replacing the casing protectors entirely, a strategy successfully implemented in the Central Region. This issue still affects the accuracy of the readings. If necessary, the SIs should be cleaned out by injecting the SI casing with water and flushing out any accumulated sediment.

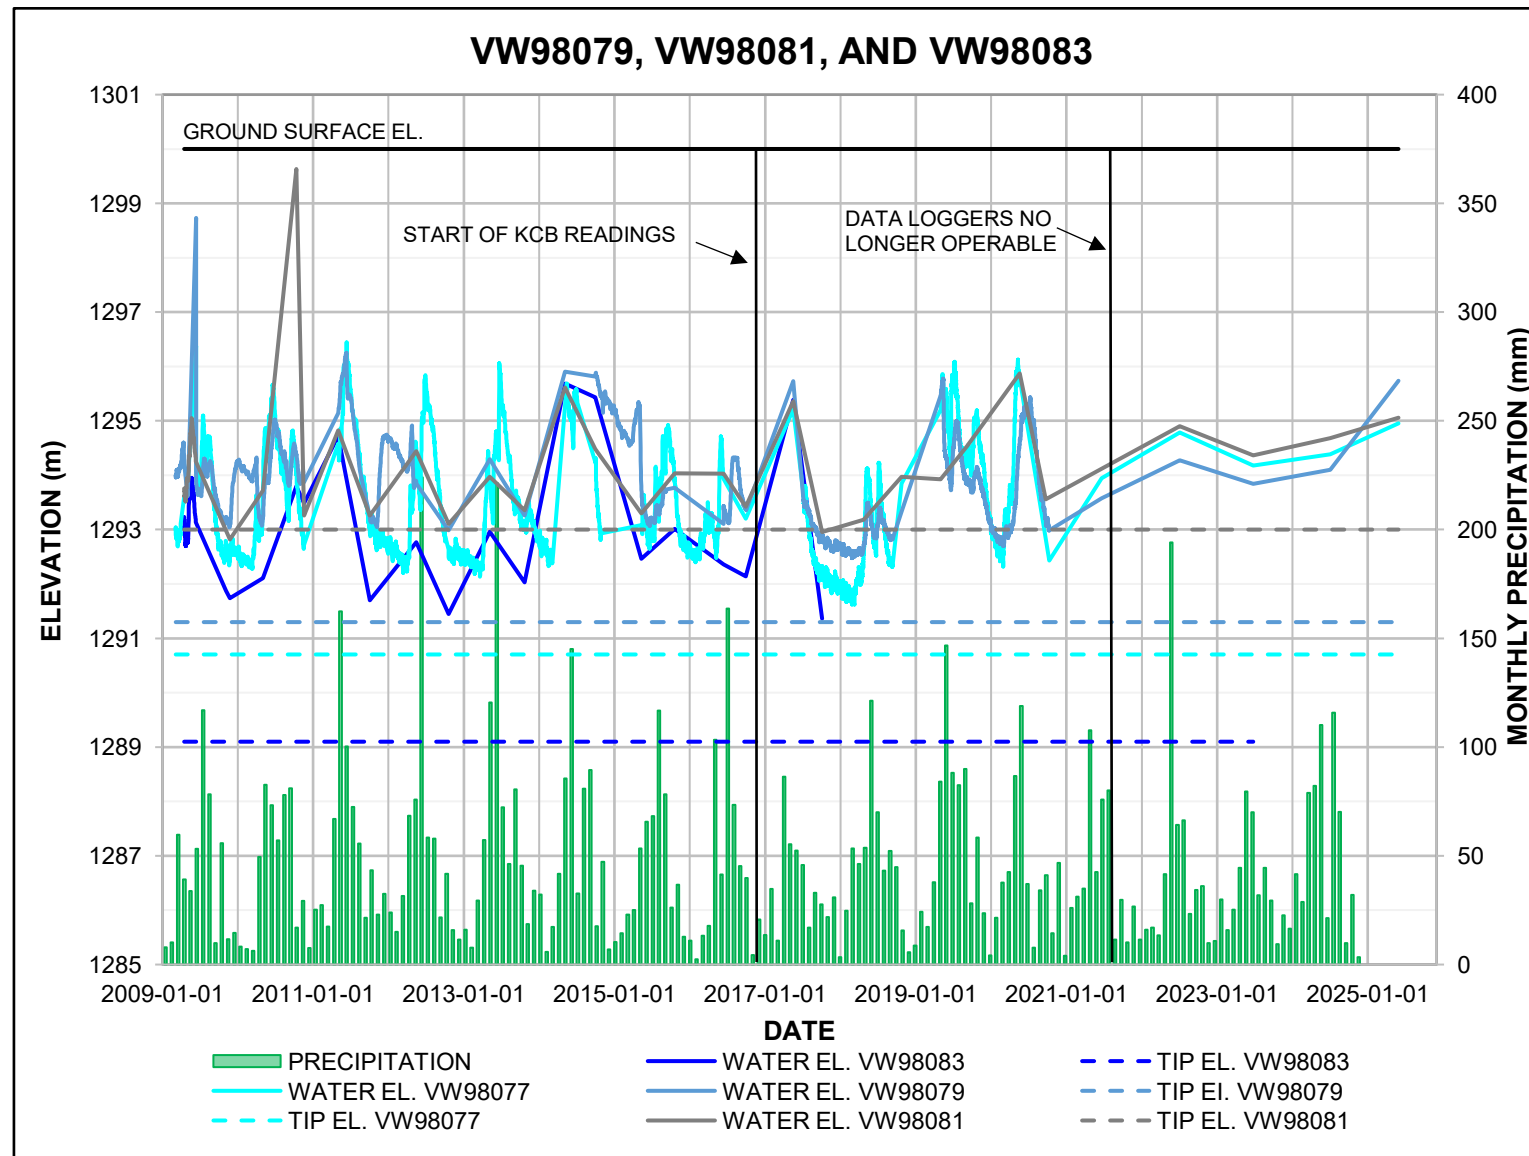
Piezometer Data
S002 - Priddis
Hwy 22:14, km 12.95

Since June 2024, water levels have increased between 0.4 m and 1.6 m in the three operable VWPs (VW98077, VW98079, and VW98081). These increases are greater than those noted in previous years. Future measurements will confirm if this is the start of a new trend. Historical rainfall data was

only available up to December 31, 2024, at the time of writing this report. Water levels recorded in the VWP appear to fluctuate seasonally, with the spring readings typically being higher than fall ones because of rainfall infiltration and groundwater flow, which then dissipate in the fall and winter when infiltration slows or stops due to lack of rainfall or freezing temperatures conditions.

1. MONTHLY PRECIPITATION DATA OBTAINED FROM THE ALBERTA CLIMATE INFORMATION SERVICE (ACIS) DATABASE, REFERENCING LEGAL SUBDIVISION T022R04W5.
2. VW98083 BECAME INOPERABLE BETWEEN THE FALL 2017 AND SPRING 2018 READINGS.
