November 26, 2025

Alberta Transportation and Economic Corridors  
2<sup>nd</sup> Floor, 803 Manning Road N.E.  
Calgary, Alberta  
T2E 7M8

**CON0022161 Southern Region GRMP Instrumentation Monitoring**  
**Site S003; H22:16 km 9.9 Cochrane**  
**Section C – 2025 Fall Readings**

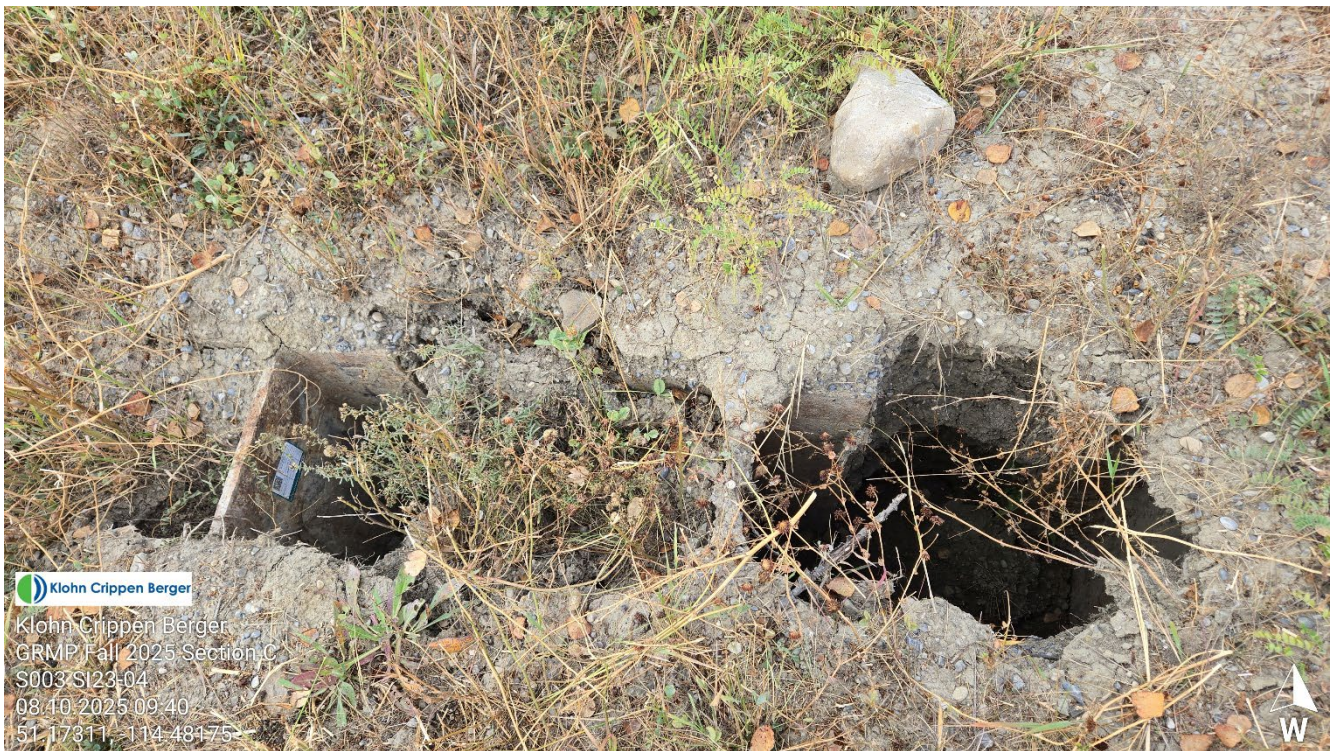
**Photo 3.1 Sinkholes between piles of the H-Pile wall near SI23-04 casing.**

Voids are observed around the piles of the H-pile wall (Photo 3.1), particularly near the SI23-04 casing, causing the SI casing to be loose in the pile. These voids should be backfilled with a combination of sand and gravel.

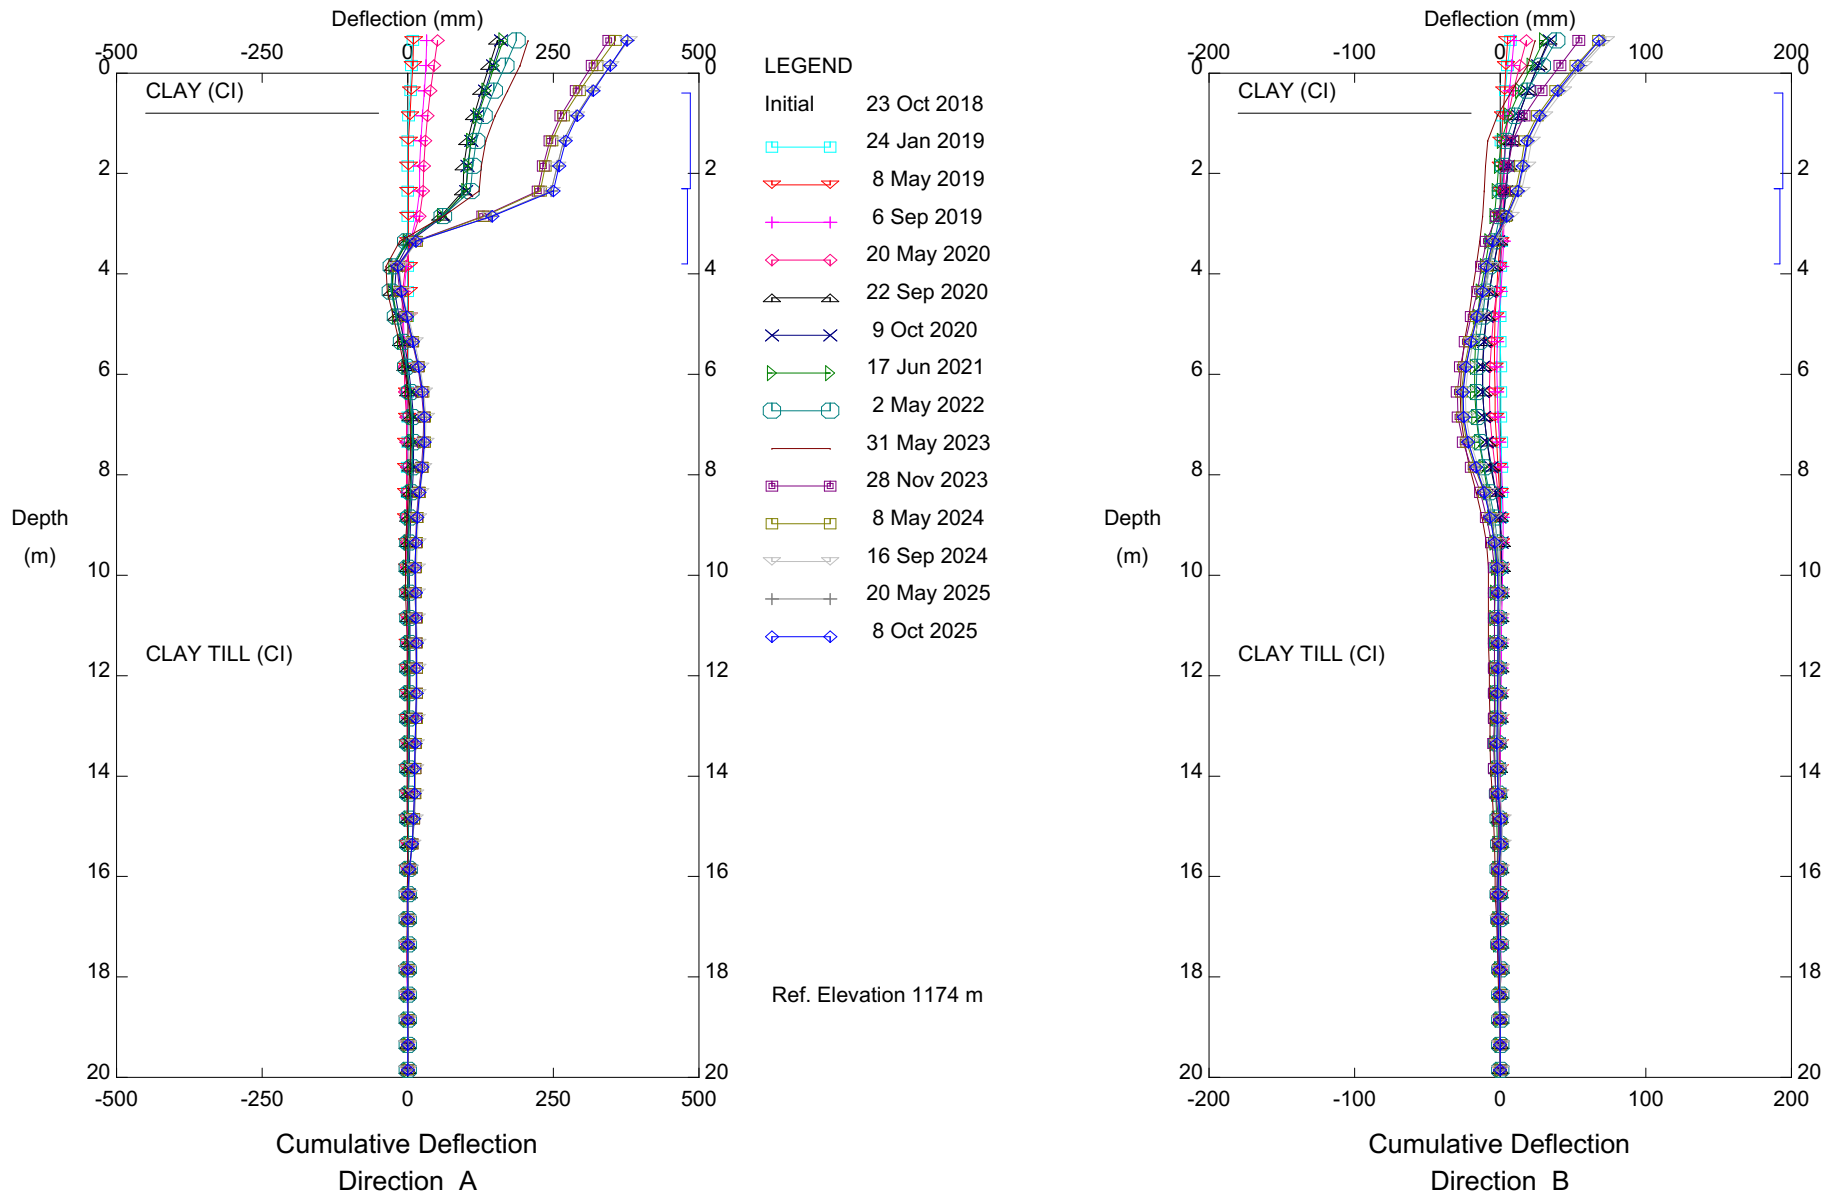
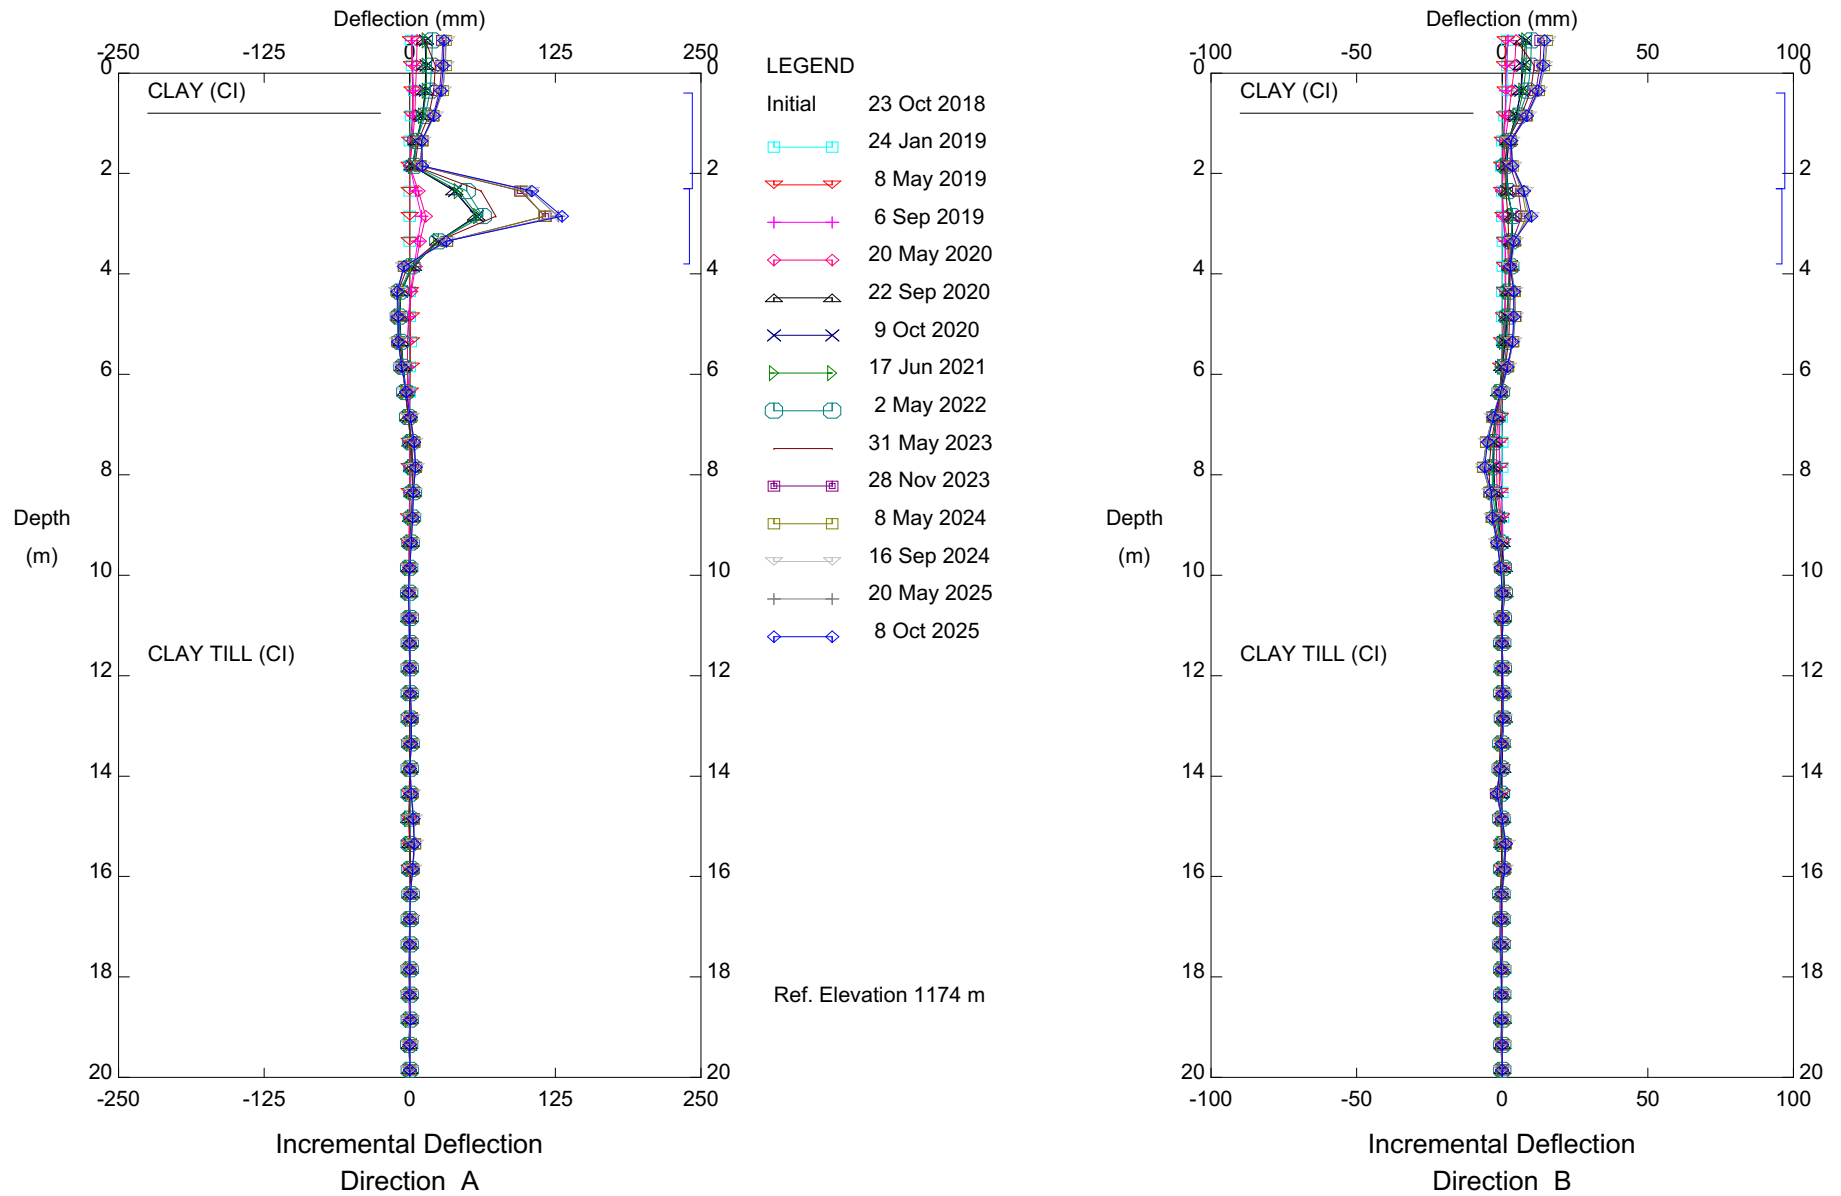
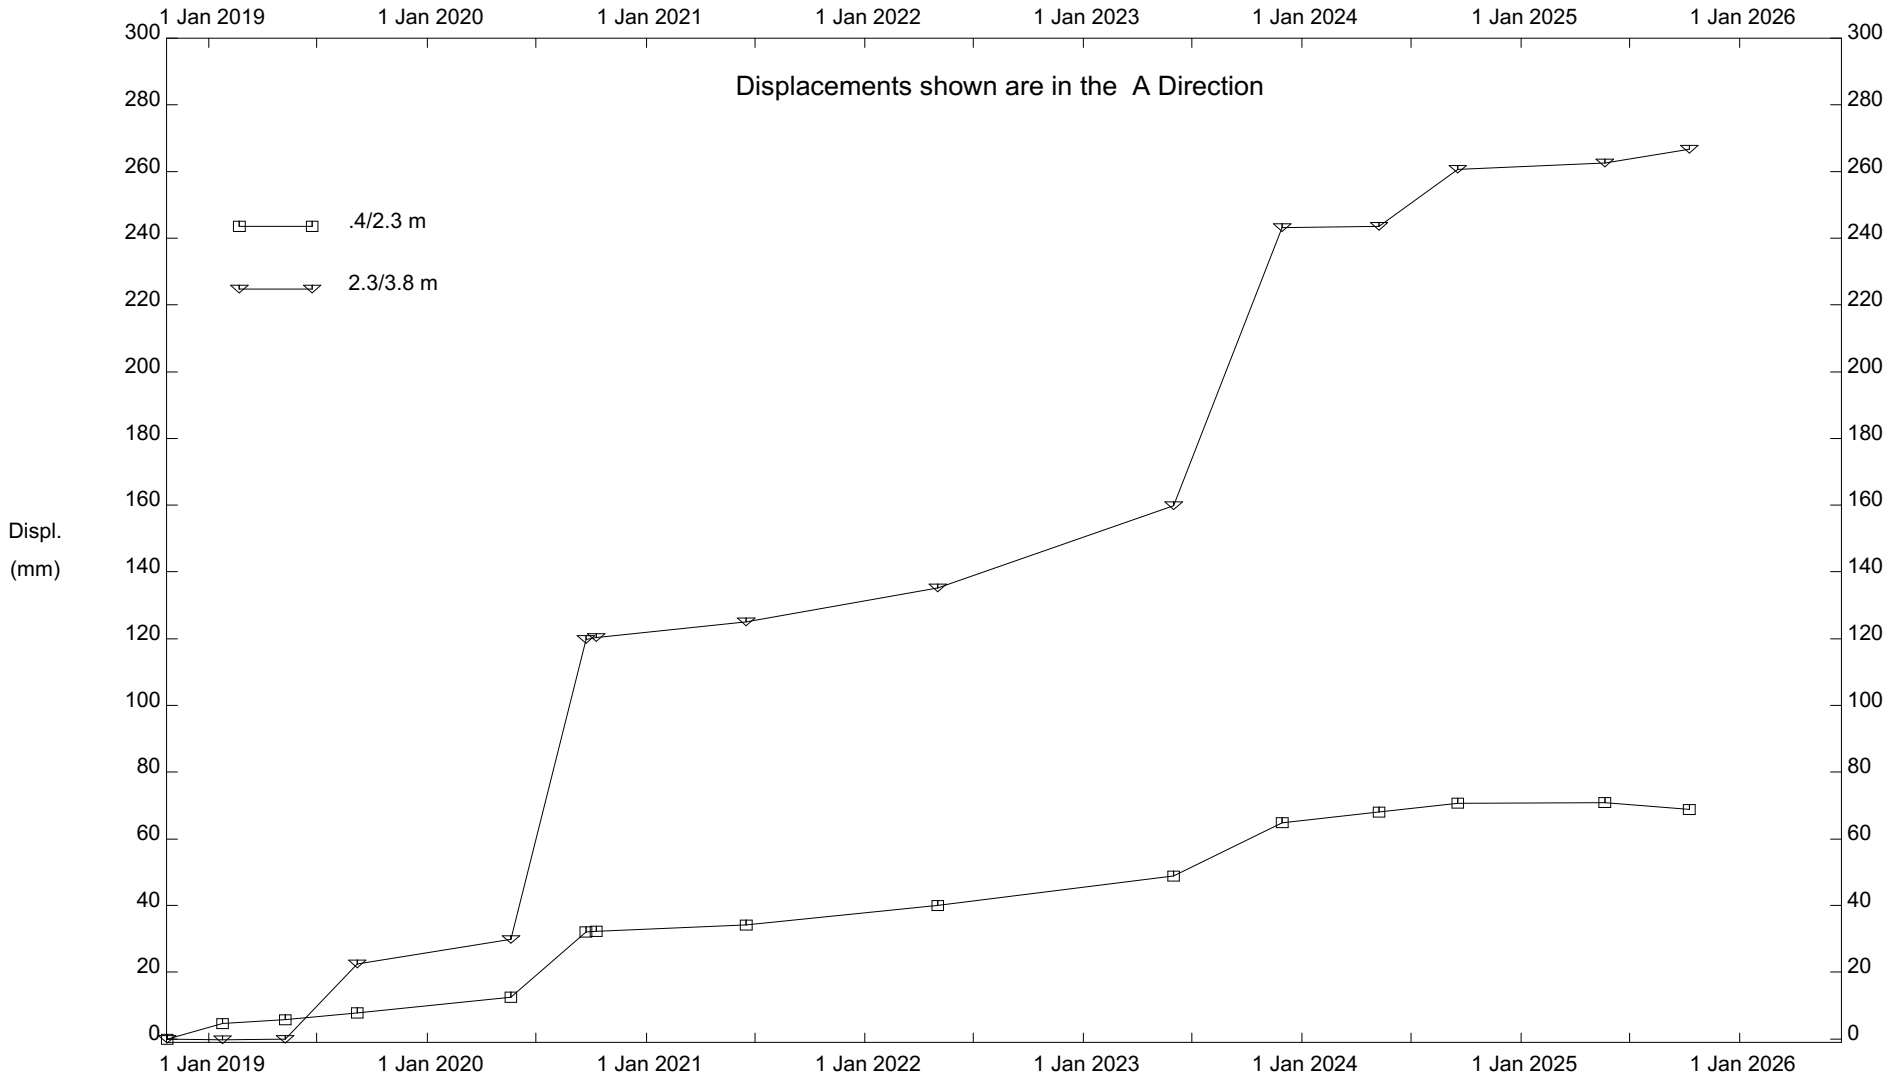
S003; H22:16, Cochrane, Inclinator SI18-01  
 Alberta Transportation

Distributed movement continues to be recorded in SI18-01 from ground surface to an approximate depth of 2.3 m below ground surface (approximately El. 1173.6 m to El. 1171.3), and possible discrete movement between 2.3 m and 3.8 m (approximately El. 1171.3 m to El. 1169.8). The casing also appears to be settling or buckling between an approximate depth of 3.8 m and 8.8 m as discussed in Section 2.3. SI18-01 is located near the middle of the slide on the downslope side of the highway.

Settlement or buckling is observed in SI18-01, from approximately 3.8 m to 8.8 m below the ground surface, which could indicate that the instrument is poorly grouted, possibly with a grout void. The readings in this segment also do not stabilize, which further indicates a possible problem with the grout or casing damage. The movements of the slide mass and the interpretation of the SI data are complicated by the potential for settlement or buckling of the SI casing within the poorly grouted segment.

In SI18-01, about 104 mm of movement was observed between the spring 2023 readings and the November 2023 measurement after pile wall construction. The measurement was from 3.8 meters below ground surface to the surface. During construction, downslope survey pins recorded horizontal movement of up to 67 mm at the surface within the slide zone. This movement is believed to result from added weight on the slope during pile installation, excess pore pressures caused by the installation, and vibrations from piling. After the pile installation (2023), the cumulative movement in SI18-01 had a sharp increase between spring and fall of 2024 of approximately 17 mm, after there had been a slow, steady increase, which could result in shearing the casing. A resistance was noticed inside the SI casing when lowering the SI probe during the 2025 fall reading, between 3.5 m and 4.0 m below ground surface. SI18-01 was installed to support the design of an H-pile wall and drainage improvements to reduce slope movement impacts on Hwy 22:16.6.

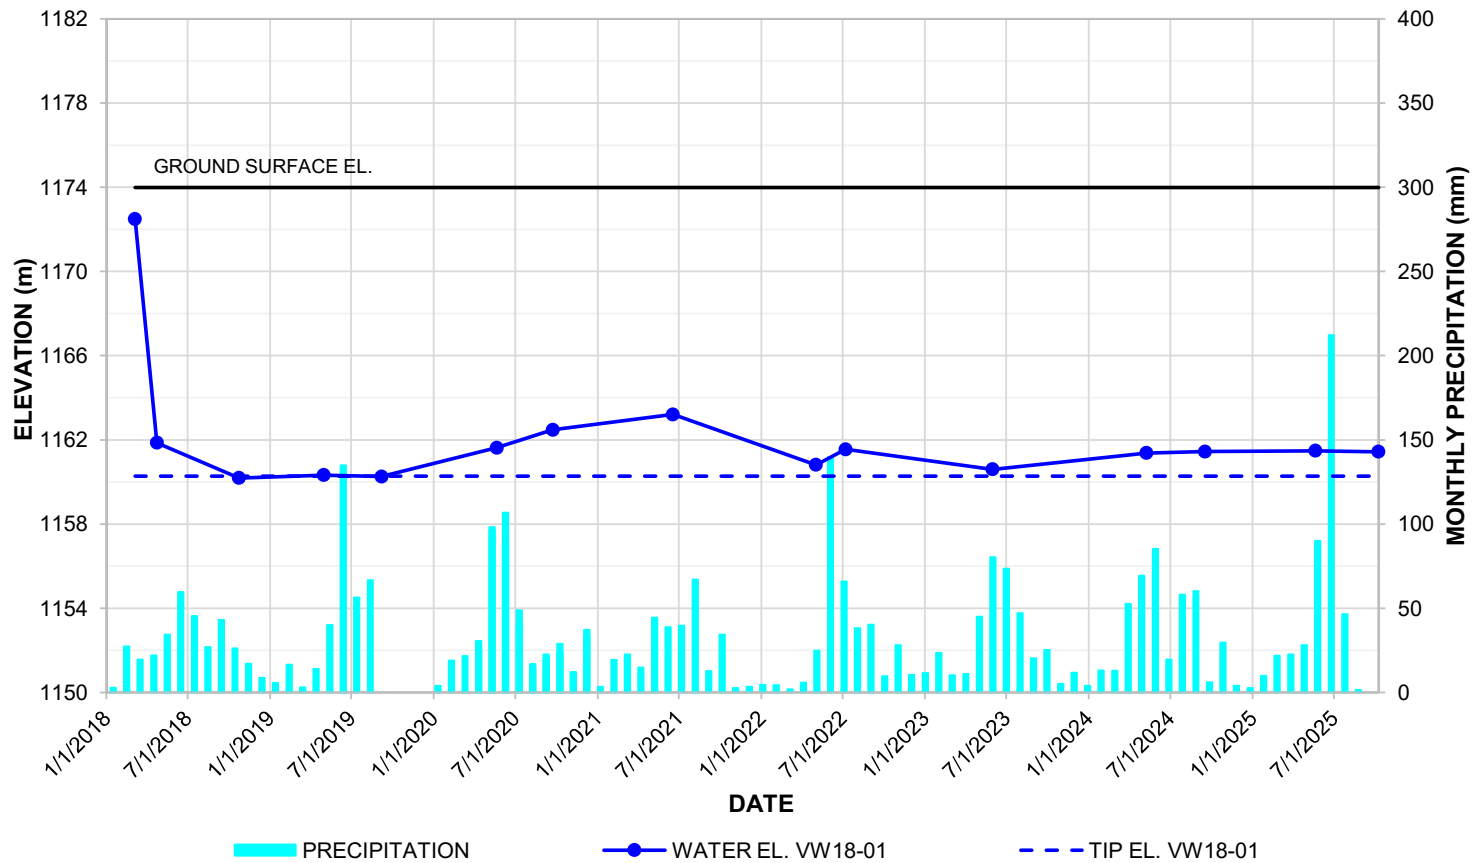
# VW18-01 (SERIAL NO. 1800200)

Excluding the first reading, water levels recorded in VW18-01 (located within the slide mass, downslope from the highway) have varied from 8.8 m to 13.4 m below ground surface, and water levels in VW18-02 (located within the slide mass, on the east shoulder of the highway) have varied from approximately 7.7 m to 10.1 m below ground surface. These water levels are below the depth of movement recorded in the SI (between the ground surface and 4.0 m below the ground surface). The data indicate that slide movements are likely in response to periods of increased precipitation, when surface water infiltrates into the top few meters, destabilizing the slope.

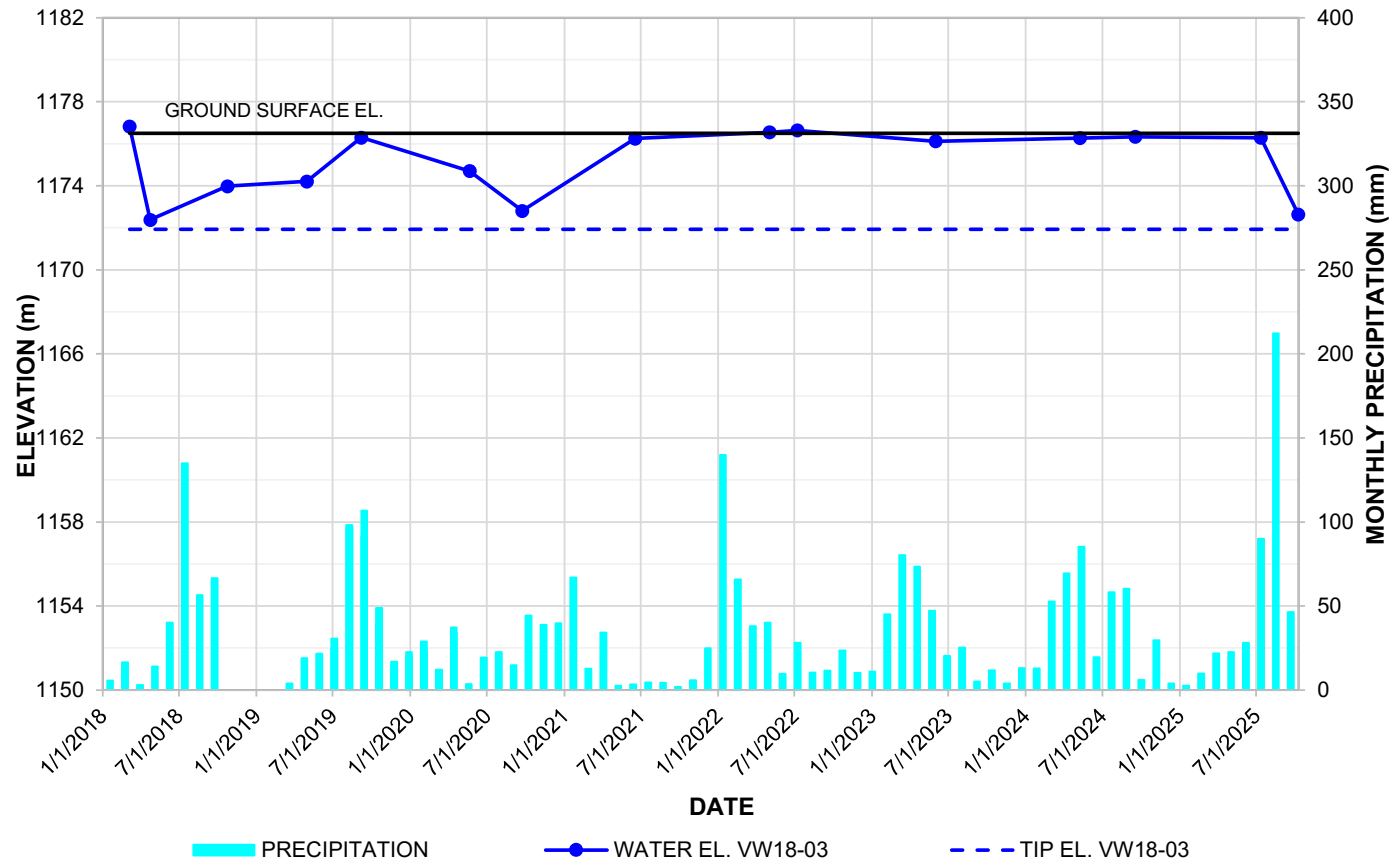
# VW18-03 (SERIAL NO. 1800201)

Water levels recorded in VW18-03 (located in the west highway ditch) have been within 0.4 m of the ground surface since 2021. The 2024 fall reading and 2025 spring reading recorded water levels at 0.2 m below the ground surface. However, the fall 2025 reading showed a sharp 3.7 m drop in water level despite having high records of precipitation in 2025; similar drops have been previously

measured in 2018, 2019, and 2020. Further readings would help confirm whether the high water level between 2024 and 2025 could have been associated with readings taken after a rainfall event and subsequent ground saturation.
