July 15, 2025

**CON0022161 Southern Region GRMP Instrumentation Monitoring**  
**Site S003; H22:16 km 9.9 Cochrane**  
**Section C – 2025 Spring Readings**

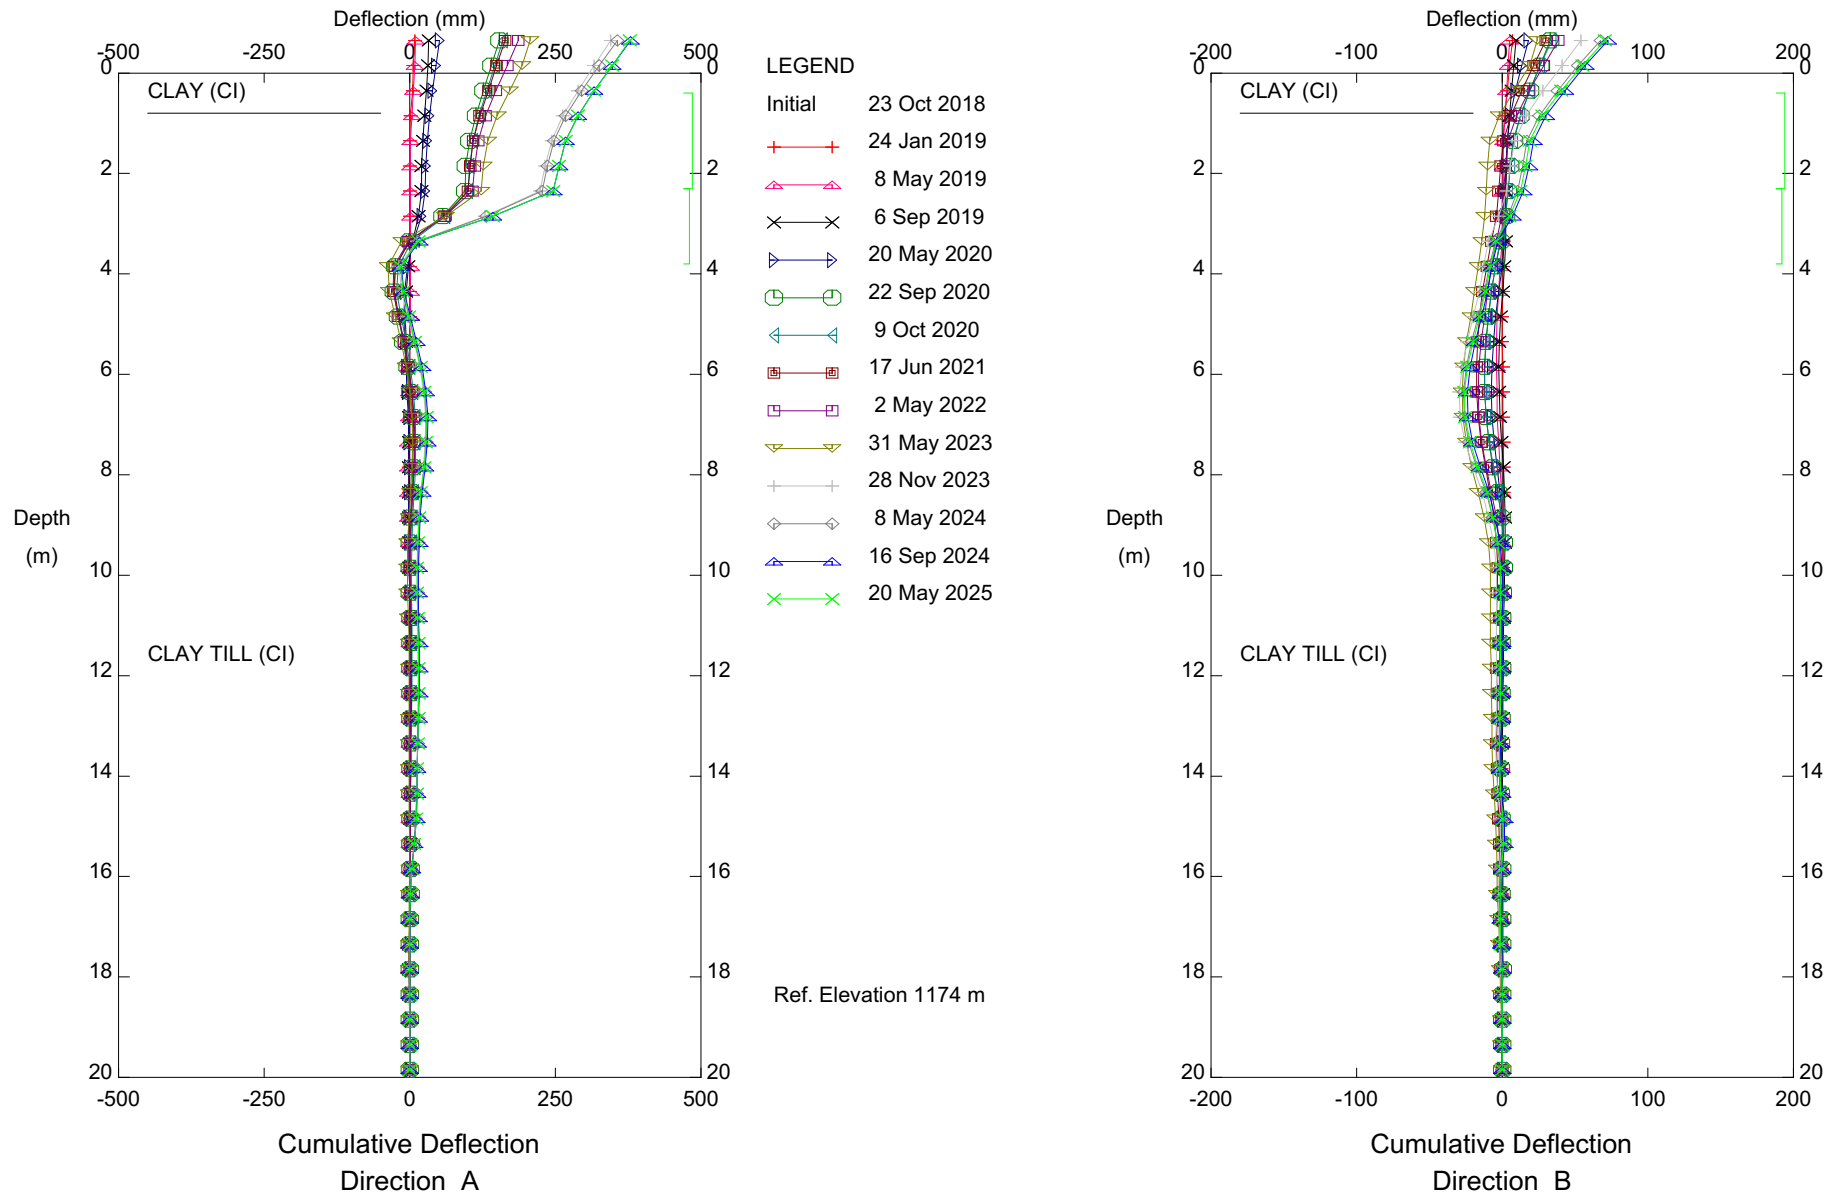
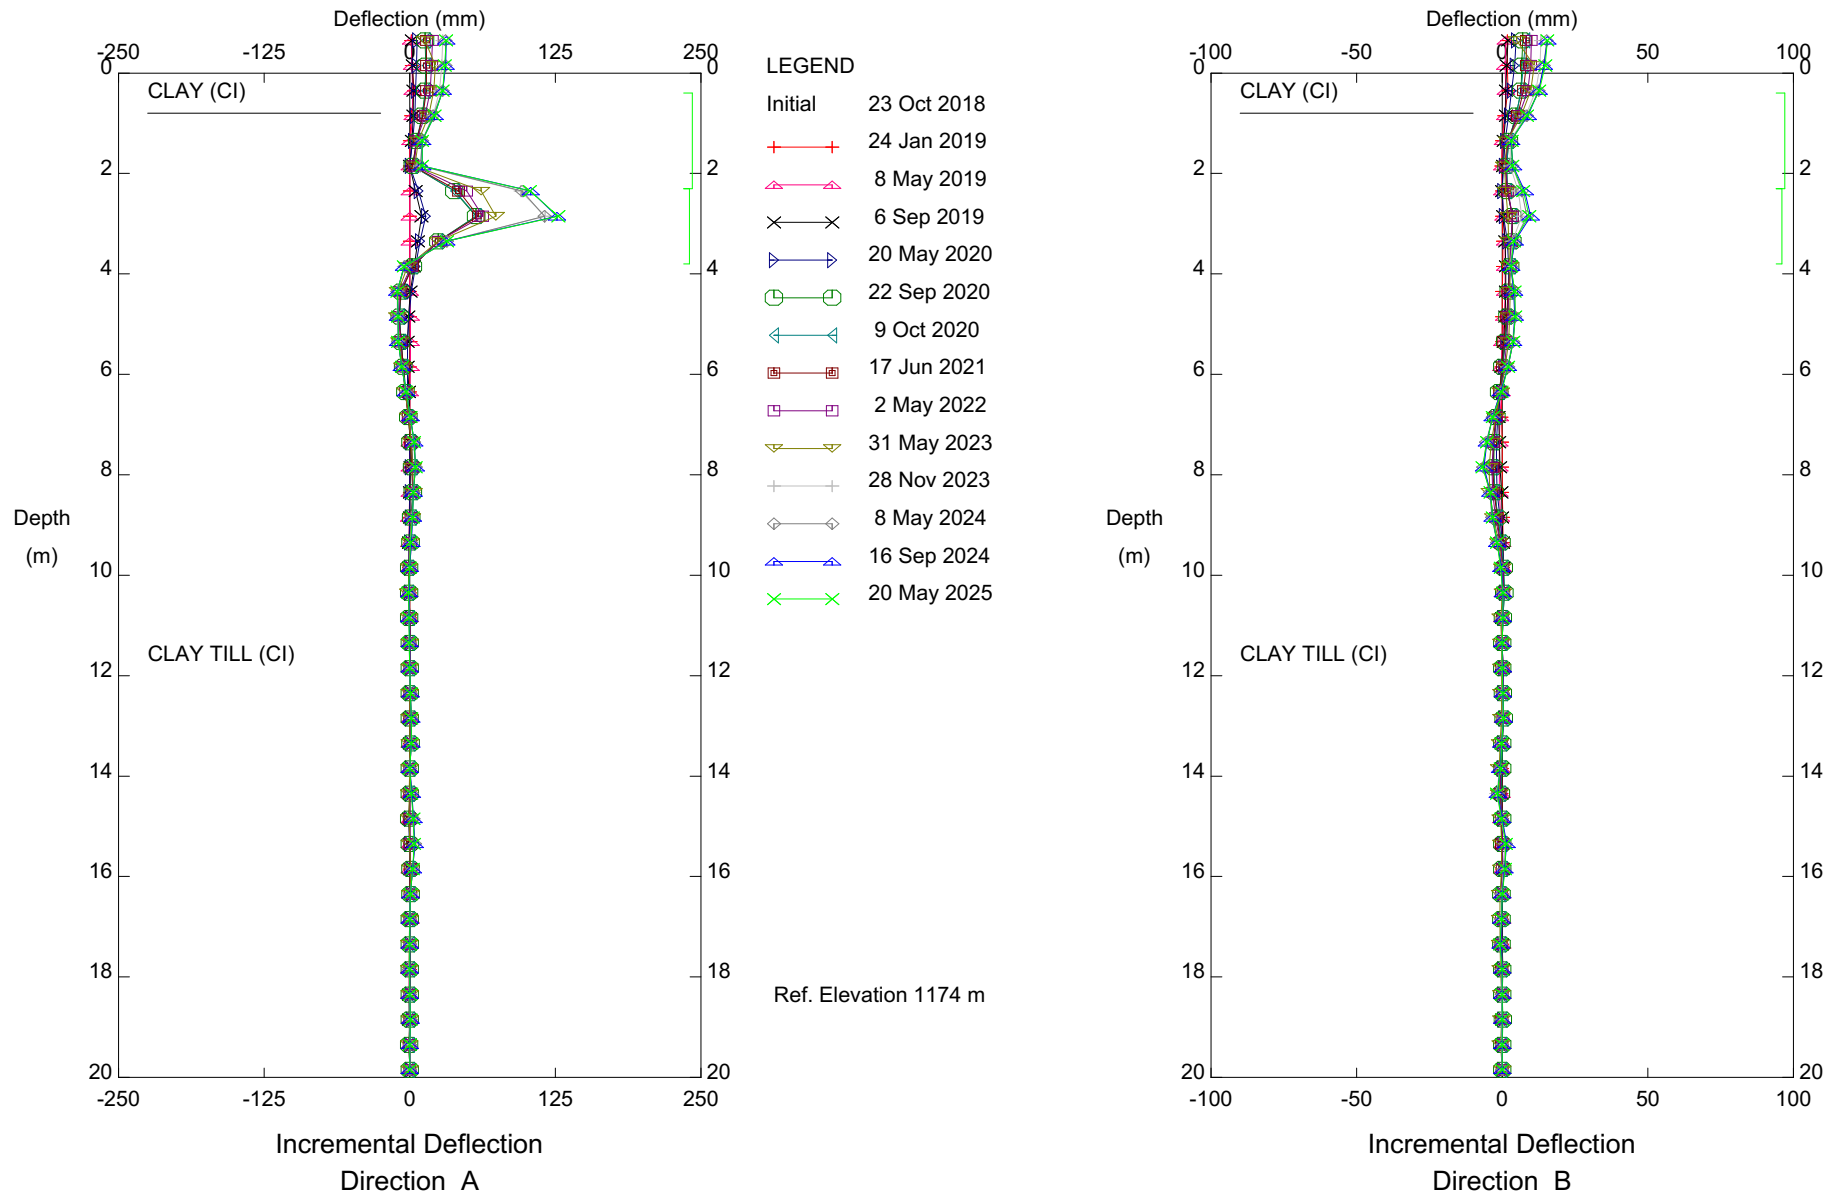
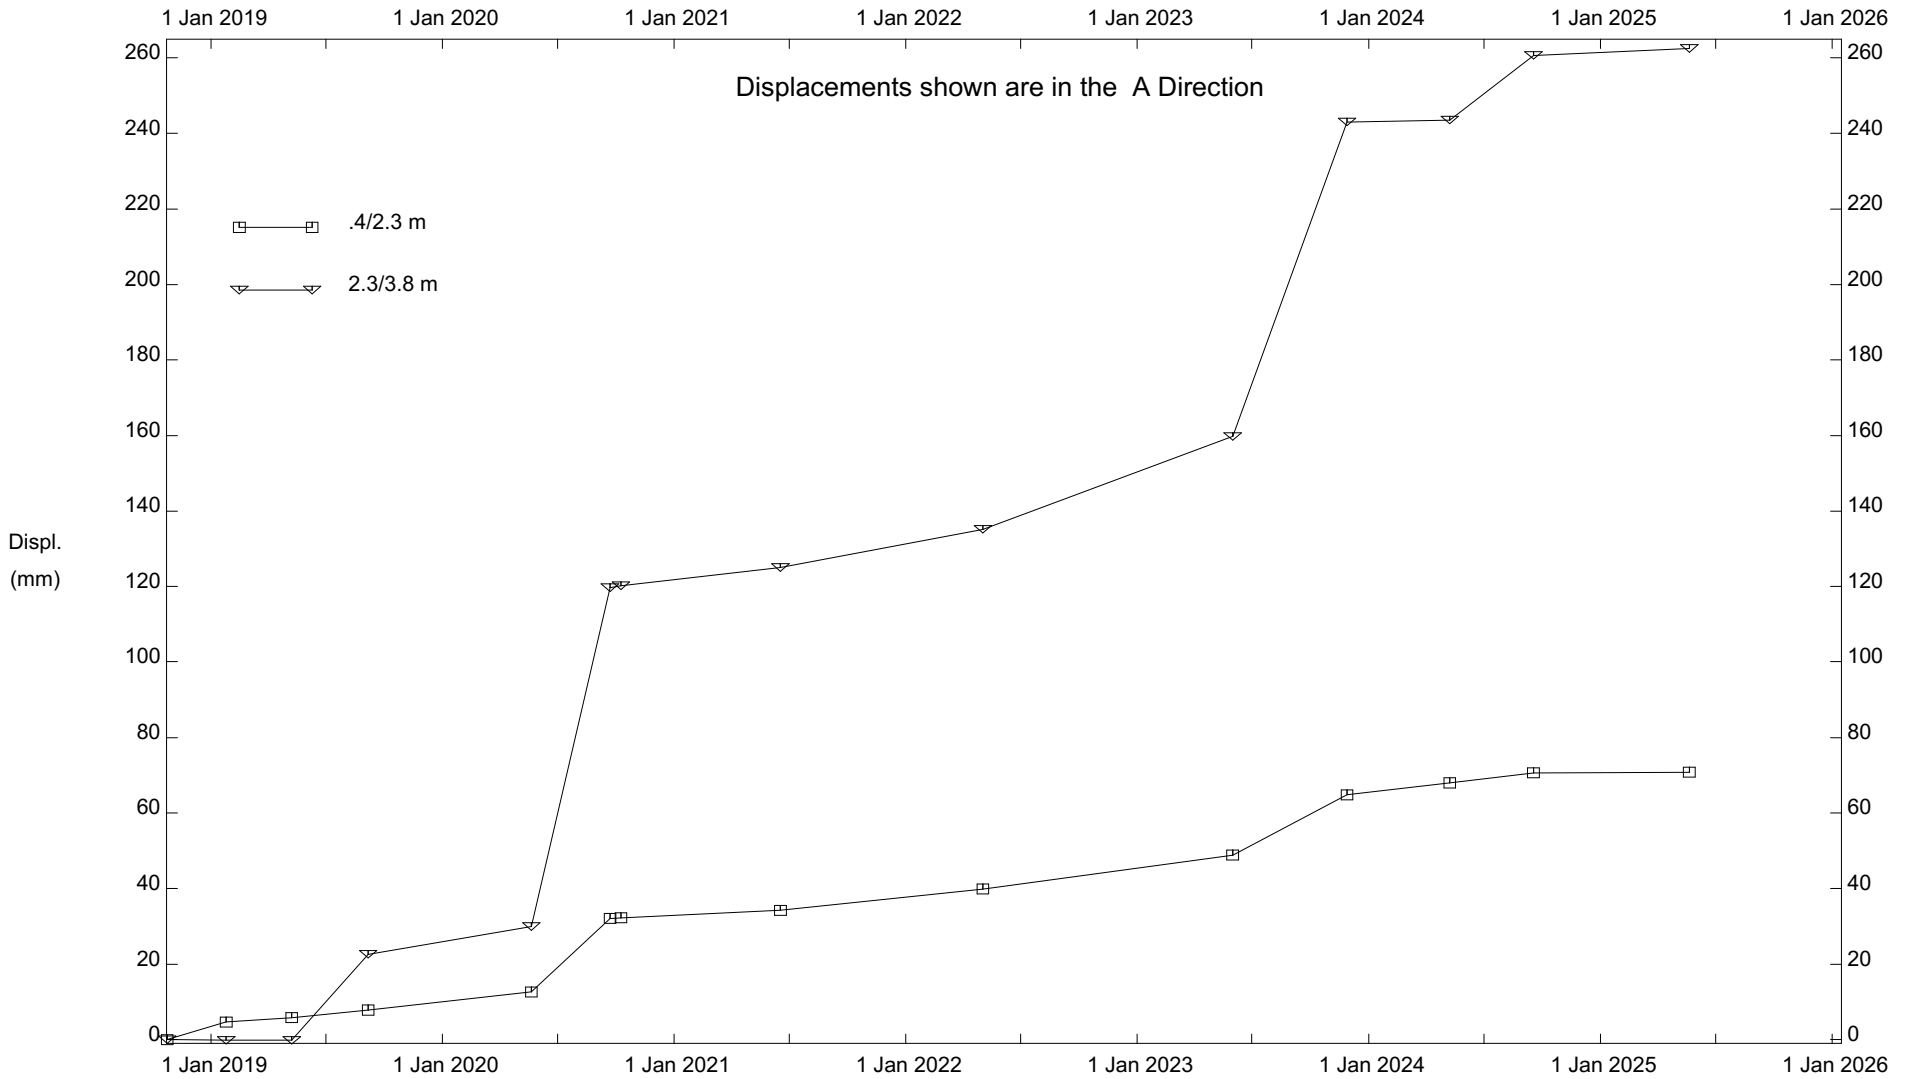
S003; H22:16, Cochrane, Inclinator SI18-01  
Alberta Transportation

Distributed movement continues to be recorded in SI18-01 from ground surface to an approximate depth of 2.3 m below ground surface (approximately El. 1173.6 m to El. 1171.3), and possible discrete movement between 2.3 m and 3.8 m (approximately El. 1171.3 m to El. 1169.8). The casing also appears to be settling or buckling between an approximate depth of 3.8 m and 8.8 m as discussed in Section 2.3. SI18-01 is located near the middle of the slide on the downslope side of the highway.

Settlement or buckling is observed in SI18-01, from approximately 3.8 m to 8.8 m below the ground surface, which could indicate that the instrument is poorly grouted, possibly with a grout void. The readings in this segment also do not stabilize, which further indicates a possible problem with the grout or casing damage. The movements of the slide mass and the interpretation of the SI data are complicated by the potential for settlement or buckling of the SI casing within the poorly grouted segment.

In SI18-01, about 104 mm of movement was observed between the spring 2023 readings and the November 2023 measurement after pile wall construction. The measurement was from 3.8 meters below ground surface to the surface. During construction, downslope survey pins recorded horizontal movement of up to 67 mm at the surface within the slide zone. This movement is believed to result from added weight on the slope during pile installation, excess pore pressures caused by the installation, and vibrations from piling. Cumulative movement in SI18-01 from fall 2024 (post-construction) to spring 2025 continues to increase, with approximately 262 mm recorded since 2023 pile wall construction from 3.8 meters below ground to the surface. The instrument is likely to shear soon. SI18-01 was installed to support the design of an H-pile wall and drainage improvements to reduce slope movement impacts on Hwy 22:16.6.

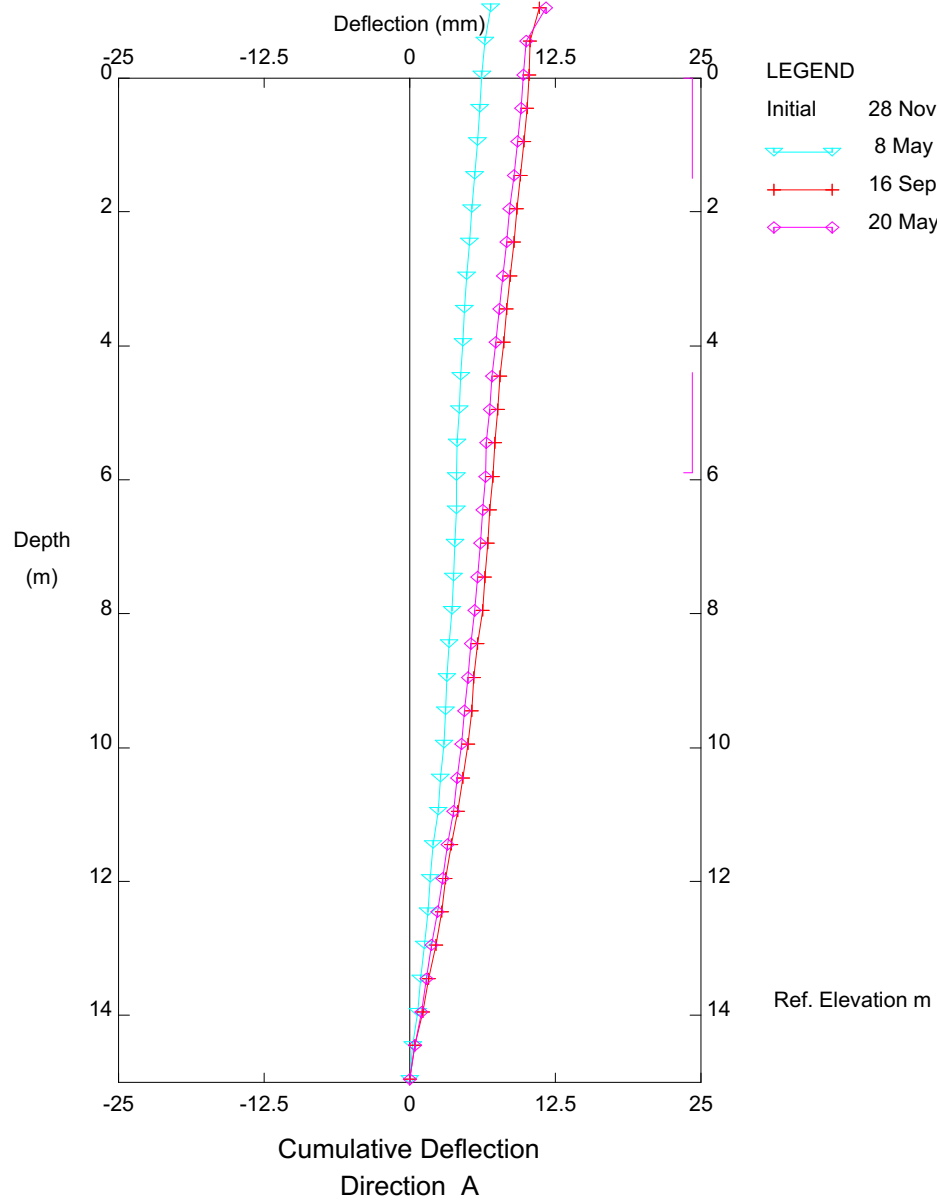
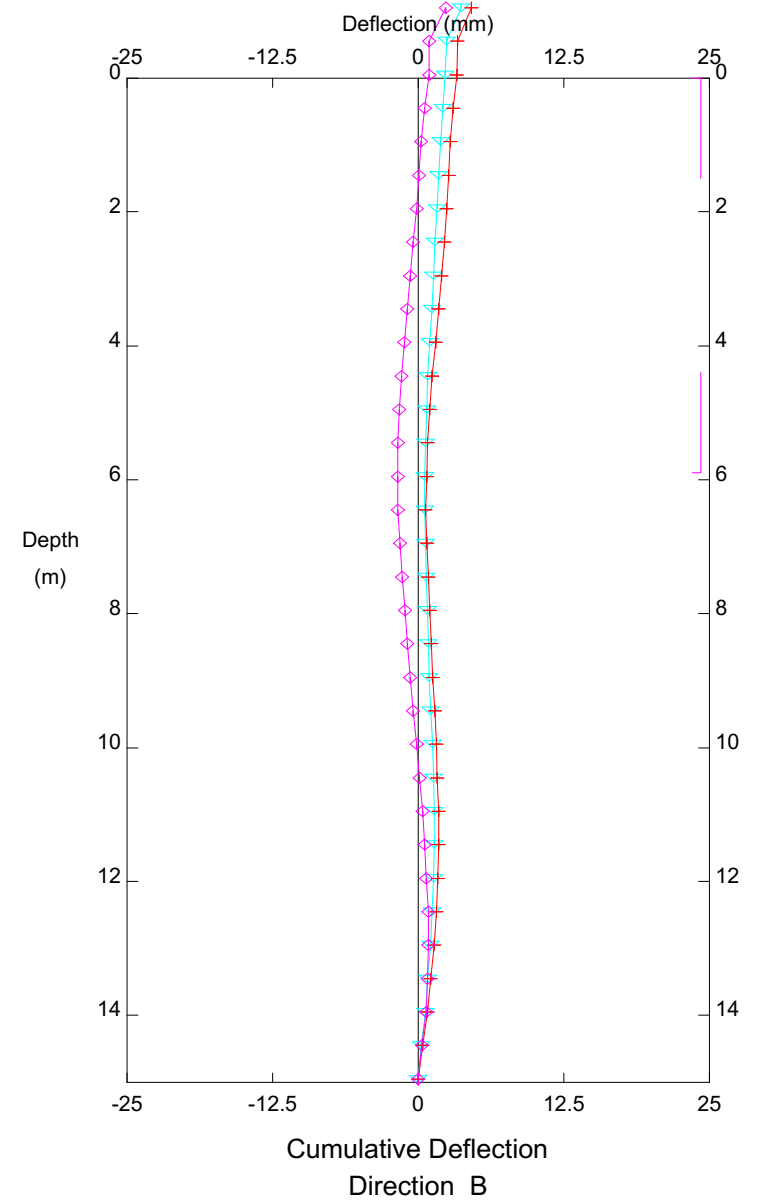
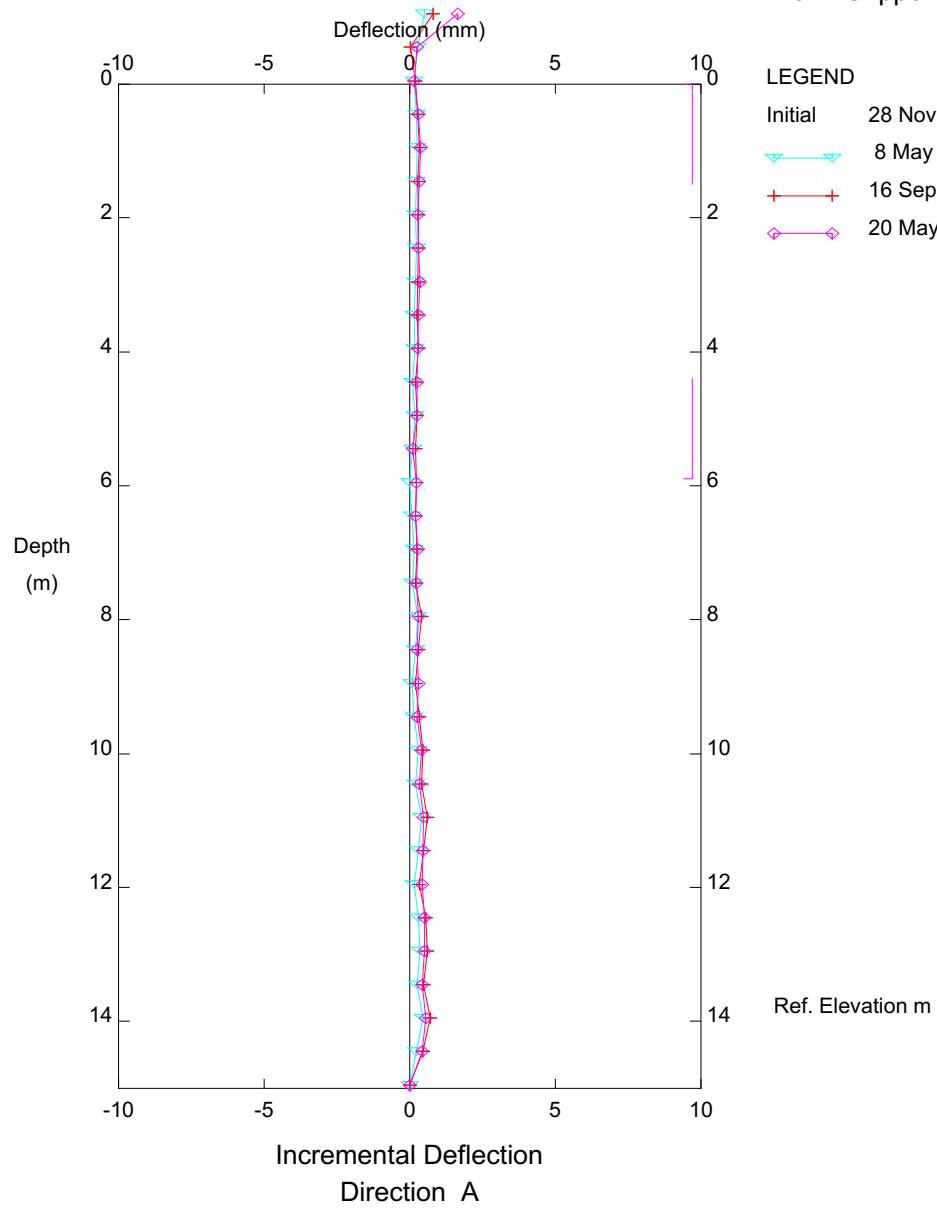
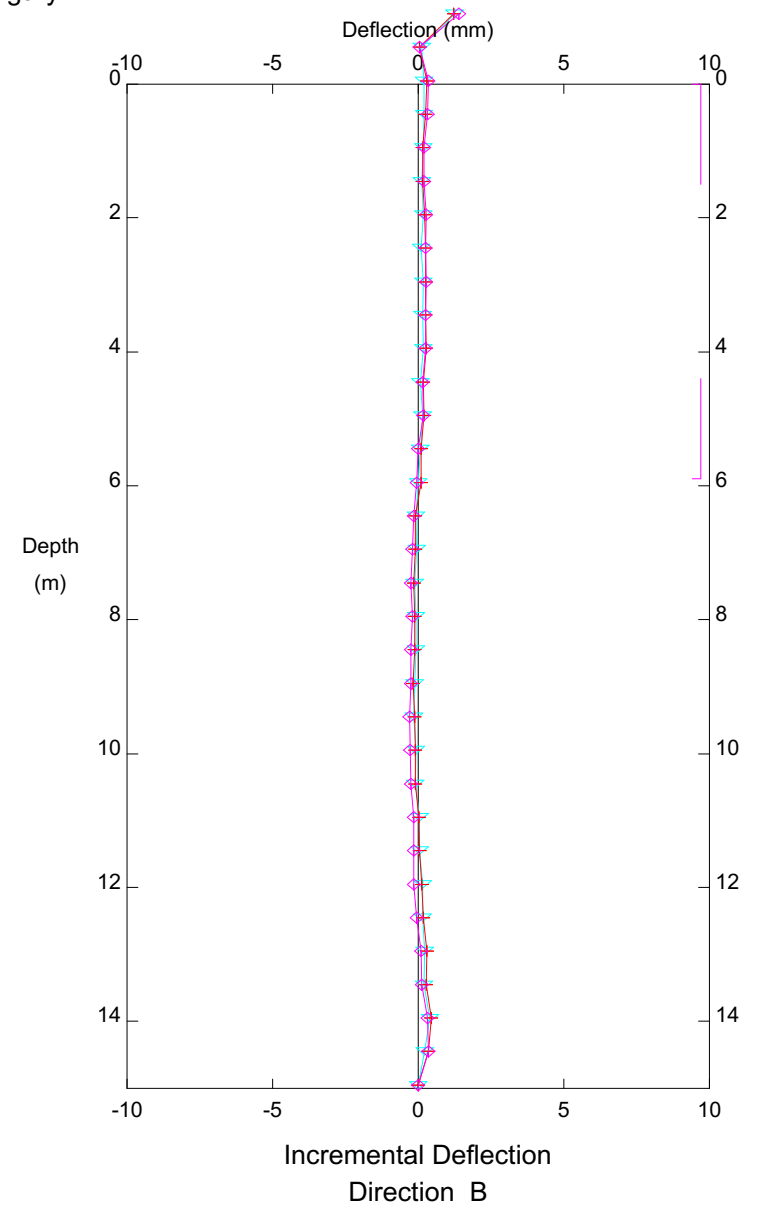
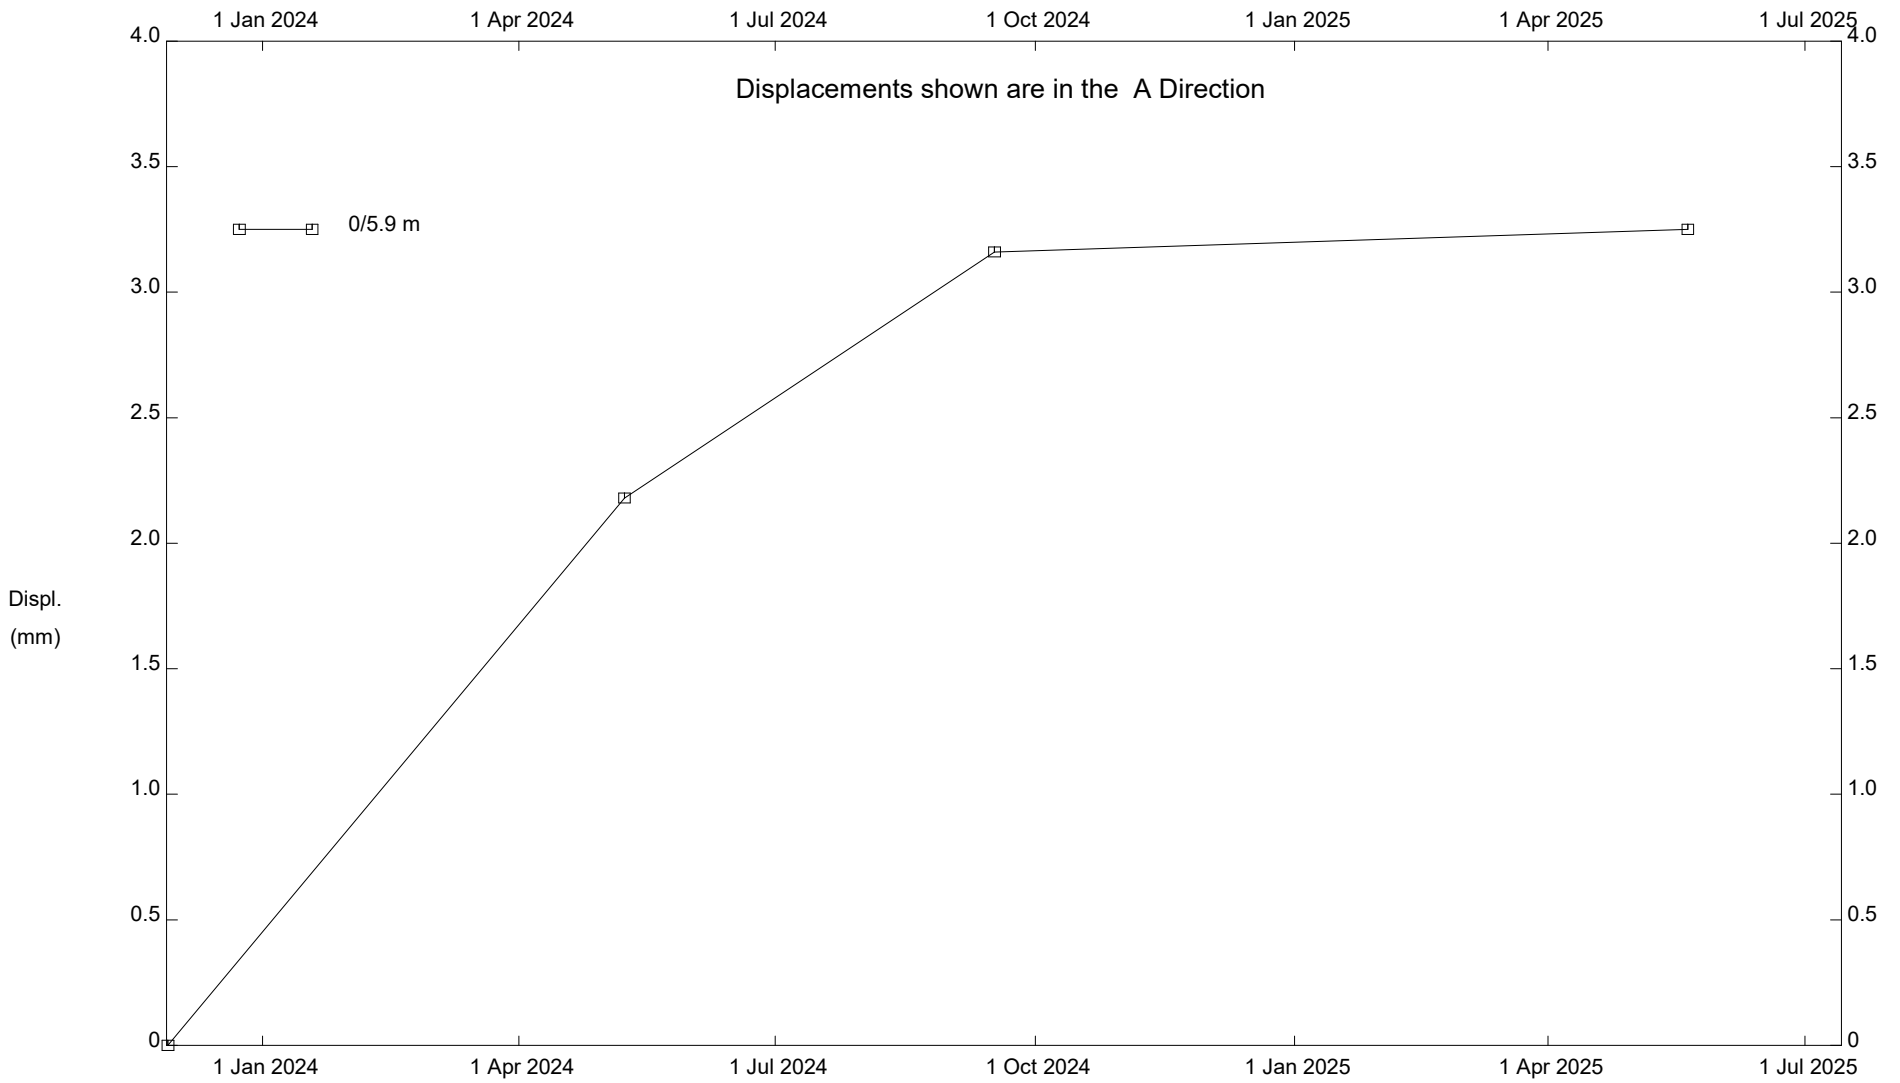
Cochrane, Inclinator 23-01

Distributed movement has started to be recorded in the SIs installed in the pile wall (SI23-01, SI23-02, and SI23-03) in the top 4 m to 6 m below the ground surface, indicating that the pile wall has begun to take load from the slide mass.

The four SIs installed during construction were initialized in November 2023 once construction was completed. The new SIs were installed inside the H-Pile flanges in steel channels and backfilled with sand. Small amounts of distributed movement (up to approximately 2.5 mm) are being measured in the top 4 to 6 meters in SI23-01, SI23-02, and SI23-03, indicating that the pile wall has begun to take load from the slide mass. Additional readings will be needed to provide further interpretation of the

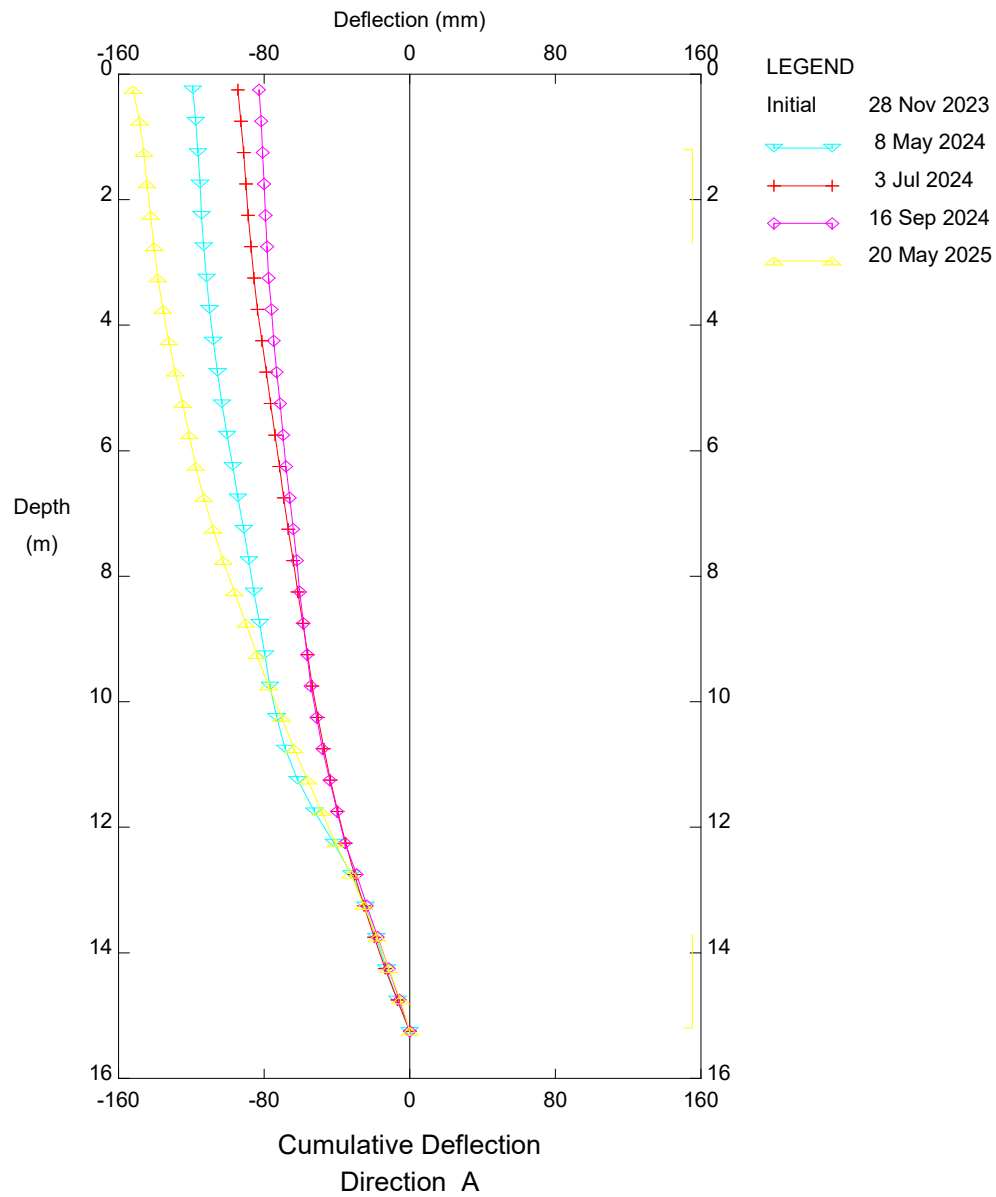
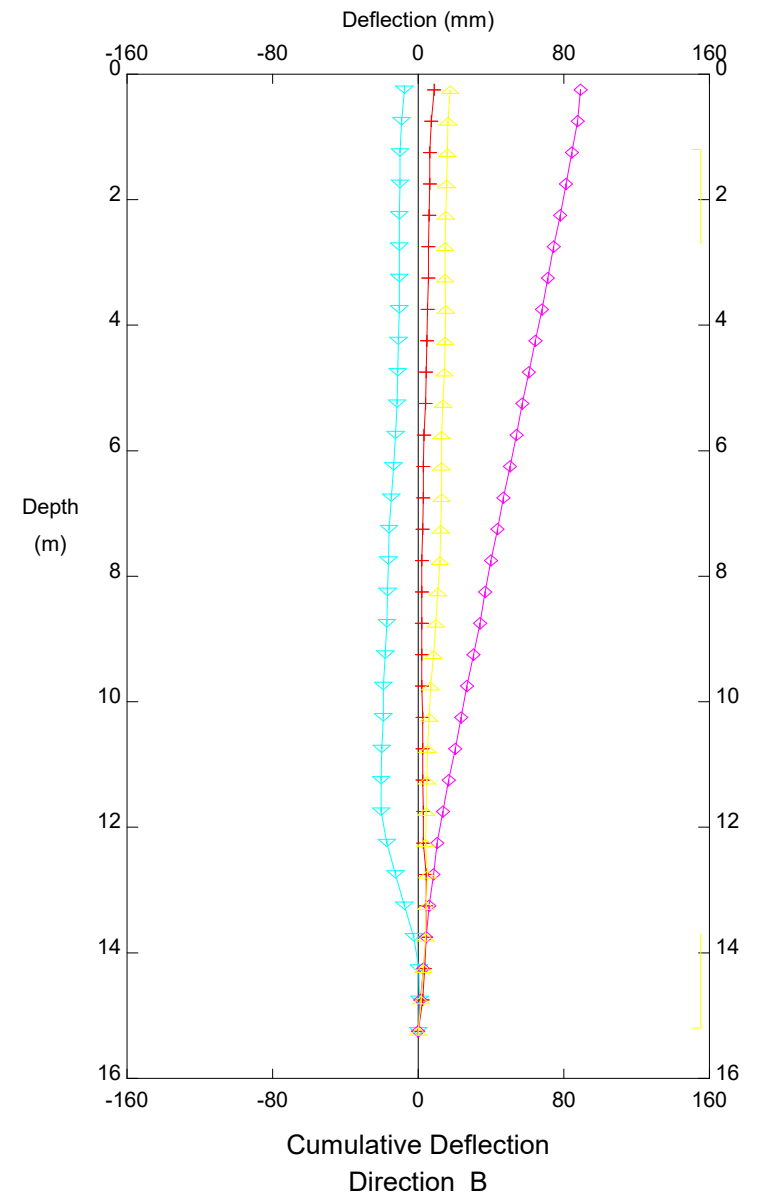
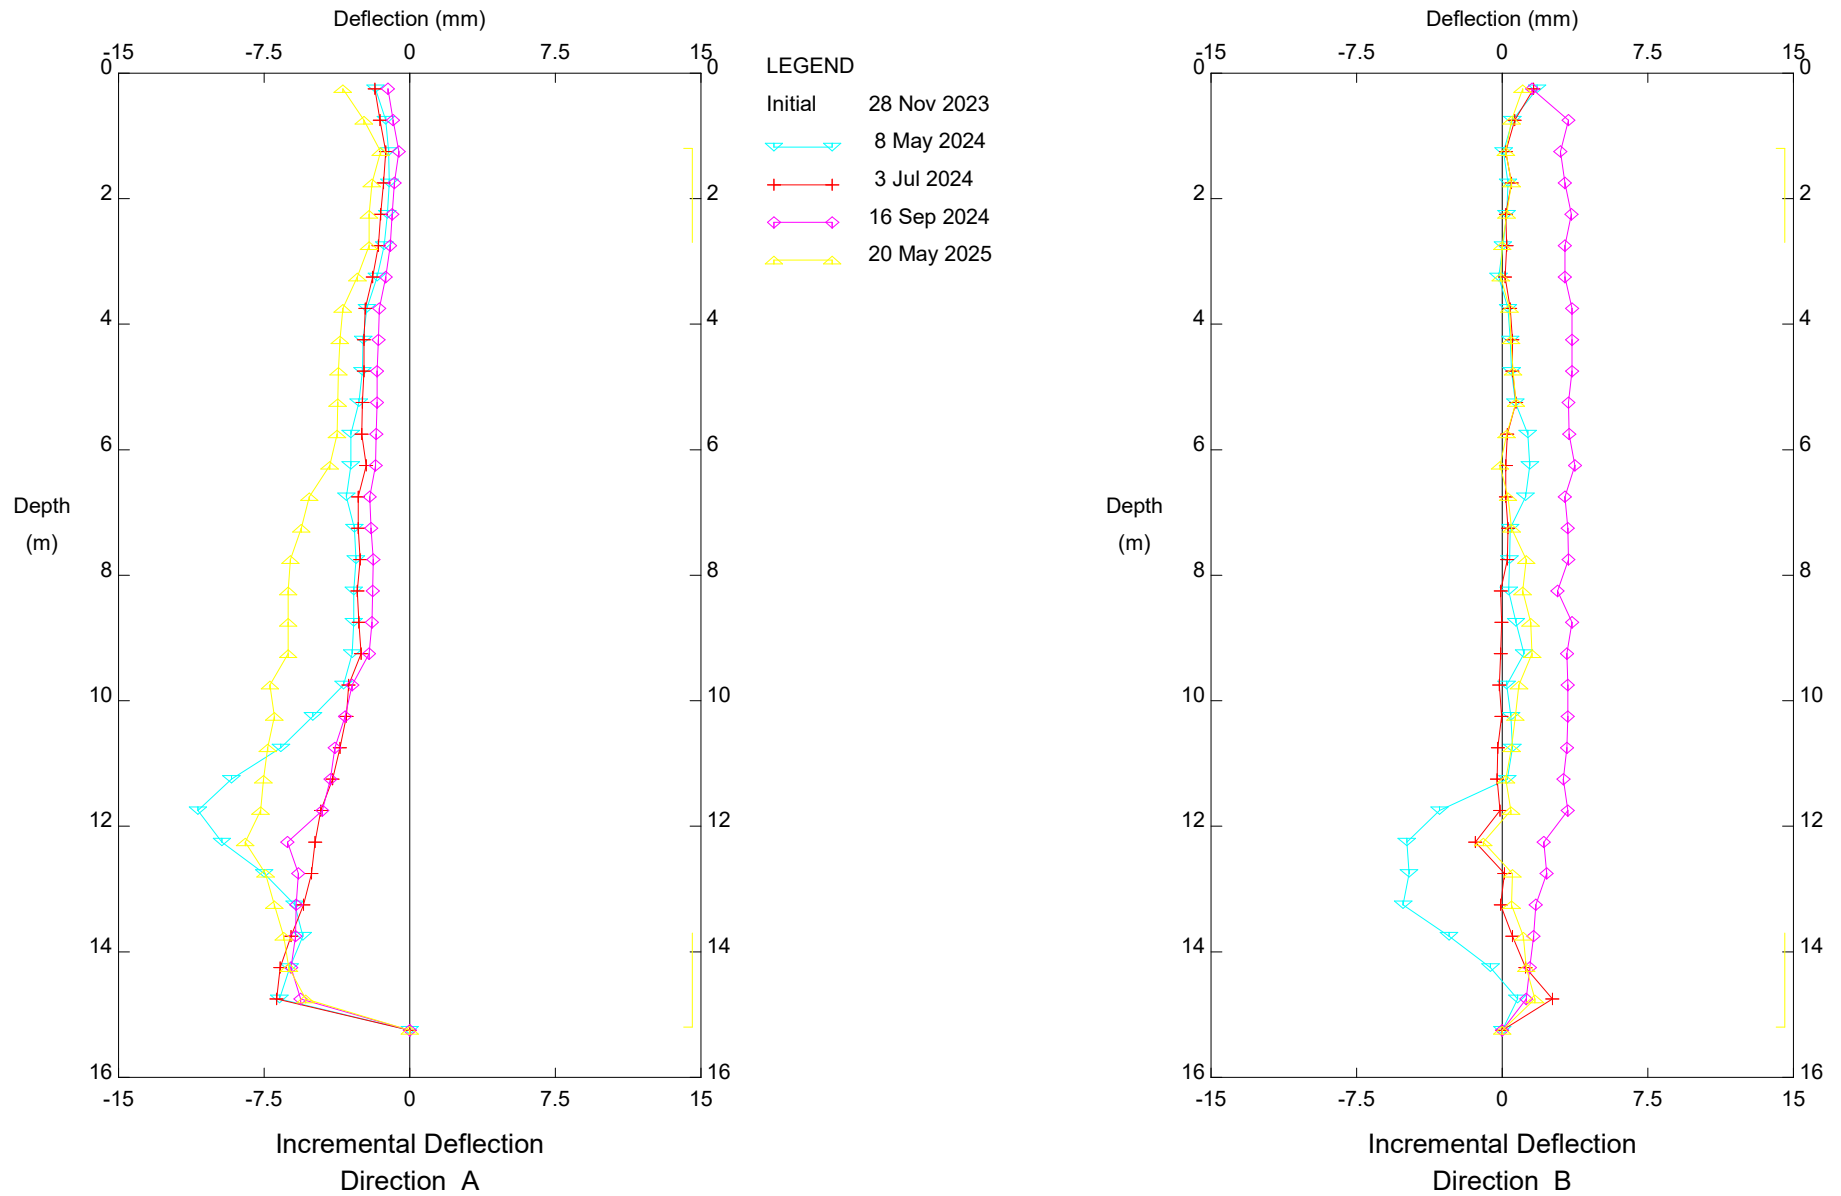
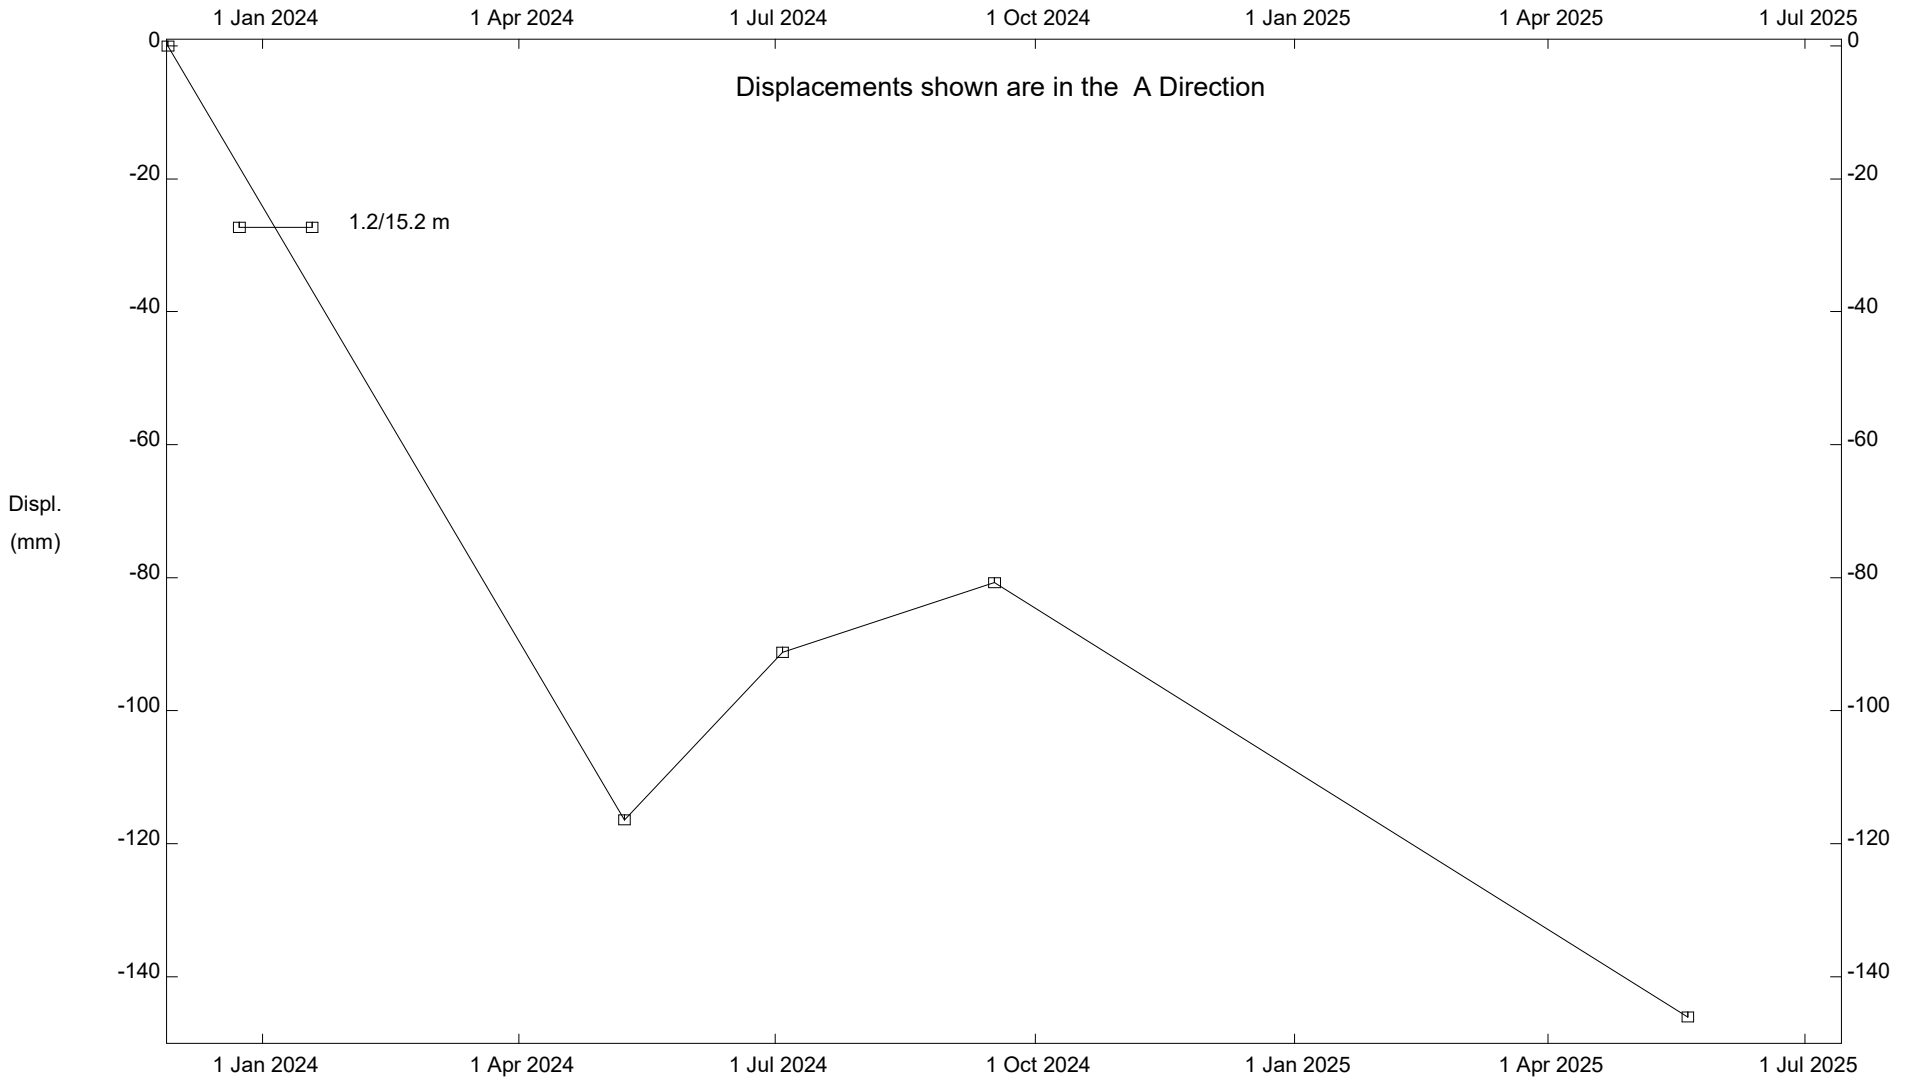
Cochrane, Inclinator 23-04

pile wall movement as it continues to take load from the slide mass. Readings taken since the installation in SI23-04 have not been consistent due to poor data quality, and they have been re-read several times to attempt to obtain consistent readings. Although the issue with the reading of SI23-04 will need to be investigated further, the readings are starting to show a trend in displacement that will need to be confirmed in subsequent readings.

It is possible that some of the sand backfills around the SI23-04 casing has migrated out from the welded channel on the H-pile, causing the SI casing to be loose in the pile.

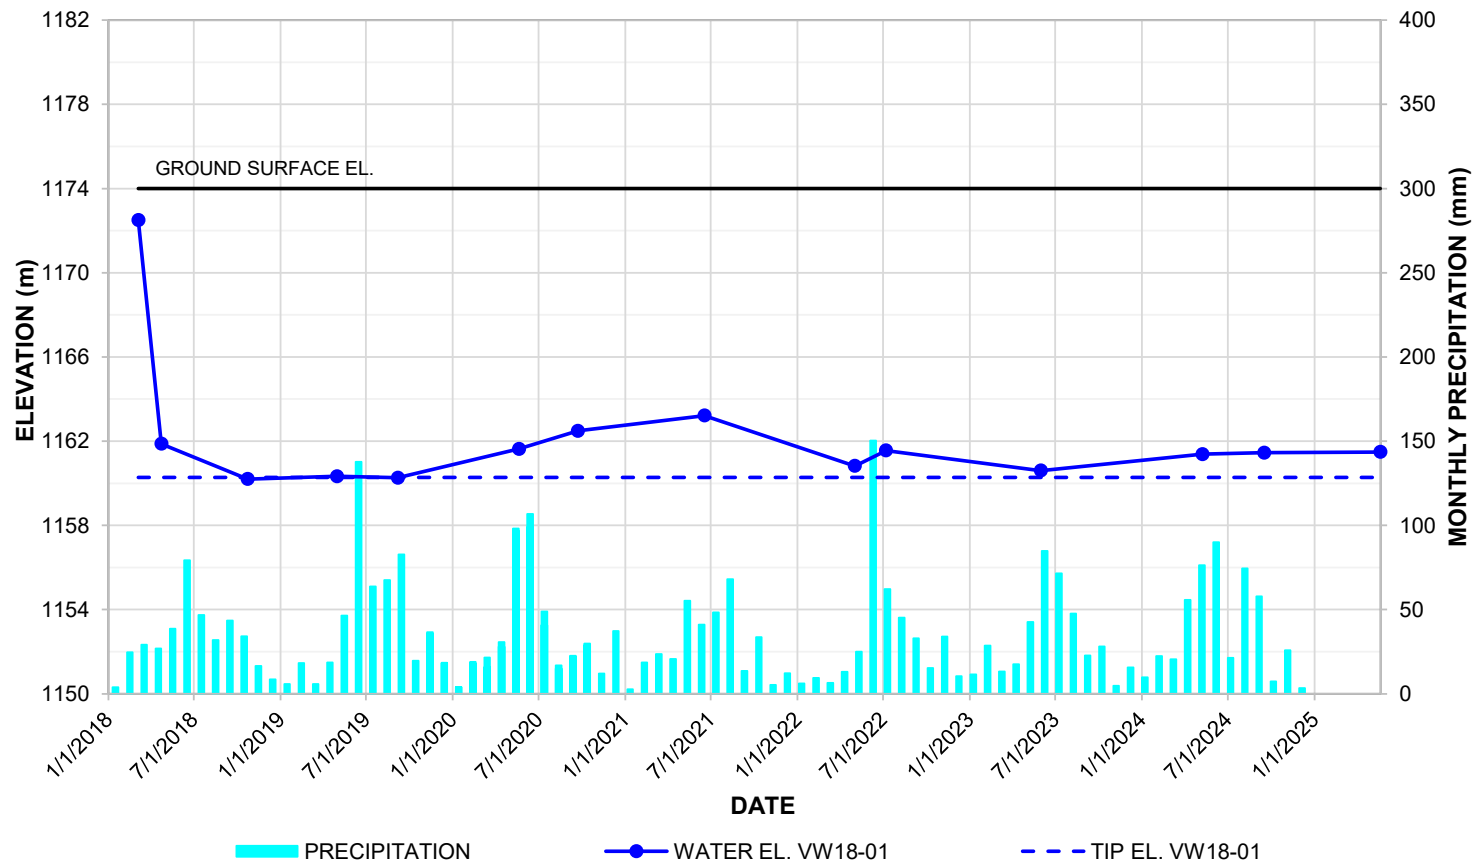
# VW18-01 (SERIAL NO. 1800200)

The initial readings for the VVPs (VW18-01 through VW18-03) were taken immediately following grouting operations. KCB believes that the initial water levels recorded in the VVPs were artificially high due to the grouting. Water levels recorded in these instruments decreased up to 12 m within a month of installation.

Excluding the first reading, water levels recorded in VW18-01 (located within the slide mass, downslope from the highway) have varied from 8.8 m and 13.4 m below ground surface, and water levels in VW18-02 (located within the slide mass, on the east shoulder of the highway) have varied from approximately 7.7 m and 10.1 m below ground surface. These water levels are below the depth of movement recorded in the SI (between the ground surface and 4.0 m below the ground surface). The data indicates that slide movements are likely in response to periods of increased precipitation, when surface water infiltrates into the top few meters, destabilizing the slope.

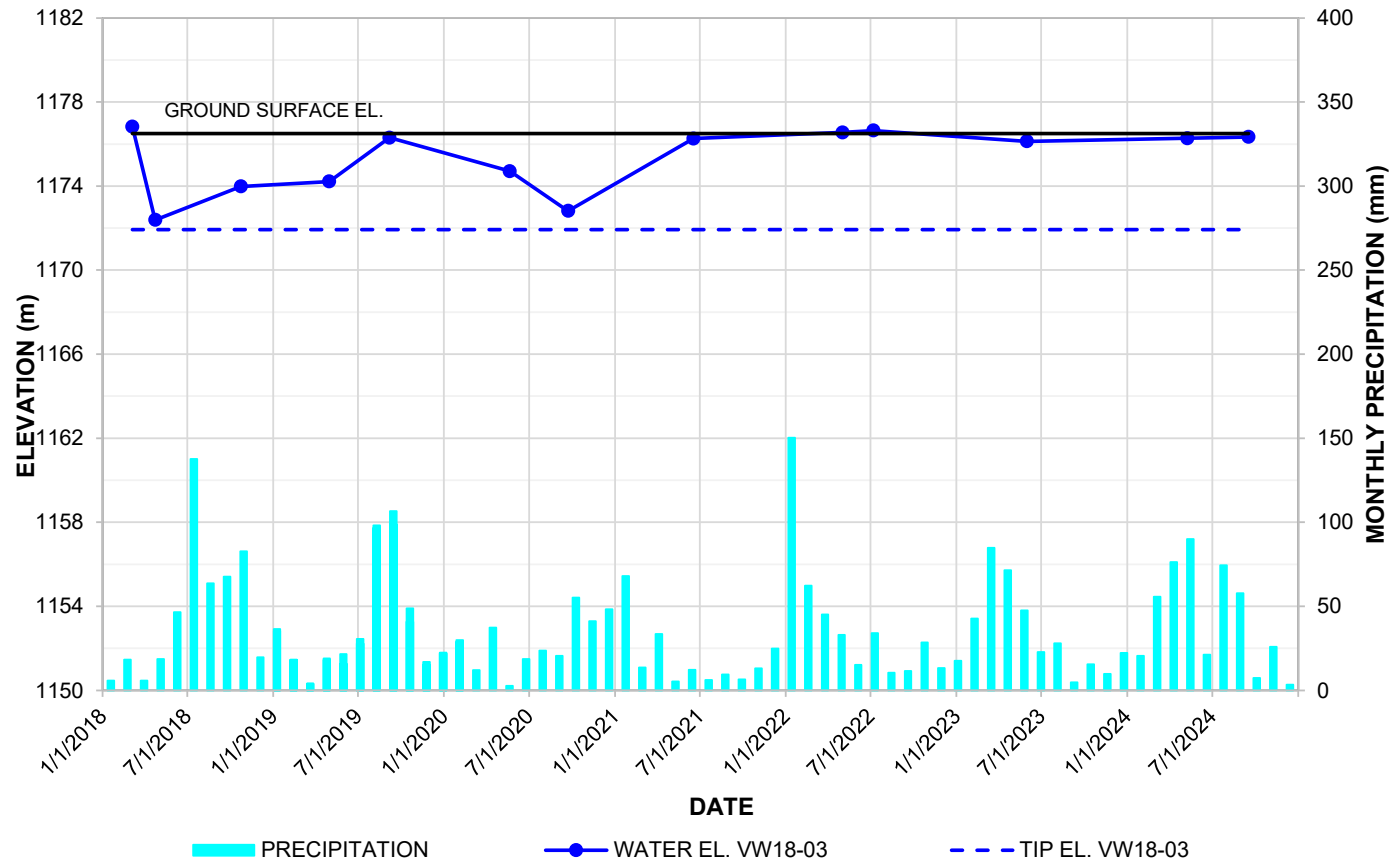
# VW18-03 (SERIAL NO. 1800201)

Water levels recorded in VW18-03 (located in the west highway ditch) have been within 0.4 m of the ground surface since 2021. The 2024 fall reading and 2025 spring reading recorded water levels at 0.2 m below the ground surface. Rainfall data for periods after December 31, 2024, was not available at the time of writing this report.
