SITE NUMBER AND NAME <b>S017-II Mount Baldy Rockfall Hazards</b>		HIGHWAY & KM 40:12, 37.302	PREVIOUS INSPECTION DATE May 17, 2022	INSPECTION DATE <b>May 27, 2024</b>
LEGAL DESCRIPTION NE 32-23-8-W5	NAD 83 COORDINATES UTM Northing Easting 11 5652484 634210		RISK ASSESMENT PF: 14 CF: 3 TOTAL: 42	
Average Annual Daily Traffic (AADT): 3430 (north) & 3330 (south) (Reference No. 53190)			Contractor Maintenance Area (CMA): 28

PROJECT SOUTHERN REGION GEOHAZARD RISK MANAGEMENT PROGRAM		
TITLE Site Plan S017 - Mount Baldy Rock Cut Hwy 40:12 km, 37.302		
SCALE 1:1,200	PROJECT No. A05115A03	FIG No. 1

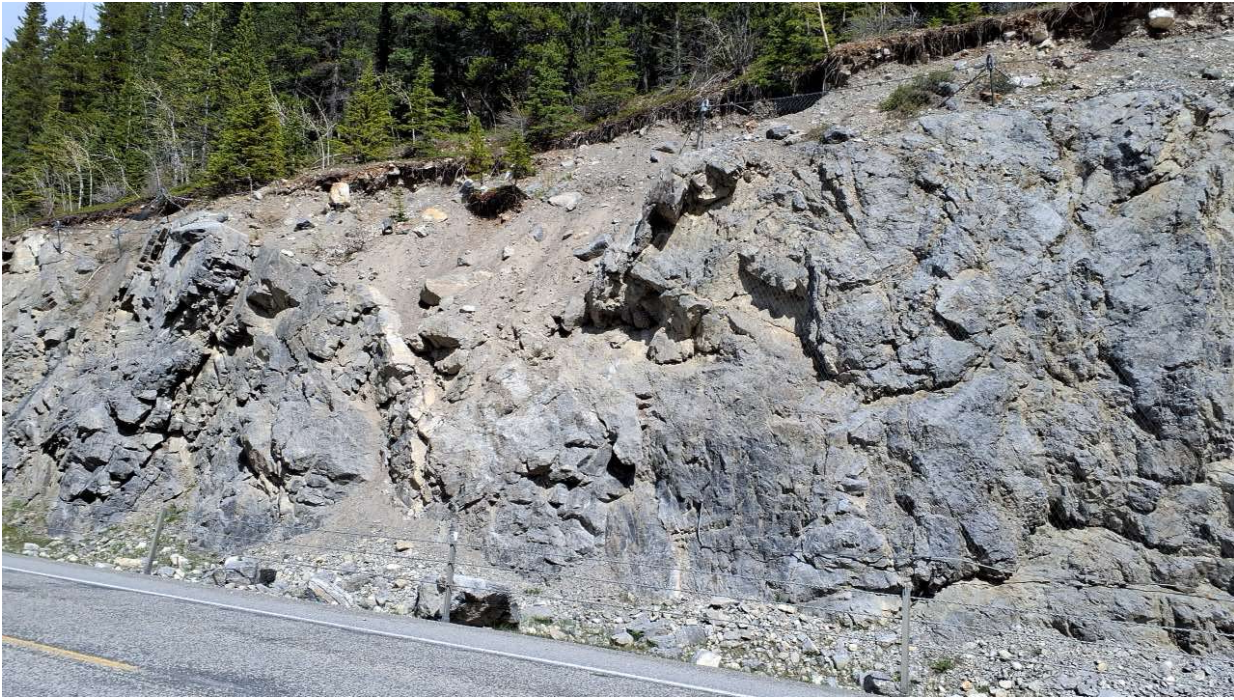
**Photo 1**      **Rock slope height is approximately 15 m. Loose material at the brow of the slope erodes and contributes to the rockfall. Photo taken facing east on May 27, 2024.**

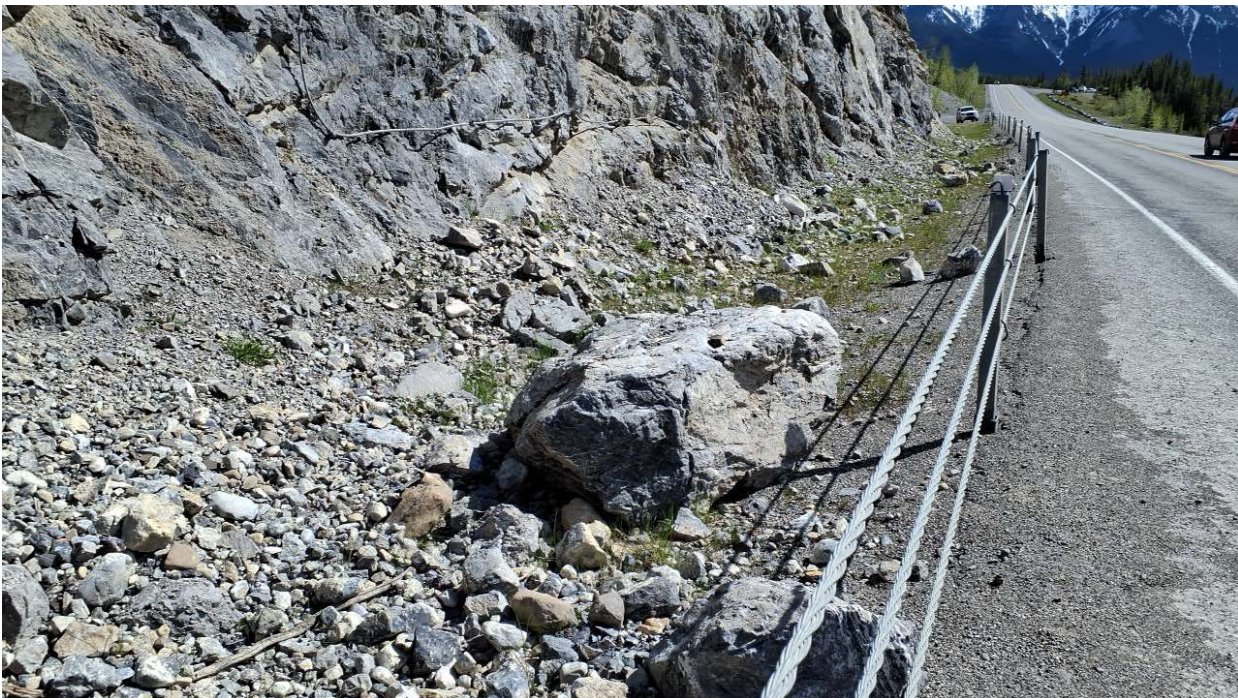
**Photo 2**      **Rock debris in ditch up to 1.7 m x 1.2 m x 0.8 m. Large boulder was in the ditch during the previous inspection in 2019. More debris noted since last inspection. Photo taken facing south on May 27, 2024.**

- The ditch should be cleaned of debris more regularly. The MCI reports that ditches are typically cleaned every 3 to 5 years.
- Reattach the mesh to the base cable so that it functions effectively.
- Assess if a lock block wall inside the HTCB would work to address issues of rockfalls reaching the highway. Could replace HTCB with W-beam guard rail to help prevent smaller rockfall debris from reaching the highway.

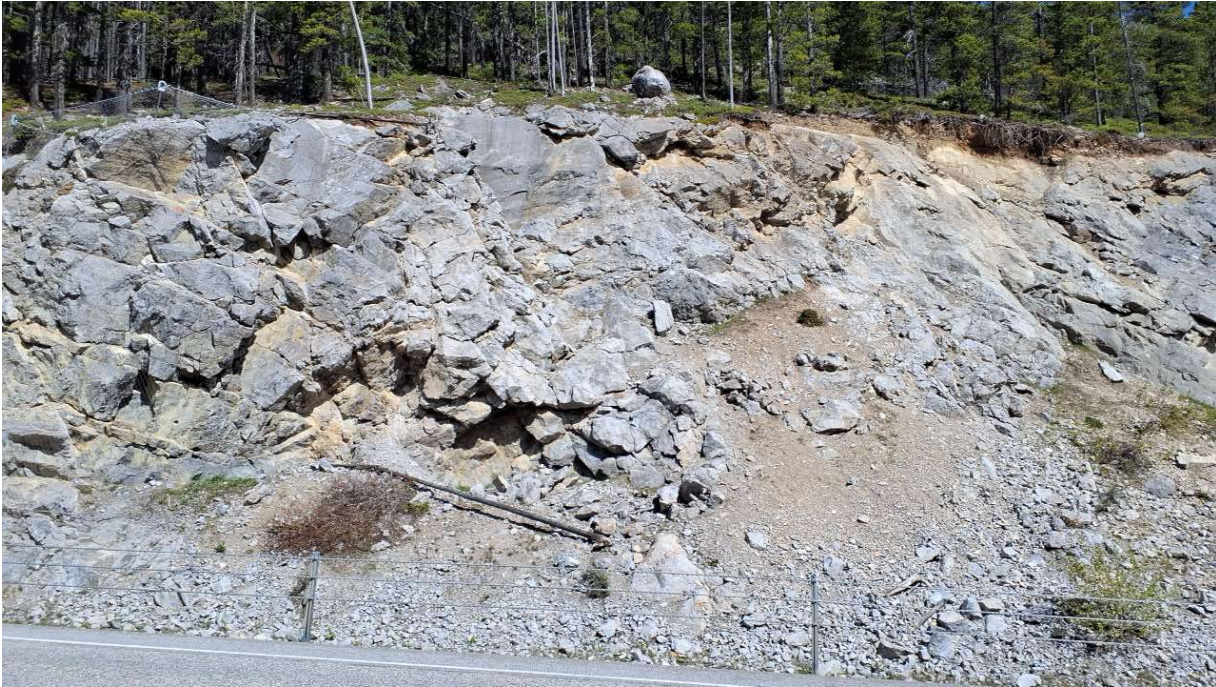
**Photo 3**      **Rock mass dilated, with large blocks noted at the brow of the slope, outside of messed area. Photo taken May 27, 2024, facing east.**

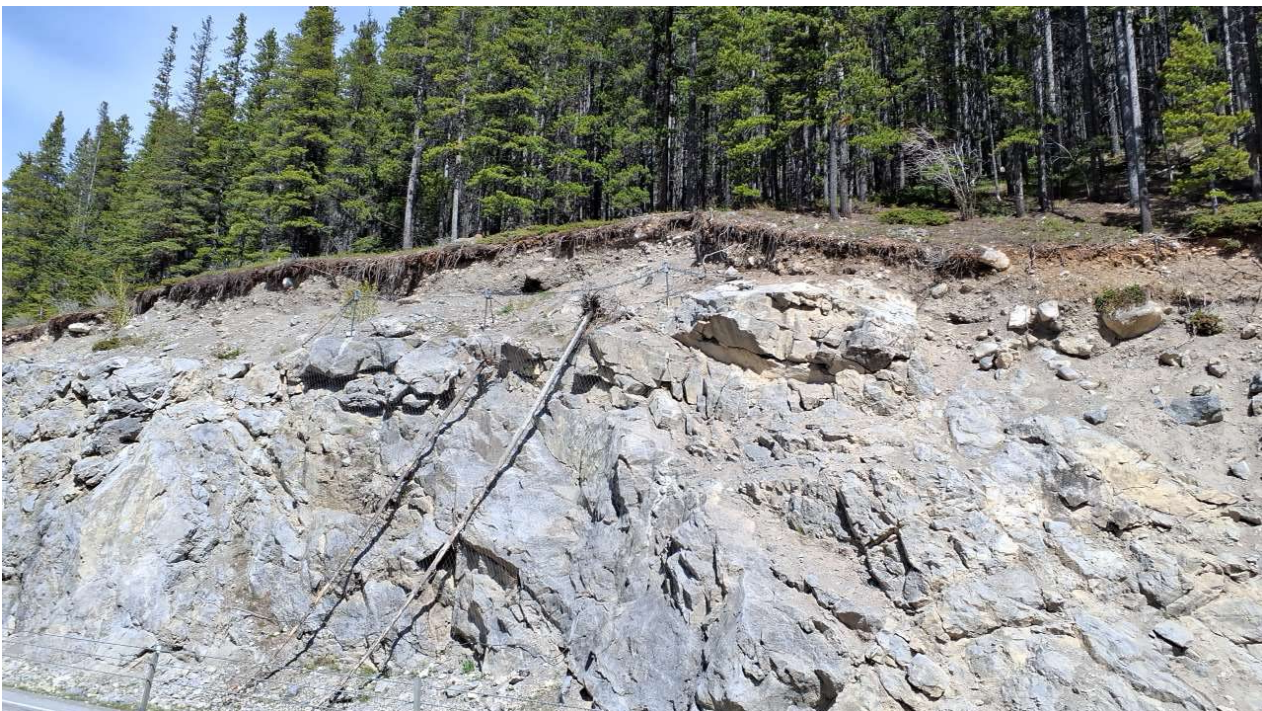
**Photo 4**      **Erosion at brow of slope, above wire mesh depositing rock debris and trees. Photo taken May 27, 2024, facing east.**
