SITE NUMBER AND NAME <b>S018-IV Rocky Creek</b>		HIGHWAY & KM 40:12, 15.88	PREVIOUS INSPECTION DATE May 17, 2022	INSPECTION DATE <b>May 27, 2024</b>
LEGAL DESCRIPTION NW 3-22-9-WM5	NAD 83 COORDINATES UTM Northing Easting 11 5634403 629029		RISK ASSESSMENT <b>S018-IV: PF: 5 CF: 6 TOTAL: 30</b>	
Average Annual Daily Traffic (AADT): 1220 (north) & 1120 (south), (Reference No. 52170)			Contractor Maintenance Area (CMA): 28

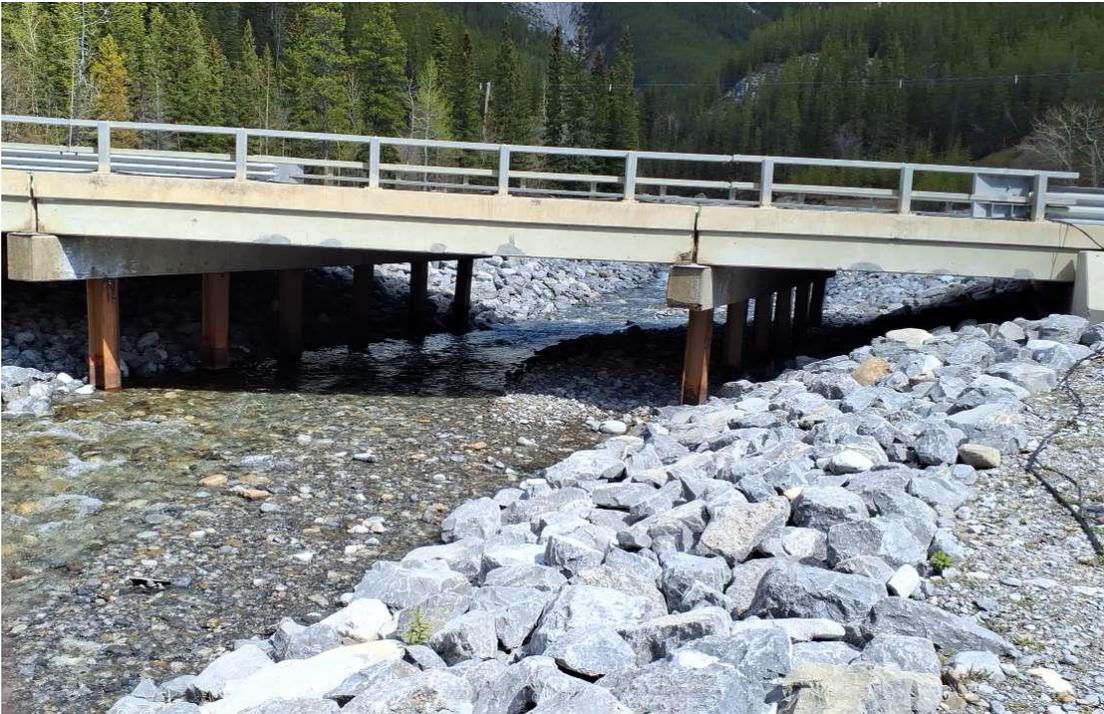
**Photo 1** Downstream side of Rocky Creek Bridge. The creek channel is well defined and the creek banks are armoured with riprap. Photo taken May 27, 2024, facing west.

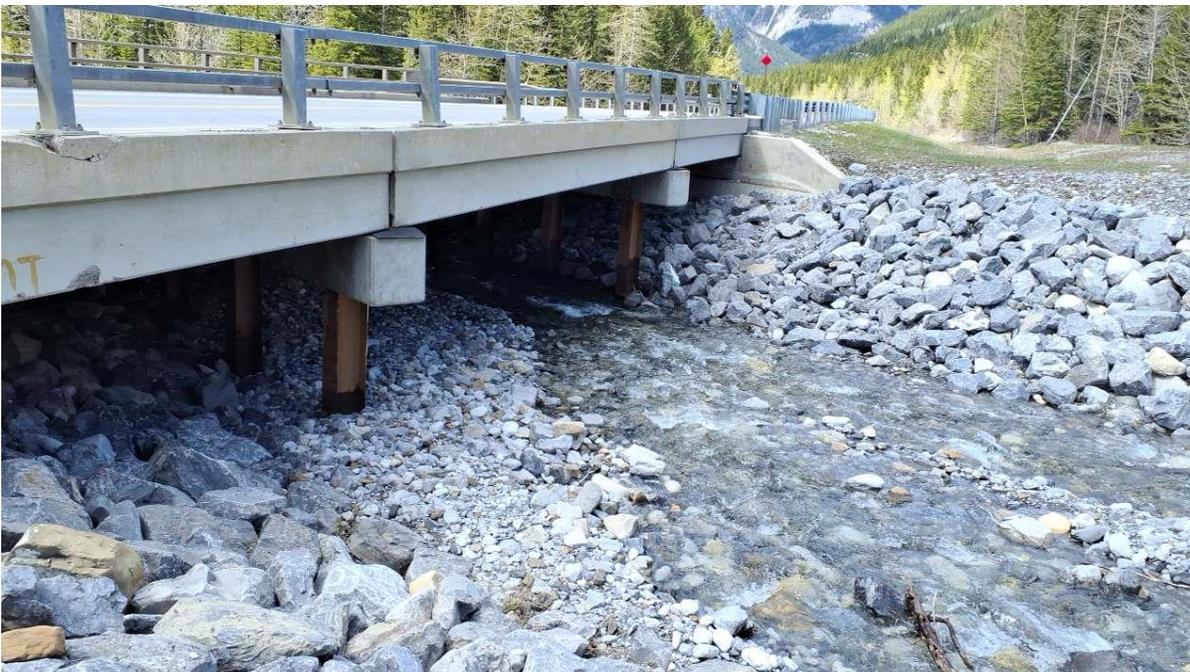
**Photo 2** Upstream side of Rocky Creek Bridge. The upstream H-piles appear partially displaced from a suspected high-water event. Photo taken May 27, 2024, facing north.

- The site should be regularly inspected by the MCI and as part of the Southern Region GRMP Section B inspections.
- The bridge piers should be monitored to assess if they continue to deflect. If the displacement of the upstream H-pile piers continues they should be repaired/reinforced. Given the previous damage to the foundation and structure, AT's bridge branch should inspect this bridge and foundation.

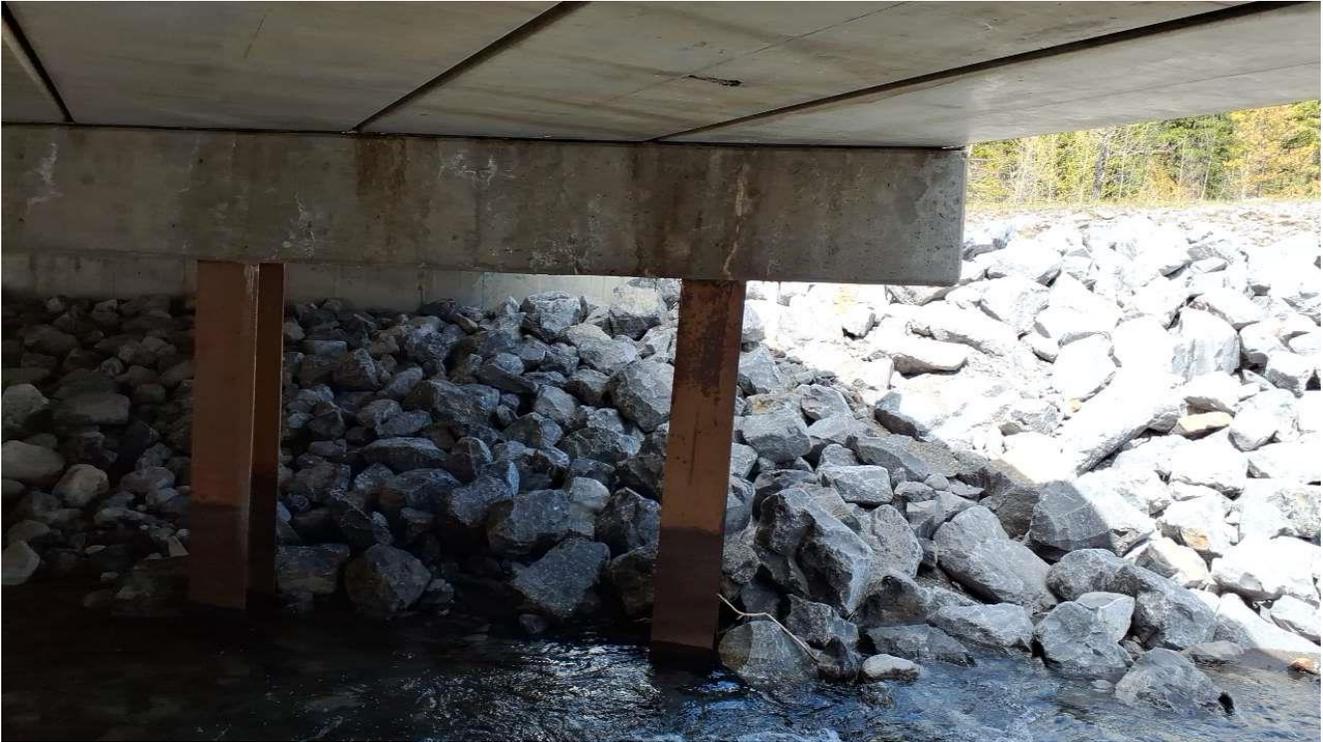
<b>COMMENTS</b>
The Rocky Creek Bridge was previous damaged during a flood event and was repaired in 2013.
The creek channel is well defined, and the creek banks have been armoured with riprap. The riprap appears to be in good condition.
The previous bridge and highway alignment is approximately 140 m west (downstream) of the current highway alignment.
There was low flow observed during the 2024 inspection
The upstream H-pile bridge piers appear to have been partially displaced, most likely due to debris (e.g., ice, logs) moving at a high rate of speed during a high-water event (Photo 3).
The pavement and guardrails leading up to and over the bridge appear to be in good condition.

**Photo 3** Upstream pile on north side of bridge. Pile looks to be displaced, but also could have been installed with some batter due to an obstruction during installation. Photo taken May 27, 2024, facing north.
