SITE NUMBER AND NAME: S060 Lost Knife Creek	HIGHWAY & KM: 40:14, 34.480	PREVIOUS INSPECTION DATE: May 27, 2024	INSPECTION DATE: May 26, 2025
LEGAL DESCRIPTION: 15-29-19-05 W5M	NAD 83 COORDINATES: UTM Northing Easting 11 5612799 665797	RISK ASSESSMENT: PF: 1 CF: 7 TOTAL: 7	
AVERAGE ANNUAL DAILY TRAFFIC (AADT): 175 (north) & 265 (south) (Reference No. 00401450)		CONTRACTOR MAINTENANCE AREA (CMA): 520

SOUTHERN REGION GEOHAZARD RISK MANAGEMENT PROGRAM

Site Plan
 S060 - Lost Knife Creek
 Hwy 40:14, km 34.480

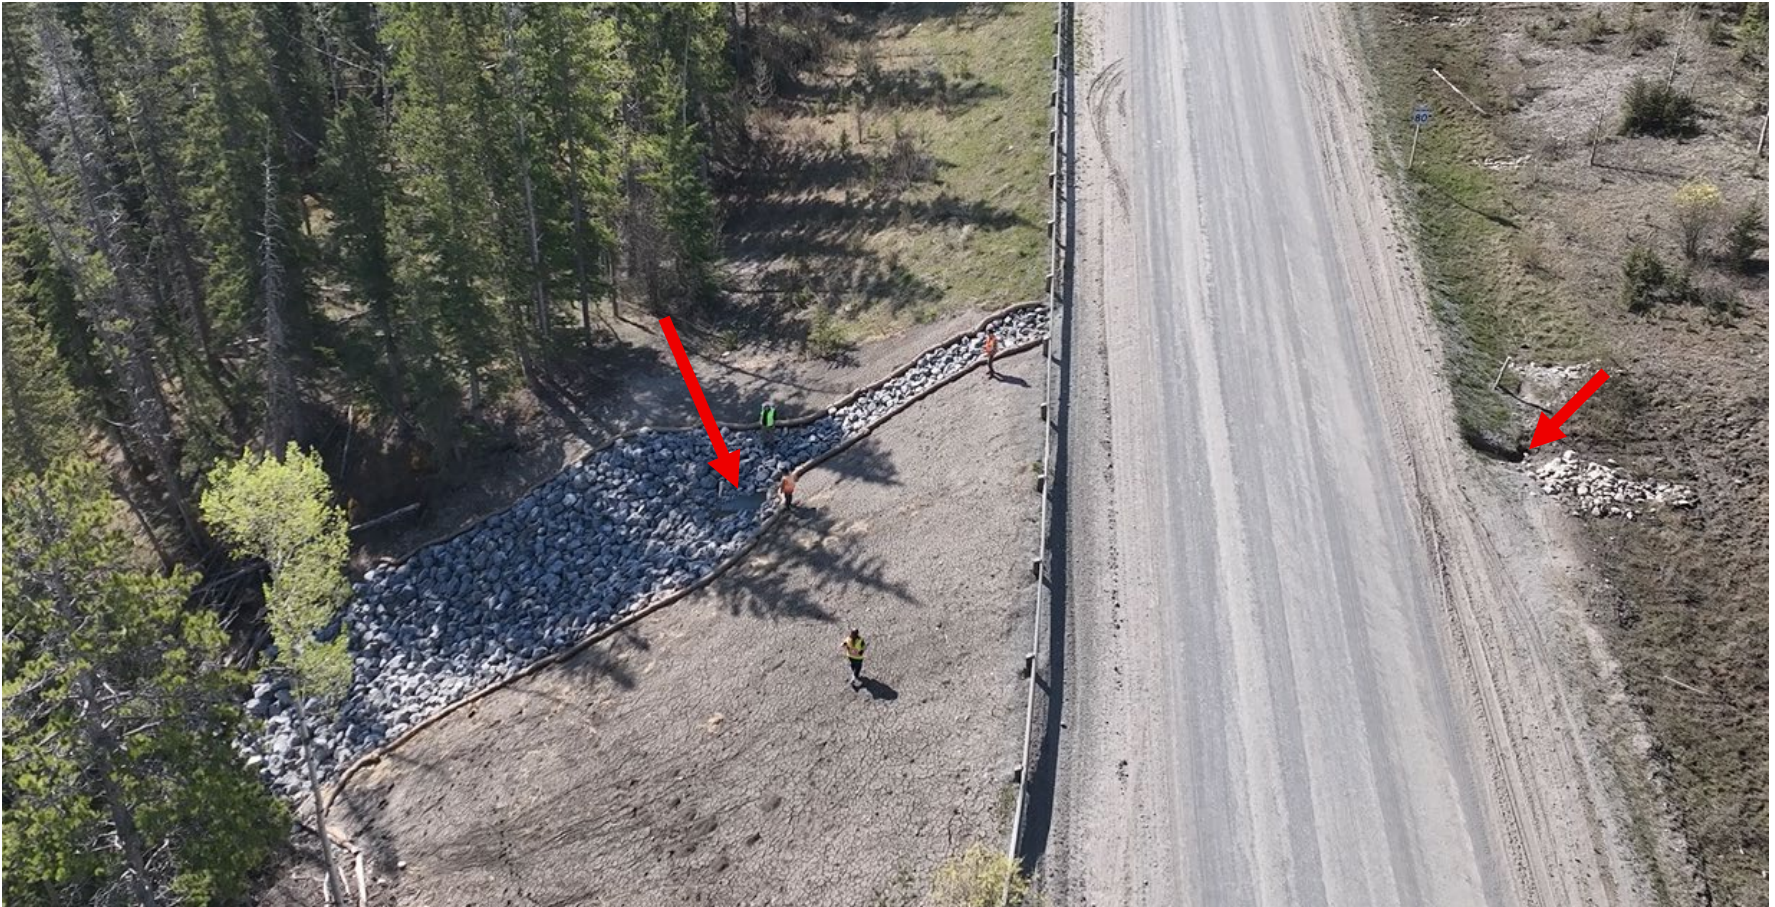
- The gravelled highway and guardrail above the repaired slope appear to be in good condition (Photos 1 and 2).
- At the time of the 2025 site inspection, the rebuilt slope was smooth with no evidence of post-construction settlement (Photo 3). Also, the slope was bare with little to no vegetation growth as it was pending to be reseeded (hydroseed was completed on July 25, 2025). Thin ground cracks were observed in the slope, likely due to desiccation.

Photo 1 Aerial photo of the site showing the rebuilt slope, riprap armoured channels, and culvert outlet and inlet (indicated by red arrows). Photo taken May 26, 2025, facing southeast.

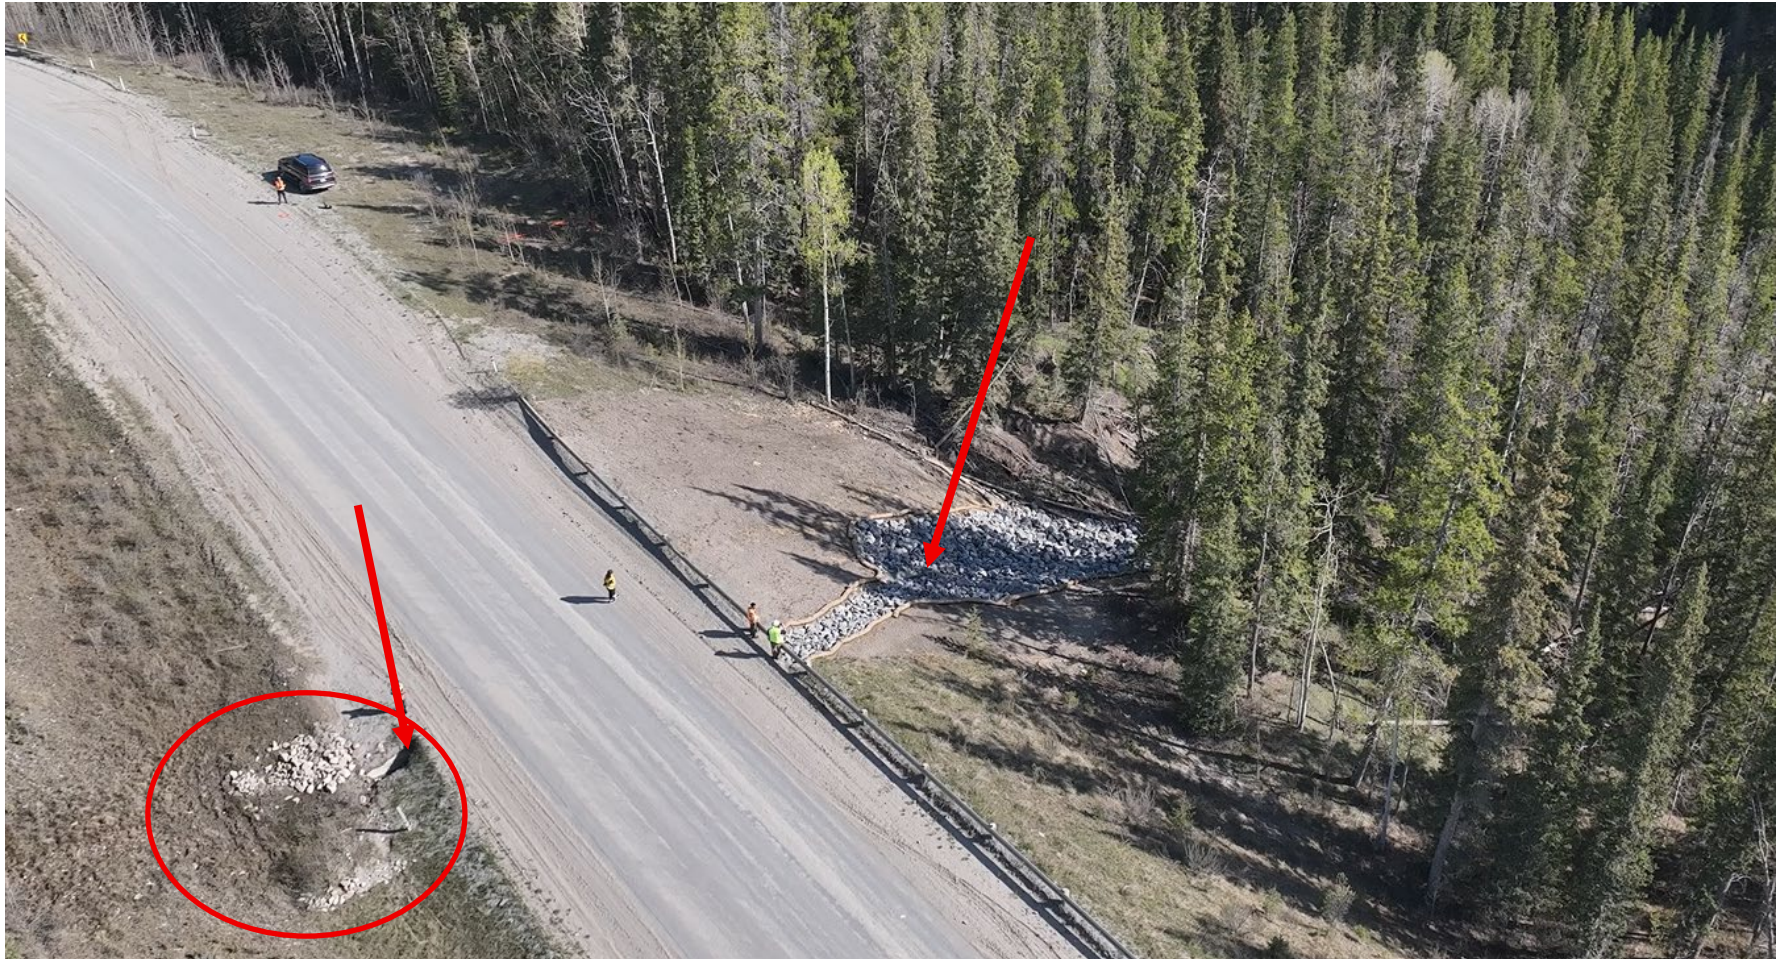
Photo 2 Aerial photo of the site showing the rebuilt slope, riprap armoured channels, and culvert outlet and inlet (indicated by red arrows). Two check dams of rounded cobbles and boulders are observed at the entrance of the culvert inlet (circle). Photo taken May 26, 2025, facing north.

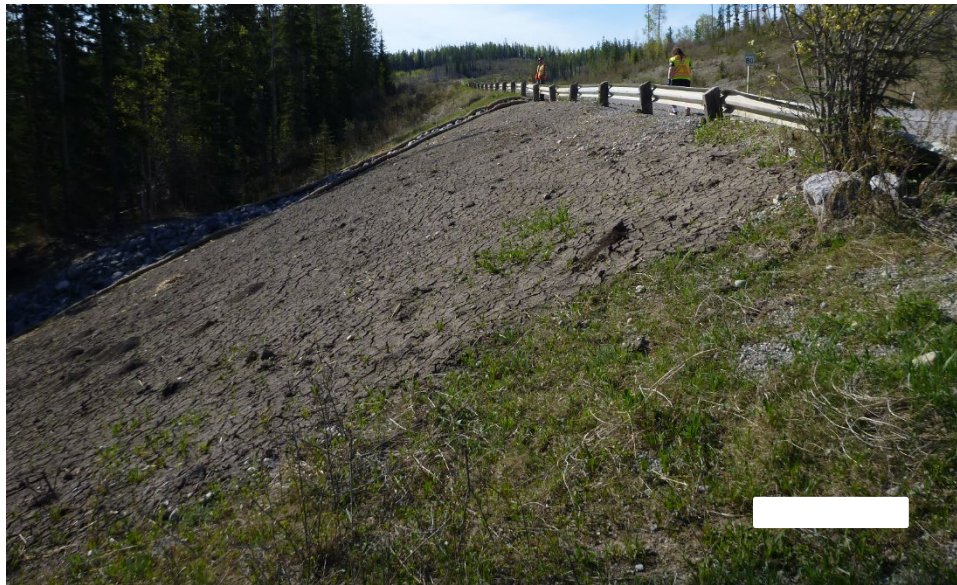
Photo 3 The rebuilt highway embankment slope was poorly vegetated during the 2025 inspection. Photo taken May 26, 2025, facing southeast.

- The site should be regularly inspected by the Maintenance Contract Inspector (MCI).
- The site should be inspected as part of the 2026 Southern Region GRMP Section B inspections to assess the performance of the repair, and then inspected once per contract afterwards.
- The warranty inspection should be performed in late 2025. The vegetation cover (reseeding was performed by the HMC in July 2025) should be assessed, as well as the low invert geometry of the 1.2 m wide section of the channel.

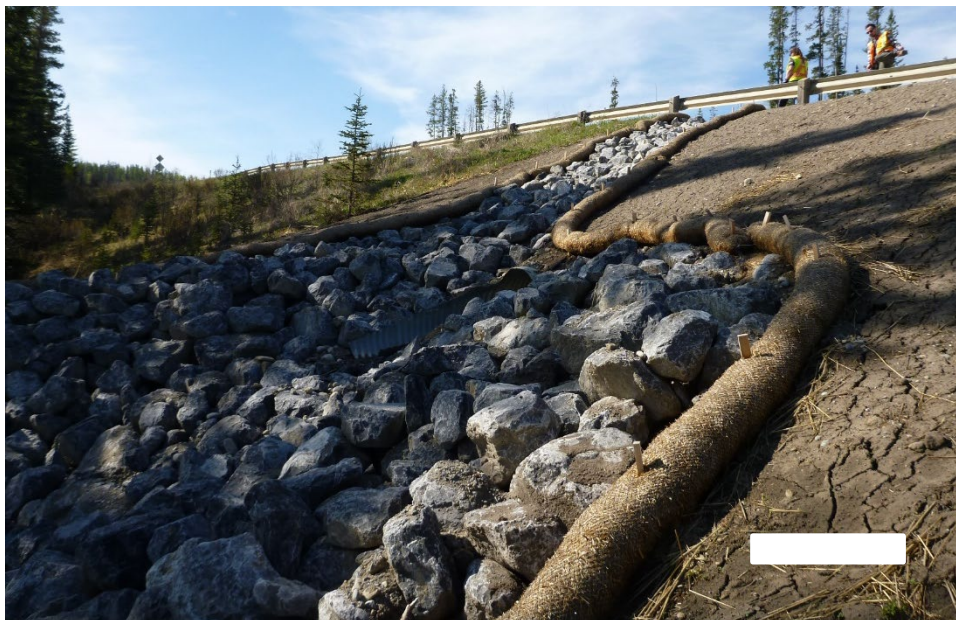
- Straw wattles were installed around the riprap armouring (channel from the edge of the pavement and the riprap apron at the culvert outlet) (Photo 4).

- The 800-mm-diameter CSP culvert extension appears to be in good condition with no post-construction settlement or deformation observed during the 2025 inspection (Photo 4).

- The riprap appears to be hard, durable particles which appear to be performing well (Photos 4 and 5).
- The riprap-lined culvert outlet channel is steep and does not have a well-defined channel, especially near the road. The upper section of the channel above the culvert has a 1.2 m wide section with 2H:1V side slopes that appears relatively flat with class 1M riprap, resulting in very little to no freeboard. Below the outlet of the culvert, the invert (2 m wide base, 1 m deep, with 2H:1V side slopes) of the channel appears far down the slope.

Photo 4 Straw wattles were installed around the riprap armoured channels as part of the 2024 construction. Photo taken May 26, 2025, facing south.

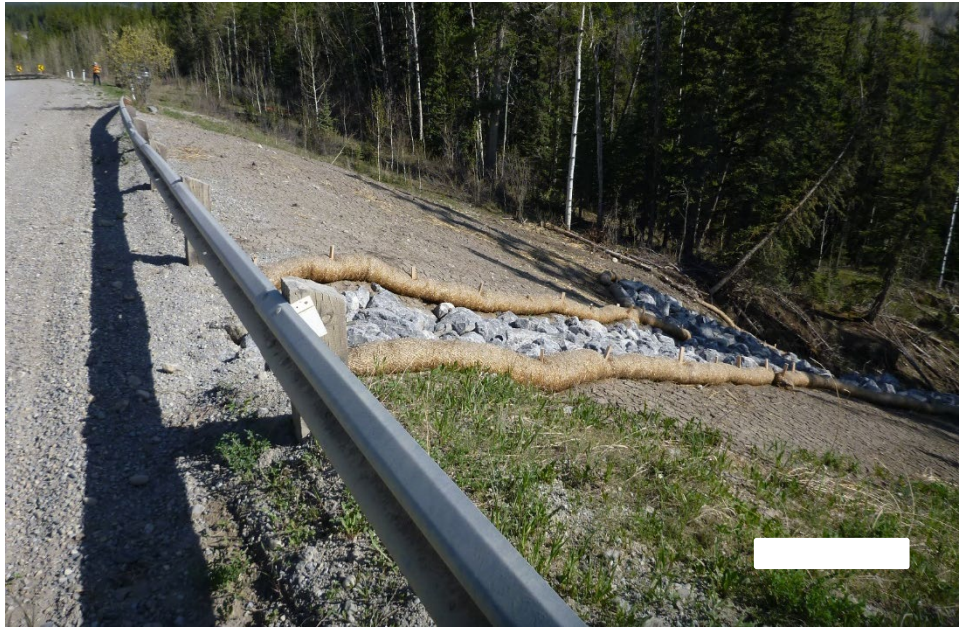
Photo 5 Channel constructed to convey surface water runoff from the highway surface to the culvert outlet channel. Photo taken May 26, 2025, facing north.

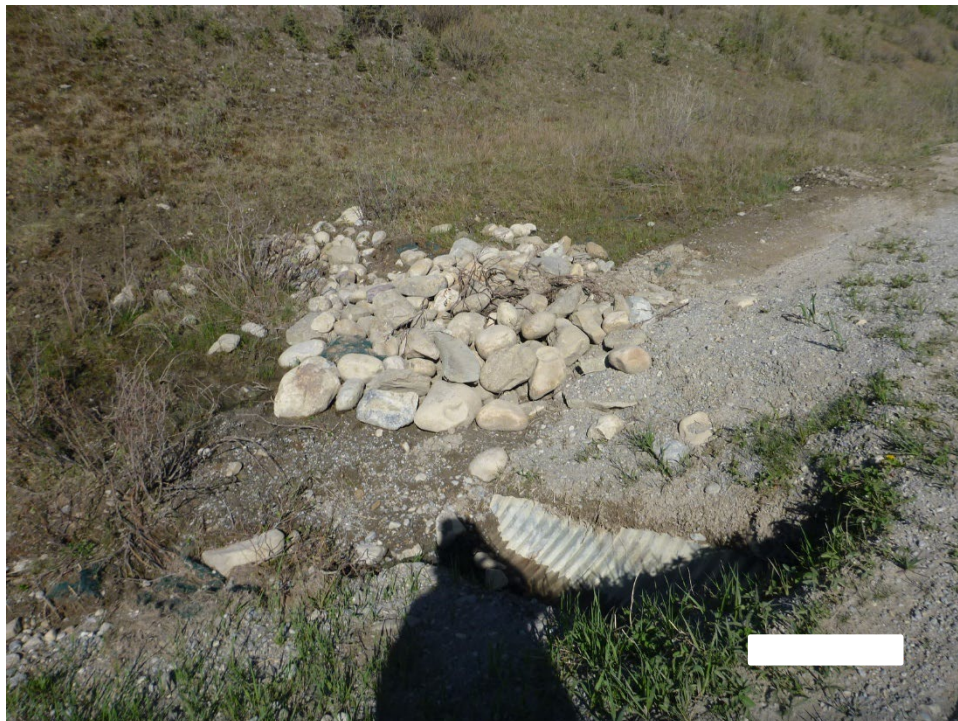
- Two check dams of rounded cobbles and boulders (up to approximately 500 mm in diameter) are located in the ditch near the culvert inlet and have been observed during previous inspection (Photo 6). The check dam on the north side entrance of the inlet appears to have been partially moved and no longer protects the full width of the ditch.

Photo 6 North check dam of cobbles and boulders at the culvert inlet. Photo taken May 26, 2025, facing northwest.
