SITE NUMBER AND NAME: S077 South Ghost Erosion	HIGHWAY & KM: 40:14, 29.00	PREVIOUS INSPECTION DATE: May 27, 2024	INSPECTION DATE: May 26, 2025
LEGAL DESCRIPTION: SW 20-27-07-W5M	NAD 83 COORDINATES: UTM Northing Easting 11 5686872 642530	RISK ASSESSMENT: PF: 9 CF: 3 TOTAL: 27	
Average Annual Daily Traffic (AADT): 175 (north) & 265 (south) (Reference No. 00401450)		CONTRACTOR MAINTENANCE AREA (CMA): 520

SOUTHERN REGION GEOHAZARD RISK MANAGEMENT PROGRAM

Site Plan
S077 - South Ghost Erosion
Hwy 40:14, km 29.00

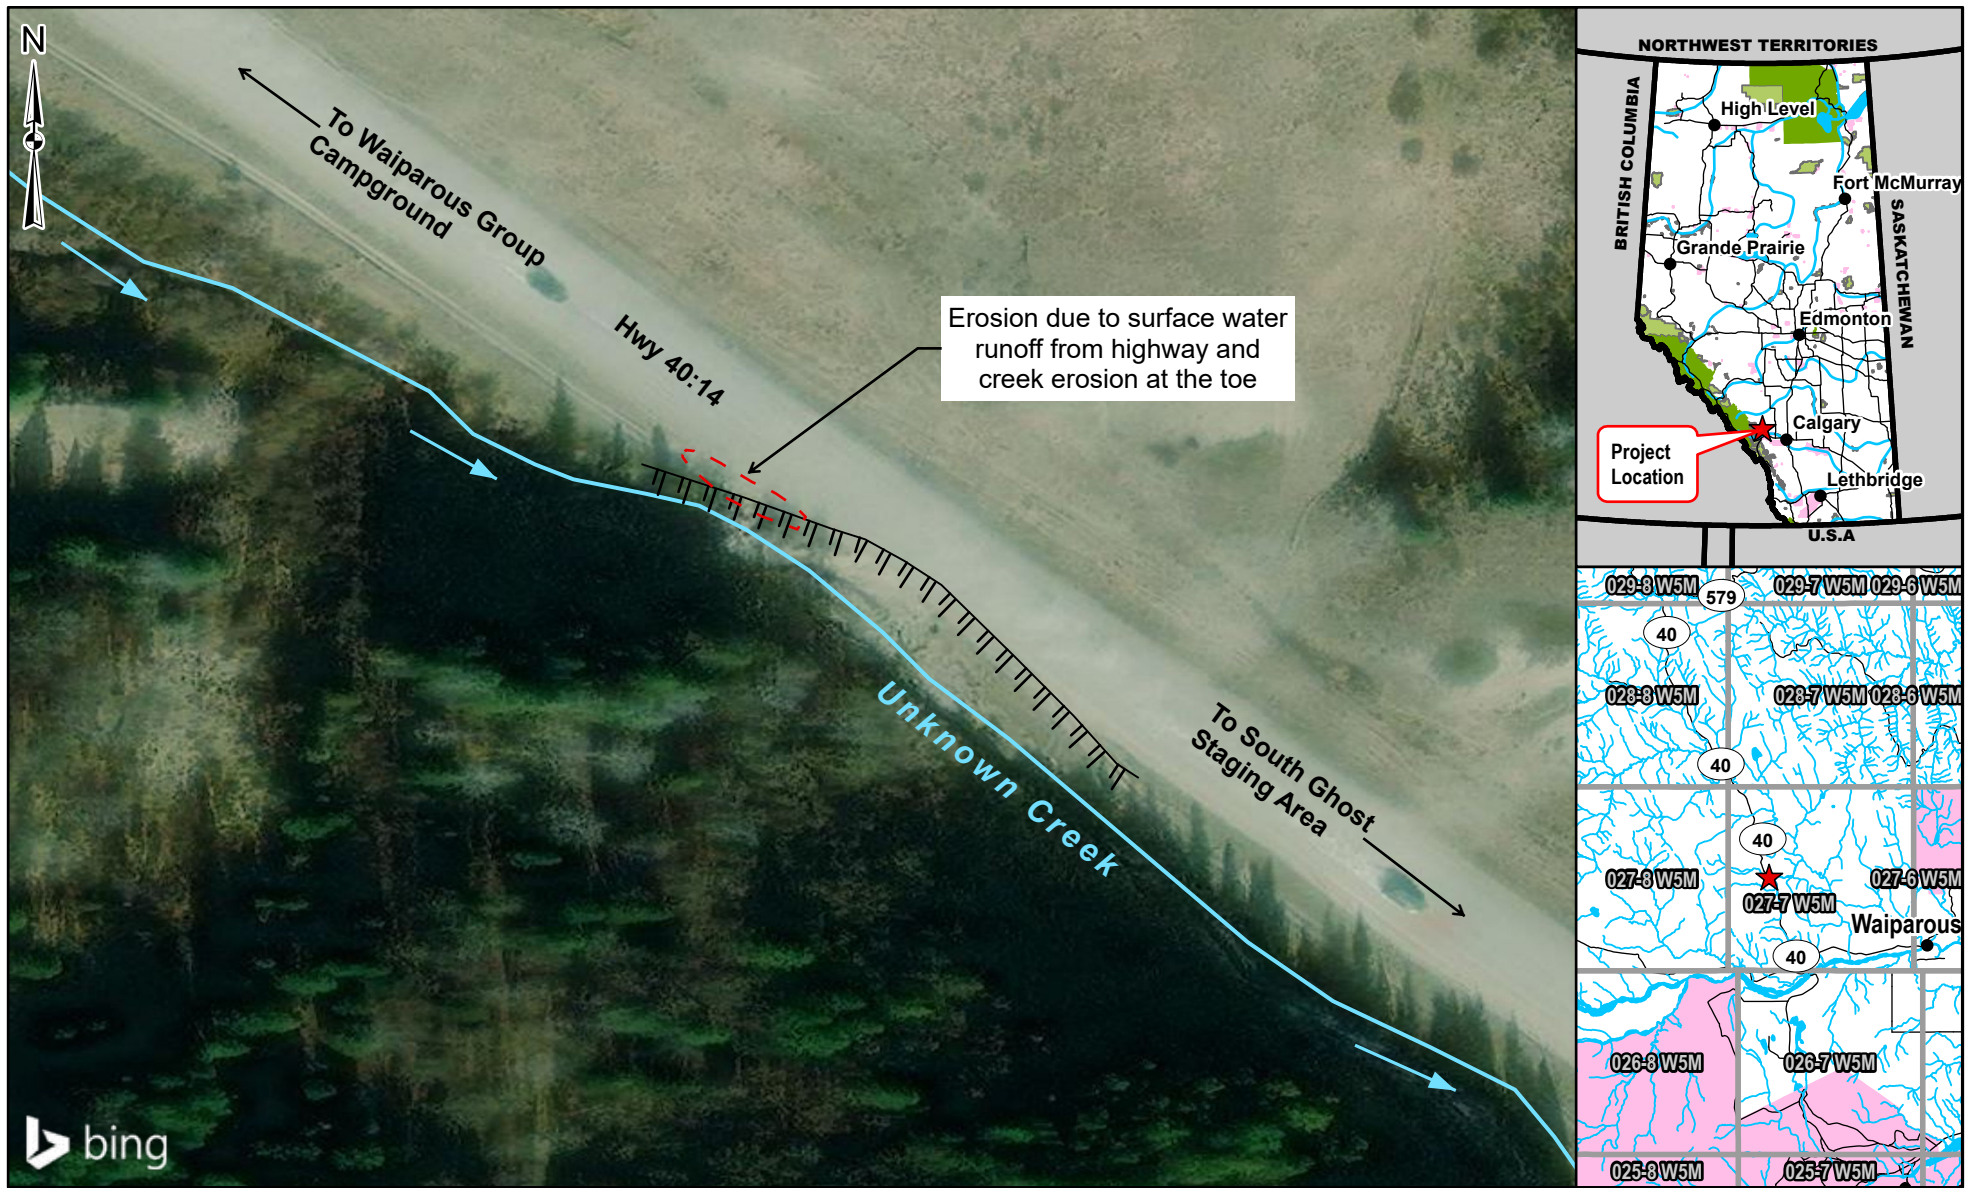
FIG No. 1

PRIMARY SITE ISSUE: Over-steepening of the creek bank/highway embankment slope due to surface water runoff erosion and creek erosion. Erosion has undermined the west (southbound) shoulder and is retrogressing to the driving lane of the highway. The west ditch has been undermined and is draining directly into the erosion feature, then into the creek.
APPROXIMATE DIMENSIONS: The erosion scarp encroaching on the edge of the highway is approximately 30 m in length. The highway embankment/creek bank is approximately 3 m tall.
DATE OF ANY REMEDIAL ACTION: N/A

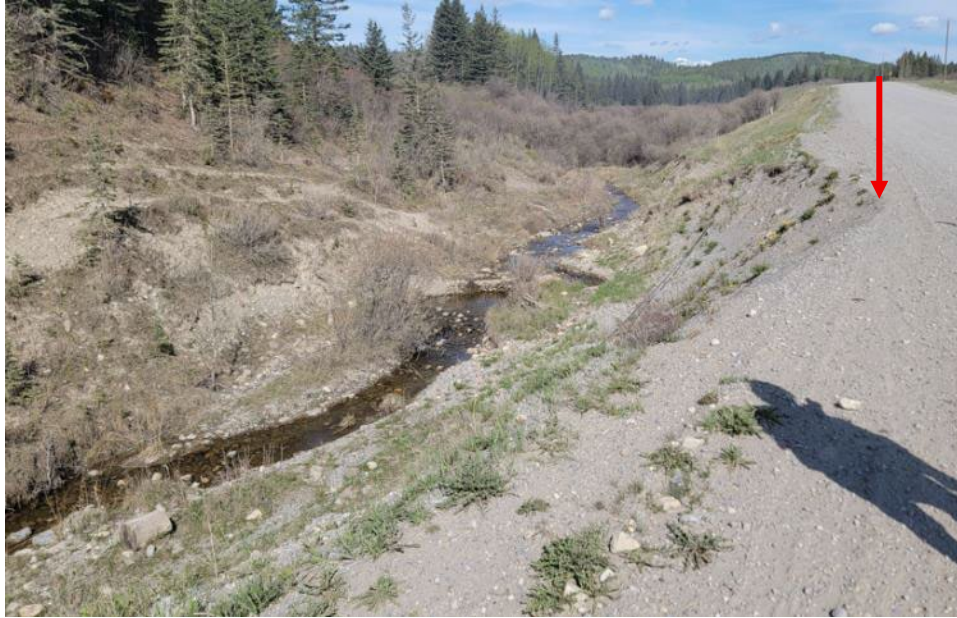
- The east bank of the creek (highway embankment slope) is eroding the shoulder of the west (southbound) lane. The erosion is over a length of approximately 30 m (Photo 1 and 2).

- The erosion has over-steepened the highway embankment slope to approximately 1H:1V, which could lead to embankment instability.
- Surface water runoff from the highway is contributing to erosion of the creek bank/west highway embankment slope. Surface water runoff from the highway is being concentrated at the north extent of the site and has formed an erosion gully approximately 0.5 m to 1.0 m wide and 0.3 m deep. The erosion gully will continue to increase in size (depth and width) if not repaired. The rate of erosion will likely be exacerbated by periods of heavy or prolonged rainfall. The erosion gully does not appear to have increased in size between the 2024 and 2025 inspections.

- Photo 1** Erosion scarp encroaching the edge of the west (southbound) shoulder and is at the edge of the driving lane (indicated by red arrow). Photo taken May 26, 2025, facing northwest.

- The site should be regularly inspected by the Maintenance Contract Inspector (MCI).
- The site should be inspected annually as part of the Southern Region GRMP Section B inspections.
- Hazards signs should be installed by TEC's HMC, northwest of the site, to warn road users of the sharp shoulder. If left unrepaired, a guardrail or temporary barriers should be installed along the site.

- The creek bank/highway embankment should be reconstructed with geogrid-reinforced granular fill. The toe of the slope should be armoured with riprap or concrete lock blocks. The repair work should address the surface water runoff from the highway surface. Depending on the final grade of the reconstructed slope, a guardrail may need to be installed along the site.
- The TELUS line should be relocated or trenched within the east highway embankment.

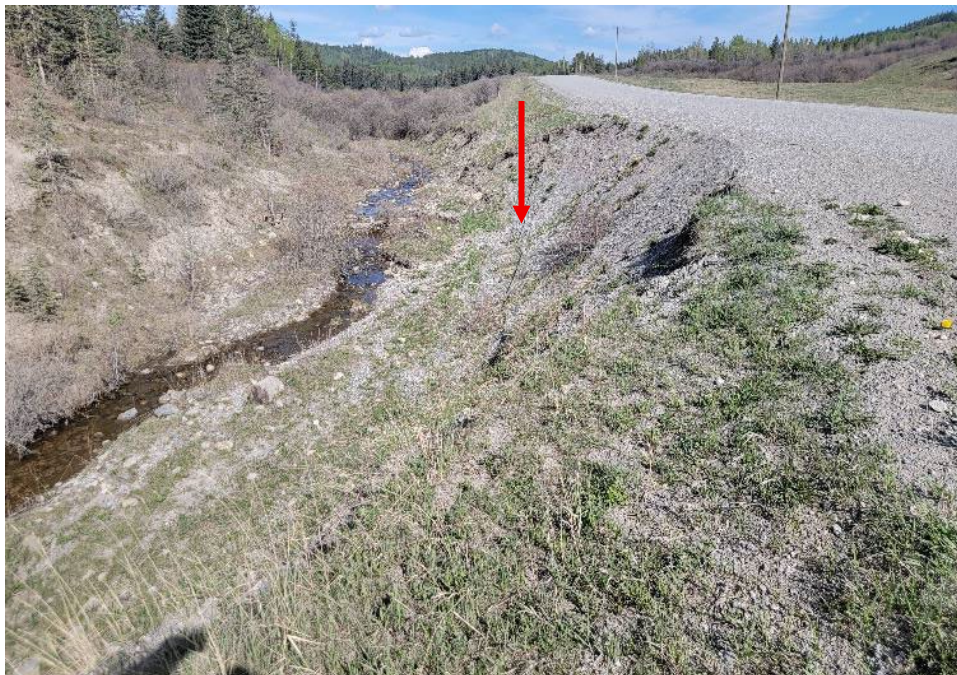
- A buried TELUS communication line runs along the west side of the highway and is exposed within the erosion feature (Photo 2). KCB submitted a one-call ticket which confirmed the line is active.

- Photo 2** Black utility line runs through the site and was exposed due to ongoing erosion at the site. Photo taken May 26, 2025, facing northwest.
