November 26, 2025

Alberta Transportation and Economic Corridors
2nd Floor, 803 Manning Road N.E.
Calgary, Alberta
T2E 7M8

CON0022161 Southern Region GRMP Instrumentation Monitoring
Site S026; H41:03, km 35.169 Elkwater Slides
Section C – 2025 Fall Readings

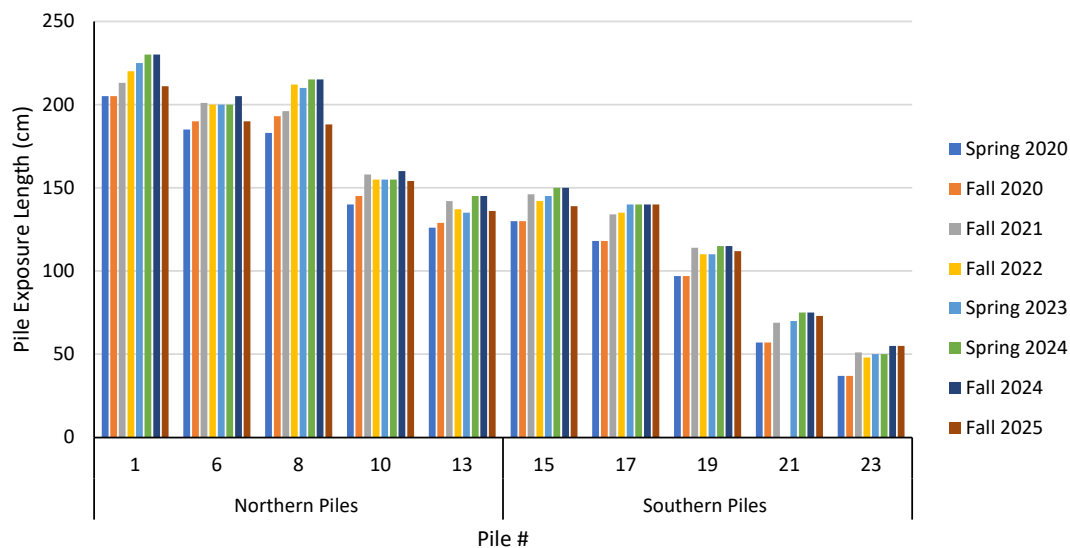
Figure 2.1 Change in pile exposure length between 2020 and 2025

Soil sliding observed downslope of the H-pile wall has exposed the H-piles and reduced the passive support of the H-pile wall on the downslope side. The movement recorded in SI12-01 reflects the movement of the H-pile occurring as the passive support is reduced.

In May 2020, KCB began measuring the exposed lengths (i.e., steel above ground surface) of the H-piles as a baseline for subsequent measurements. The pile exposure measurements at ten (10) locations decrease towards the southern part of the H-pile wall. Some piles show slight decreases in exposed pile length, associated with erosion of the surrounding material that accumulates at the bottom and covers the extended exposure. As of October 2025, the exposed height of the H-pile (Piles 1 through 23) varied from approximately 0.55 m to 2.31 m, a negligible increase since May 2025.

Instrument readings should include measurements and photographs of the length of the H-pile exposed on the downslope side of the H-pile wall to monitor ongoing slope movements and erosion downslope of the H-pile wall.

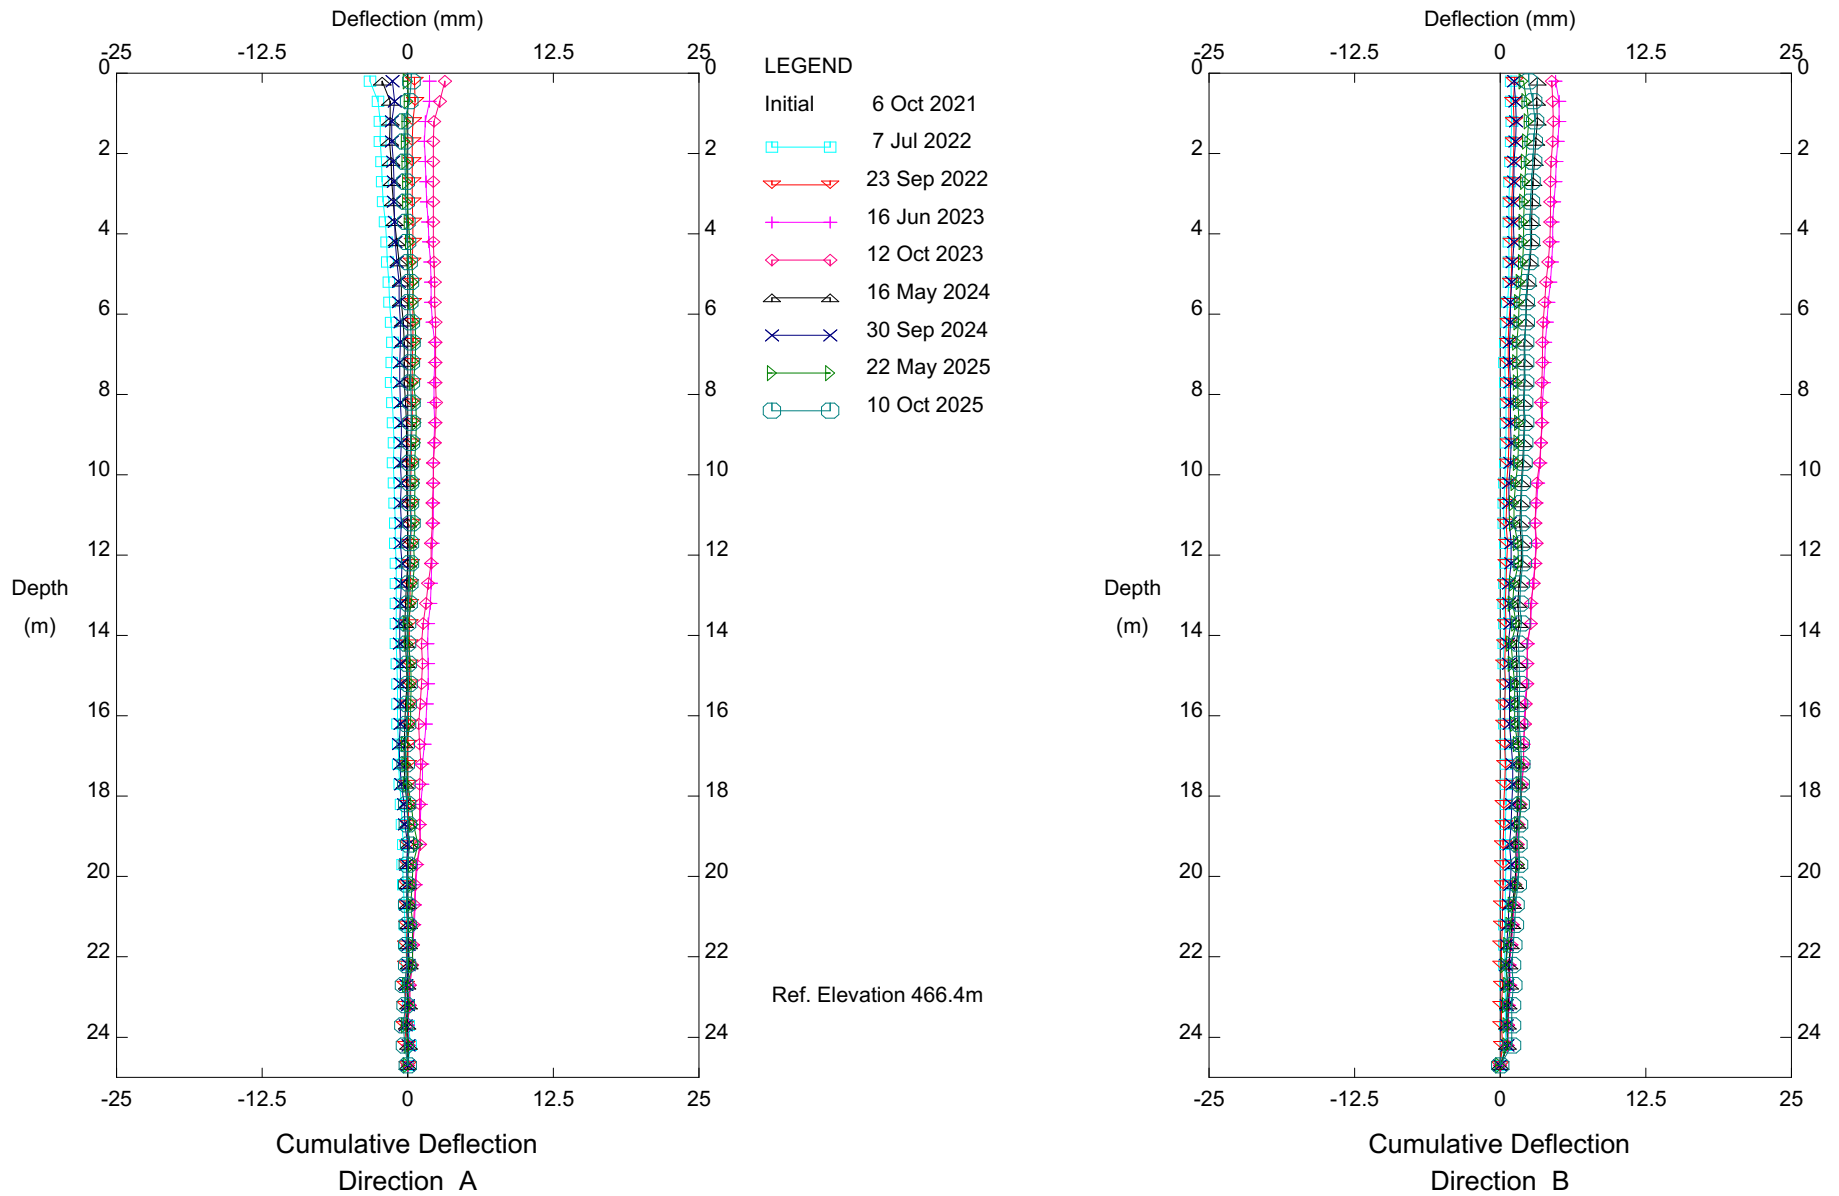
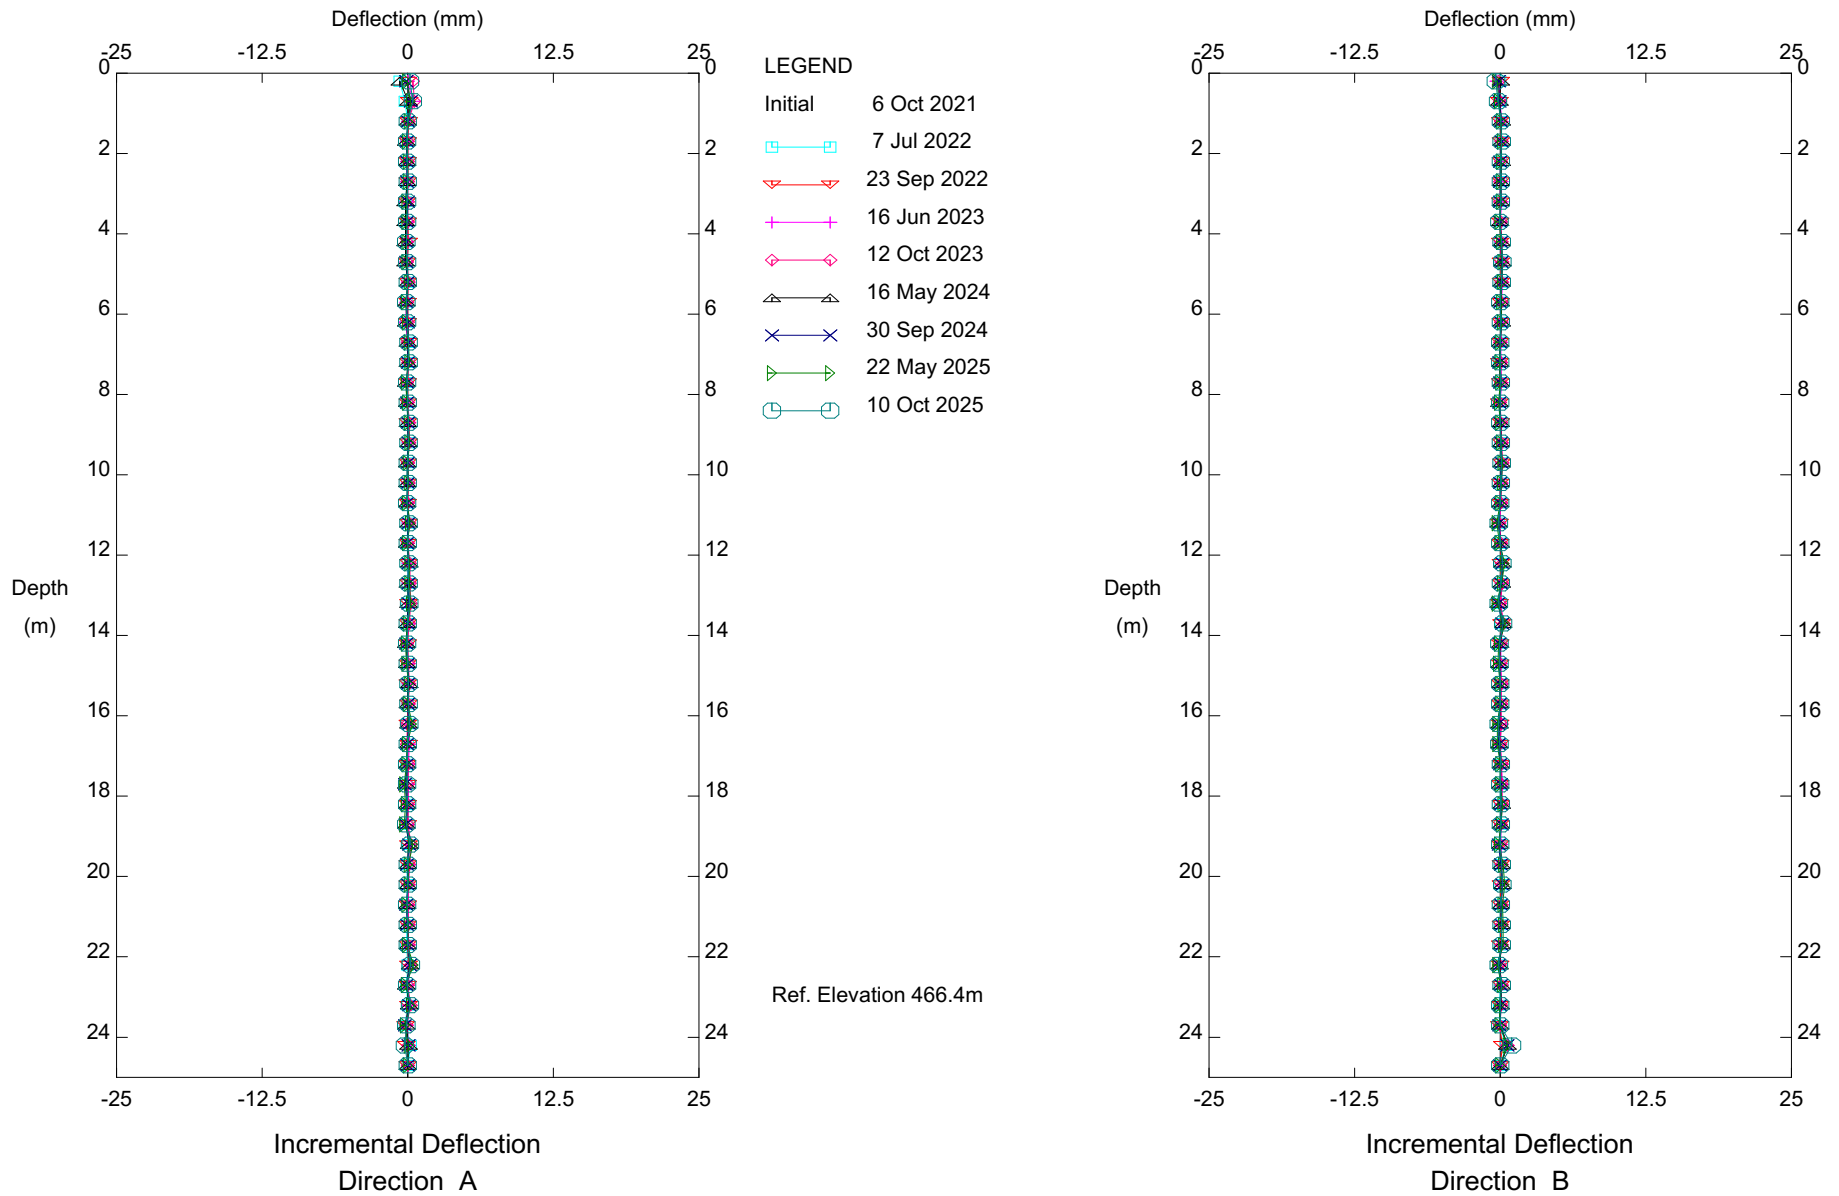
S026; H41:03, Elkwater Slides, Area A, Inclinator SI08-1

No discernible movement has been recorded in SI08-01 or SI08-03.

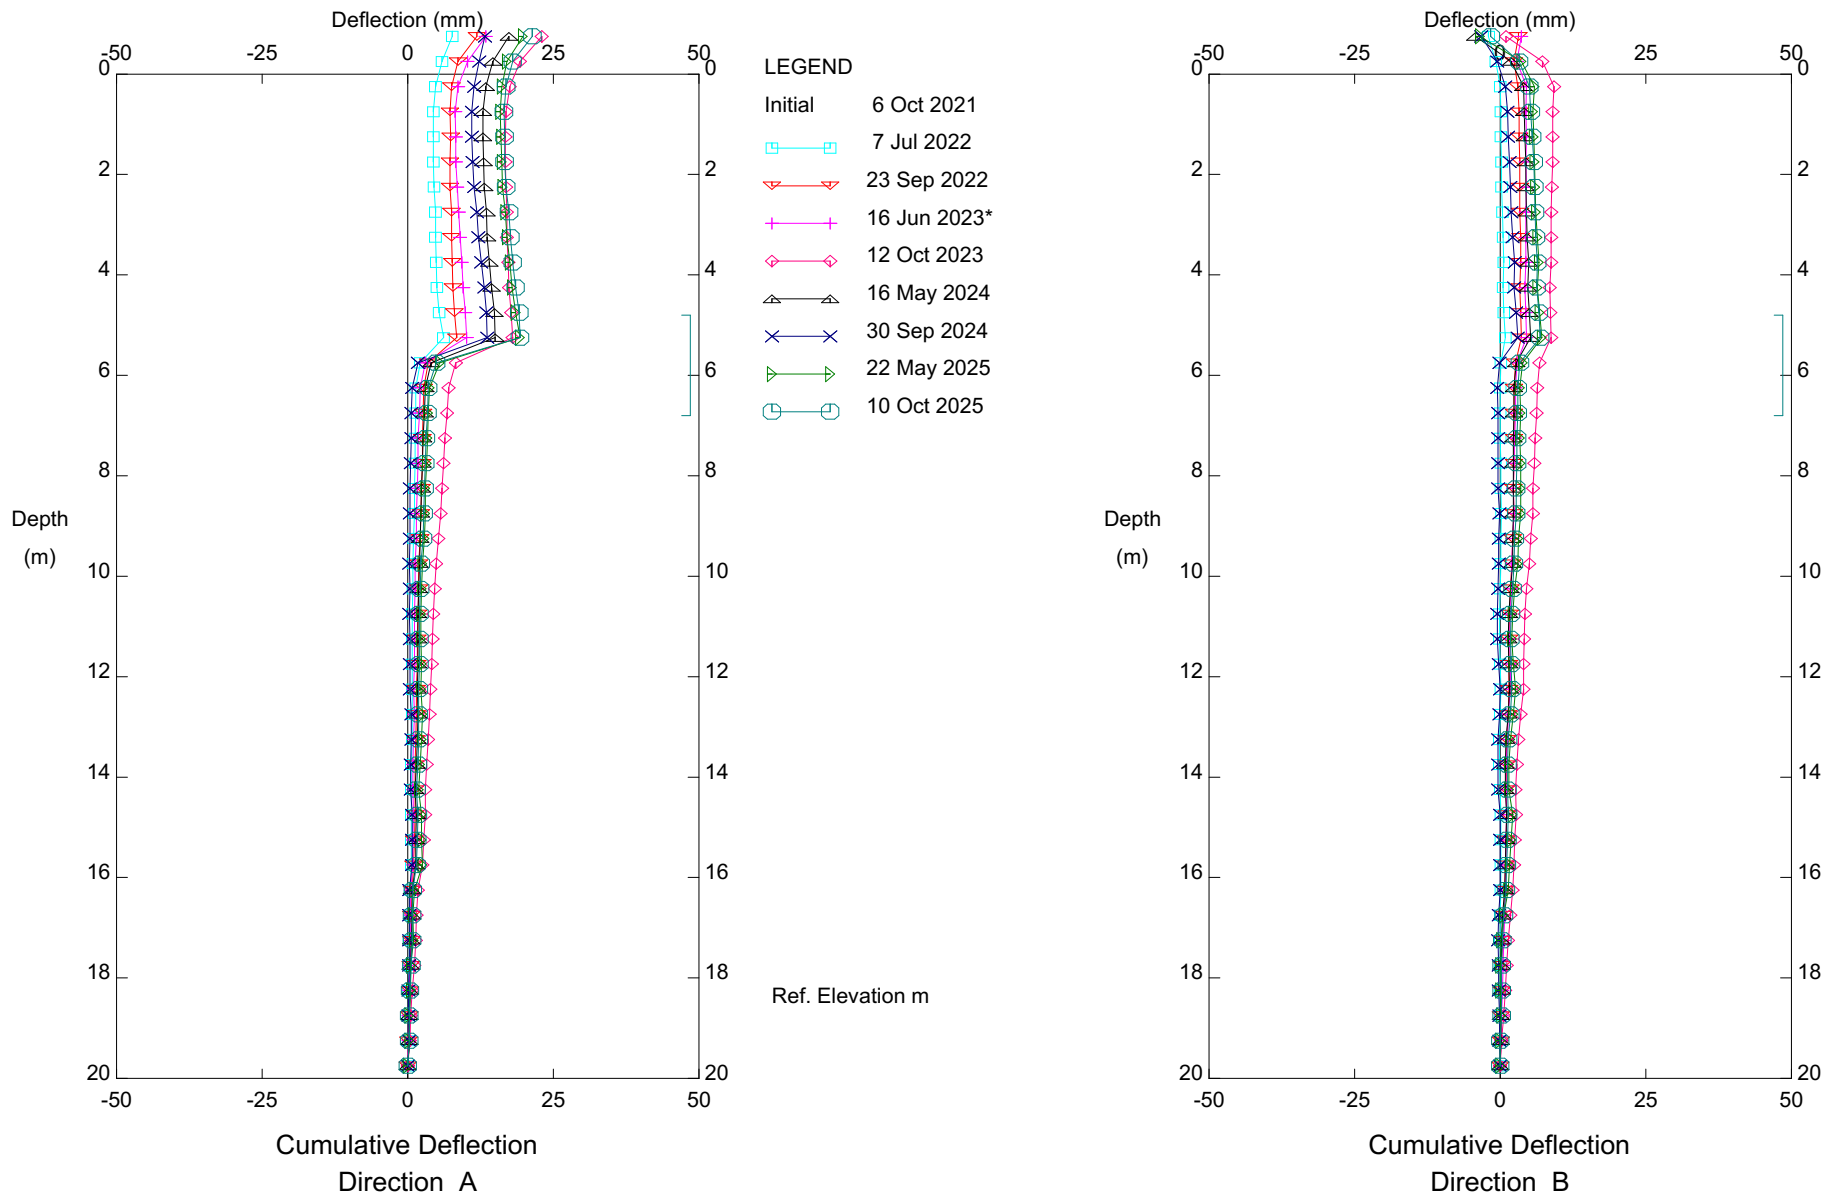
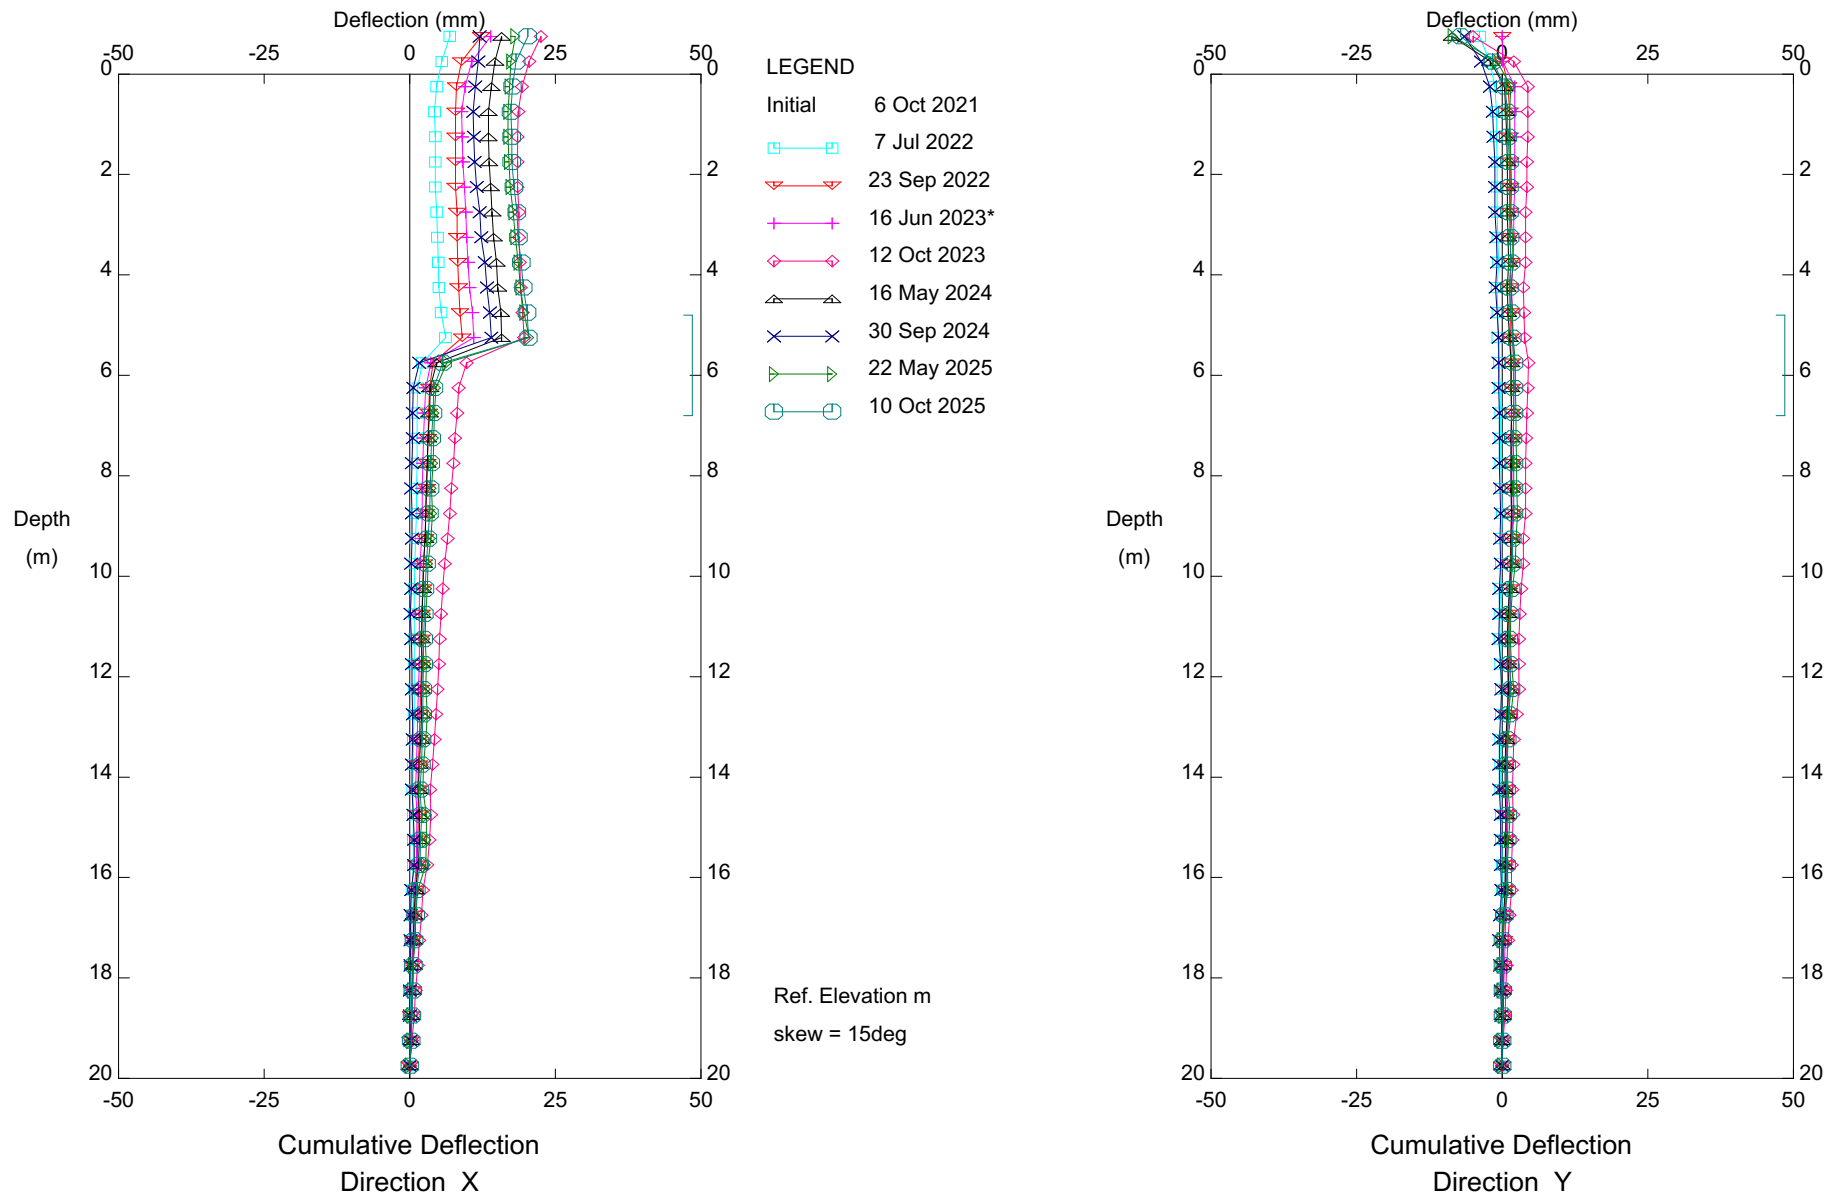
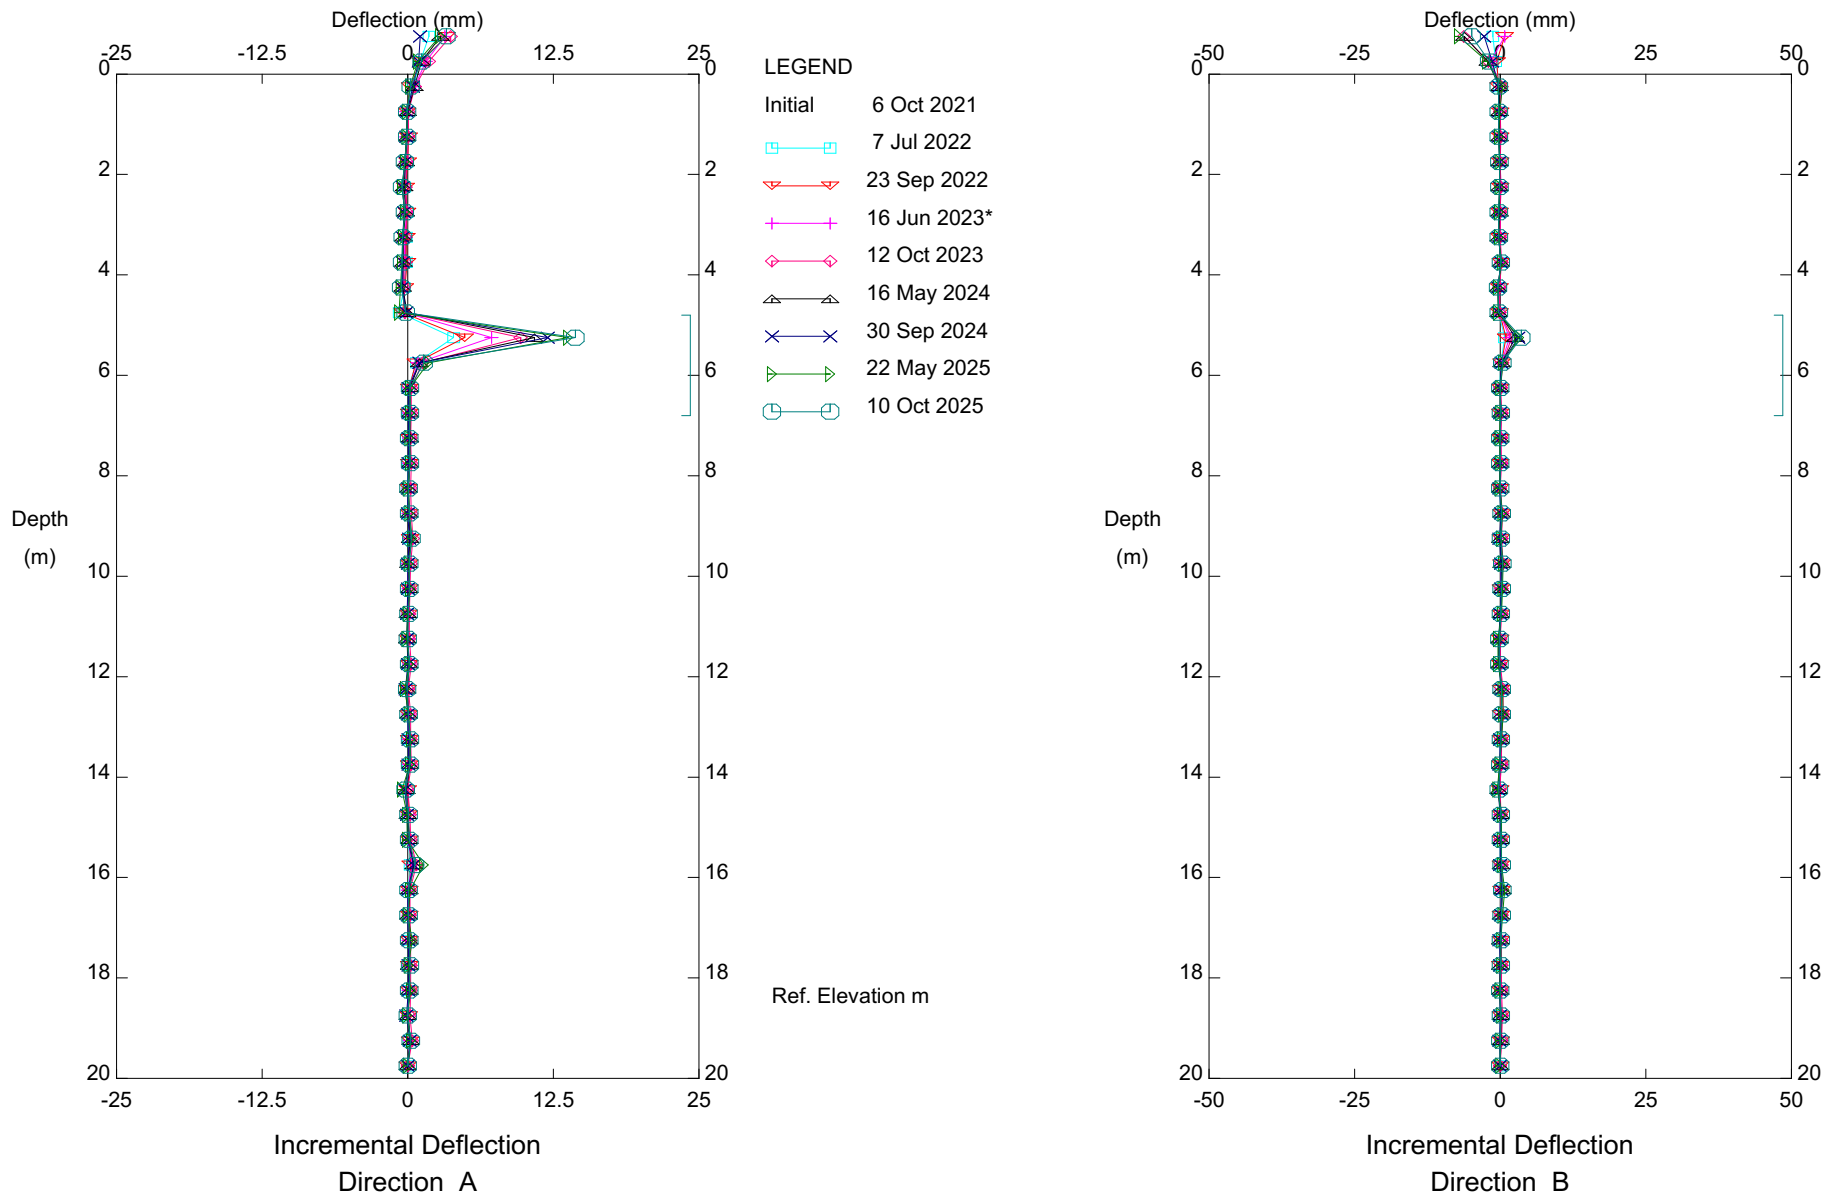
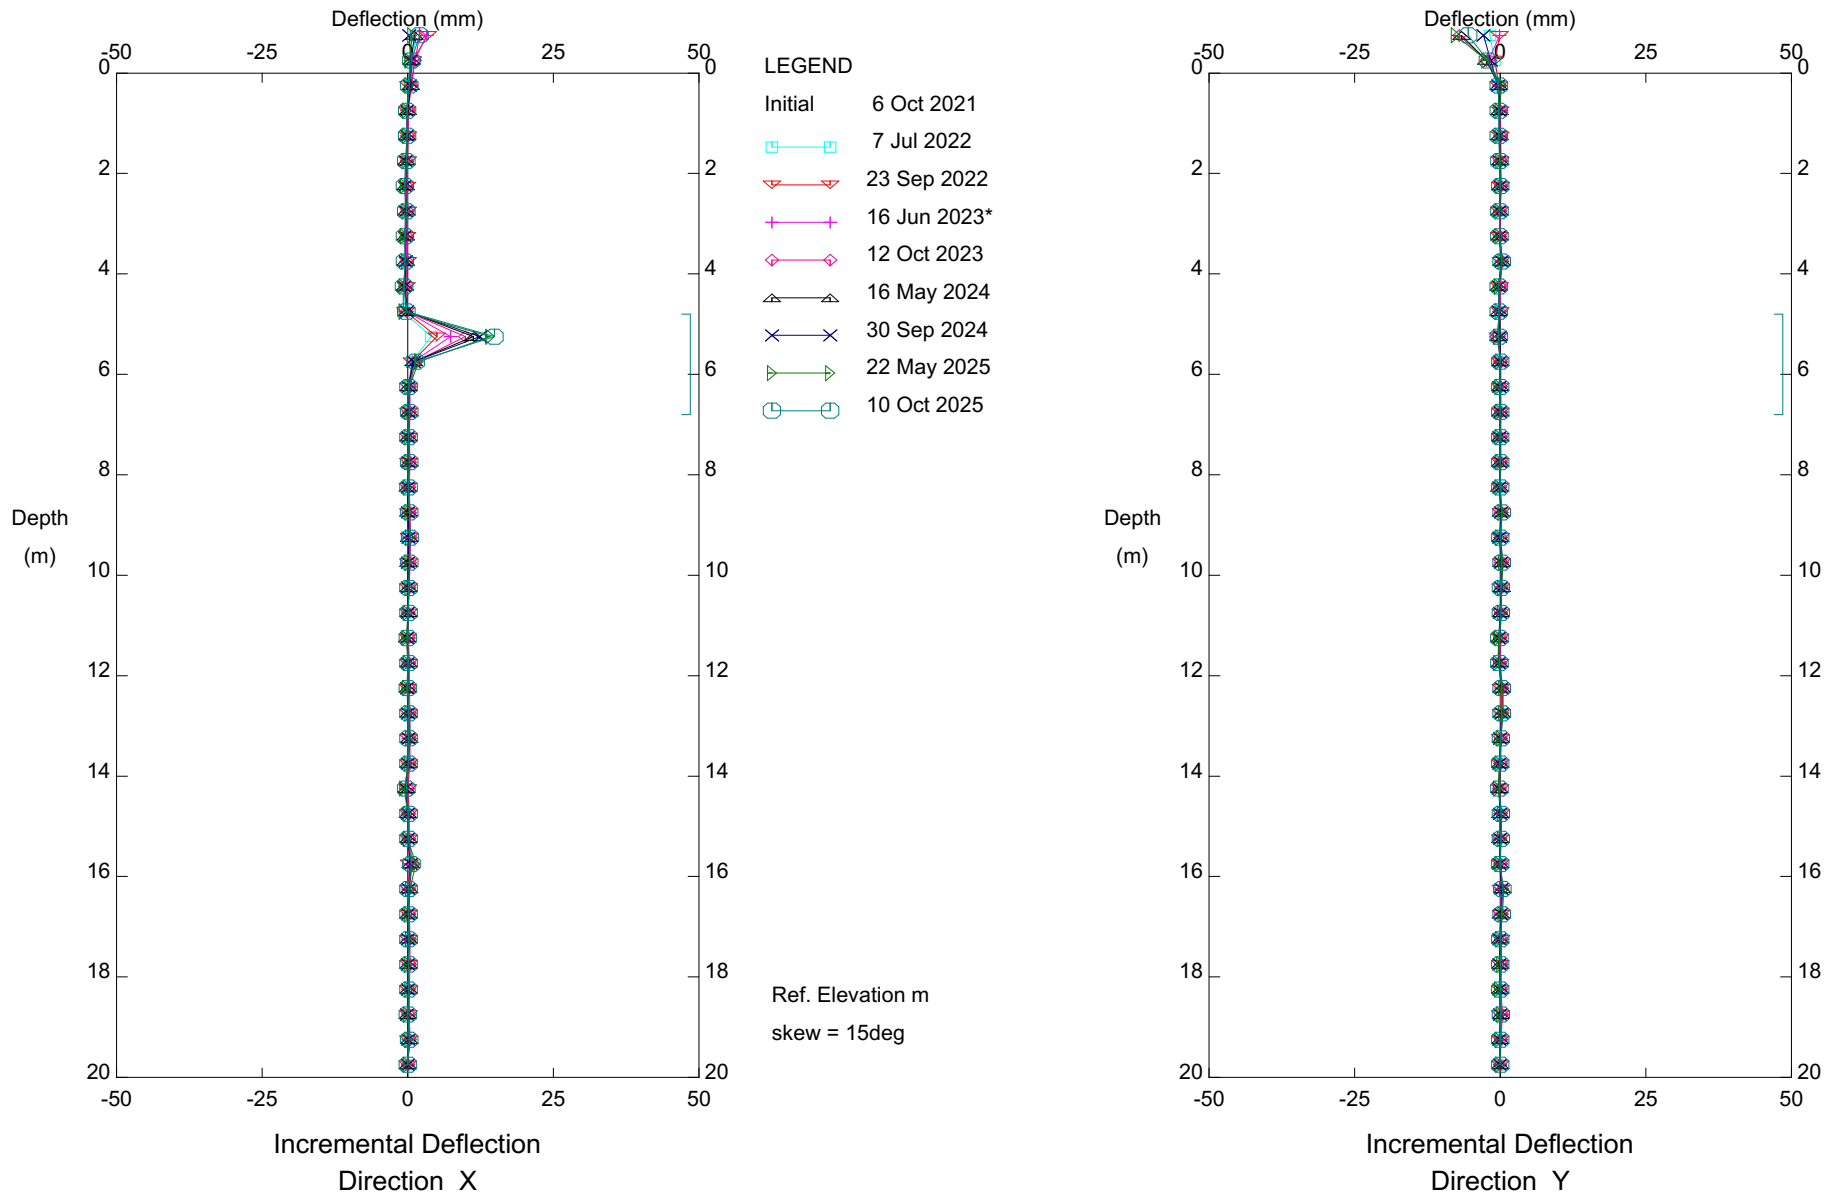
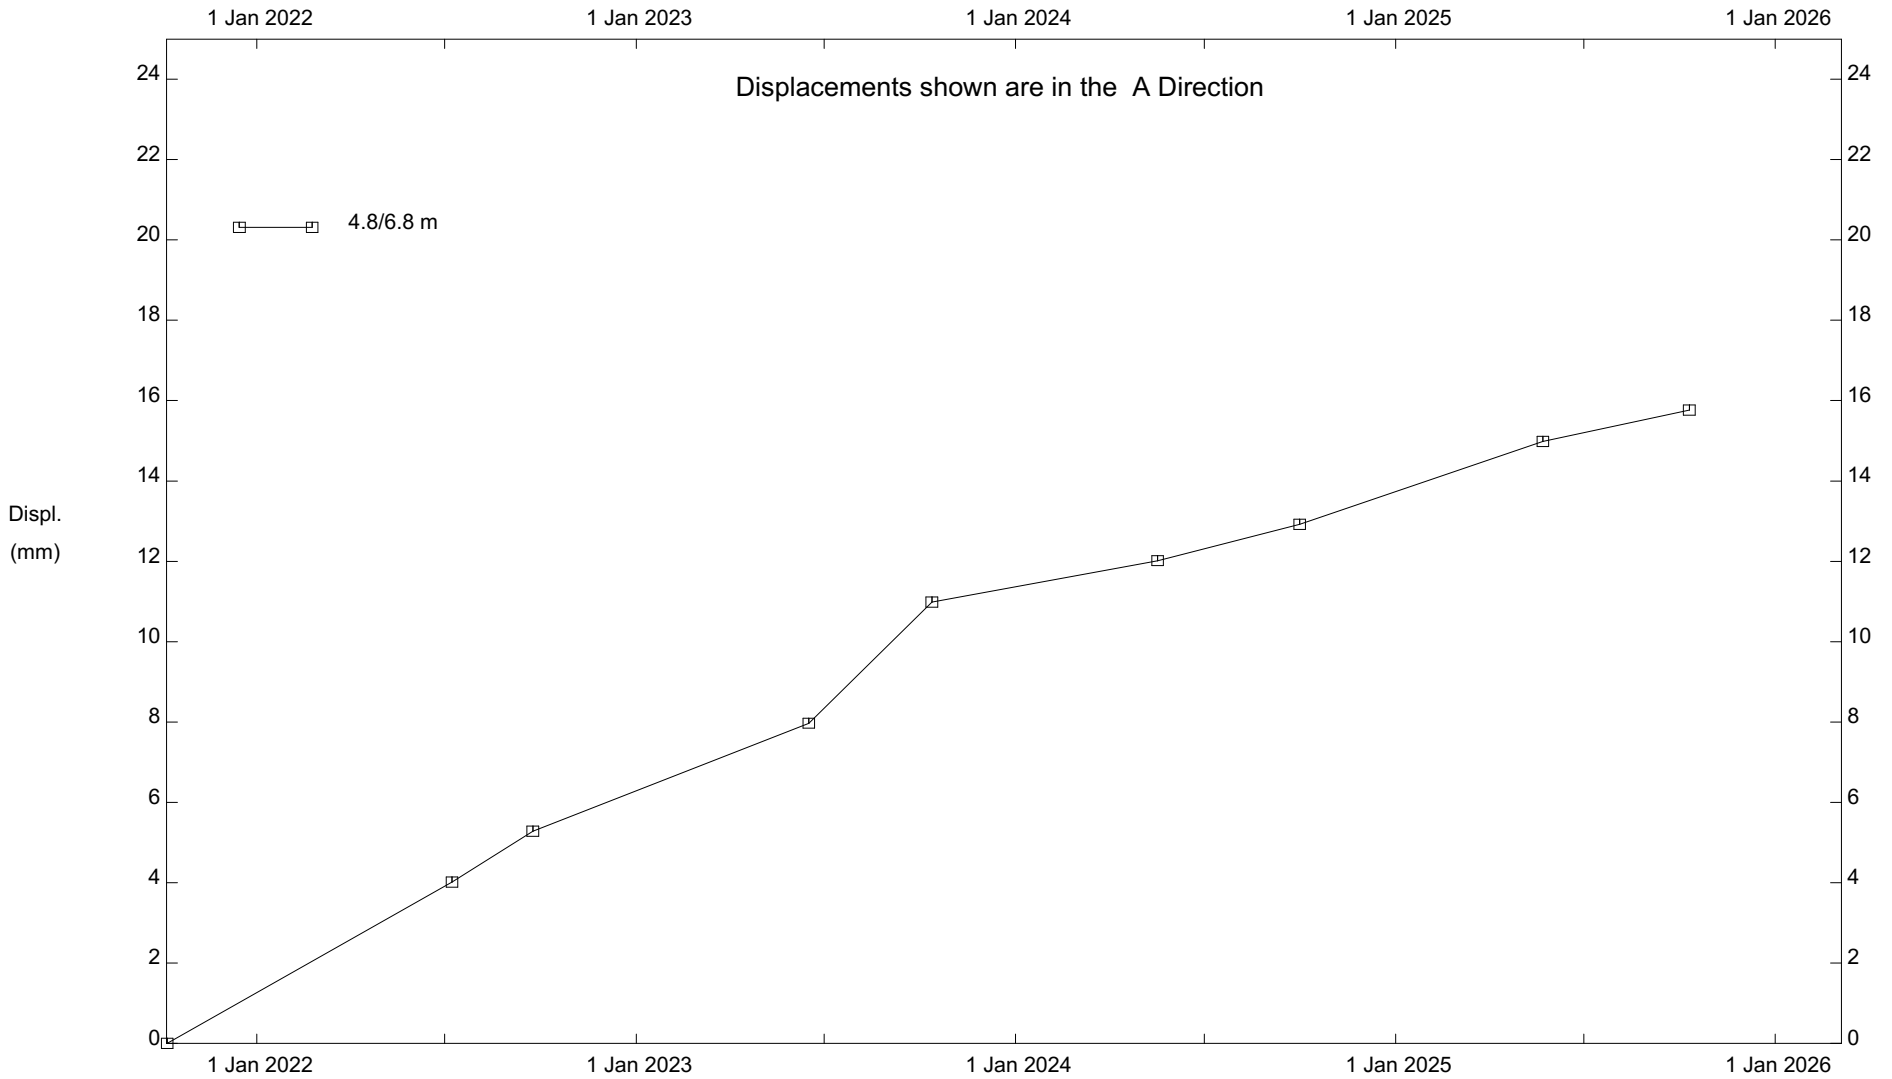
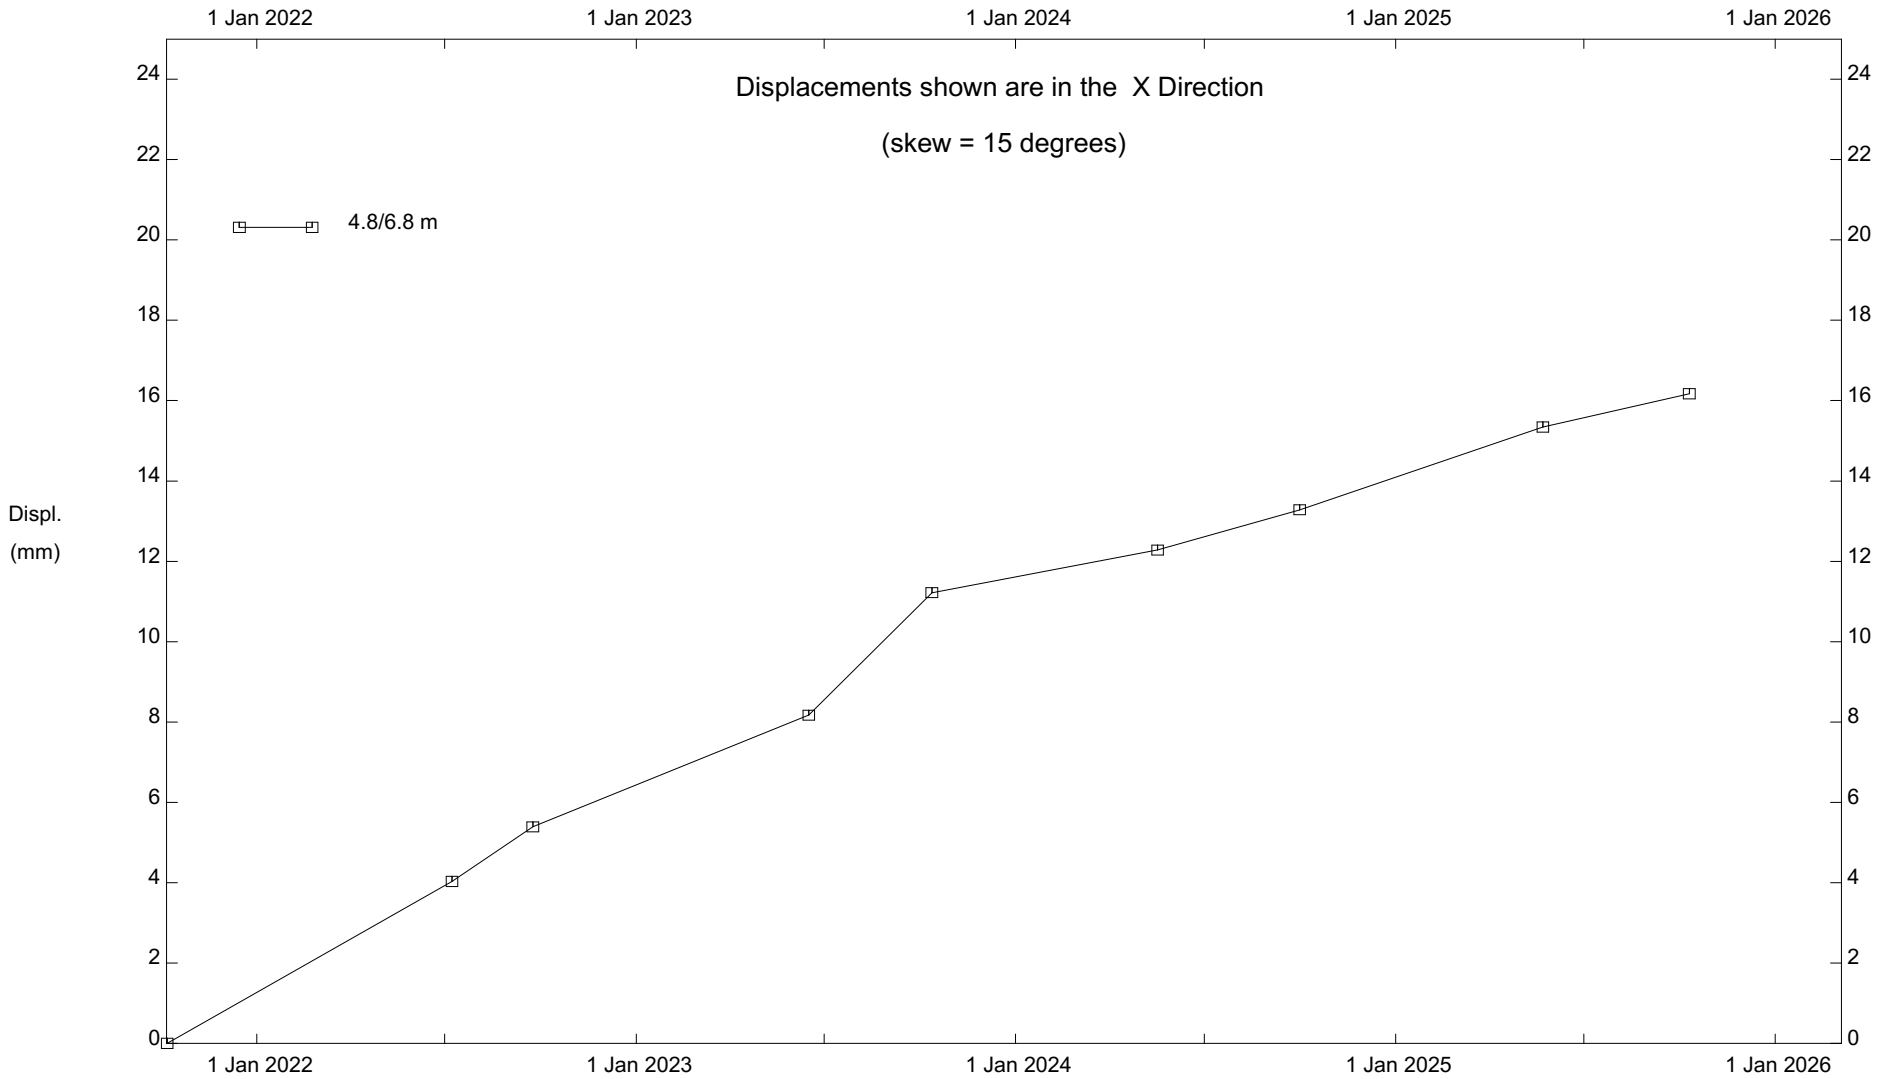
S026; H41:03, Elkwater Slides, Area B, Inclinator SI12-01

Discrete movement has been recorded in SI12-01 between an approximate depth of 4.5 m and 6.5 m below ground surface.

The zone of movement recorded in SI12-01 is occurring at a similar depth to the original slide plane reported by the previous consultant prior to construction of the H-pile wall.

Since KCB took over the instrument readings in 2016, the rate of movement recorded in SI12-01 has been relatively steady (approximately 5 mm/year), except for an increased rate of movement recorded in the fall of 2017 and fall of 2021 (approximately 13.7 mm/year and 16.1 mm/year, respectively). The increased rate of movement recorded in the fall of 2021 could be due to a small data shift caused by KCB changing the SI reading equipment when the old equipment became inoperable. However, the increased rate of movement recorded in 2017 reflected site observations made by KCB and TEC during the 2017 Section B inspection.

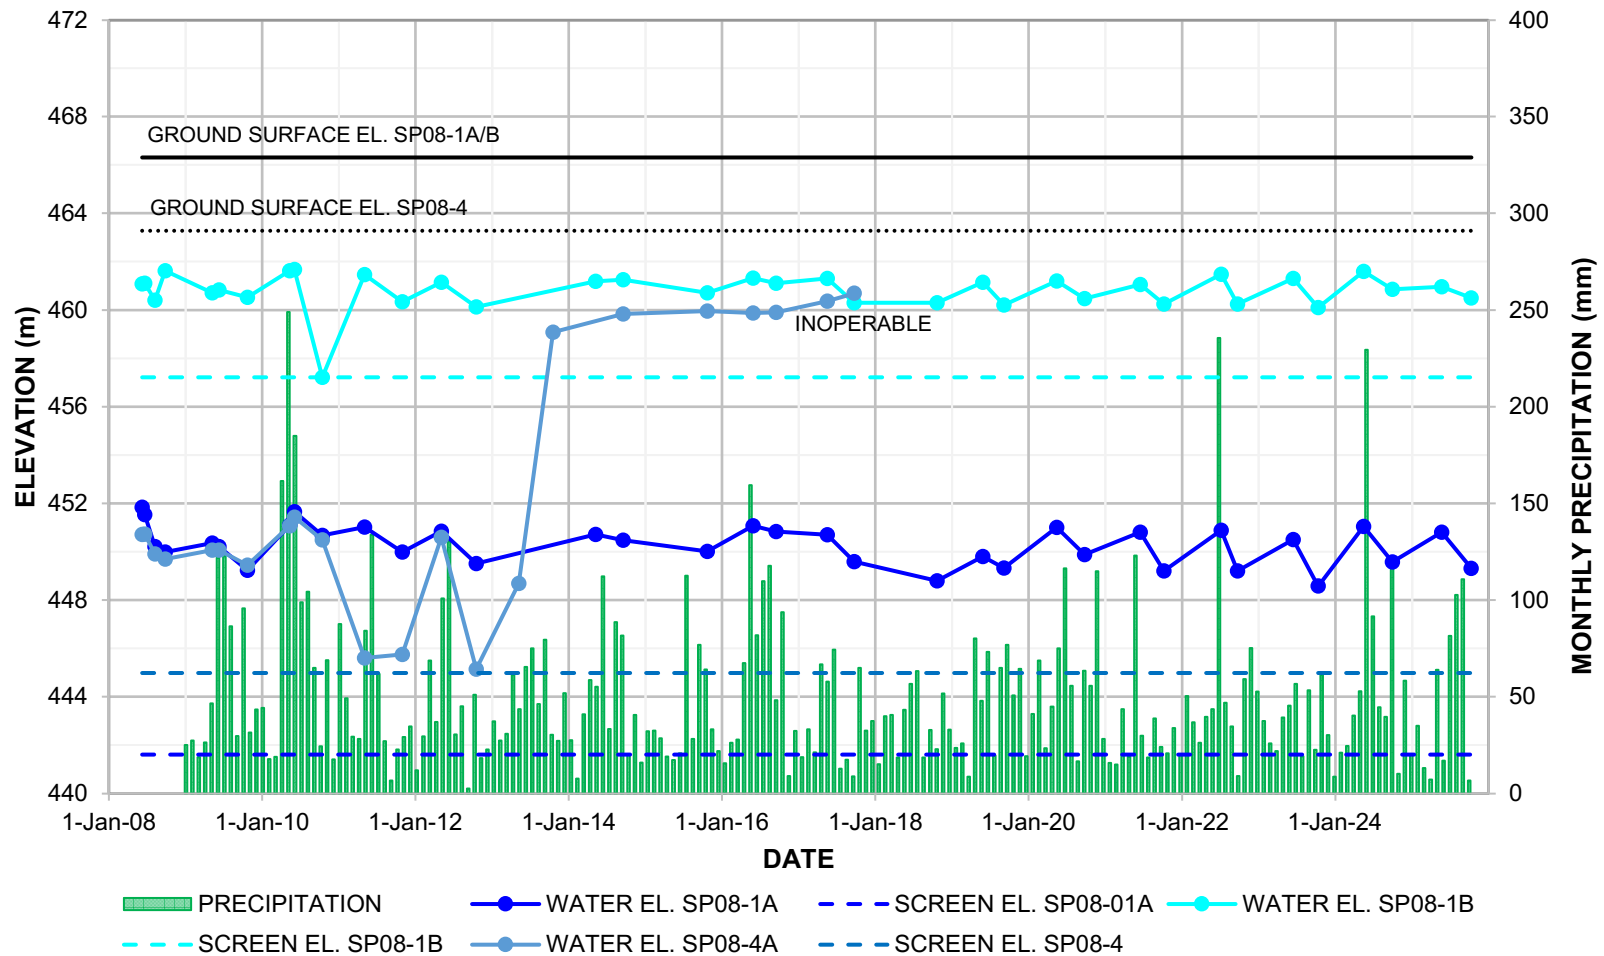
Piezometer Data
S026 - Elkwater Slide Area A
Hwy 41:03, km 35.169

Water levels recorded in SP08-01A and SP08-01B appear to fluctuate seasonally (with the spring readings being higher than fall readings) from an approximate depth of 14.4 m to 17.5 m below ground surface and 4.8 m to 6.8 m below ground surface, respectively. The October 2025 readings were consistent with historical trends observed in these instruments, with decreases of 1.5 m and 0.5 m recorded in SP08-01A and SP-01B, respectively. The spring 2024 report noted the water levels recorded were the highest recorded since installation, which based on the precipitation data,

corresponds with a large amount of precipitation (191 mm) in May 2024. The water levels have since returned to normal.

- Installing a data logger in one or more of the SPs to assess for short-term fluctuations (e.g., increases and decreases) in groundwater level that could be occurring in response to periods of heavy or prolonged rainfall or freshet infiltration between readings.
- A geotechnical site investigation (drilling and instrument installations) to assess the depth of movement in recently active slide areas to support a repair design. Two additional SIs should be installed in Area B, one upslope of the H-pile wall near its south end and one adjacent to the highway north of the H-pile wall, to monitor for movement.
