SITE NUMBER AND NAME: S026 Elkwater Slides	HIGHWAY & KM: 41:03, 35.169	PREVIOUS INSPECTION DATE: May 11, 2023	INSPECTION DATE: May 28, 2025
LEGAL DESCRIPTION SE-18-008-02 W4M and 16-07-008-02 W4M	NAD 83 COORDINATES: UTM Northing Easting 12 5499046 553536	RISK ASSESSMENT: Site A: PF: 8 CF: 6 TOTAL: 48 Site B: PF: 9 CF: 5 TOTAL: 45	
AVERAGE ANNUAL DAILY TRAFFIC (AADT): 660 (north), 400 (south), (Ref. No. 138060)		CONTRACTOR MAINTENANCE AREA (CMA): 523

PRIMARY SITE ISSUE: Sliding in the highway embankment and back slopes located within a creek valley. Erosion at the toe of the embankment from the creek and high groundwater table appears to be the triggering mechanism.
APPROXIMATE DIMENSIONS: The extent of the sliding mass is continuous over approximately 600 m from the south end to the north end of the site and between Sites A and B. The embankment height varies from 5 to 10 m high and is sloped between approximately 4H:1V to 5H:1V.
DATE OF ANY REMEDIAL ACTION: Site A: Between 1970 and 1990 – Shallow drainage was installed near the south end of the site. Fall 2016 – The slope was graded. Site B: 2012 – A 60-m-long H-pile was installed. The H-pile wall repair was preceded by a tempora

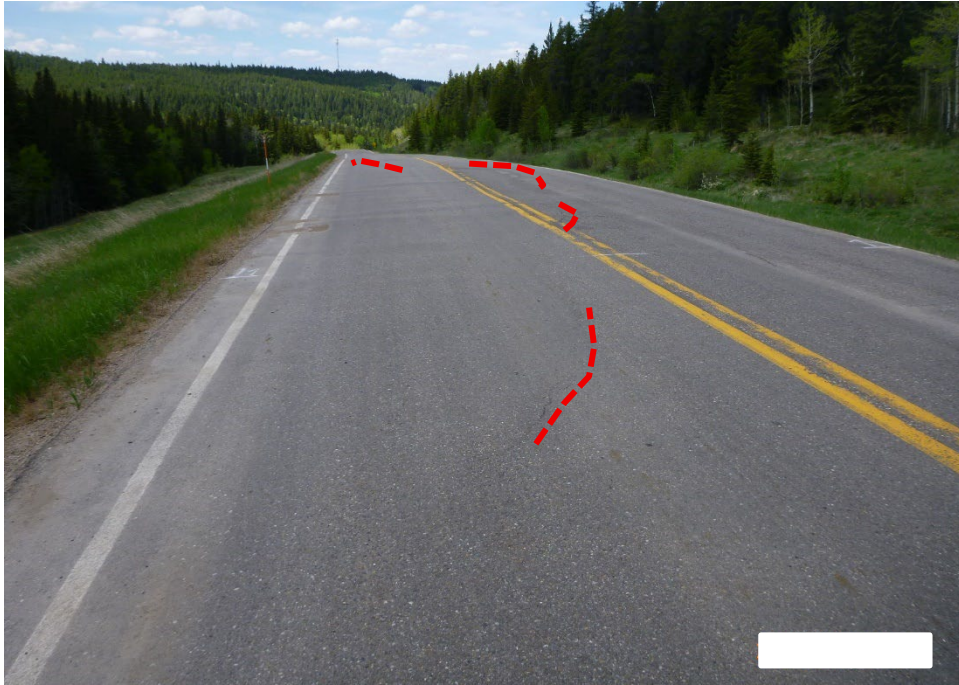
- The highway was resurfaced between the 2023 and 2025 inspections. During the 2025 inspection, some minor pavement distress (pavement cracking and settlement) was observed, but it was not as severe as during the 2023 inspection (Photos 1 and 2). However, there was some "rippling" observed in the highway surface, which was not observed during the 2023 inspection.

Photo 1 Pavement cracking and settlement (red dashed line) reflected through a recent pavement patch at Site A. Photo taken May 28, 2025, facing northwest.

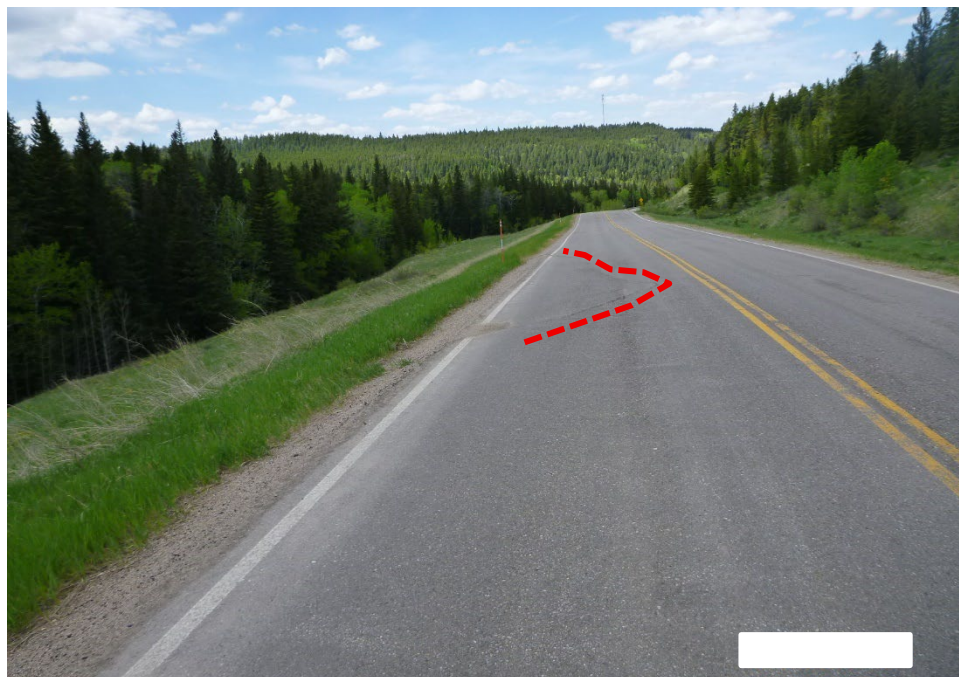
Photo 2 Pavement cracking and settlement (red dashed line) reflected through a recent pavement patch at Site A. Photo taken May 28, 2025, facing northwest.

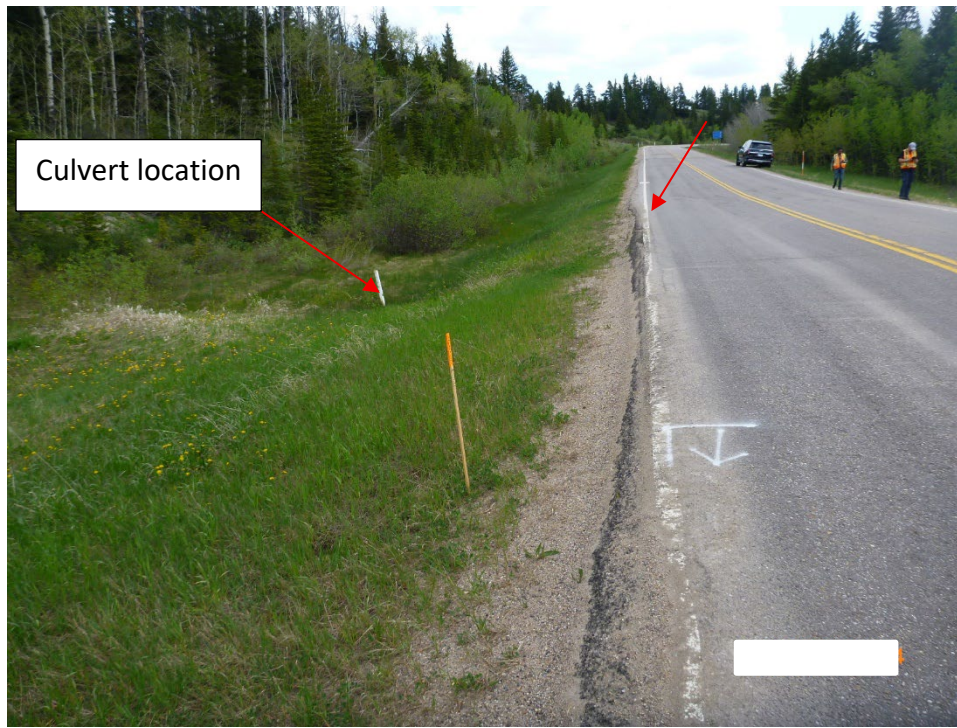
- There is a flow through the culvert underlying the highway. No erosion was observed at the outlet during the 2025 inspection (Photo 4). However, there is settlement above the culvert within the east (northbound) highway embankment slope (Photo 3).

Photo 3 Settlement in the east (northbound, red arrow) highway embankment slope above the culvert underlying the highway. Photo taken May 28, 2025, facing southeast.

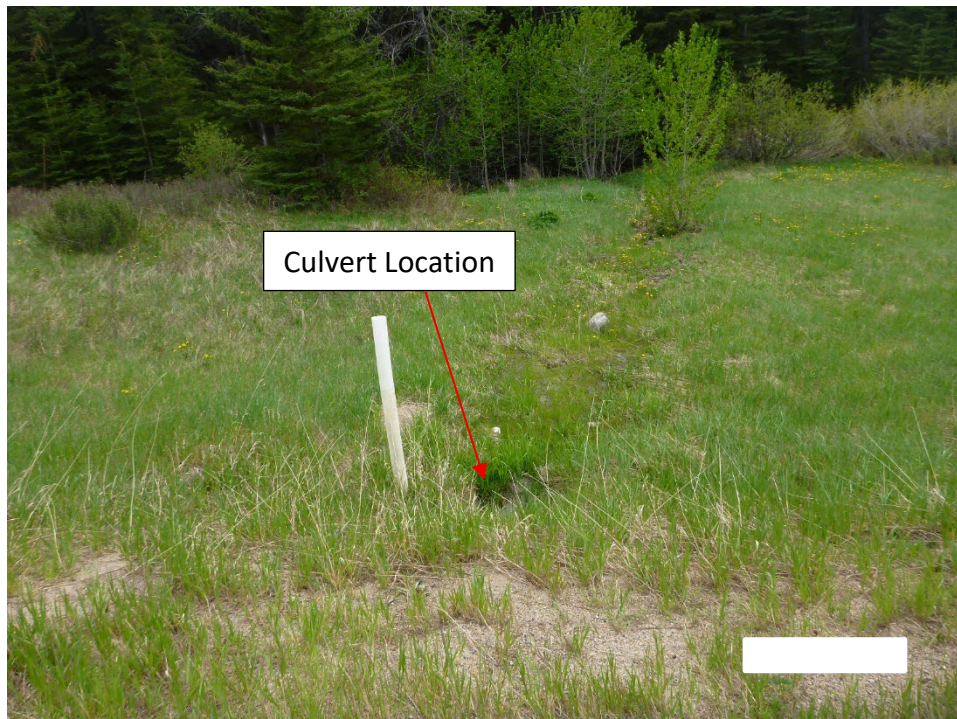
Photo 4 Low flow through the culvert underlying the highway and no erosion observed during the 2025 inspection. Photo taken May 28, 2025, facing west.

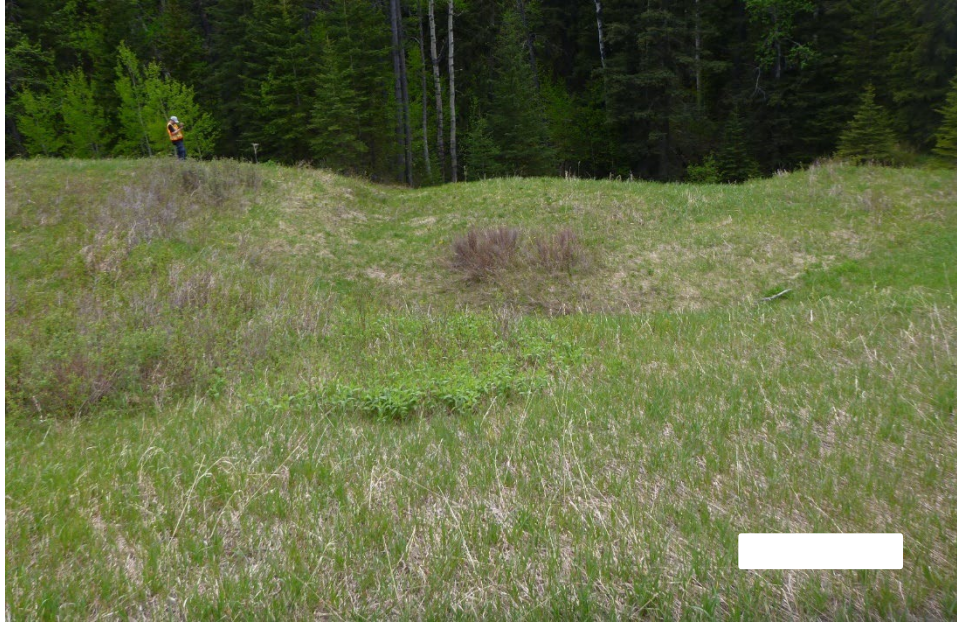
- Near the north extent of Site A, two successive slip surfaces from a potential retrogression failure were observed during the 2025 inspection on the west (southbound) highway embankment with a slump mass near the toe of the embankment (Photo 5). The slide is approximately 25 m to 30 m wide, with the head scarp approximately 15 m from the edge of movement. The slide appears to have expanded between the 2023 and 2025 inspections, but it does not appear to be impacting the highway surface at the current moment.

Photo 5 Near the north extent of Site A there is a slide (approximately 25 m to 30 m wide and 15 m from the edge of pavement) in the west (southbound) highway embankment slope near the toe of the embankment. Photo taken May 28, 2025, facing west.

- Carry out additional ground investigation, including boreholes and installation of additional geotechnical instrumentation, to assess the depth of movement in recently active areas for repair design options evaluation. Potential repair options include additional pile walls in slide areas, with drainage trenches installed at the toe of the landslide zone to lower the groundwater table and improve slope stability.

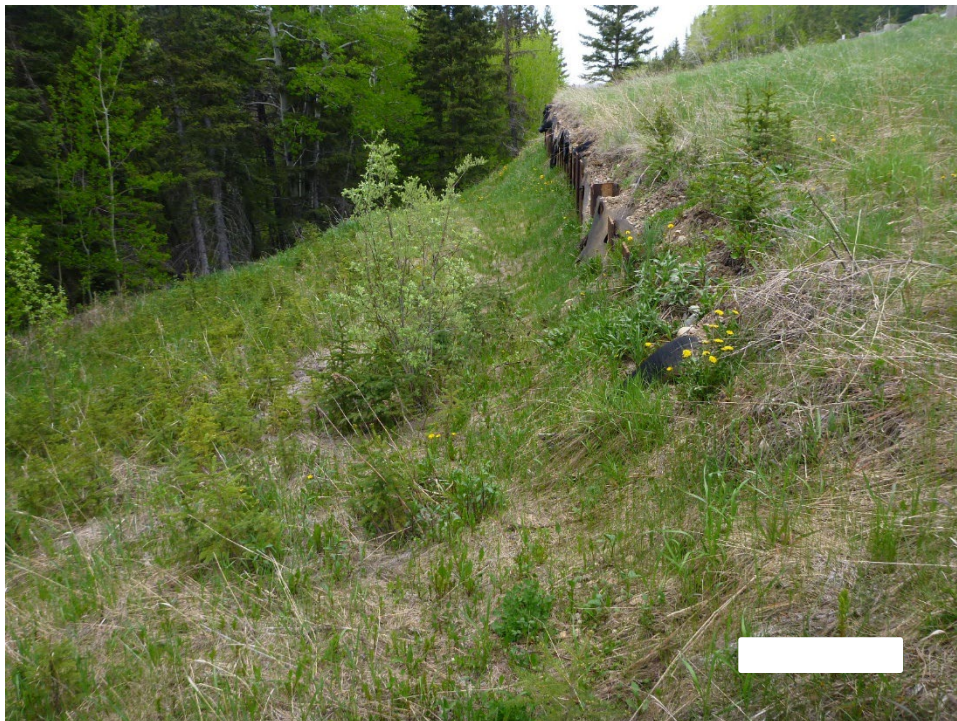
- The upper portion of the H-pile wall and non-woven geotextile has been exposed by soil sliding downslope of the H-pile wall and soil erosion between the individual H-piles (Photos 6 through 8).

Photo 6 Southeast extent of H-pile wall installed at Site B. Photo taken May 28, 2025, facing northwest.

- The Highway Maintenance Contractor (HMC) should collapse any soil voids forming between the H-pile wall and edge of the highway. Collapsed voids should be backfilled with sand and gravel.

- The HMC should installed timber lagging between the H-piles and backfill behind the lagging with compacted sand and gravel.
- The H-pile wall should be extended to the north (including timber lagging between H-piles) where the existing H-pile wall is being outflanked. The H-pile wall will need to be extending at an angle to address the sliding towards the north.

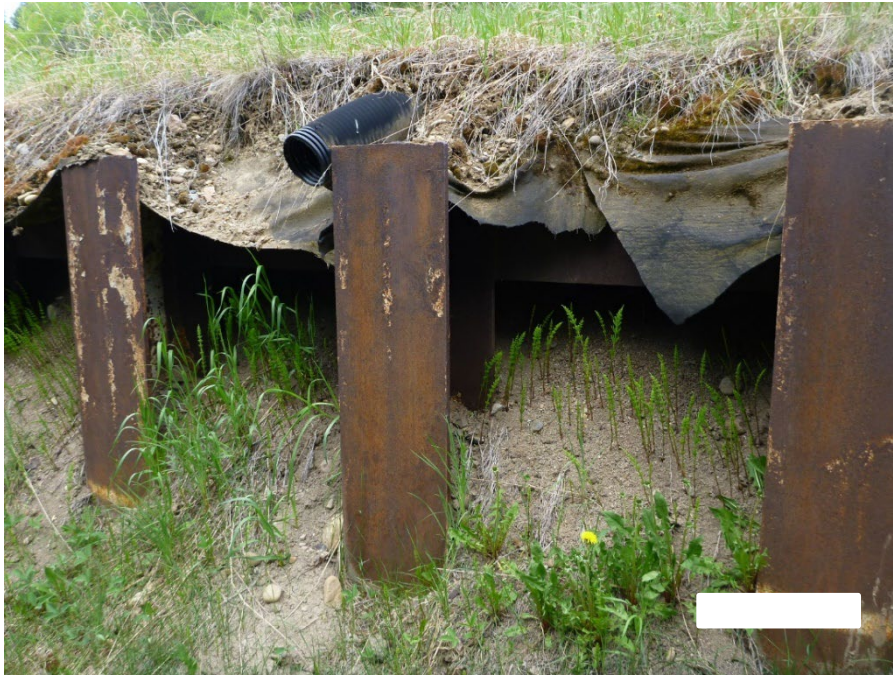
Photo 7 Drainpipe and exposed non-woven geotextile and upper portion of the H-piles at Site B. Photo taken May 28, 2025, facing north.

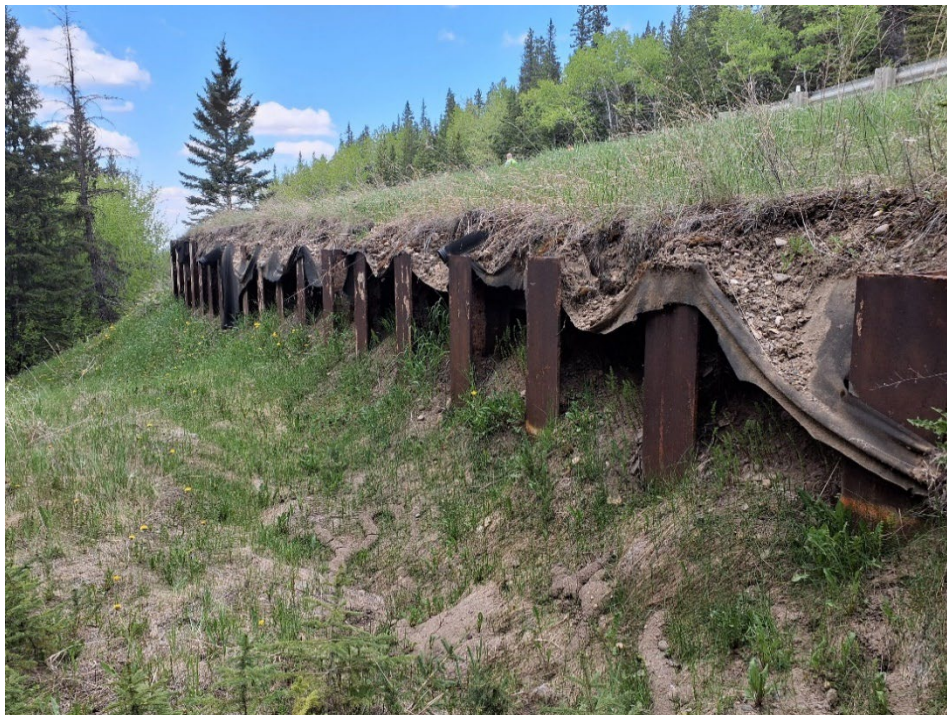
Photo 8 Exposed non-woven geotextile and upper portion of the H-piles. Photo taken May 28, 2025, facing northwest.

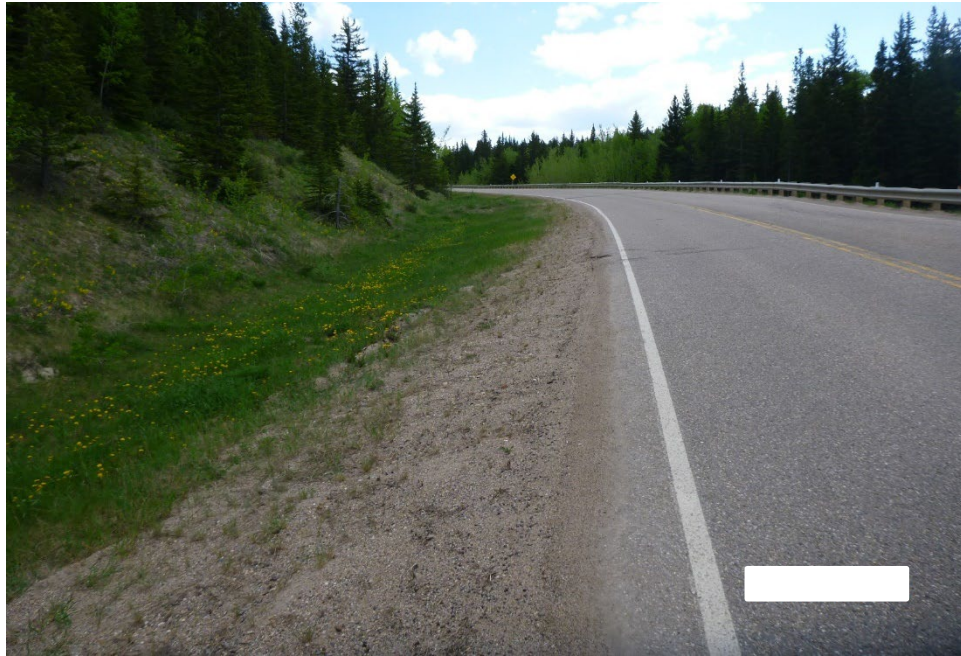
- Minor pavement cracking upslope of the H-pile wall has been observed at the southern end of the wall and does not appear to have worsened between the 2023 and 2025 inspections (Photo 9).

Photo 9 Pavement and east (northbound) ditch upslope of Site B. Photo taken May 28, 2025, facing southeast.

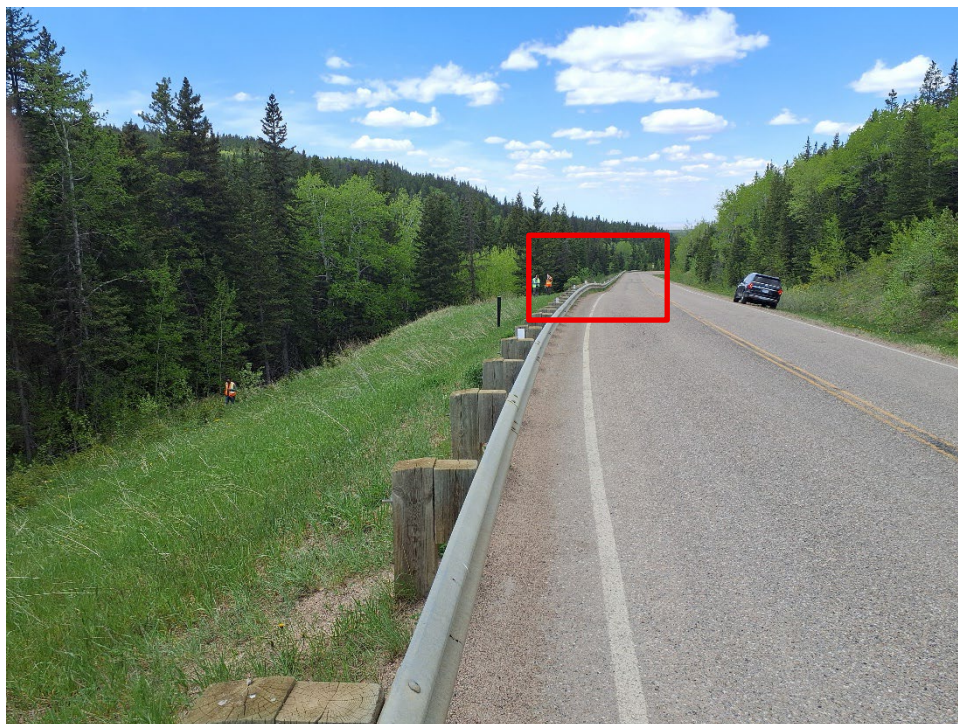
- During the 20205 inspection, pavement distress (cracking and settlement) and evidence of slope movement was observed north of the northern extent of the H-pile wall, indicating the slide is outflanking the H-pile wall. The guardrail at the north edge of the H-pile wall has settled up to approximately 0.5 m and appears worse than during the 2023 inspection (Photo 10).

Photo 10 Guardrail deflection at Site B (indicated by red rectangle). Photo taken May 28, 2025, facing north.

- A mitigation assessment should be conducted to review how much tolerable deformation the existing H-pile wall can handle and prepare a design for a pile wall extension. The installation of a waler and tie-back anchors may be required to stabilize the slide. If the H-pile wall is not repaired, this could potentially lead to excessive deformation and retrogression of the active wedge to where movement has not been observed. If the H-pile wall is not repaired, the loss of the wall's functionality is a possibility.
