July 15, 2025

Alberta Transportation and Economic Corridors
2nd Floor, 803 Manning Road N.E.
Calgary, Alberta
T2E 7M8

CON0022161 Southern Region GRMP Instrumentation Monitoring
Site S026; H41:03, km 35.169 Elkwater Slides
Section C – 2025 Spring Readings

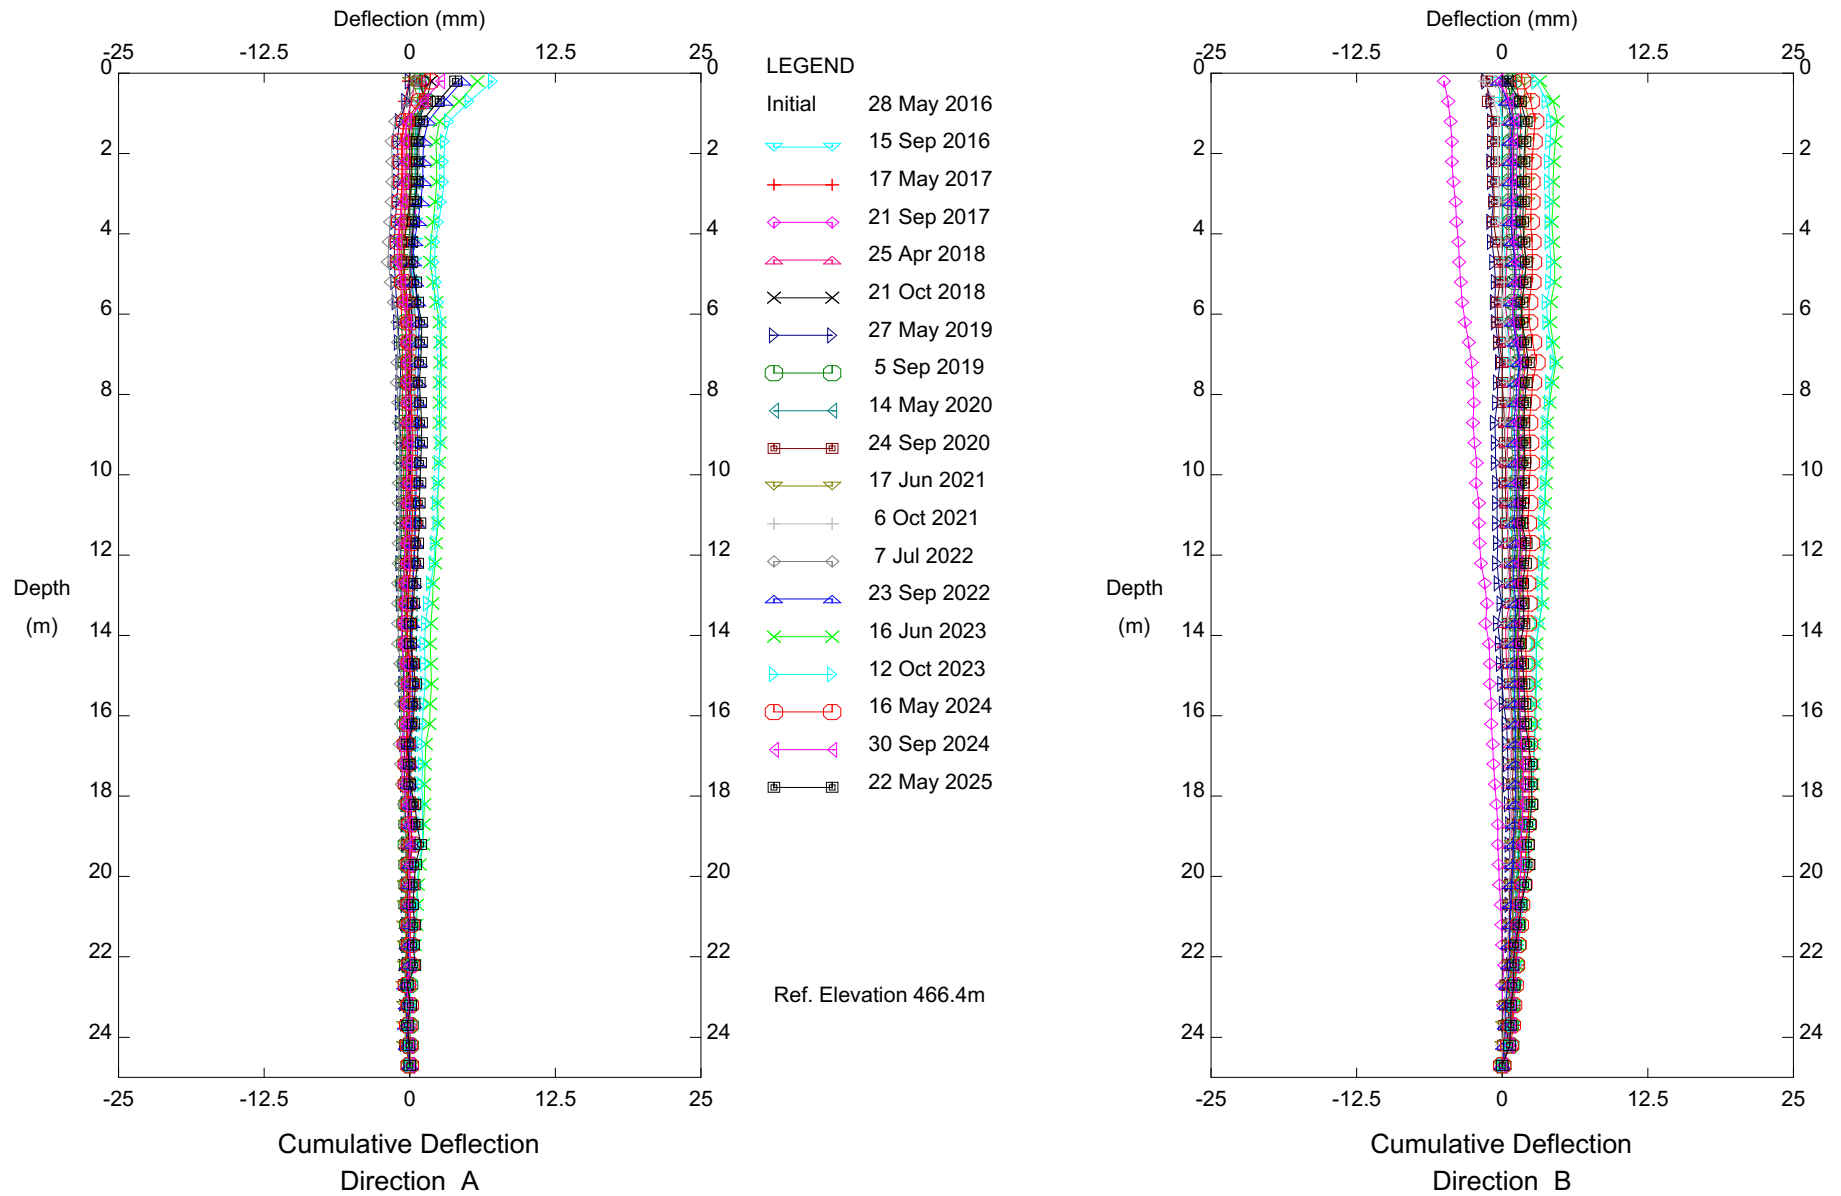
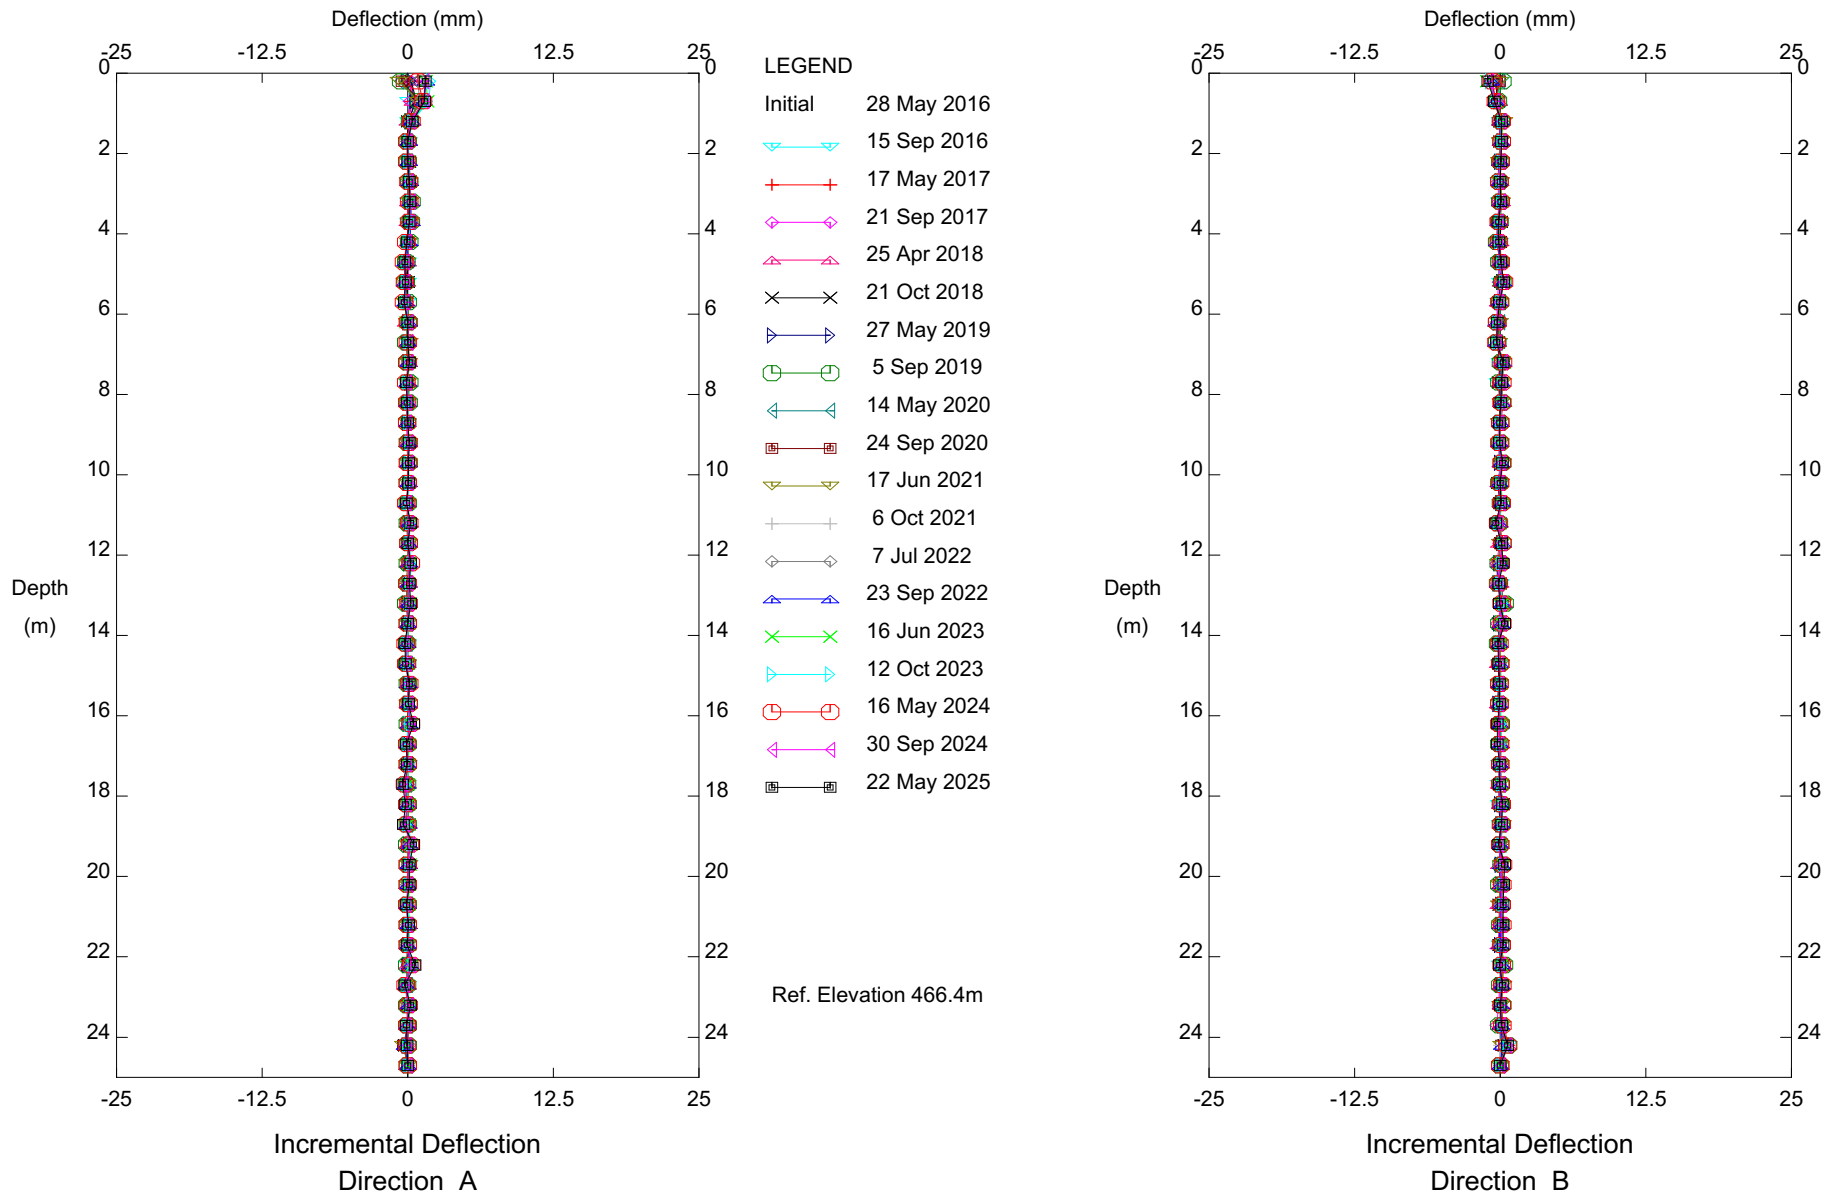
S026; H41:03, Elkwater Slides, Area A, Inclinator SI08-1

No discernible movement has been recorded in SI08-01 or SI08-03.

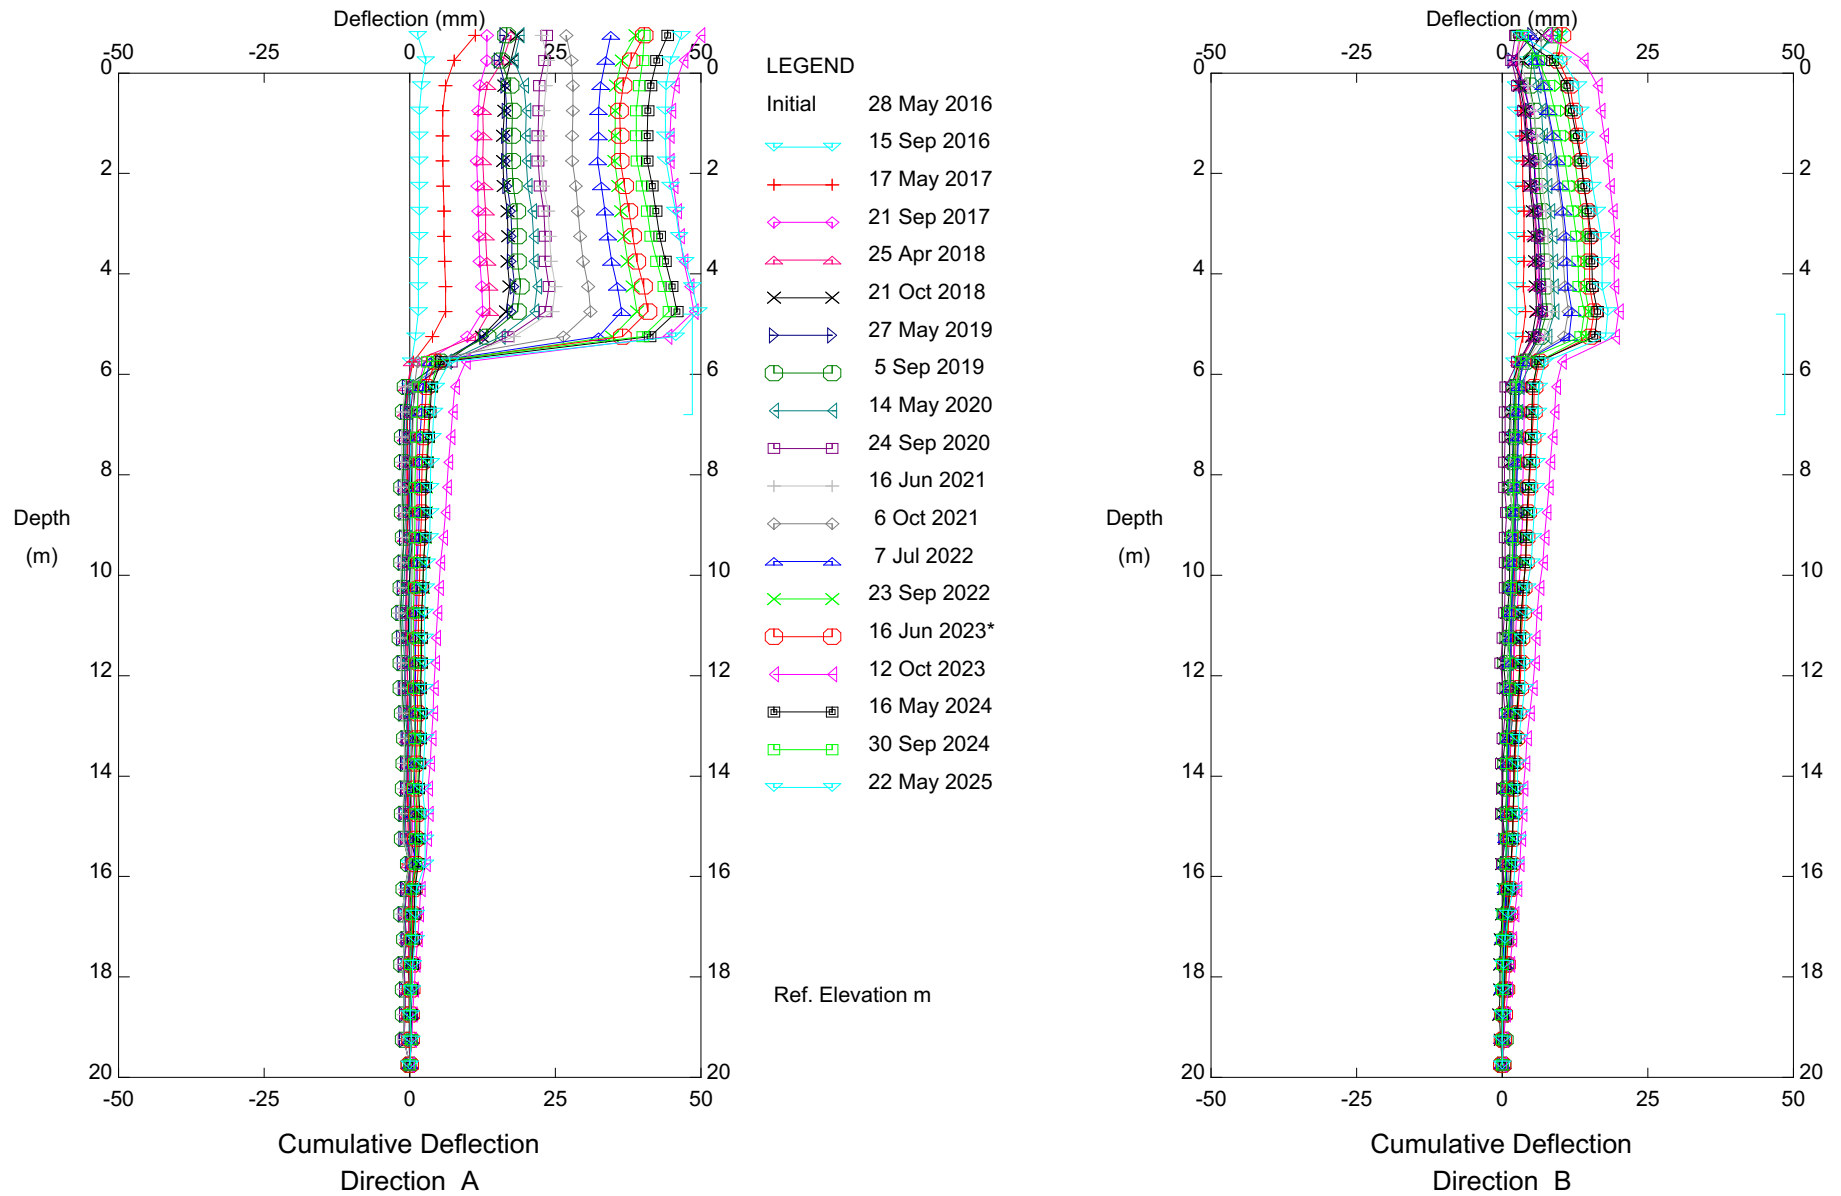
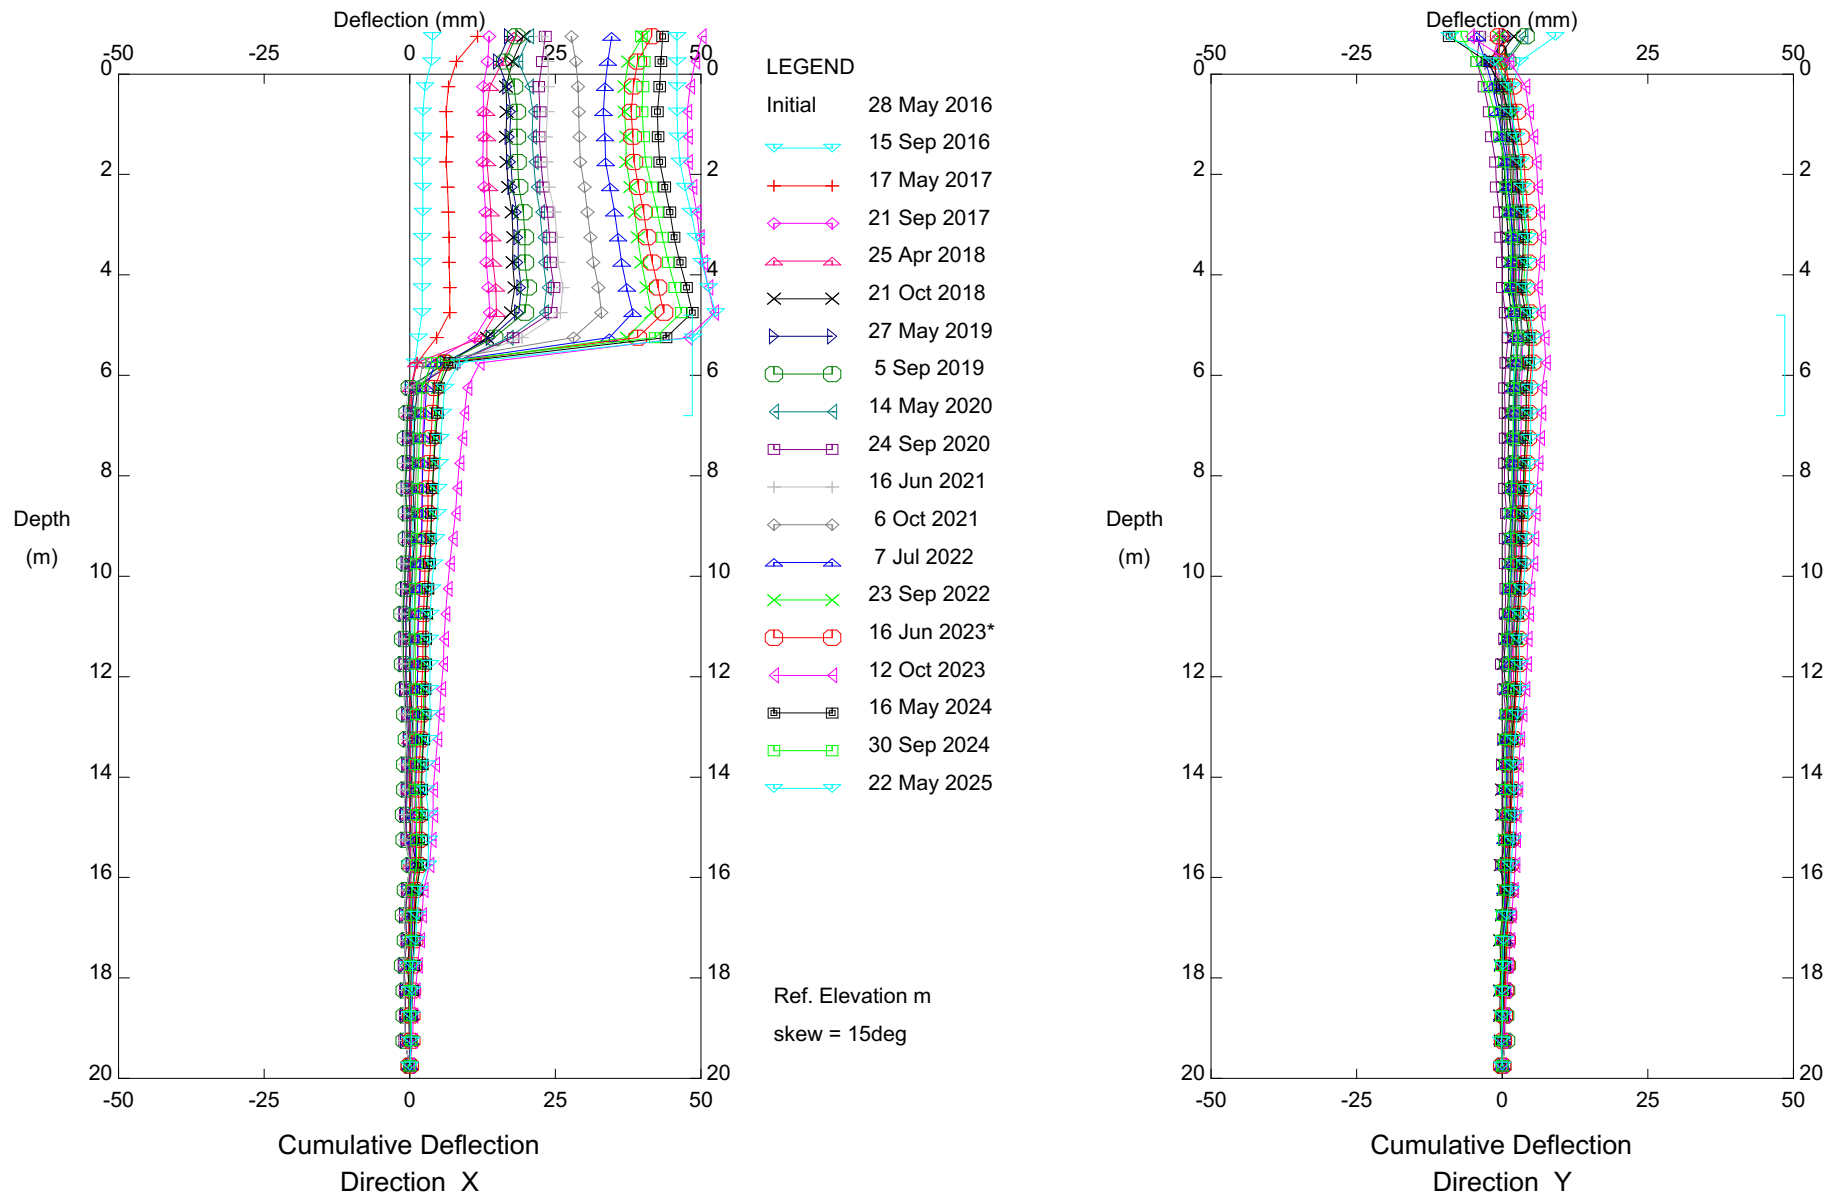
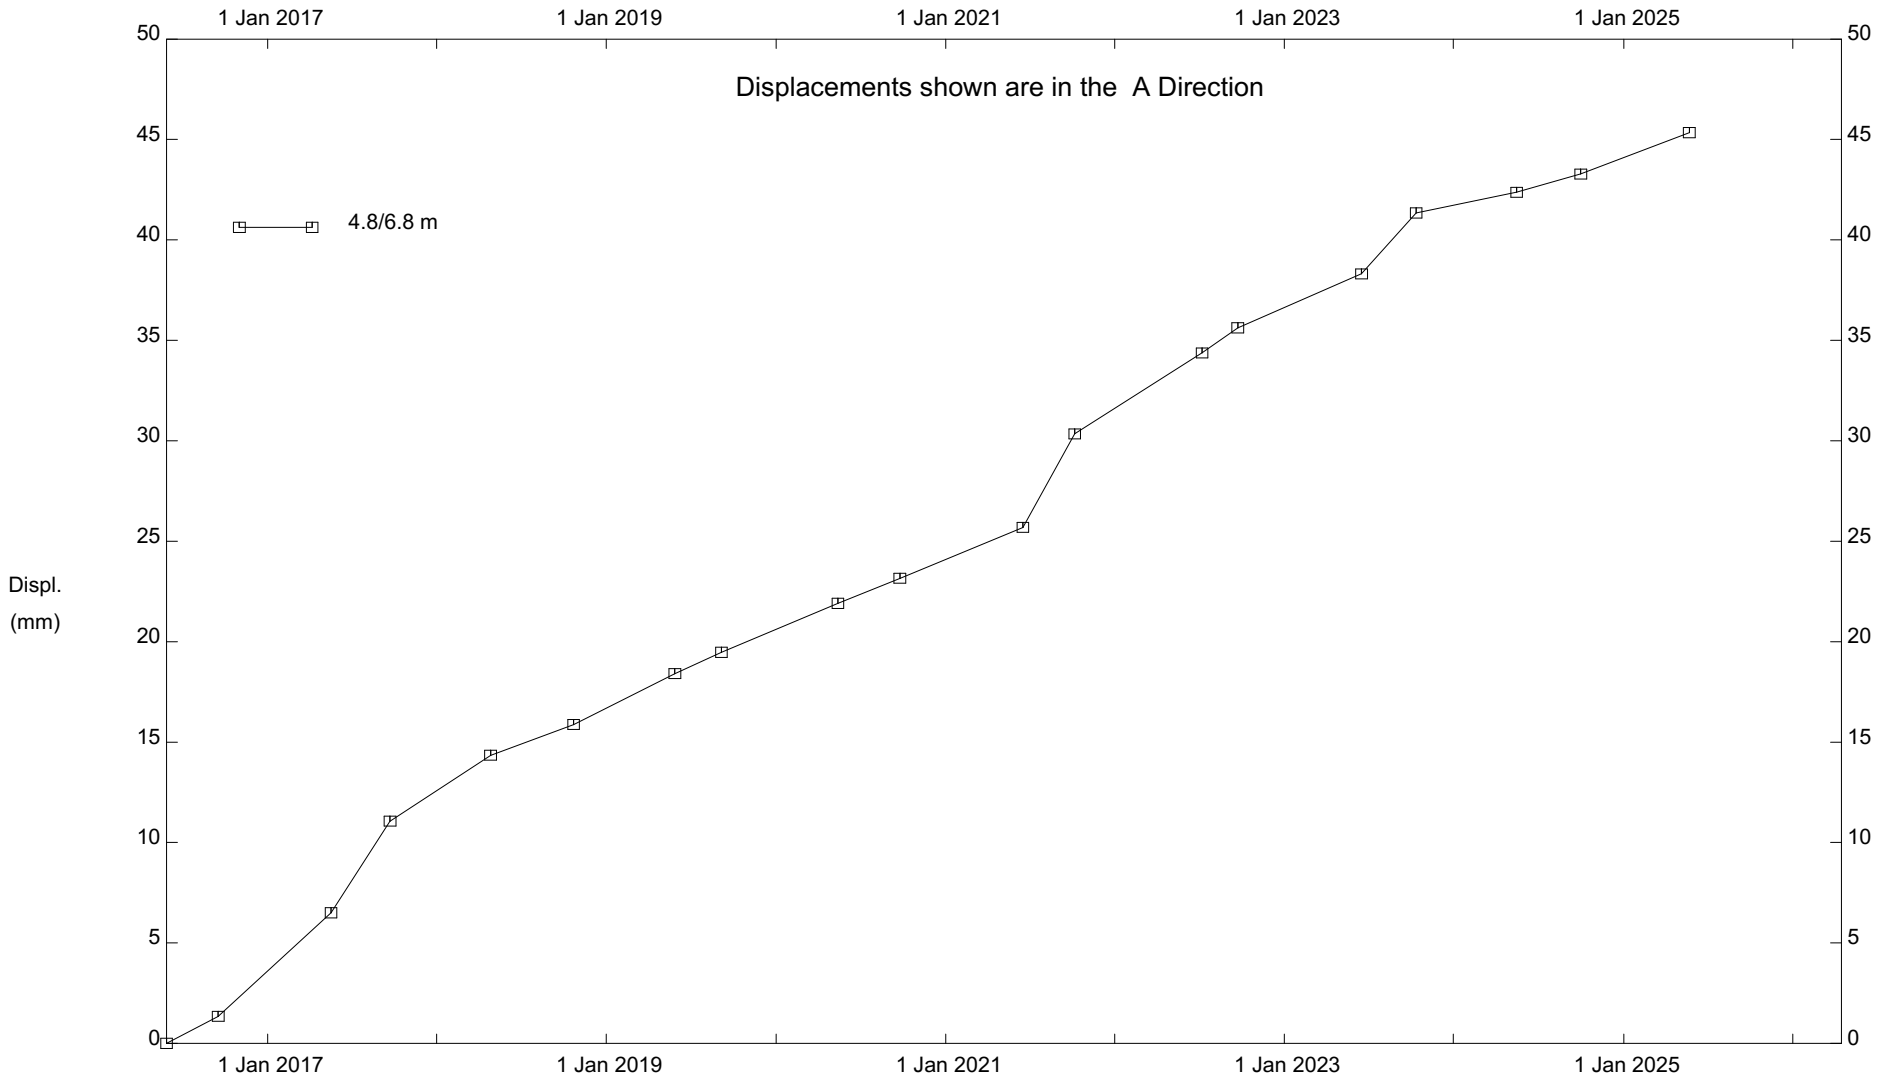
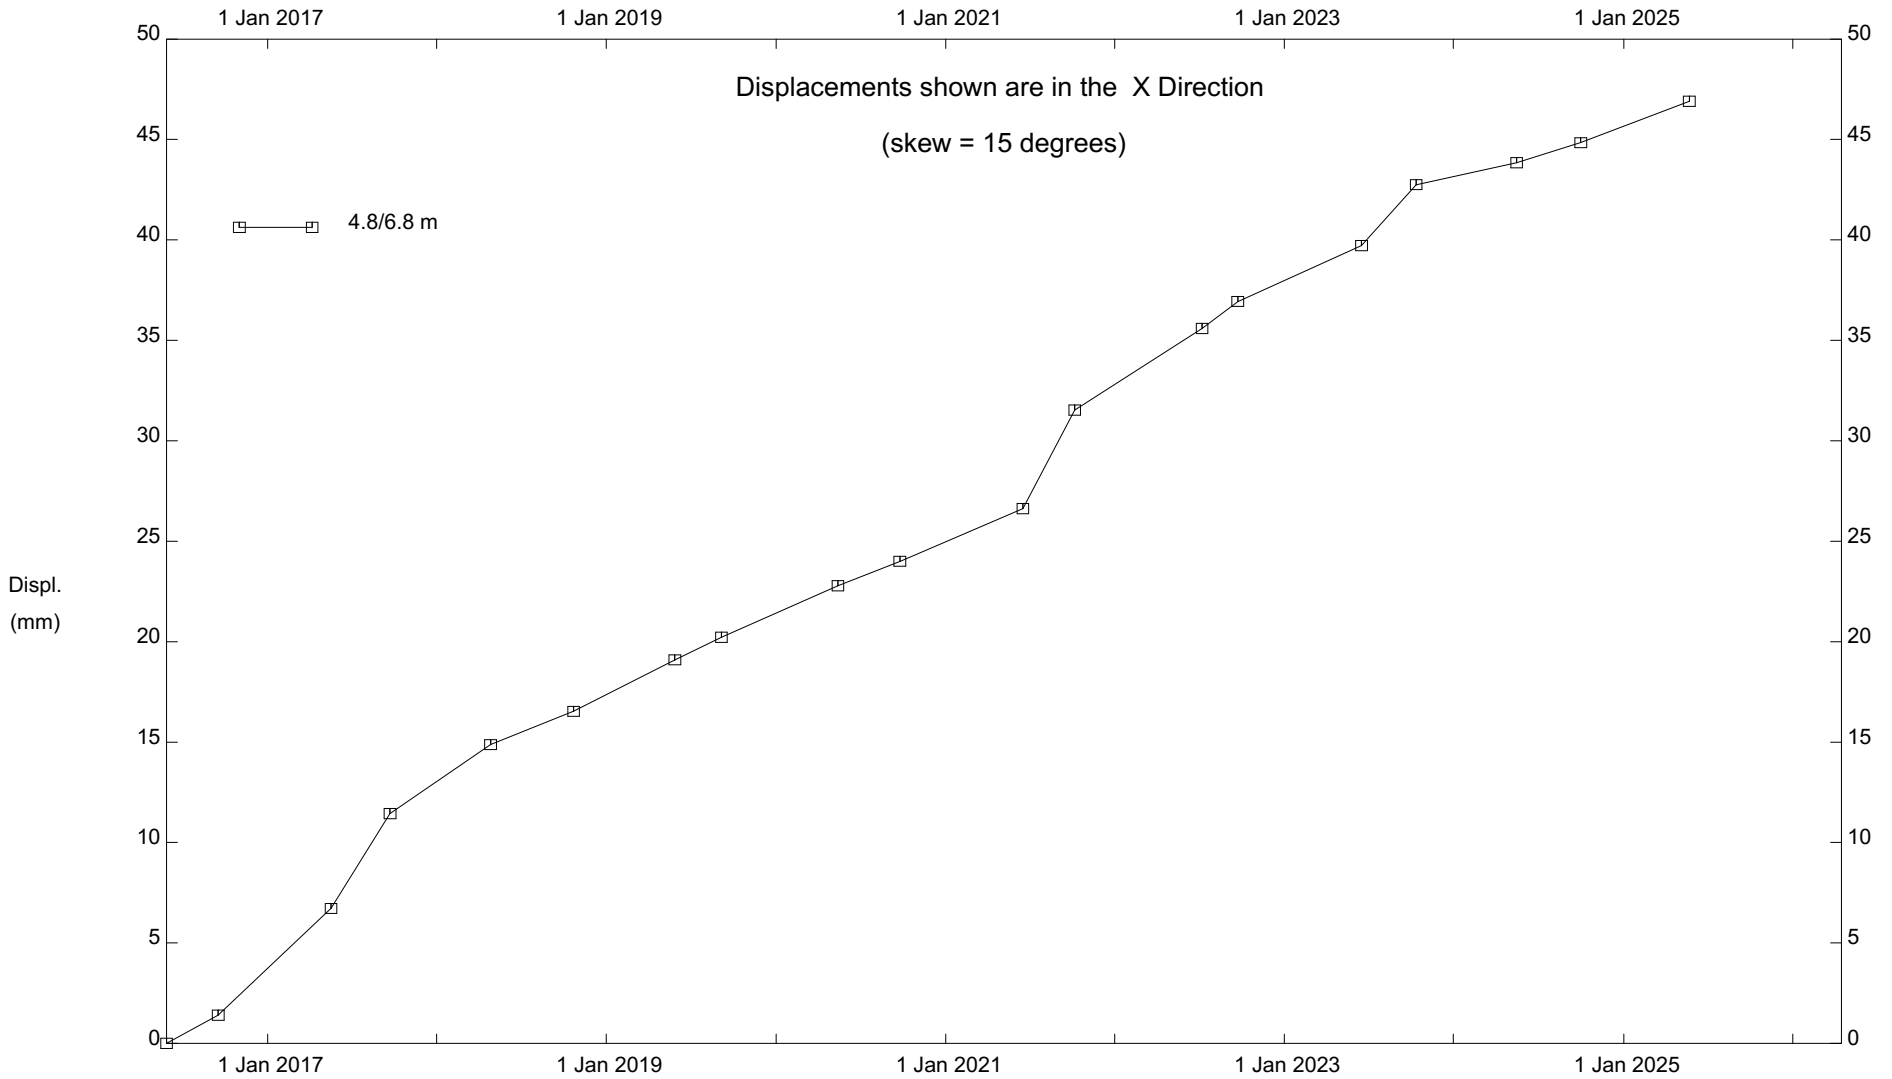
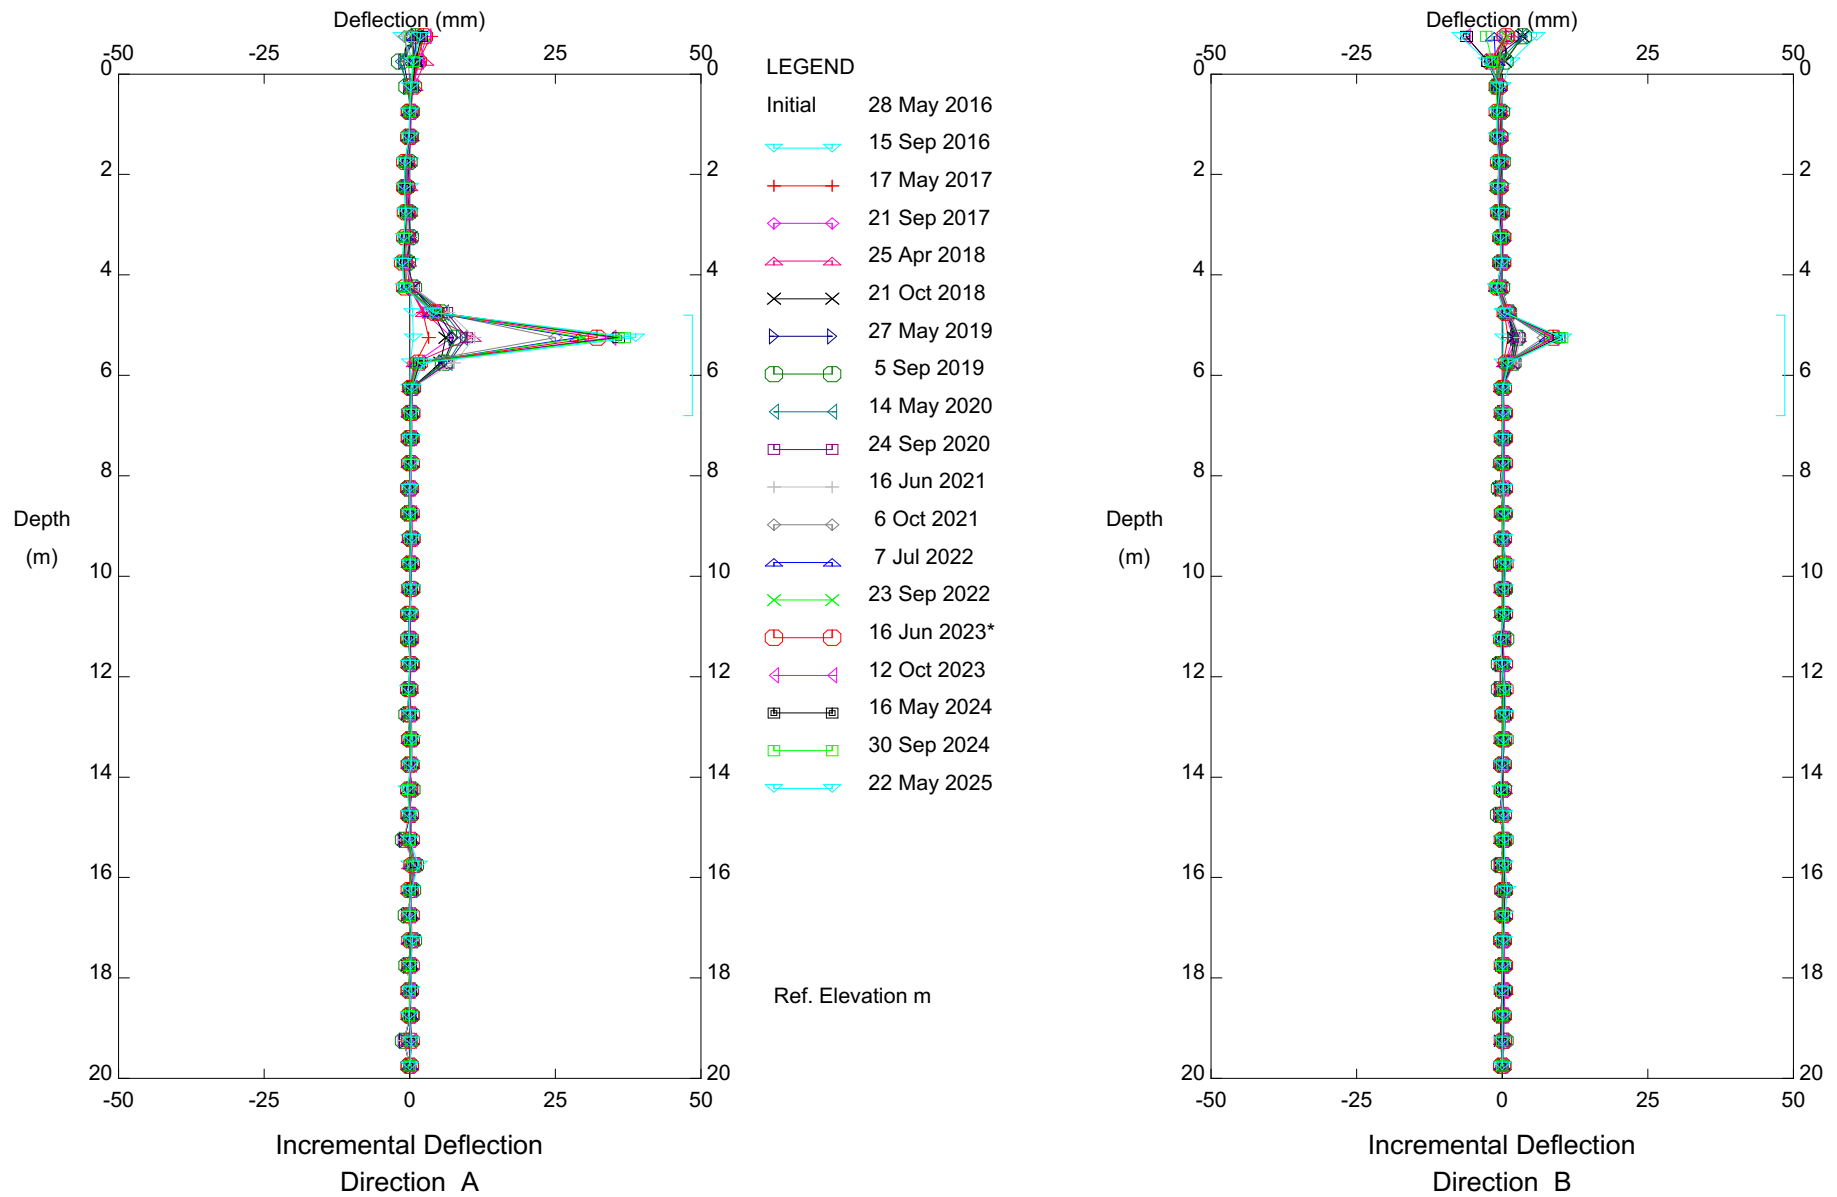
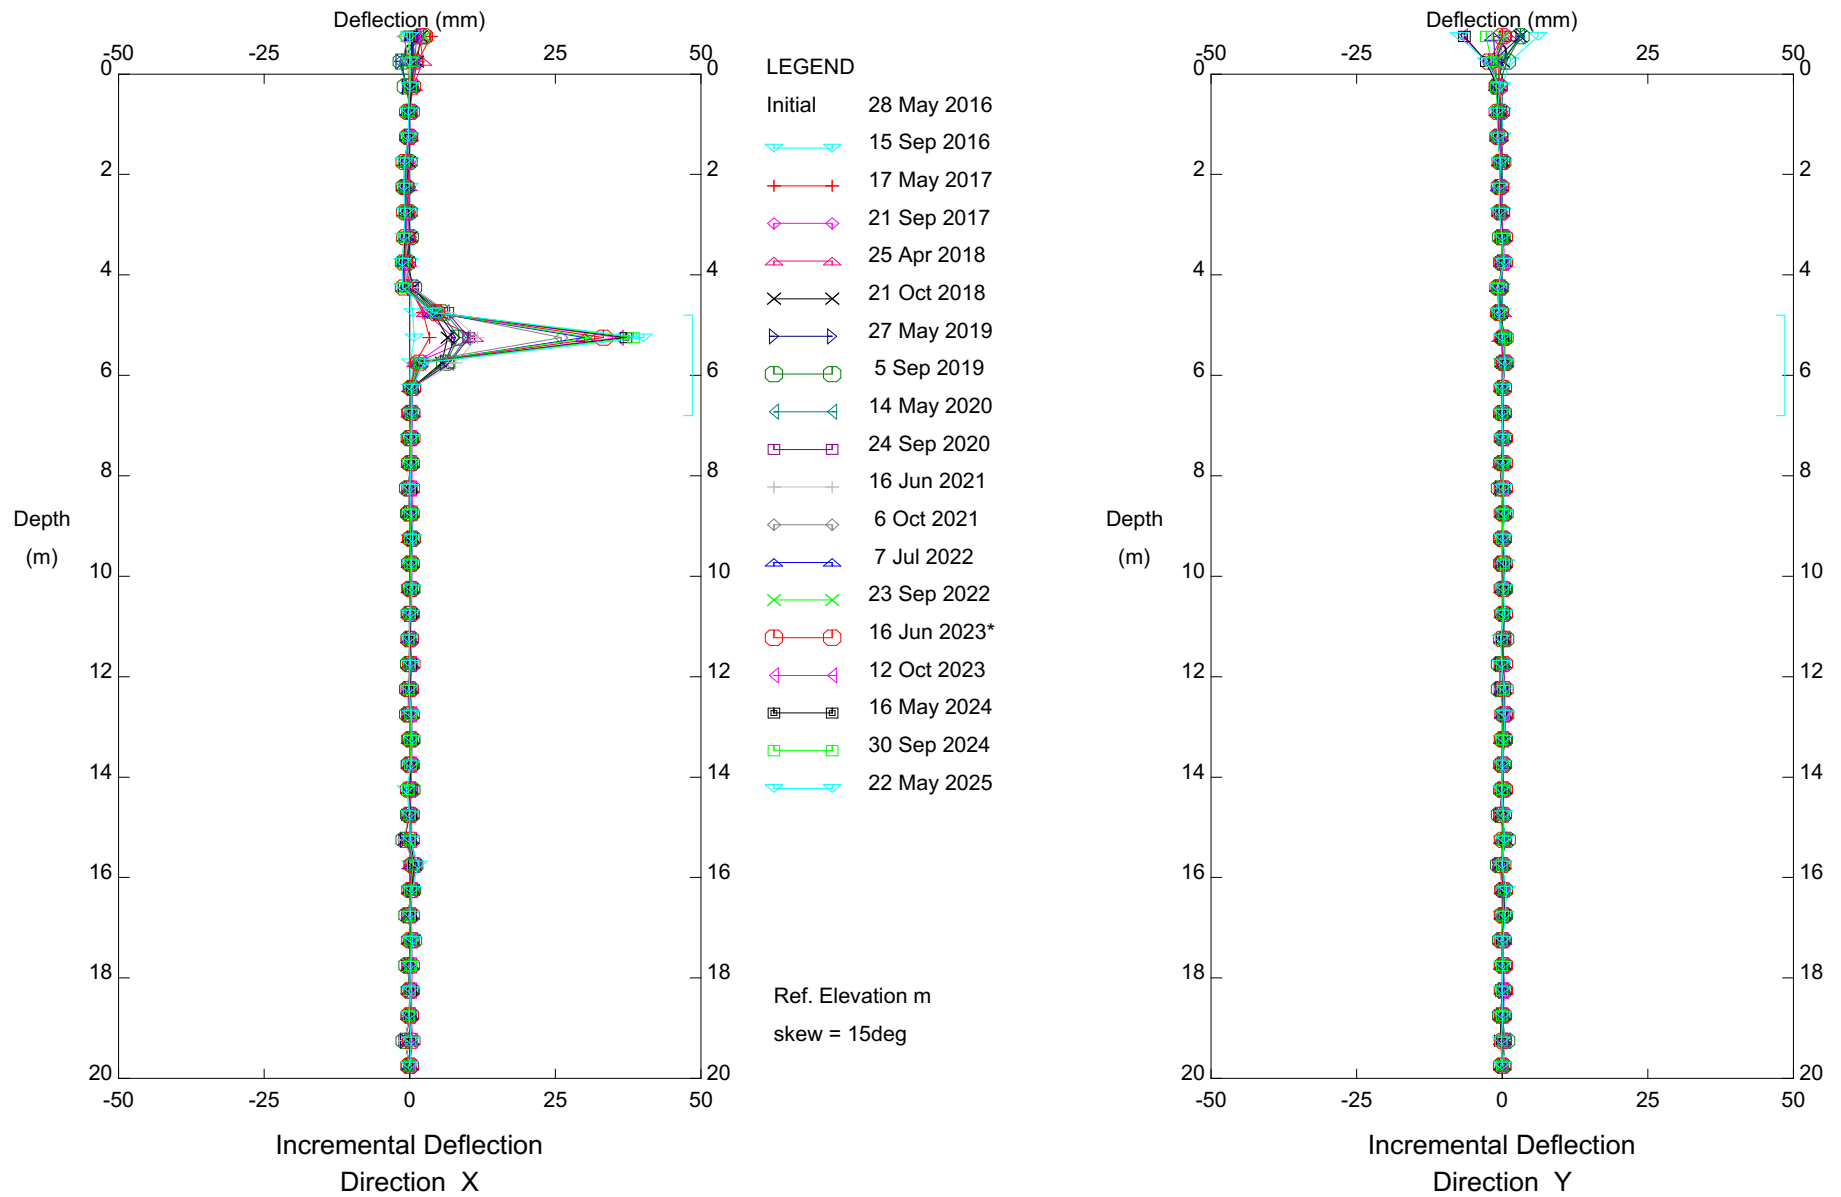
S026; H41:03, Elkwater Slides, Area B, Inclinator SI12-01

Discrete movement has been recorded in SI12-01 between an approximate depth of 4.5 m and 6.5 m below ground surface.

The zone of movement recorded in SI12-01 is occurring at a similar depth to the original slide plane reported by the previous consultant prior to construction of the H-pile wall.

Since KCB took over the instrument readings in 2016, the rate of movement recorded in SI12-01 has been relatively steady (approximately 5 mm/year), except for an increased rate of movement recorded in the fall of 2017 and fall of 2021 (approximately 13.7 mm/year and 16.1 mm/year, respectively). The increased rate of movement recorded in the fall of 2021 could be due to a small data shift caused by KCB changing the SI reading equipment when the old equipment became inoperable. However, the increased rate of movement recorded in 2017 was reflective of site observations made by KCB and Alberta Transportation and Economic Corridors (TEC) during the 2017 Section B inspection.

Soil sliding observed downslope of the H-pile wall has exposed the H-piles and reduced the passive support of the H-pile wall on the downslope side. The movement recorded in SI12-01 reflects the movement of the H-pile occurring as the passive support is reduced.

Instrument readings should include measurements and photographs of the length of the H-pile exposed on the downslope side of the H-pile wall to monitor ongoing slope movements and erosion downslope of the H-pile wall.

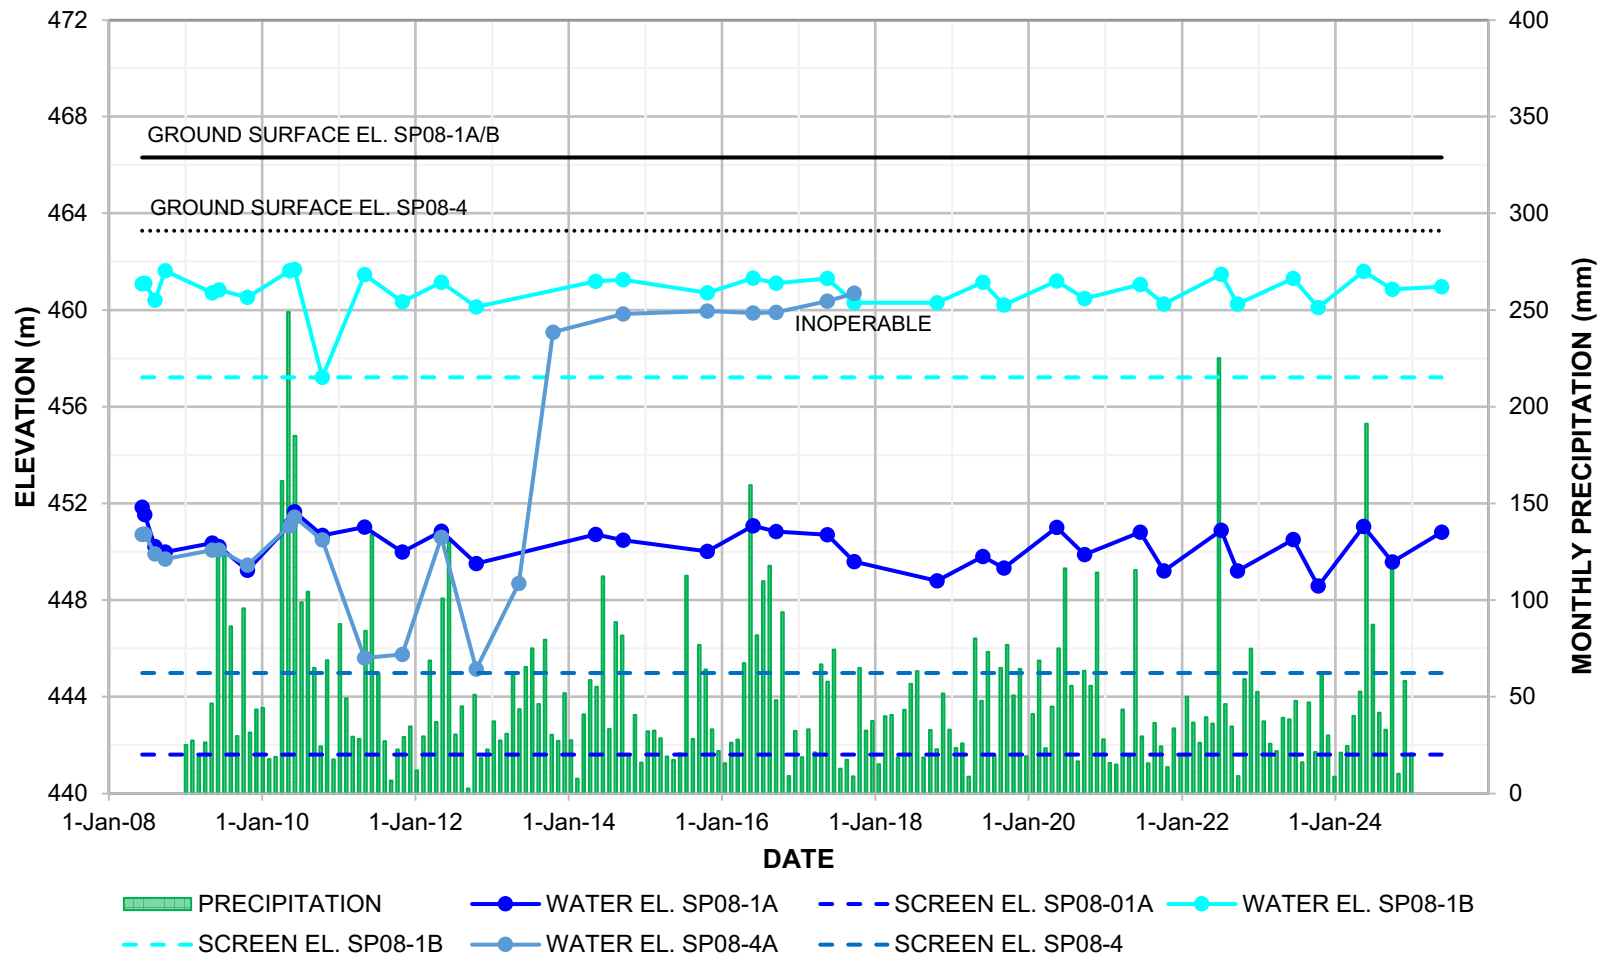
Piezometer Data
S026 - Elkwater Slide Area A
Hwy 41:03, km 35.169

Water levels recorded in SP08-01A and SP08-01B appear to fluctuate seasonally (with the spring readings being higher than fall readings) from an approximate depth of 14.4 m to 17.5 m below ground surface and 4.5 m to 6.1 m below ground surface, respectively. The May 2025 readings were consistent with historical trends observed in these instruments, with decreases of 1.2 m and 0.1 m recorded in SP08-01A and SP-01B, respectively. The spring 2024 report noted the water levels recorded were the highest recorded since installation, which based on the precipitation data, corresponds with a large amount of precipitation (191 mm) in May 2024. The water levels have since returned to normal.

- A data logger could be installed in one or more of the SPs to assess for short-term fluctuations (e.g., increases and decreases) in groundwater level that could be occurring in response to periods of heavy or prolonged rainfall or freshet infiltration between readings.
- A geotechnical site investigation (drilling and instrument installations) to assess the depth of movement in recently active slide areas to support repair design. Two additional SIs should be installed in Area B, one upslope of the H-pile wall near its south end and one adjacent to the highway north of the H-pile wall, to monitor for movement.
