SITE NUMBER AND NAME: <b>S042-1 Spray Lakes Rockfall Barrier</b>		HIGHWAY & KM: 25291:02, 30.434	PREVIOUS INSPECTION DATE: May 27, 2024	INSPECTION DATE: <b>May 26, 2025</b>
LEGAL DESCRIPTION: SW-25-024-11 M5	NAD 83 COORDINATES: UTM    Northing    Easting 11       5658604    611006		RISK ASSESSMENT: 2013 Rockfall event: PF: 7   CF: 7   TOTAL: 49 Rockfall: PF: 13   CF: 5   TOTAL: 65	
AVERAGE ANNUAL DAILY TRAFFIC (AADT): 980 (west) & 1840 (east) (Reference No. 70000698)			CONTRACTOR MAINTENANCE AREA (CMA): 28

SOUTHERN REGION GEOHAZARD RISK MANAGEMENT PROGRAM

Site Plan  
 S042 - Spray Lakes Rockfall Barrier  
 Hwy 25291:02, km 30.434

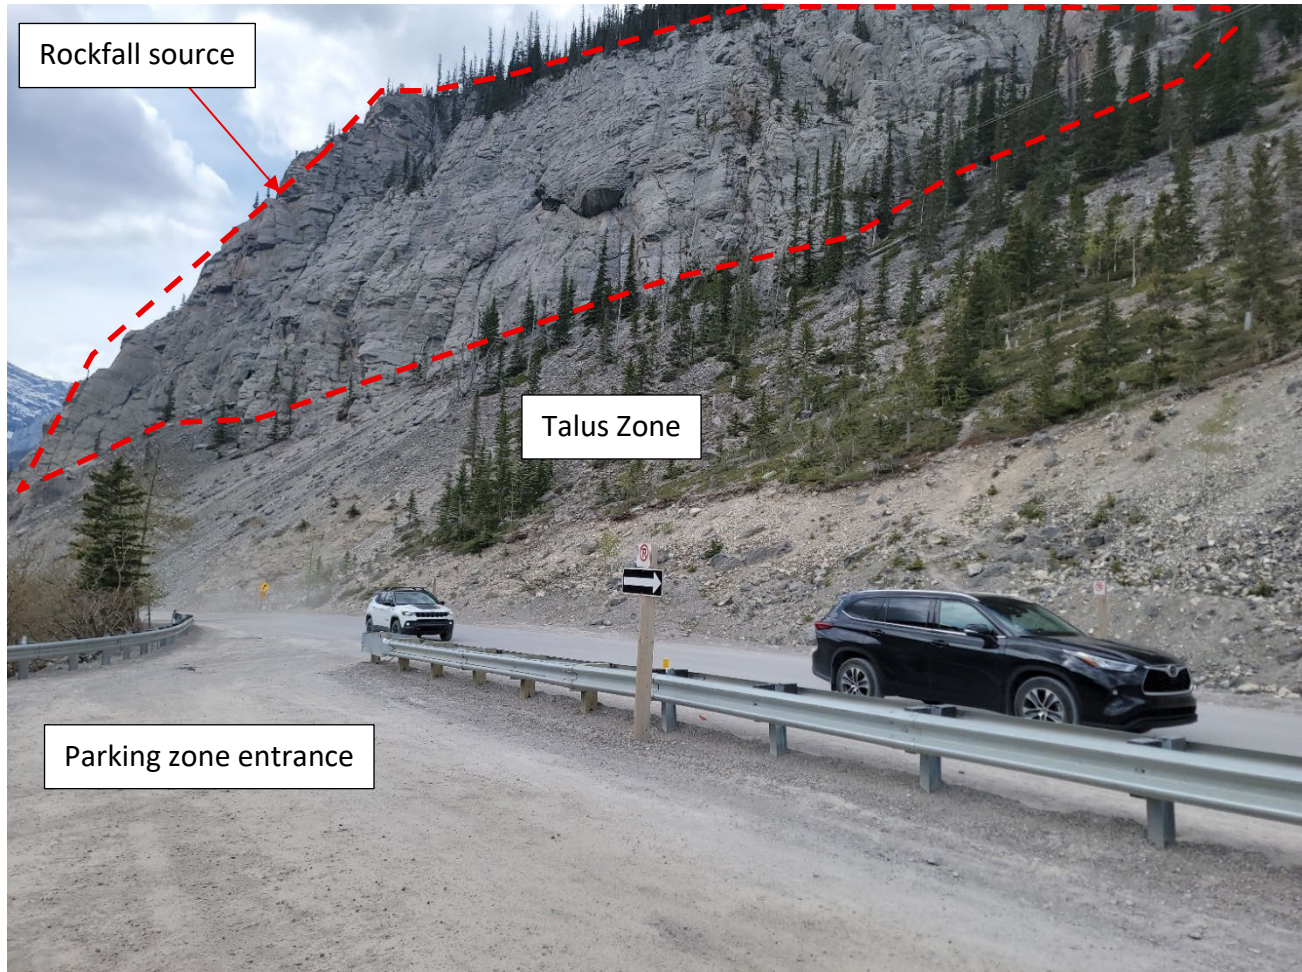
**Photo 1** Source area for rockfall, talus deposit, and entrance to parking zone, on the north side of the site. Photo taken May 26, 2025, facing southwest.

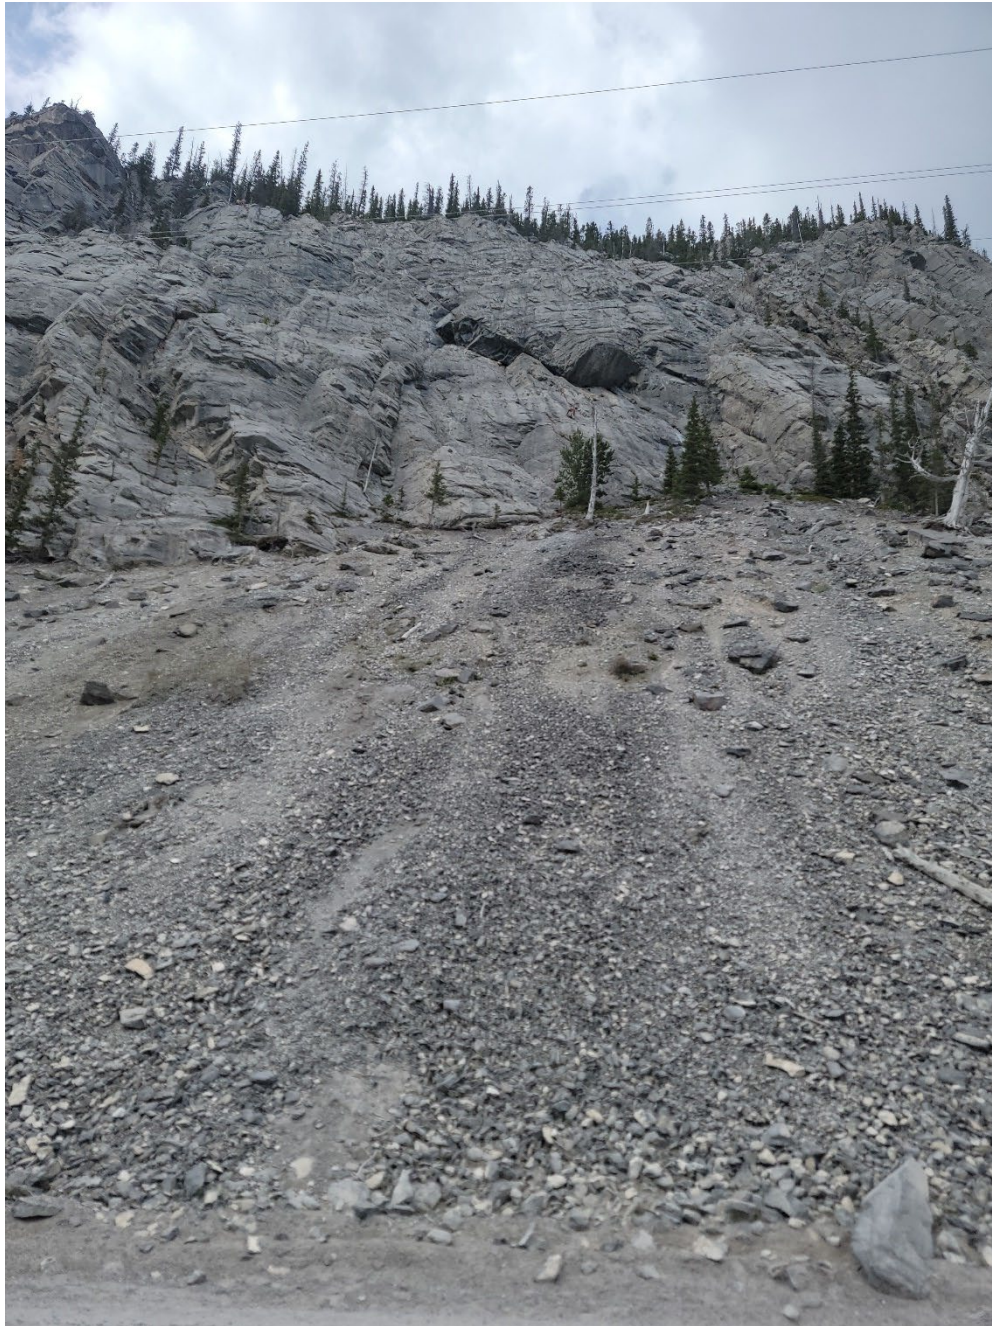
**Photo 2**      **Rock slope and talus deposit up to the toe of the slope on the north side of the site.**  
**Photo taken May 26, 2025, facing west.**

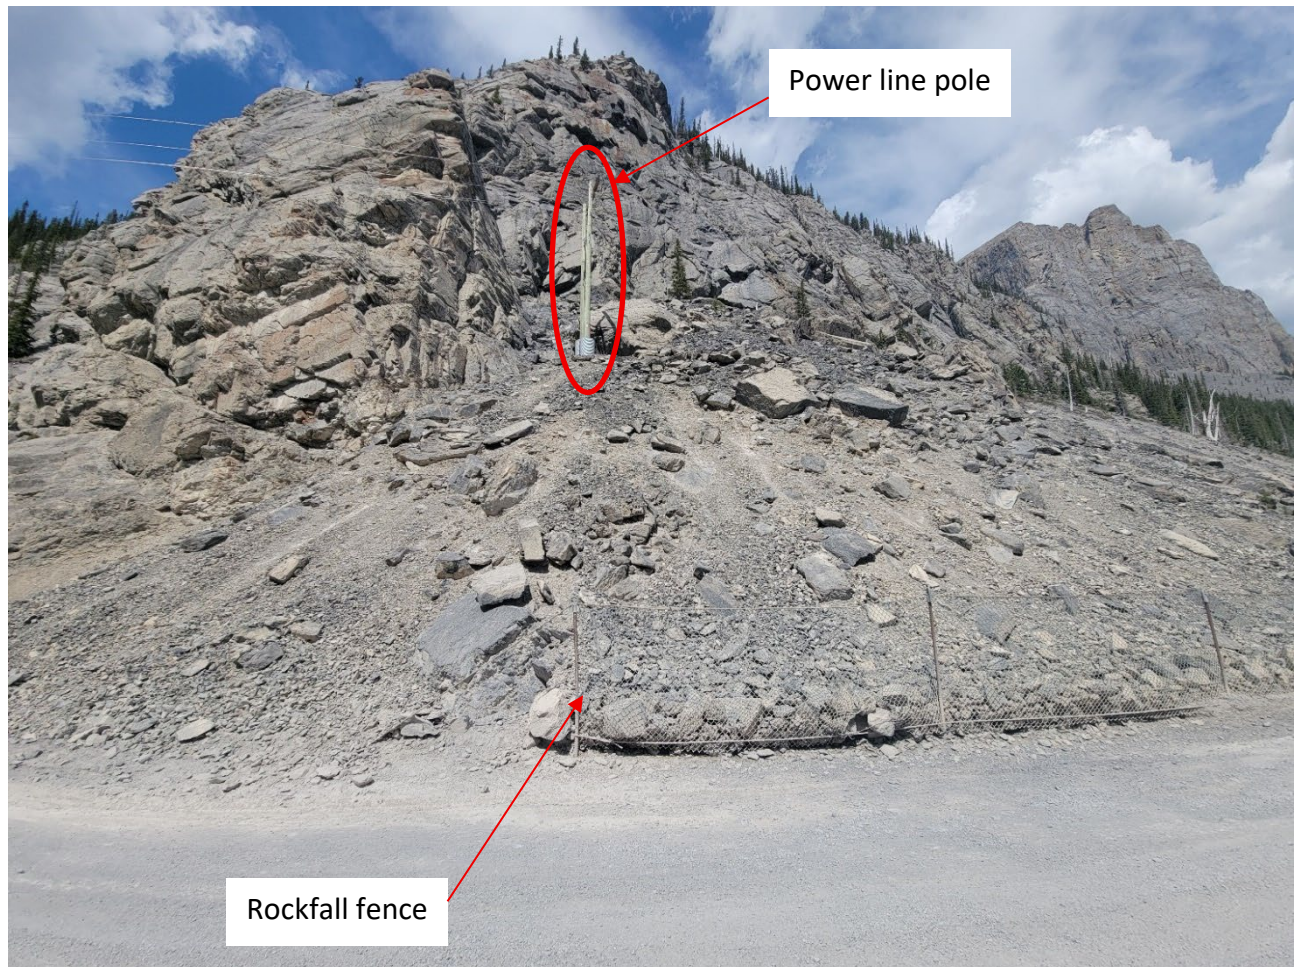
**Photo 3**      **Rock slope, overhead power line, and rock block accumulation on the rockfall fence at the edge of the highway. Photo taken May 26, 2025, facing west.**

- Continue to monitor the site and clean out rockfall accumulated behind rockfall fence to maintain storage capacity for future rockfalls.
- Additional road signage is recommended to warn road users of risk of fallen rocks on highway.
- Continue annual survey and update of change detection analysis to monitor potential changes in slope performance and inform existing estimates of annual failure volumes and relative frequency of rockfall events. A LiDAR/radar survey should continue to be done every 1-2 years (as part of the KCB-TEC-U of A research project) to monitor the location and frequency of rockfalls, as well as any potential continued

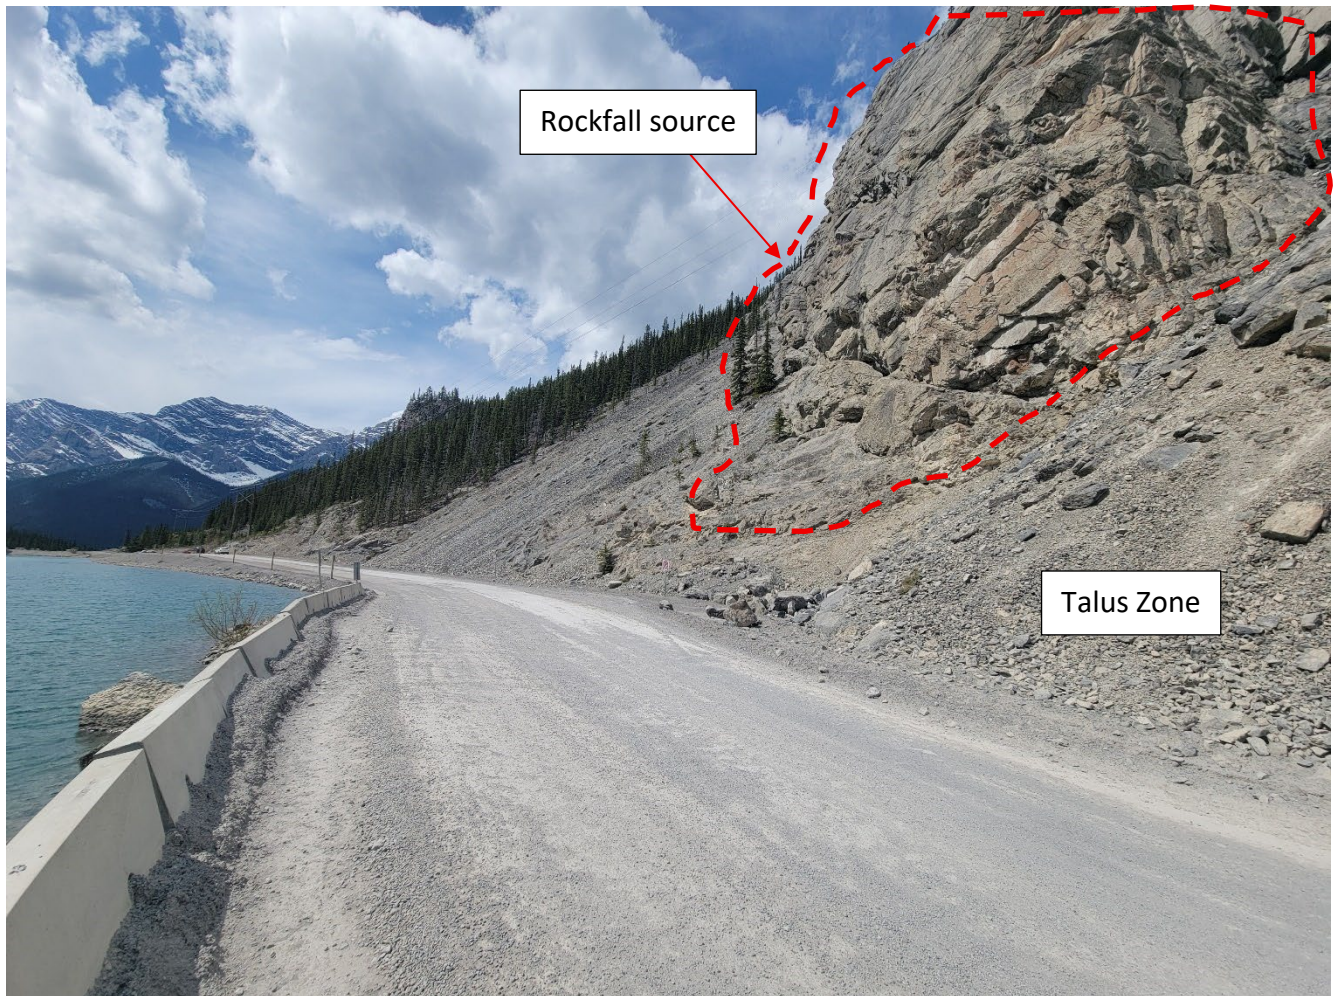
**Photo 4**      **Source area for rockfall and talus deposit on the south side of the site. Photo taken May 26, 2025, facing south.**

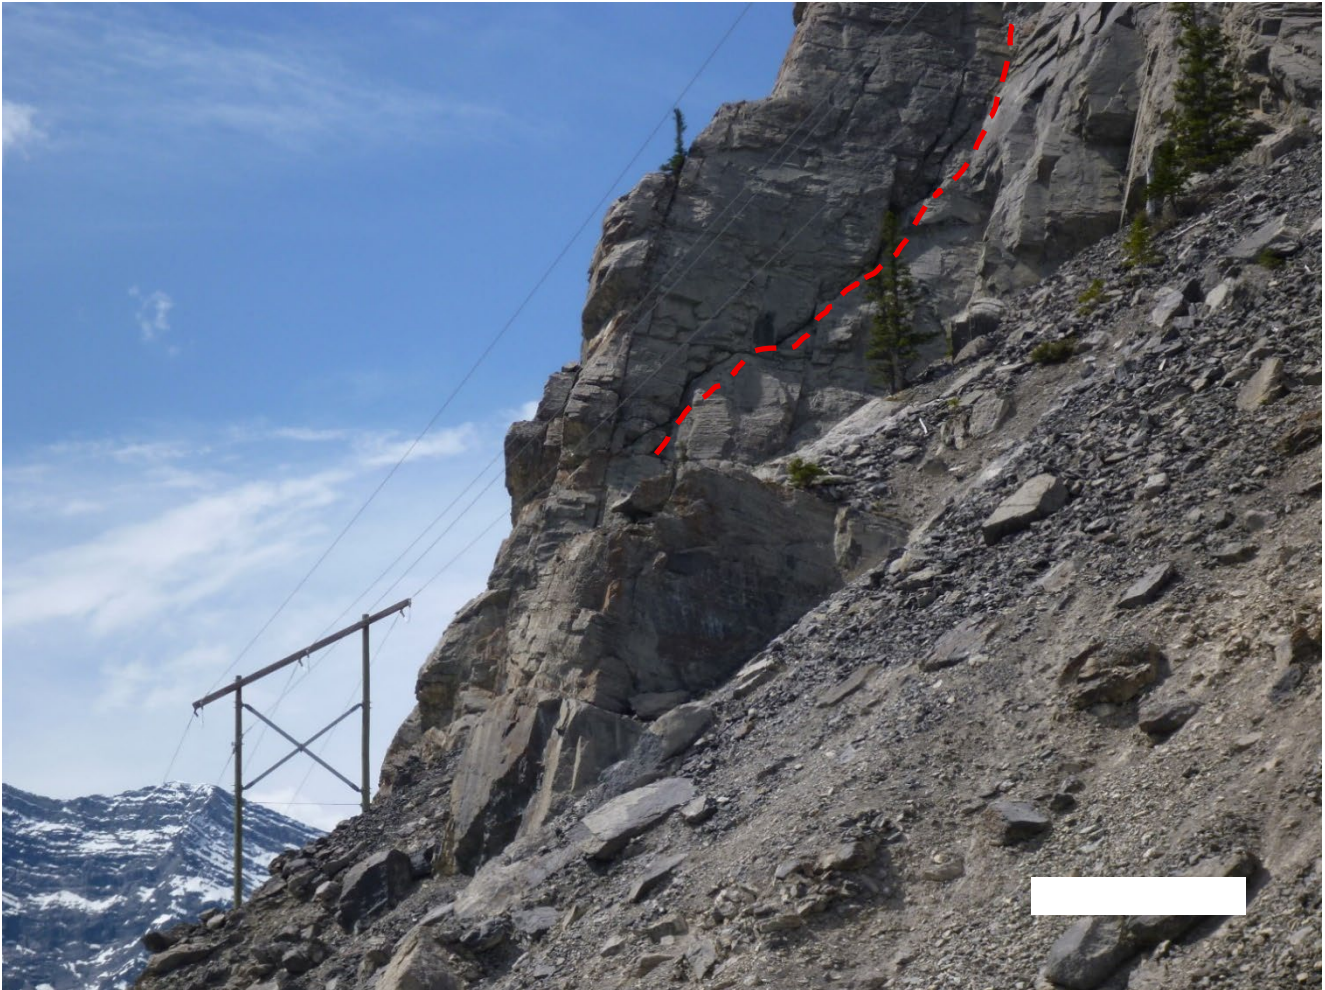
Previous site inspections have identified the presence of pre-sheared jointed sets near the south side of the site (Photo 5).

**Photo 5**      **Pre-sheared joint set (red dashed line) located between the north and south side of the site. Photo taken May 26, 2025, facing south.**
