<b>SITE NUMBER AND NAME</b> <b>S051 Pekisko Bank Erosion</b>	<b>HIGHWAY &amp; KM</b> 540:02, 4.624	<b>PREVIOUS INSPECTION DATE</b> May 28, 2024	<b>INSPECTION DATE</b> <b>May 27, 2025</b>
<b>LEGAL DESCRIPTION</b> 08-14-17-02 W5M	<b>NAD 83 COORDINATES</b> UTM    Northing    Easting 11       5590158    701158	<b>RISK ASSESSMENT</b> PF: 10    CF: 10    TOTAL: 100	
<b>AVERAGE ANNUAL DAILY TRAFFIC (AADT):</b> 780 (east) (Ref. No. 71130)		<b>CONTRACTOR MAINTENANCE AREA (CMA):</b> 521

<b>PRIMARY SITE ISSUE:</b> Bank erosion on the outside of a bend along a reach of Stimson Creek. The head scarp has encroached onto highway right-of-way and undermined the north (westbound) highway ditch. Flows from the ditch are being conveyed over the slope, exacerbating erosion.
<b>APPROXIMATE DIMENSIONS:</b> The site is approximately 100 m long. The length of the fence that is undermined is approximately 25 m. The erosion scarp is approximately 5 m away from the edge of the highway.
<b>DATE OF ANY REMEDIAL ACTION:</b> There have been no repairs to the slope. However, tarps have been installed by KCB along the left (south) bank of Stimson Creek as part of bank swallow mitigation measures ahead of summer 2

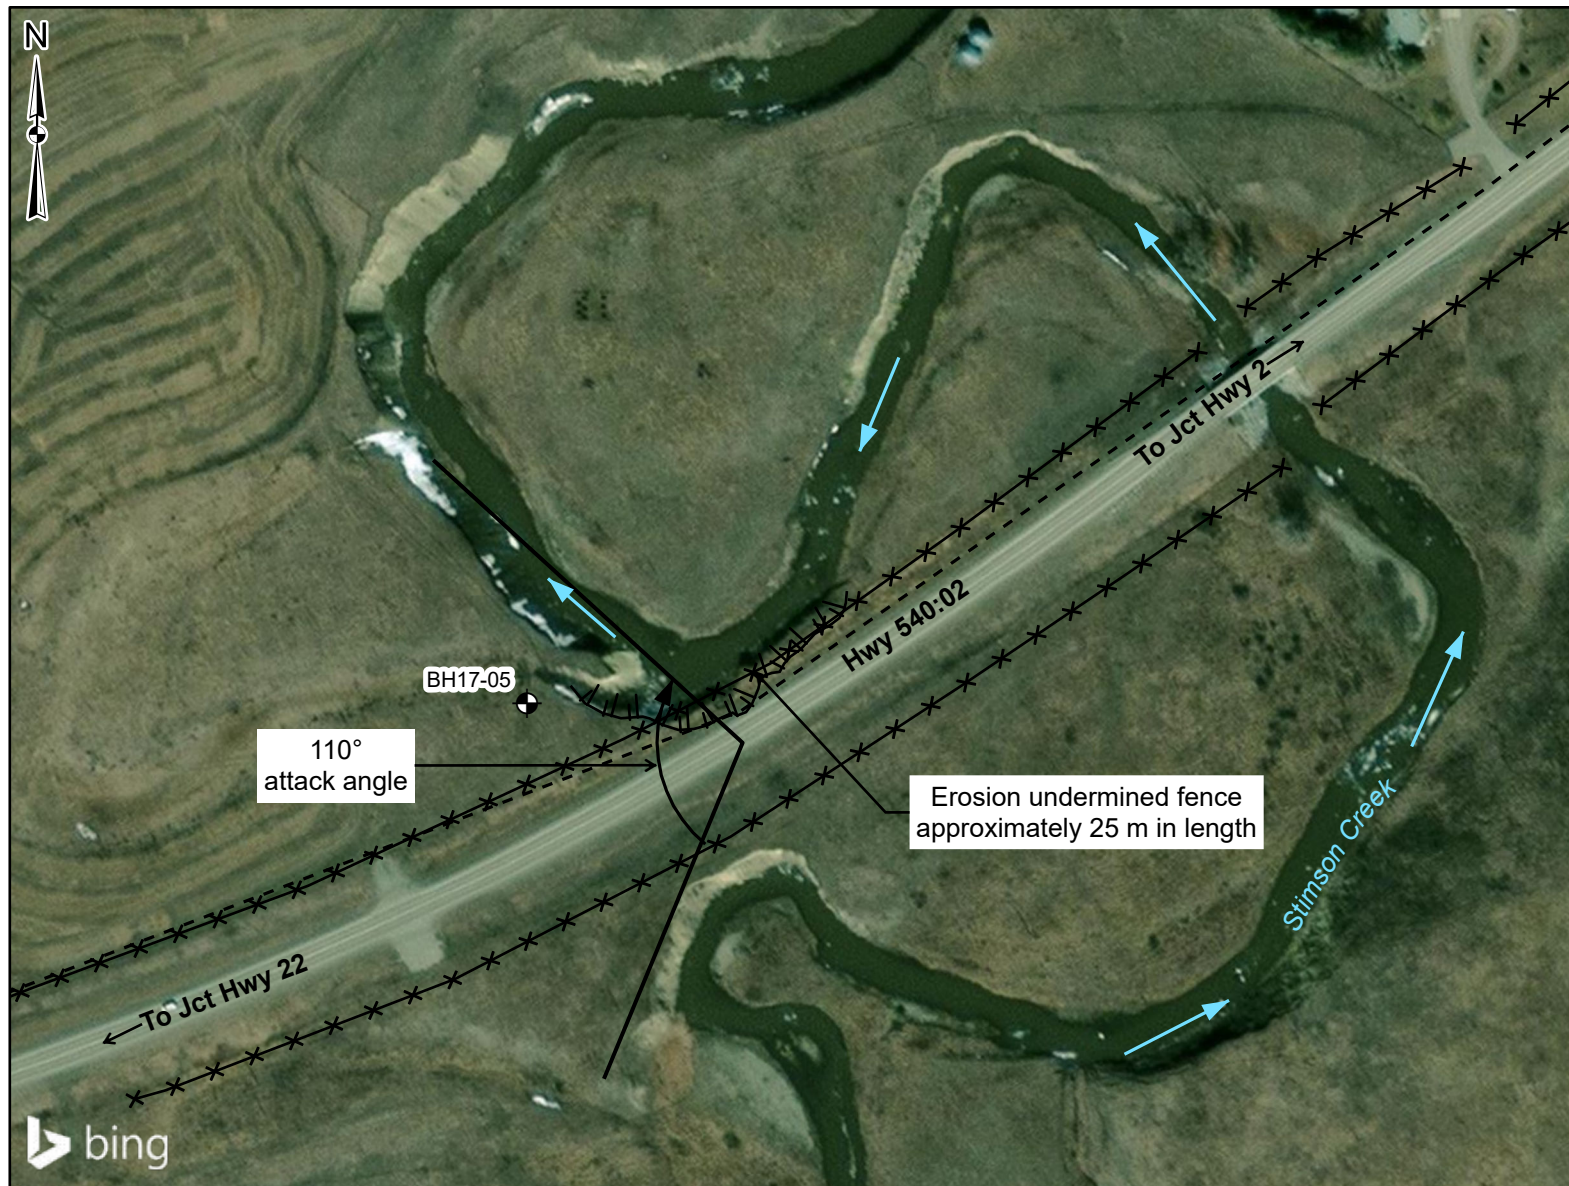
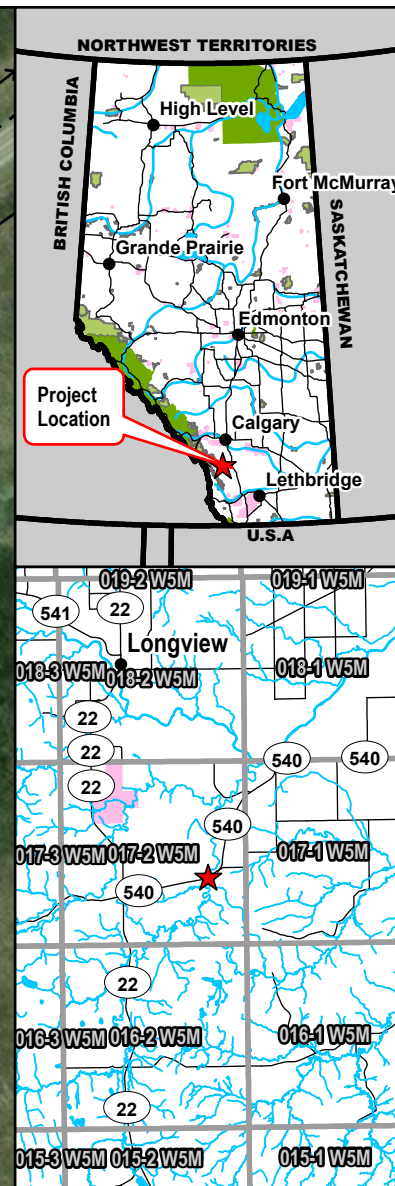
FIG No. 1

Site Plan  
S051 - Pekisko Bank Erosion  
Hwy 540:02, km 4.591

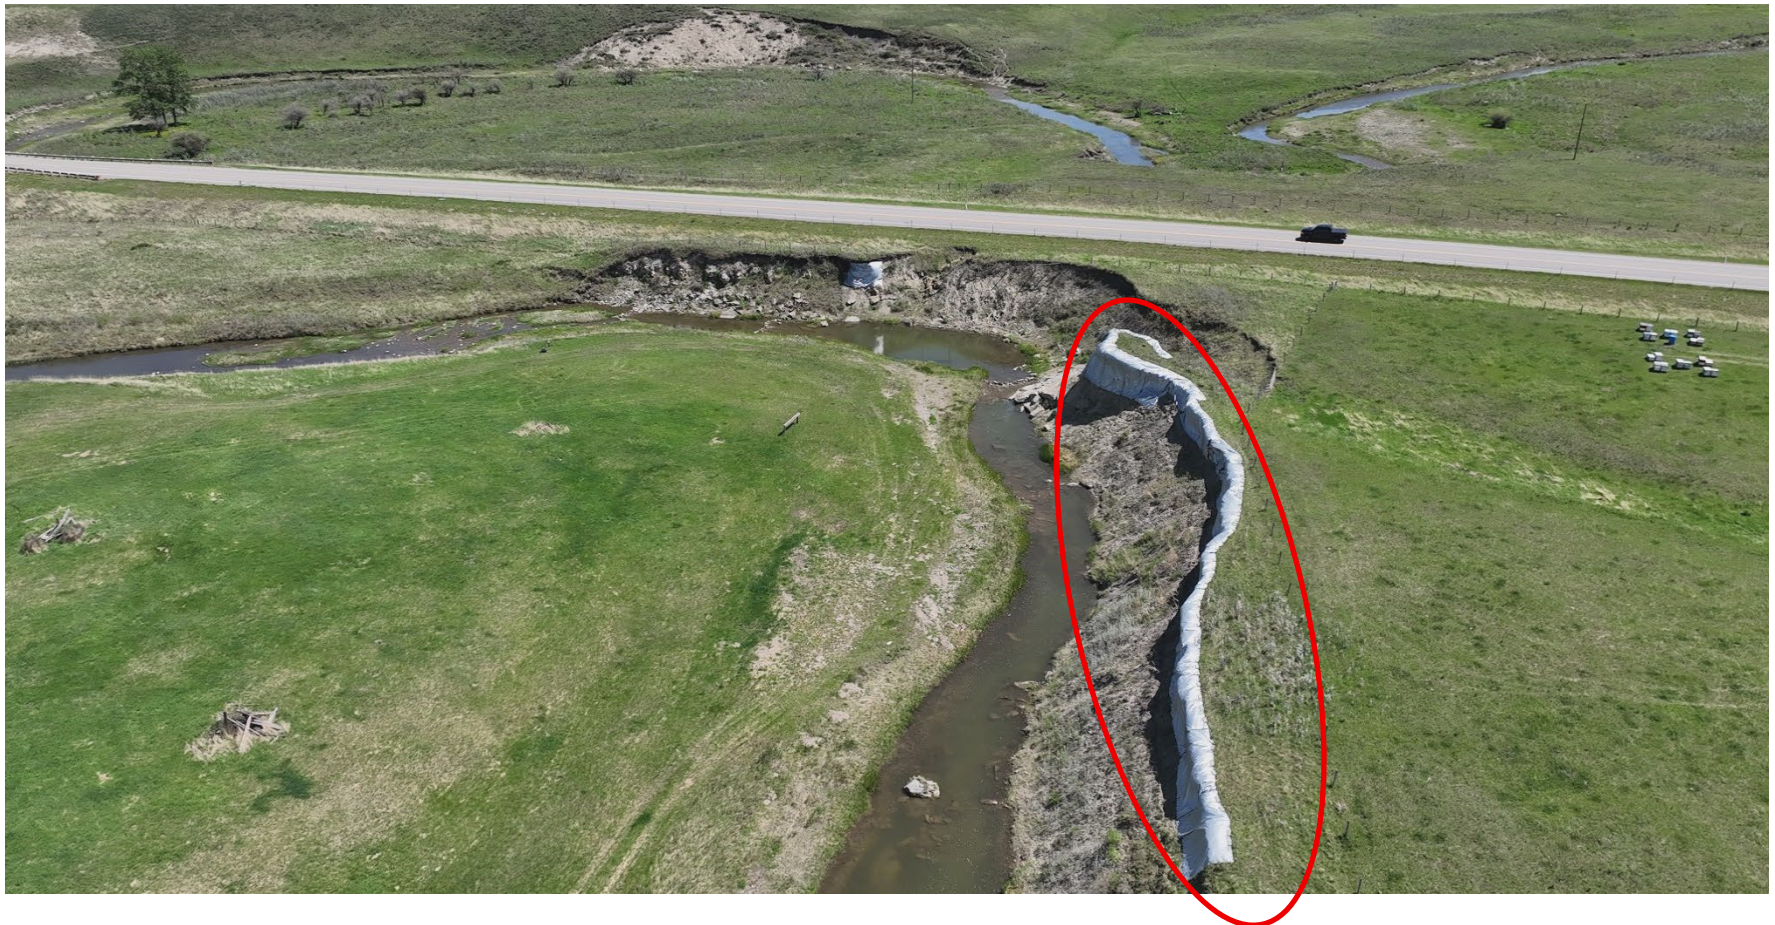
- The site is along the south (left) shoreline of Stimson Creek (Photos 1 and 2). The angle of attack for Stimson Creek is 110°.
- The erosion is impacting the north (westbound) ditch (Photos 3 and 5), within approximately 5 m of the high-tension cable barrier (HTCB), has undermined the barbed wire fence along the site (Photo 3), and has exposed a black telecommunications cable that is owned by TELUS (Photo 5).

- A tension crack was observed near the western extent of the site.
- In spring 2025, tarps were installed by KCB at the crest of the slope (Photos 1, 2, and 6) to reduce the likelihood of bank swallows nesting ahead of construction (planned for late-summer/early-fall 2025). The tarps appear to be in good condition, and no swallows were observed where the tarps were installed. Many swallows were observed further north along the shoreline, outside of the construction footprint and required an offset.

**Photo 1** Aerial photo of the site highlighting Stimson Creek, erosion and slope instability, and tarps (red line) installed as part of bank swallow mitigation measures. Photo taken May 27, 2025, facing southeast.

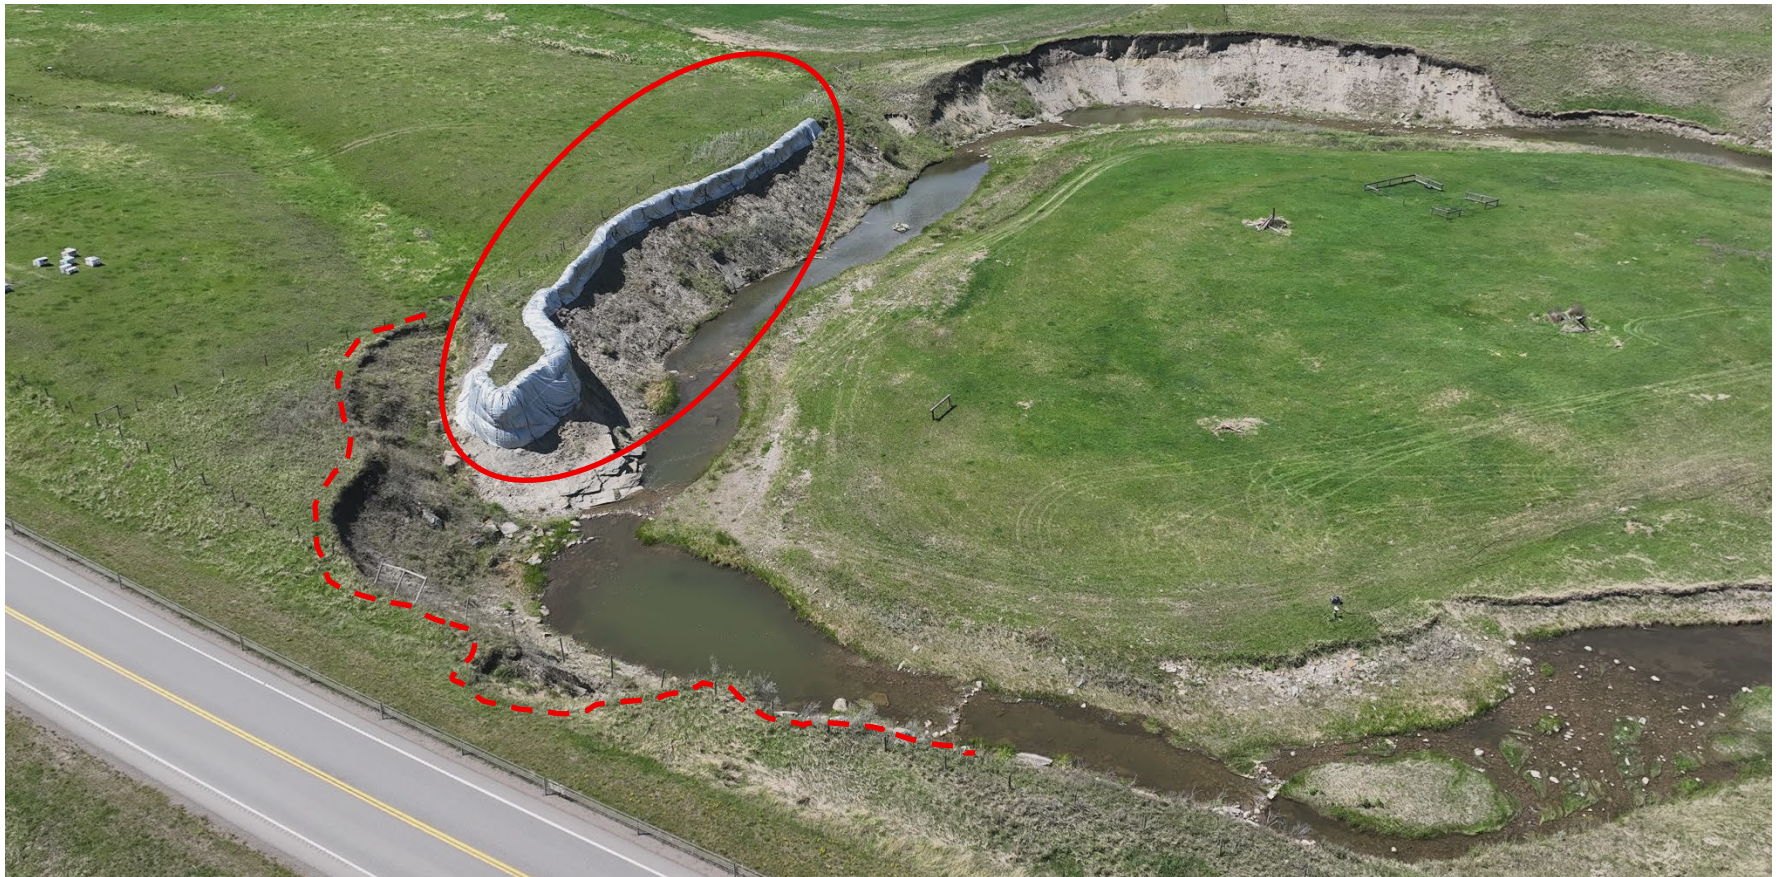
**Photo 2** Aerial photo of the site highlighting Stimson Creek, erosion and slope instability (red dashed line), and tarps (red line) installed as part of bank swallow mitigation measures. Photo taken May 27, 2025, facing northwest.

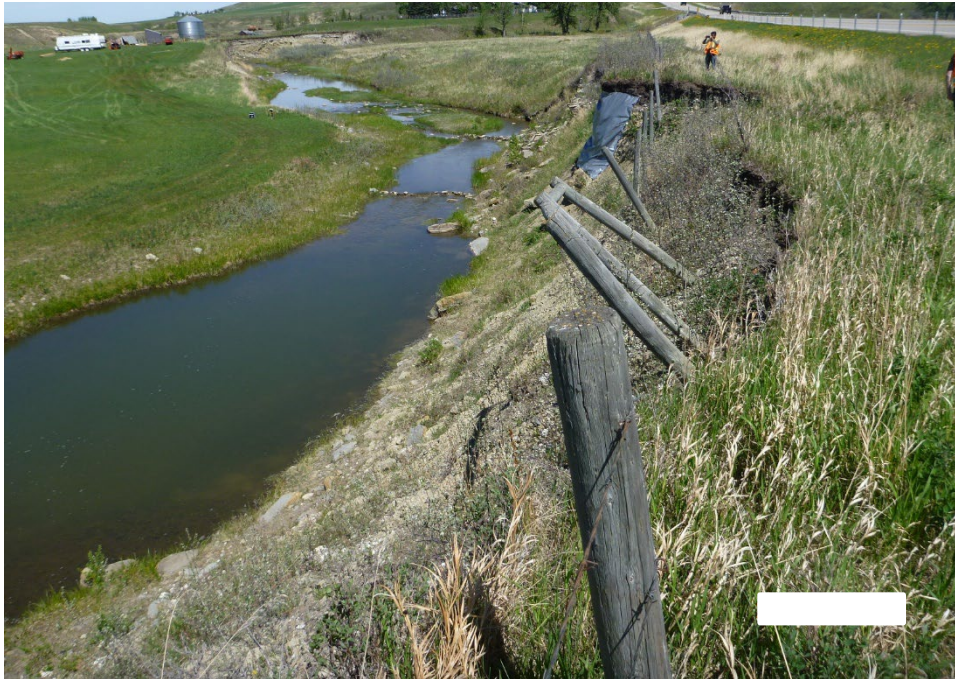
- During the 2025 inspection, eight fence posts were undermined and are hanging (Photos 3 and 4). The length of the fence that is undermined is approximately 25 m.

**Photo 3** Erosion and hanging barbed wire fence along the site. Photo taken May 27, 2025, facing east.

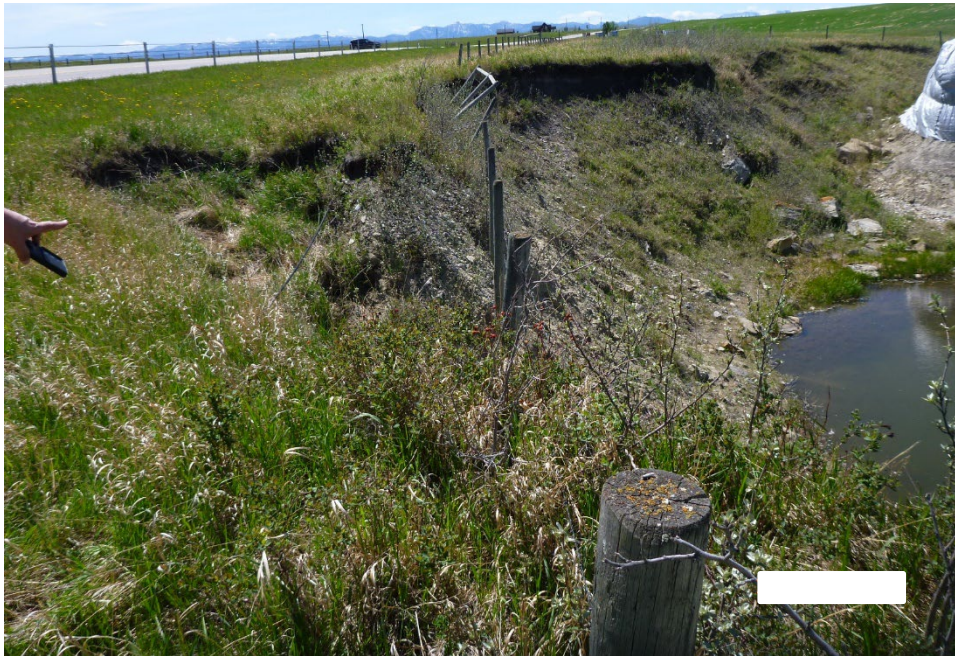
- Flow from the ditch is being redirected into the failure zone, exacerbating erosion (Photo 4). Between the 2024 and 2025 inspections, no significant changes to the erosion feature were observed.

**Photo 4** Erosion and hanging barbed wire fence along the site. Photo taken May 27, 2025, facing west.

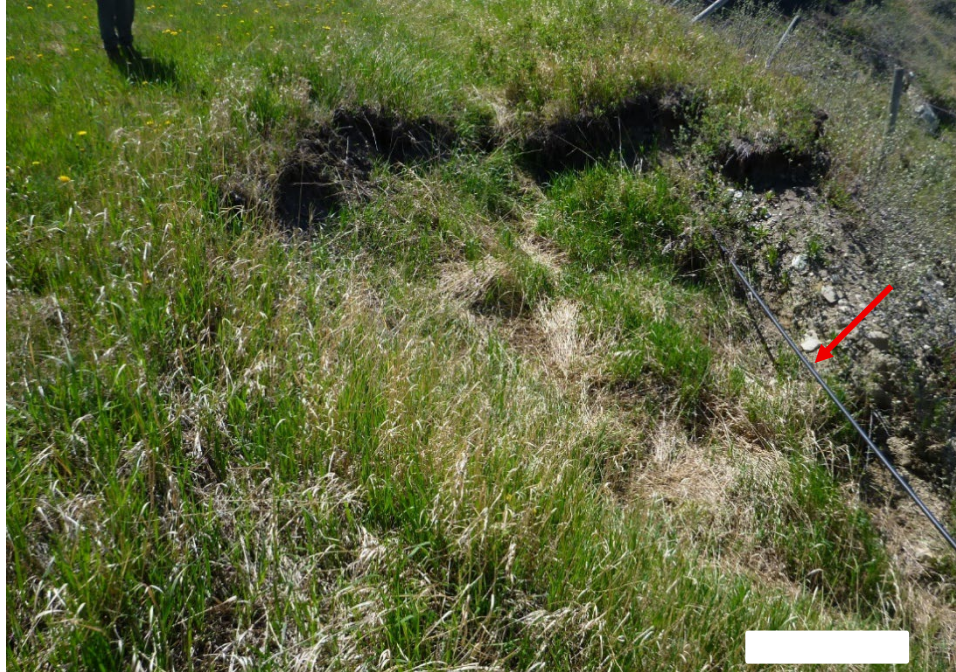
**Photo 5** Erosion undermining the north (westbound) ditch and has exposed a black telecommunication line (indicated by red arrow) owned by TELUS. Photo taken May 27, 2025, facing west.

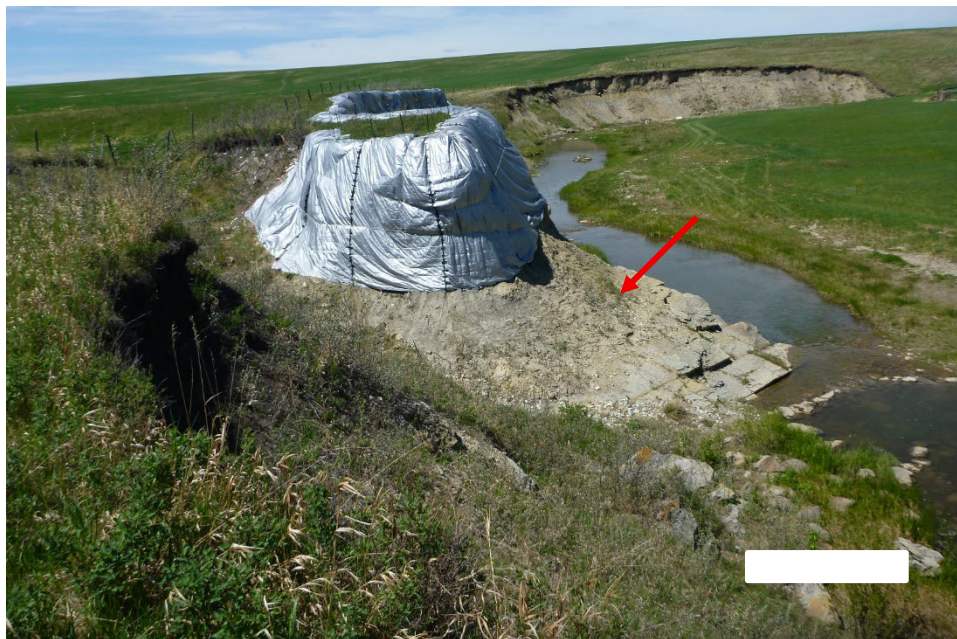
- There are bedrock outcrops along the toe of the slope along the left bank of Stimson Creek. The exposed bedrock appears to be fractured and highly weathered (Photo 6).

**Photo 6** Tarps installed by KCB as part of the ongoing bank swallow mitigation measures. Bedrock outcrop at the toe of the slope indicated by red arrow. Photo taken May 27, 2025, facing northwest.
