| SITE NUMBER AND NAME S075 Pekisko Creek Slides | HIGHWAY & KM 540:02, 5.772 | PREVIOUS INSPECTION DATE May 9, 2023 | INSPECTION DATE May 27, 2025 |

SOUTHERN REGION GEOHAZARD RISK MANAGEMENT PROGRAM

Site Plan
S075 - Pekisko Creek Slides
Hwy 540:02, km 5.72

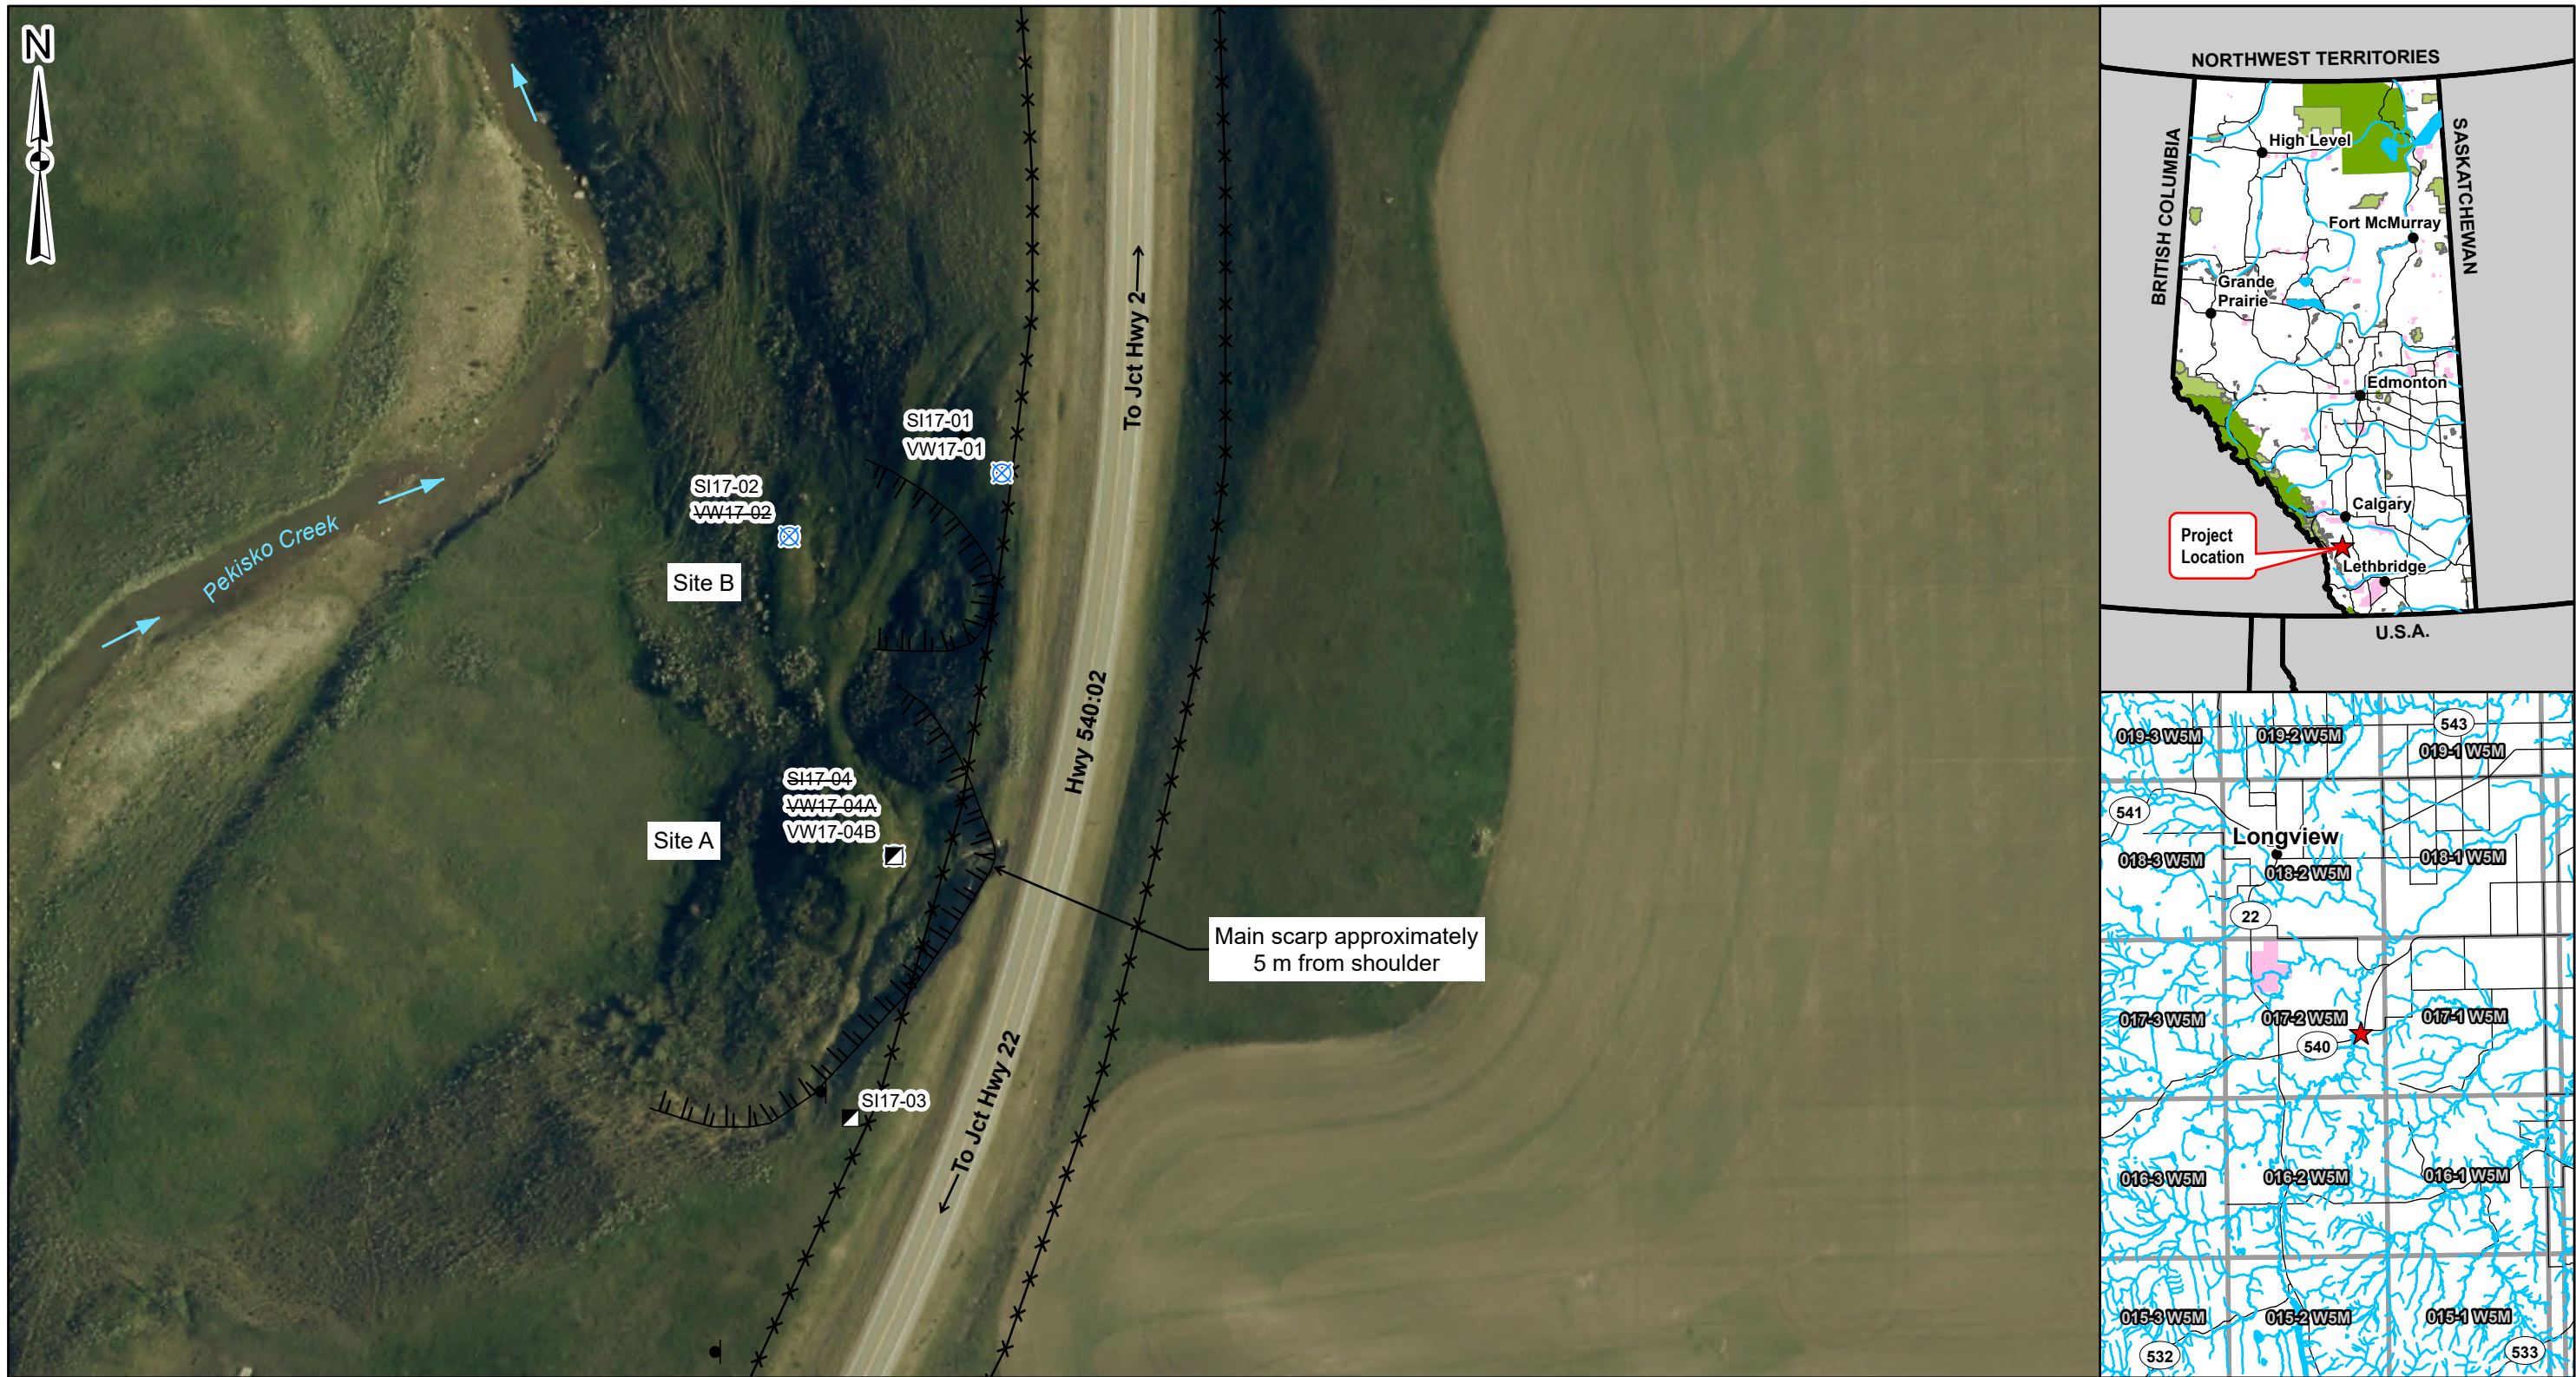
FIG No. 1

| PRIMARY SITE ISSUE: Site A & B are two slides located approximately 30 m apart along the left (south) valley slope of Stimson Creek. The slope is relatively steep, and sliding is likely caused by elevated groundwater during precipitation events, further accelerated by surface water flow from the ditch. The head scarp at Site A has encroached onto the highway right-of-way and has undermined the highway ditch, re-directing ditch flows onto the failed slope. The head scarp of Site B is outside of the fence and is not impacting the highway ditch. |
| APPROXIMATE DIMENSIONS: Site A has undermined approximately 30 m of fence line, with a total length of the slide being approximately 100 m, and the head scarp is located approximately 6.5 m from the edge of the west (southbound) lane. Site B has a width of approximately 20 m, and the head scarp is located 1.7 m from the fence line. |

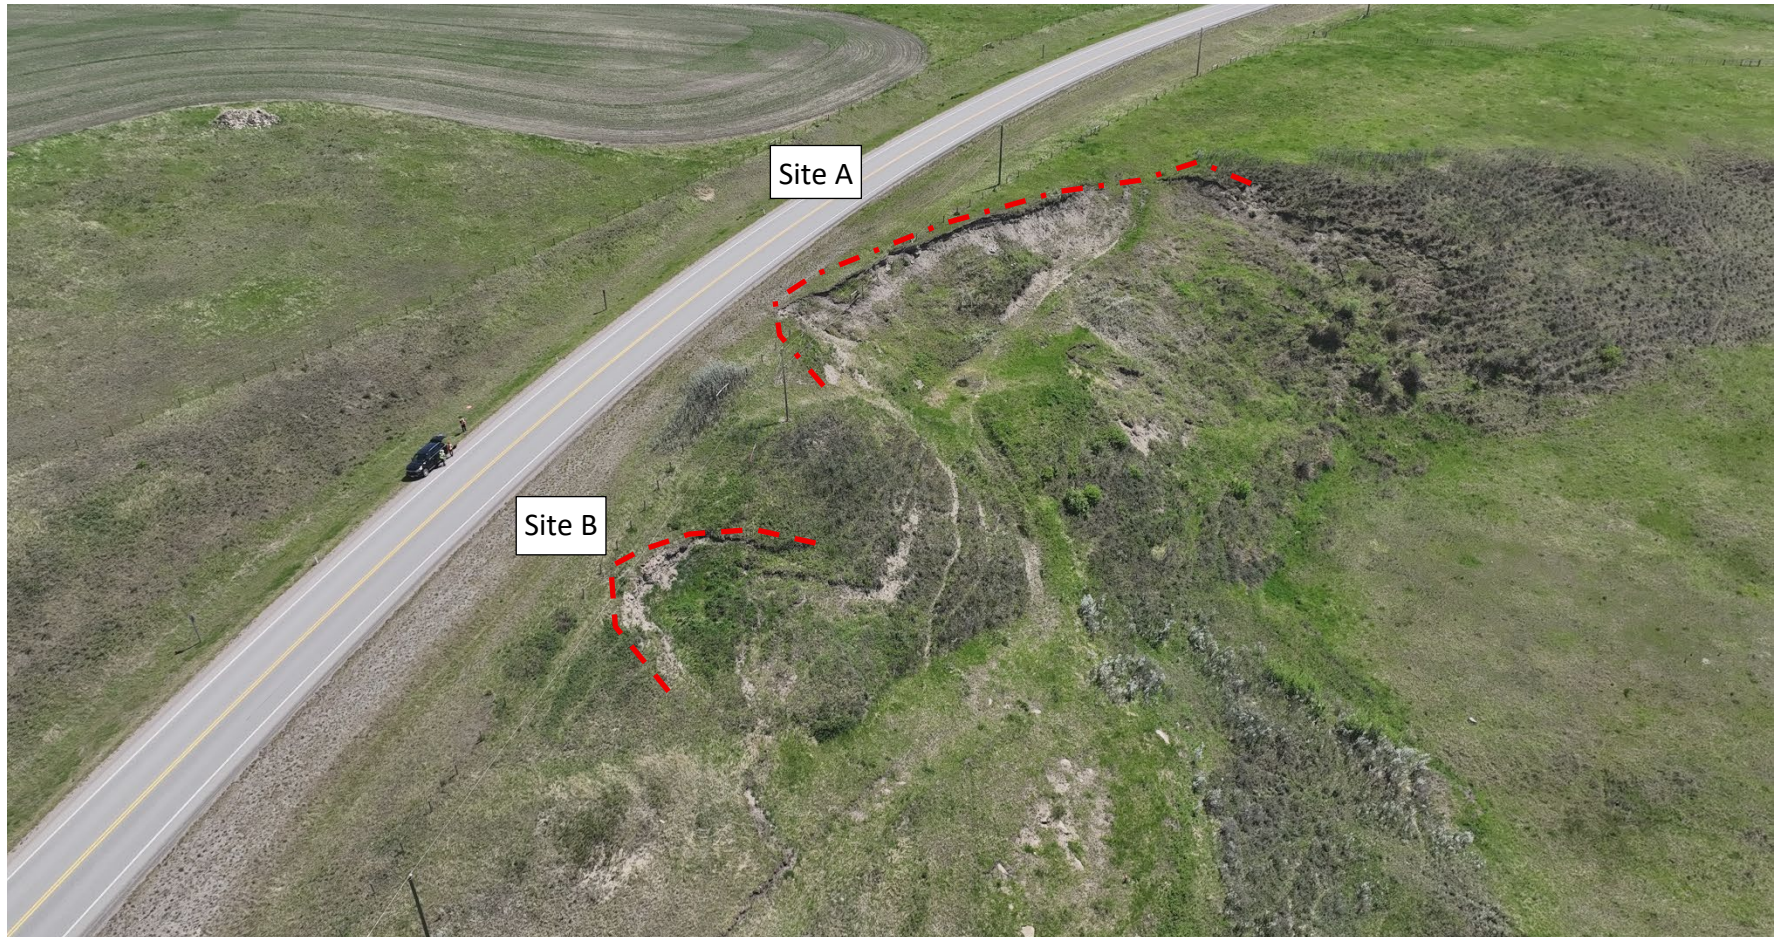
- The head scarp has retrogressed into the west (southbound) ditch, and the fence is undermined. The edge of the scarp is approximately 6 m to 7 m from the edge of the highway surface (Photo 1 and 2).

- No pavement distress was observed.
- In general, the west (southbound) highway ditch and slope are well vegetated. The head scarp has unvegetated areas that are susceptible to erosion during spring freshet and precipitation events (Photo 1).
- The ditch along the site is well defined and is not conveying surface water flow onto the slide.
- The slide is approximately 1.5 m west of the fence. The head scarp does not appear to have retrogressed between the 2024 and 2025 inspections (Photo 5).

Photo 1 Aerial photo of the S075 site, showing both the Site A and Site B slides. Photo taken May 27, 2025, facing southeast.

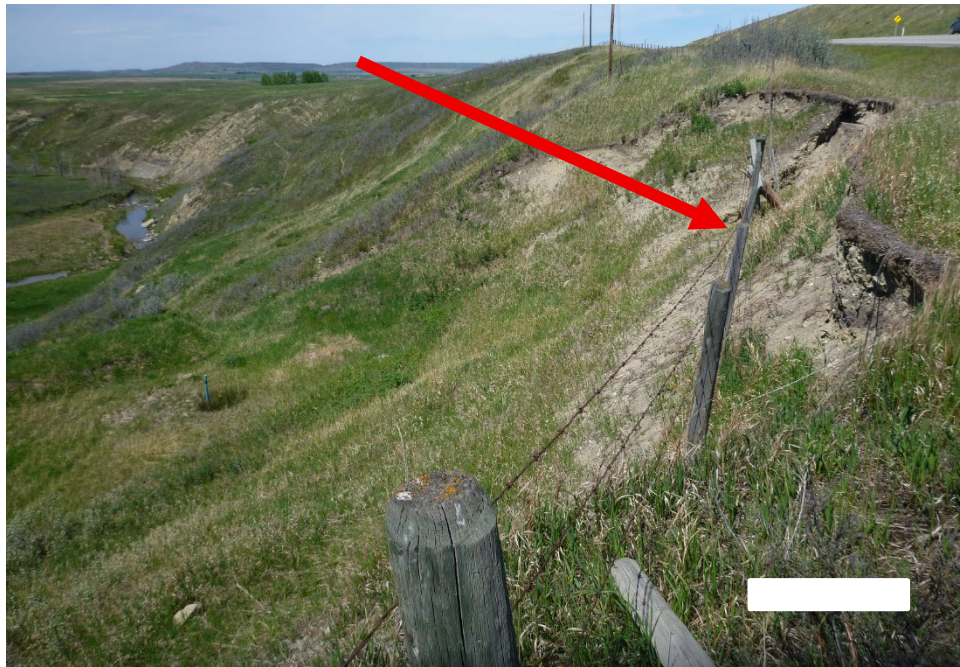
- Eight fence posts were observed to be hanging during the 2025 inspection (Photo 2). The landowner installed a rope fence below the hanging fence (likely to contain livestock).

- Flow from the west (southbound) ditch is being conveyed into the slide area (Photo 2 and 3). The slope appears saturated with visible seepage observed on the slope surface during previous inspections.

Photo 2 Head scarp and hanging fence (red arrow) at Site A. Photo taken May 27, 2025, facing north.

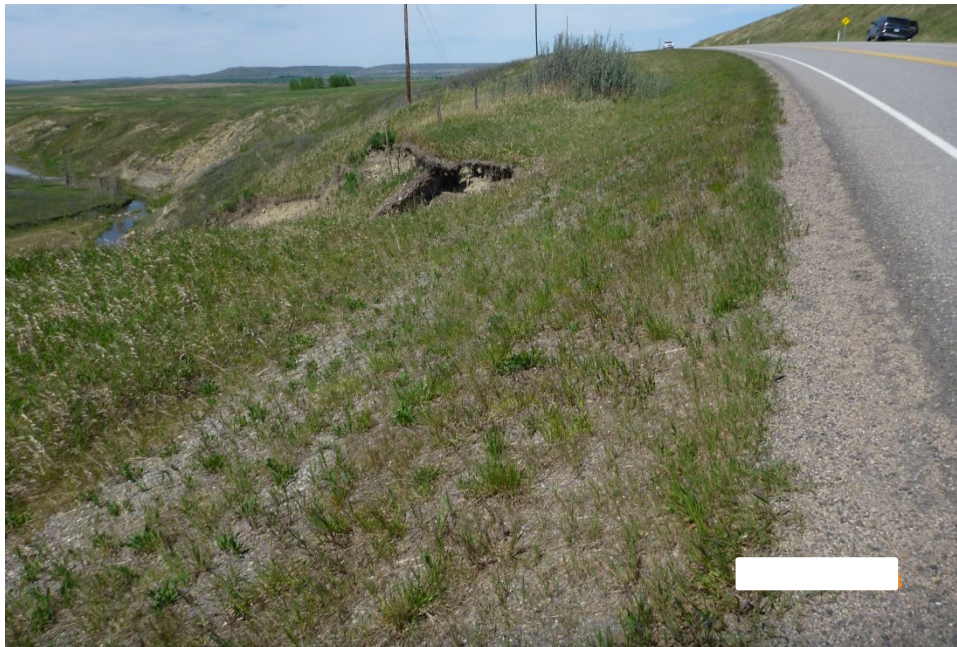
Photo 3 The ditch is well vegetated along Site A. The erosion of the head scarp near the north extent of the site is retrogressing towards the ditch/highway surface. Photo taken May 27, 2025, facing north.

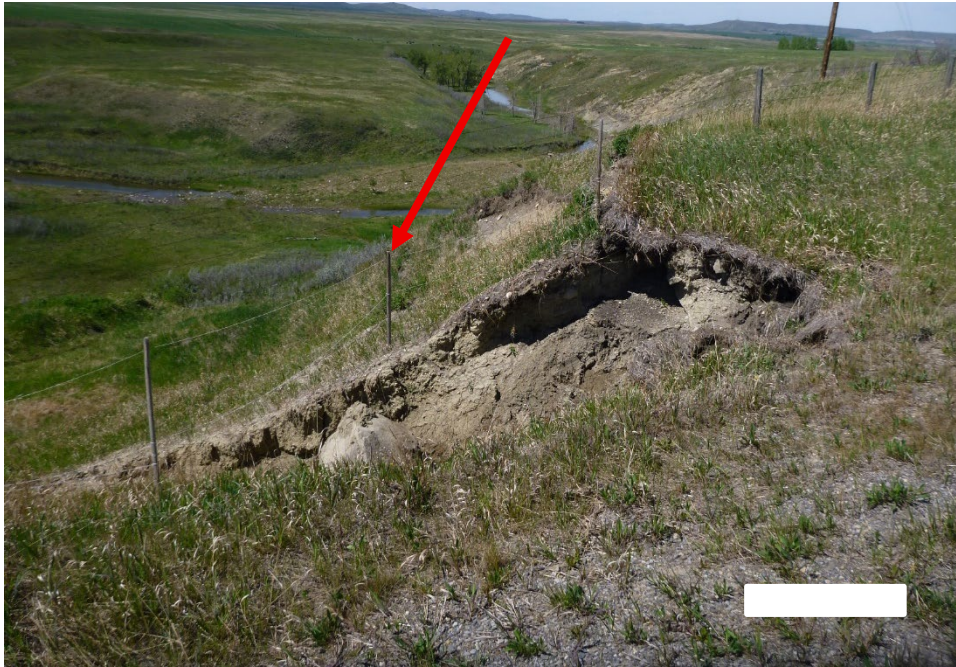
- A boulder, dislodged from near the head scarp on the north extent of the backslope due to erosion, was observed on the slide surface during the 2025 inspection (Photo 4).

Photo 4 Erosion of the head scarp and hanging fence (red arrow) near the north extent of Site A. Photo taken May 27, 2025, facing north.

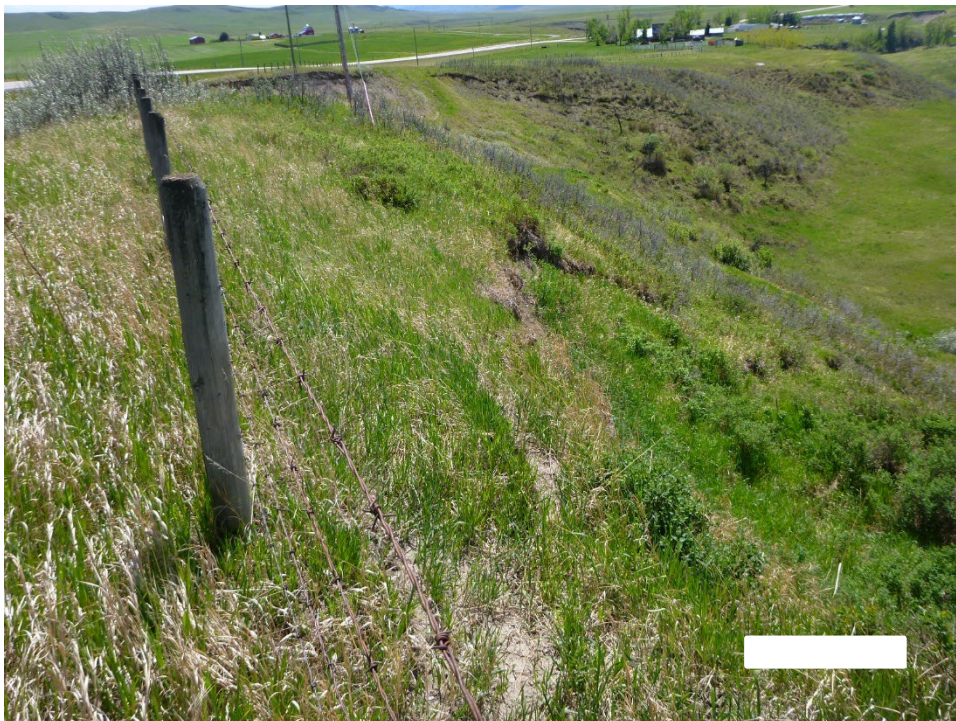
Photo 5 The slide at Site B is well vegetated and no deformation of the fence was observed. Photo taken May 27, 2025, facing south.
