SITE NUMBER AND NAME: S020 Highwood House Rockfall Hazard		HIGHWAY & KM: 541:02, 0.817	PREVIOUS INSPECTION DATE: July 9, 2021	INSPECTION DATE: May 9, 2023
LEGAL DESCRIPTION: 04-33-016-05 W5M	NAD 83 COORDINATES: UTM Northing Easting 11 5584038 667795		RISK ASSESMENT: PF: 14 CF: 5 TOTAL: 70	
AVERAGE ANNUAL DAILY TRAFFIC (AADT): 260 (west), 240 (east), (Ref. No. 59130)			CONTRACTOR MAINTENANCE AREA (CMA): 27

PROJECT SOUTHERN REGION GEOHAZARD RISK MANAGEMENT PROGRAM		
TITLE Site Plan S020 - Highwood House Rockfall Hazard Hwy 541:02, km 0.817		
SCALE 1:1,500	PROJECT No. A05116A03	FIG No. 1

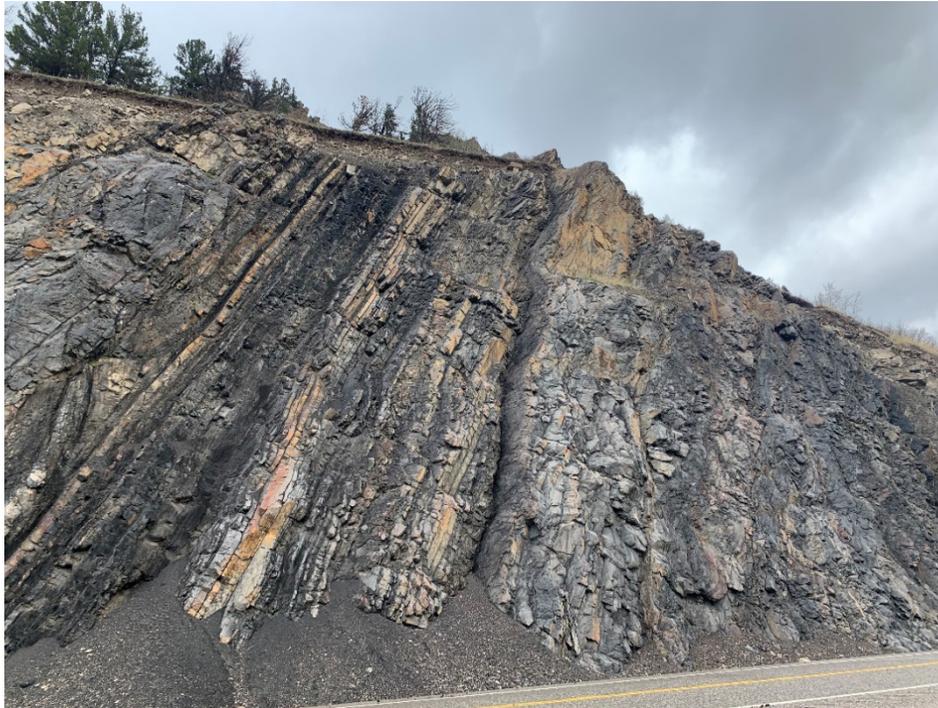
Photo 1 Rock slope has a maximum height of approximately 20 m, with continuous joints in an adverse orientation. Photo was taken facing north on May 9, 2023.

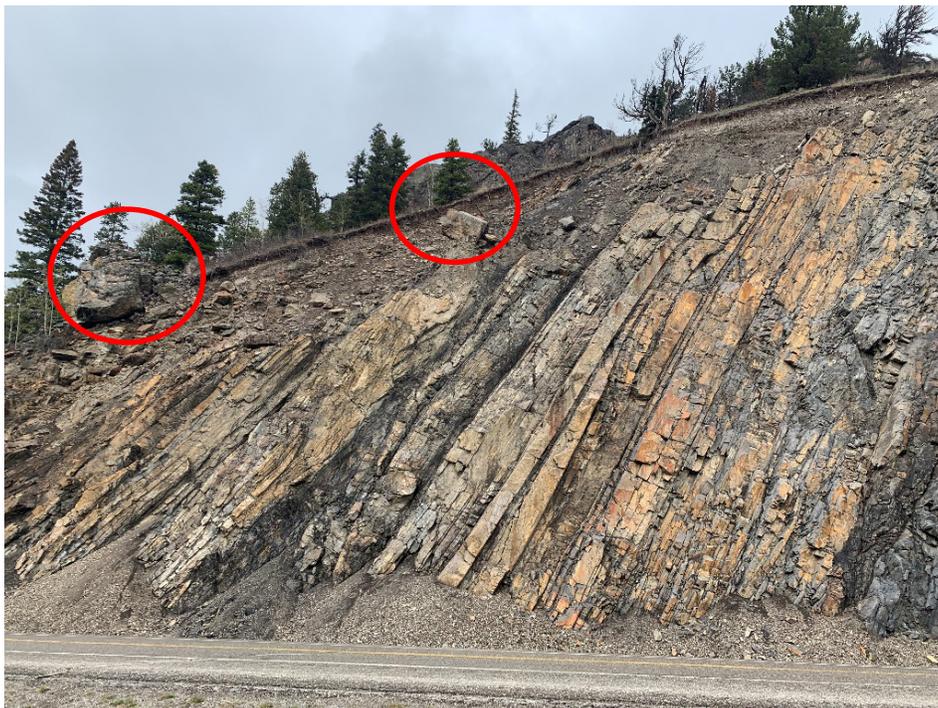
No significant change in extent of soil erosion at brow of hill since 2021 was observed during the site inspection. Surface runoff down the slope is leading to erosion and washout of material, which is being deposited in fans at the base of the slope.

Photo 2 Erosion of soil at brow of slope leading to rockfalls and debris fans in the ditch. Note large boulders at crest of slope. Photo was taken facing northwest on May 9, 2023.

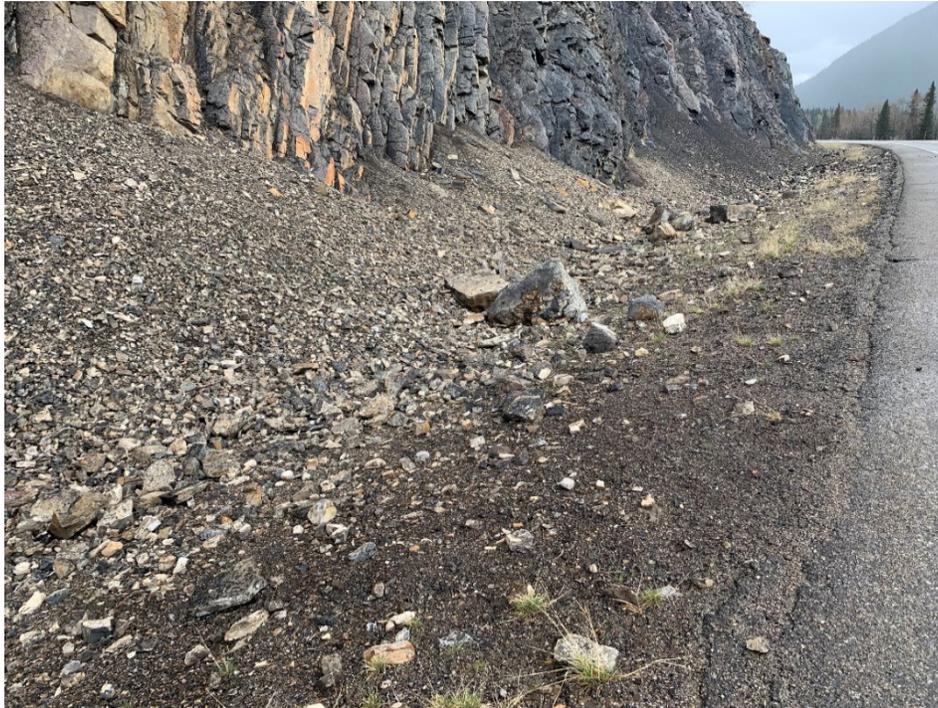
Photo 3 Active rockfall - debris fans and large rocks in ditch. The ditch should be regularly cleaned of debris. Photo taken facing east on May 9, 2023.

- Continue to monitor site and clean out ditch regularly to maintain storage capacity for future rockfalls;
- Continue annual photogrammetric survey and 3D surface modelling to monitor potential changes in slope performance and inform existing estimates of annual failure volumes and relative frequency of rockfall events.
- Confirm hazard assessment at the site based on the ongoing UAV photogrammetry change detection work being completed by the U of A.

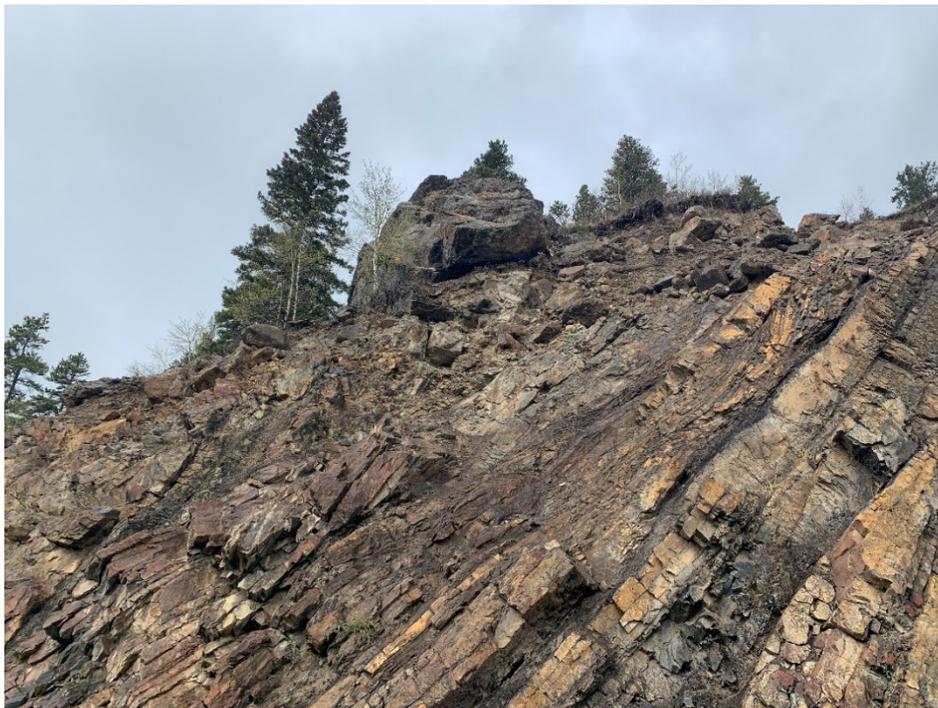
COMMENTS
Overall, no significant changes to the site when compared to 2021. Ongoing rockfalls at the site, the majority of which are retained in the ditch, but some rocks are falling onto and across the highway.
Rockfall debris observed in the ditch during the 2023 inspection. MCI reports that ditch needs cleaning out at least once per year. The MCI noted that during 2021, ten tabular blocks of approximately 0.3 m x 0.3 m, and a boulder (approximately 1 m x 1 m x 1 m) had fallen into the ditch.
Loose blocks and boulders up to 0.5 m x 0.5 m x 0.5 m present along the top of the rock slope. Some blocks of rock are within the soil at the brow of slope and are being eroded out and will eventually fall. One large boulder at the brow of western end of the slope, and one smaller boulder midslope are both perched at the crest of the exposed bedrock.

Photo 4 Large rock perched on top of cliff. Photo taken facing northwest on May 9, 2023.

- Rock face scaling, including check scaling of loose blocks (for safety), clearance of trees and loose debris from the brow of the slope, and removal of the large potentially unstable rock blocks on the upper portion of the rock slope (possibly requiring drilling and blasting);
- Place rock slope mesh in critical areas to protect road users, leaving gaps for sheep passage; and
- Increase the ditch depth/width and evaluate the addition of HTC/B or possible barrier wall at the toe of the rock slope (between rock slope and highway).
- Jersey barriers could be installed as an alternative to HTC/B or rockfall barrier.
