SITE NUMBER AND NAME: S020 Highwood House Rockfall Hazard		HIGHWAY & KM: 541:02, 0.817	PREVIOUS INSPECTION DATE: May 9, 2023	INSPECTION DATE: May 28, 2024
LEGAL DESCRIPTION: 04-33-016-05 W5M	NAD 83 COORDINATES: UTM Northing Easting 11 5584038 667795		RISK ASSESSMENT: PF: 14 CF: 5 TOTAL: 70	
AVERAGE ANNUAL DAILY TRAFFIC (AADT): 260 (west), 260 (east), (Ref. No. 59130)			CONTRACTOR MAINTENANCE AREA (CMA): 27

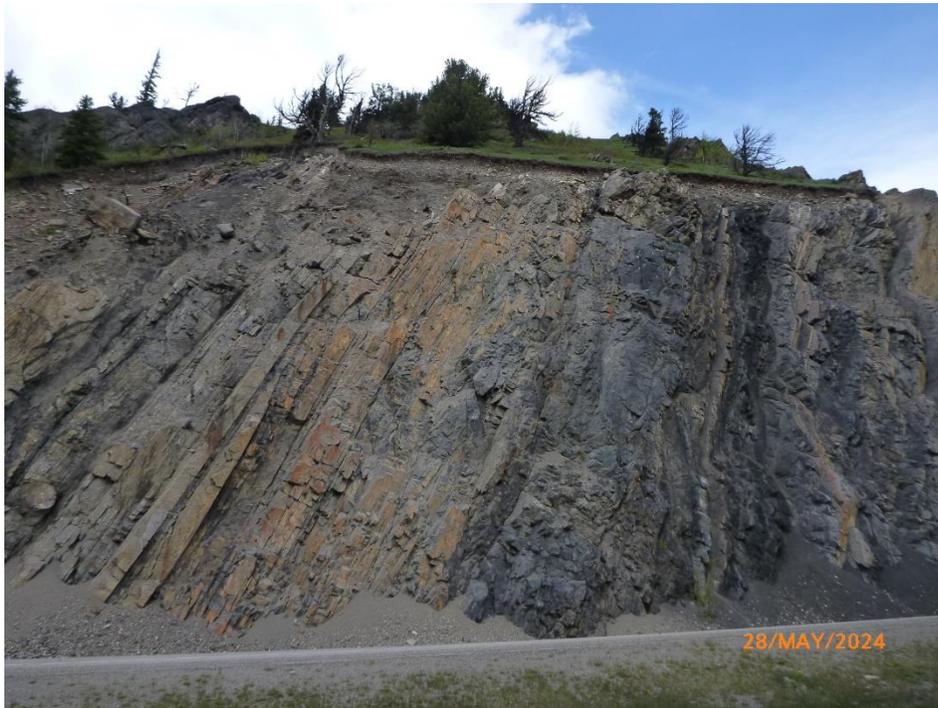
Photo 1 Rock slope has a maximum height of approximately 20 m, with continuous joints in an adverse orientation. Photo was taken facing north on May 28, 2024.

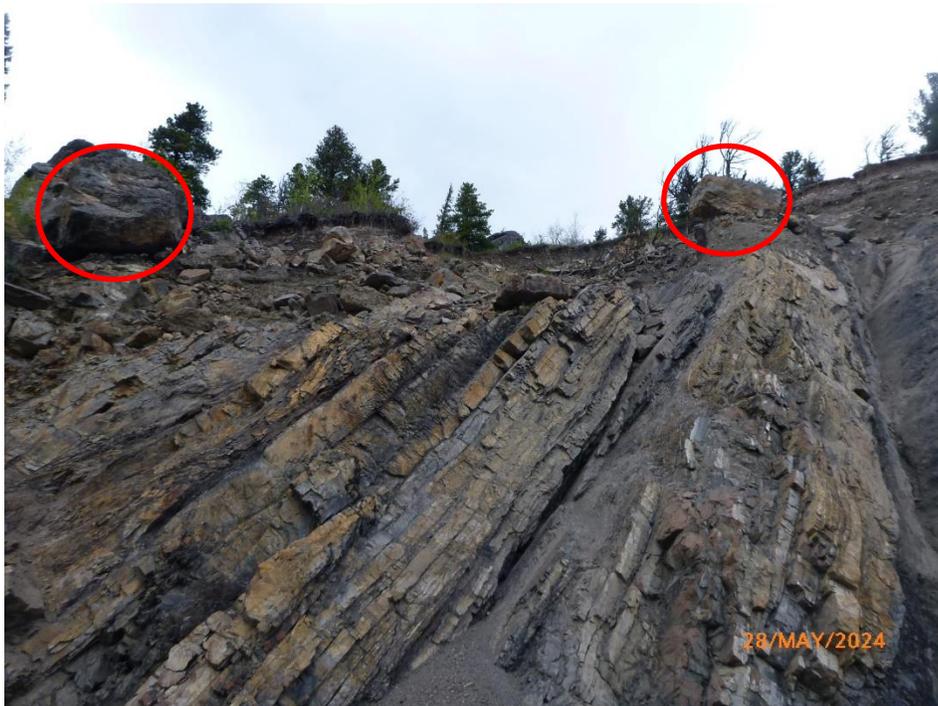
No significant change in extent of soil erosion at brow of hill since 2023 was observed during the site inspection. Surface runoff down the slope is leading to erosion and washout of material, which is being deposited in fans at the base of the slope.

Photo 2 Erosion of soil at brow of slope leading to rockfalls and debris fans in the ditch. Note large boulders at crest of slope. Photo was taken facing north on May 28, 2024.

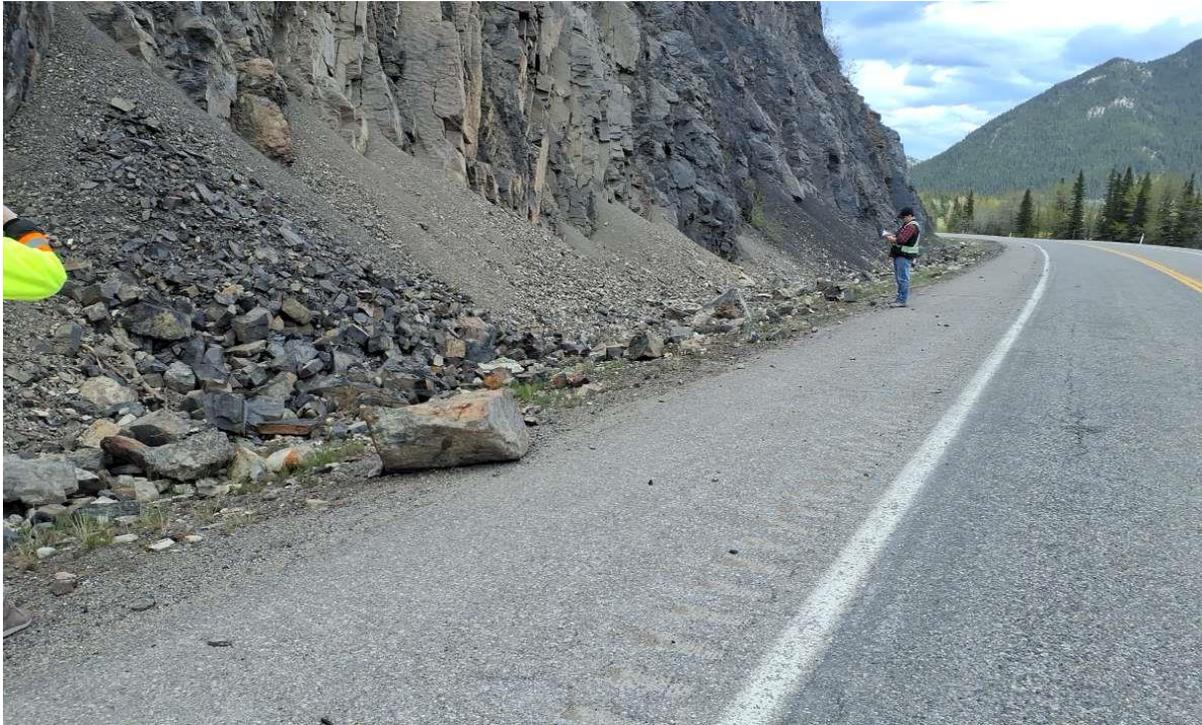
Photo 3 Active rockfall - debris fans and large rocks in ditch. The ditch should be regularly cleaned of debris. Photo taken facing east on May 28, 2024.

- Continue to monitor site and clean out ditch regularly to maintain storage capacity for future rockfalls;
- Continue annual photogrammetric survey and 3D surface modelling to monitor potential changes in slope performance and inform existing estimates of annual failure volumes and relative frequency of rockfall events.
- Confirm hazard assessment at the site based on the ongoing UAV photogrammetry change detection work being completed by the U of A.

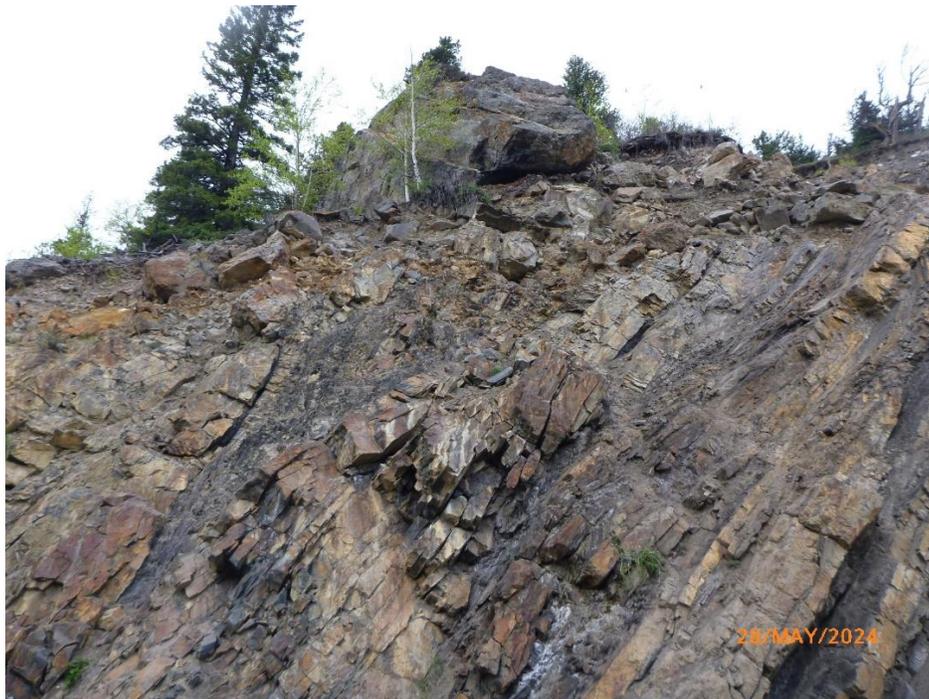
Photo 4 Large rock perched on top of cliff. Photo taken facing northwest on May 28, 2024.

- Rock face scaling, including check scaling of loose blocks (for safety), clearance of trees and loose debris from the brow of the slope, and removal of the large potentially unstable rock blocks on the upper portion of the rock slope (possibly requiring drilling and blasting);
- Place rock slope mesh in critical areas to protect road users, leaving gaps for sheep passage; and
- Increase the ditch depth/width and evaluate the addition of HTC/B or possible barrier wall at the toe of the rock slope (between rock slope and highway).
- Jersey barriers could be installed as an alternative to HTC/B or rockfall barrier.
