SITE NUMBER AND NAME: <b>S020 Highwood House Rockfall Hazard</b>		HIGHWAY & KM: 541:02, 0.817	PREVIOUS INSPECTION DATE: May 28, 2024	INSPECTION DATE: <b>May 27, 2025</b>
LEGAL DESCRIPTION: 04-33-016-05 W5M	NAD 83 COORDINATES: UTM Northing Easting 11 5584038 667795		RISK ASSESSMENT: Rockfall: PF: 14 CF: 5 TOTAL: 70	
AVERAGE ANNUAL DAILY TRAFFIC (AADT): 260 (west), 260 (east), (Ref. No. 59130)			CONTRACTOR MAINTENANCE AREA (CMA): 520

PRIMARY SITE ISSUE: Rockfall from the rock cutting, large rock block potentially unstable (west end), and soil debris flows due to surface water runoff erosion (gullyng) from the brow of the slope.
APPROXIMATE DIMENSIONS: The site is approximately 180 m in length and over 40 m high.
DATE OF ANY REMEDIAL ACTION: Ditches cleaned periodically. Rockfall debris has accumulated along the ditch of the westbound lane, and it appears that it was cleaned out last year for large rock blocks, but the debris fan remained.

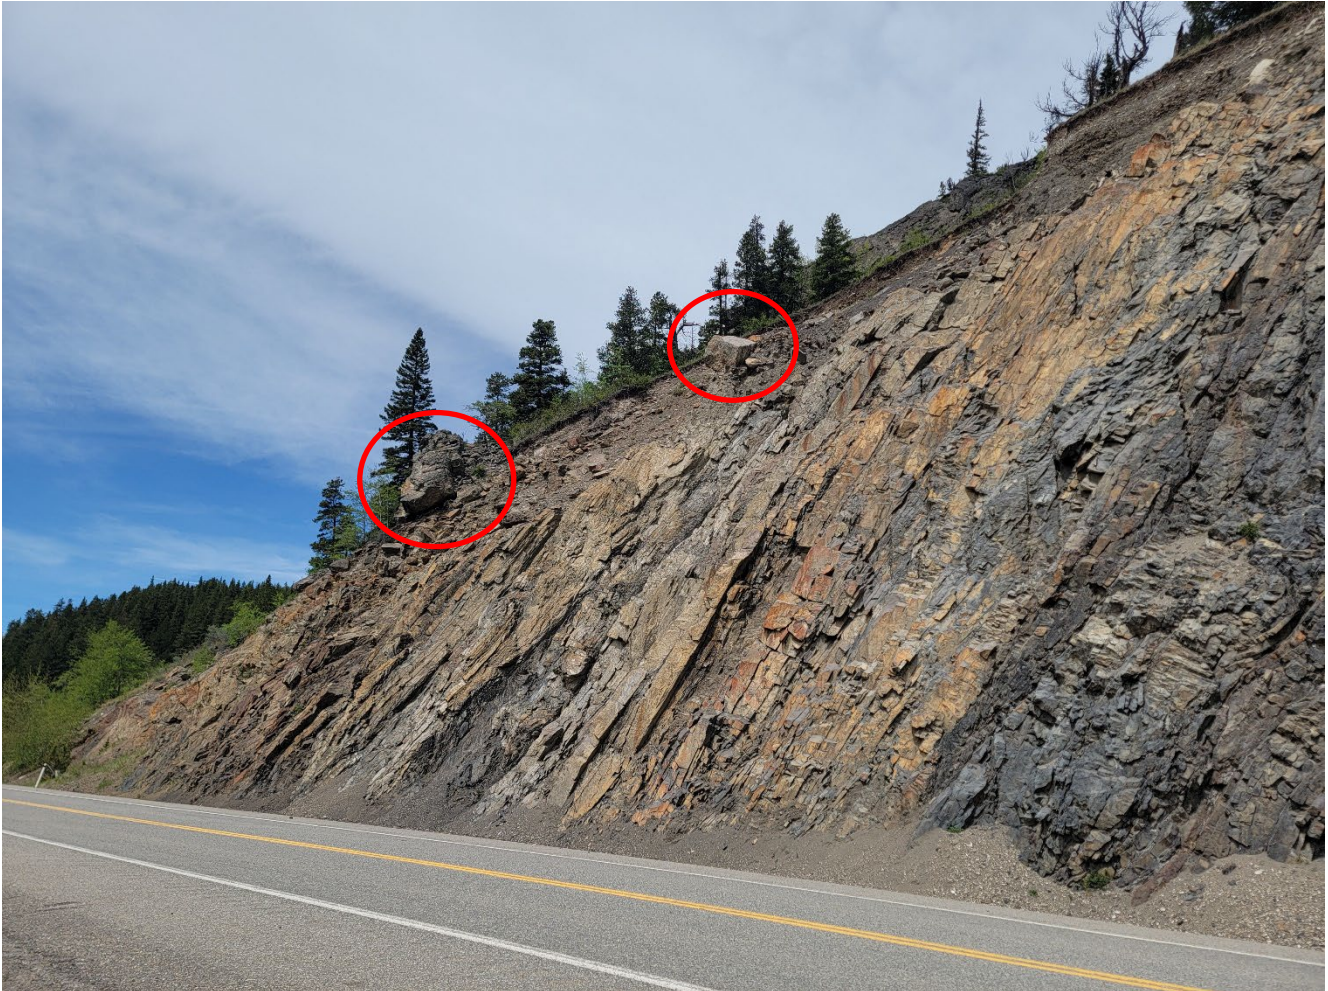
- Loose blocks and boulders up to 0.5 m x 0.5 m x 0.5 m present along the top of the rock slope. Some rocks embedded in the soil at the brow of slope and are being eroded and may eventually fall. There is a large boulder of 130 cu.m. at the western end of the slope's crest, and a 6 cu.m. boulder mid-slope, both perched at the crest.

- No significant changes in the extent of soil erosion at the brow of the slope since 2024 were observed during the site inspection. Surface runoff down the slope is leading to erosion and washout of material, which is being deposited in fans at the base of the slope.

**Photo 1**      **Rock slope cut with a vertical height of about 35 metres, featuring continuous joints and extensive soil erosion at the brow on the west side of the site. Also note the large overhang at the crest of the slope on the west end of the site. Photo was taken facing north on May 27, 2025.**

- Execute S020 rockfall mitigation design, which includes:
  - Rock face scaling, including check scaling of loose blocks (for safety), clearance of trees and loose debris from the brow of the slope, and removal of the large potentially unstable rock blocks on the upper portion of the rock slope (possibly requiring drilling and blasting).
  - Place a rock of a rockfall barrier along the edge of pavement to protect road users.
  - Place a "F"-Shape barrier along the edge of pavement to avoid blocks from rolling into the highway.

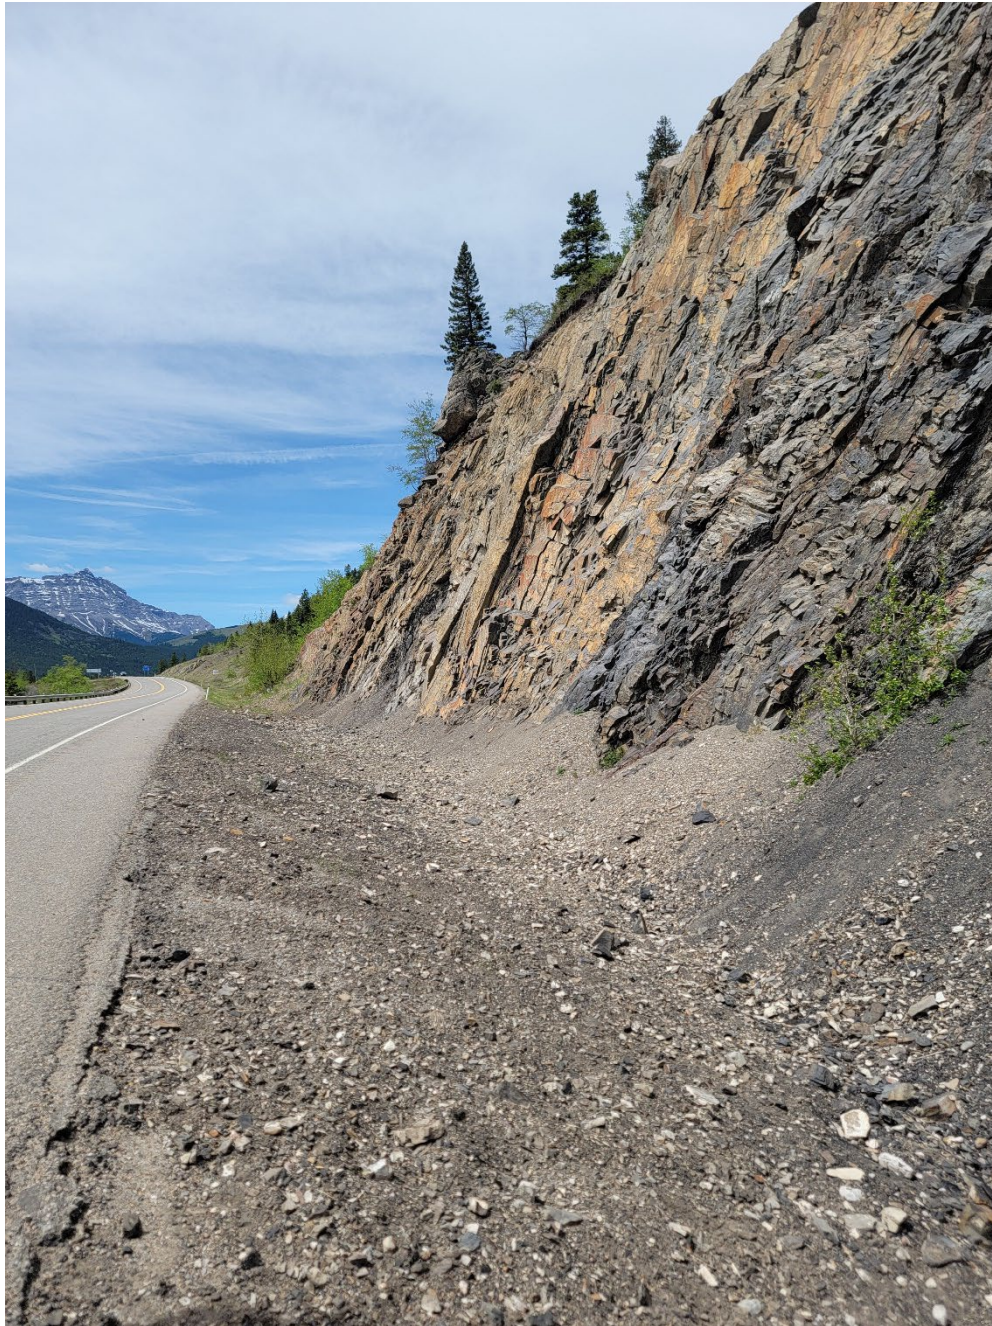
- Rockfall debris observed in the ditch during the 2025 inspection; however, no new large particles were found. The observed large particles were reported in the 2024 inspection.

**Photo 2**      **Active rockfall - debris fans and small rocks in the ditch towards the west end of the site. Photo was taken facing north on May 27, 2025.**

- Continue to monitor the site and clean out the ditch regularly to maintain storage capacity for future rockfalls.
- The collaborative work between the University of Alberta (UofA) and KCB as part of the research project continues the annual photogrammetric survey and 3D surface modelling to monitor potential changes in slope performance and inform existing estimates of annual failure volumes and relative frequency of rockfall events.

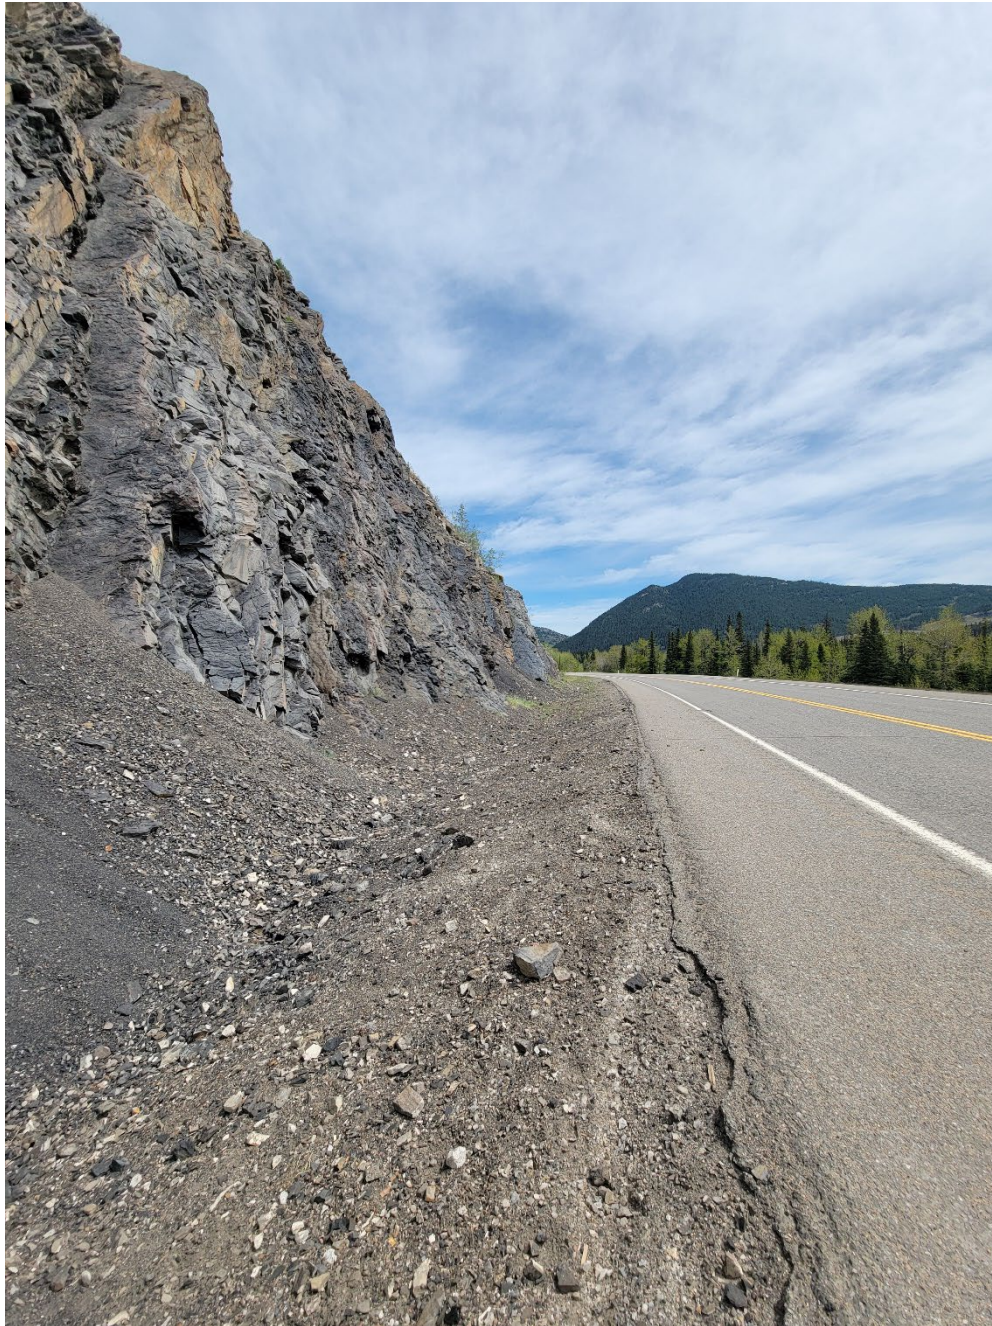
**Photo 3**      **Active rockfall - debris fans and small rocks in the ditch towards the east end of the site. Photo taken facing east on May 27, 2025.**

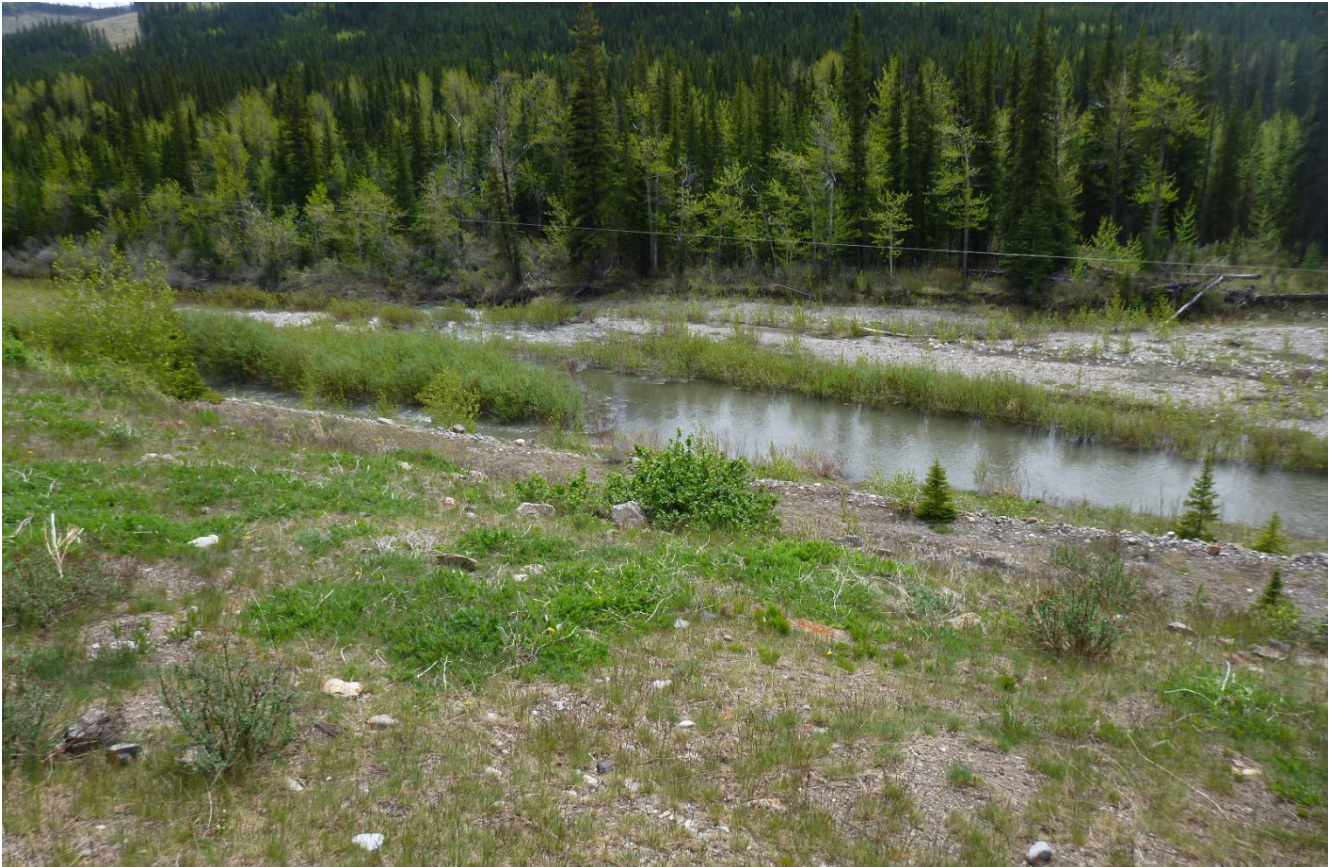
- During the 2025 inspection, small gravel-sized particles were observed across the road. A few particles were found behind the guardrail, with the largest near the pavement edge measuring 0.3 meters in diameter.

**Photo 4**      **Rock blocks found across the highway. Photo taken facing northwest on May 27, 2025.**
