<b>SITE NUMBER AND NAME:</b> <b>S056-1 West Gorge Creek</b>	<b>HIGHWAY &amp; KM:</b> 25002:02, 7.693	<b>PREVIOUS INSPECTION DATE:</b> May 28, 2024	<b>INSPECTION DATE:</b> <b>May 27, 2025</b>
<b>LEGAL DESCRIPTION:</b> 15-29-019-05 W5M	<b>NAD 83 COORDINATES:</b> UTM    Northing    Easting 11       5612799    665797	<b>RISK ASSESSMENT:</b> PF: 13    CF: 10    TOTAL: 130	
<b>MONTHLY AVERAGE DAILY TRAFFIC (MADT):</b> May 2024 - 242 (west) & 232 (east) (Reference No. 55460220)		<b>CONTRACTOR MAINTENANCE AREA (CMA):</b> 521

<b>PRIMARY SITE ISSUE:</b> Erosion on the south side of the highway due to surface runoff, precipitation, and seepage through the slope. The highway is located at the crest of a steep valley slope above Sheep Creek River. The south (eastbound) ditch has been undermined and is draining directly onto the erosion feature. The erosion has encroached on the highway's guardrail.
<b>APPROXIMATE DIMENSIONS:</b> The erosion is approximately 20 m wide at the crest of a 30 m high slope above Sheep River. Approximately 1/4 of the way down the slope, the failure area narrows to a 3 m to 5 m wide erosion gully.
<b>DATE OF ANY REMEDIAL ACTION:</b> N/A

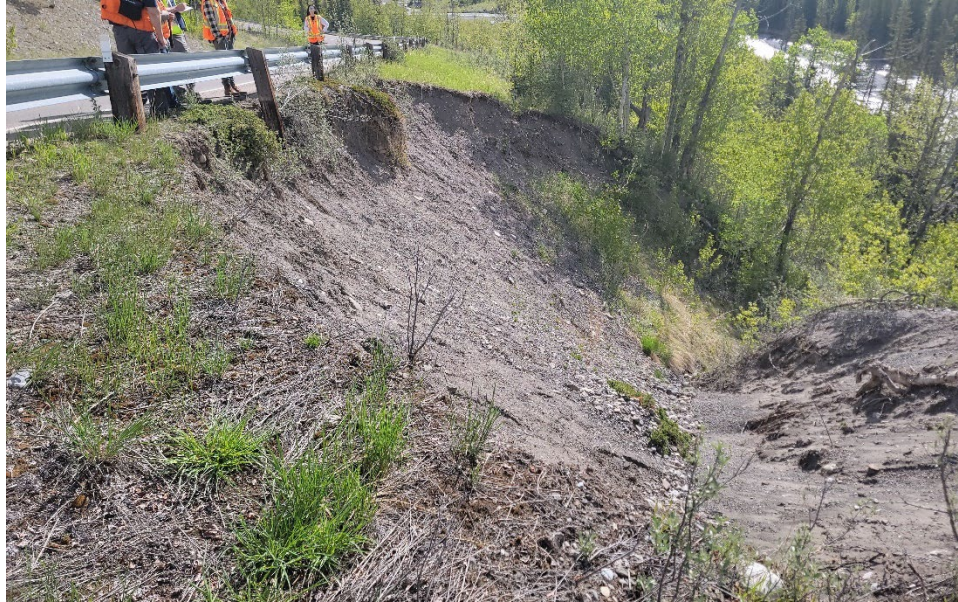
- The erosion fully is approximately 20 m wide near the edge of the highway and narrows to approximately 3 m to 5 m approximately 8 m below the highway surface (Photos 1, 3, 5, and 6).

- The erosion is within approximately 1 m from the edge of the highway (Photo 1 and 2). Erosion has completely undermined the south (eastbound) ditch and has begun to undermine the guardrail posts, and one guardrail post is mostly exposed (Photo 2). No pavement distress or guardrail deflection has been observed.

- Surface water runoff from the south (eastbound) ditch is being conveyed onto the erosion gully (Photo 3). Flow is exacerbating erosion as there is no vegetative cover in the erosion gully (Photos 1 through 3).

- Photo 1** Erosion located downslope (south) of the highway is within 1 m of the edge of the driving lane, and the south ditch has been undermined. The degree of erosion appears similar to during the 2024 Section B Inspection. Photo taken May 27, 2025, facing east.

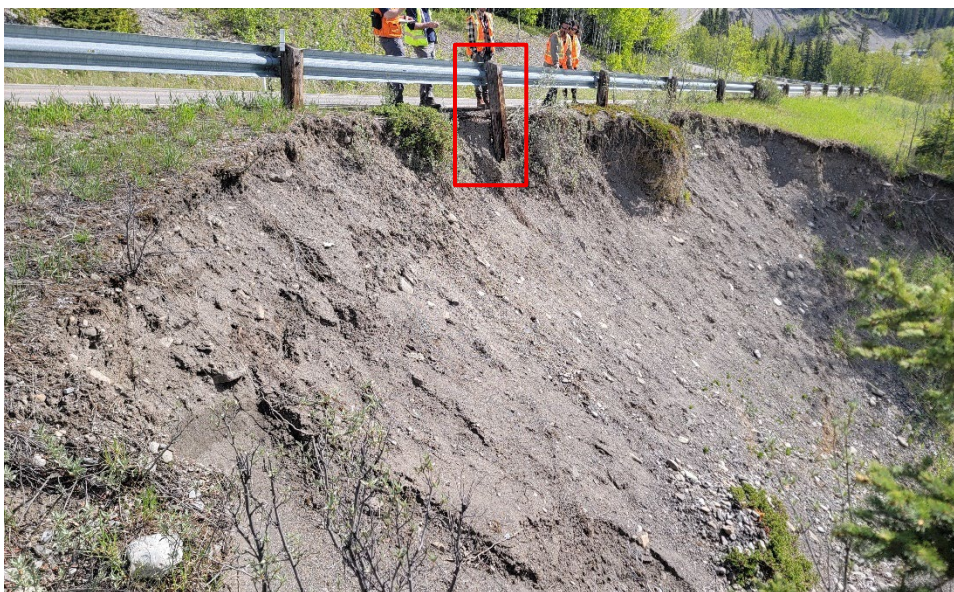
- Photo 2** Near-vertical erosion face near the edge of the highway. Erosion is beginning to undermine the guardrail posts and on is partially hanging (indicated by red rectangle). Photo taken May 27, 2025, facing northeast.

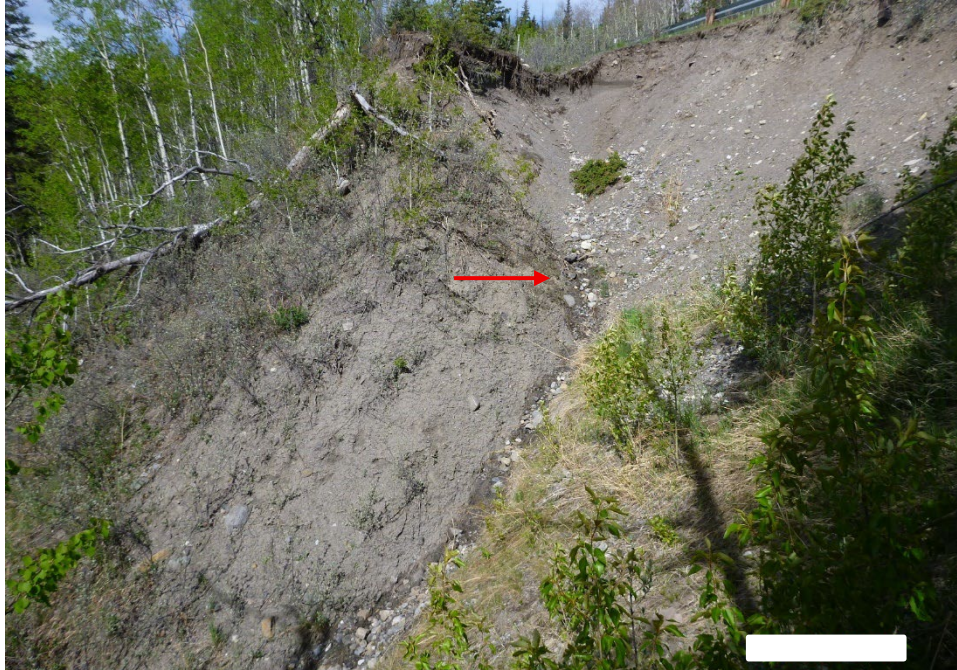
- Seepage through the slope has been observed in the erosion gully approximately 3 m to 4 m below the highway elevation (Photo 3). There does not appear to be a significant change in the seepage between the 2024 and 2025 inspections.

**Photo 3** Flow path of water conveyed by the south (eastbound) ditch through the area of erosion. Seepage observed near the base of the erosion feature (indicated by red arrow). Photo taken May 27, 2025, facing northwest.

- A cross culvert should be installed below the highway, west (upstream) of the site to convey surface water flow from the south ditch to the north ditch. Due to the relatively shallow depth of the ditches (between approximately 0.70 m and 0.85 m), inlet and outlet structures will be required, and the culvert will need to be installed at a skew angle from the highway to achieve positive drainage. The culvert should be thicker with stronger corrugation due to the limited cover available. A ditch block should be constructed downstream (east) of the culvert inlet to direct flow into the culvert inlet.

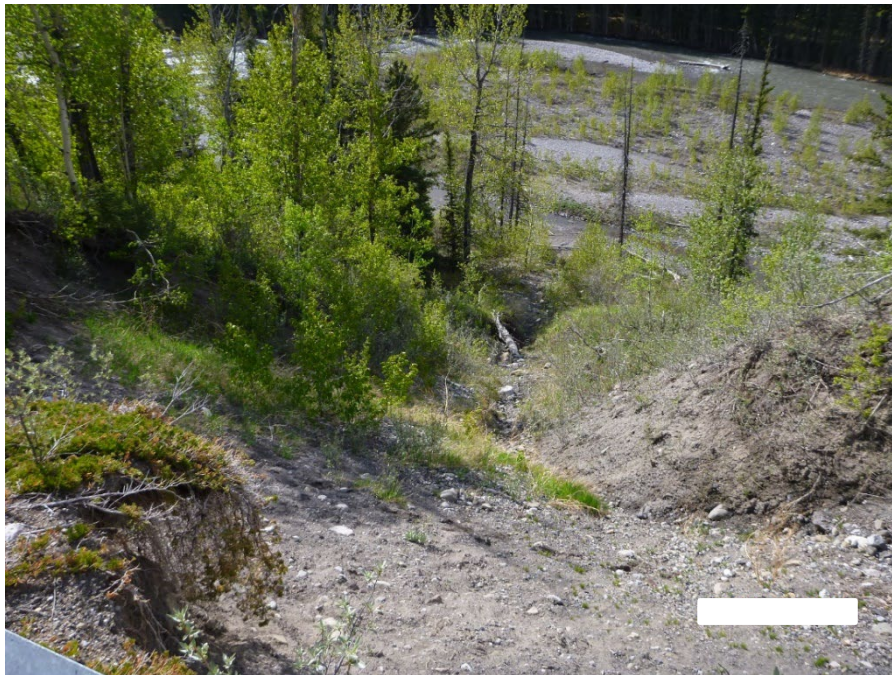
**Photo 4** Erosion as viewed from the edge of the south lane. Photo taken May 27, 2025, facing south.

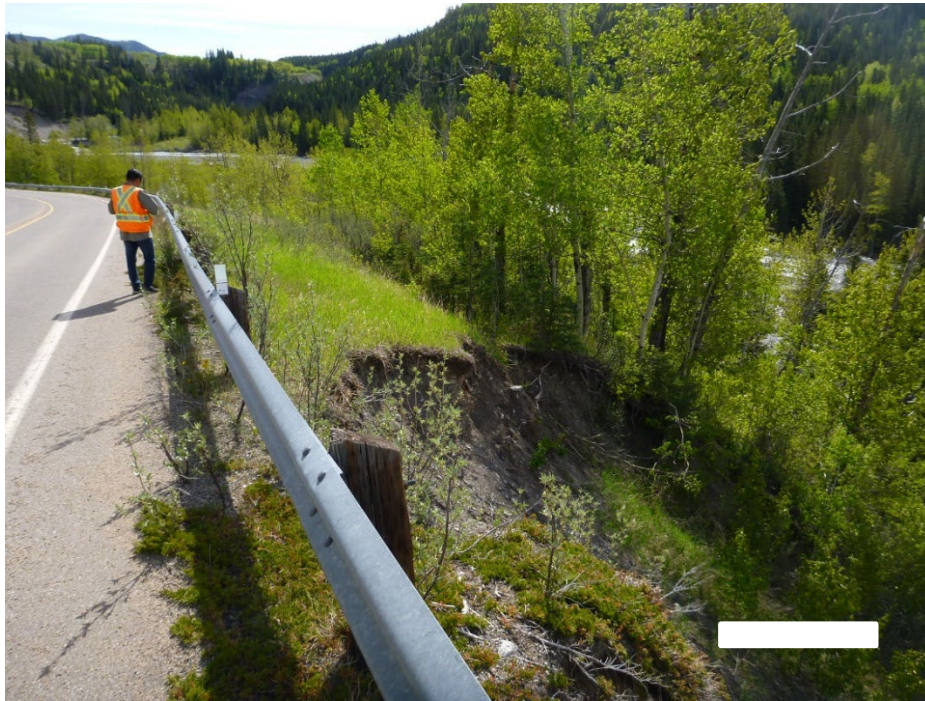
- Outside of the erosion gully, the highway embankment and river valley slopes are well vegetated with grass, shrubs, and trees (Photo 5).
- Erosion of the slope appears to be depositing an alluvial fan into Sheep River.

**Photo 5** East extent of the site. Photo taken May 27, 2025, facing east.

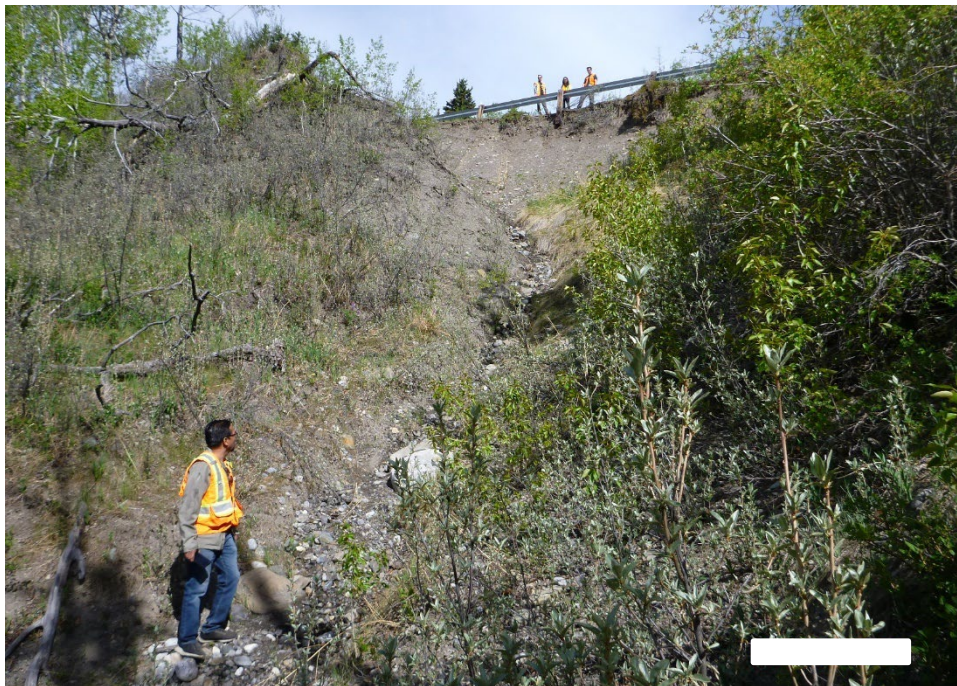
**Photo 6** Midslope extent of the erosion where the erosion feature narrows to approximately 3 m to 5 m wide. A relatively shallow erosion gully extends downstream towards Sheep River. Photo taken May 27, 2025, facing north.

- Installing a retaining wall and reinforced slope. The retaining wall should be installed where the erosion gully narrows to 3 m to 5 m and a reinforced slope (geogrid-reinforced granular fill) built above the retaining wall. Drainage pipes should be installed behind the retaining wall and erosion protection should be installed downslope of the retaining wall. Construction should be performed to limit disturbance to the well vegetated slopes outside of the erosion gully.

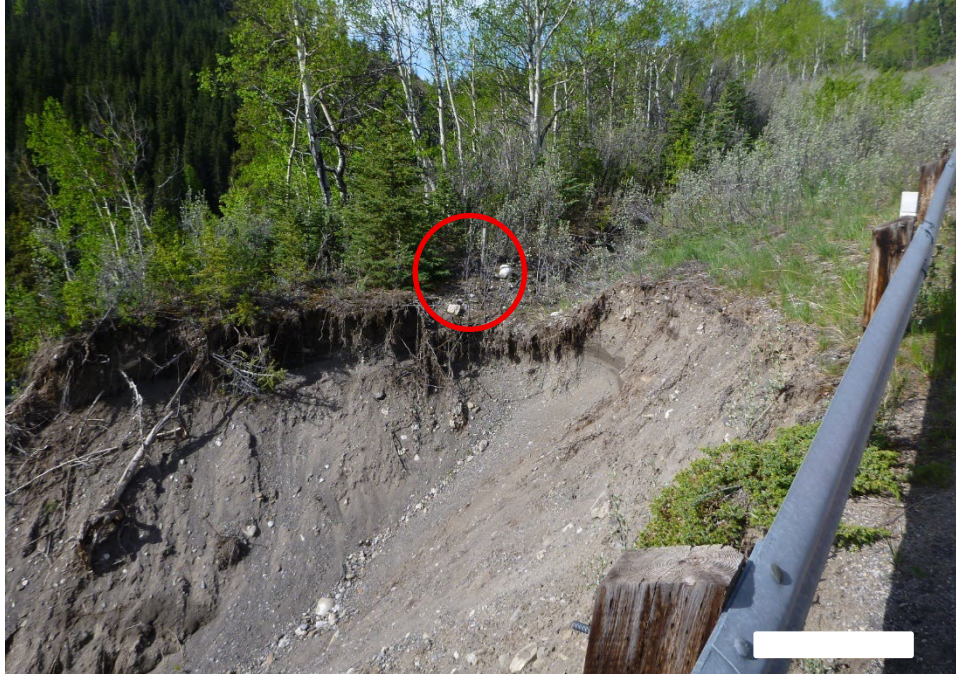
- In 2022, a wooden stake was installed and painted orange, west of the erosion gully edge, to estimate gully expansion. During 2022-2023 inspections, the stake was about 1.7 m from the edge; no measurements were taken in 2024-2025. Visual inspection suggests it's now approximately 1.5 m away (Photo 7).

**Photo 7**      **Wooden stake (indicated by red circle) used to estimate the rate of erosion between inspections was approximately 1.5 m from the edge of the erosion gully. Photo taken May 27, 2025, facing west.**

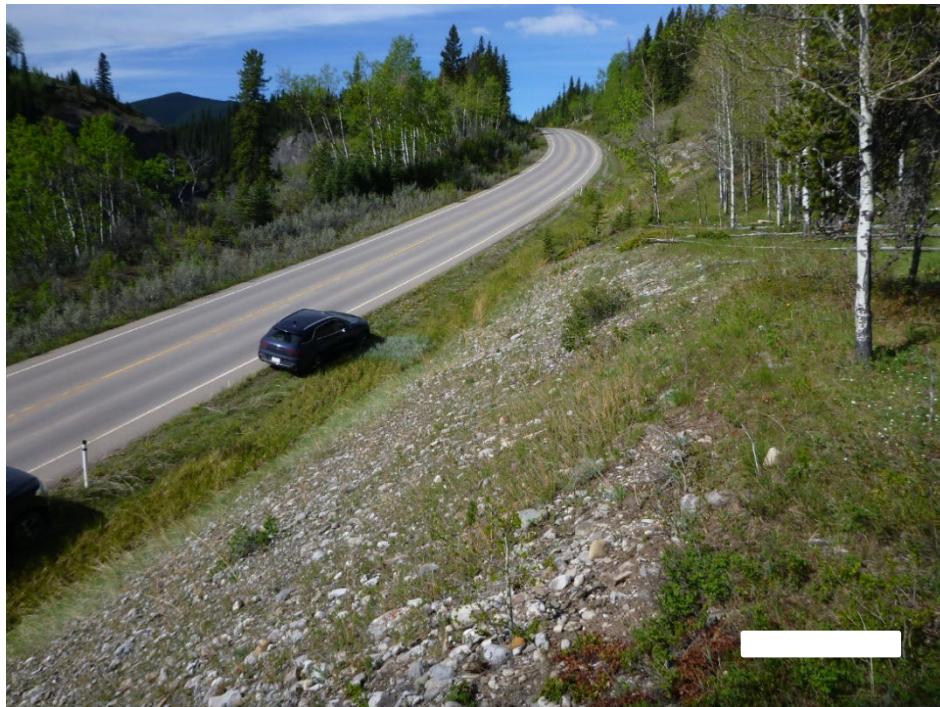
- The north backslope is sloped at approximately 2H:1V and appears to consist of mostly coarse-grained soils (sand and gravel with cobbles) (Photo 8). The slope appears unchanged and not showing a deep seated movement.

**Photo 8**      **North backslope near the west extent of the site. No evidence of shallow bedrock was observed. Photo taken May 27, 2025, facing west.**
