SITE NUMBER AND NAME: S056-4 West Gorge Creek, West of Turner Valley		HIGHWAY & KM: 25002:02, 13.6	PREVIOUS INSPECTION DATE: May 27, 2024	INSPECTION DATE: May 27, 2025
LEGAL DESCRIPTION: 12-36-019-05 W5M	NAD 83 COORDINATES: UTM Northing Easting 11 5614130 671333		RISK ASSESSMENT: Rockfall: PF: 14 CF: 6 TOTAL: 84	
MONTHLY AVERAGE DAILY TRAFFIC (MADT): May 2024 242 (west) & 232 (east) (Reference No. 55460220)			CONTRACTOR MAINTENANCE AREA (CMA): 521

PRIMARY SITE ISSUE: Rockfalls from the rock cutting on the north side of the highway, weathering coal seams, undermining more competent bedrock. And rockfalls are generated from the weathering of overburden at the brow of the slope.
APPROXIMATE DIMENSIONS: Rock cut is approximately 228 m long, ranging from 20 m to 40 m in height. On the south side of the highway, surface runoff erosion has undermined the safety barrier in one location.
DATE OF ANY REMEDIAL ACTION: N/A

SOUTHERN REGION GEOHAZARD RISK MANAGEMENT PROGRAM

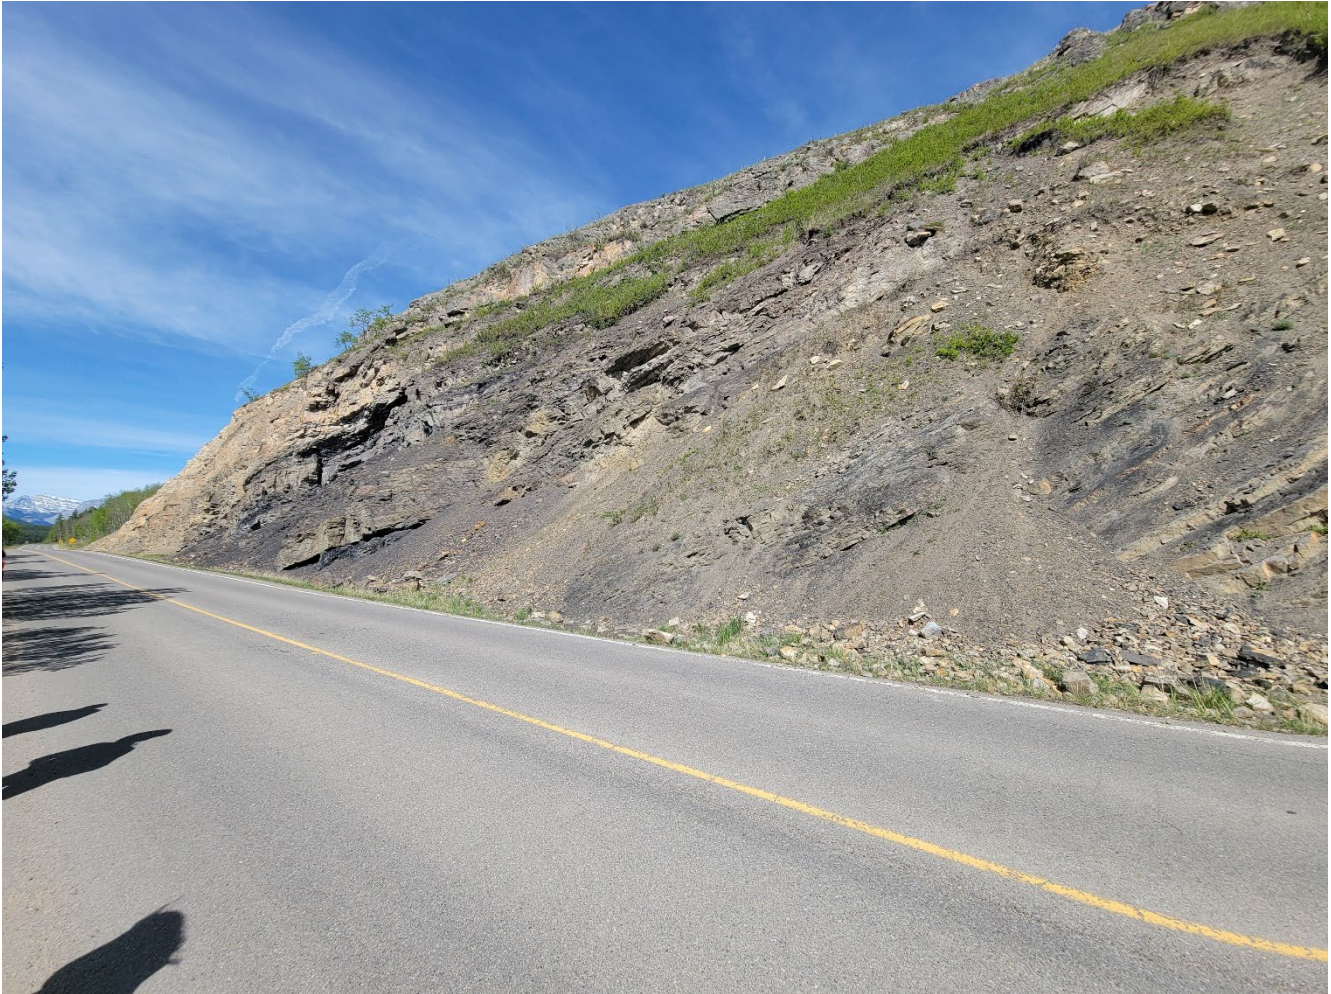
The rock slope on the north side of the highway consists of folded and fractured sandstone and conglomerate with claystone and interbedded coal seams (Photo 1). The toe ditch is shallow, and rockfalls have partially blocked the drainage. Weathering of the slope has resulted in rockfalls of various sizes (i.e. gravel to cobble size) falling close to the highway.

Erosion at the brow of the slope is causing debris to fall into the ditch and onto the highway (Photos 1, 3 and 4).

Photo 1 **Rock slope north of highway. Photo was taken facing east on May 27, 2025.**

- The site should be regularly inspected by TEC's MCI and annually as part of the Southern Region GRMP Section B inspections.
- Clean out the toe ditch regularly to maintain storage capacity for future rockfalls; and
- Unplug the culvert beneath the road to minimize runoff erosion at the existing erosion site.
- Installation of a rockfall fence partway up the rock slope to catch rocks with the potential to bounce onto the highway.
- Install jersey barriers at the edge of the pavement to help prevent rockfall particles from reaching the highway.

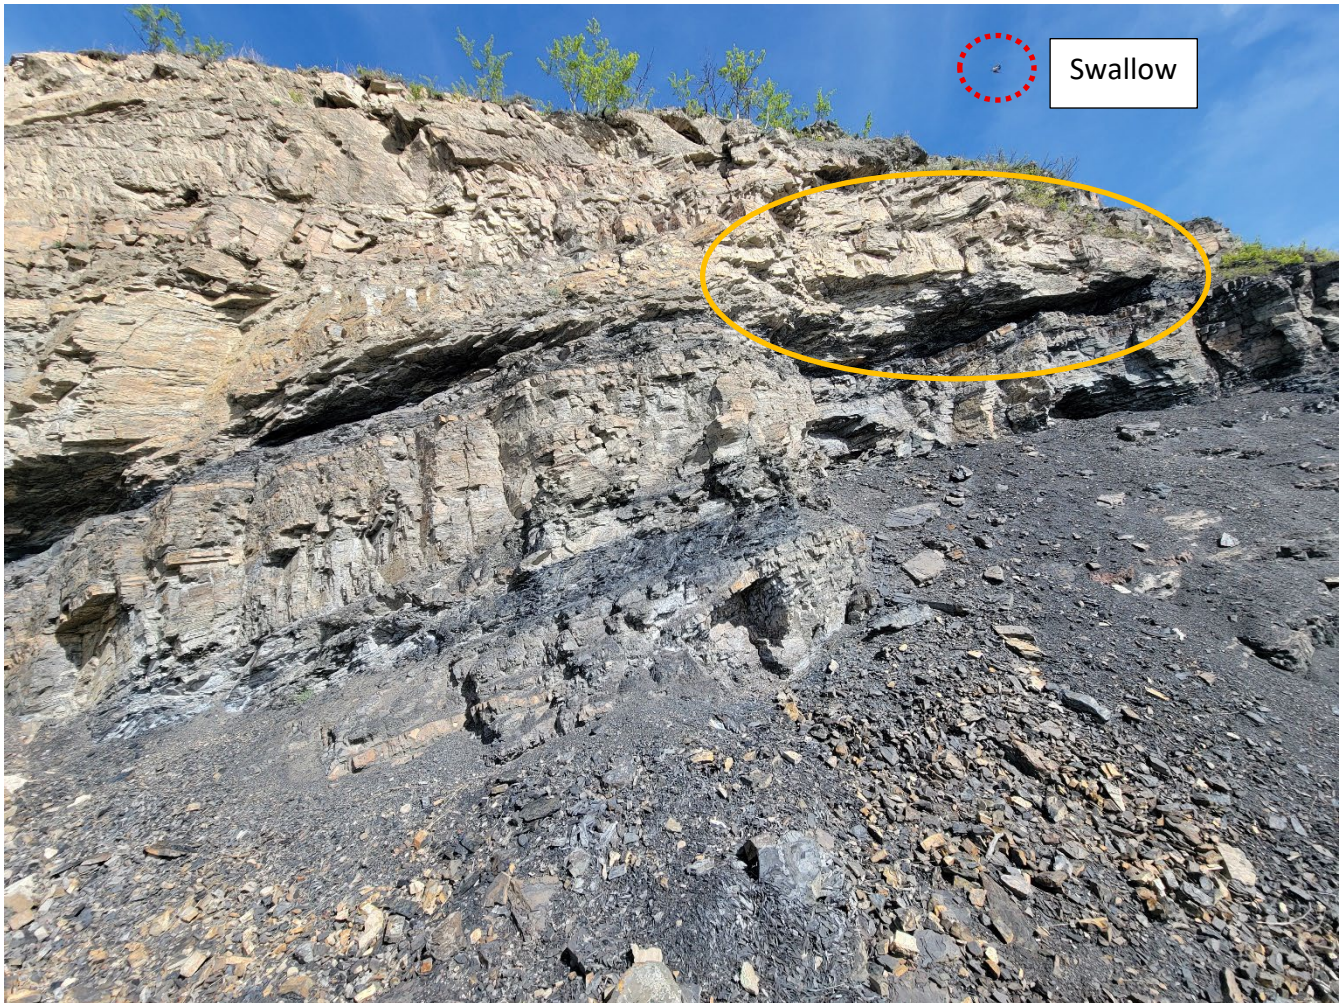
One large and fractured overhang block (Photo 2) of approximately 20 cu.m at 15 m height from the road appears to be marginally stable and could fall after heavy precipitation.

Bird swallows were observed flying around the cliff during the inspection (Photo 2); this could result in potential scheduling restrictions for remediation or maintenance activities.

Photo 2 Weathered coal seams create a large rock overhang (orange line) on the north slope.
Photo taken facing northwest on May 27, 2025.

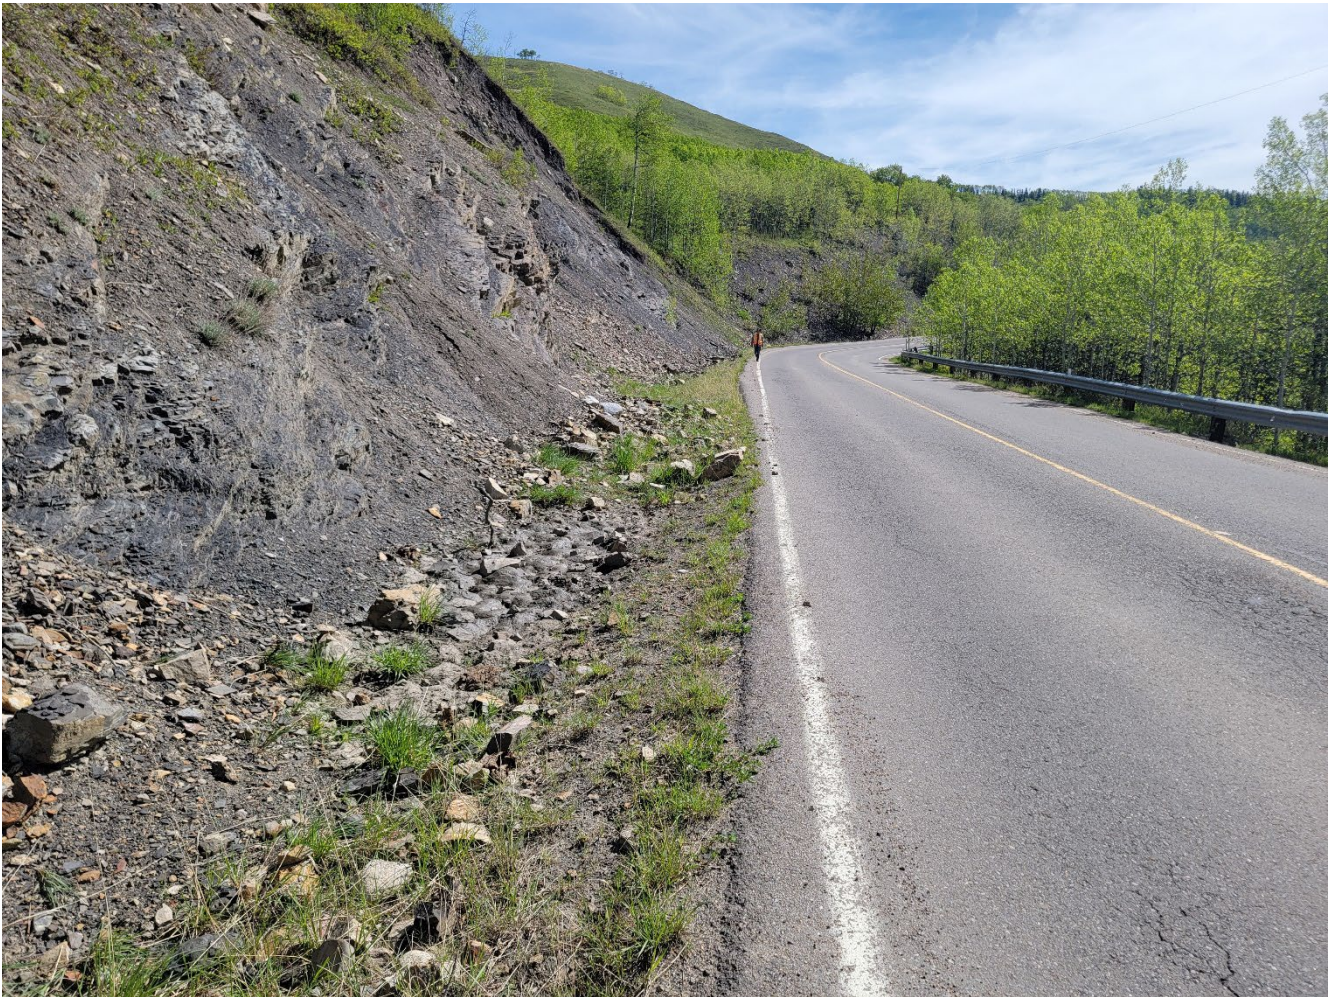
Photo 3 Rock slope north of highway. Photo taken facing northeast on May 27, 2025.

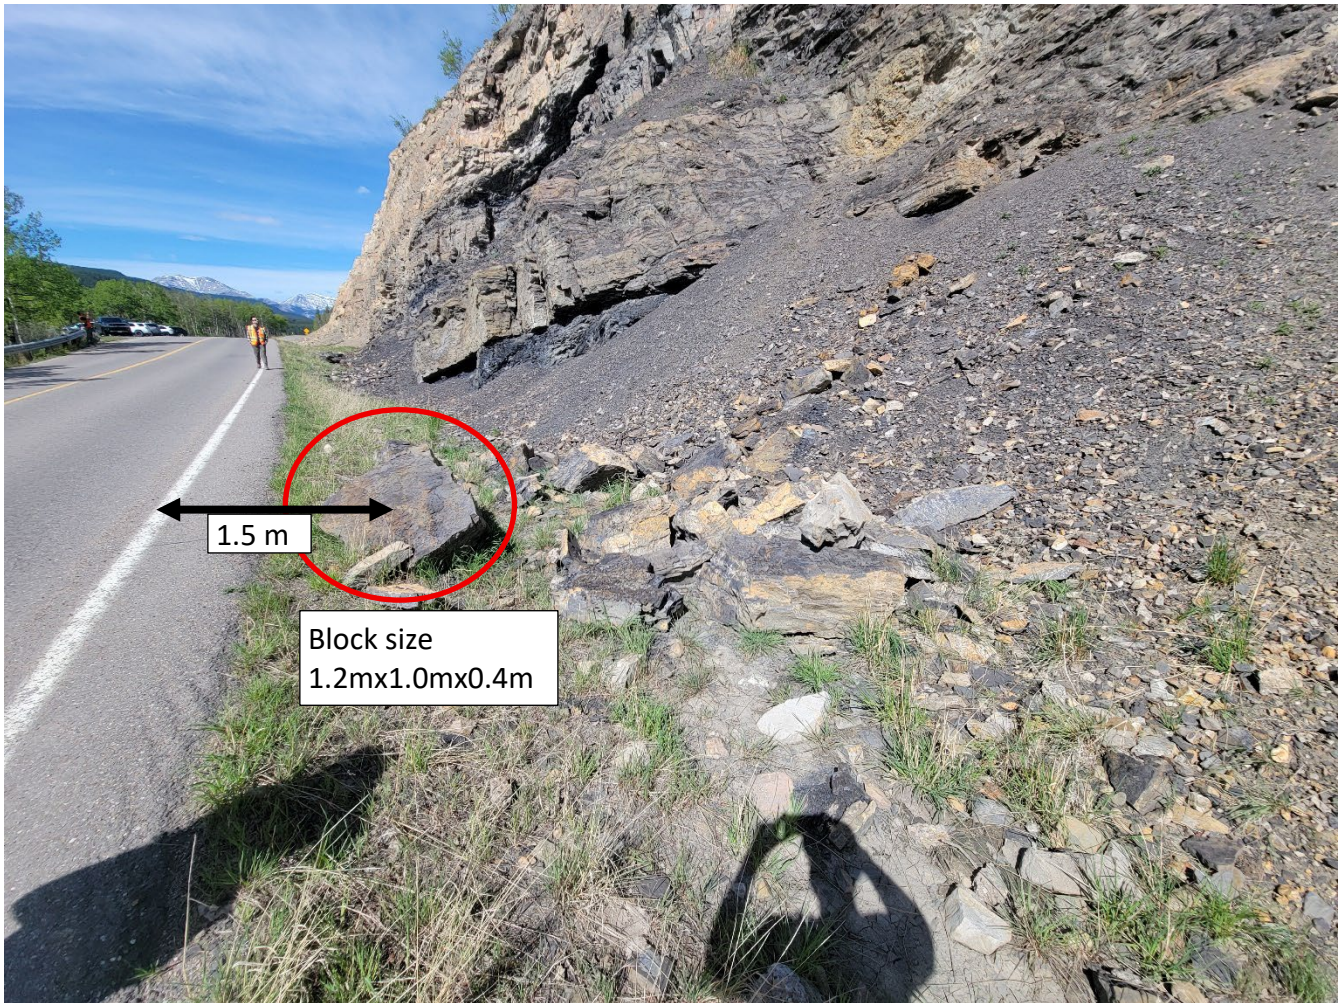
A large rock block, measuring up to 1.2 m x 1.0 m x 0.4 m, has been observed in the ditch since the 2024 inspection (WP01), approximately 1.5 m from the edge of the driving lane. On the west side, the bedrock appears to be underlain by a colluvium deposit.

The MCI reported that rock falls appeared to be increasing in frequency and that the ditch was being cleaned out annually. However, the large rock block (WP01) found in the ditch was also observed during the 2024 Inspection (Photo 2).

Photo 4 Large rock block in the ditch on the north side of the highway, which was also observed in the 2024 Inspection. Photo taken facing west on May 27, 2025.

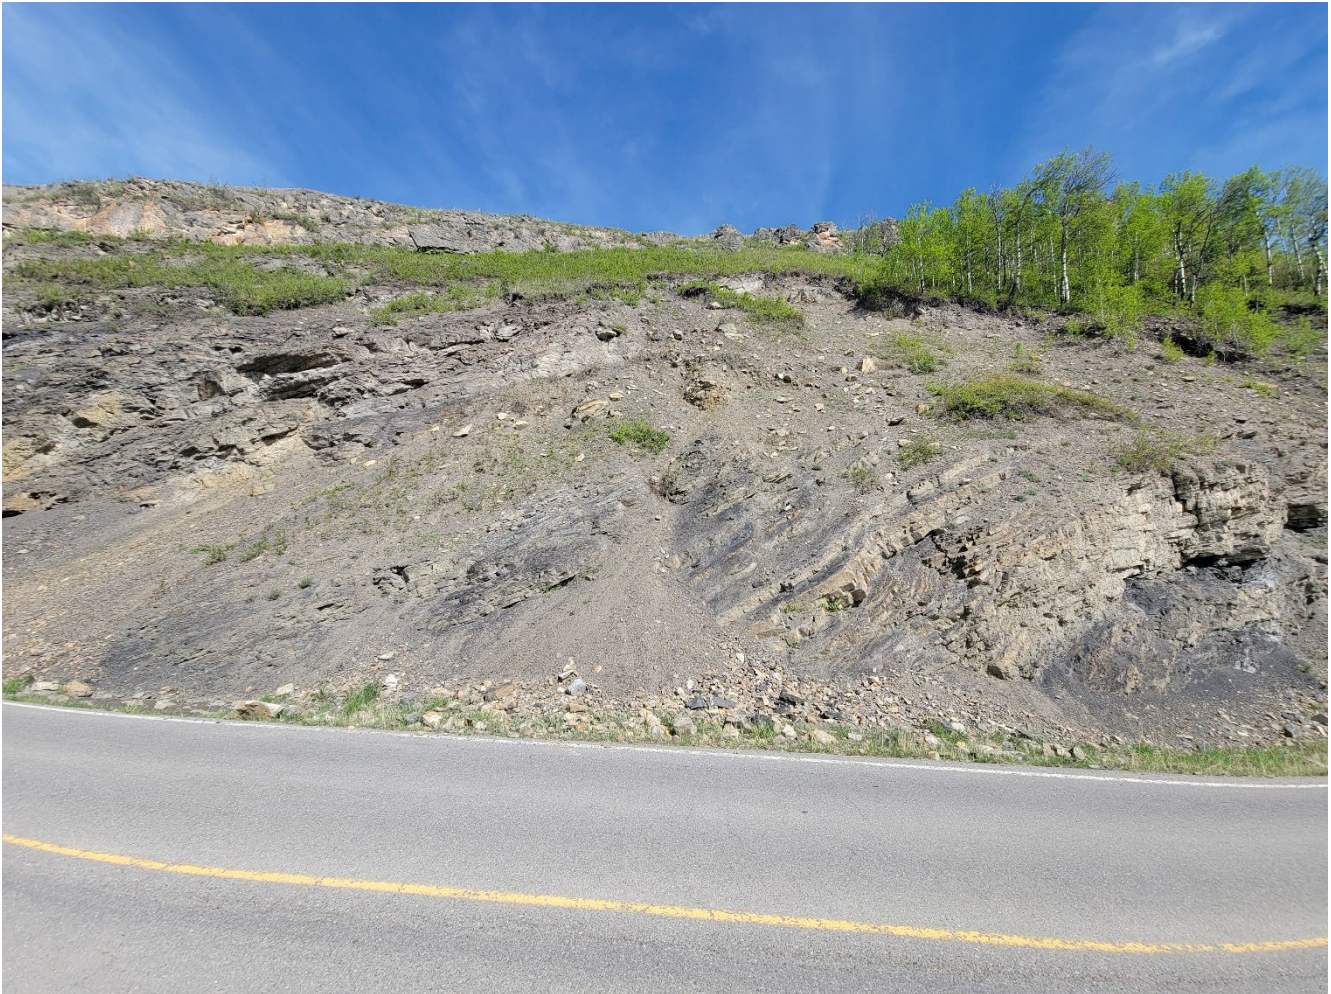
Photo 5 **East end of rock slope north of highway. Photo taken facing northwest on May 27, 2025.**

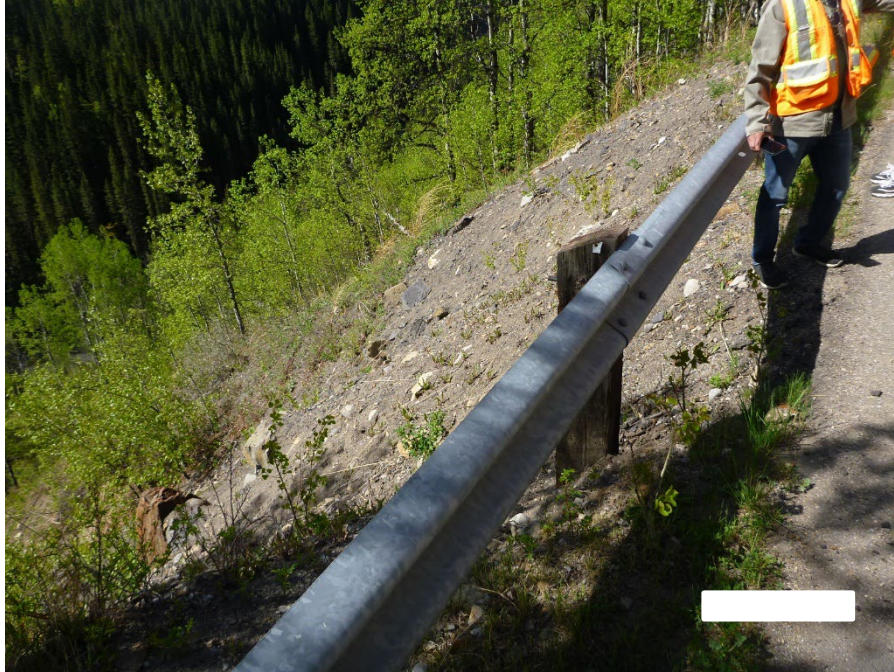
Surface runoff from the highway is eroding the slope on the south side of the highway (Photo 6). Erosion has undermined the guardrail and reached the pavement edge at one location, but no pavement distress was visible in 2024 (WP02).

Photo 6 **Surface runoff erosion on the south side of highway has undermined the guardrail and reached the pavement edge. There was no evidence of pavement cracks during the 2024 and 2025 inspections. Photo taken facing southeast on May 27, 2025.**
