**HIGHWAY 549:02 – THREEPOINT CREEK  
CALL-OUT REPORT**

Submitted to:  
**Alberta Transportation**  
Calgary, Alberta

Submitted by:  
**AMEC Environment & Infrastructure,**  
**a division of AMEC Americas Limited**  
Calgary, Alberta

August 2012

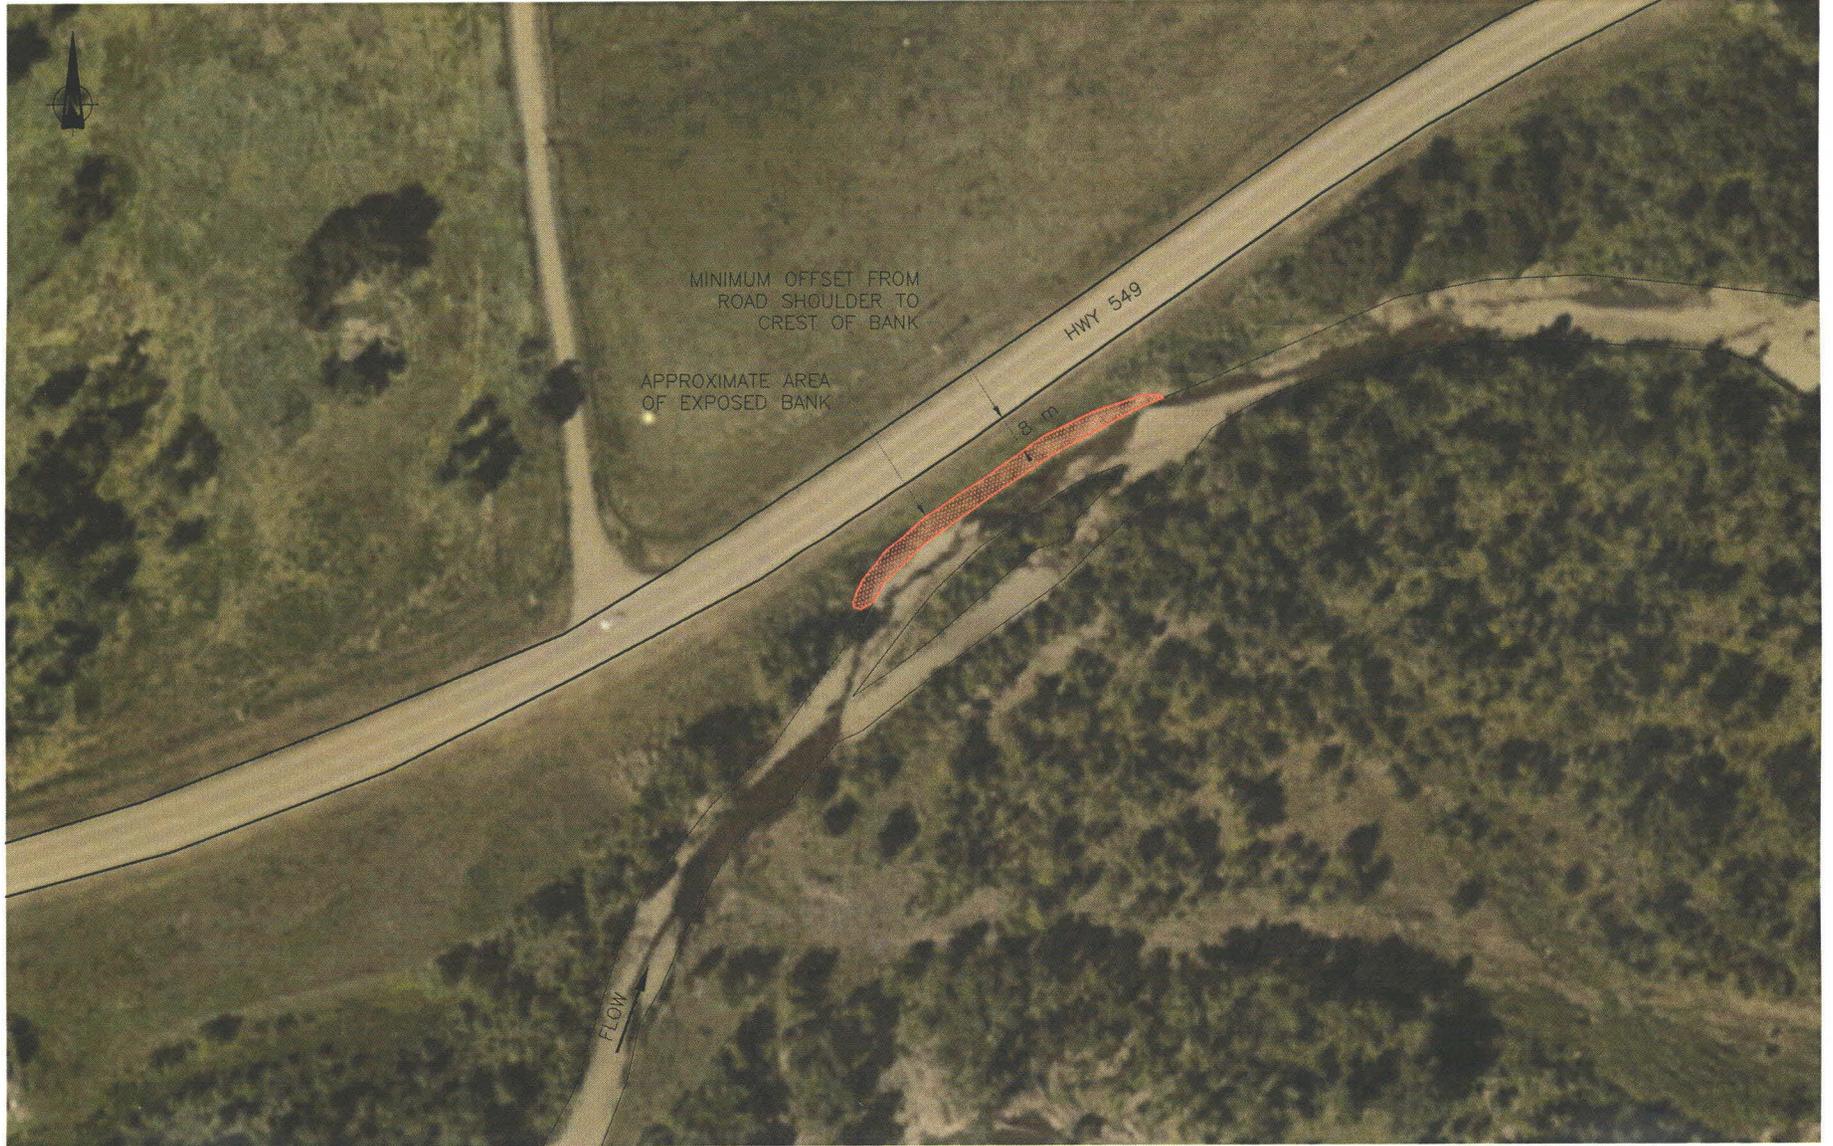
PROJECT: <b>HWY 549:02 - THREEPOINT CREEK CALL-OUT INSPECTION</b>			
		TITLE: <b>EAST SITE PLAN</b>			
CLIENT:	<b>ALBERTA TRANSPORTATION</b>		DATE:	JOB No.:	CAD FILE:
			AUGUST 2012	CG25399	25399B01.dwg
				FIGURE No.:	REV.
				FIGURE 1	A

- The creek flowing south of the road was approximately 300 mm deep during the inspection but appeared to have a 1 to 2 m deep flood flow previously this year.
- The east-flowing creek bends toward the northwest forming a bank exposure on the south side of the road for approximately 60 to 80 m.

- The bank is up to 6 m high, nearly vertical from the base with the upper 1 to 2 m at a 15-20° angle, and has a minimum offset of 8 m from the road edge.
- The bank had seepage 2 m from the base and was made up of erodible silt, sand and cobbles (likely of fluvial origin) and clay.

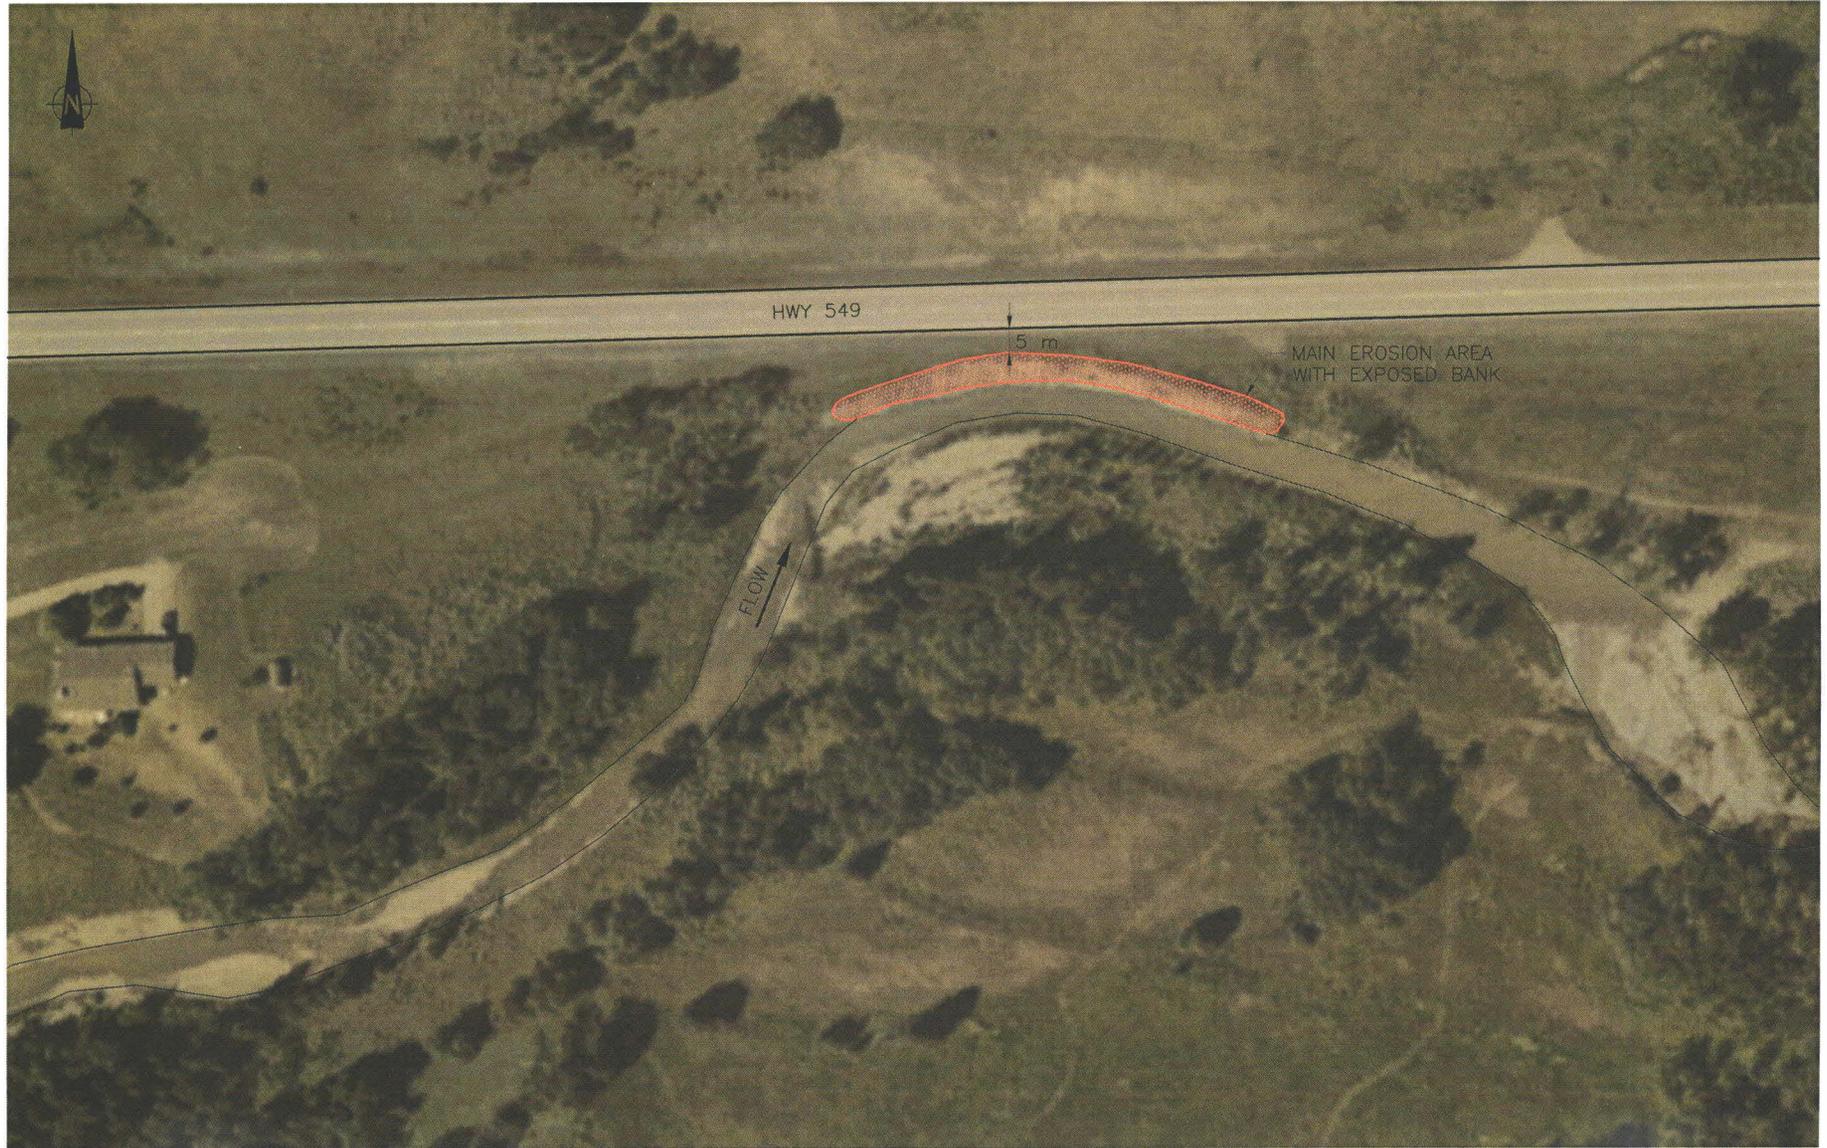
**WEST SITE PLAN**

- A very similar condition to what was observed to be occurring at the East Site.
- The upstream creek flow appeared to more constricted, flow energy was higher and the angle of attack towards the bank was higher relative to the East Site.
- The bank exposure here is approximately 40 to 50 m long.
- The bank is vertical for 2 m at the top and then slopes to approximately 50°, with a total bank height of 5 to 6 m.
- The bank edge has a minimum offset of 5 m from the south road shoulder.

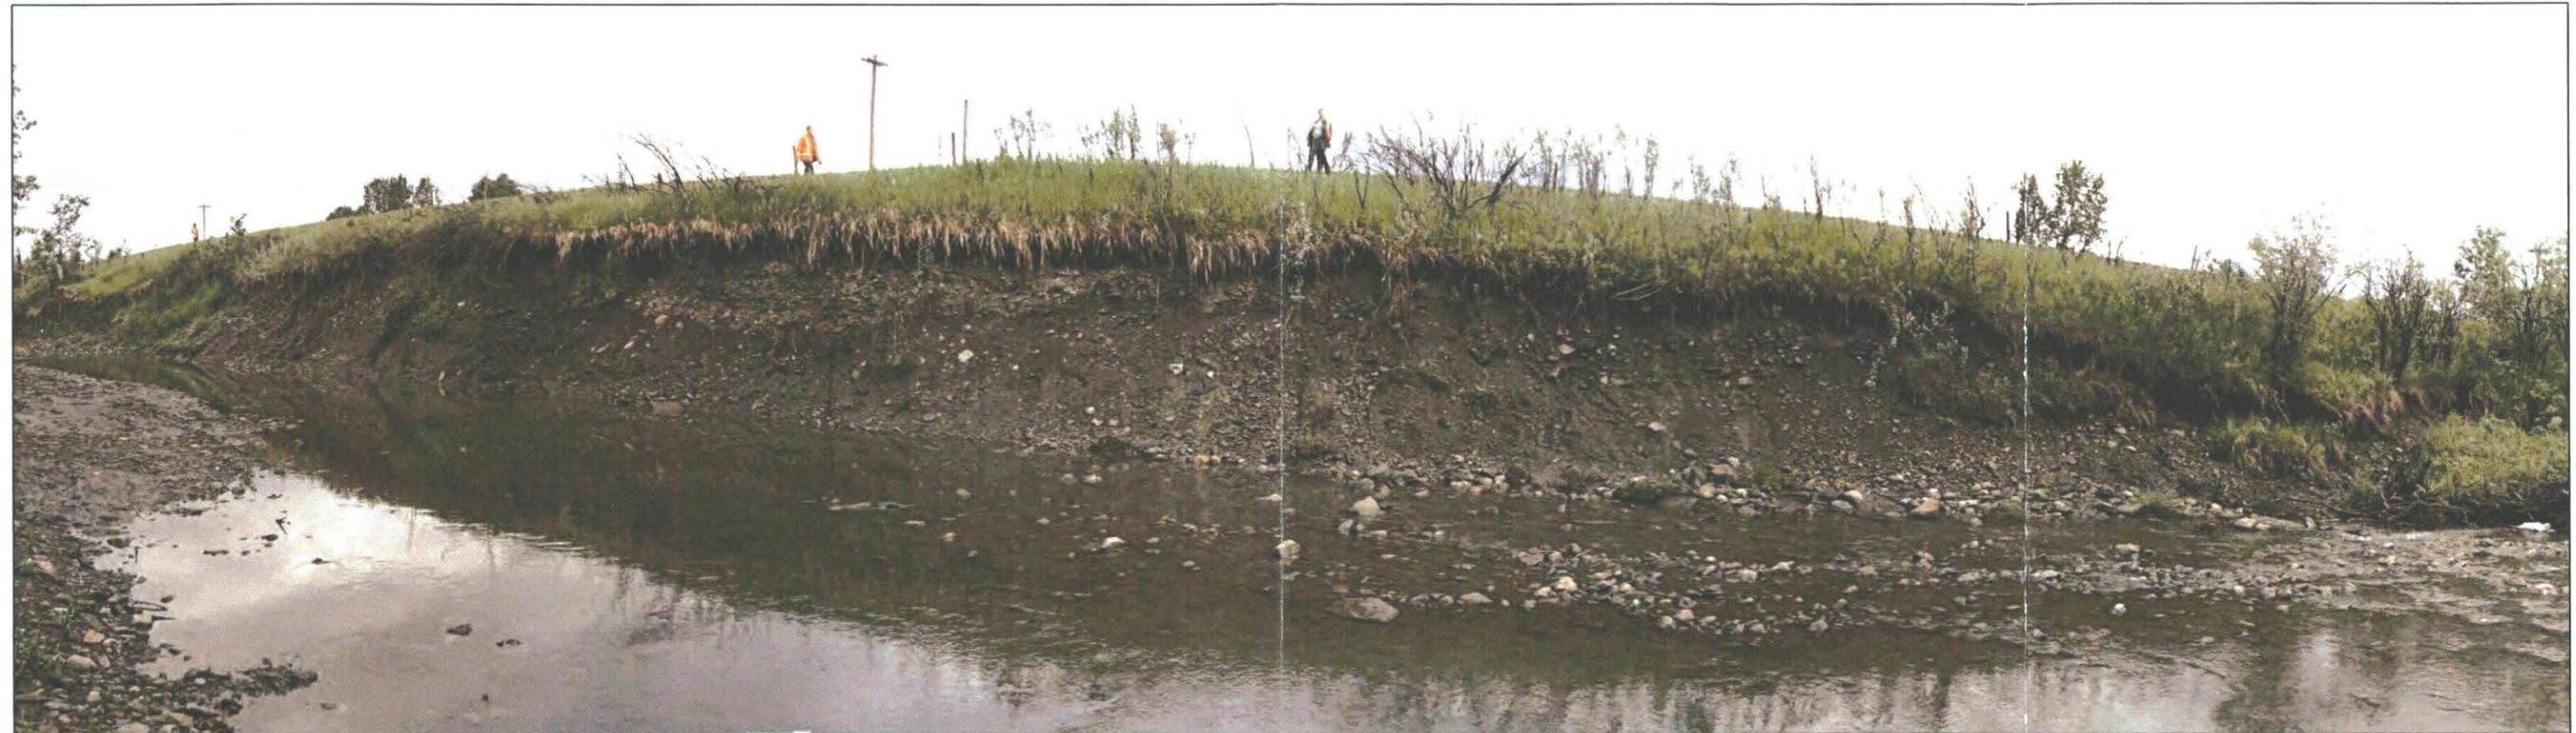
- Probability Factor of 11, based on the ongoing movement and that the scarp of the bank is expected to continually retrogress and cause settlement or damage to a portion of the road. Erosion and retrogression rates will likely increase during years of high precipitation.
- Consequence Factor of 2, reflecting the fact that a large sudden failure is unlikely and only one lane of the highway is currently affected. To date the remaining highway lane appears unaffected by the erosion and bank encroachment.

Photo 1 – At the East Site standing on the south bank of Threepoint Creek, looking towards the highway at the main section of the north bank exposure.

- To slow erosion and encroachment towards the highway, mitigation could involve armouring the exposed bank via gabion basket or cobble placement. Alternatively options involving the feasibility of channel re-alignment could be evaluated.

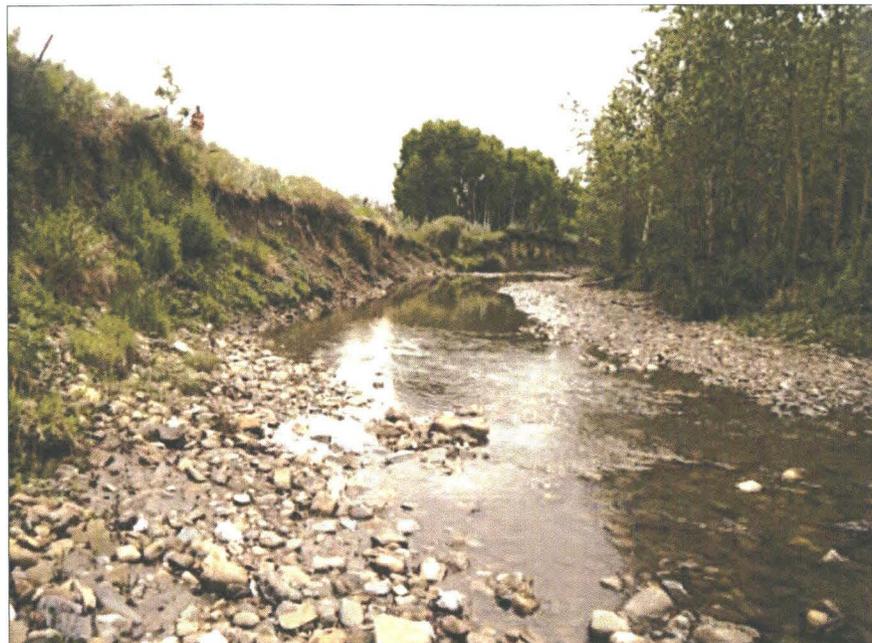
Photo 2 (above) – At the west end of the East Site, looking downstream (east) Threepoint Creek.

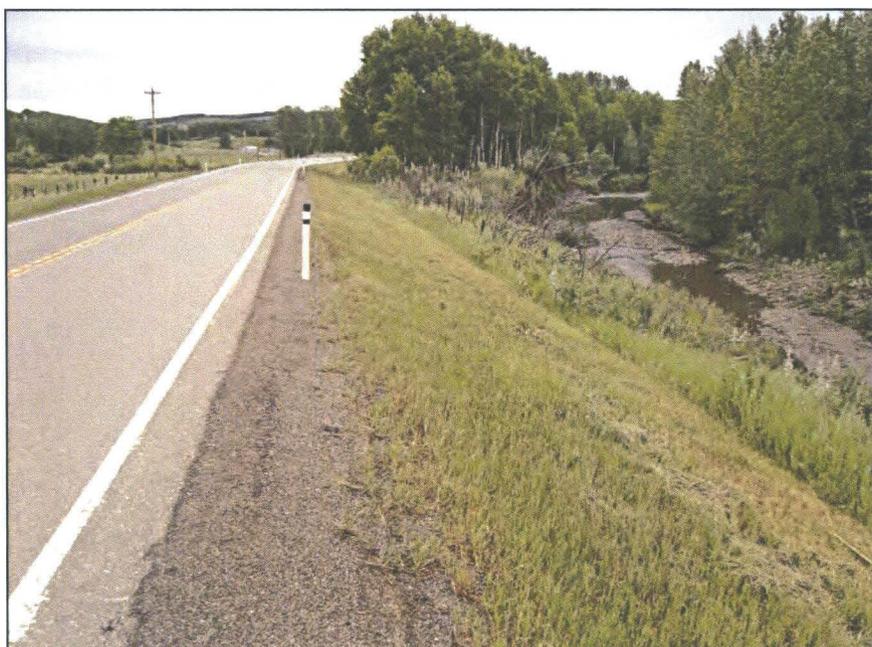
Photo 3 (above) – At the west end of the East Site, looking towards the east along the road shoulder where the minimum offset was measured.

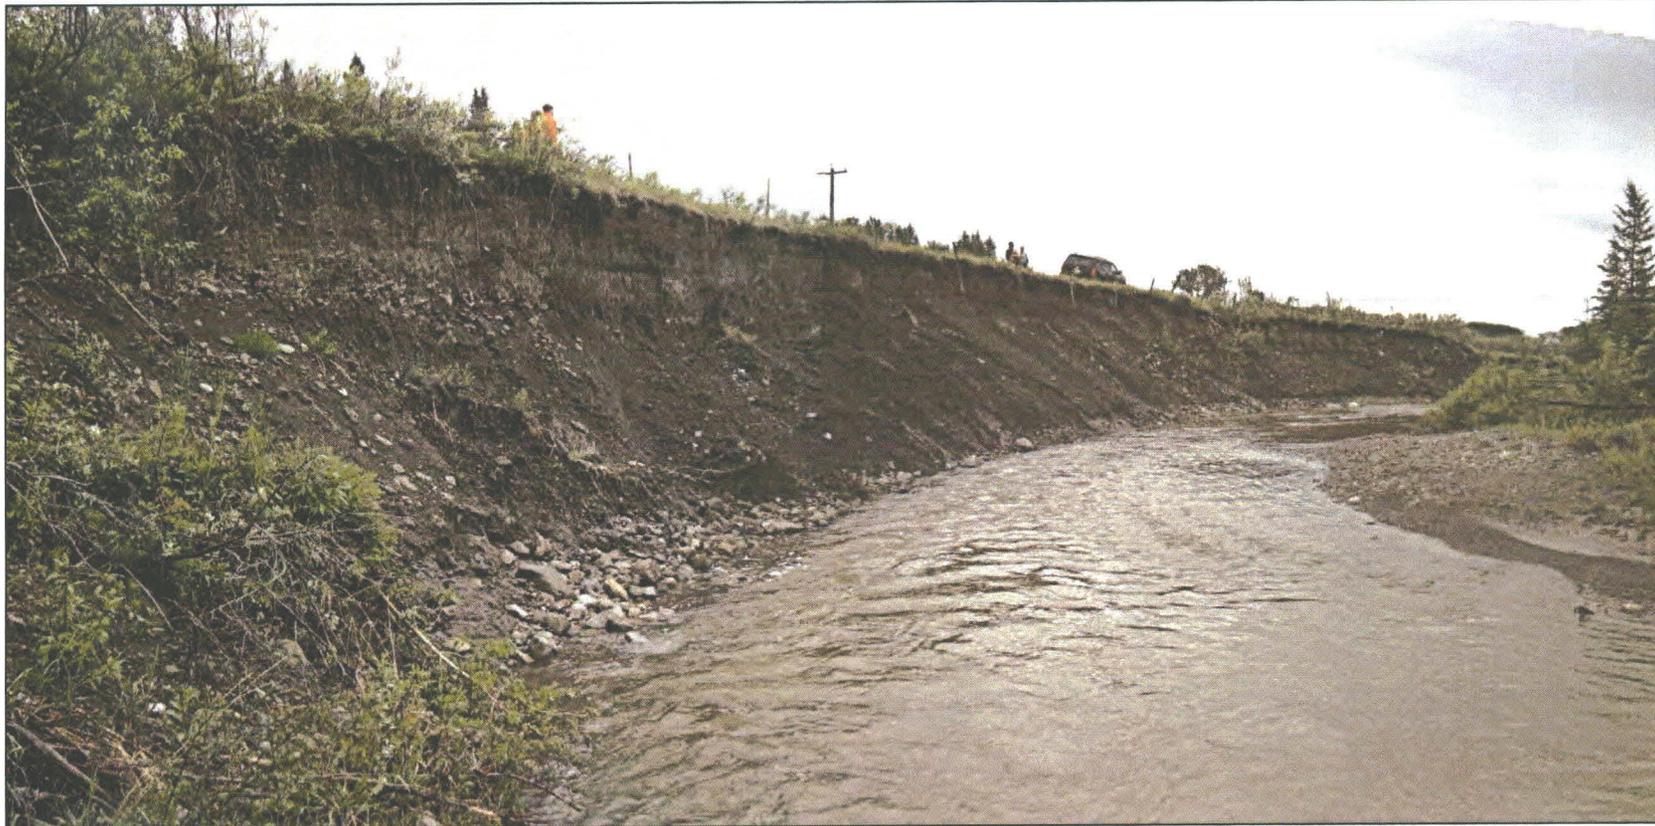
- Probability Factor of 12, based on the ongoing movement and current offset between the road and bank edge. The bank scarp is expected to continually retrogress and cause settlement or damage to a portion of the road. Erosion and retrogression rates will likely increase during years of high precipitation.
- Consequence Factor of 2, reflecting the fact that a large sudden failure is unlikely and only one lane of the highway is currently affected. To date the remaining highway lane appears unaffected by the erosion and encroachment.

Photo 4 (above) – At the West Site, looking downstream towards the northeast at the highway and main section of the north bank exposure.

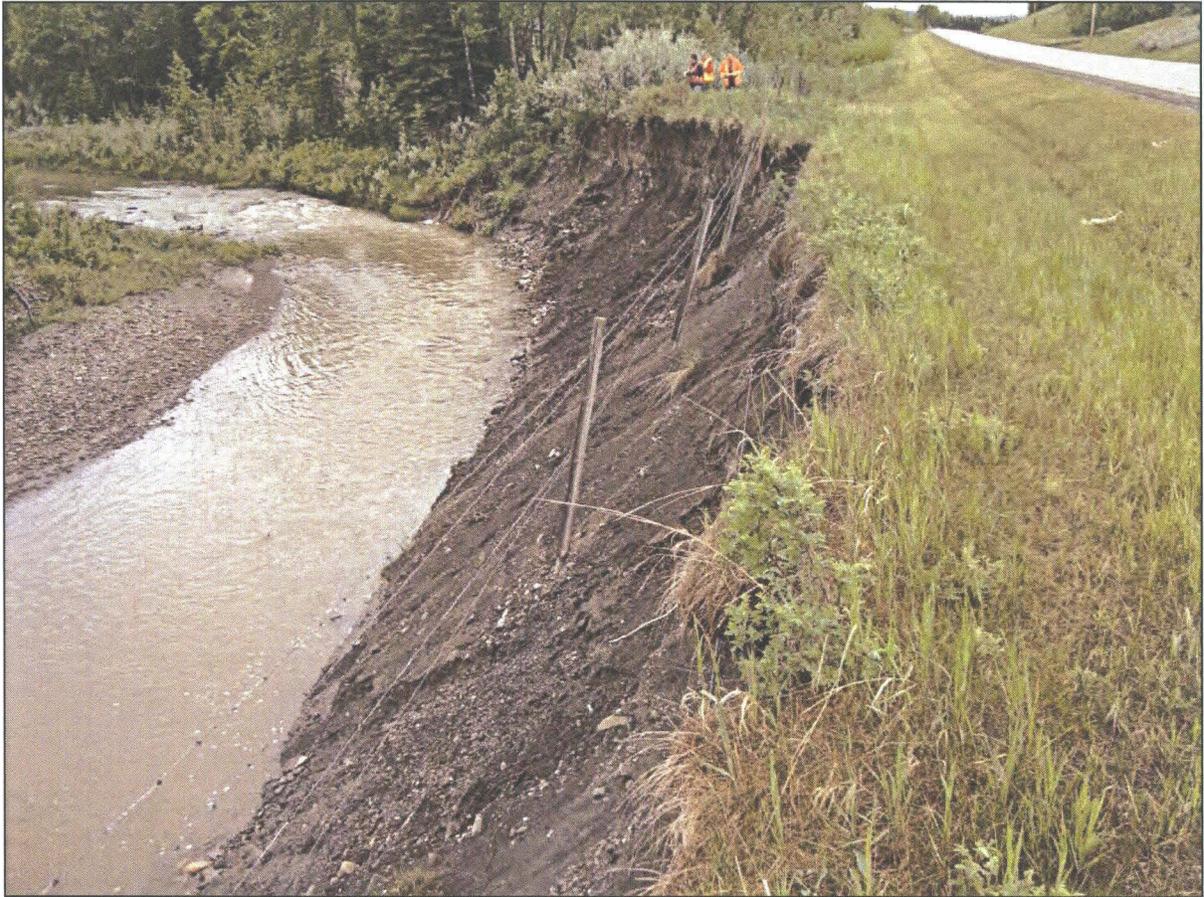
Photo 5 (above) – At the West Site, looking upstream (west) along the south road ditch where the minimum offset between the bank crest and road shoulder was measured.
