SITE NUMBER AND NAME: <b>S045-I Threepoint Creek</b>		HIGHWAY & KM: 549:02, 12.315	PREVIOUS INSPECTION DATE: May 29, 2017	INSPECTION DATE: <b>May 1, 2018</b>
LEGAL DESCRIPTION: 02-08-021-03 W5M	NAD 83 COORDINATES: UTM Northing Easting 11 5626611 684647		RISK ASSESSMENT: PF: 7 CF: 4 TOTAL: 28	
AVERAGE ANNUAL DAILY TRAFFIC (AADT): 900 (east), (Ref No. 65170)			CONTRACTOR MAINTENANCE AREA (CMA): 27

PROJECT SOUTHERN REGION GEOHAZARD RISK MANAGEMENT PROGRAM		
TITLE Site Plan S045-1 - Threepoint Creek H549:02, km 10.704		
SCALE 1:2,000	PROJECT No. A05115A03	FIG No. 1

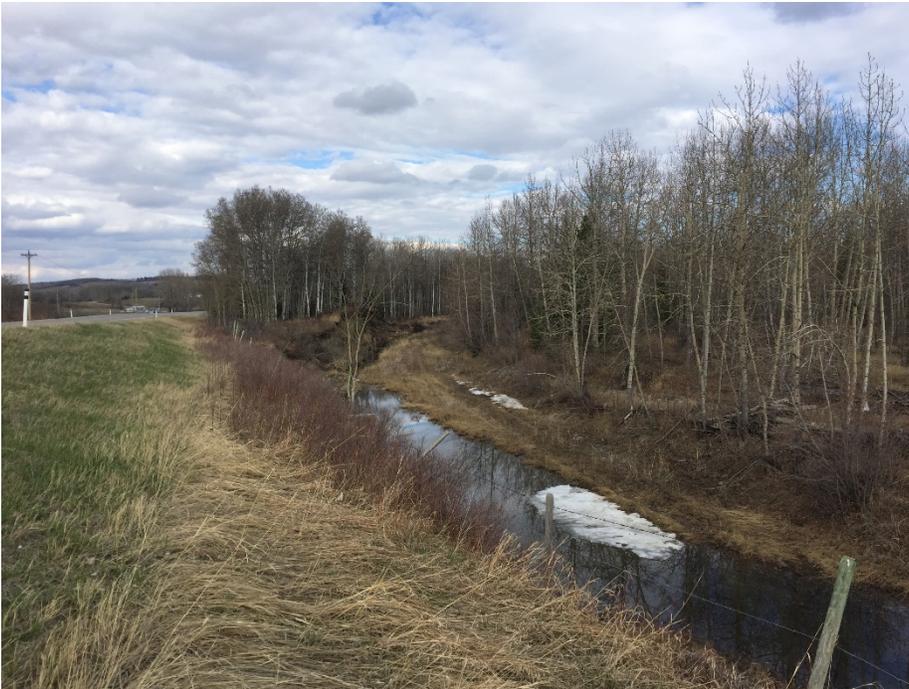
**Photo 1** Highway and bank above cut bank on secondary channel S45-I. Photo was taken facing northeast on May 1, 2018.

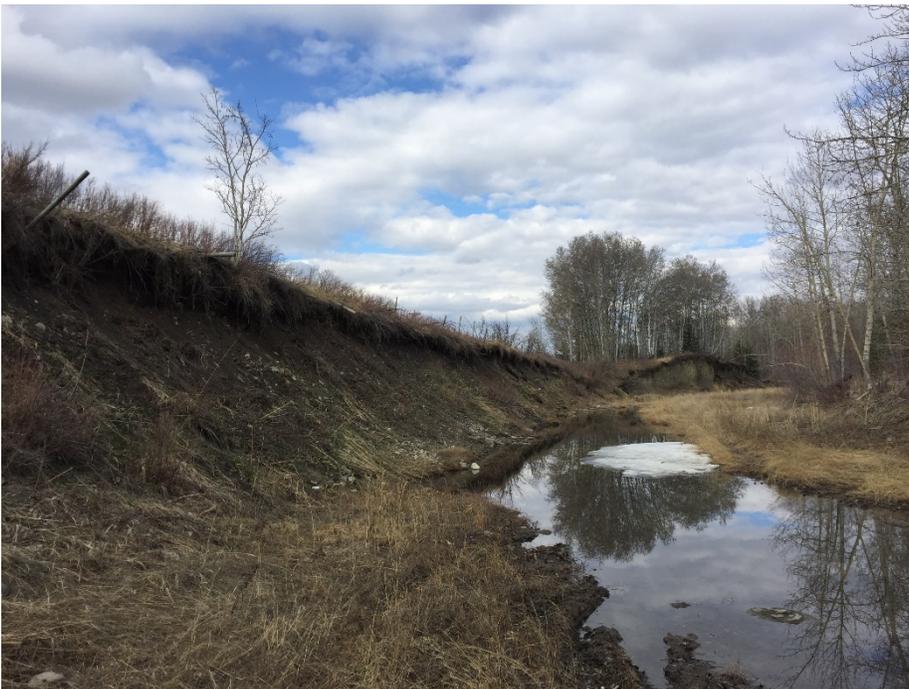
**Photo 2** Downstream of eroded slope. No change in creek erosion towards road embankment in approximately 5 years. Photo was taken facing northeast on May 1, 2018.

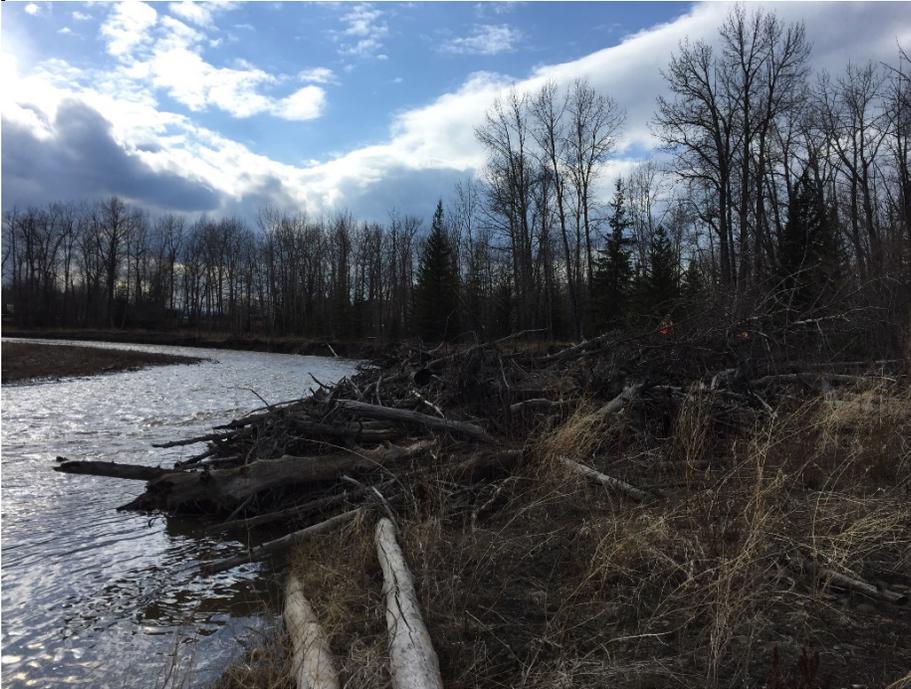
**Photo 3**      **Tree debris blocking river from entering creek. No change in tree debris from 2017 inspection. Some additional plant growth. Photo was taken facing northwest on May 1, 2018.**
