SITE NUMBER AND NAME: S045-I West Fisher Creek		HIGHWAY & KM: 549:02, 10.704	PREVIOUS INSPECTION DATE: July 5, 2021	INSPECTION DATE: May 9, 2023
LEGAL DESCRIPTION: 16-08-021-03 W5M	NAD 83 COORDINATES: UTM Northing Easting 11 5626463 683084		RISK ASSESMENT: PF: 10 CF: 10 TOTAL: 100	
AVERAGE ANNUAL DAILY TRAFFIC (AADT): 800 (east), (Ref. No. 65170)			CONTRACTOR MAINTENANCE AREA (CMA): 27

PROJECT SOUTHERN REGION GEOHAZARD RISK MANAGEMENT PROGRAM		
TITLE Site Plan S045-1 - West Fisher Creek Hwy 549:02; km 10.704		
SCALE 1:1,000	PROJECT No. A05116A03	FIG No. 1

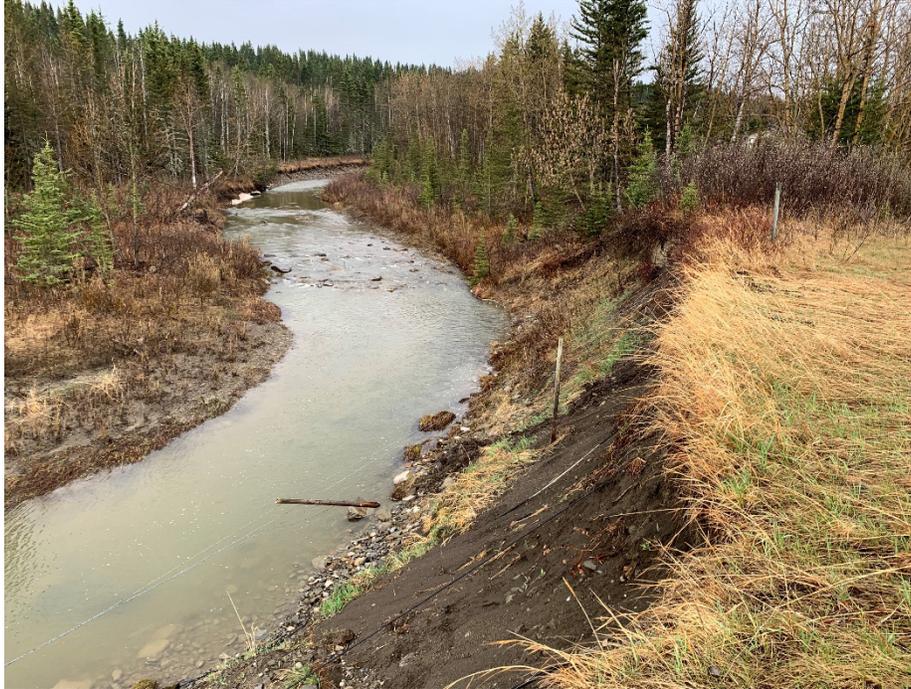
Erosion and sloughing of the slope are undermining the fence. Recently displaced blocks of grass and soil were observed. The equivalent of thirteen fence posts were hanging from the fence in 2020. In 2021 and 2023, all the fence posts had fallen off and KCB were not able to confirm whether the erosion limits had extended laterally.

There are three black utility cables in the slope, exposed by erosion (two cables have snapped).

Photo 1 Active slope erosion from creek flow. The ditch has eroded and is draining onto the slope. Hanging fence and exposed utility cables in scarp. Photo was taken facing southwest on May 9, 2023.

- Short-Term
 - Monitor location during and after high flows and significant antecedent rain or snow melt.
 - Divert surface water flow away from site.
- Long-Term
 - Slope reconstruction with traditional riprap armouring and geogrid reinforcement gravel. The design solution has been finalized and KCB have completed a tender document for S045-I. Construction is currently scheduled for 2024.

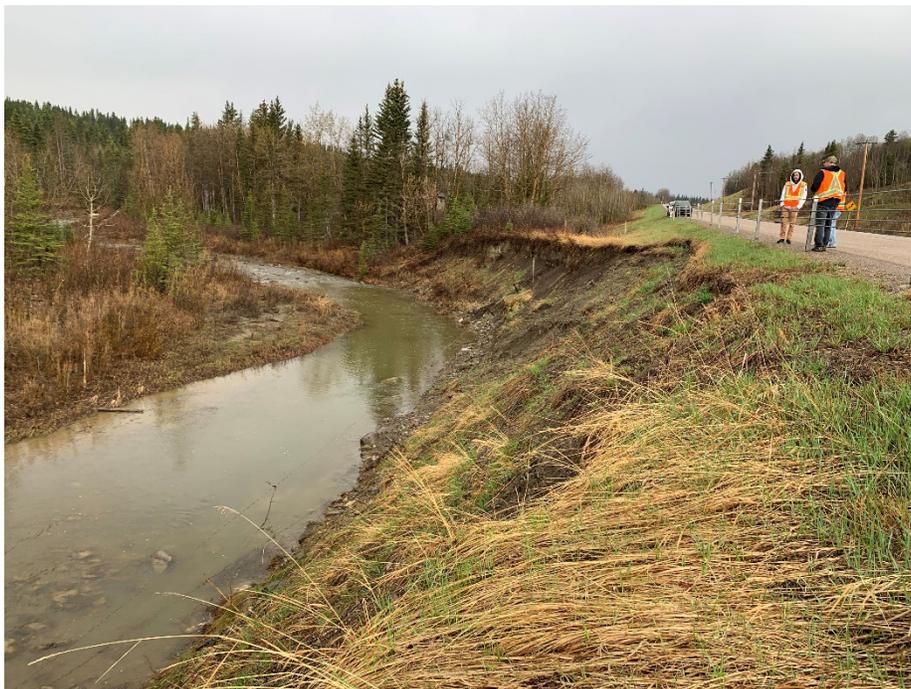
Photo 2 Upstream corner of slope erosion (west end). Photo was taken facing west on May 9, 2023.

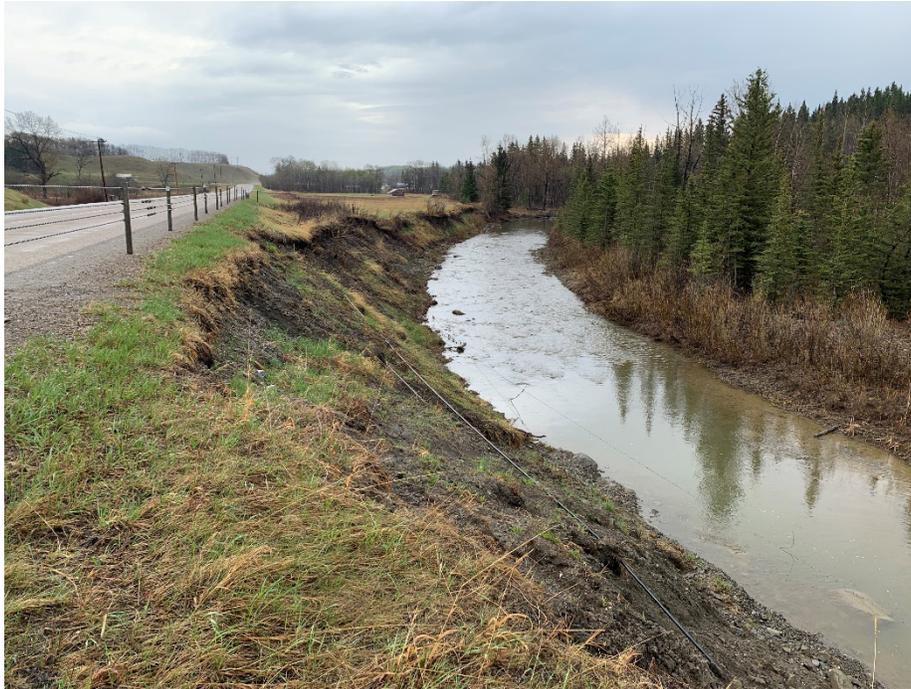
Photo 3 Displaced grass and soil due to surface runoff and ongoing bank erosion from Fisher Creek. Photo taken facing east on May 9, 2023.

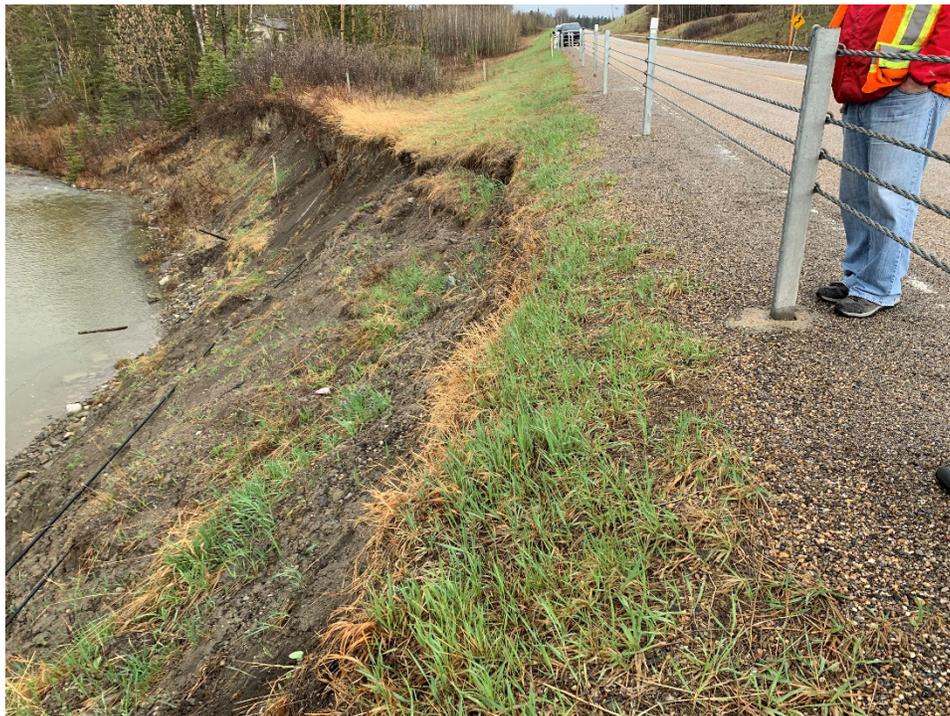
PRIMARY SITE ISSUE: Active slope erosion due to seasonal high flows and flood flows at meander bend in Fisher Creek. Seepage and surface runoff erosion threatens to undermine road. Crest of the erosion feature is approximately 1.1 m from edge of pavement (was 2.7 m during 2016 inspection, 2.0 m during the 2017 and 2018 inspections, 1.9 m during 2019 inspection, 1.4 m during the 2020 inspection, 1.2 m during 2021 inspection).

Photo 4 Crest of erosion approximately 1.1 m from guardrail. Photo taken facing west on May 9, 2023.
