SITE NUMBER AND NAME: S045-1 West Fisher Creek	HIGHWAY & KM: 549:02, 10.704	PREVIOUS INSPECTION DATE: May 9, 2023	INSPECTION DATE: May 26, 2025
LEGAL DESCRIPTION: 16-08-021-03 W5M	NAD 83 COORDINATES: UTM Northing Easting 11 5626463 683084	RISK ASSESSMENT: PF: 1 CF: 6 TOTAL: 6	
AVERAGE ANNUAL DAILY TRAFFIC (AADT): 800 (east), (Ref. No. 65170)		CONTRACTOR MAINTENANCE AREA (CMA): 521

SOUTHERN REGION GEOHAZARD RISK MANAGEMENT PROGRAM

Site Plan
S045-1 - West Fisher Creek
Hwy 549:02, km 10.704

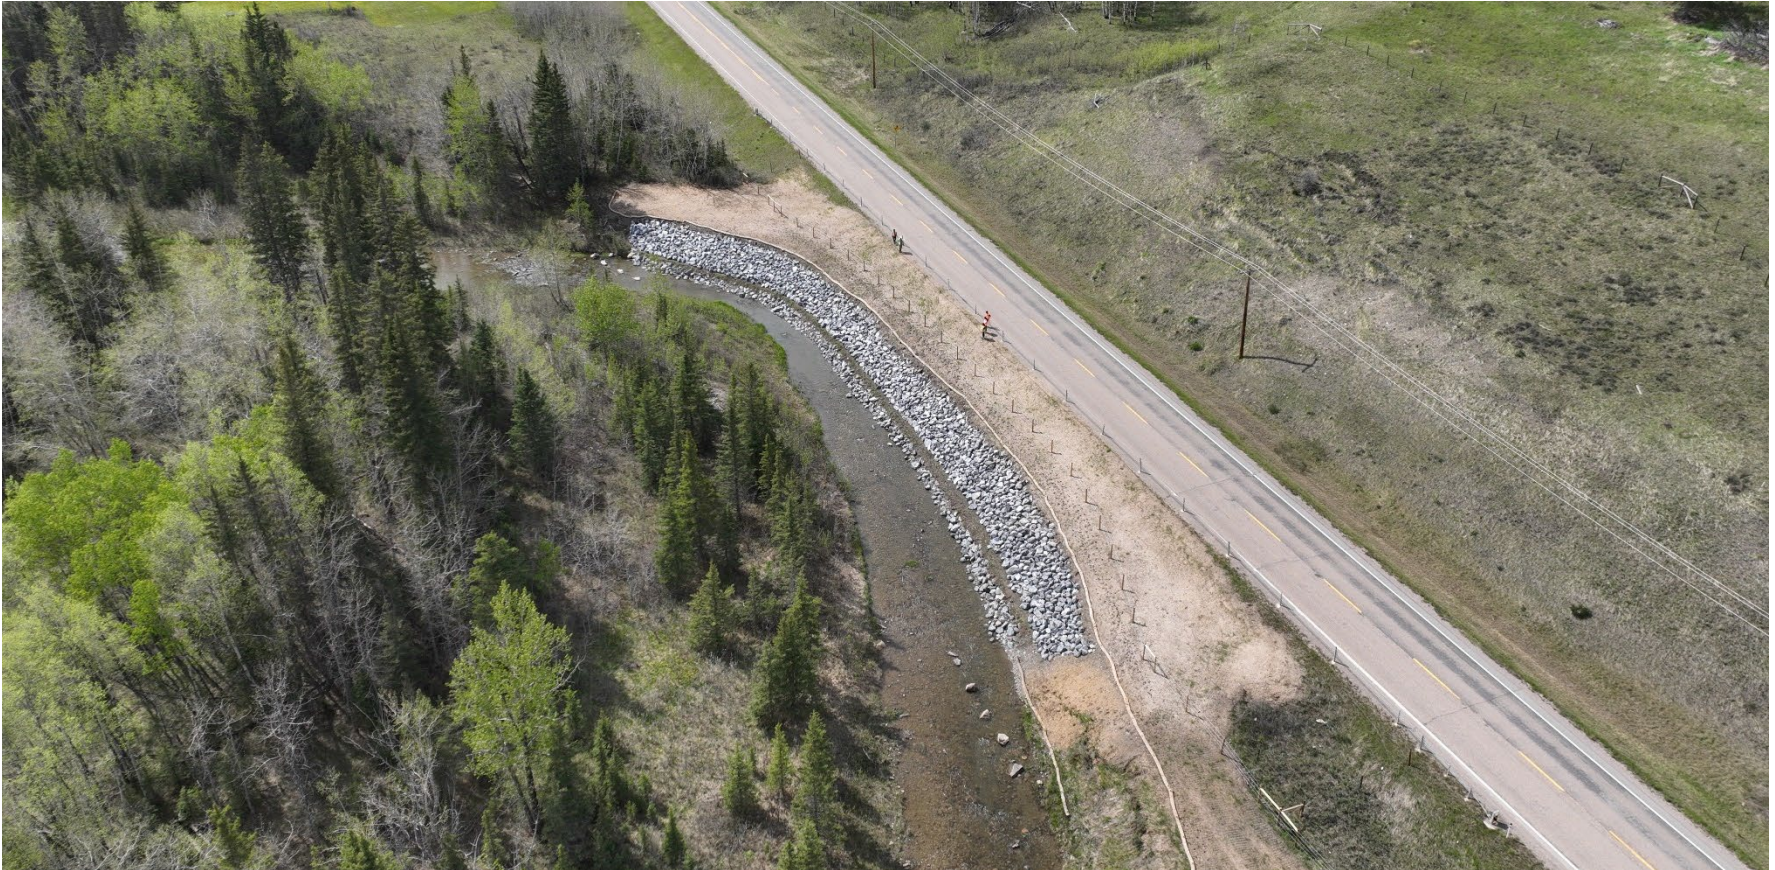
Photo 1 Aerial view of the S045-1 site showing the repair extents. Photo taken May 26, 2025, facing northwest.

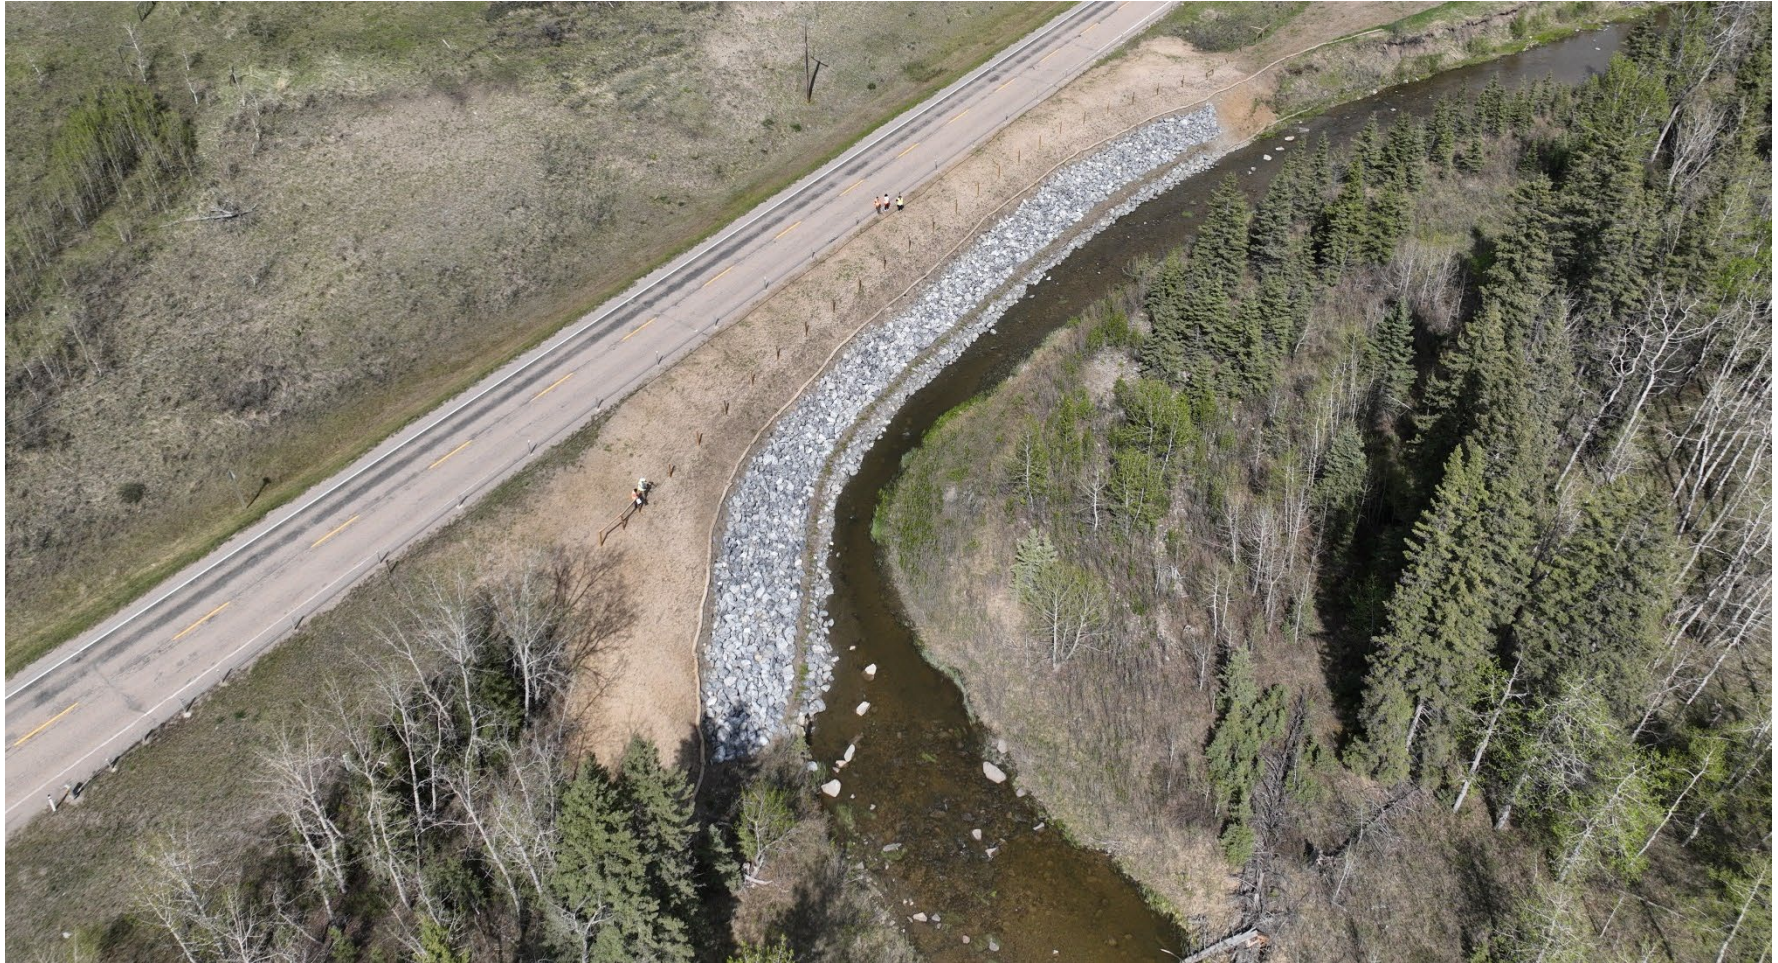
Photo 2 **Aerial view of the S045-1 site showing the repair extents. Photo taken May 26, 2025, facing northeast.**

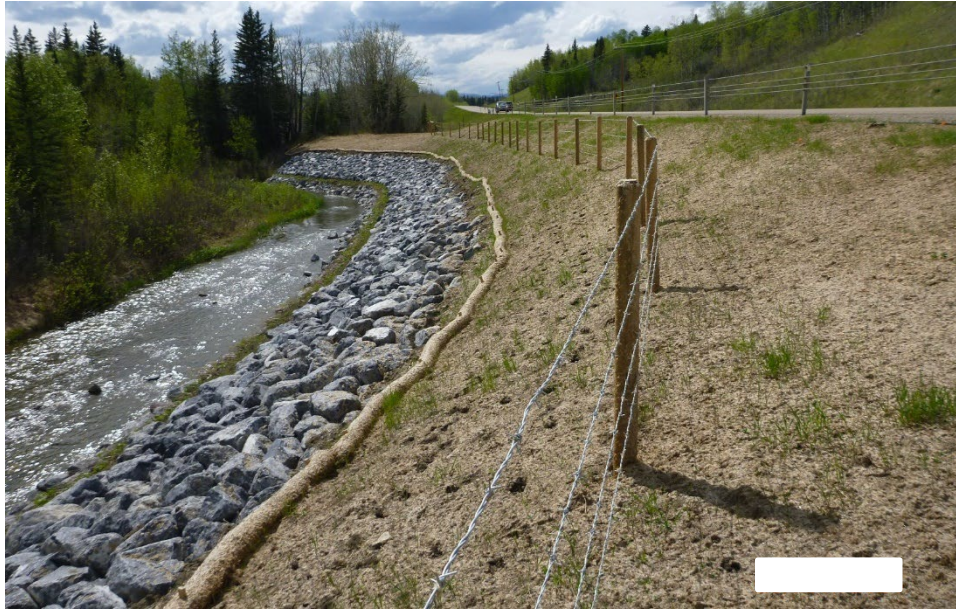
Photo 3 The east end of the S045-1 site. The 2024 repair (new barbed wire fence, reconstructed slope, riprap armouring, and brush later) appeared to be in good condition. Photo taken May 26, 2025, facing west.

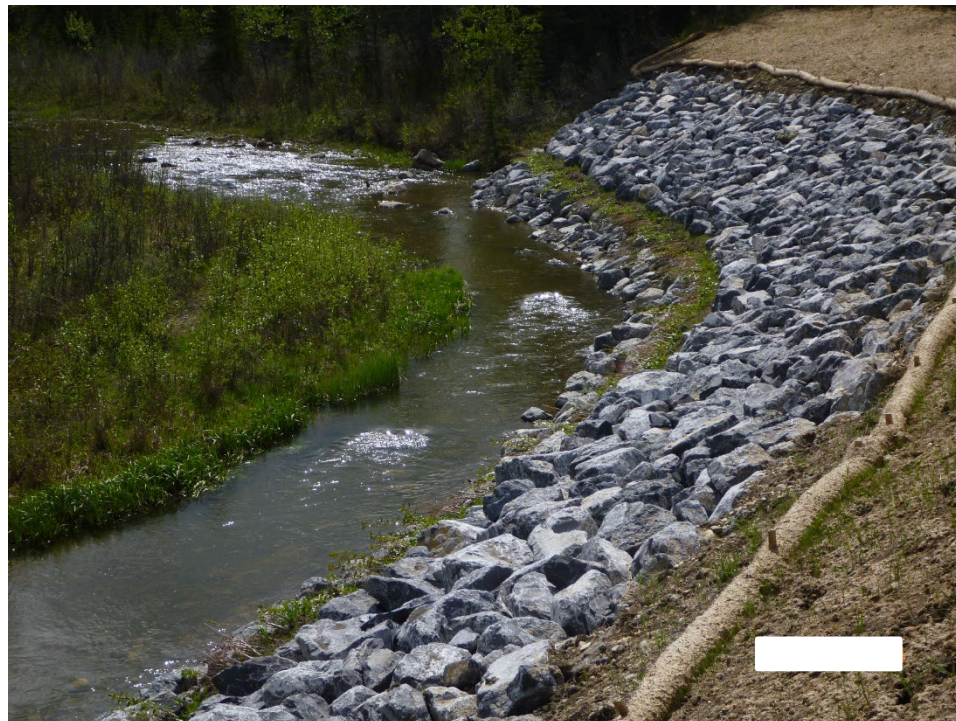
Photo 4 The west extent of the S045-1 site. The riprap appeared to be well-placed, and the brush layer appeared to be growing well during the inspection. Photo taken May 26, 2025, facing west.

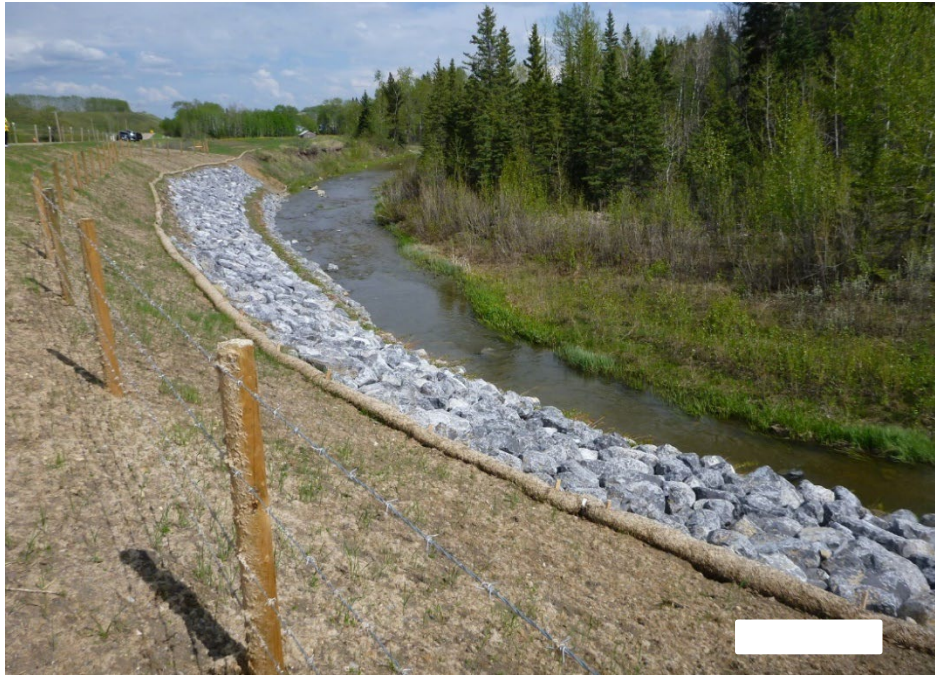
Photo 5 **The Class 2 riprap was in good condition and the brush layer appeared to be growing well. Photo taken May 26, 2025 facing east.**

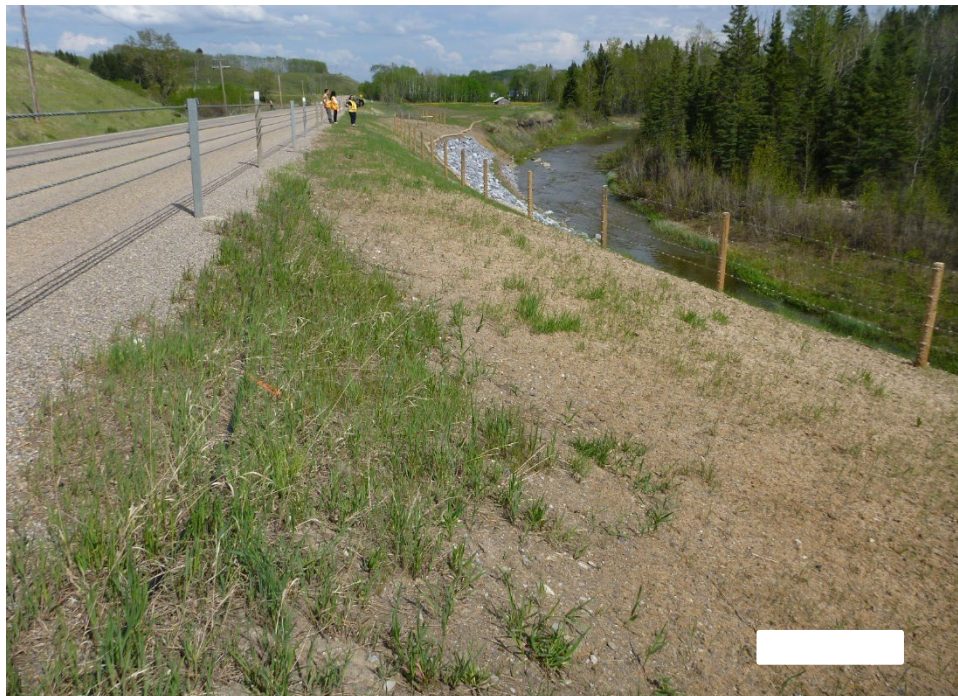
Photo 6 **The crest of the slope between the HTCB and barbed wire fence was relatively smooth, and grass was growing on the slope. Photo taken May 26, 2025, facing east.**
