November 26, 2025

Alberta Transportation and Economic Corridors
2nd Floor, 803 Manning Road N.E.
Calgary, Alberta
T2E 7M8

CON0022161 Southern Region GRMP Instrumentation Monitoring
Site S012; H742:02, km 4.319 Spray Lakes Road
Section C – 2025 Fall Readings

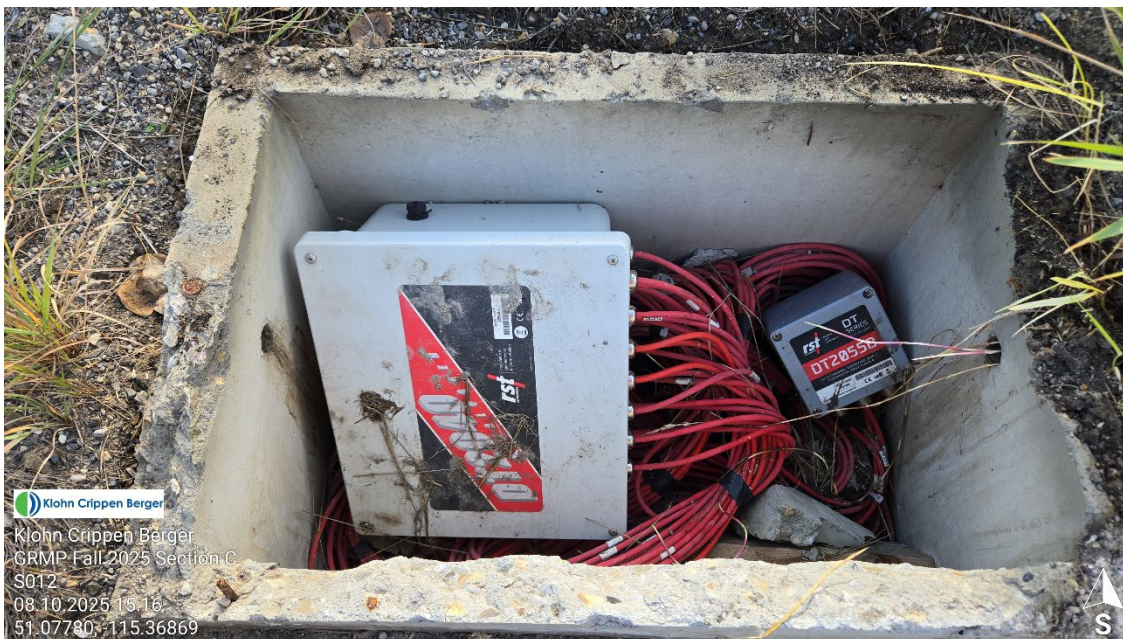
The concrete enclosure where the data loggers are stored continues to be damaged, and the steel plate cover can no longer be securely fastened to the concrete. This damage was caused between the spring 2024 and fall 2024 readings. The MCI confirmed that a subcontractor of HMC, who was cutting the grass, was responsible for the damage to the data logger enclosure. KCB is to coordinate with TEC and the MCI regarding the request to the HMC for repairs to the enclosure. Currently, the cover is held in place with a thick plastic sheet secured with a ratchet strap.

Photo 3.1 Damaged concrete enclosure where the data loggers are stored

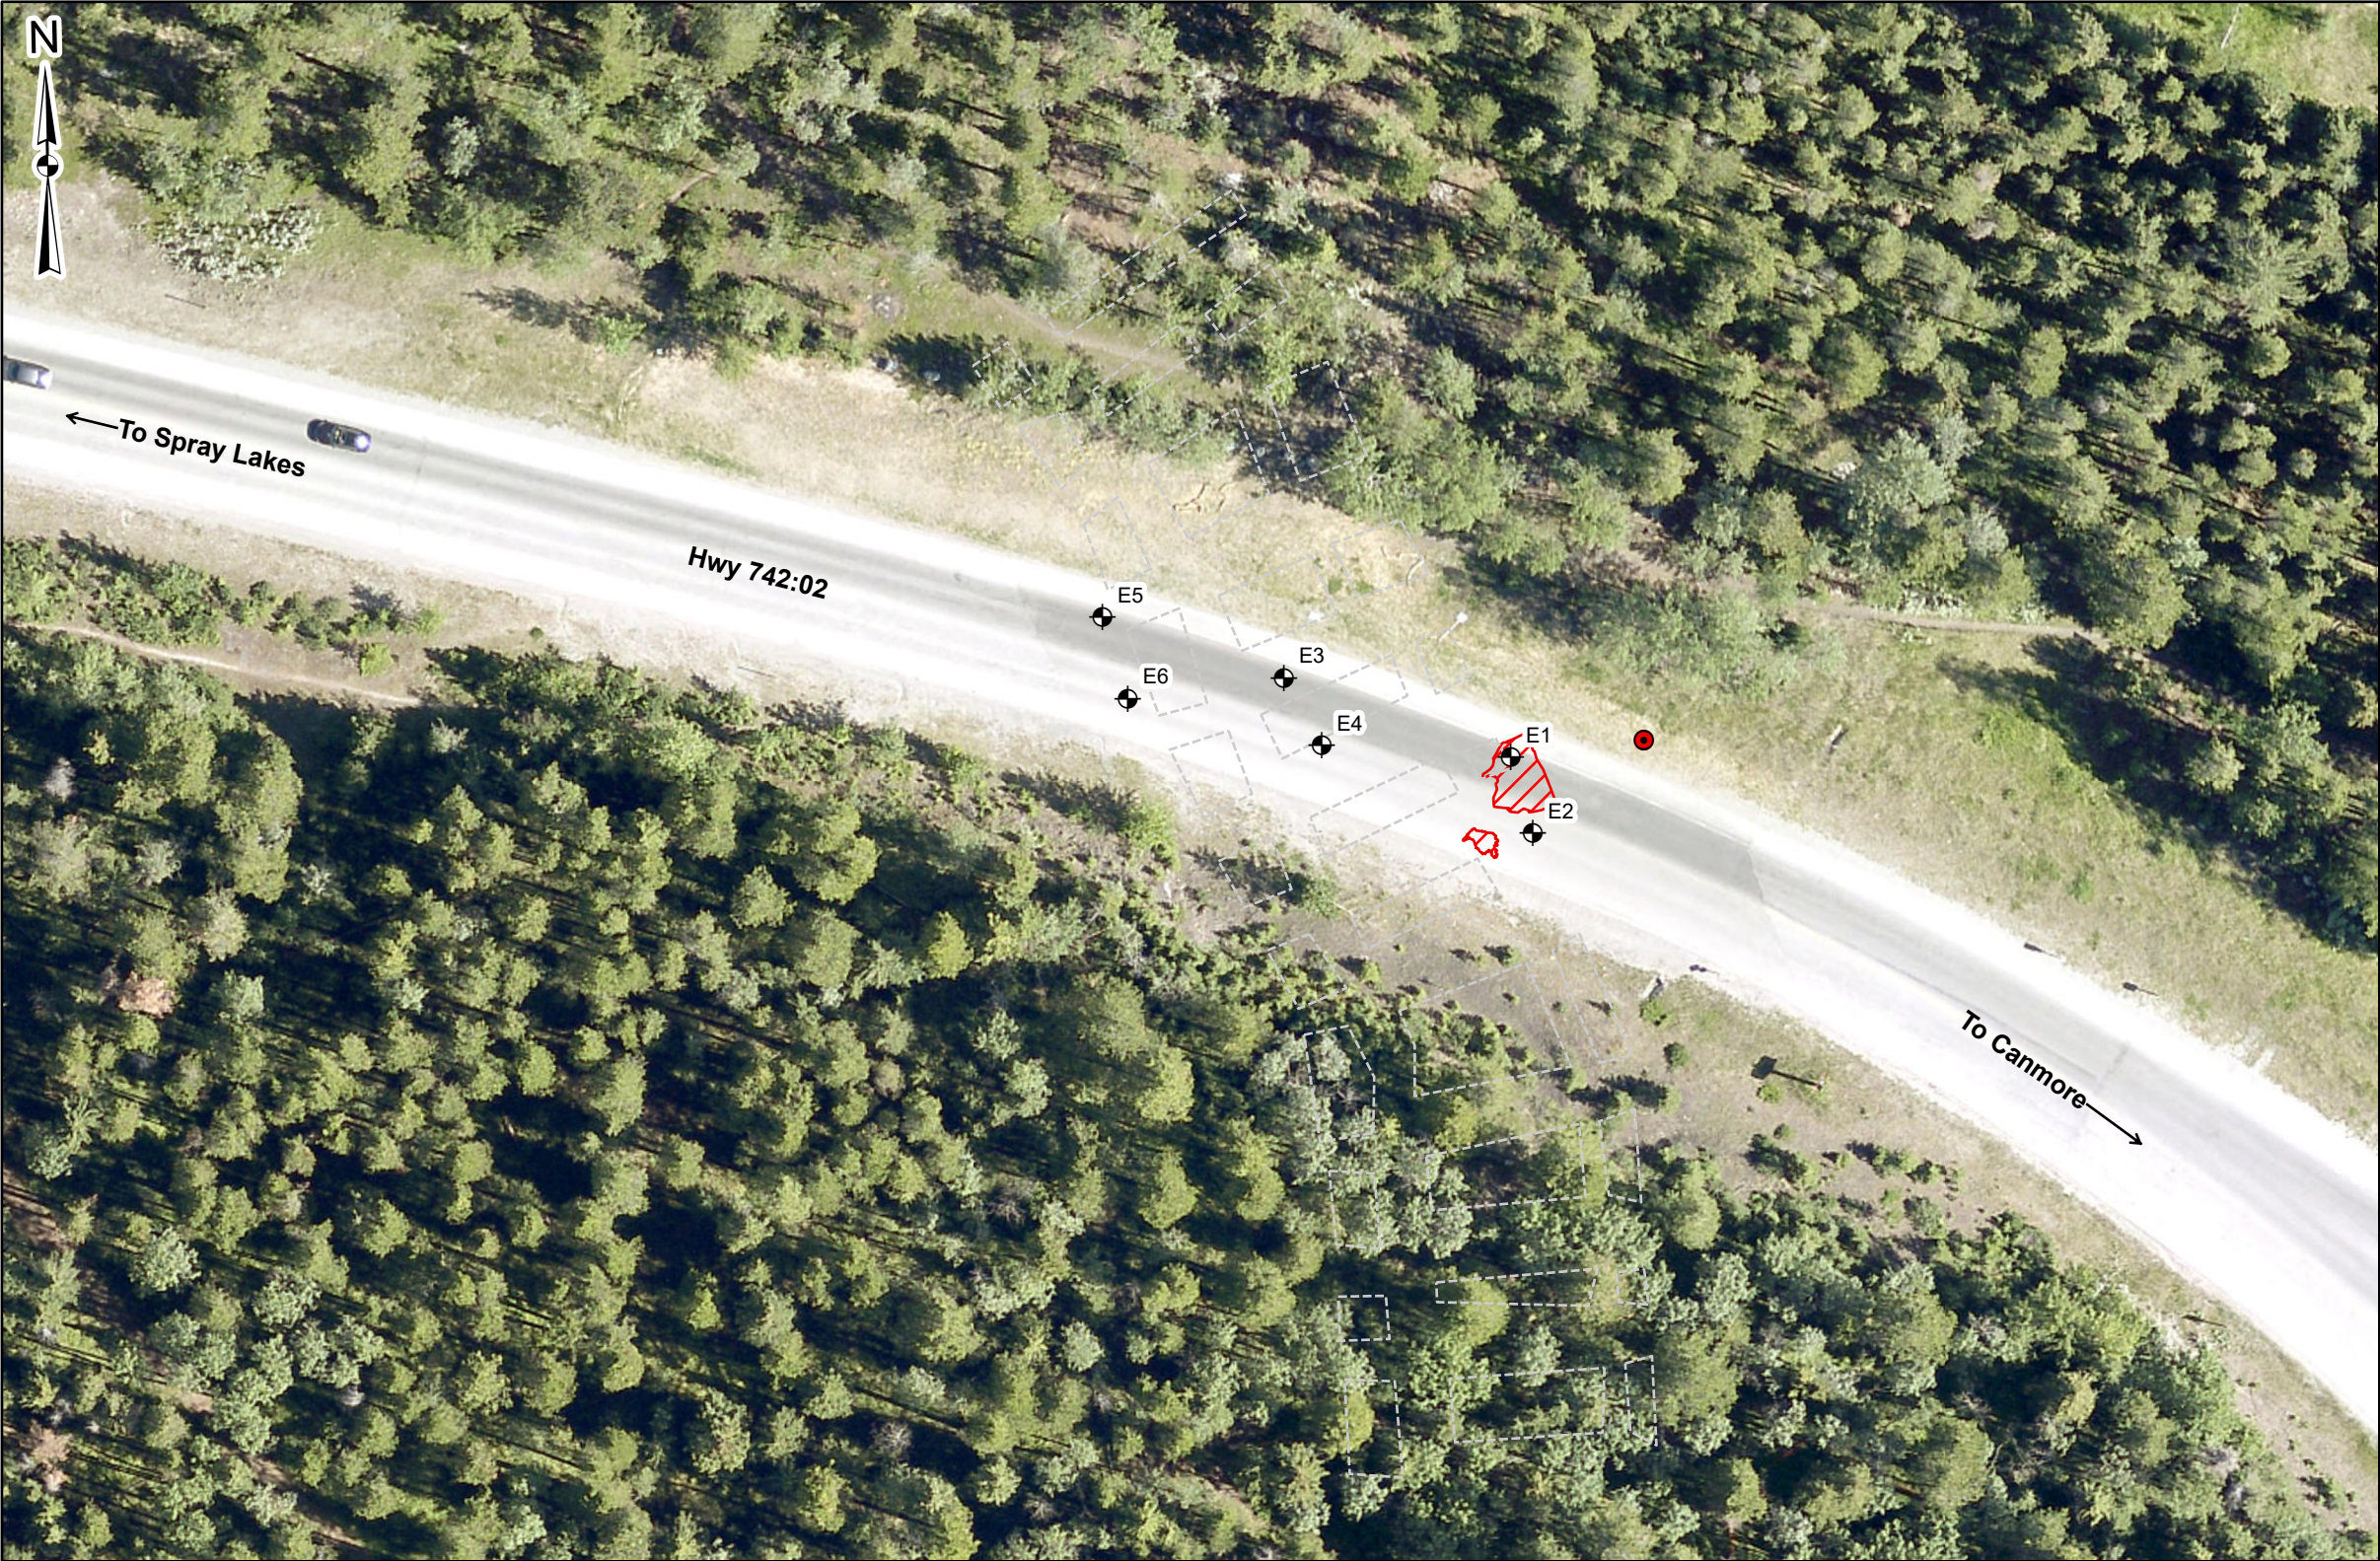
SCALE 1:600 PROJECT No. A05116A03 FIG No. 1

The VWI extensometers were first read in October 2021. Instrumentation installation details are tabulated in Table 1.1. Instrument locations are shown in Figure 1.

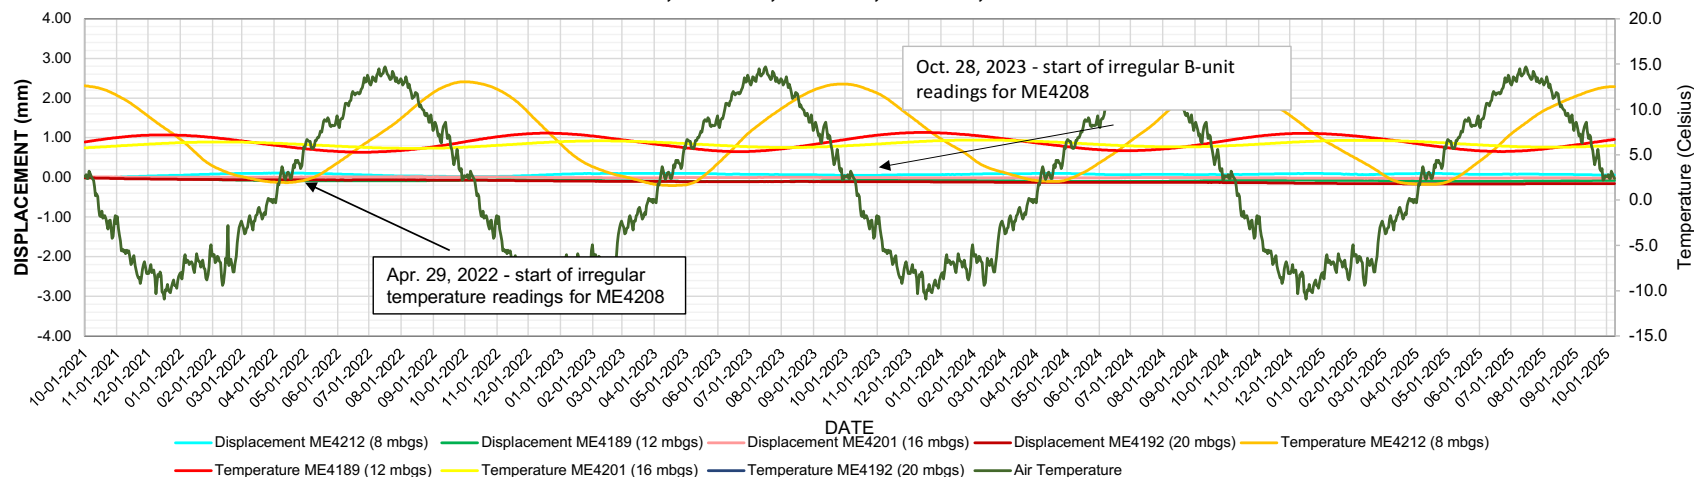
E5: ME4189, ME4192, ME4201, ME4208, AND ME4212

- The maximum positive (i.e. lengthening) net displacement (difference between current reading and initial reading) in the extensometers is 0.96 mm, recorded in E4 ME4204 (2 mbgs). Only 3 other extensometers recorded net positive displacement, which E3 ME4202 (6 mbgs), E3 ME4193 (14 mbgs), and E5 ME4212 (8 mbgs). All other extensometers have recorded negative (i.e., shortening) net displacement since the initial readings, with a maximum of -1.19 mm, recorded in E4 ME4207 (2 mbgs).
- E5 ME4208 (4 mbgs) and E6 ME4211 (4 mbgs) have recorded irregular temperature readings since April 29, 2022 and June 28, 2022, respectively, and are inoperable. E5 and E6 are both located at the west extent of the repair site in the westbound and eastbound lanes, respectively.

The connection between the cable leads for E5 ME4208 and E6 ME4211 and the RST data loggers were inspected and reconnected during the 2023, 2024, and 2025 instrument readings to check if a poor connection was attributing to the irregular data being recorded for those two instruments. After completing this, the instruments were still recording irregular data. KCB will discuss with the supplier, RST, why these instruments are recording irregular data.

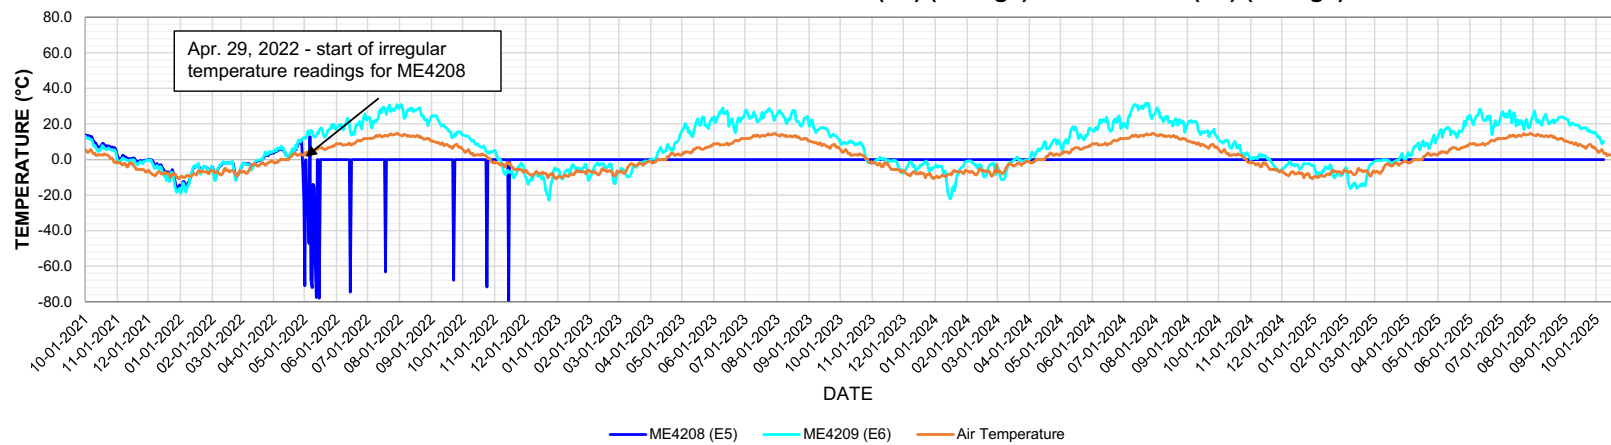
TEMPERATURE DATA FOR ME4208 (E5) (4 mbgs) AND ME4209 (E6) (4 mbgs)

³ ME4208 and ME4211 have recorded irregular temperature readings since April 29, 2022 and June 28, 2022, respectively, and are currently inoperable.
