SITE NUMBER AND NAME: S031-2 Mystery Culvert	HIGHWAY & KM: 762:02, 17.660	PREVIOUS INSPECTION DATE: May 28, 2024	INSPECTION DATE: May 26, 2025
LEGAL DESCRIPTION: 07-19-22-04-W5M	NAD 83 COORDINATES: UTM Northing Easting 11 5639613 672917	RISK ASSESSMENT: PF: 8 CF: 4 TOTAL: 32	
AVERAGE ANNUAL DAILY TRAFFIC (AADT): 1090 (north) & 1380 (south) (Reference No. 65170 & 60180)		CONTRACTOR MAINTENANCE AREA (CMA): 521

PRIMARY SITE ISSUE: Slope instability in the west highway embankment impacting the west (southbound) lane. APPROXIMATE DIMENSIONS: The slide is approximately 40 m wide. Settlement is approximately 2 m of the west (southbound) lane. The height of the highway embankment is approximately 4 m to 5 m. DATE OF ANY REMEDIAL ACTION: Regular pavement patches have been completed at the site, with the most recent one being completed in the summer or fall of 2022. February 2025 – A site investigation was performed at the site, which included one borehole and the installation of one SI and two VWPs. Previous repairs might have included a toe berm that was noticed during the 2025 inspection, which appears to extend past the fence along the west side of the highway. There are no known detail

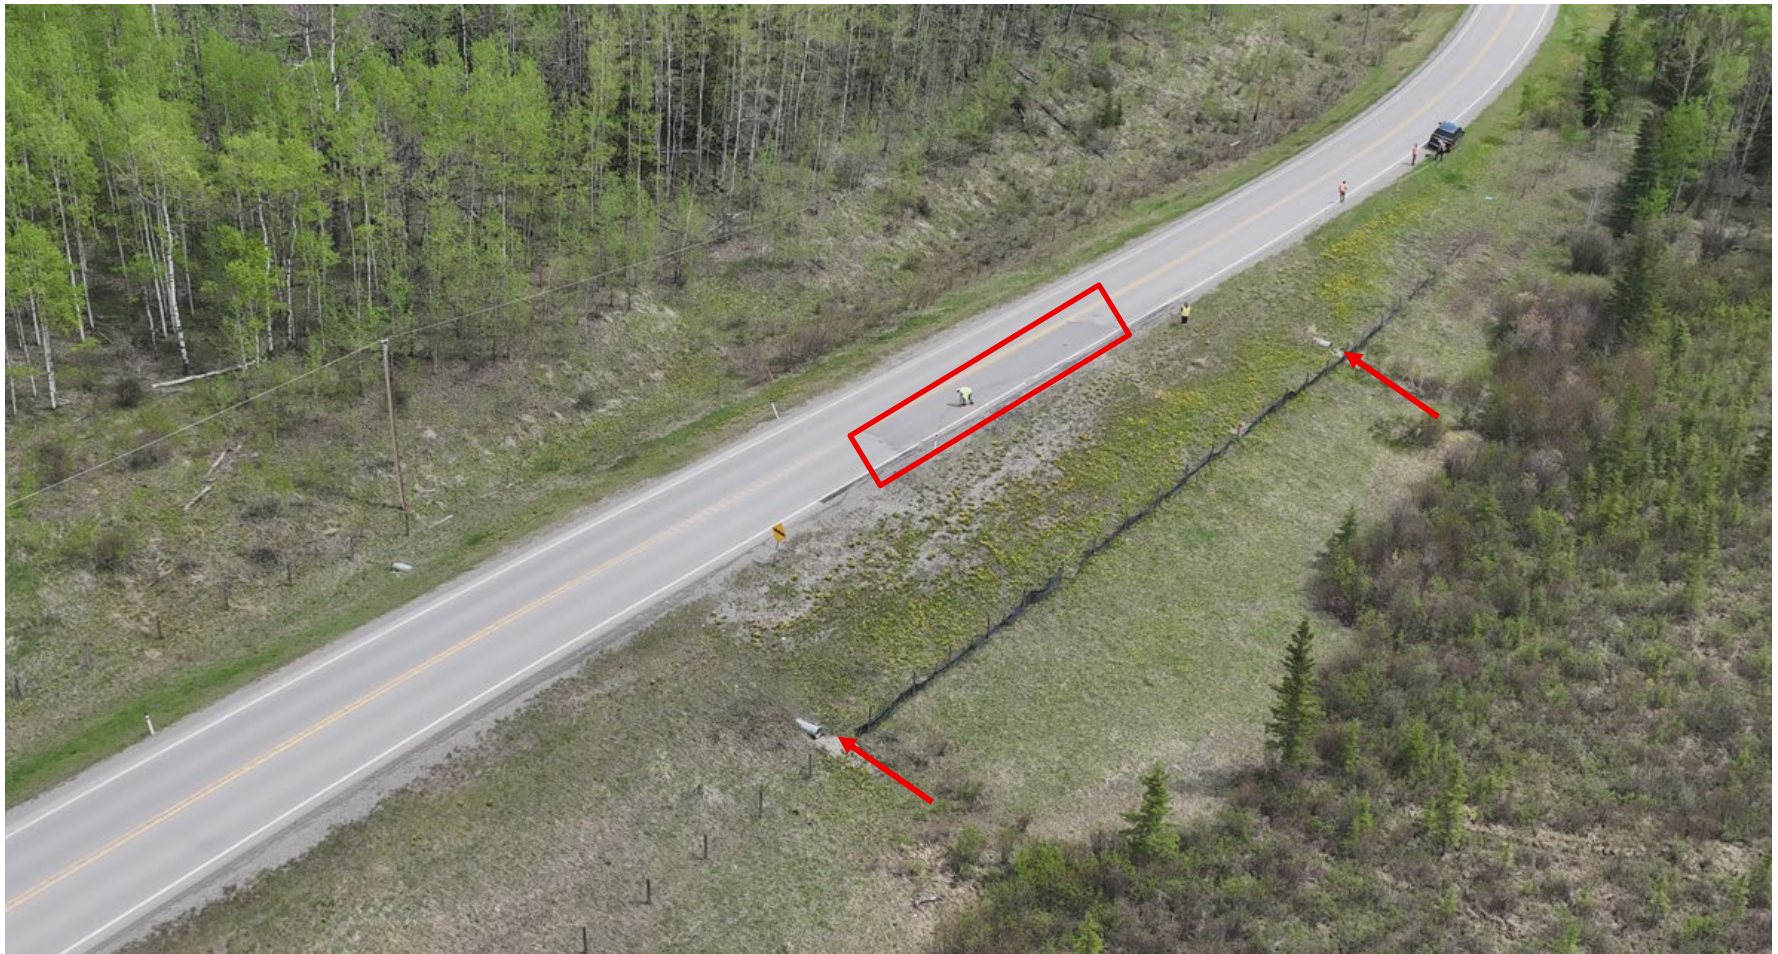
- The slope instability is along an approximate 40 m length of the highway and is impacting the west (southbound) lane (Photos 1 and 2)
- Regular pavement patching has been completed at the site with the latest pavement patch completed between the 2022 and 2023 inspections (Photos 1 and 2). There is longitudinal pavement cracking (up to approximately 10 mm wide) along the west shoulder and settlement (up to approximately 20 mm) in the west (southbound) lane. Pavement cracking appears most severe at the north and south extents of the pavement patch (Photo 2).

Photo 1 Aerial photo of the S031-2 site, highlighting the area of pavement distress (indicated by red rectangle) and culvert outlets (indicated by red arrows). Photo taken May 26, 2025, facing southeast.

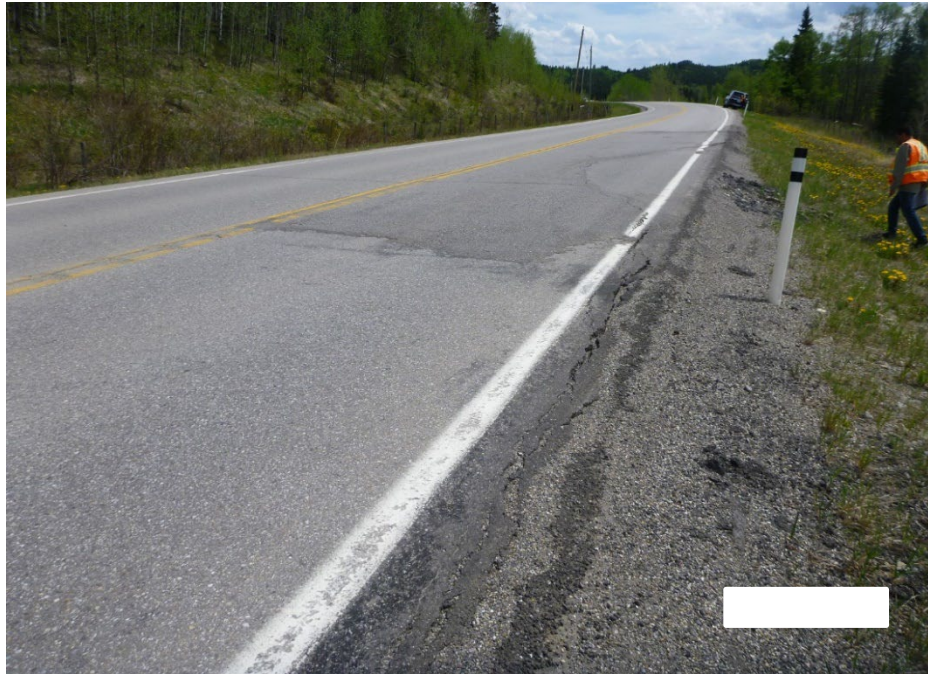
Photo 2 Pavement patch, cracking, and settlement in the west (southbound) lane. Settlement up to approximately 20 mm was overserved. Photo taken May 26, 2025, facing south.

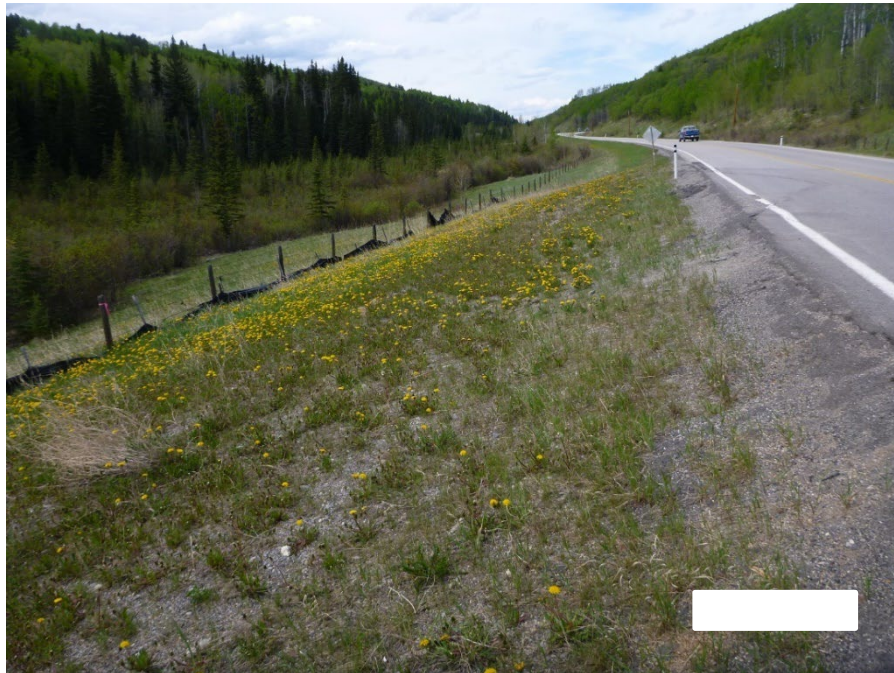
- The west (southbound) highway embankment slope is relatively well vegetated (Photos 3 and 4). There is evidence of a previous repair at the site, which could have included a toe berm extending past the fence along the west side of the highway (Photos 3 and 4).

Photo 3 The west (southbound) highway embankment below the area of pavement distress (cracking and settlement). Photo taken May 26, 2025, facing north.

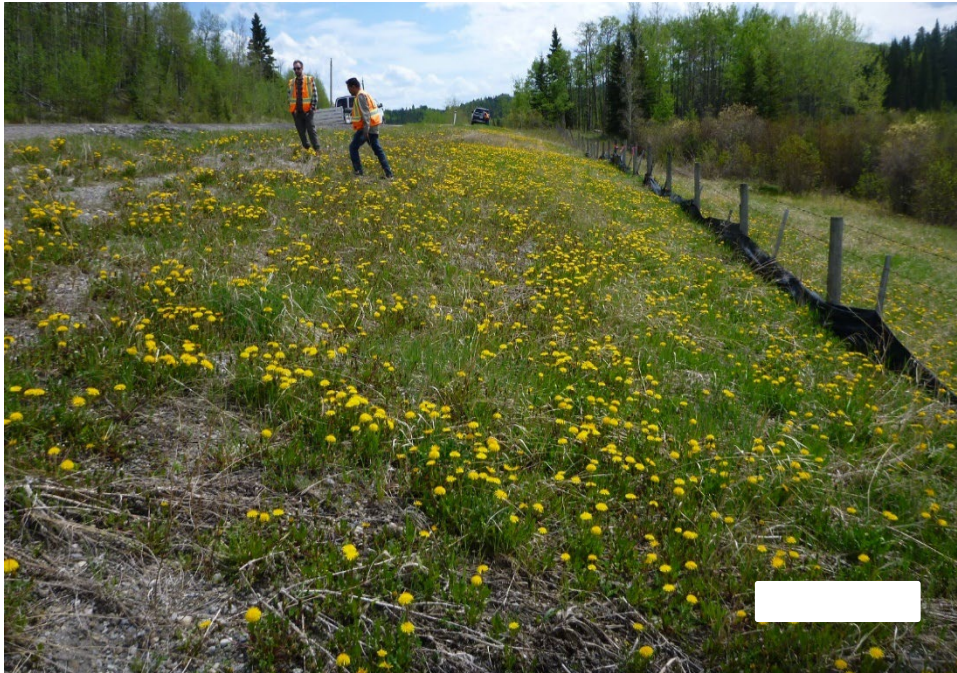
Photo 4 The west (southbound) highway embankment slope is well vegetated. Photo taken May 26, 2025, facing south.

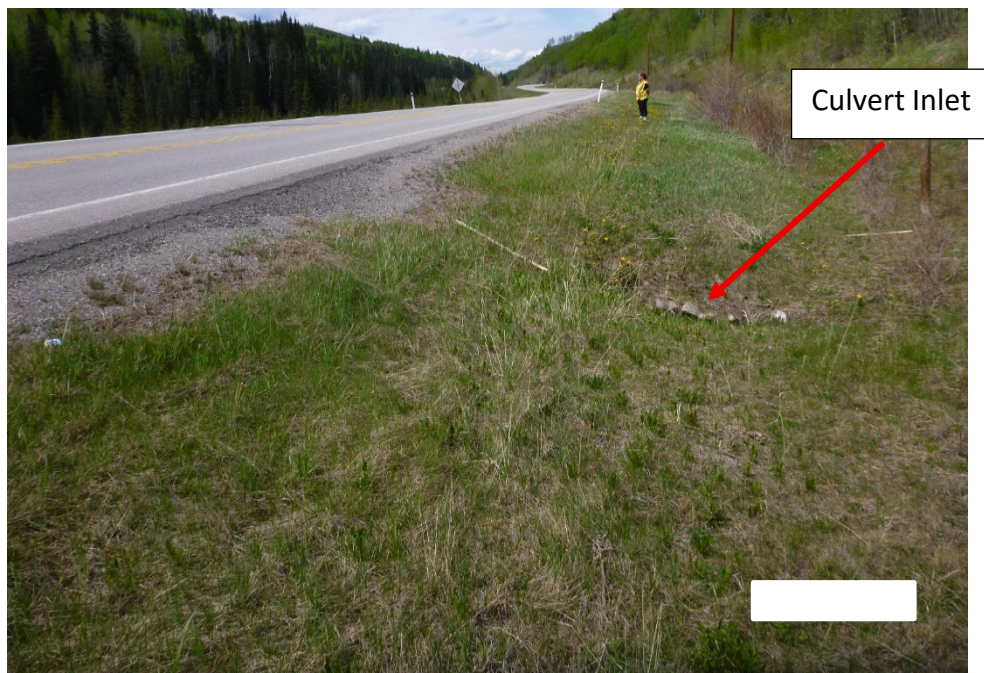
- The east (northbound) ditch appears poorly drained. Wet areas were observed along the ditch during the 2025 inspection (Photo 5).
- There are two corrugated-steel-pipe (CSP) culverts at the site that are underlying the highway (oriented east-west). The culverts were installed to convey flows from the east ditch to the west ditch. The south culvert was replaced as part of the 2017 repair work at the S031-1 site, and the north culvert is outside the site limits. Both culverts are deformed and bent beneath the highway embankment due to potential settlement. An asphalt apron was installed at the outlet of the north culvert.

Photo 5 The eastbound ditch is well-vegetated, and no erosion was observed around the culvert inlet. Photo taken May 26, 2025, facing north.
