November 26, 2025

CON0022161 Southern Region GRMP Instrumentation Monitoring
Site S031-II; Hwy 762:02, km 17.660; Mystery Culvert
Section C – 2025 Fall Readings

KLOHN CRIPPEN BERGER LTD.

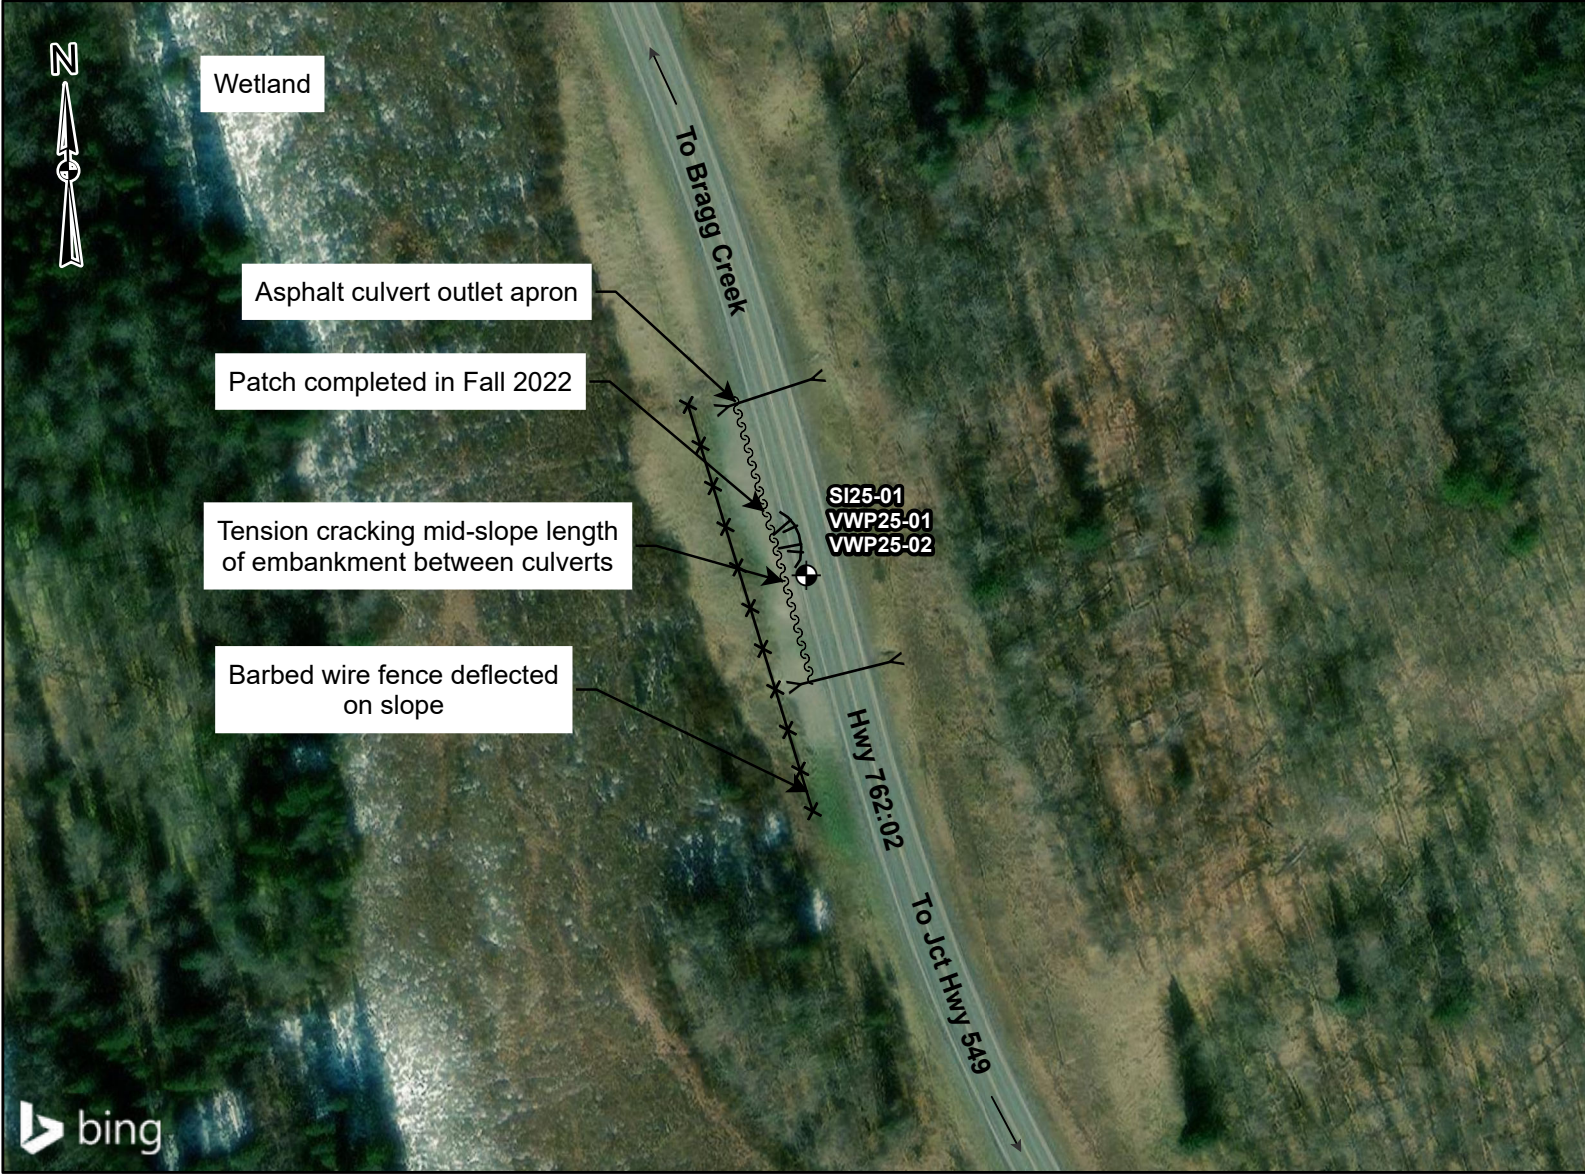
PROJECT SOUTHERN REGION GEOHAZARD RISK MANAGEMENT PROGRAM		
TITLE Site Plan S031-2 - Mystery Culvert Hwy 762.02, km 17.660		
SCALE 1:1,500	PROJECT No. A05116A03	FIG No. 1

approximately 10 m of clay till, and weak, poorly indurated siltstone bedrock below 15 m. One SI and two nested VWP's were installed after drilling was completed. Instrument locations are shown in Figure 1. Instrument installation details are included below in Table 1.1.

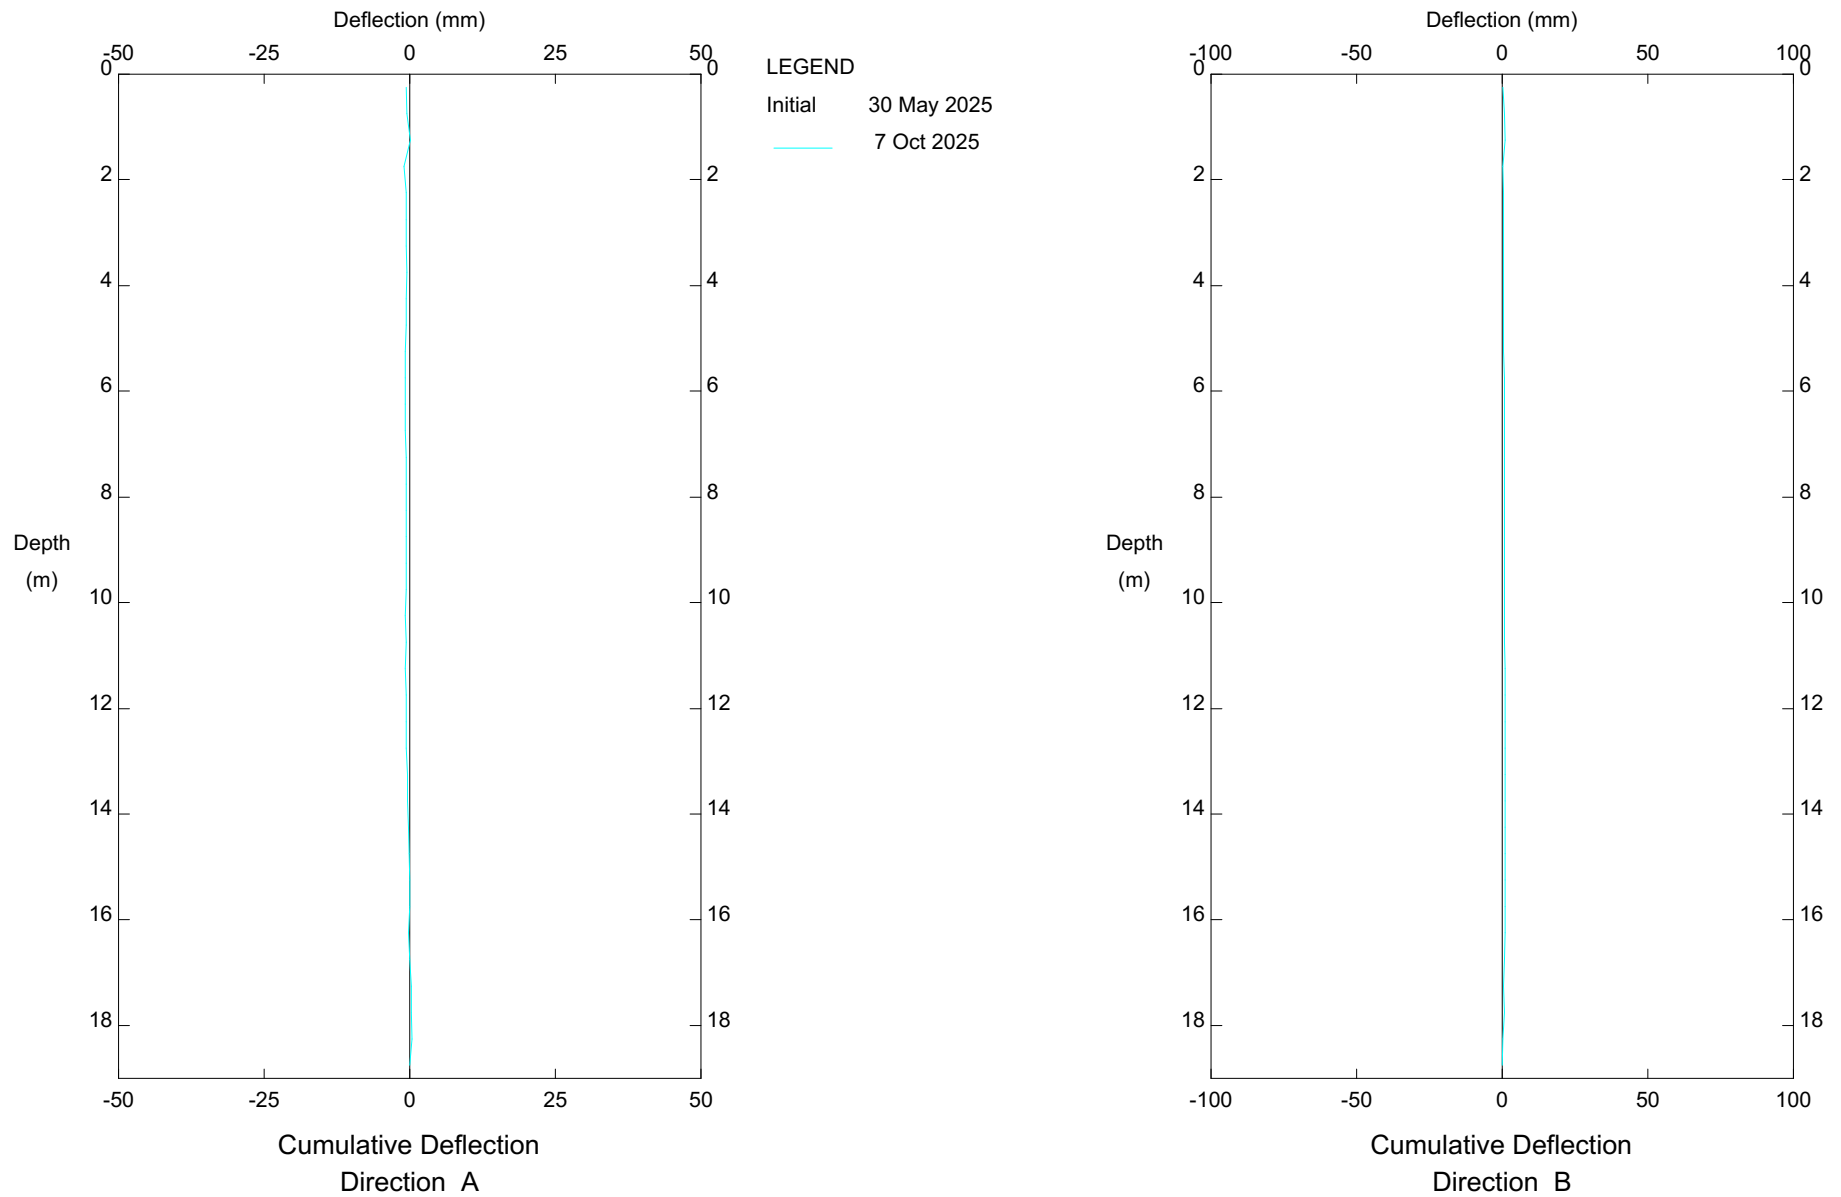
S031-II, Inclinator BH25-01

SI25-01 was initialized during the spring 2025 readings and has only been read once since then in the fall 2025 readings. No discernible zones of movement have been identified.

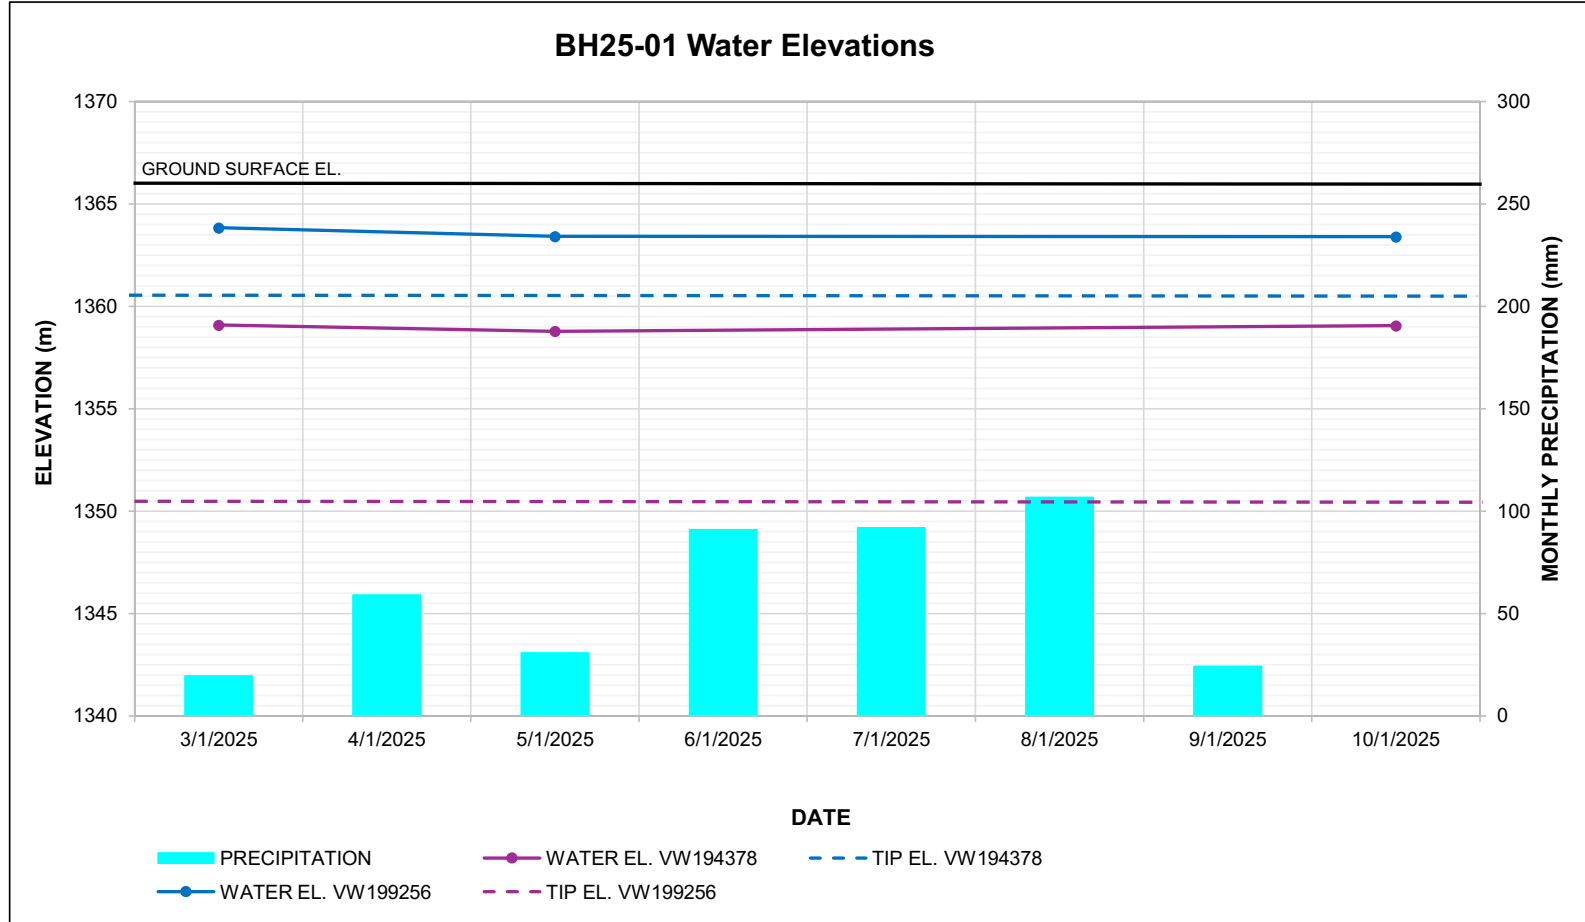
PROJECT SOUTHERN REGION GEOHAZARD RISK MANAGEMENT PROGRAM	
		TITLE Vibrating Wire Piezometer Data S031-II - Mystery Culvert Hwy 762:02, km 17.66	
SCALE	PROJECT No.	01A05116A03	FIG No.

VWP readings indicate that the groundwater elevation has stayed stable since installation in February 2025. The upper VWP (VW199256) readings have ranged from 2.2 to 2.6 mbgs, and the lower VWP (VW194378) readings have ranged from 6.9 to 7.2 mbgs. The different piezometric elevations suggest the possible presence of two perched water tables, likely associated with the more permeable sandy gravel fill at the surface. Still, a correlation between changes in the water table and precipitation events is not conclusive at this point, since readings could reflect a high water table from a high precipitation period.
