November 26, 2025

Alberta Transportation and Economic Corridors  
2<sup>nd</sup> Floor, 803 Manning Road N.E.  
Calgary, Alberta  
T2E 7M8

**CON0022161 Southern Region GRMP Instrumentation Monitoring**  
**Site S008; H762:02, km 2.125 Fisher Creek Pile Wall**  
**Section C – 2025 Fall Readings**

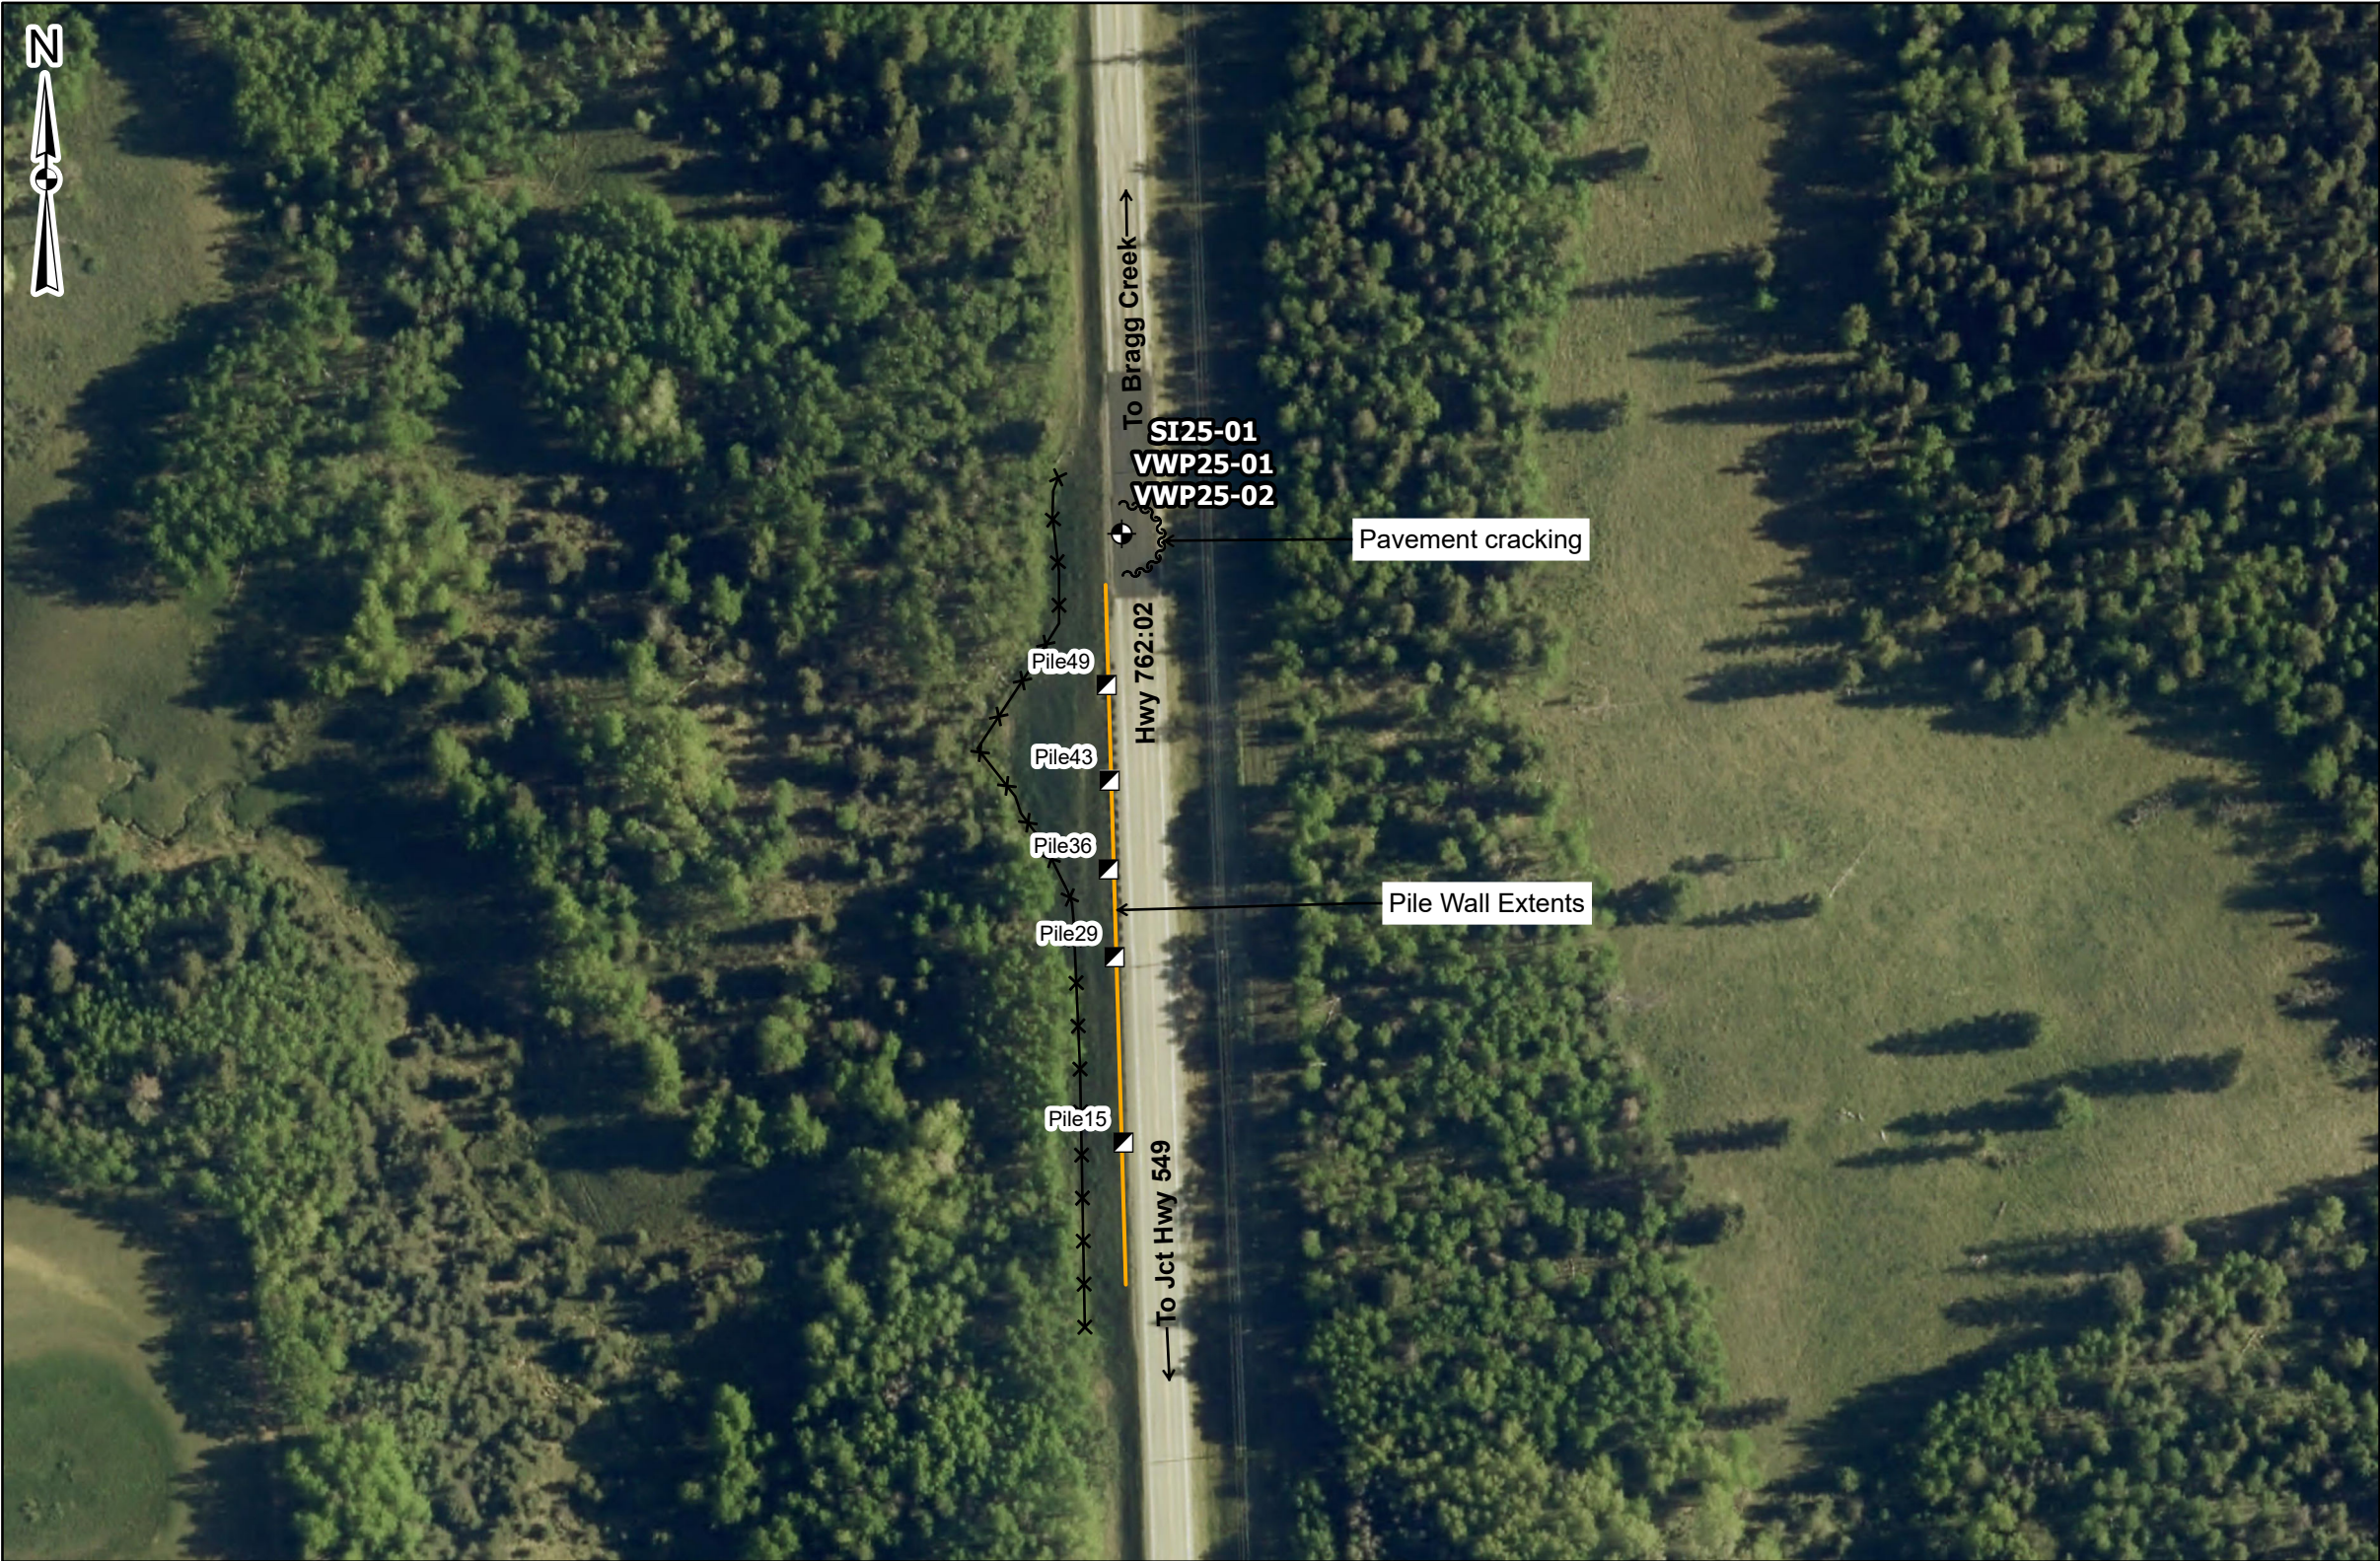
SCALE 1:1,500 PROJECT No. A05116A03 FIG No. 1

The pavement distress north of the pile wall could indicate the slide is outflanking the pile wall at its north extent. No discernable movement has been recorded in Pile 49, the closest SI to the pavement distress, since 2021. During the 2025 fall readings, a new layer of asphalt was noted, with no cracking observed.

The movement recorded from BH25-01 is minor, approximately 2 mm, and may be within the limit of detection of the SI instrument. However, the movement and direction align with the location of previously observed pavement cracking during the 2024 Section B inspection (Figure 1). Pavement patching at this location was observed during the 2025 Section inspection and the 2025 fall readings. The movement measured at BH25-01 will need to be validated in subsequent instrument readings.

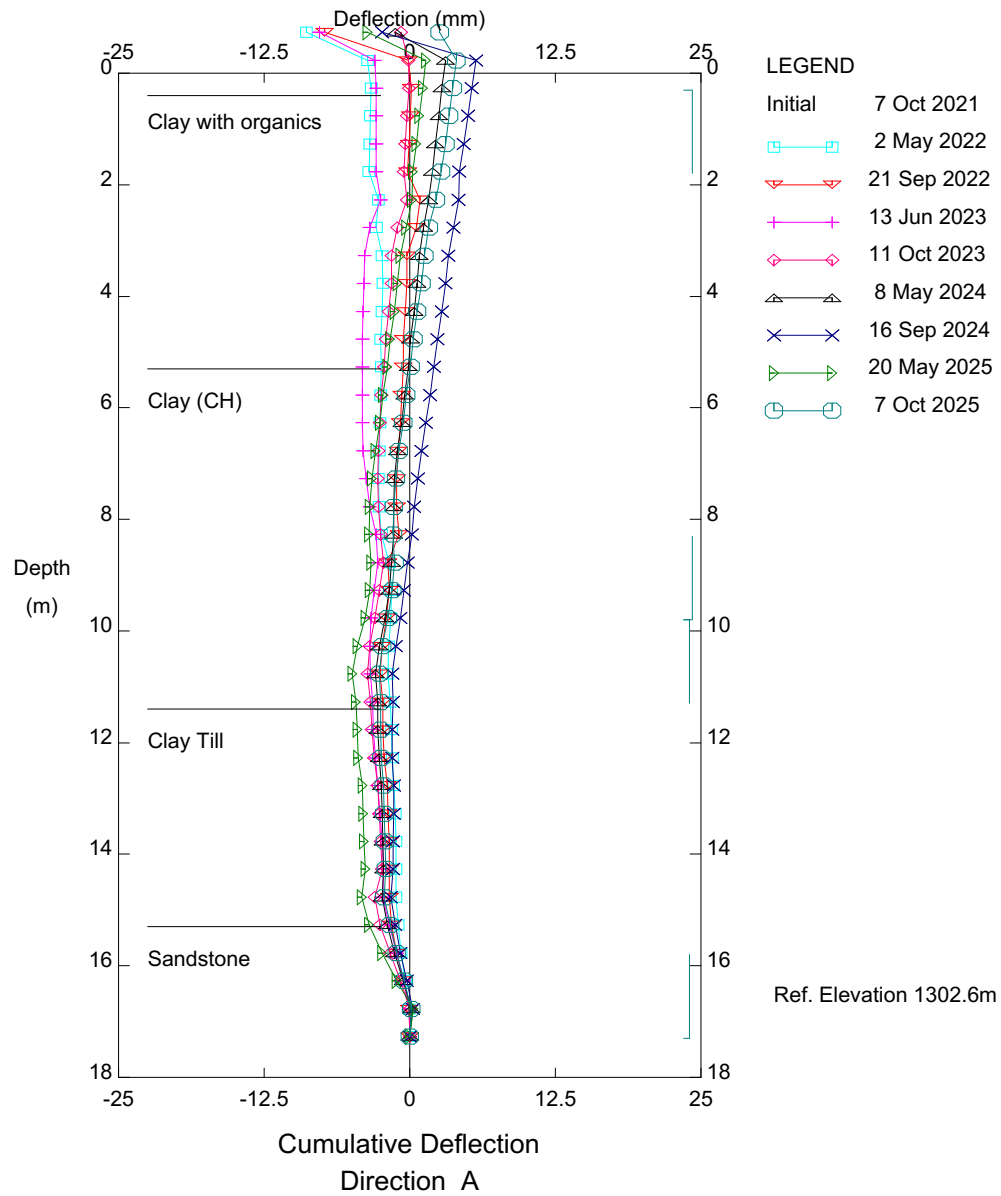
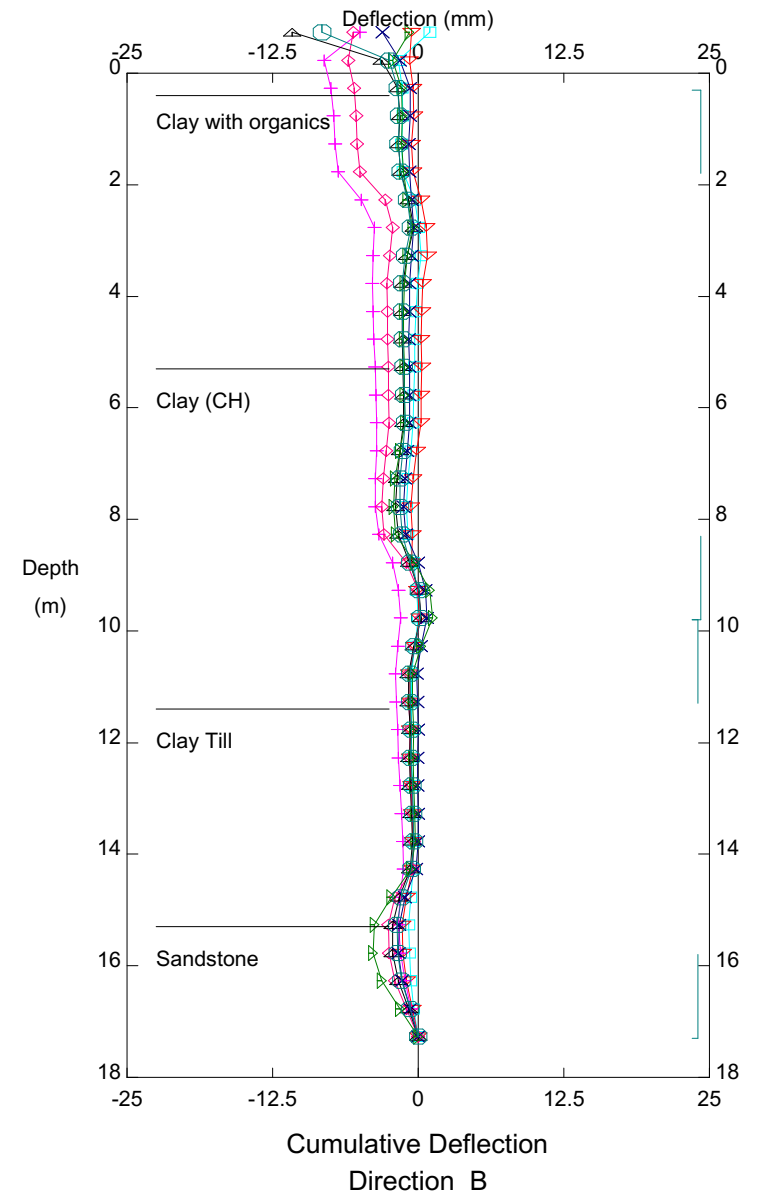
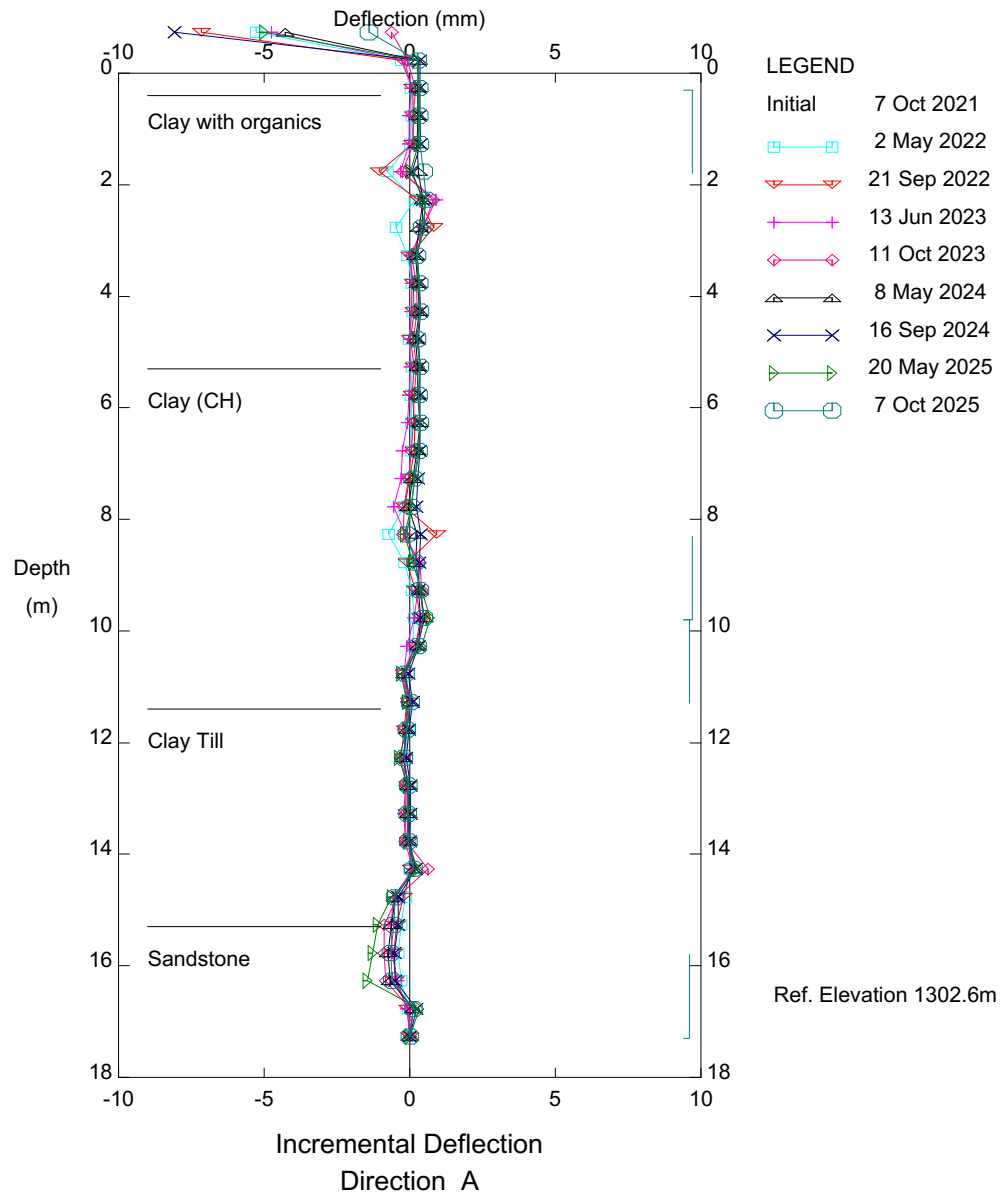
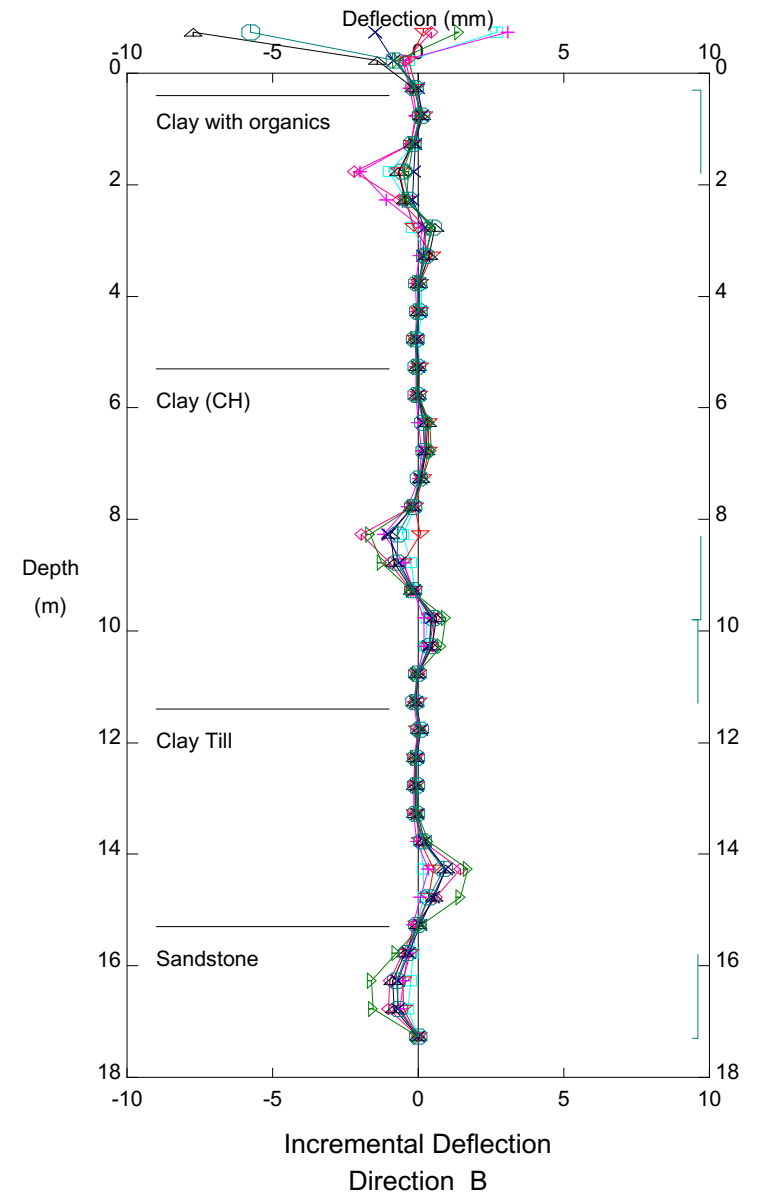
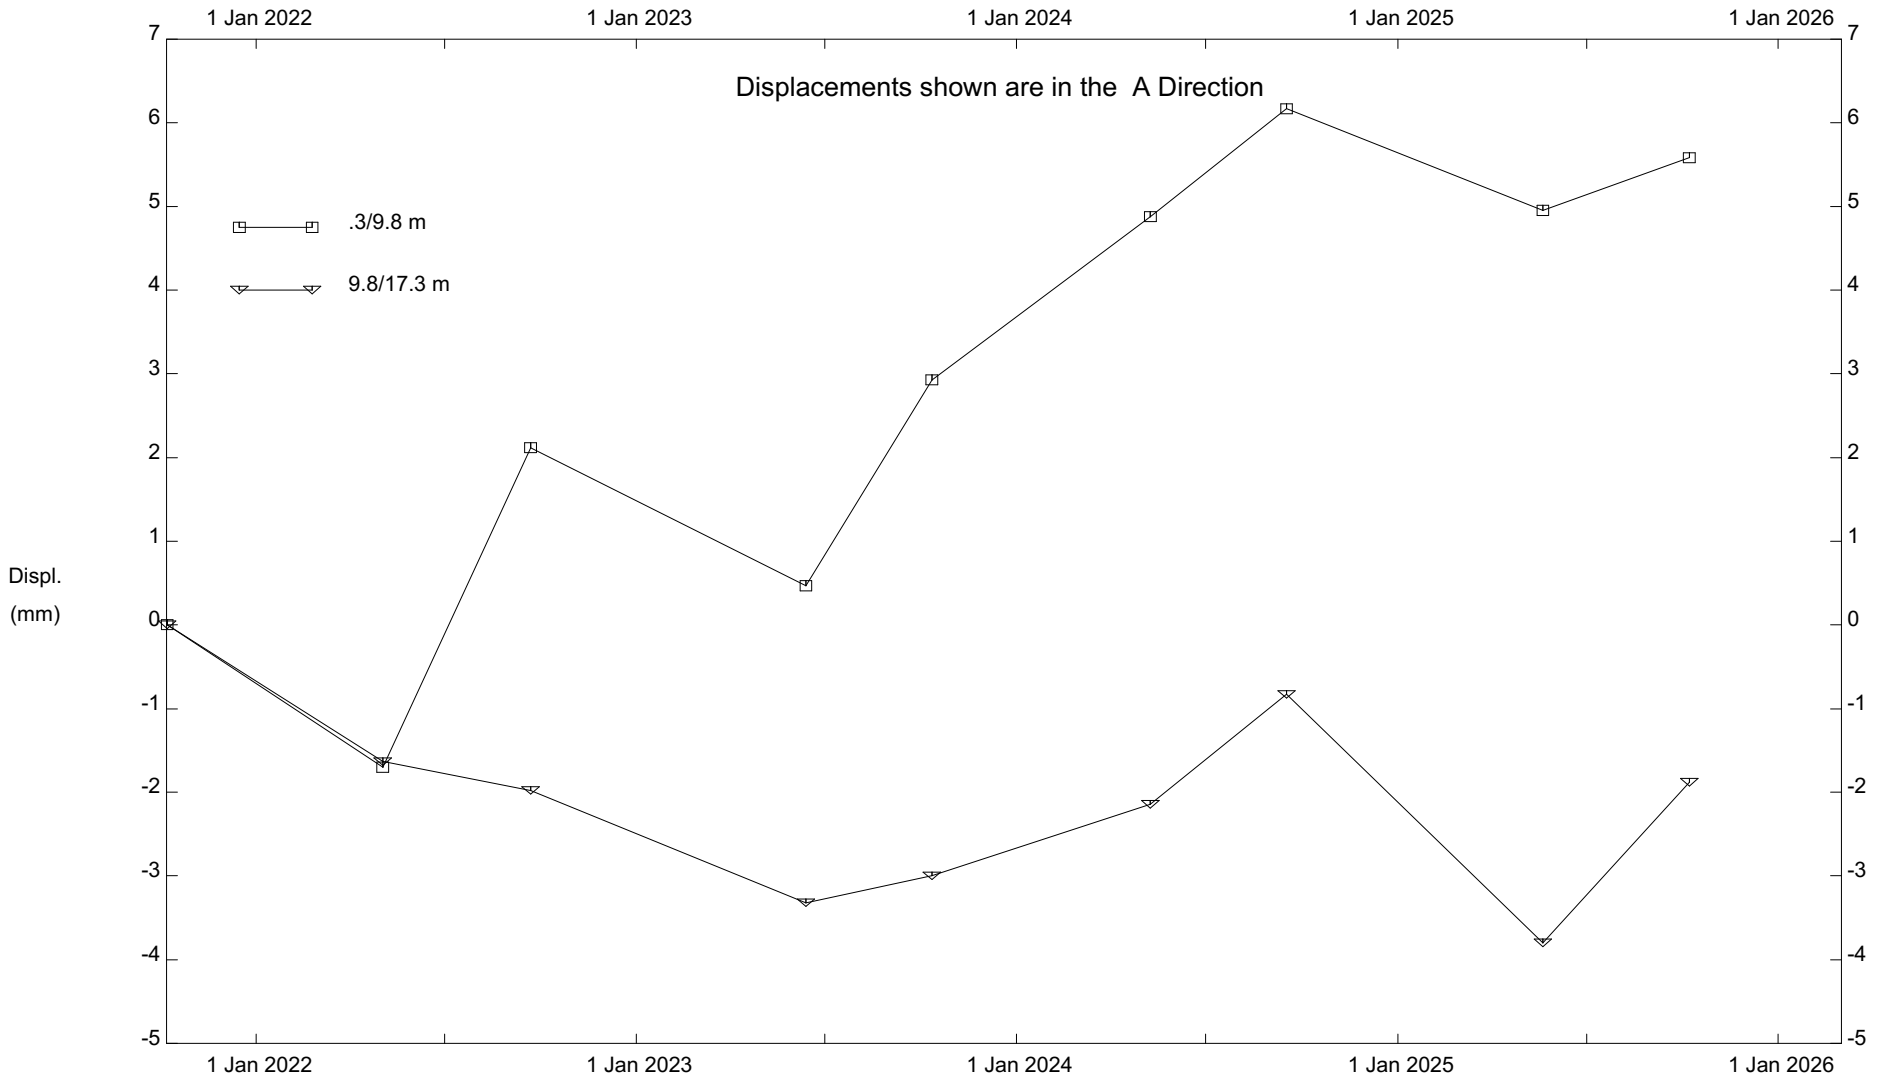
S008; H762:02, Fisher Creek, Inclinator PILE15

Most of the readings recorded since KCB re-initialized the SI in the Pile can be considered negligible initially; however, Pile 15 has picked up almost 6 mm of movement, which, combined with the cumulative movement taken by other consultants, totals about 30 mm. Pile 15 is located approximately 35 m from the south end of the pile wall, the movement recorded in the B-direction at appears to be SI casing joints, based on an approximate spacing of 3 m intervals between joints.

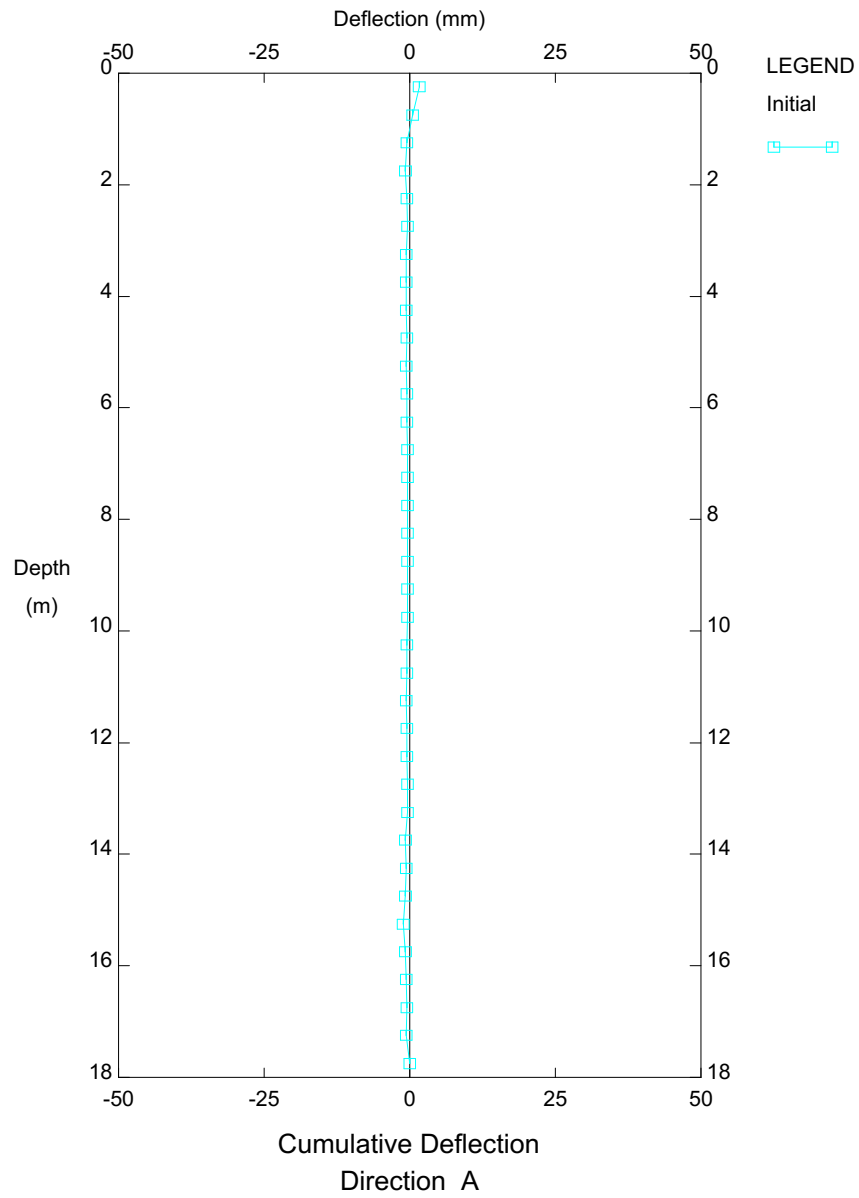
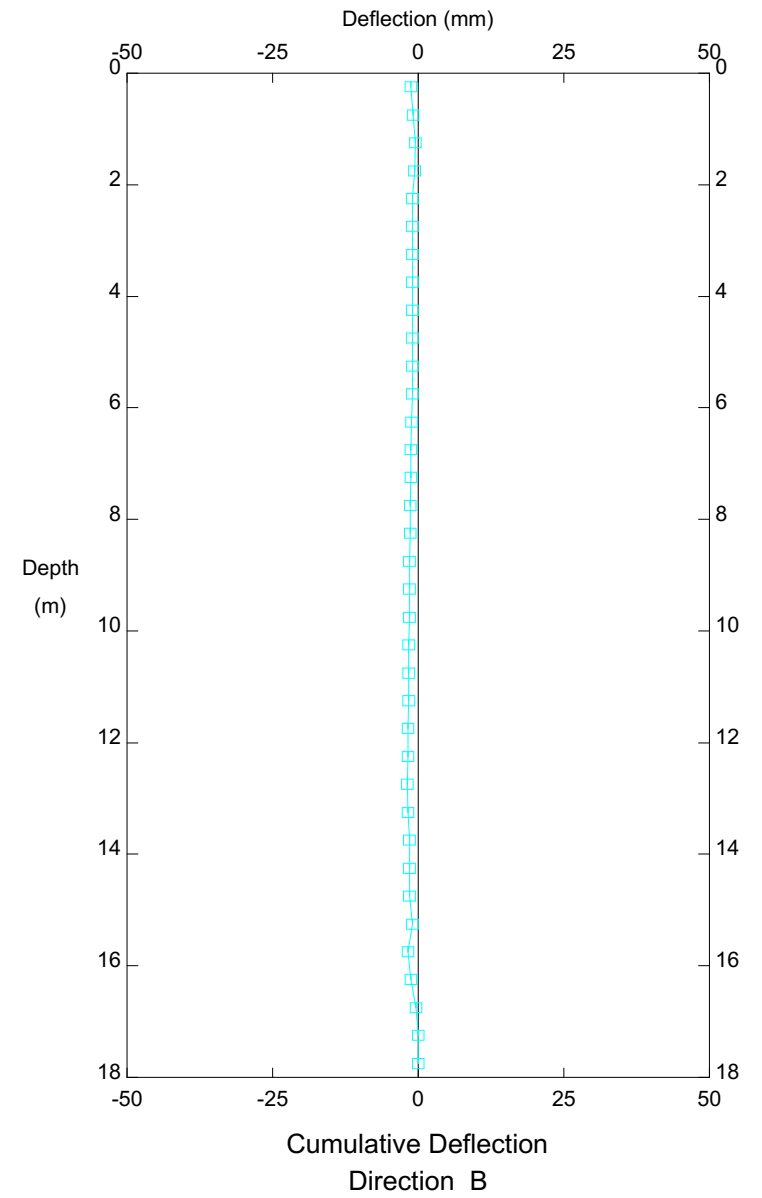
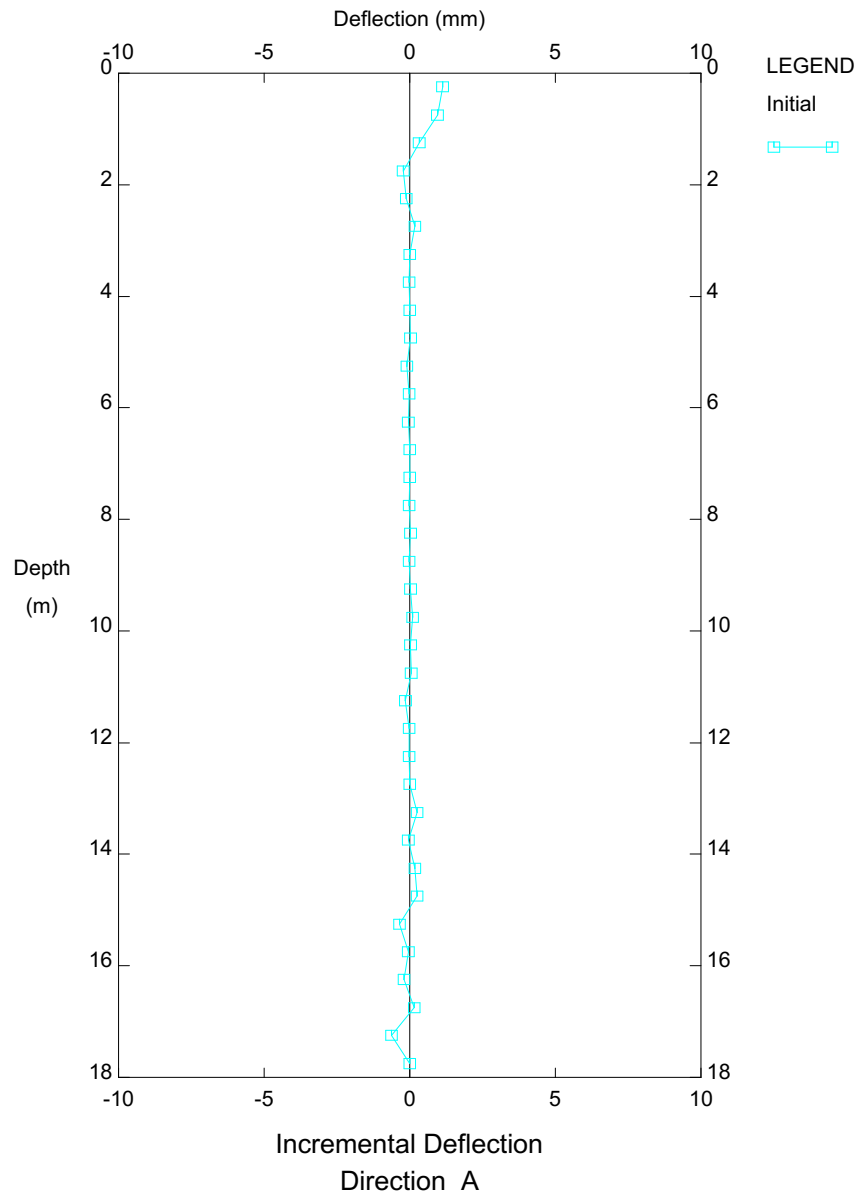
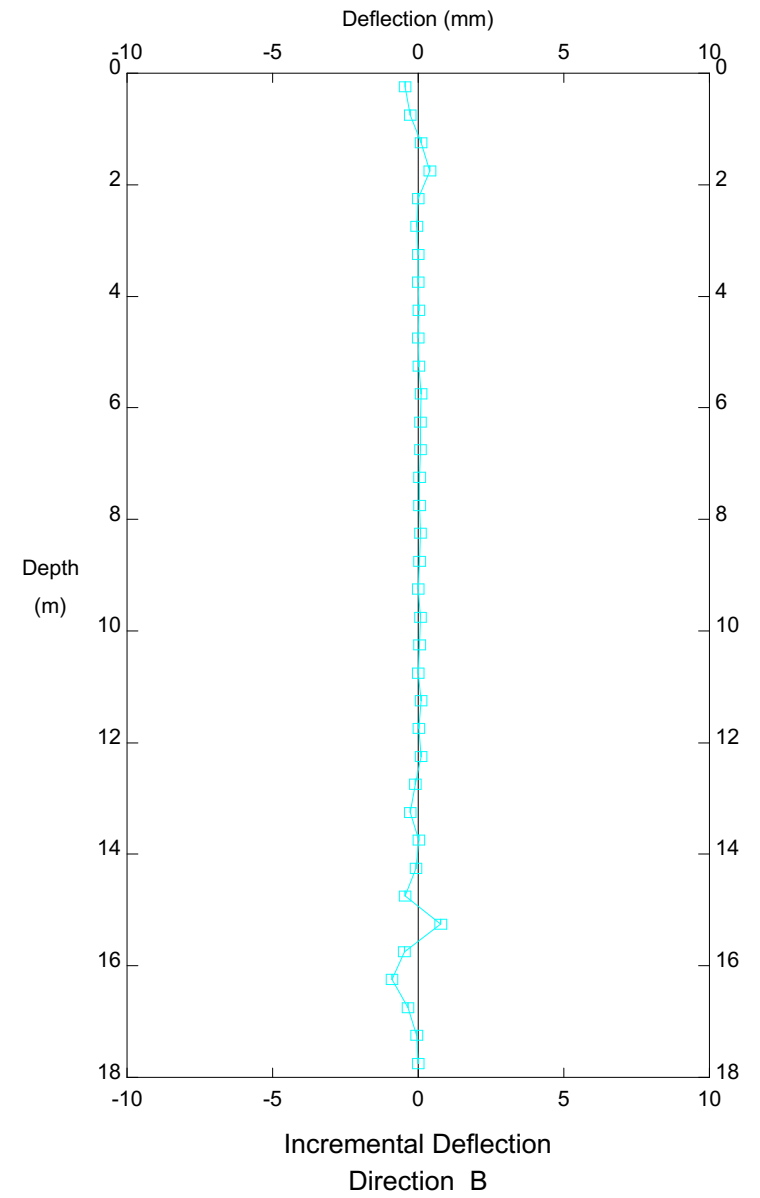
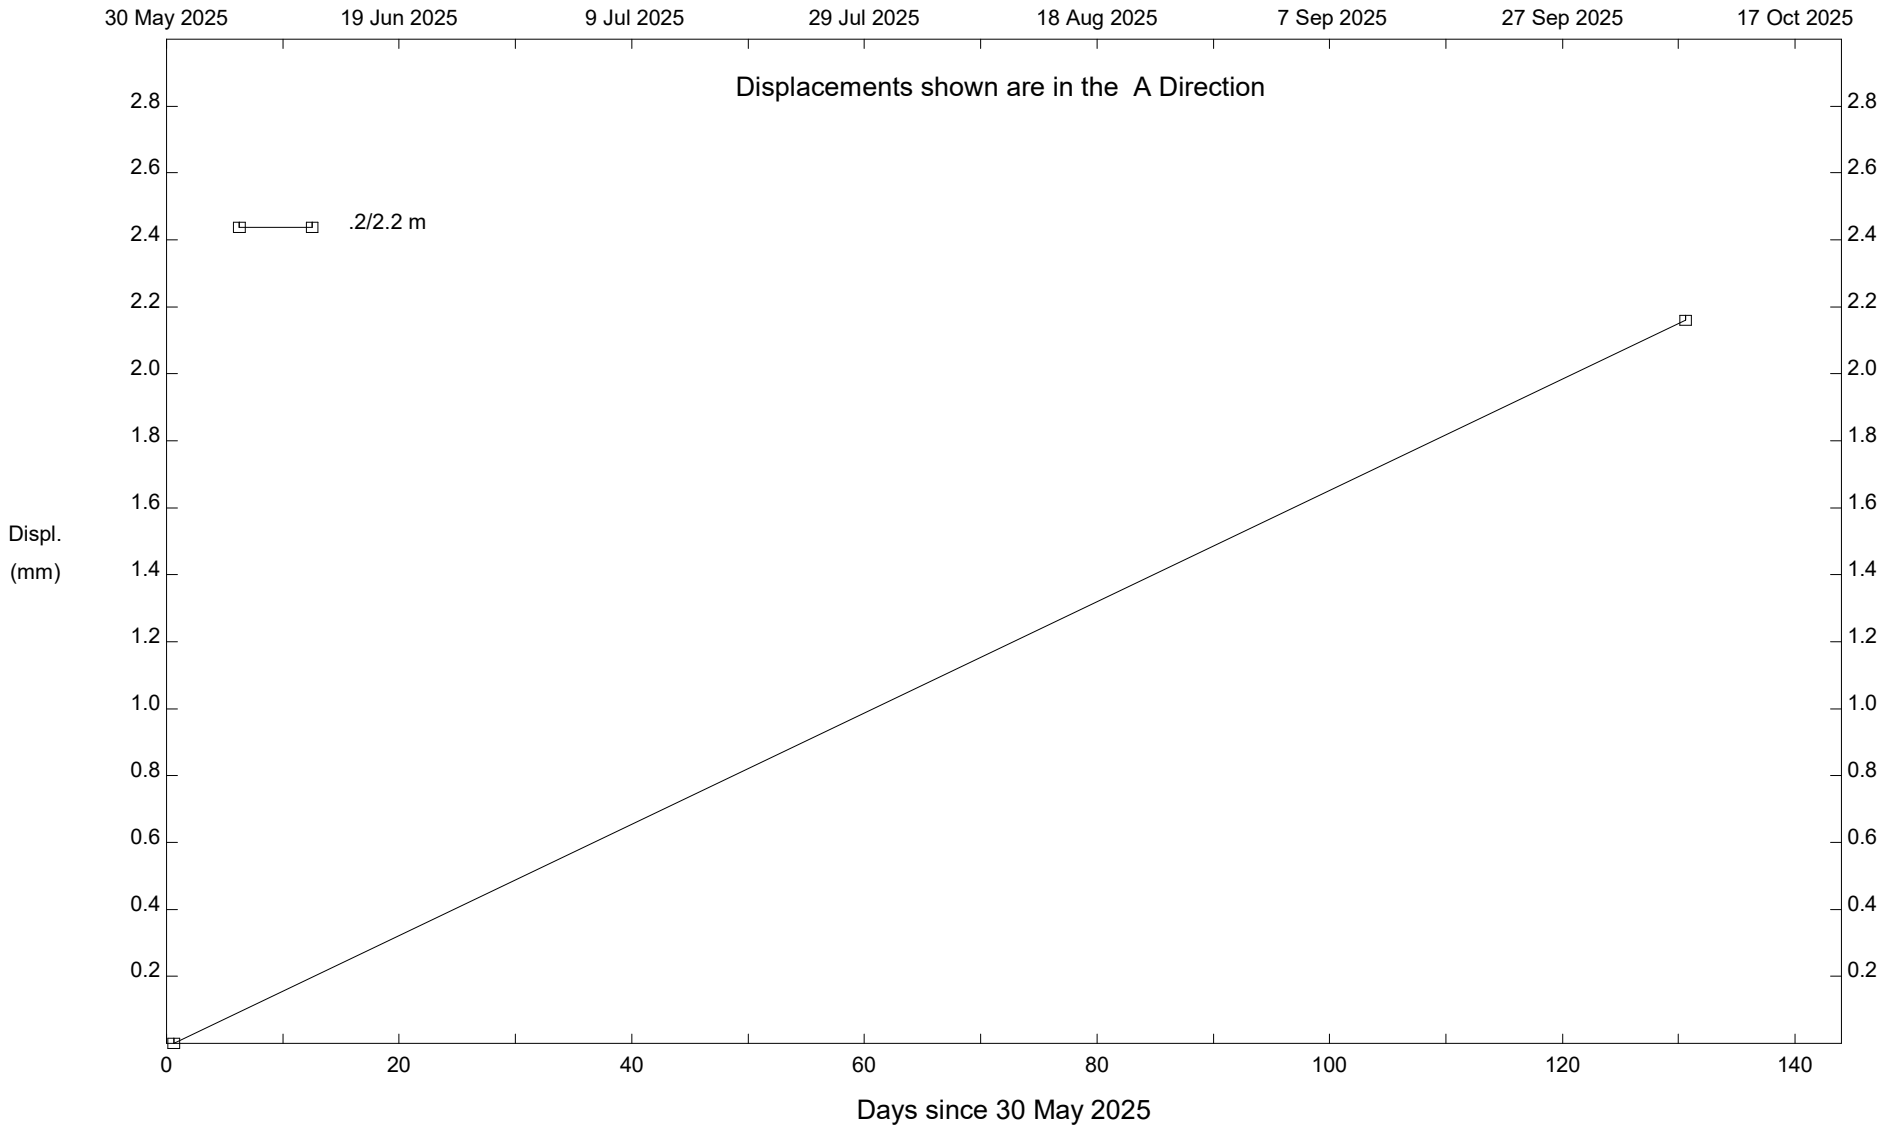
S008, Inclinator BH25-01

Also, the fall 2025 reading taken in SI25-01 after initialization in May 2025 shows that there is minor movement near the surface at 2.2 m below ground surface.

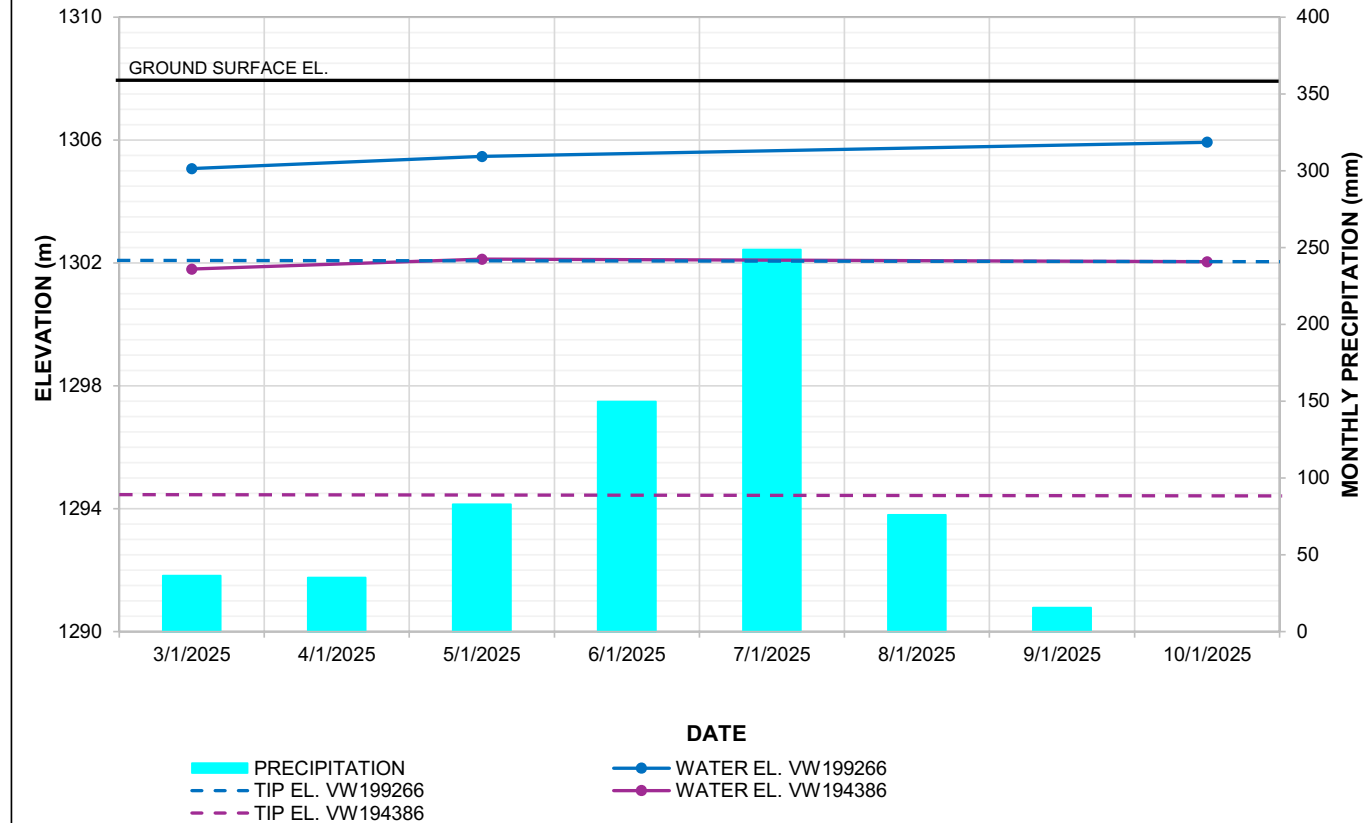
## BH25-01 Water Elevations

Since March 2025, the water levels recorded by the two VWP's installed in February 2025 have remained steady, at 2.2 mbgs and 6 mbgs for VW199266 and VW194386, respectively. No notable changes in precipitation are currently detected by the instruments. However, it is noteworthy that two different pressure levels are measured within the same borehole at varying VWP tip elevations, possibly indicating a perched water level. Continued monitoring of future readings will help to confirm the relationship between VWP data and precipitation effects on water levels.
