SITE NUMBER AND NAME: S008 Fisher Creek Pile Wall	HIGHWAY & KM: 762:02, 2.125	PREVIOUS INSPECTION DATE: May 28, 2024	INSPECTION DATE: May 26, 2025
LEGAL DESCRIPTION: 09-10-21-04 W5M	NAD 83 COORDINATES: UTM Northing Easting 11 5627342 678866	RISK ASSESSMENT: PF: 8 CF: 6 TOTAL: 48	
AVERAGE ANNUAL DAILY TRAFFIC (AADT): 1090 (north) & 1380 (south) (Reference No. 65170 & 60180)		CONTRACTOR MAINTENANCE AREA (CMA): 521

TITLE
Site Plan
S008 - Fisher Creek Pile Wall
Hwy 762:02, km 2.125

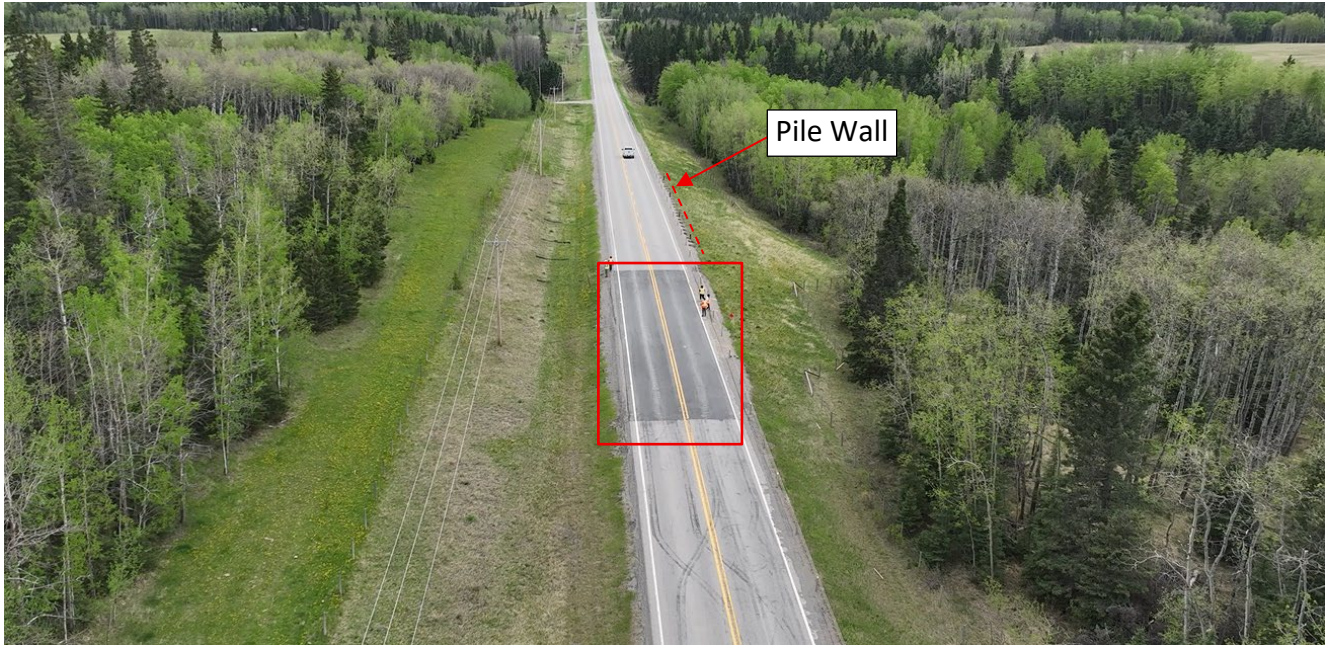
- A pavement patch north of the concrete pile wall was completed between the 2024 and 2025 inspections (Photo 1).
- There is negligible movement being recorded in the pile-wall SIs, and no pavement cracking has been observed directly upslope of the pile wall.

Photo 1 Between the 2024 and 2025 inspections a pavement patch was completed north of the existing concrete pile wall (indicated by red rectangle). Photo taken May 26, 2025, facing south.

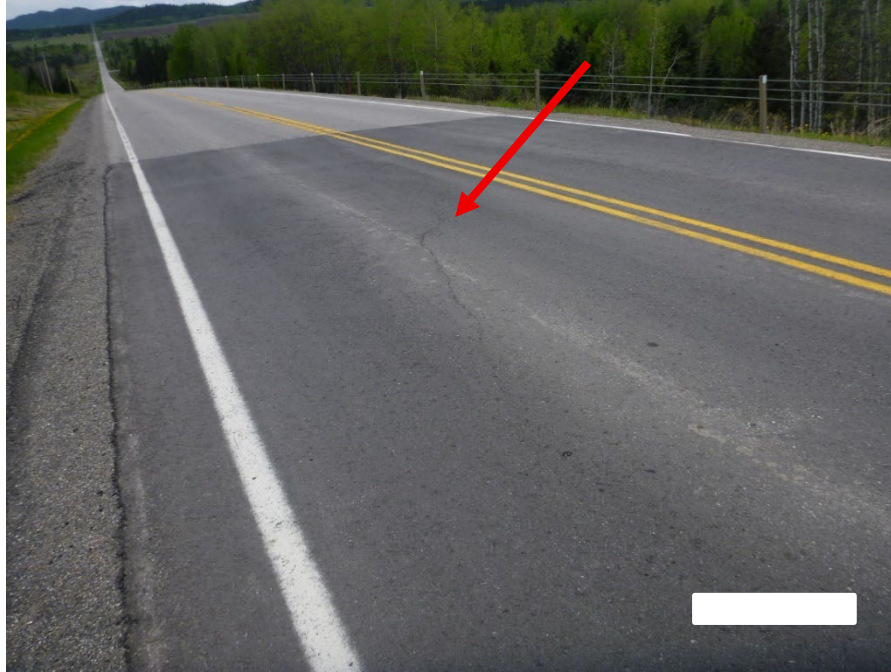
- During the 2025 inspection, a thin pavement crack (approximately 10 mm wide) was observed in the east (northbound) lane that is reflecting through the pavement patch (Photo 2). The pavement crack begins approximately 7 m north of the existing pile wall. Cracking and settlement in the highway surface north of the pile wall have been observed since 2020. The pavement cracking and settlement north of the pile wall could indicate the slide has begun to outflank the pile wall.

Photo 2 A thin pavement crack (red dashed line) beginning approximately 7 m north of the concrete pile wall was observed during the 2025 inspection. Photo taken May 26, 2025, facing south.

- The instruments should be read twice per year (spring and fall) as part of the Southern Region GRMP Section C readings. The 2025 instruments should be incorporated into the Section C readings in fall of 2025.
- The pavement cracks should be sealed and the voids above the pile wall should be backfilled to reduce infiltration and potential erosion undermining the east (southbound) lane.
- A timber or welded plate lagging system should be installed between piles, and voids should be backfilled using coarse gravel, to provide containment, reduce infiltration and potential erosion undermining the east (southbound) lane.

- If movements continue or accelerate, impacting the highway surface and road user safety, the pile wall should be extended north by at least 25 m to 30 m to stabilize the highway embankment.

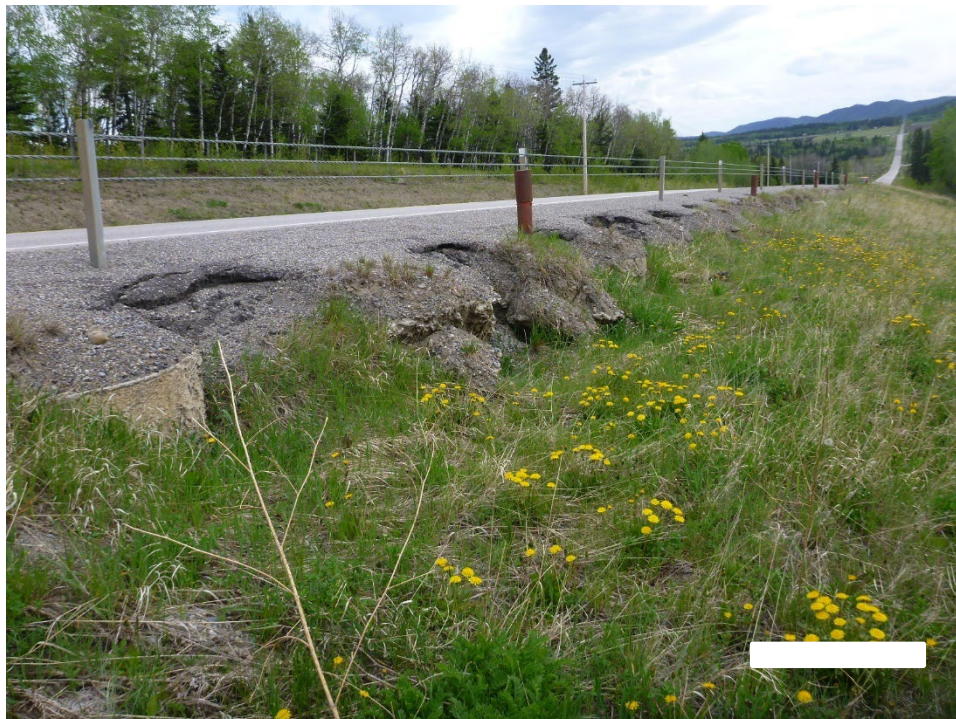
- In 2018, fill on the west side of the highway began settling around the concrete piles, creating tension cracks downslope of the pile wall and some localized sinkholes above the pile wall (Photos 3 through 6). The ground surface downslope of the pile wall appears to have settled between 0.4 m to 0.7 m, creating a ledge that could potentially pond water, leading to increased infiltration

Photo 3 Settlement of the highway embankment slope and void formation along the top of the concrete piles. Photo taken May 26, 2025, facing southeast.

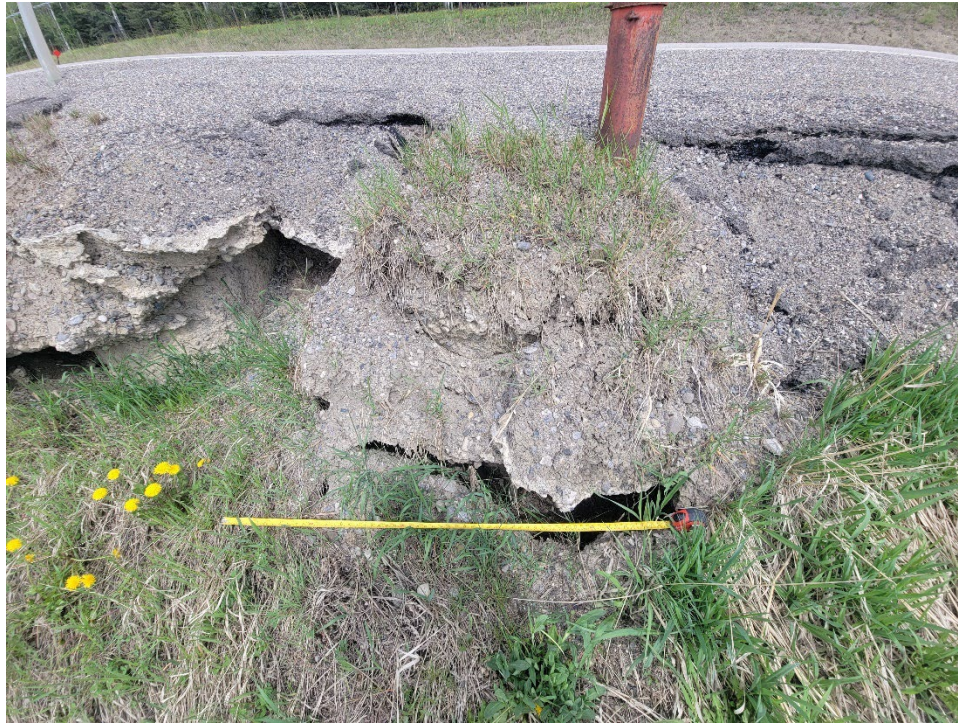
- Surface water runoff has enlarged existing sinkholes at the pile locations (Photos 4 and 5) and likely has contributed to embankment settlement downslope of the pile wall.

Photo 4 Settlement of the highway embankment slope and void formation along the top of the concrete piles. Photo taken May 26, 2025, facing east.

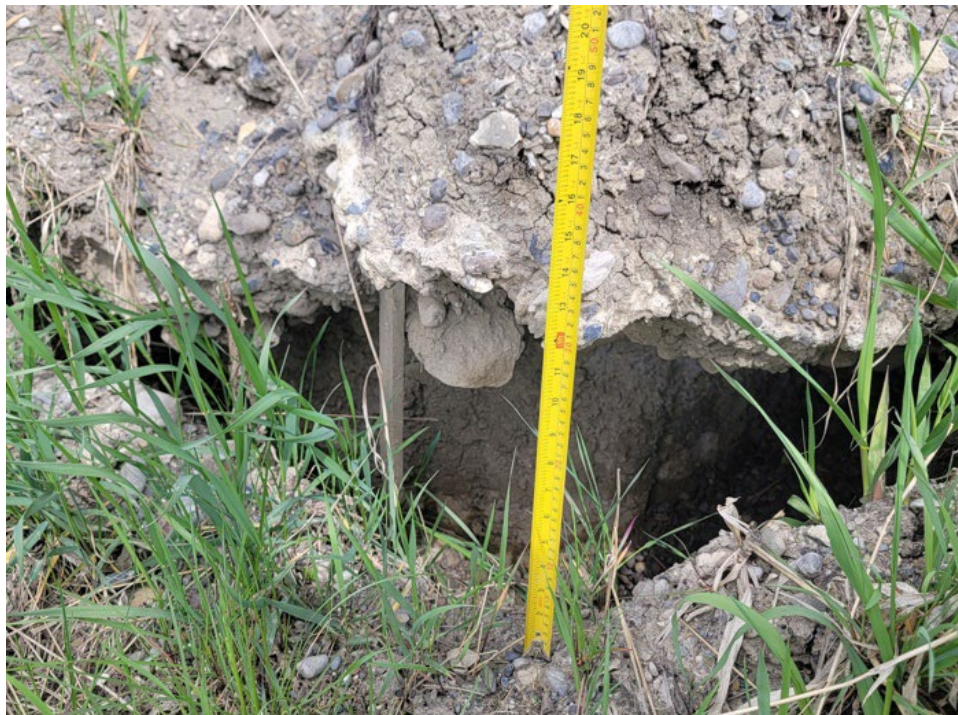
Photo 5 Settlement of the highway embankment slope and void formation along the top of the concrete piles. Photo taken May 26, 2025, facing east.

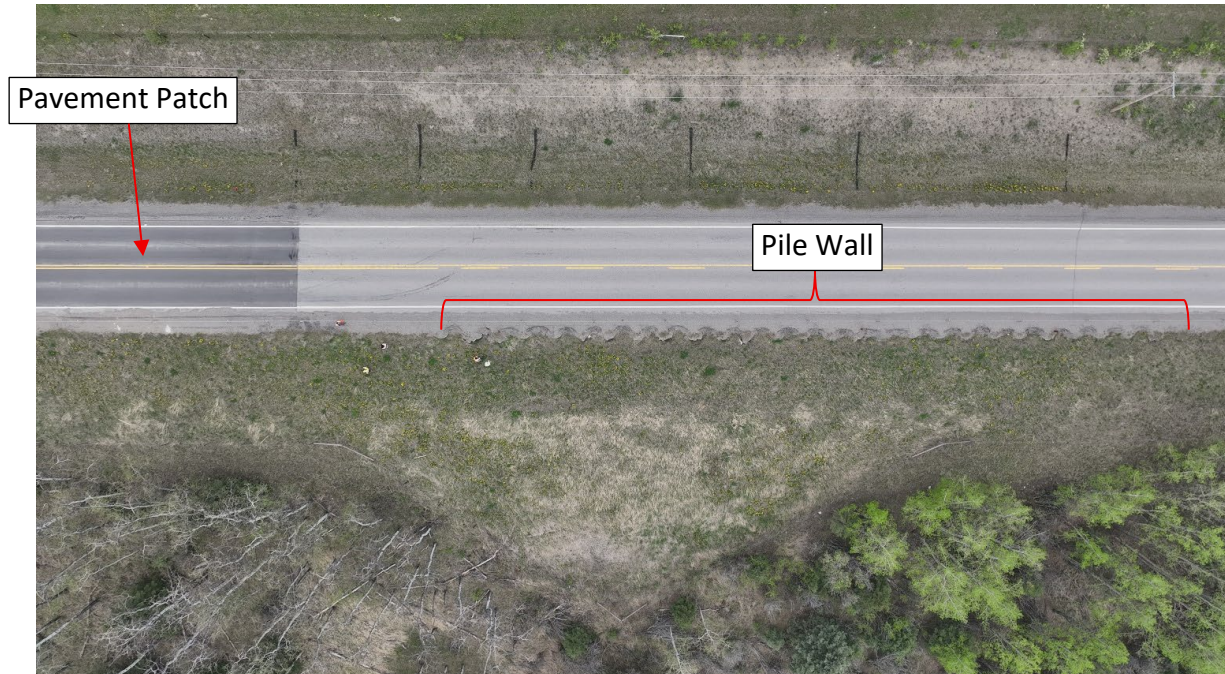
Photo 6 The highway embankment slope and circular erosion features formed between piles along the top of the wall, as well as pavement Patches north of the pile wall.
Photo taken May 26, 2025, facing top down.

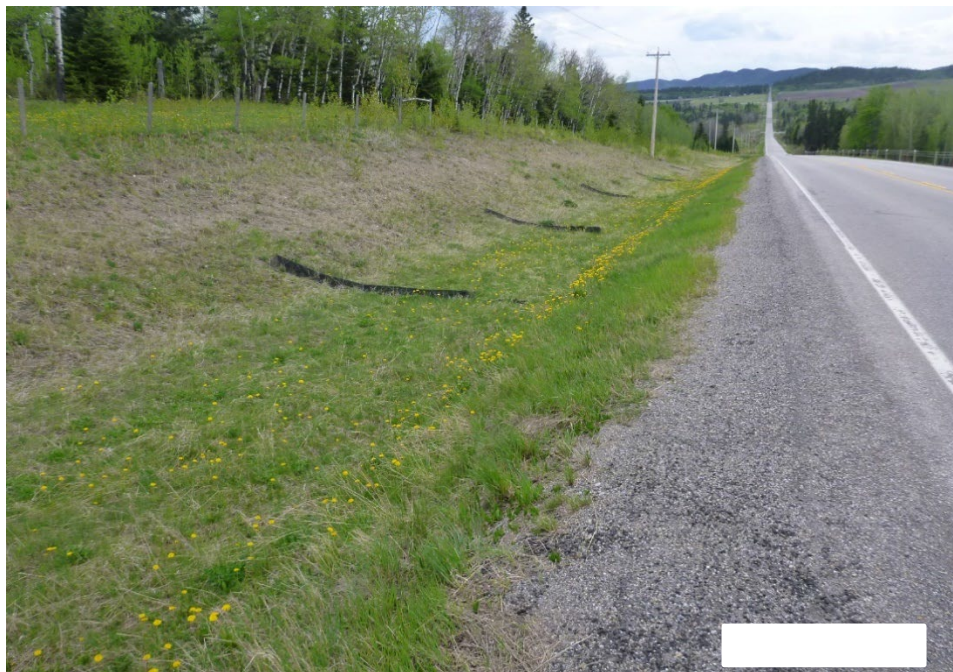
- During the 2025 inspection, the east (northbound) ditch was well vegetated, dry, and in good condition (Photo 7).

Photo 7 The east (northbound) ditch is well vegetated and is in good condition. Plastic ditch blocks previously installed at an unknown date. Photo taken May 26, 2025, facing south.
