July 10, 2024

**CON0022161 Southern Region GRMP Instrumentation Monitoring
Site S036; H800:02, km 9.05 Belly River
Section C – 2024 Spring Readings**

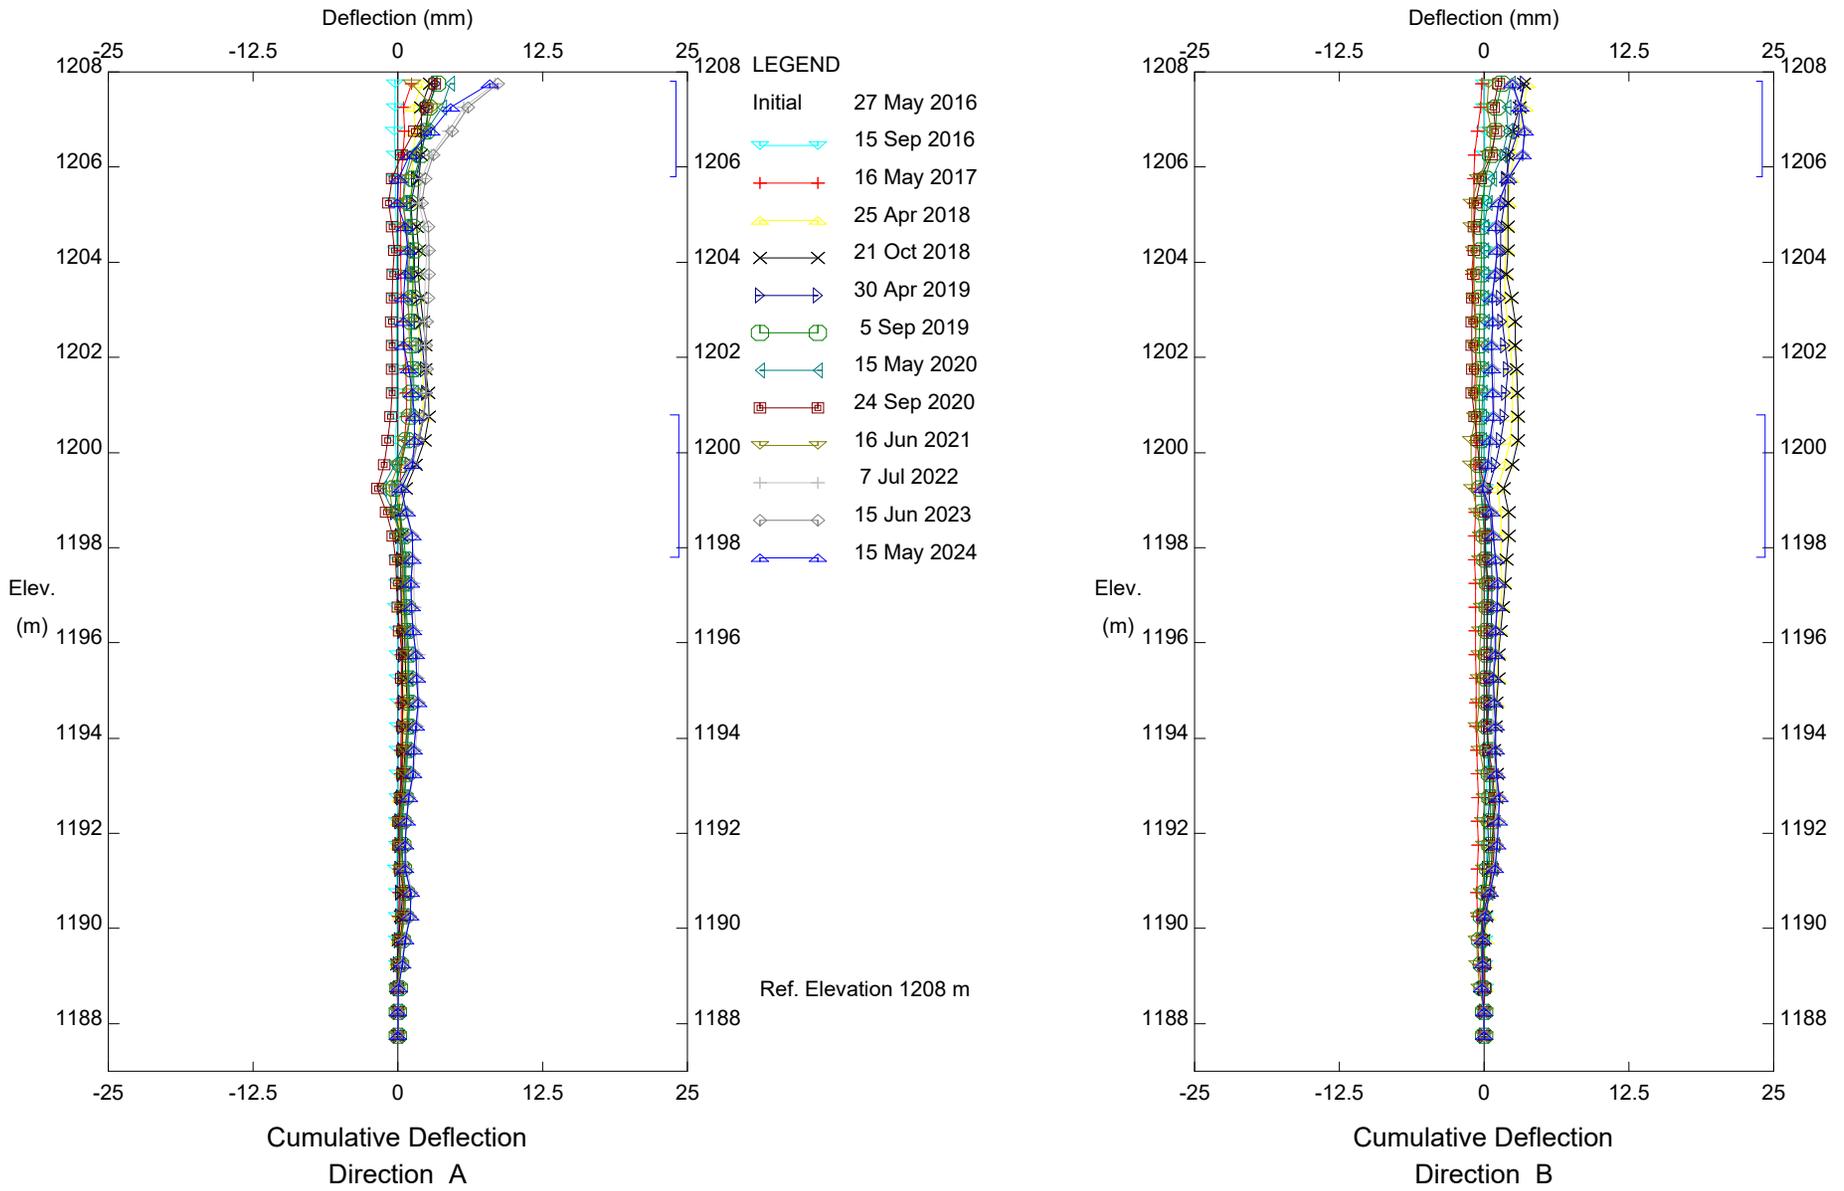
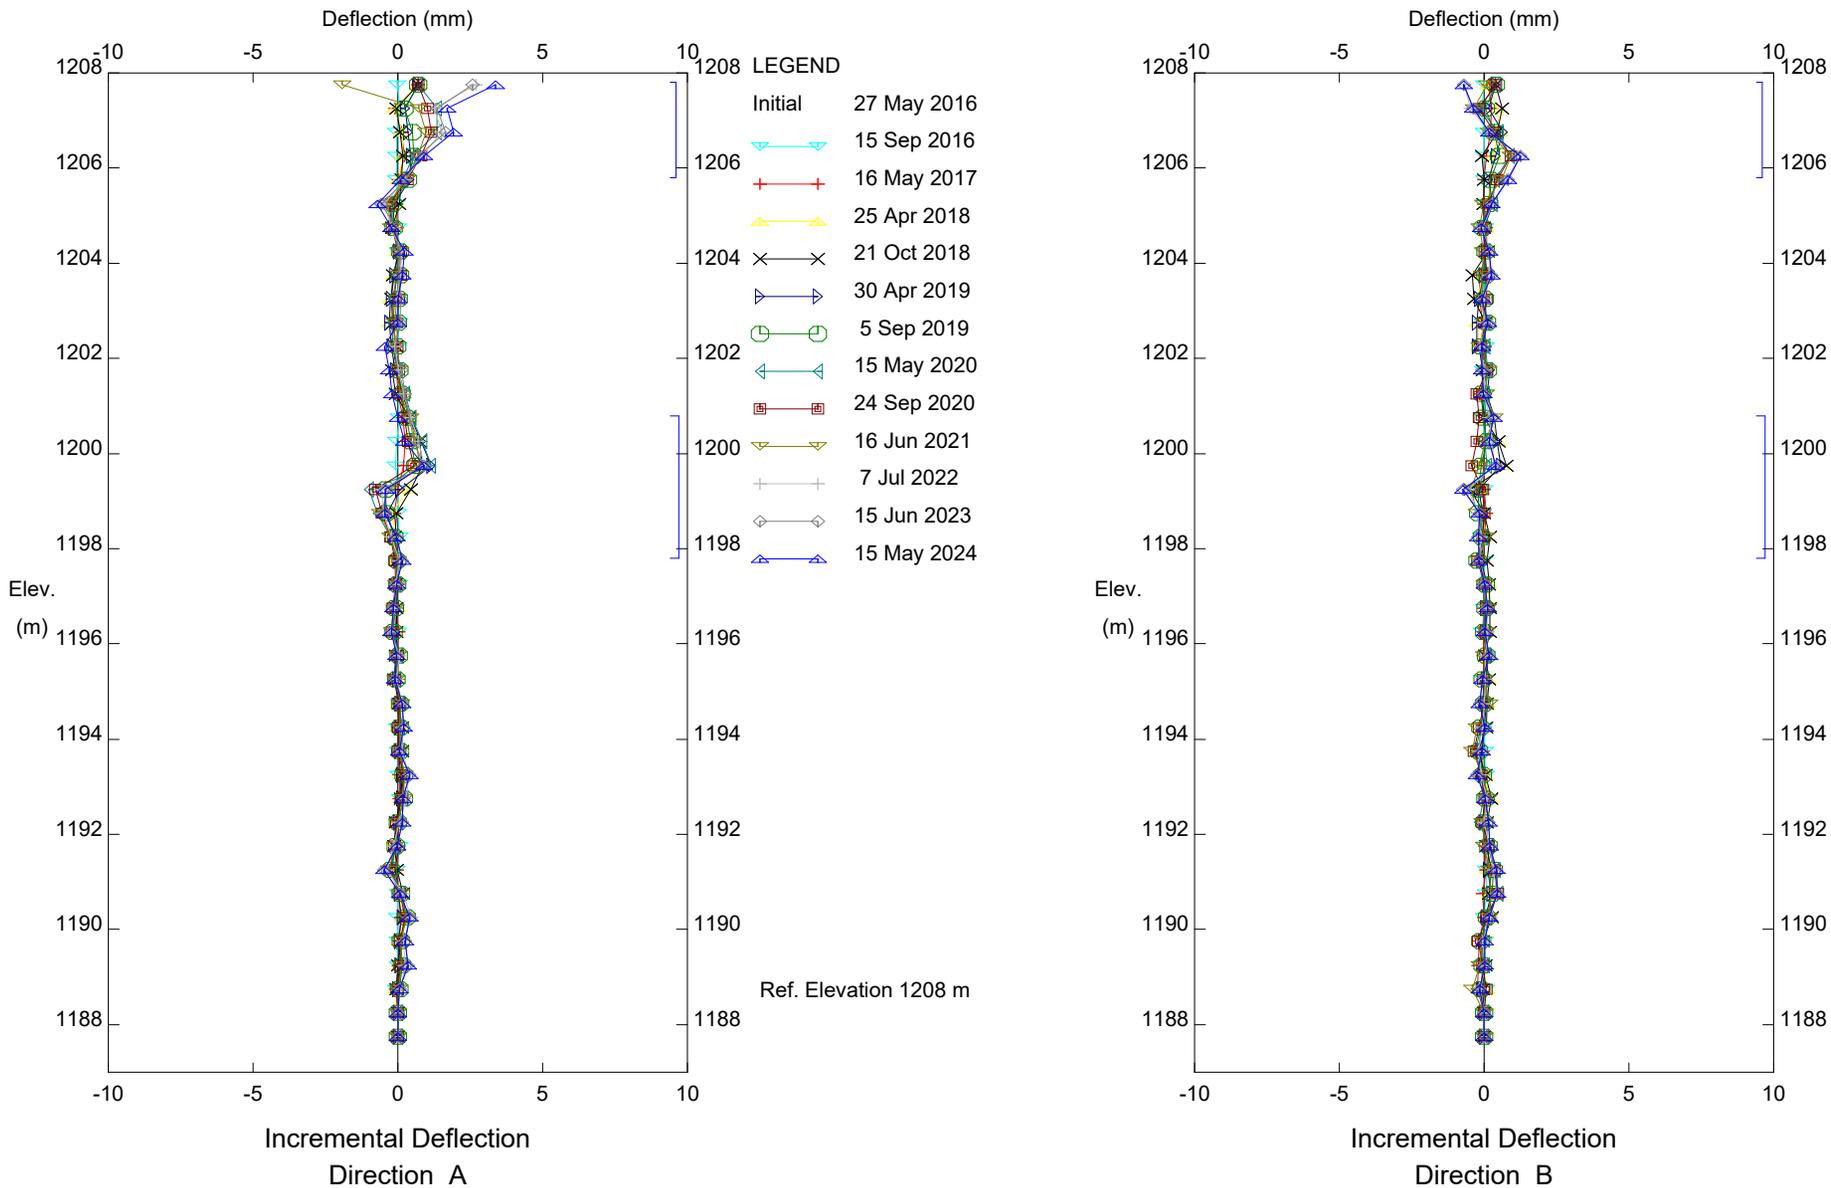
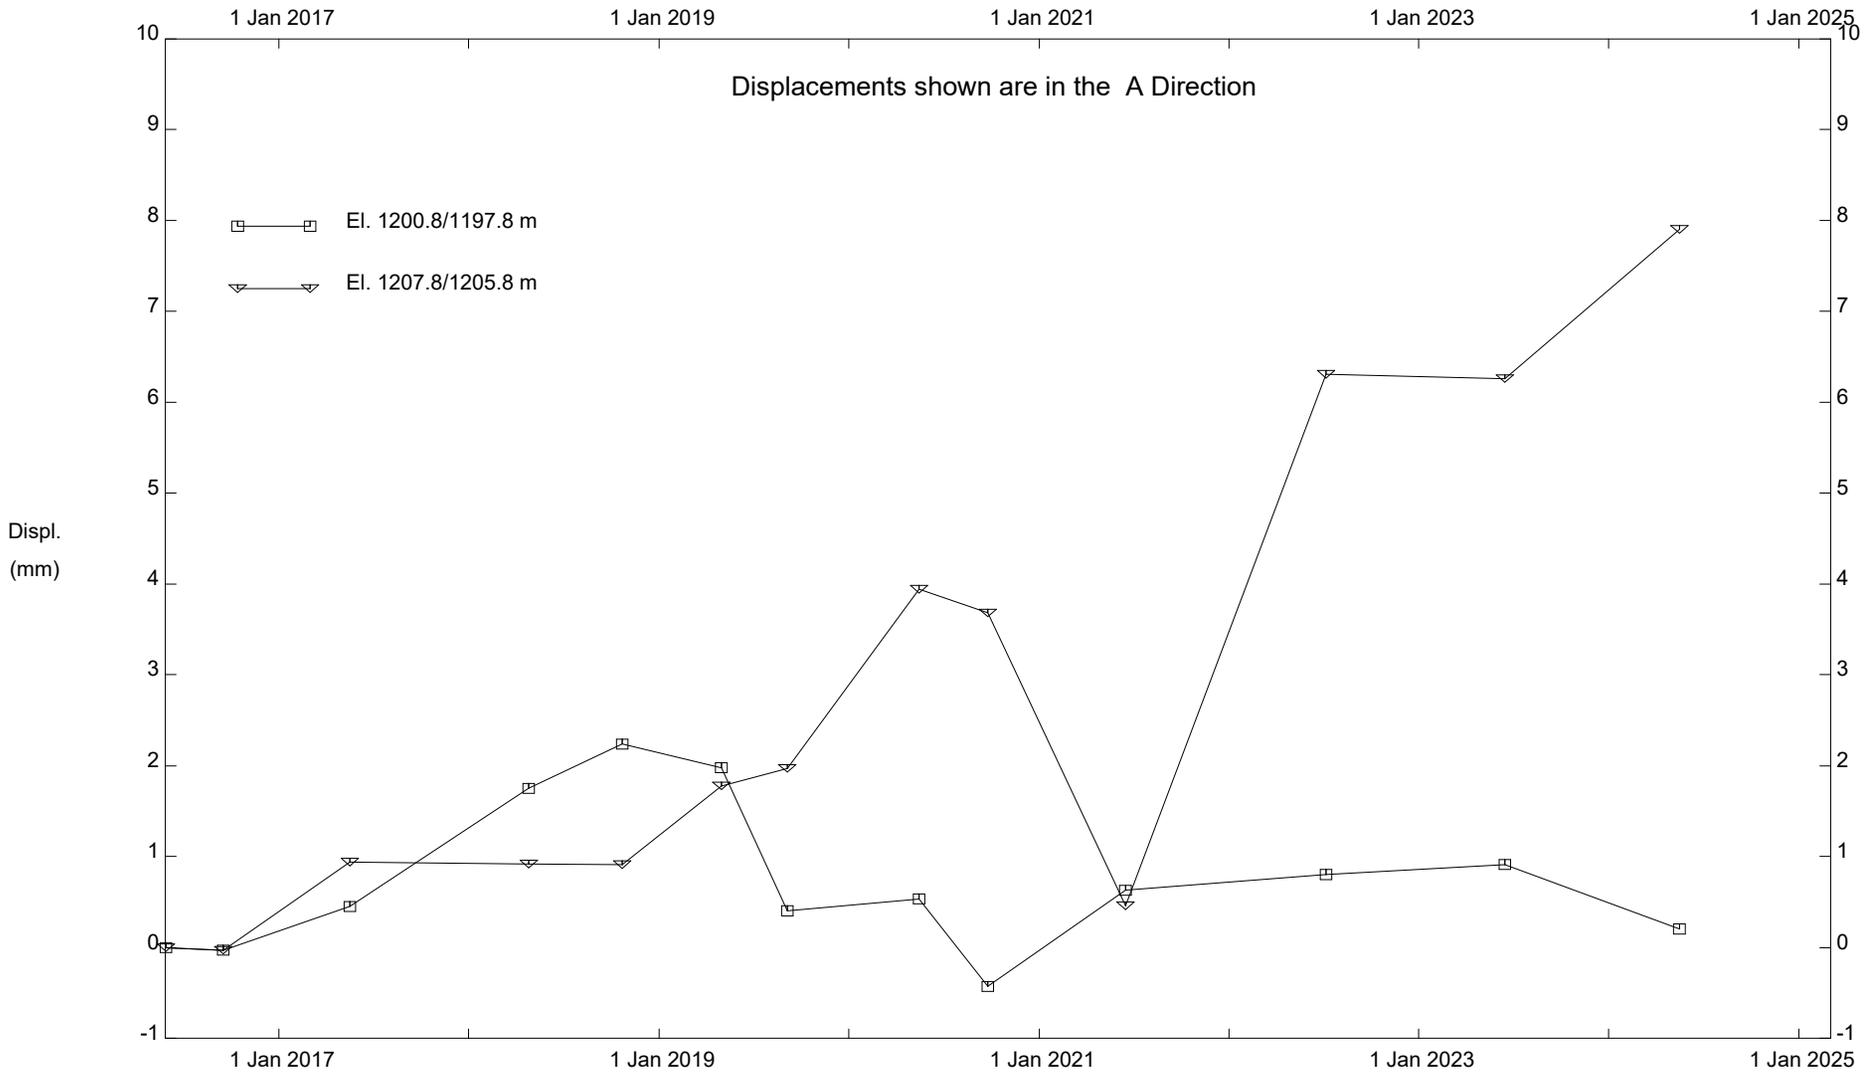
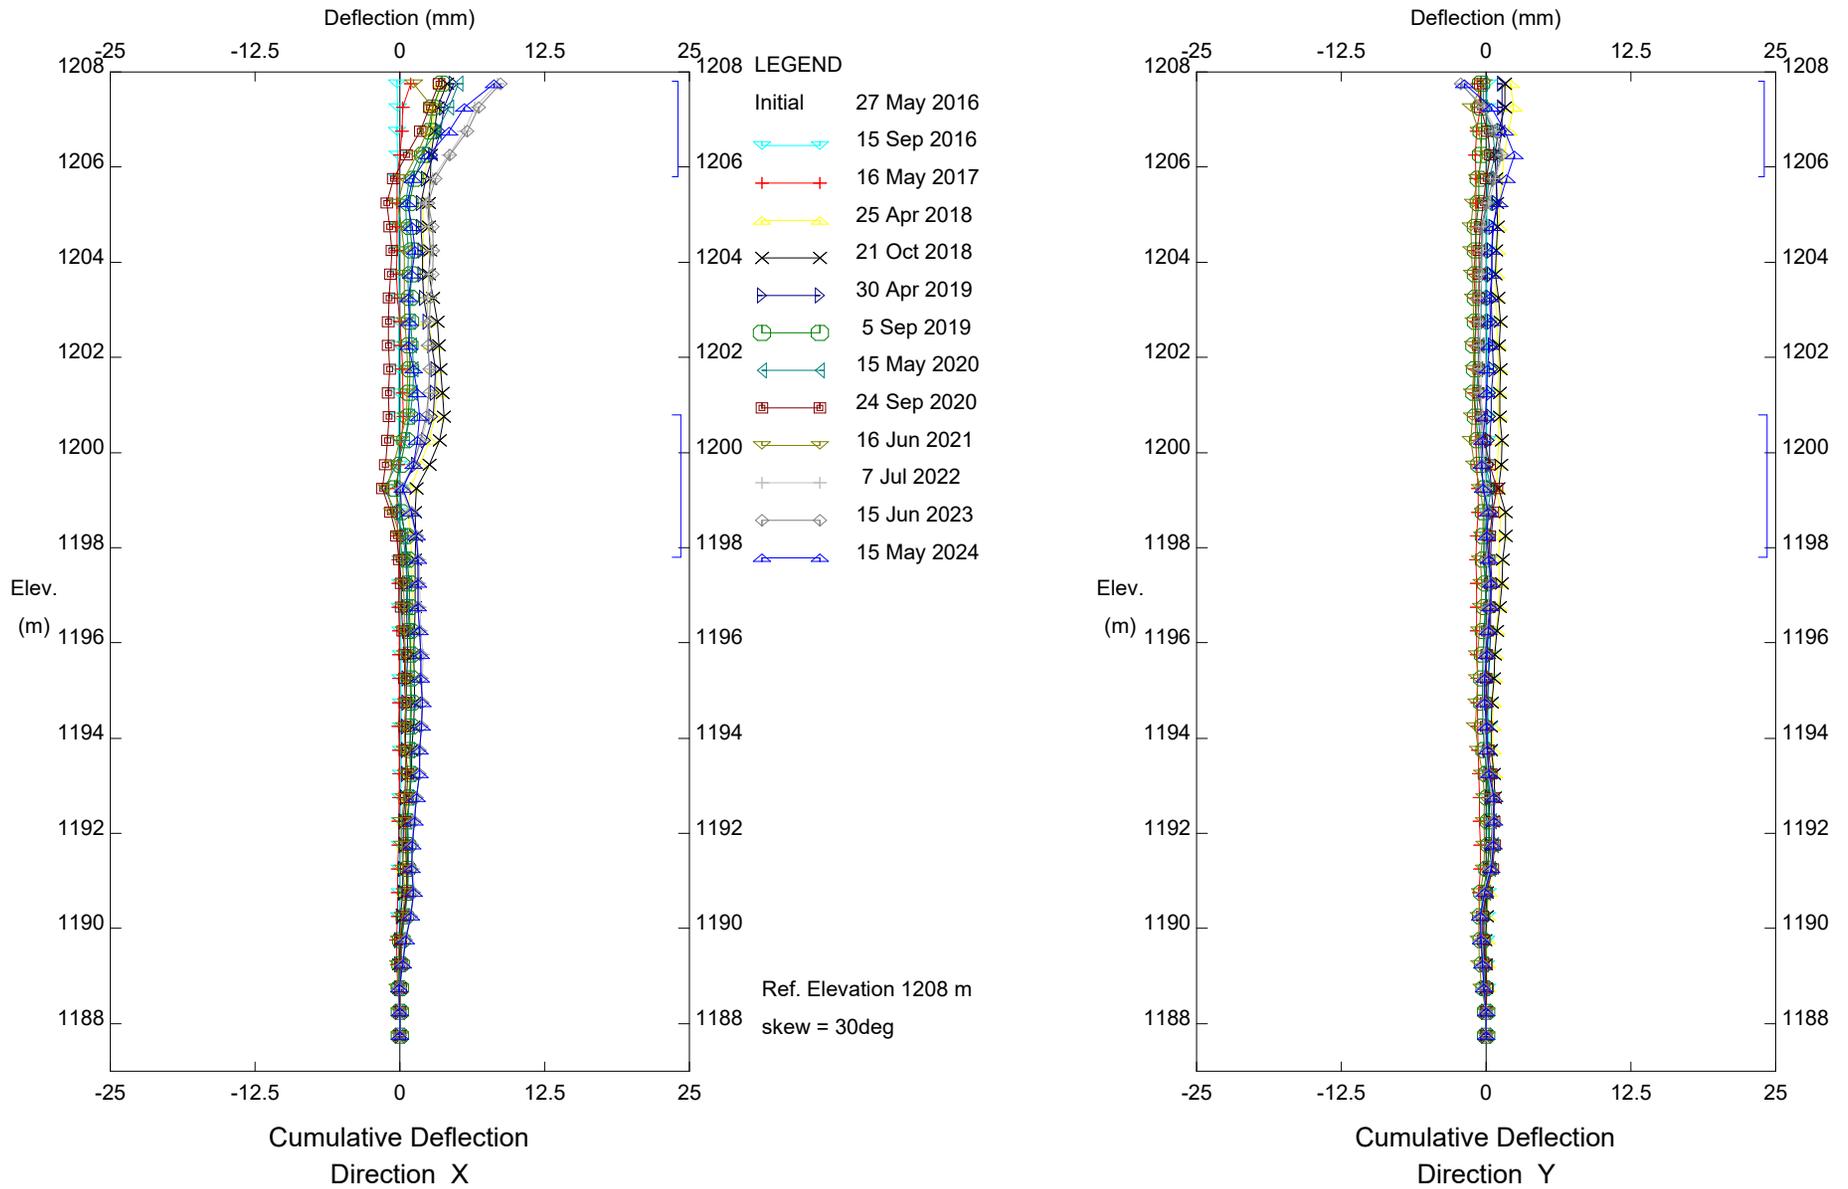
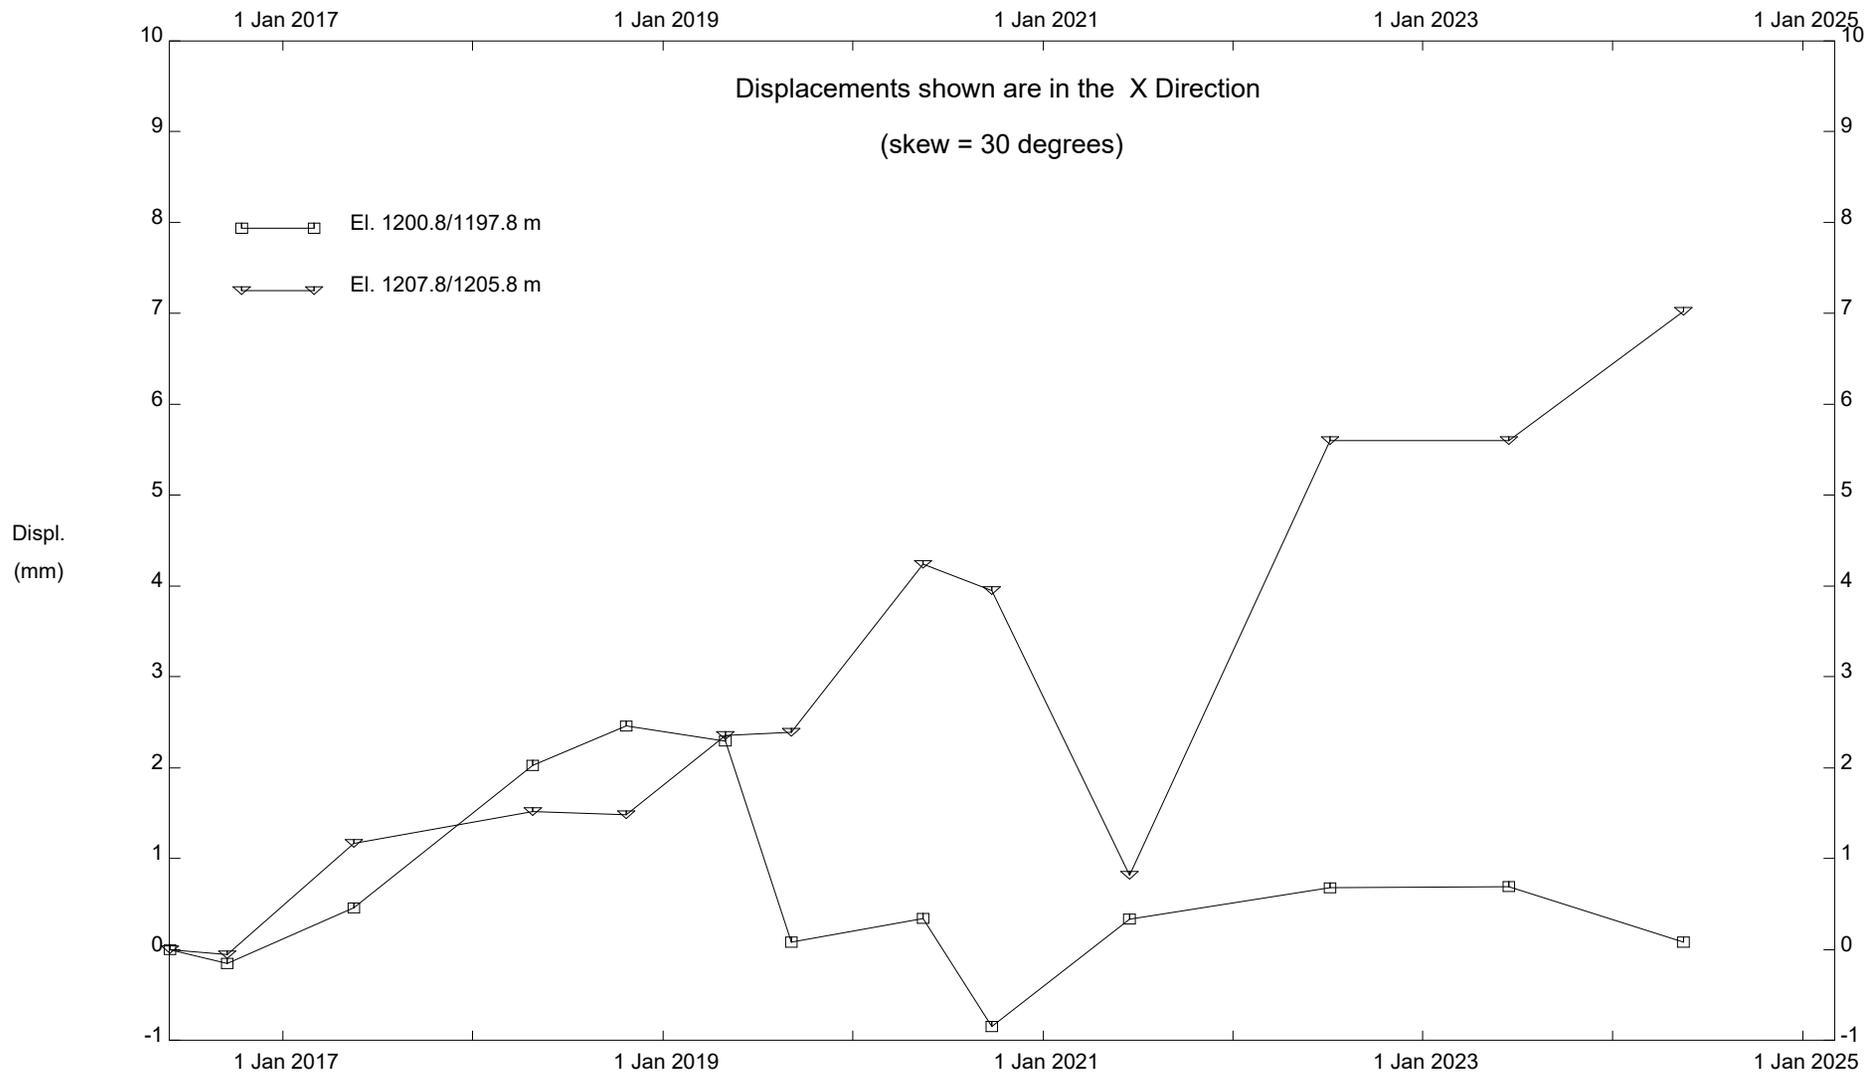
S036; H800:02, Belly River, Inclinator SI11-01
 Alberta Transportation

Movement has been recorded in SI11-01 from an approximate depth of 7 m to 10 m below ground surface (approximately El. 1198 m to El. 1201 m). Shallow movement from ground surface to approximately 2 m below ground surface (El. 1206 m) was also recorded between June 2021 and July 2022.

Since KCB took over the instrument readings at the site, the rate of movement recorded in SI11-01 and SI11-02 has been slow (less than 1 mm/year overall) and is currently negligible. The negative rate of movement recorded in these instruments during some readings indicates the rate of movement is within the accuracy of the reading equipment.

Tightness and difficulty passing the SI probe at approximately 8 m in SI11-01 has been noted over the past several years and during the spring 2024 readings the probe was no longer able to pass through this zone. Since 2017 the SI reading check sums have been high though this zone which could indicate separation of one of the SI casing joints. SI11-01 was read from where the probe was unable to pass (8 mbgs) to surface and showed no signs of additional movement. There were no signs of ground deformation on the slope of highway surface.

A downhole camera could be used to investigate the SI probe being unable to pass through a depth of 8 m in SI11-01.

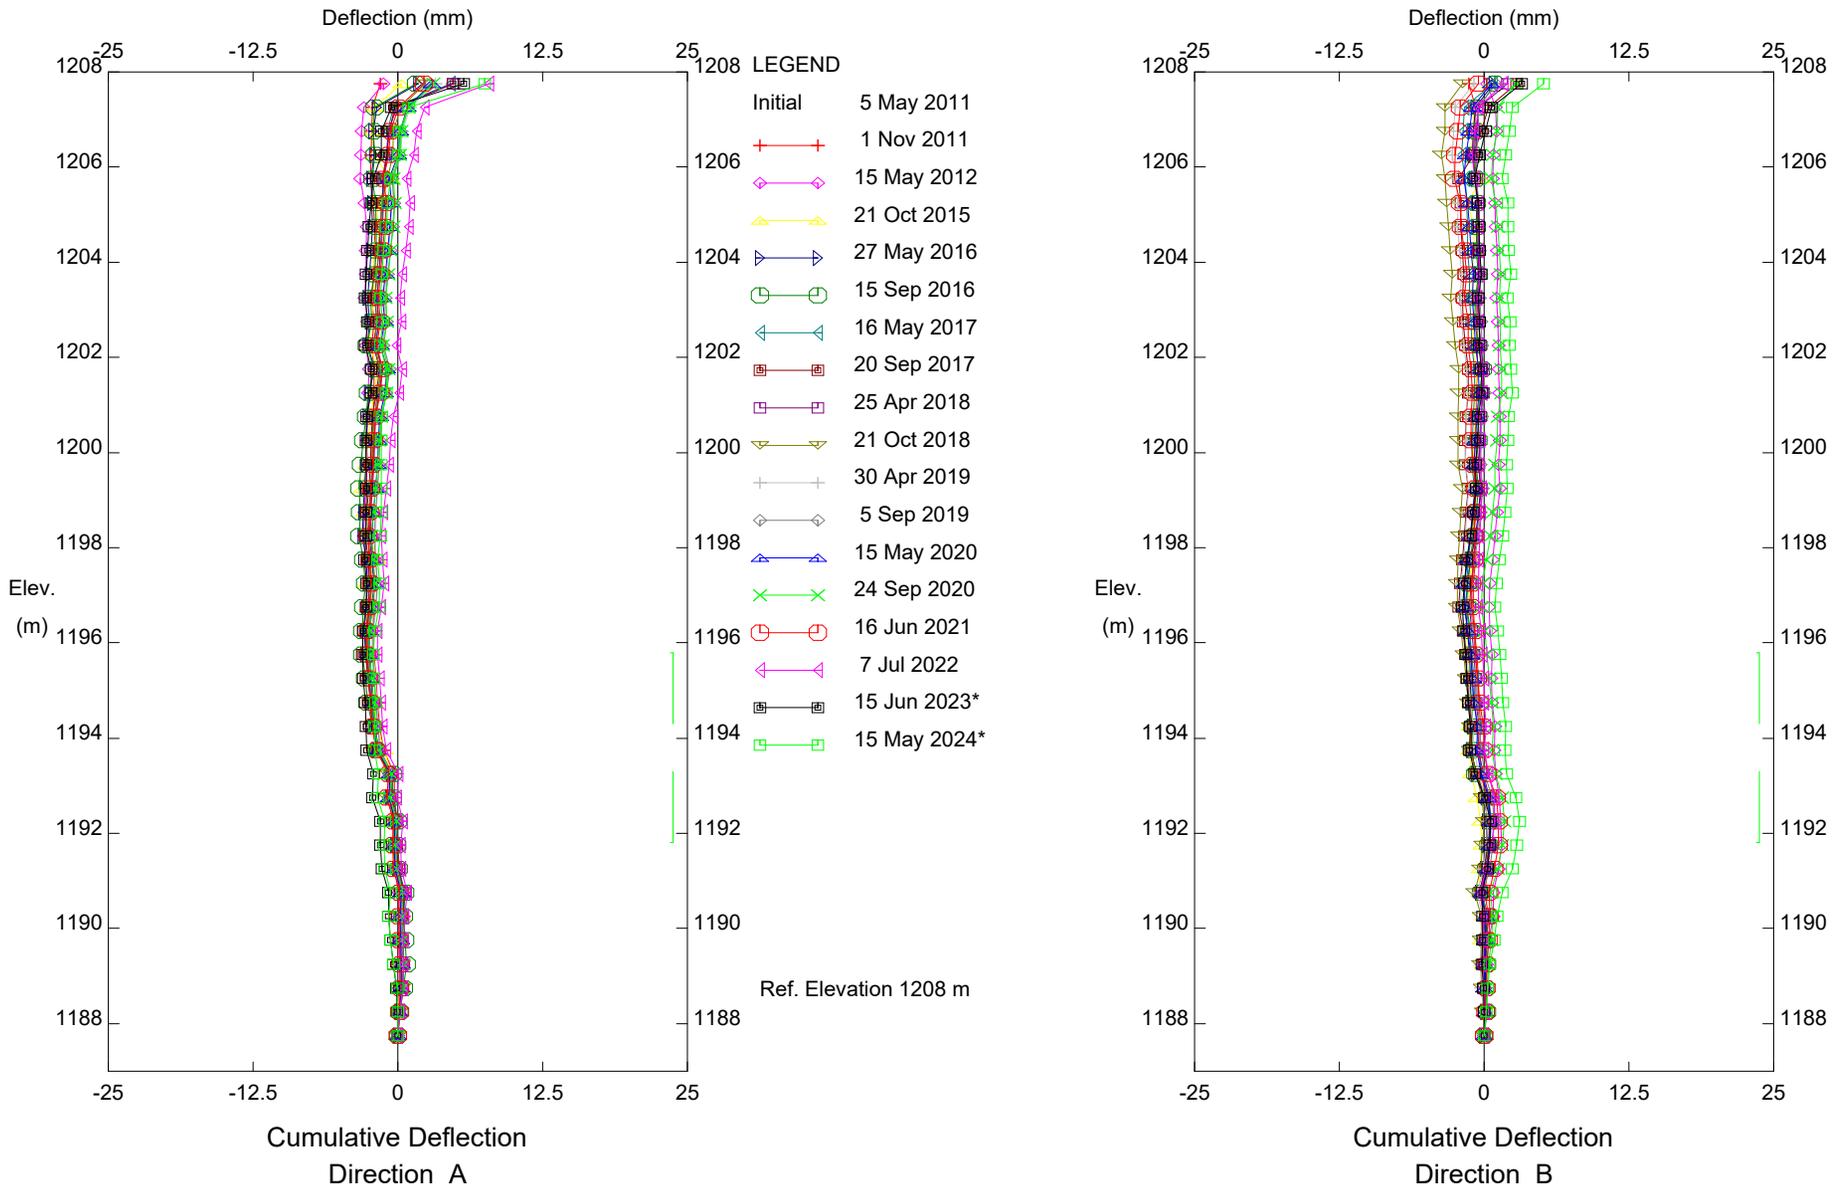
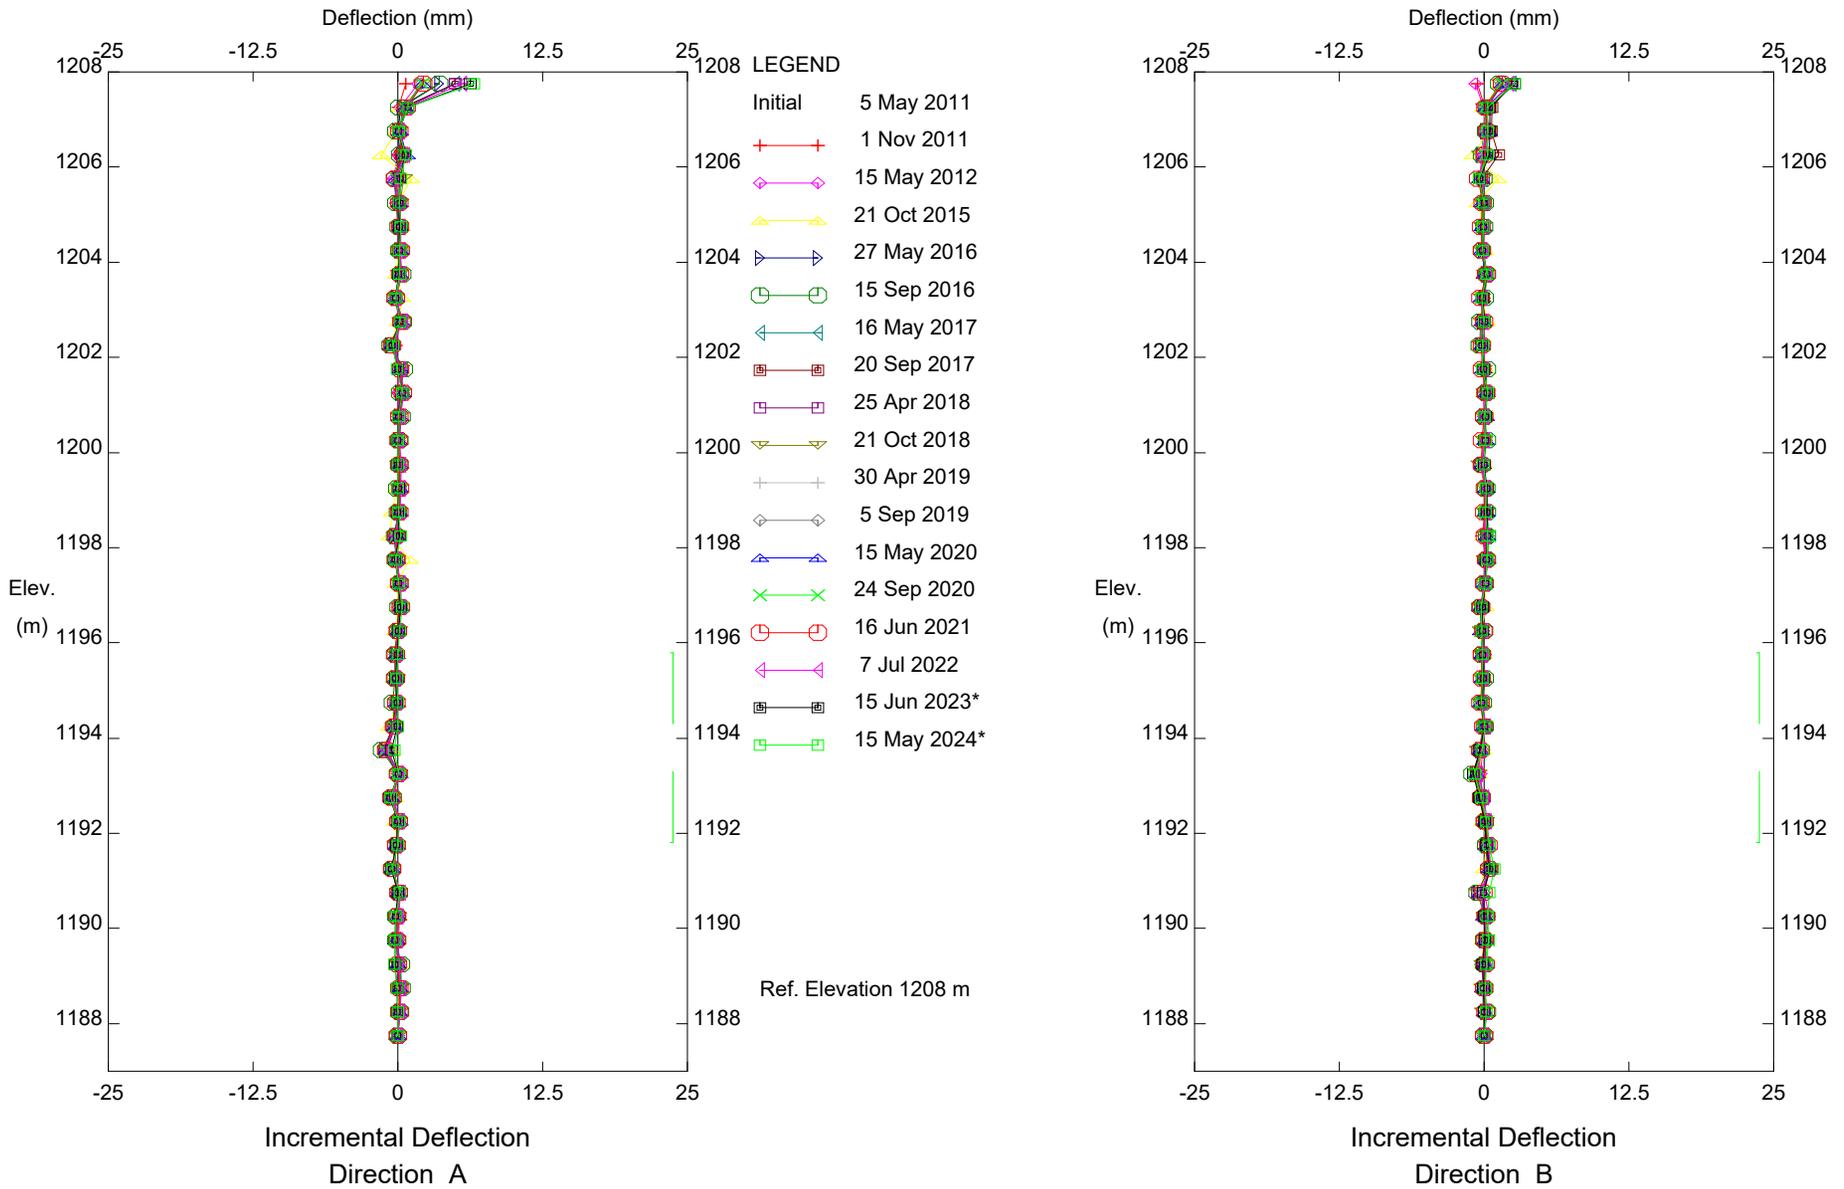
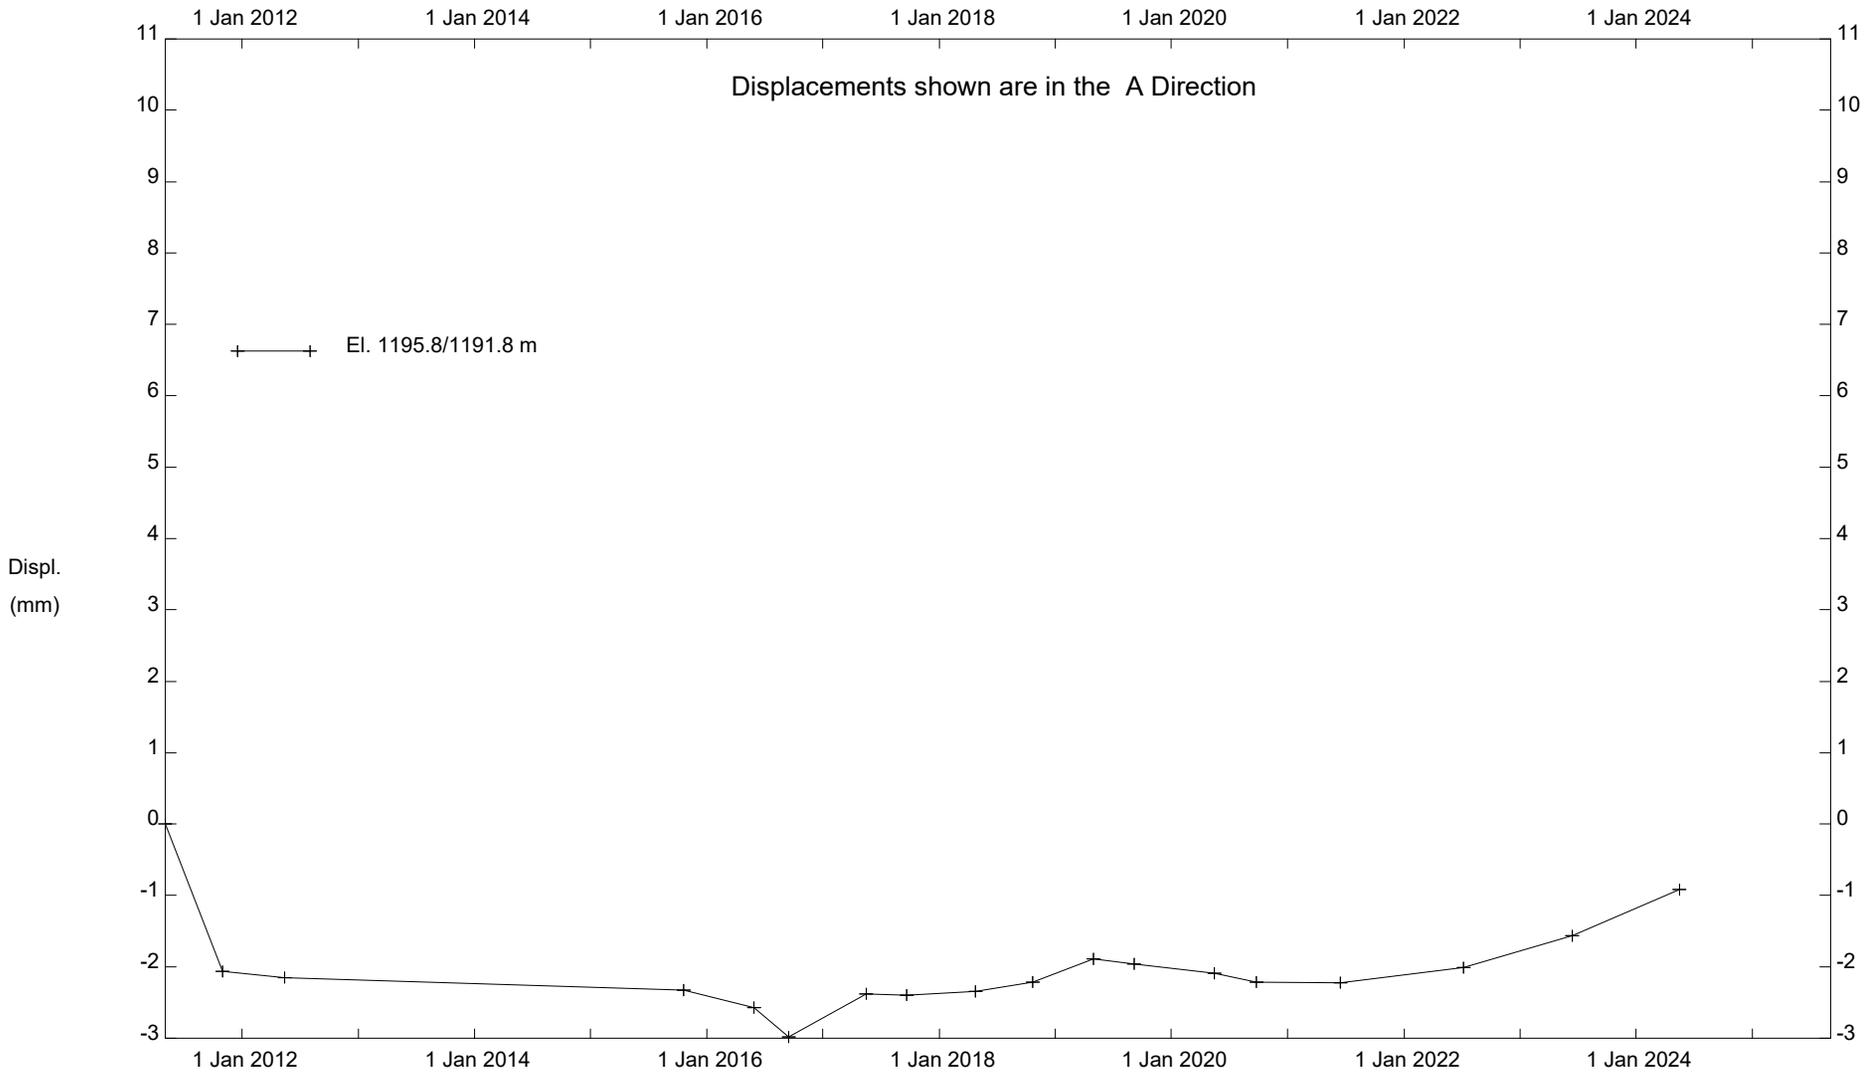
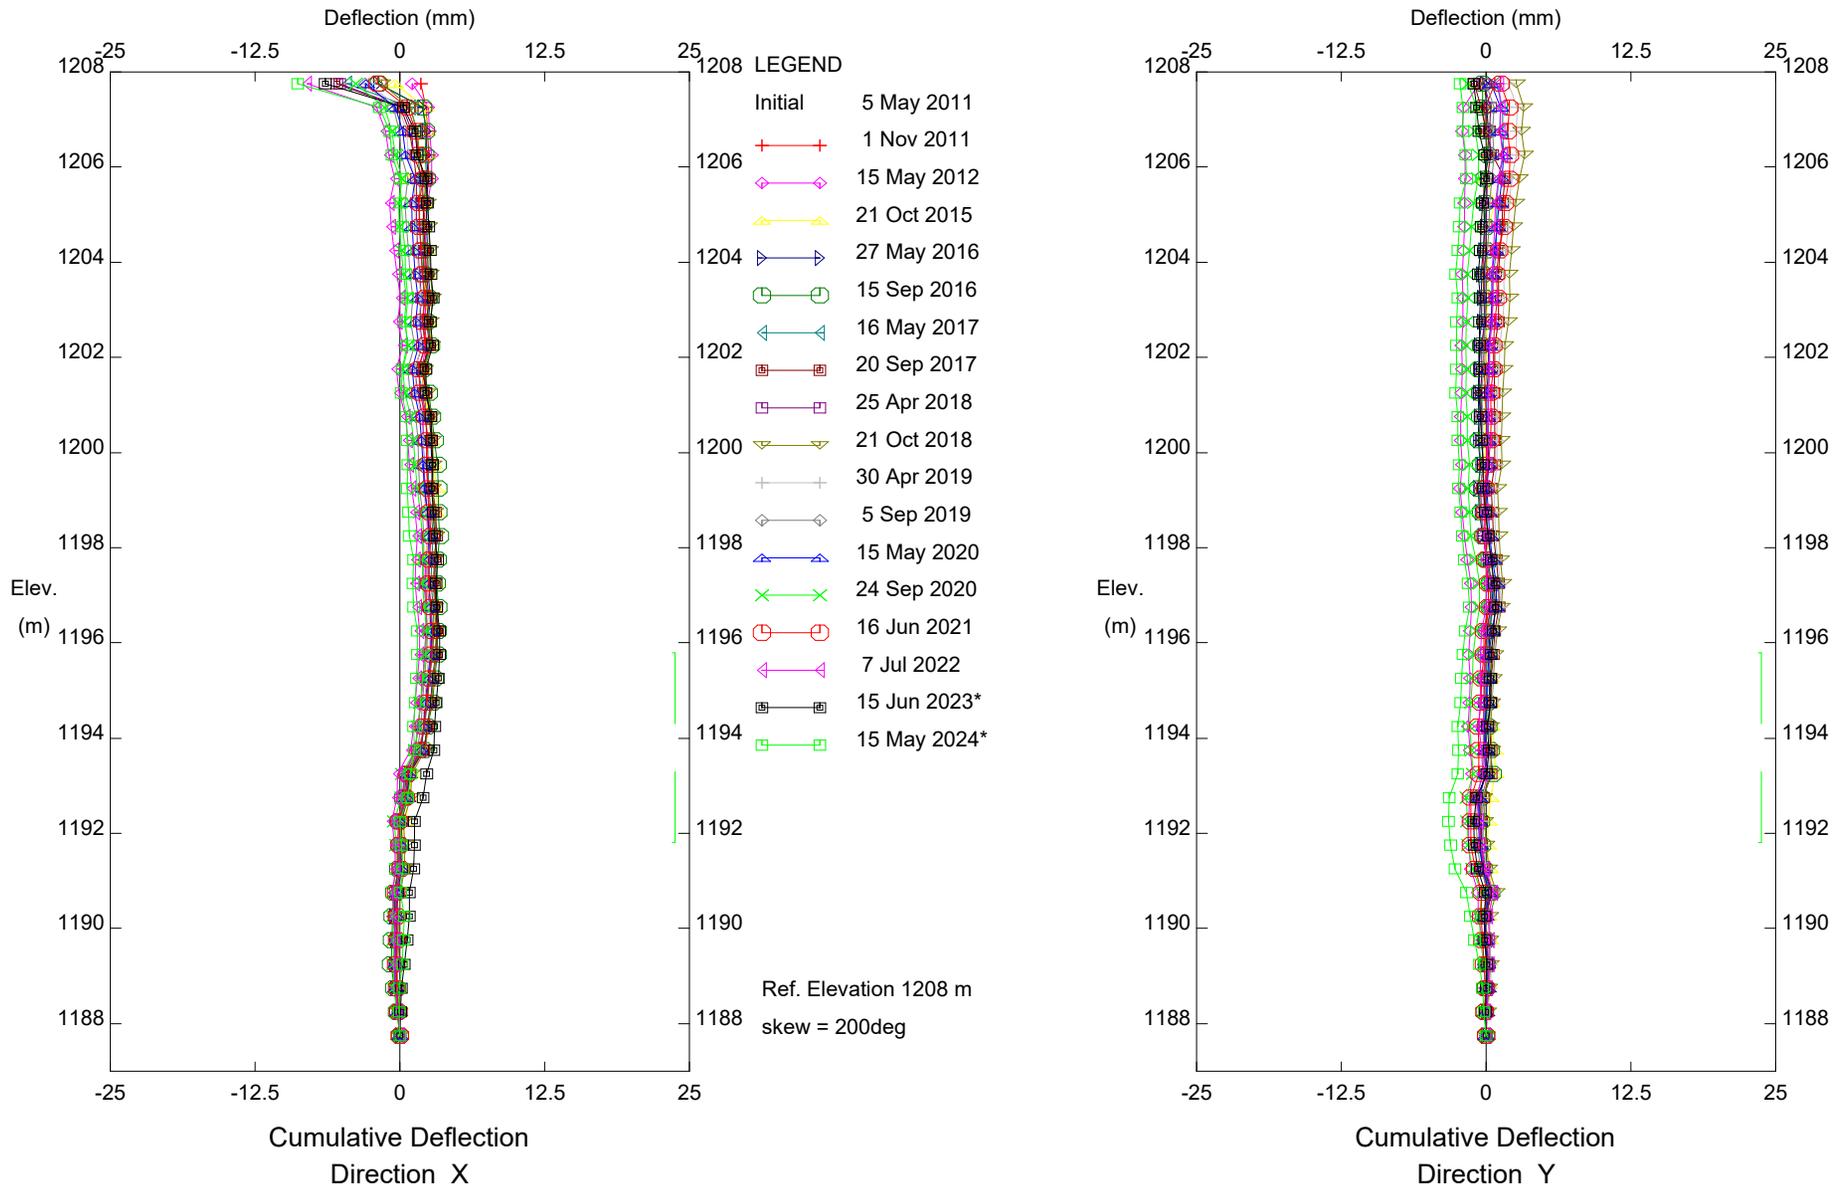
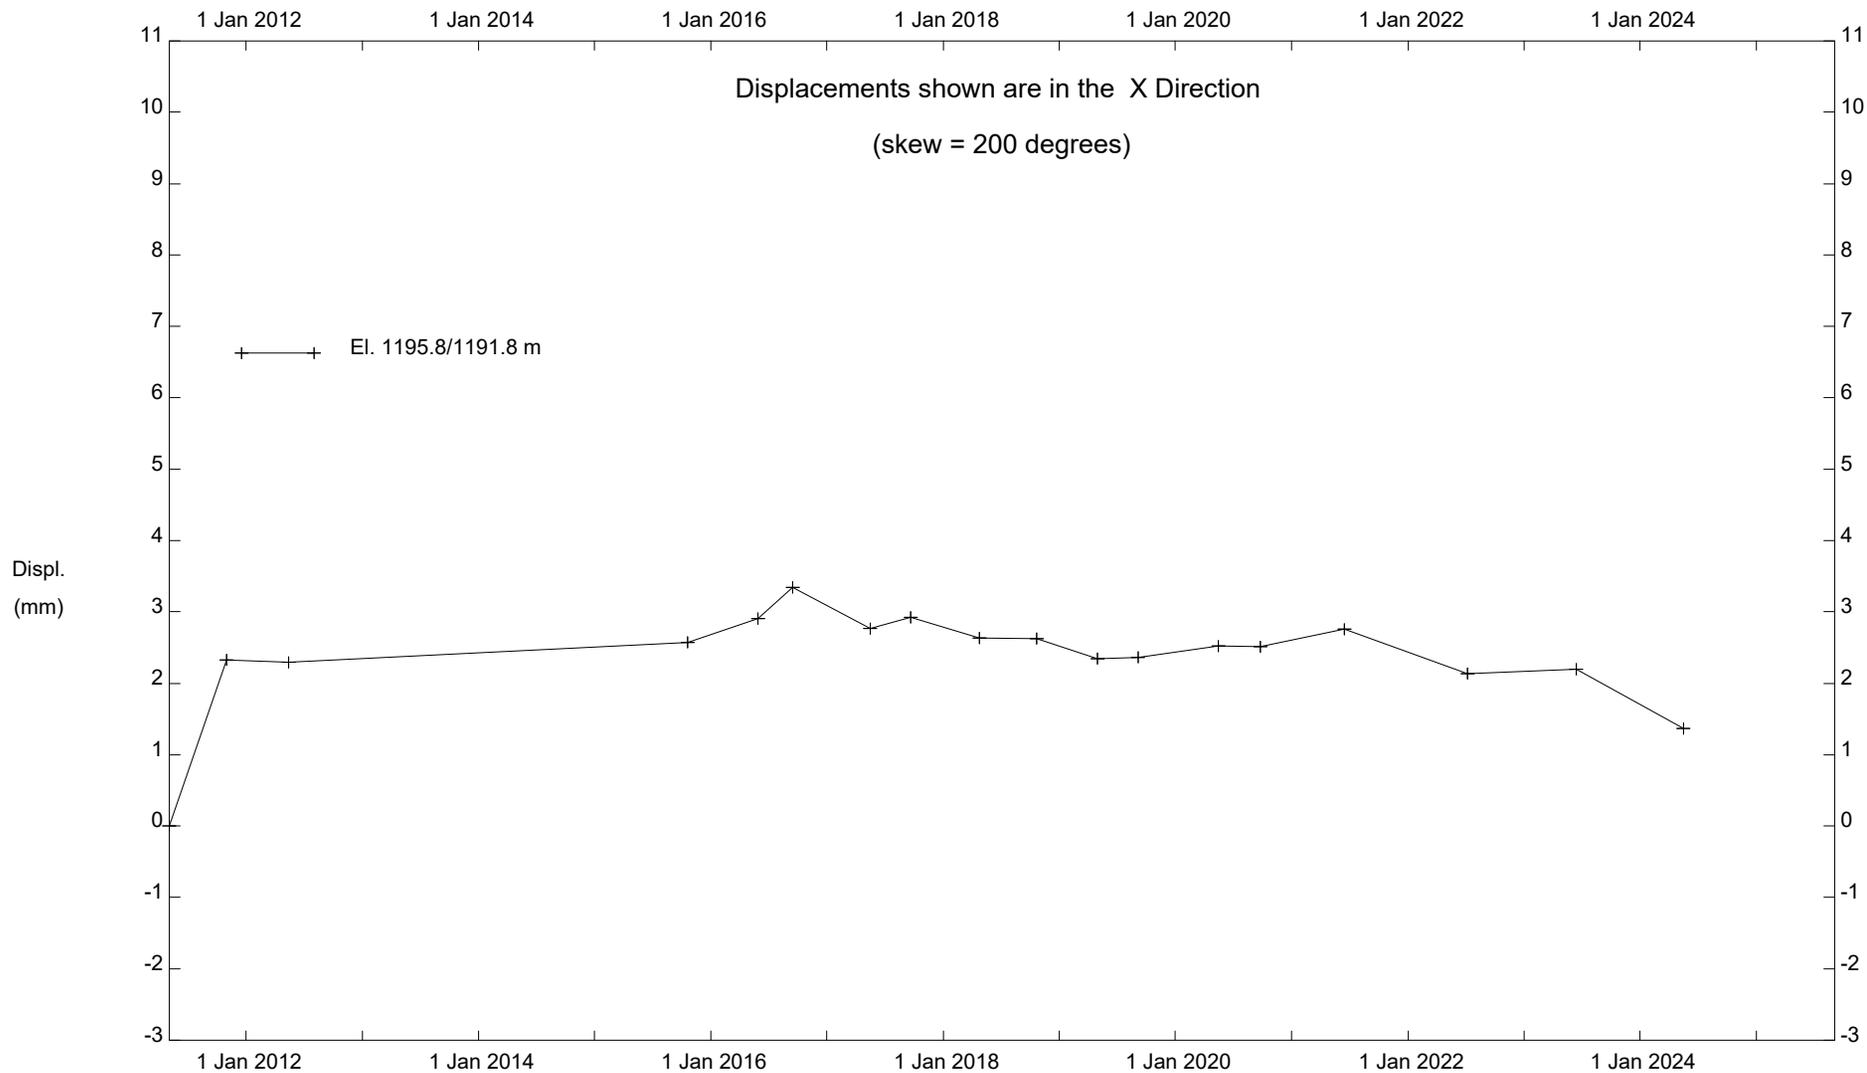
S036; H800:02, Belly River, Inclinator SI11-02

Movement has been recorded in SI11-02 from an approximate depth of 16 m to 20 m below ground surface (approximately El. 1192 m to El. 1196 m).
