July 10, 2024

**CON0022161 Southern Region GRMP Instrumentation Monitoring
Site S036; H800:02, km 9.05 Belly River
Section C – 2024 Spring Readings**

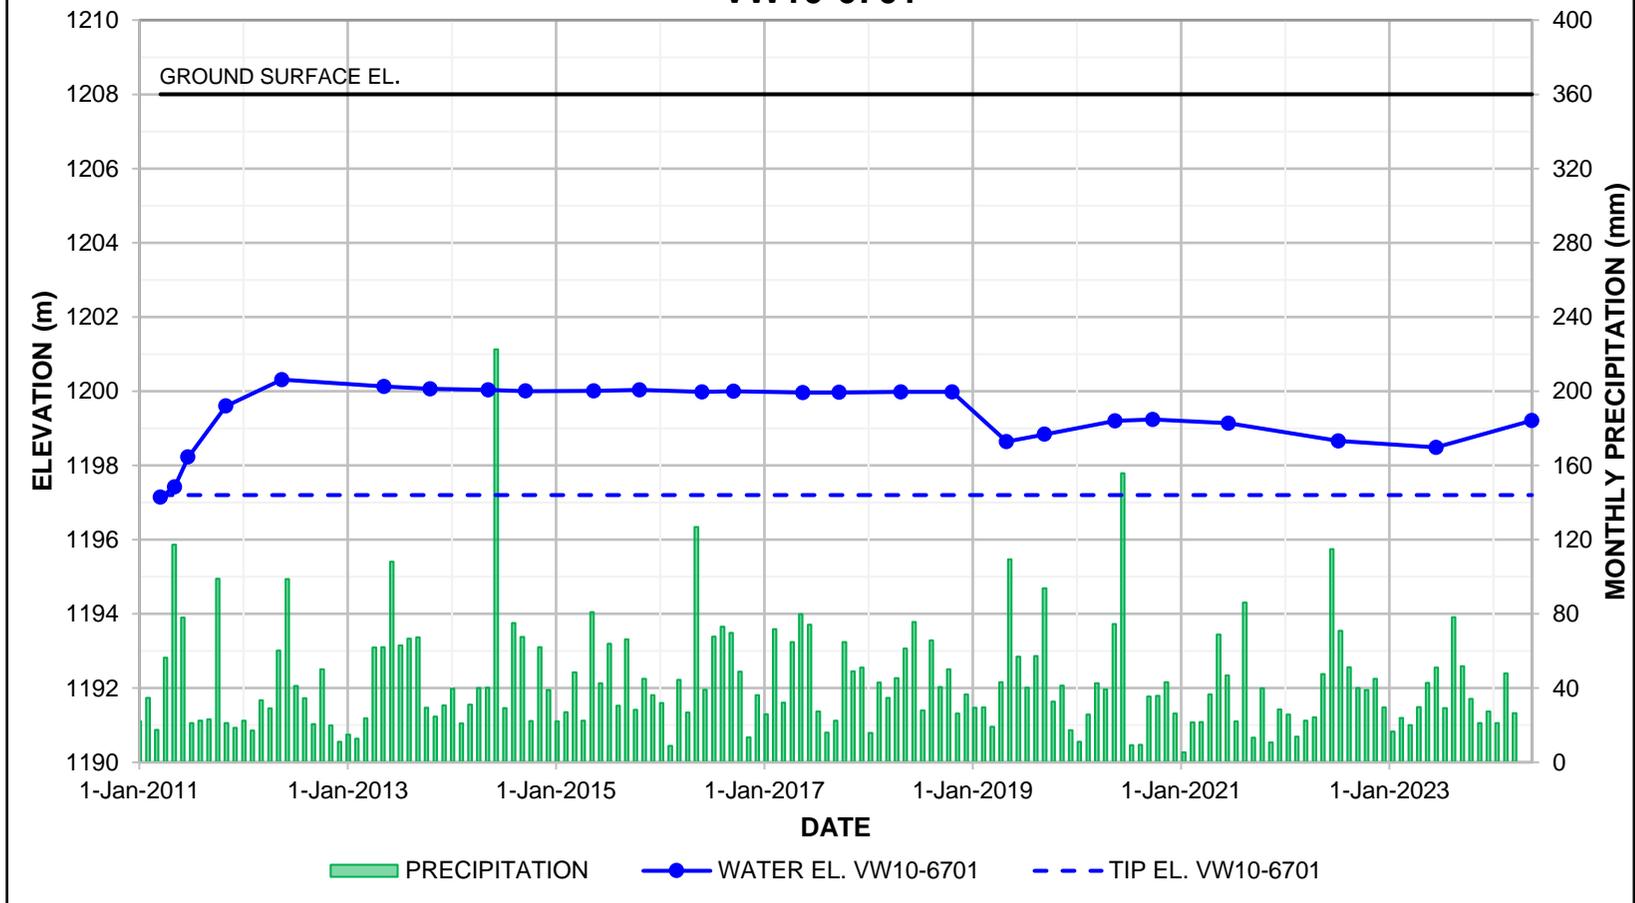
VW10-6701 and VW10-6706 were installed outside of the active slide zone, between the head of the slide and the west (southbound) lane of the highway. A steady increase (up to approximately 3 m) in water level was recorded in VW10-6701 and VW10-6706 between March 2011 (when the instruments were installed) and May 2012. Without reviewing previous borehole records, construction records for the site, or installation details for the instruments, KCB is unable to assess the cause of the increase in water level at this time. KCB suspects the increase may be attributed to a delayed response to 2010 construction activities or post-installation instrument stabilization.

Following construction in 2012, water levels recorded in VW10-6701 remained relatively steady until a 1.4 m decrease was recorded between October 2018 and April 2019. The cause of the decrease is unknown. Since April 2019, water levels recorded in VW10-6701 have fluctuated from approximately 8.8 m to 9.5 m below ground surface.

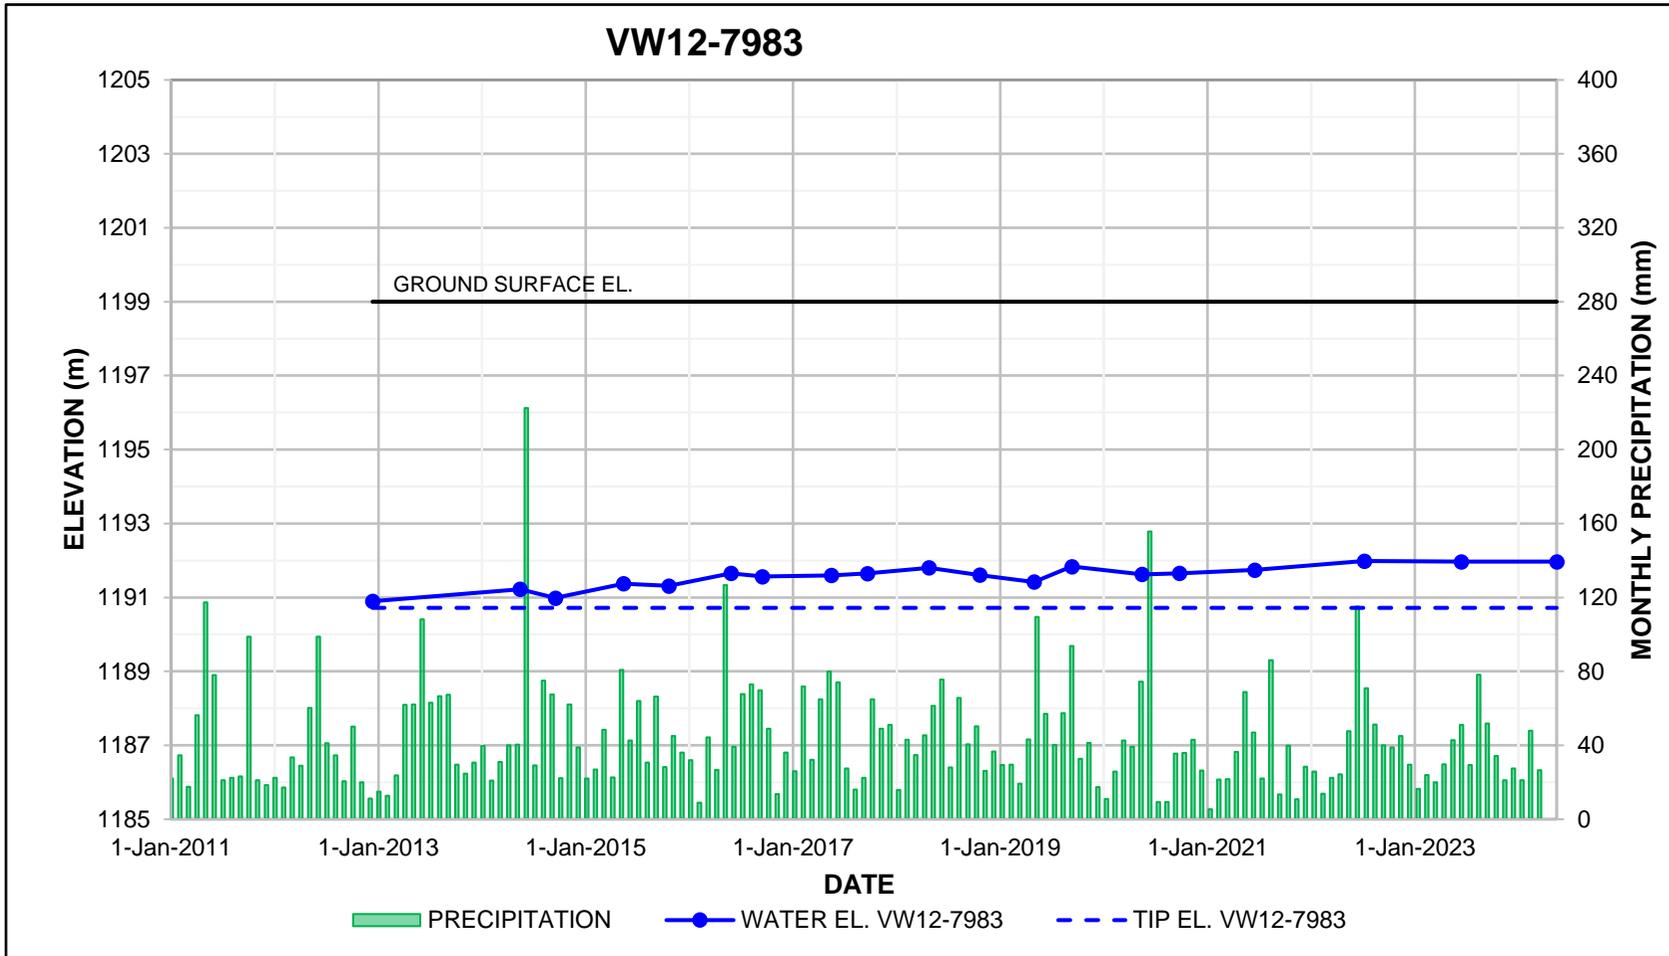
Water levels recorded in VW12-7888 and VW12-7899 have been relatively steady since installation between an approximate depth of 2.6 m to 3.1 m and 0.3 m to 1.1 m, respectively. Whereas water levels recorded in VW12-7051 and VW12-7983 have been increasing (approximately 1.0 m and 1.1 m overall, respectively), with some seasonal variations noted. The rate of increase recorded in VW12-7983 appears to be slowing or flattening as the recorded water level has been consistent since spring 2022.
