SITE NUMBER AND NAME: S055 East of Gleichen	HIGHWAY & KM: 901:14, 9.2	PREVIOUS INSPECTION DATE: May 12, 2023	INSPECTION DATE: May 28, 2025
LEGAL DESCRIPTION: 02-12-022-22 W4M	NAD 83 COORDINATES: UTM Northing Easting 12 5634864 364825	RISK ASSESSMENT Slide: PF: 7 CF: 2 TOTAL: 14 Erosion: PF: 2 CF: 2 TOTAL: 4	
AVERAGE ANNUAL DAILY TRAFFIC (AADT): 300 (west), (Ref. No. 109170)		CONTRACTOR MAINTENANCE AREA (CMA): 521

Inspection Photographs

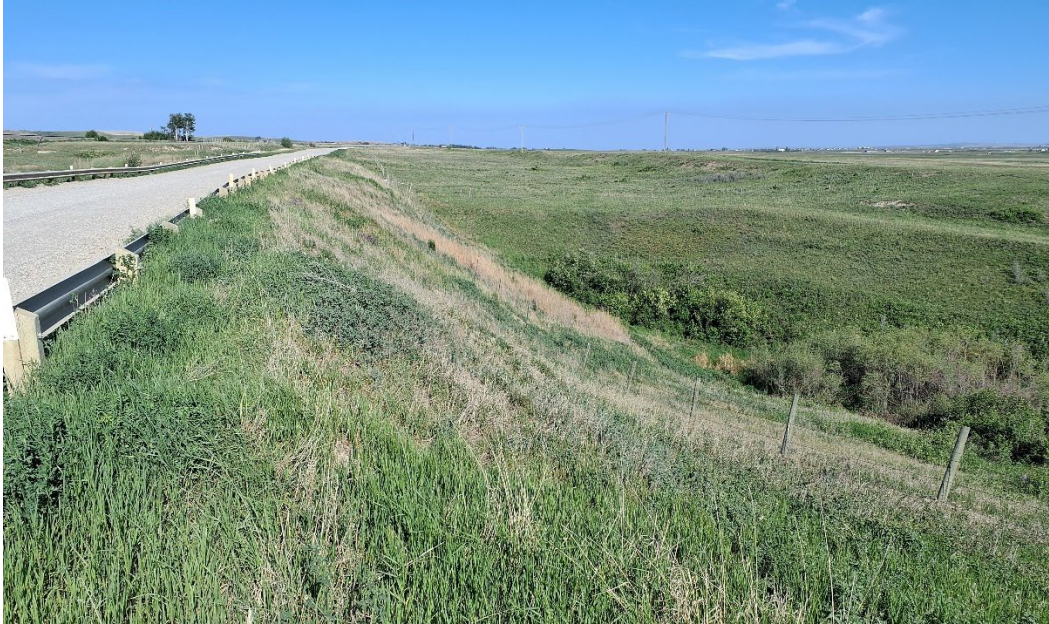
- During the 2025 inspection, no evidence of movement (cracking or settlement) along the crest of the slope or guardrail deflection was observed (Photo 1). The highway embankment slope is relatively steep, sloping close to 2H:1V.

- Photo 1** South (eastbound) highway embankment slope was relatively well vegetated, and no ground cracks or guardrail settlement were observed. Photo taken May 28, 2025, facing east.

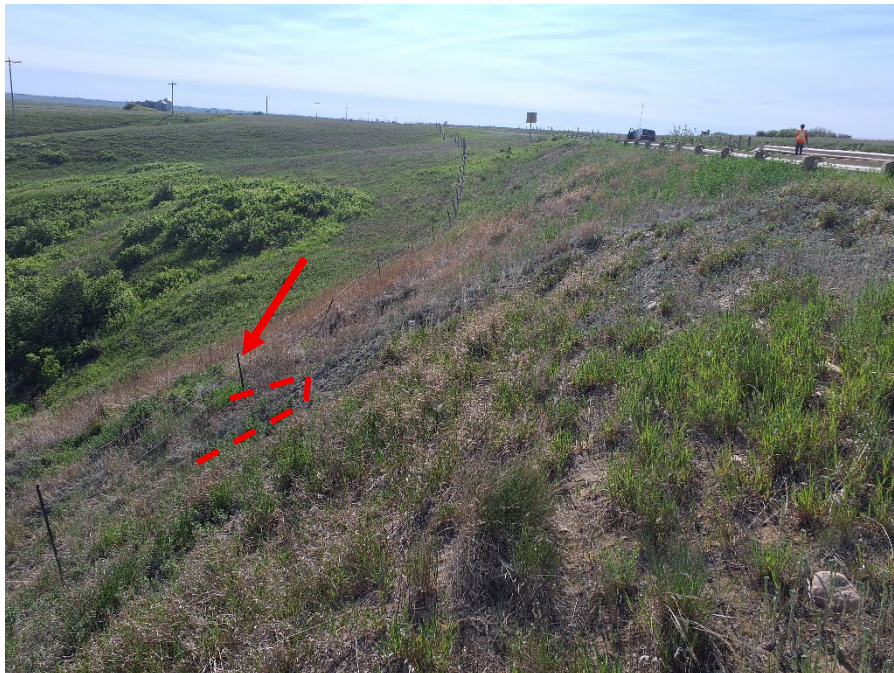
- During the 2020 inspection, tension cracking was observed midslope on the east and west flanks (left and right, respectively) of the repaired area. The failed material is displacing the fence downslope, with one fence post leaning significantly. There are three discernible zones of slope instability, with the head scarps approximately 3 m upslope (north) from the fence line. The sloughing width ranges from approximately 2 m to 8 m (Photos 2 and 3).

- Photo 2** Small slide (red dashed line) was observed in the south (eastbound) highway embankment slope that is impacting the fence (red arrow). Photo taken May 28, 2025, facing west.

- If slope instability continues that impacts the highway surface, the following repair work could be completed:
 - Improve highway drainage to limit surface water runoff into the sloughing zone (e.g., construct a berm on the south side of the highway or grade the highway surface);
 - Install an erosion control product on the embankment surface to reduce infiltration and erosion; and
 - Stabilize the slope (e.g., geogrid-reinforced granular fill, constructing or toe berm, or an active ground anchoring solution).

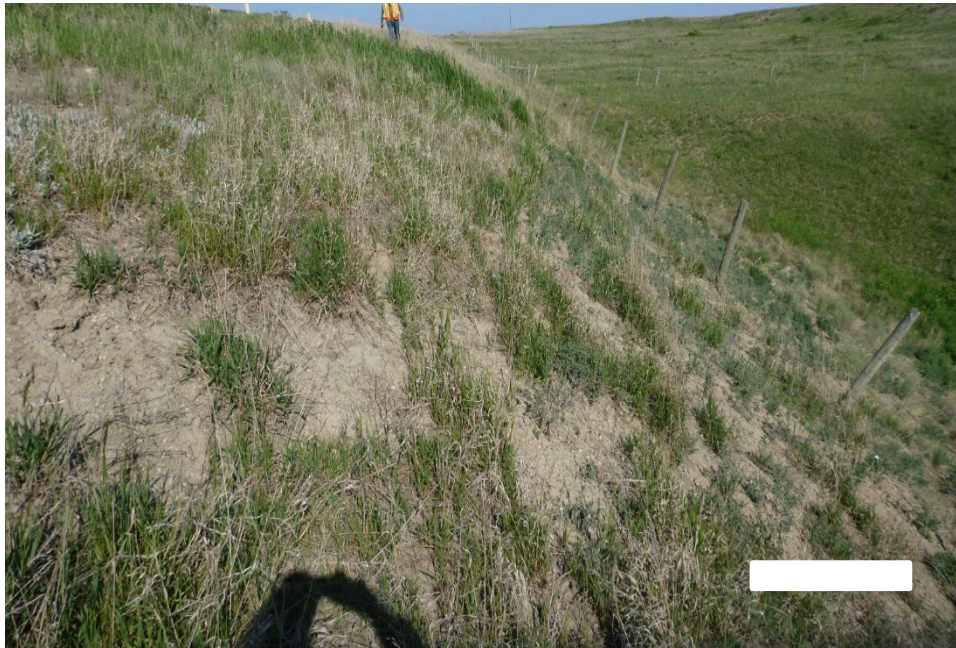
- The vegetation coverage on the highway embankment slope is relatively poor and is primarily weeds (Photo 3). The embankment slope is steep, and the site is dry, which likely limits vegetation growth. KCB suspects that surface water runoff is contributing to ground infiltration and saturation, and that the granular fill is acting as a preferential flow pathway.

Photo 3 Slide in the south (eastbound) highway embankment that is impacting the fence. Photo taken May 28, 2025, facing east.

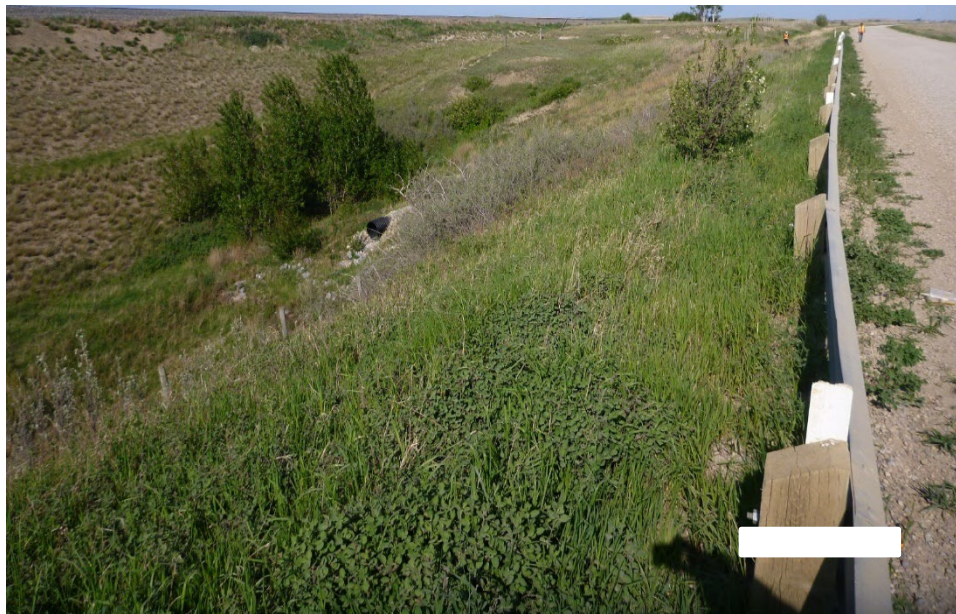
- The north (westbound) highway embankment slope and ditch are well vegetated and appear to be performing well (Photos 4 and 5).
- Erosion (up to 0.15 m deep and 0.5 m wide) was observed upstream (east) of the HDPE slope drain inlet.

Photo 4 The north (westbound) highway embankment slope was relatively vegetated and appears to be performing well after the 2018 repair. Photo taken May 28, 2025, facing east.

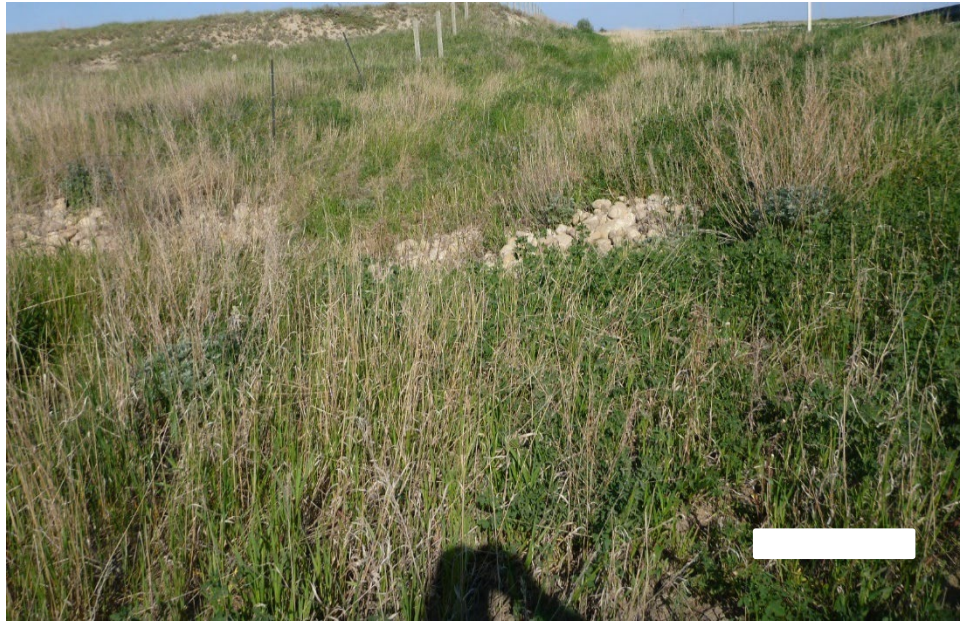
Photo 5 Highway embankment slope and ditch upslope (east) of the HDPE culvert slope drain is well vegetated. Photo taken May 28, 2025, facing east.

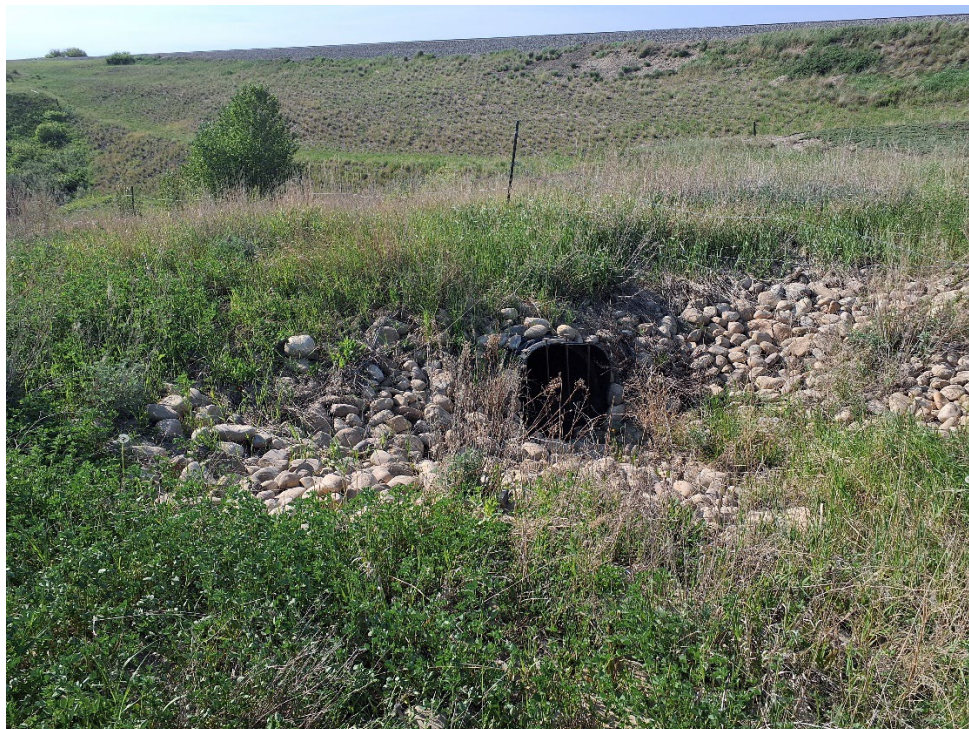
- The riprap placed at the HDPE slope drain inlet and outlet was in good condition (Photos 4 through 7).
- The HDPE slope drain inlet was open, and the trash rack was in good condition (Photo 6). No evidence of flow overtopping the berm at the inlet of the slope drain was observed.

Photo 6 The HDPE culvert inlet appeared to be in good condition. Photo taken May 28, 2025, facing west.

- Clean out the CSP culverts to restore full flow capacity and to improve drainage from the agricultural land north of the CP Rail line (north of the site).
- Install geofabric at the inlet to the slope drain to direct all ditch flow into the HDPE pipe. A custom “boot” is recommended around the HDPE pipe to provide a full seal around the pipe.

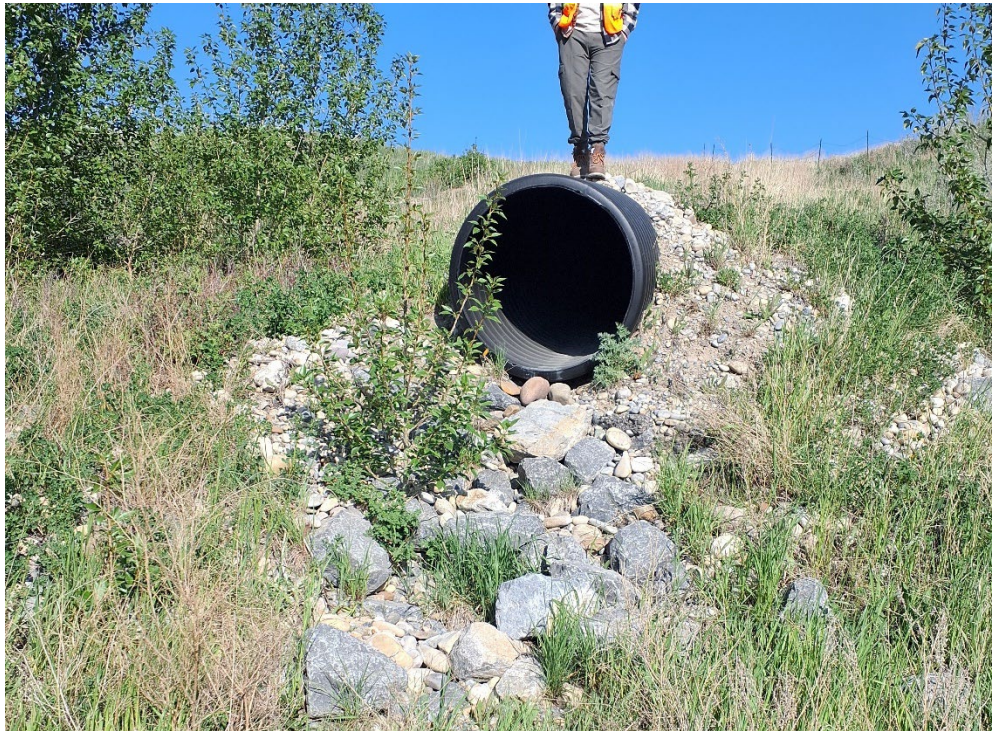
- The HDPE slope drain outlet is elevated above the riprap apron (150 mm minus particles). No evidence of erosion was observed, and the riprap apron has vegetation growing between the riprap particles (Photos 7 and 8). The vegetation was very tall downstream of the riprap apron (Photo 8).

Photo 7 **The HDPE culvert outlet appeared to be in good condition. Photo taken May 28, 2025, facing southeast.**

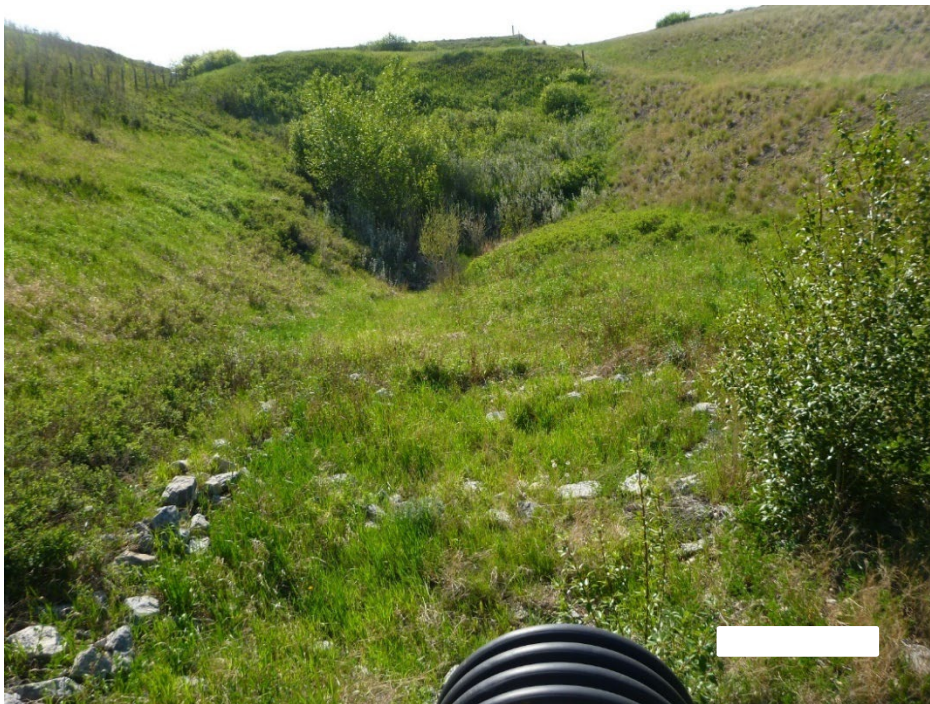
Photo 8 **The ditch downstream of the HDPE culvert outlet was well vegetated and appeared to be performing well. Photo taken May 28, 2025, facing east.**
