November 26, 2025

**CON0022161 Southern Region GRMP Instrumentation Monitoring**  
**Site S054; H22:10, km 37.817 Longview Bridge**  
**Section C – 2025 Fall Readings**

2025 S054 Fall Report  
A05116A03

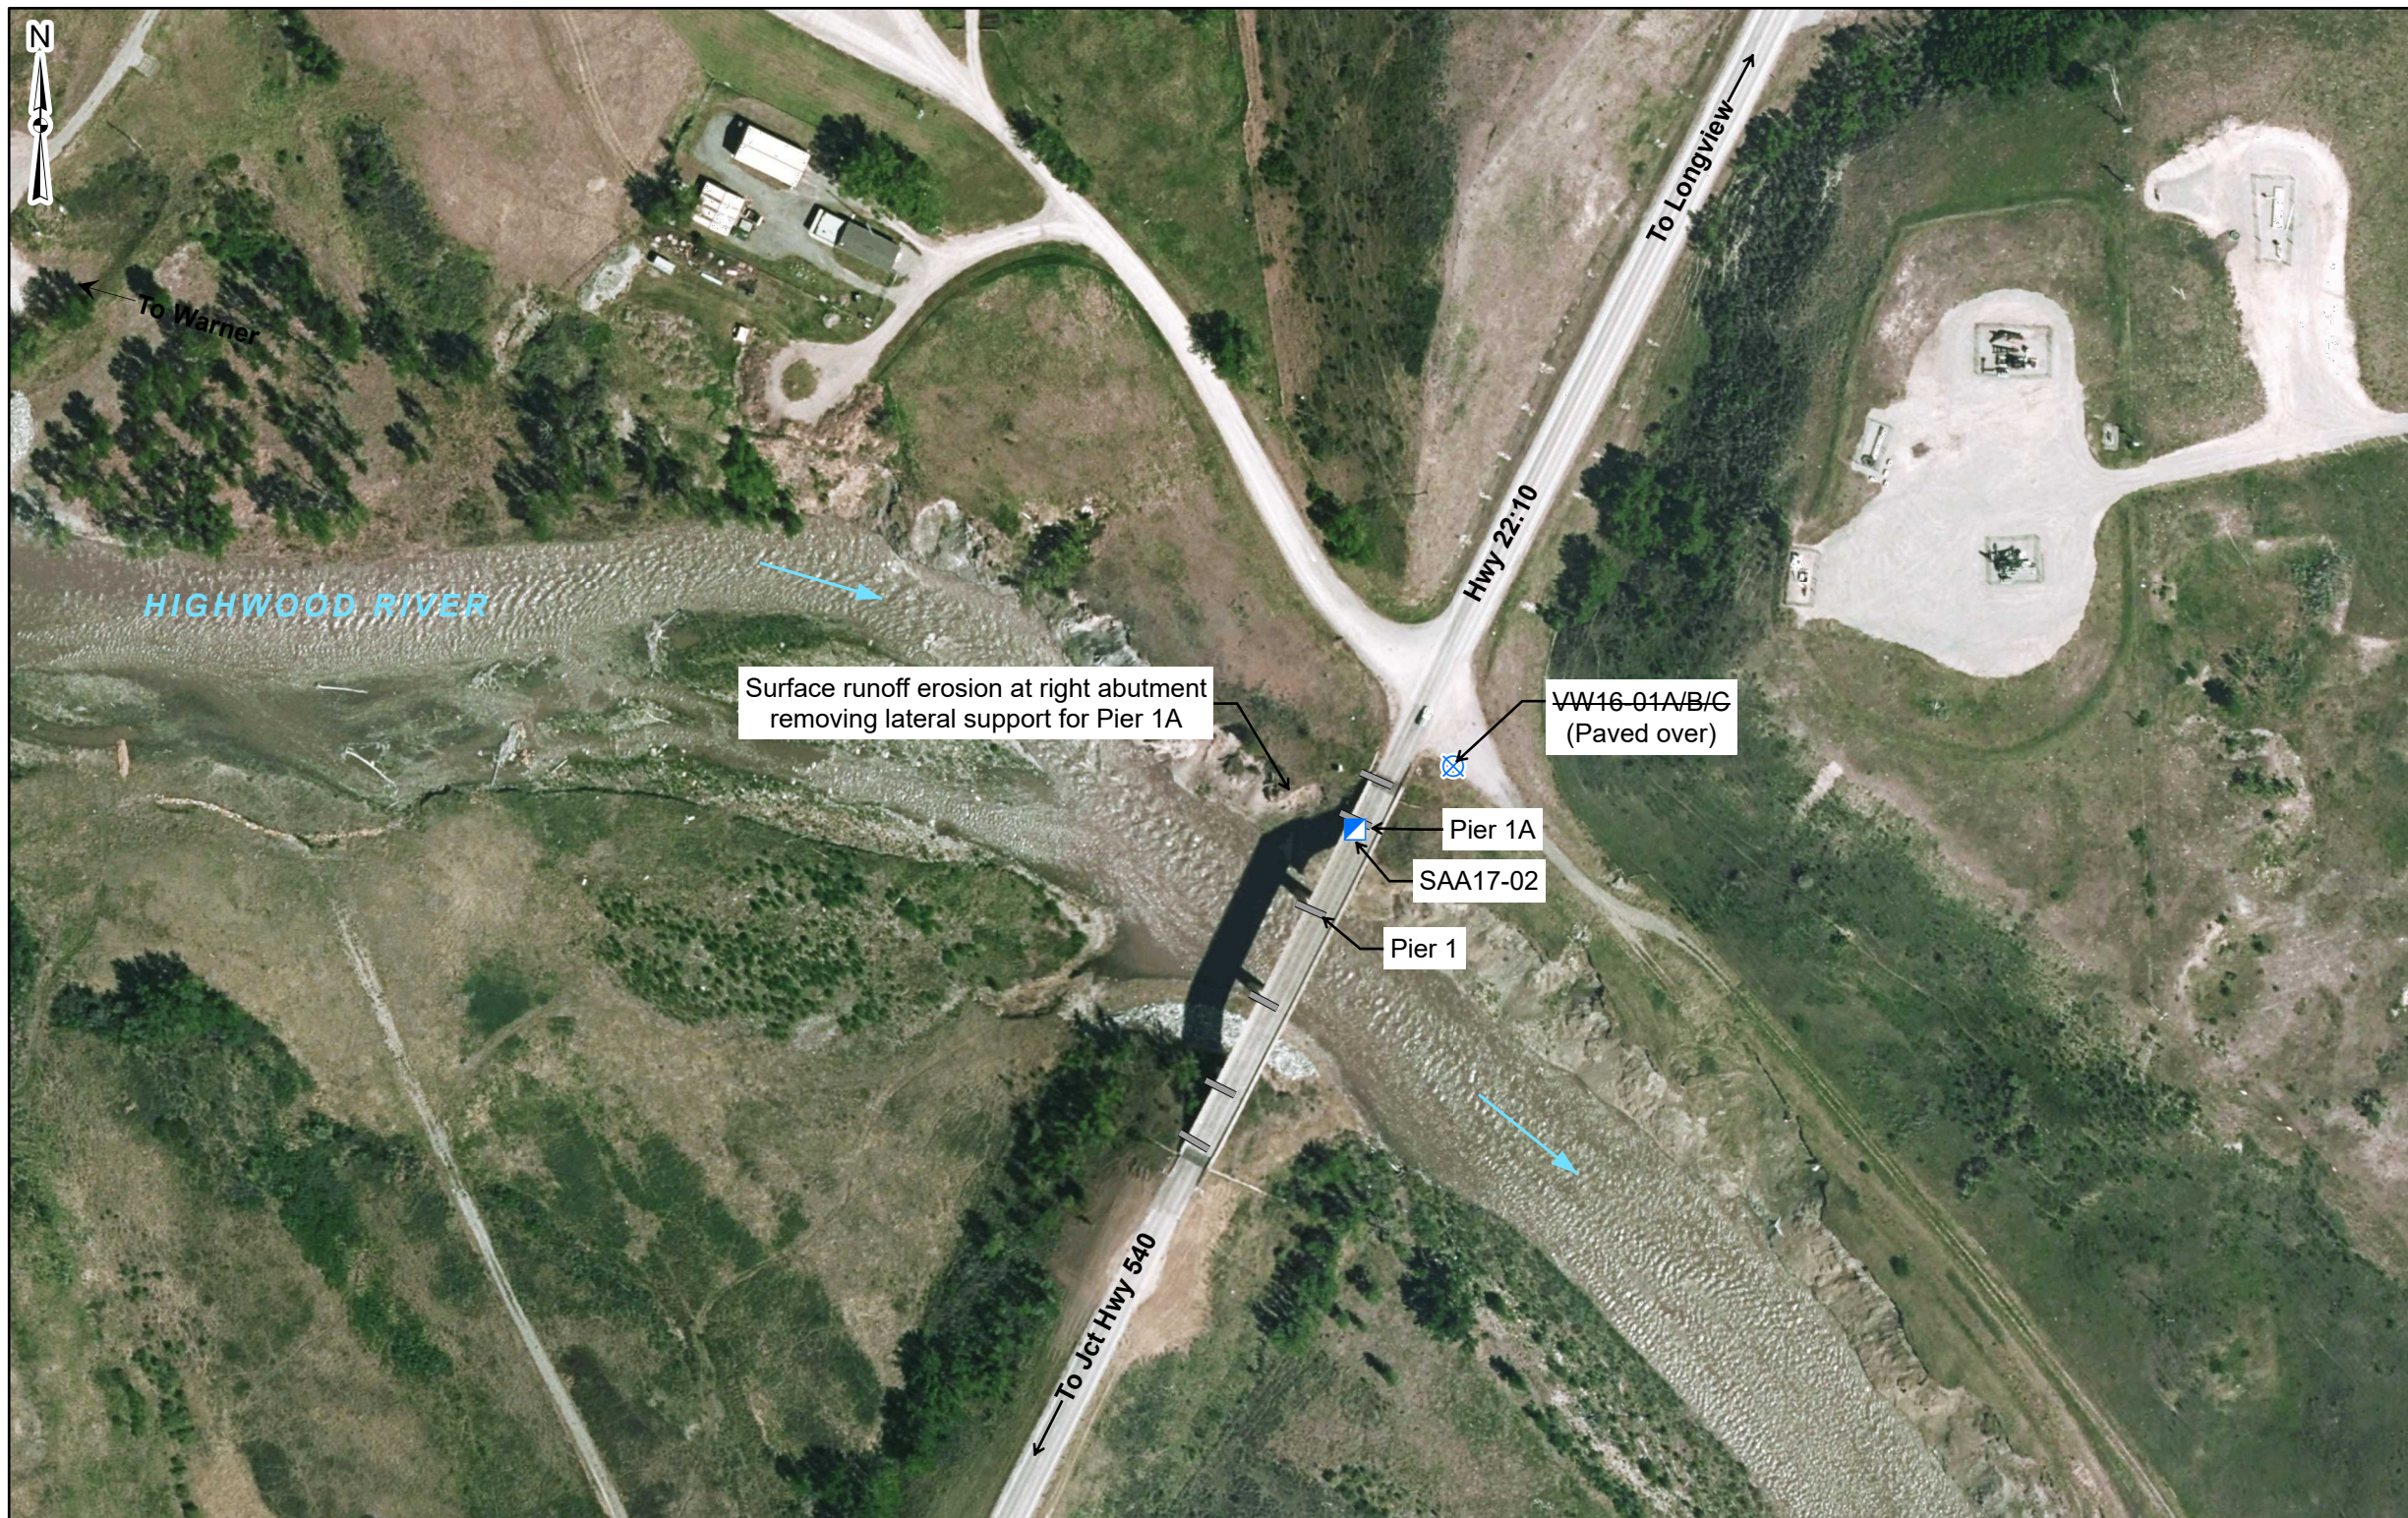
Klohn Crippen Berger		TITLE	
			Site Plan	
			S054 - Longview Bridge	
		Hwy 22:10, km 37.817		
		SCALE	PROJECT No.	FIG No.
		1:2,000	A05115A03	1

One shape array accelerometer (SAA) (SAA17-02) was read at the S054 site in Southern Region on October 8, 2025, by Mr. Shawn Keegan, E.I.T., of Klohn Crippen Berger Ltd. (KCB). This instrument was read as part of the Southern Region Geohazard Risk Management Program (GRMP). The site is located on Hwy 22:10 km 37.817, at the north abutment of the Highwood River Bridge (BF1741), approximately 1 km south of Longview, Alberta. The approximate site coordinates are 5600426 N, 696051 E (UTM Zone 11, NAD 83). A site plan is presented in Figure 1.

SAA17-02 (Serial No. 147741) is 31 m deep and located below the bridge deck at the crest of the north riverbank, in the southeast corner of Pier 1A. SAA17-02 is connected to a data-logger system consisting of a CR800 data logger, SSA232 connection cable, Microhard Bullet-LTE gateway telemetry system (no sim card), and an antenna. However, there is no long-term power supply for the data-logger system (KCB has replaced the battery five times since 2020), so the instrument is read manually using a USB-Serial cable and Campbell Scientific LoggerNet software.

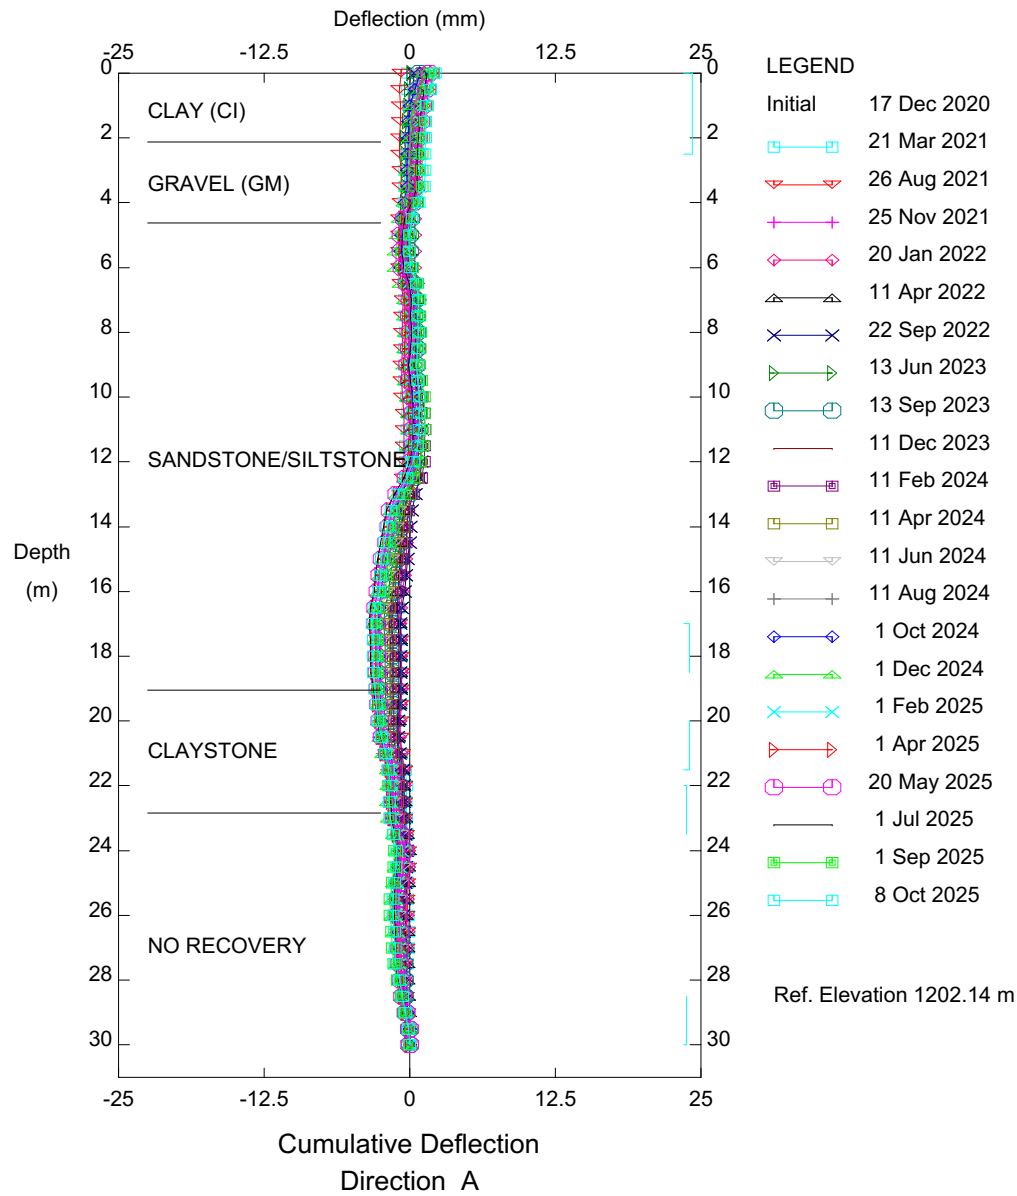
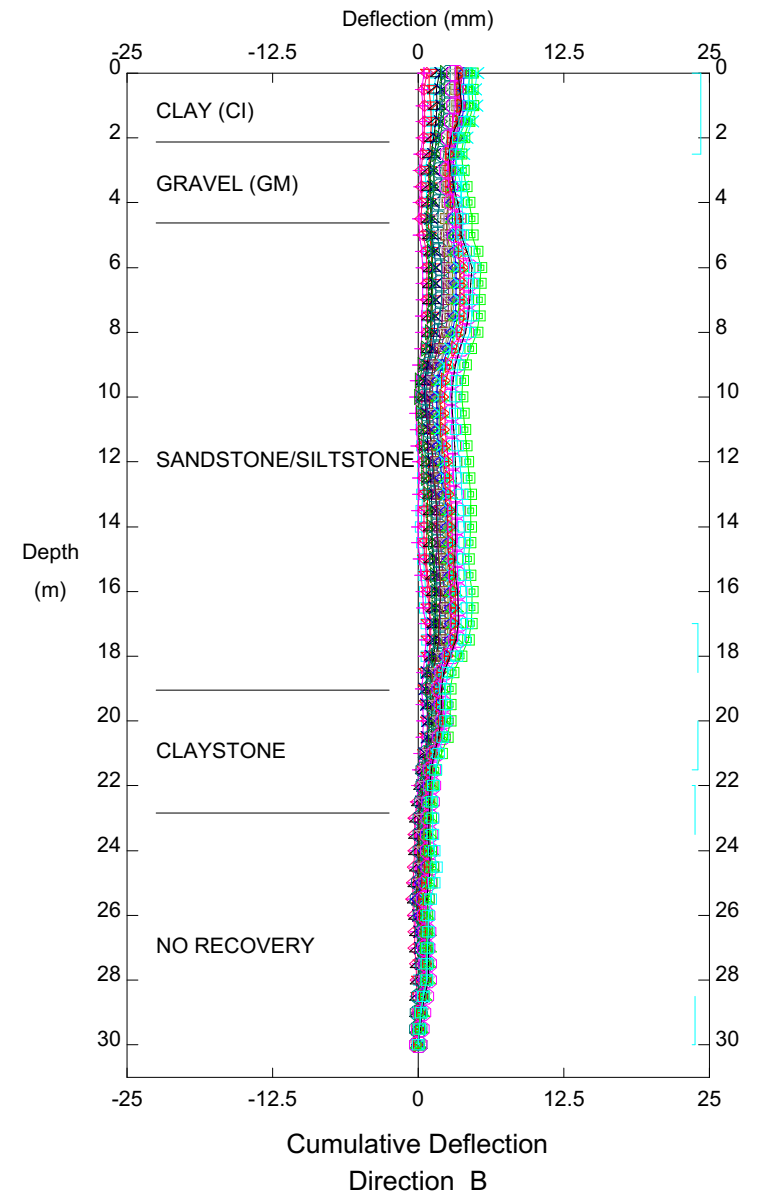
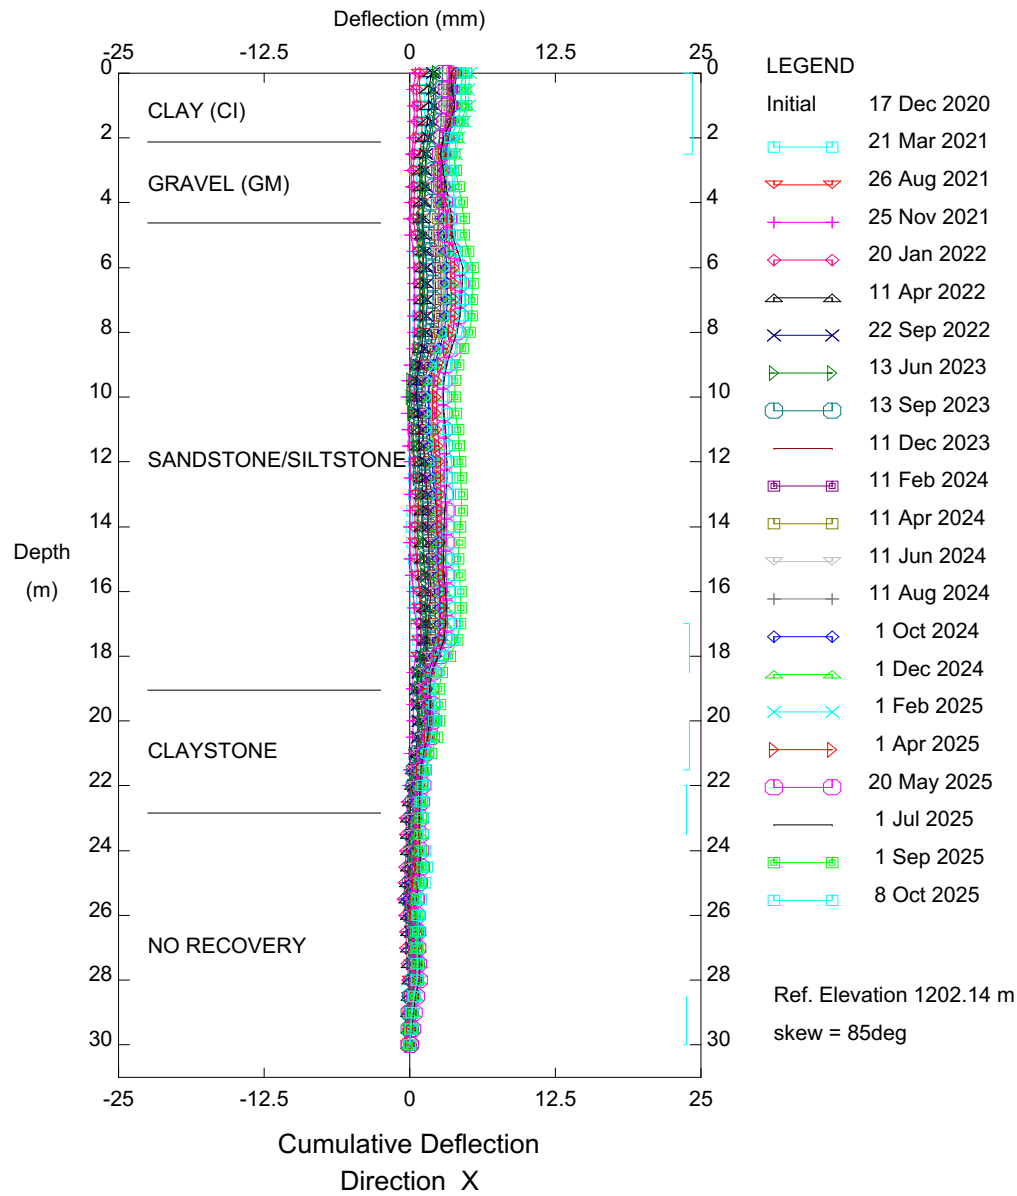
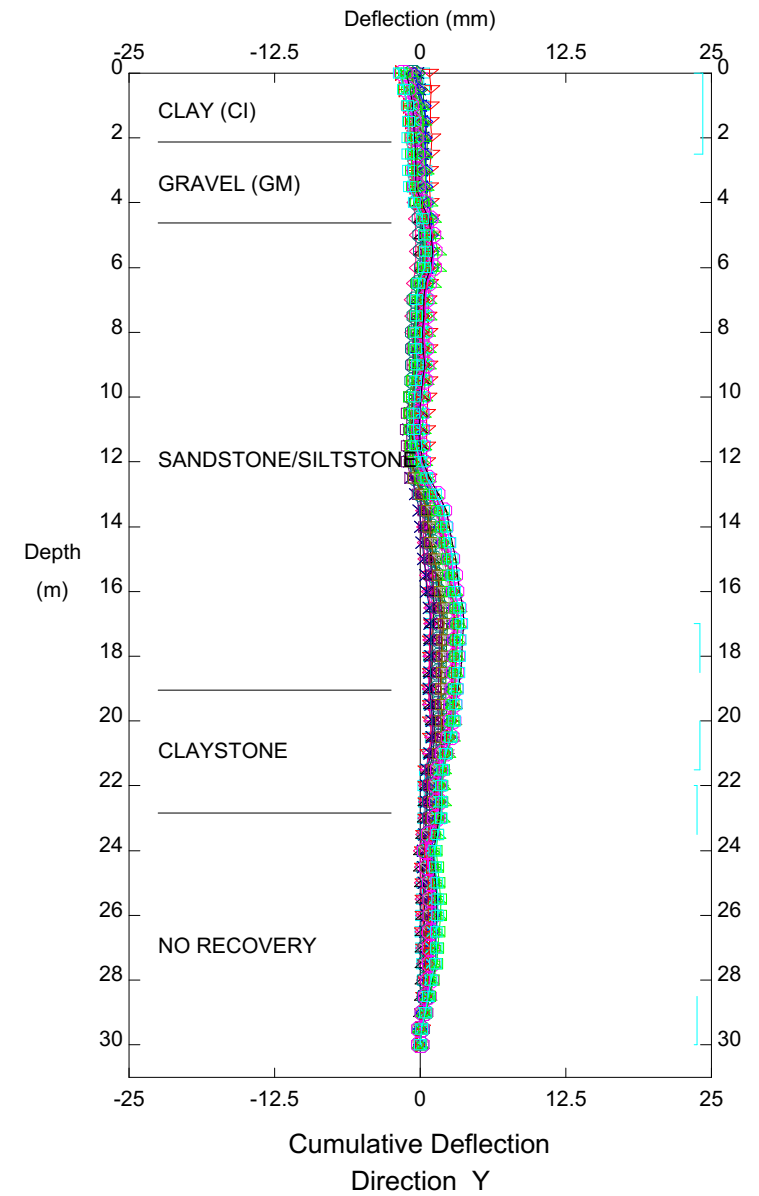
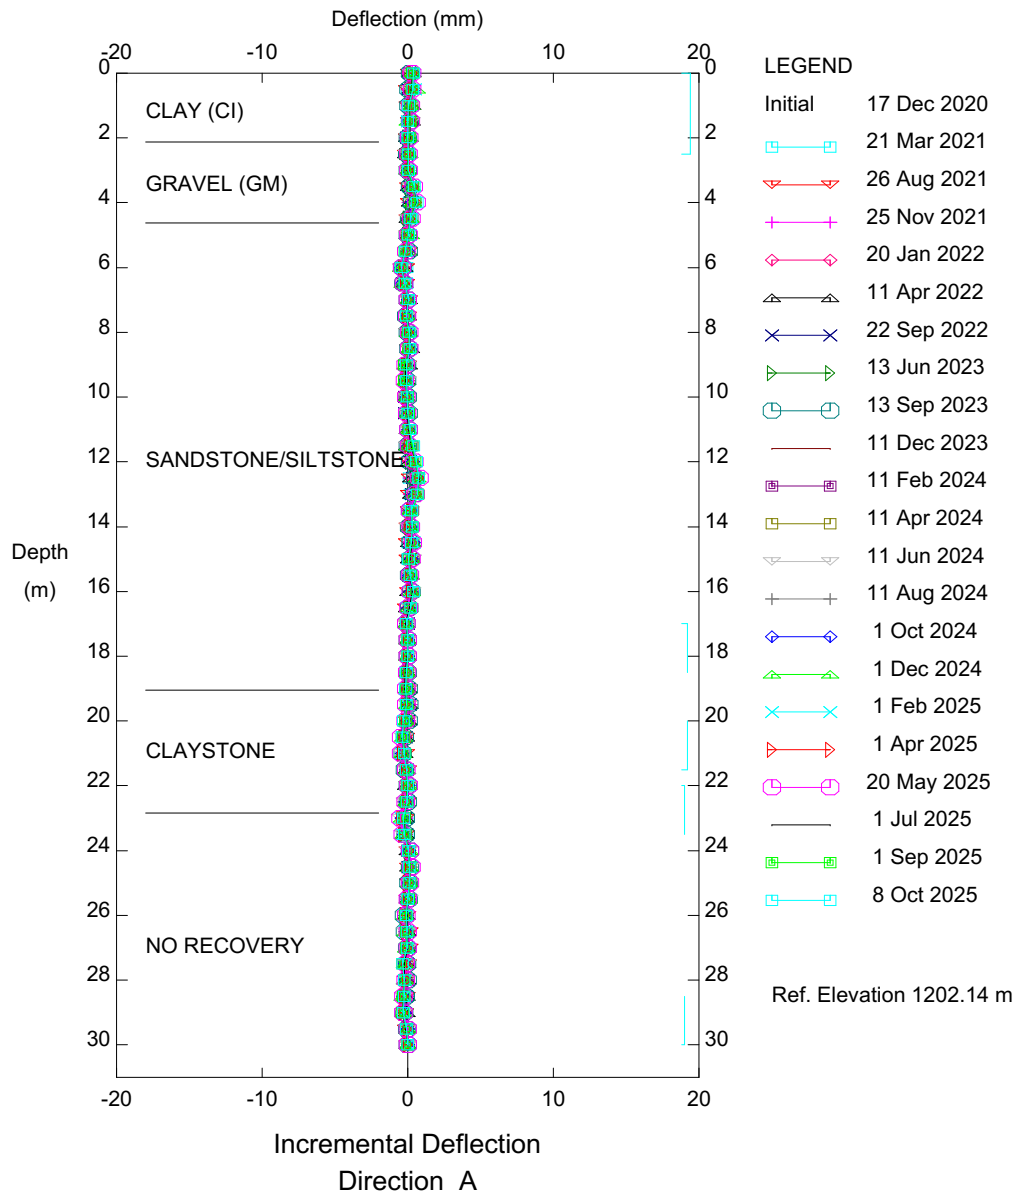
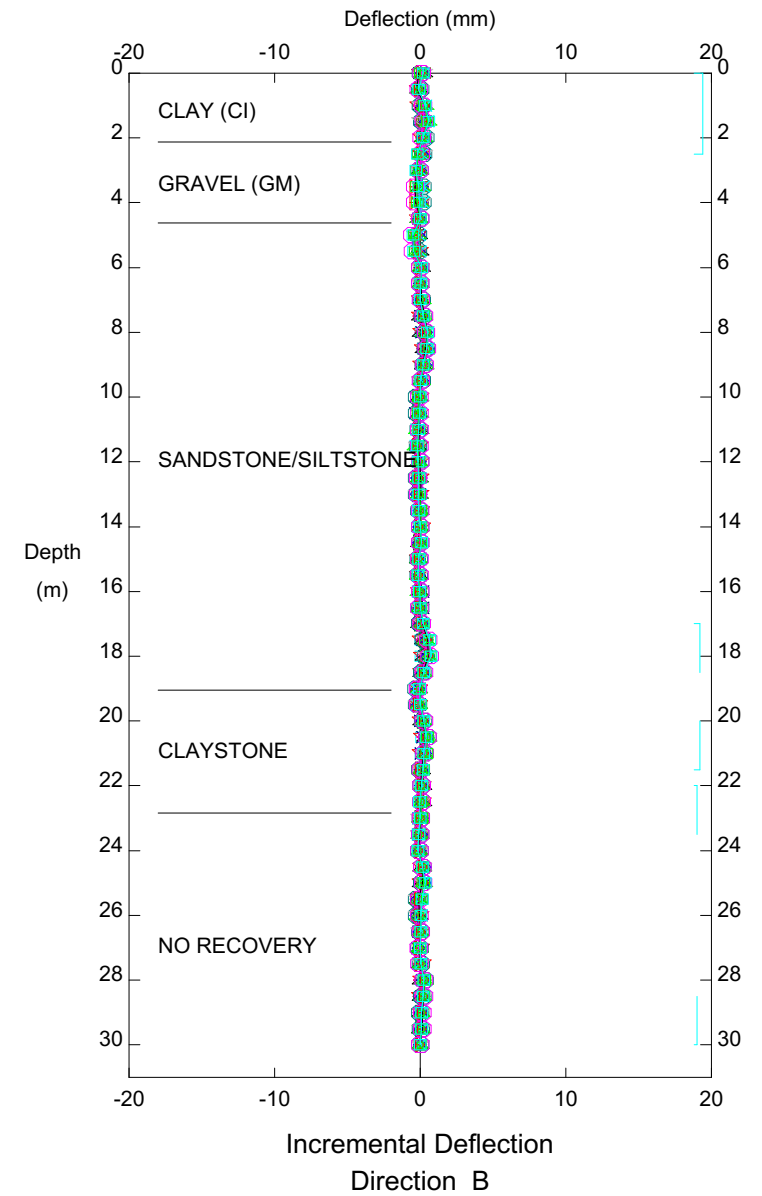
There are three zones of distributed movement being recorded in SAA17-02, which include:

- a shallow zone from ground surface to an approximate depth of 2.5 m below ground surface, in the medium plastic clay;
- a deeper zone from an approximate depth of 17.0 m to 21.5 m below ground surface, at the base of the sandstone/siltstone unit and into the underlying claystone; and,
- the deepest zone from an approximate depth of 22.0 m below ground surface to near the base of the instrument, from the base of the identified claystone unit to a lower unidentified unit.

These zones of differential movement could also indicate sections of poor casing backfill or other installation issues.

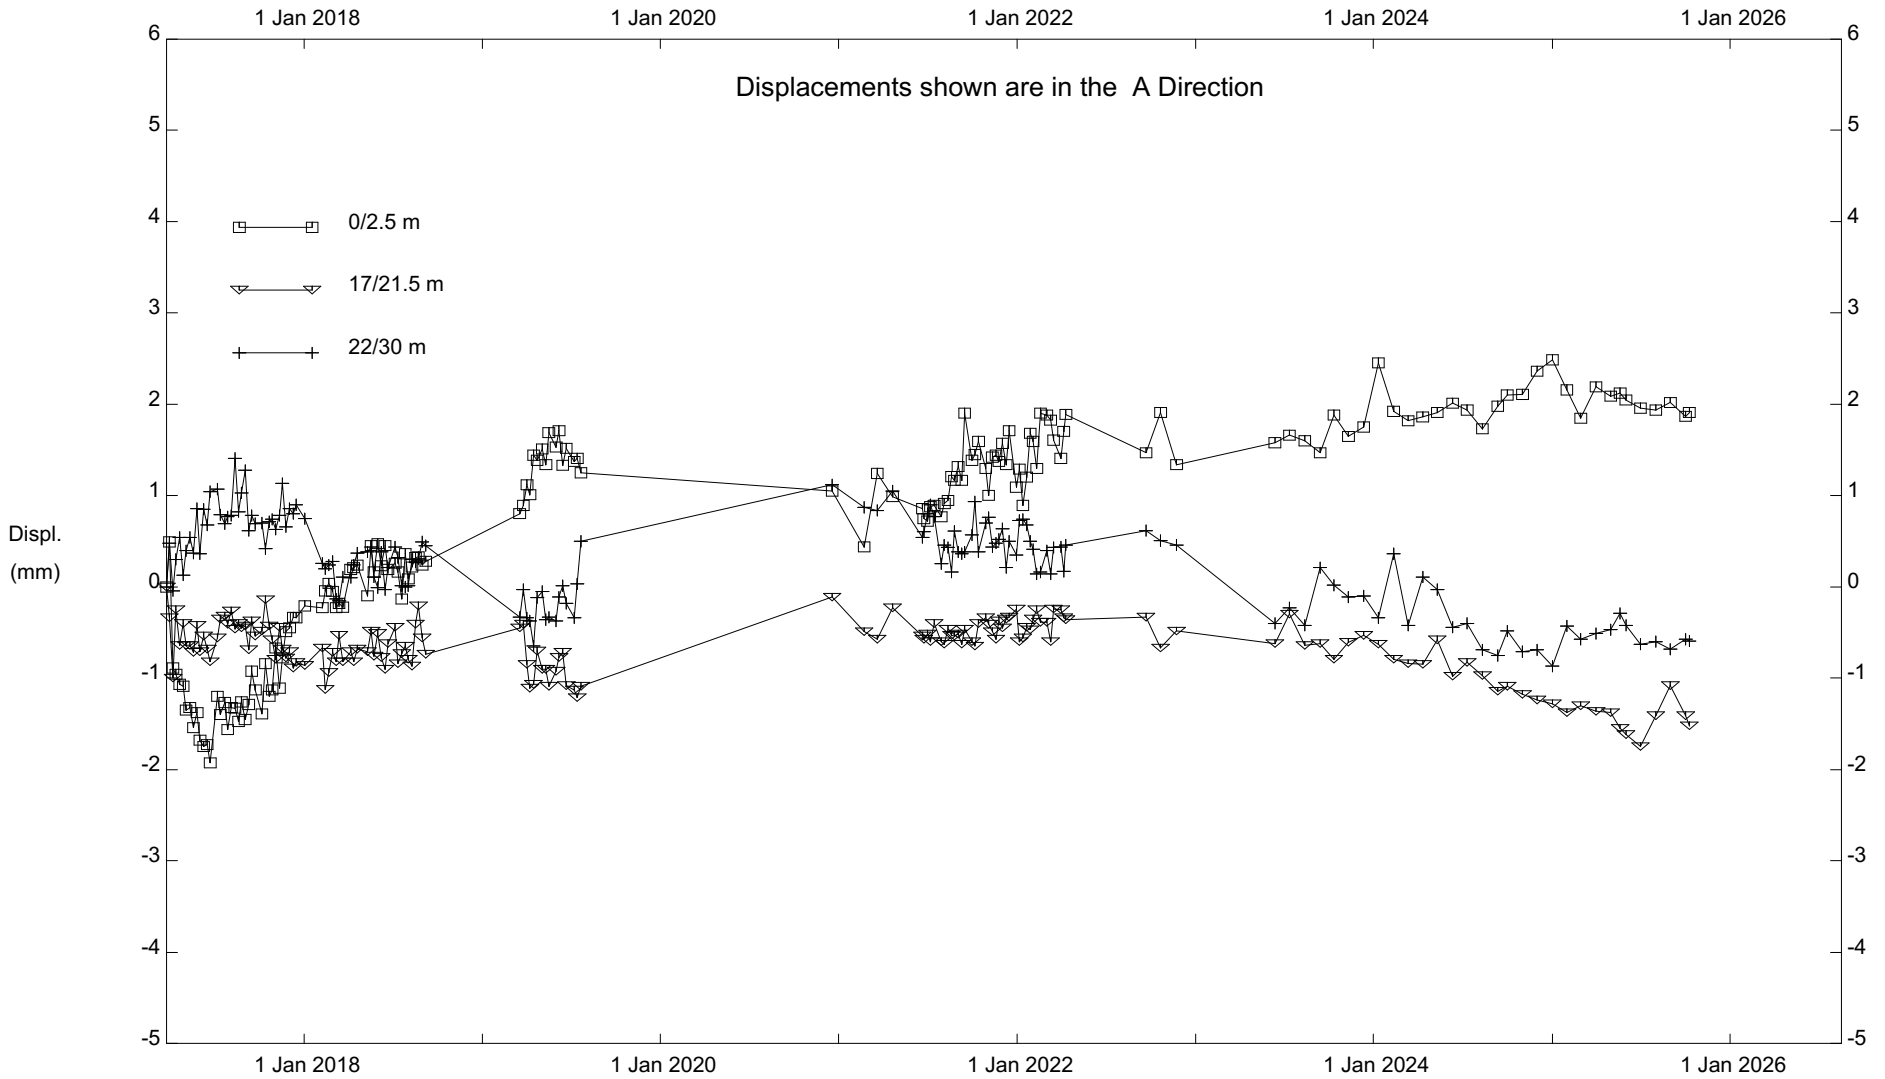
S054; H22:10 Longview Bridge, Inclinometer SAA17-02

Since December 2020, the SAA has shown small fluctuations in the rate of movement (less than 5 mm/year) in SAA17-02. Based on the May 2025 data obtained from this instrument; the SAA has shown an increasing trend of movement across the three zones. This increment is most significant in the middle zone between 17 m and 21.5 m below ground surface, while there is little to no change in the movement in the upper and lower zones. Overall, the instruments show:

- in the upper monitoring zone approximately 7 mm of distributed movement has been recorded in the medium plastic clay, with most of the movement occurring shortly after installation.
- in the middle monitoring zone approximately 9 mm of distributed movement has been recorded from near the base of the sandstone/siltstone to the base of the claystone unit, with most of the movement occurring before 2020.
- in the lower monitoring zone approximately 5 mm of distributed movement has been recorded from near the base of the claystone unit to the base of the instrument, with most of the movement occurring shortly after installation.

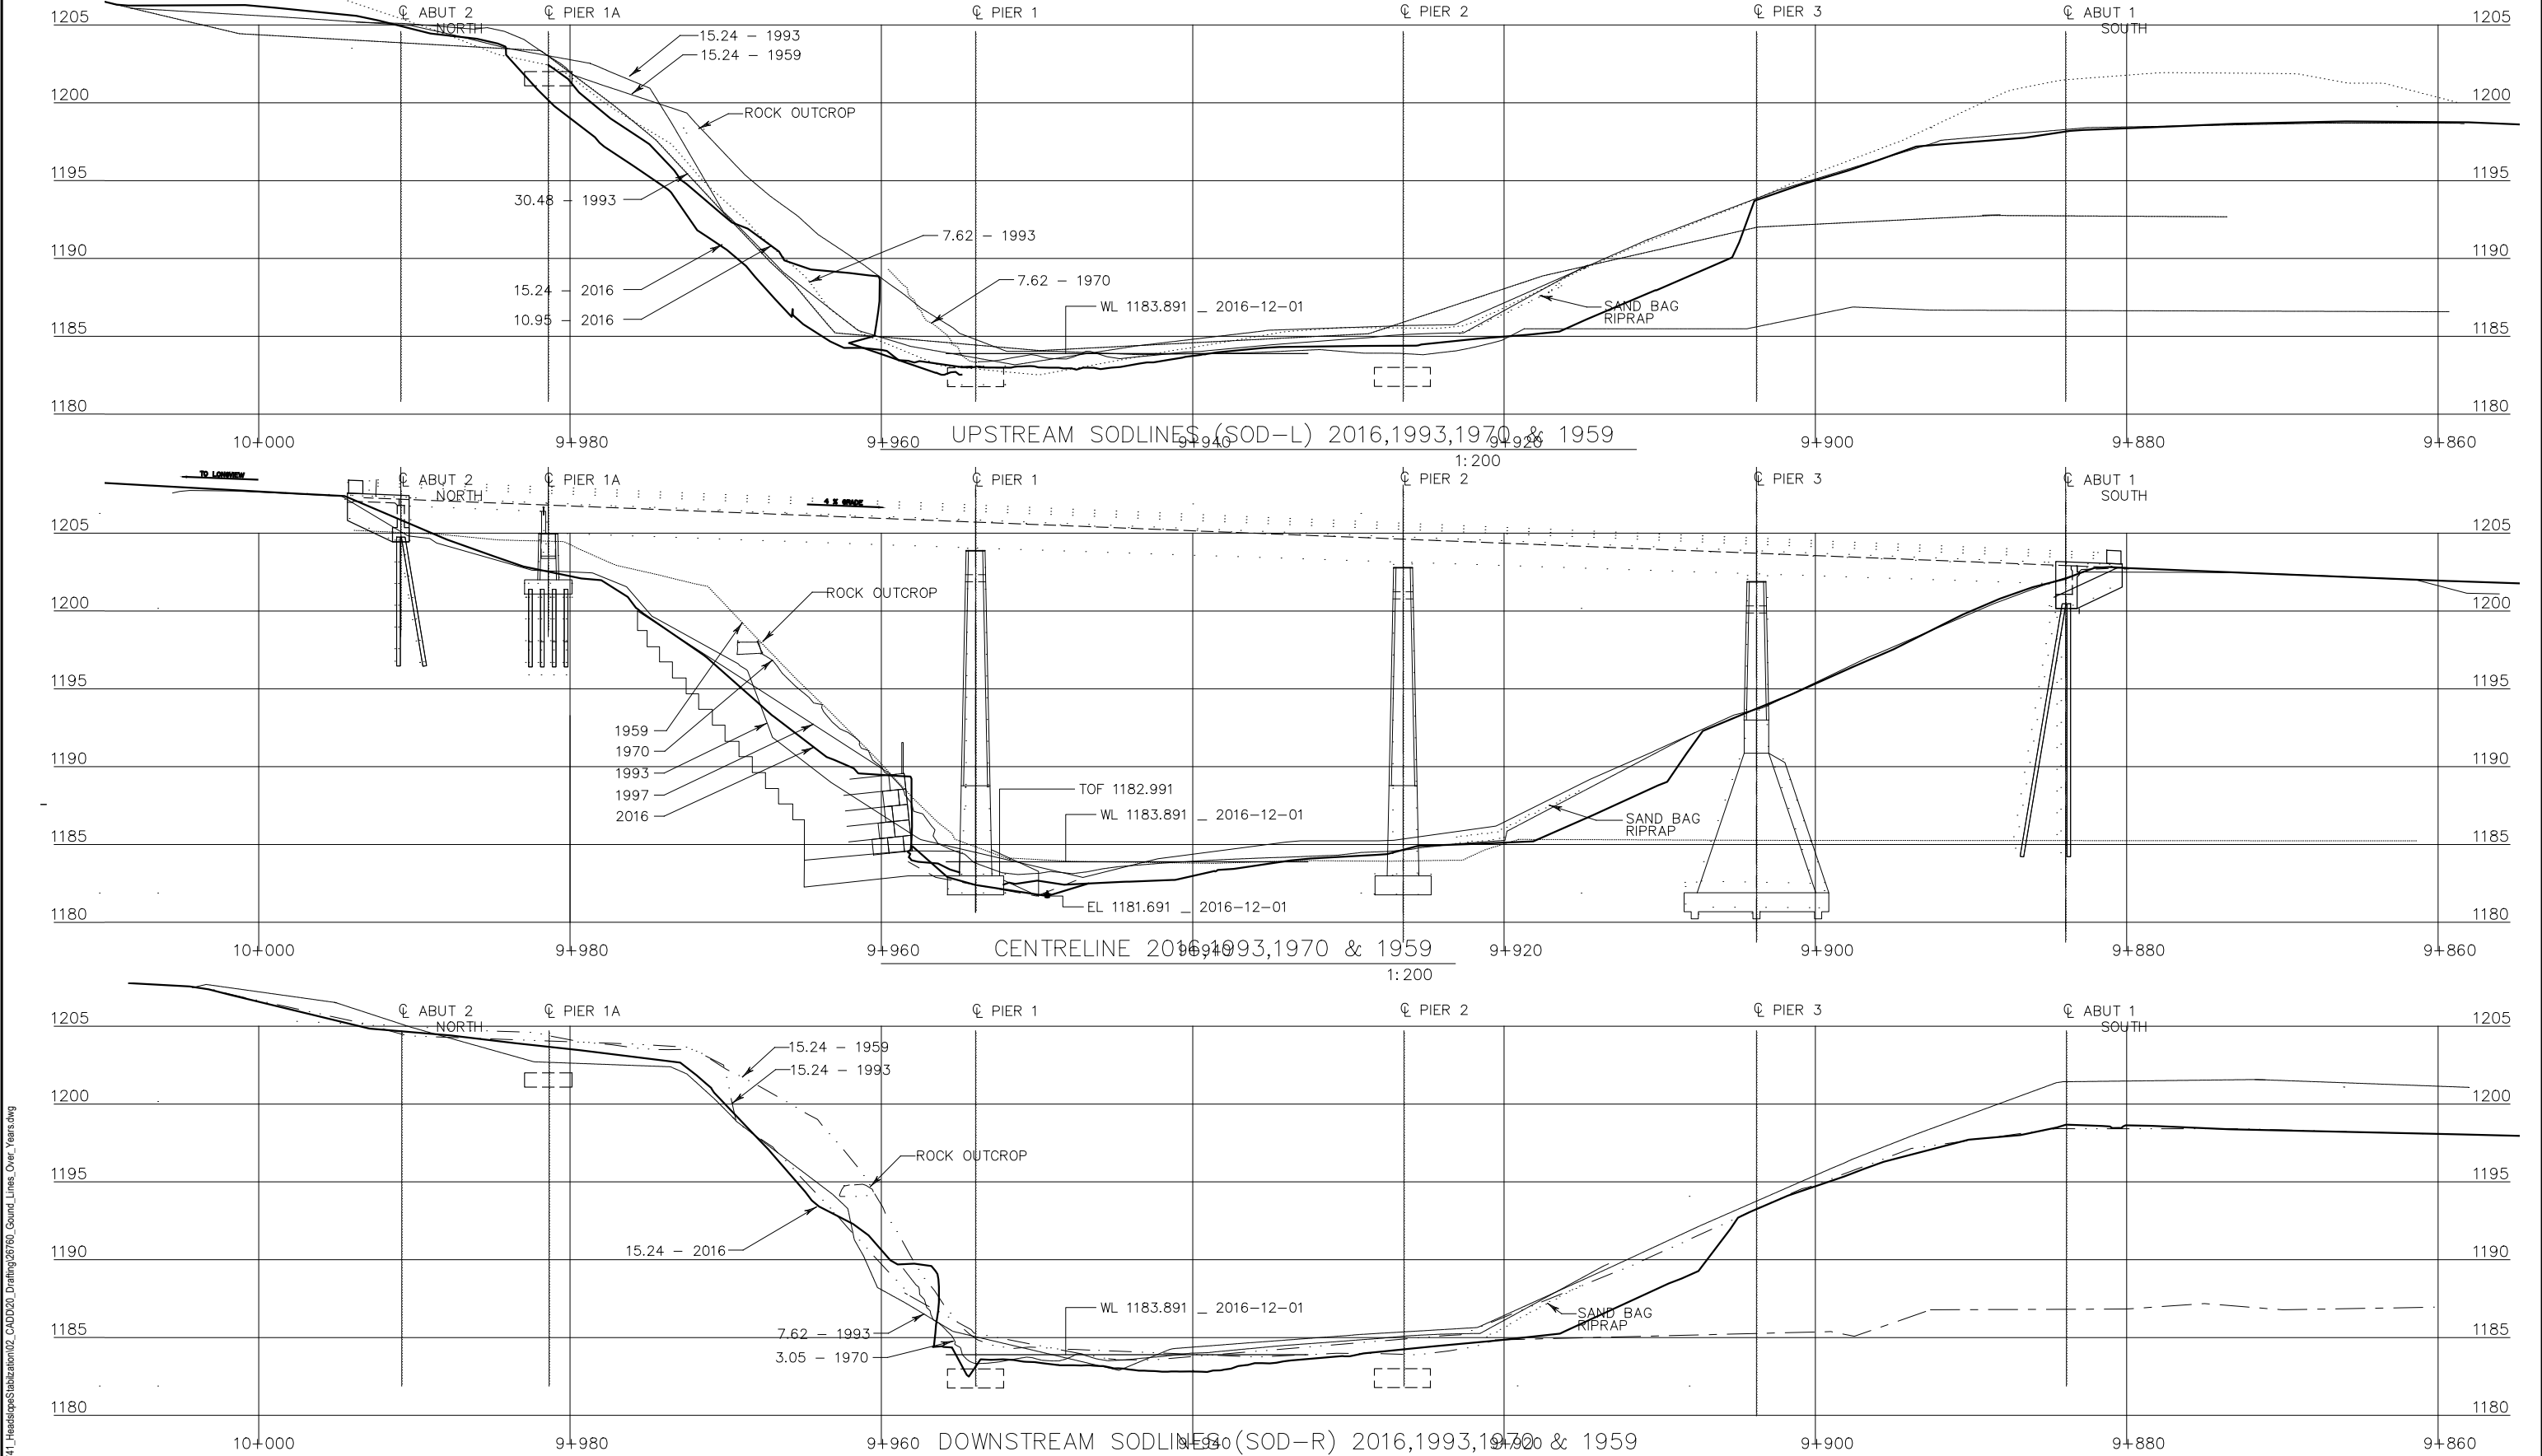
The north abutment height is approximately 22 m, and the north riverbank slope from the south side of Pier 1A to the top of the gabion wall was estimated to be approximately 1.2H:1V. Immediately downslope of the south side of Pier 1A, tension cracking approximately 12 m to 15 m in length has been observed during previous site inspections.
