**S32 - HIGHWAY 56 – BOW RIVER,
UPSTREAM OF CROWFOOT FERRY
5 MAY 2016 CALL-OUT REPORT**

Submitted to:
Alberta Transportation
Calgary, Alberta

Submitted by:
Amec Foster Wheeler Environment & Infrastructure
Calgary, Alberta

CG25399.400

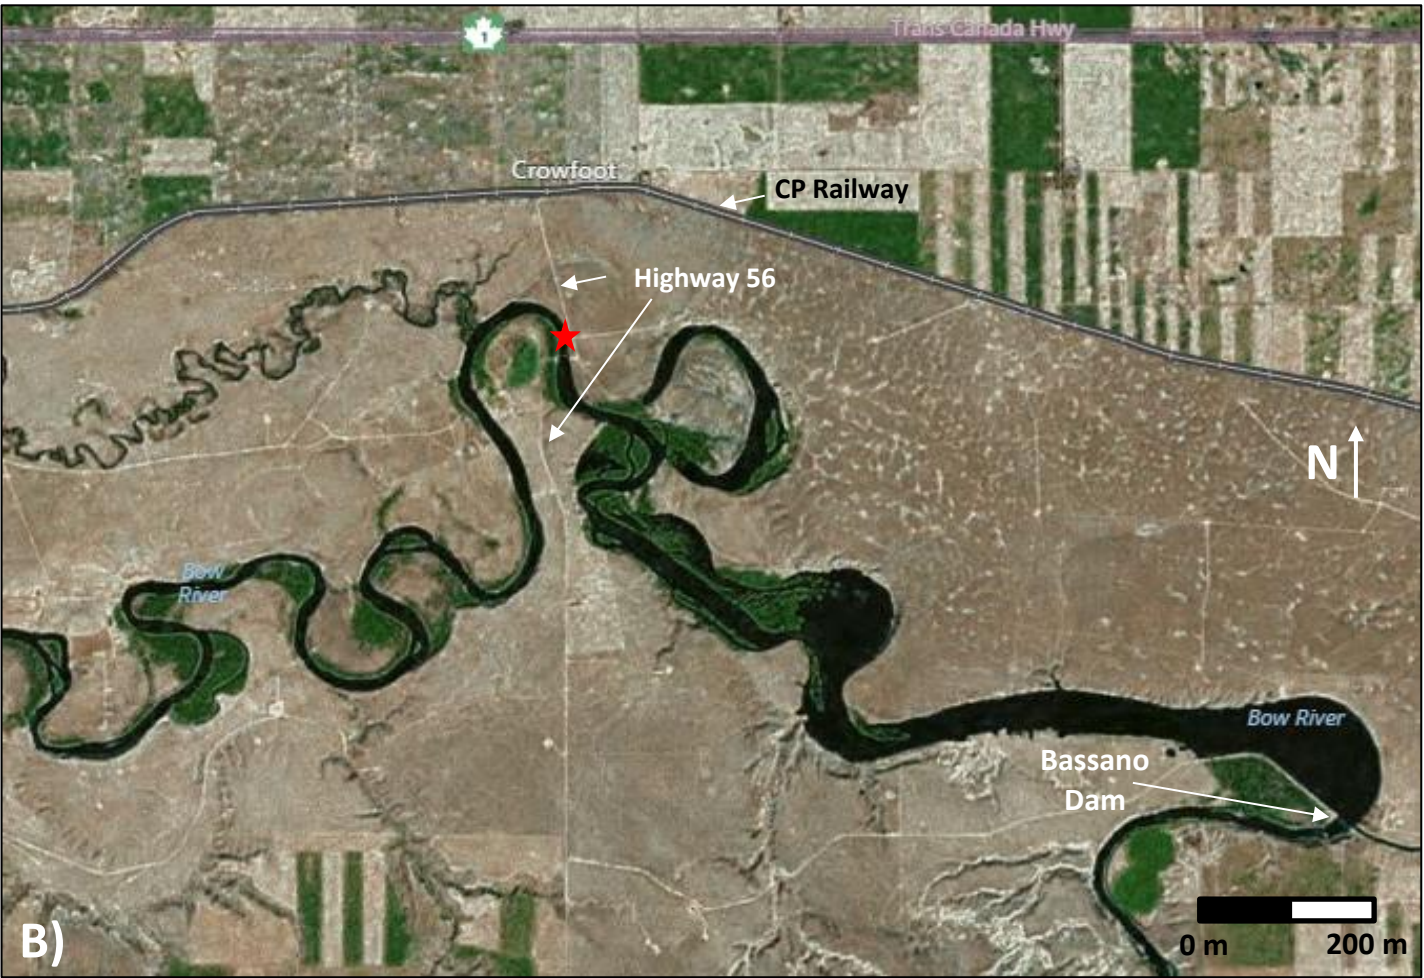
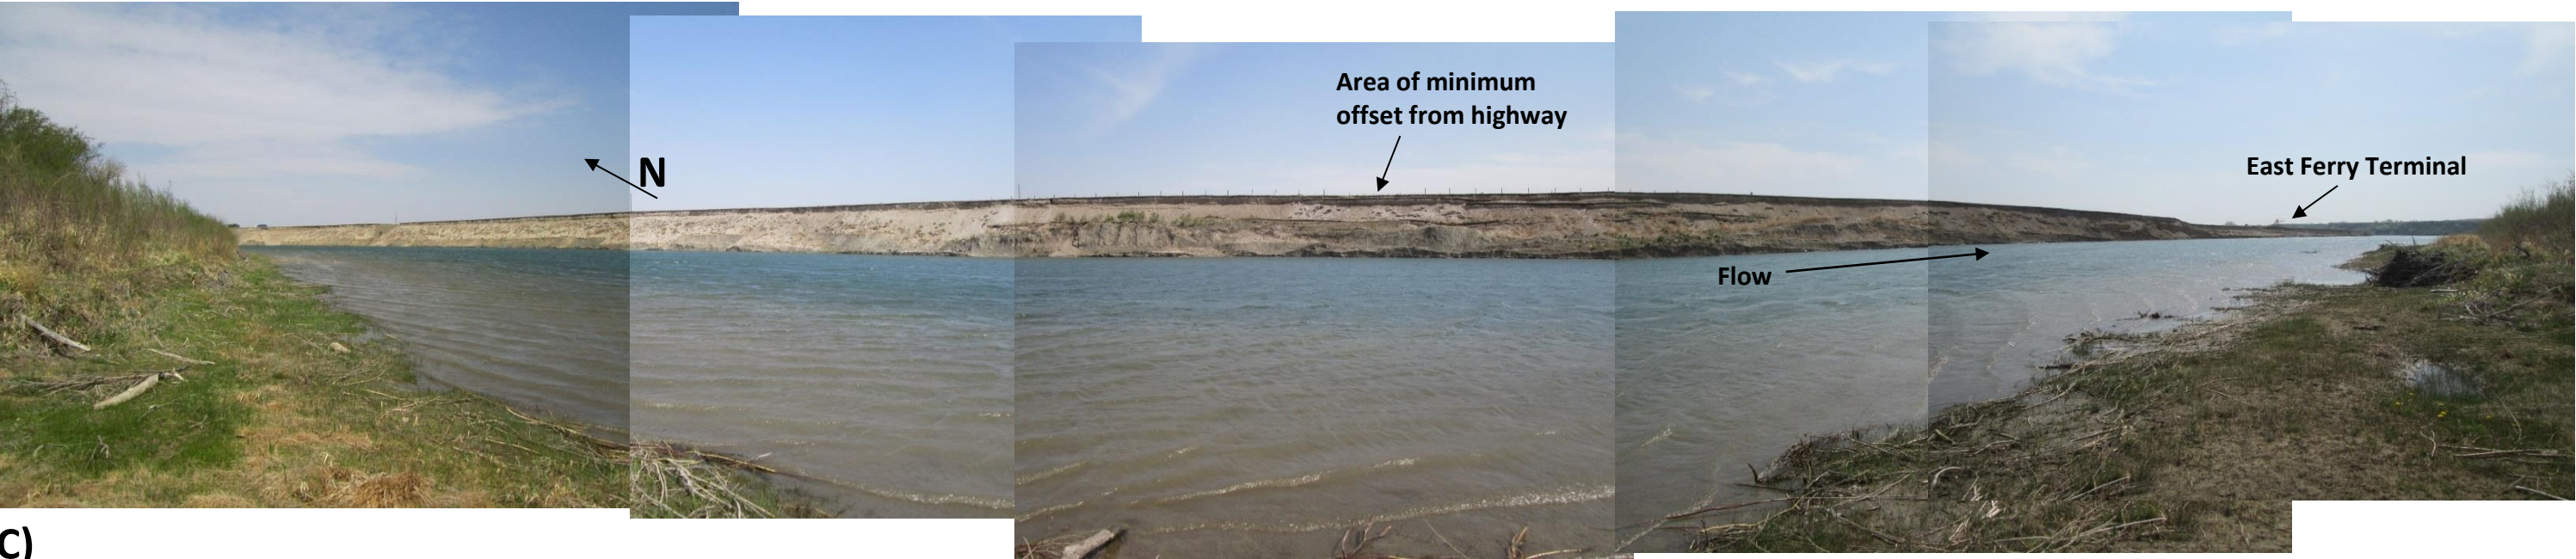
Transportation</div>		PROJECT: S32 - Crowfoot Ferry Call-Out Inspection				
		TITLE: Site Overview				
CLIENT: Alberta Transportation		DATE:	JOB No.:	FILE:	FIGURE No.:	REV.
		May 2016	CG25399	Figure 1.xlsx	1	A

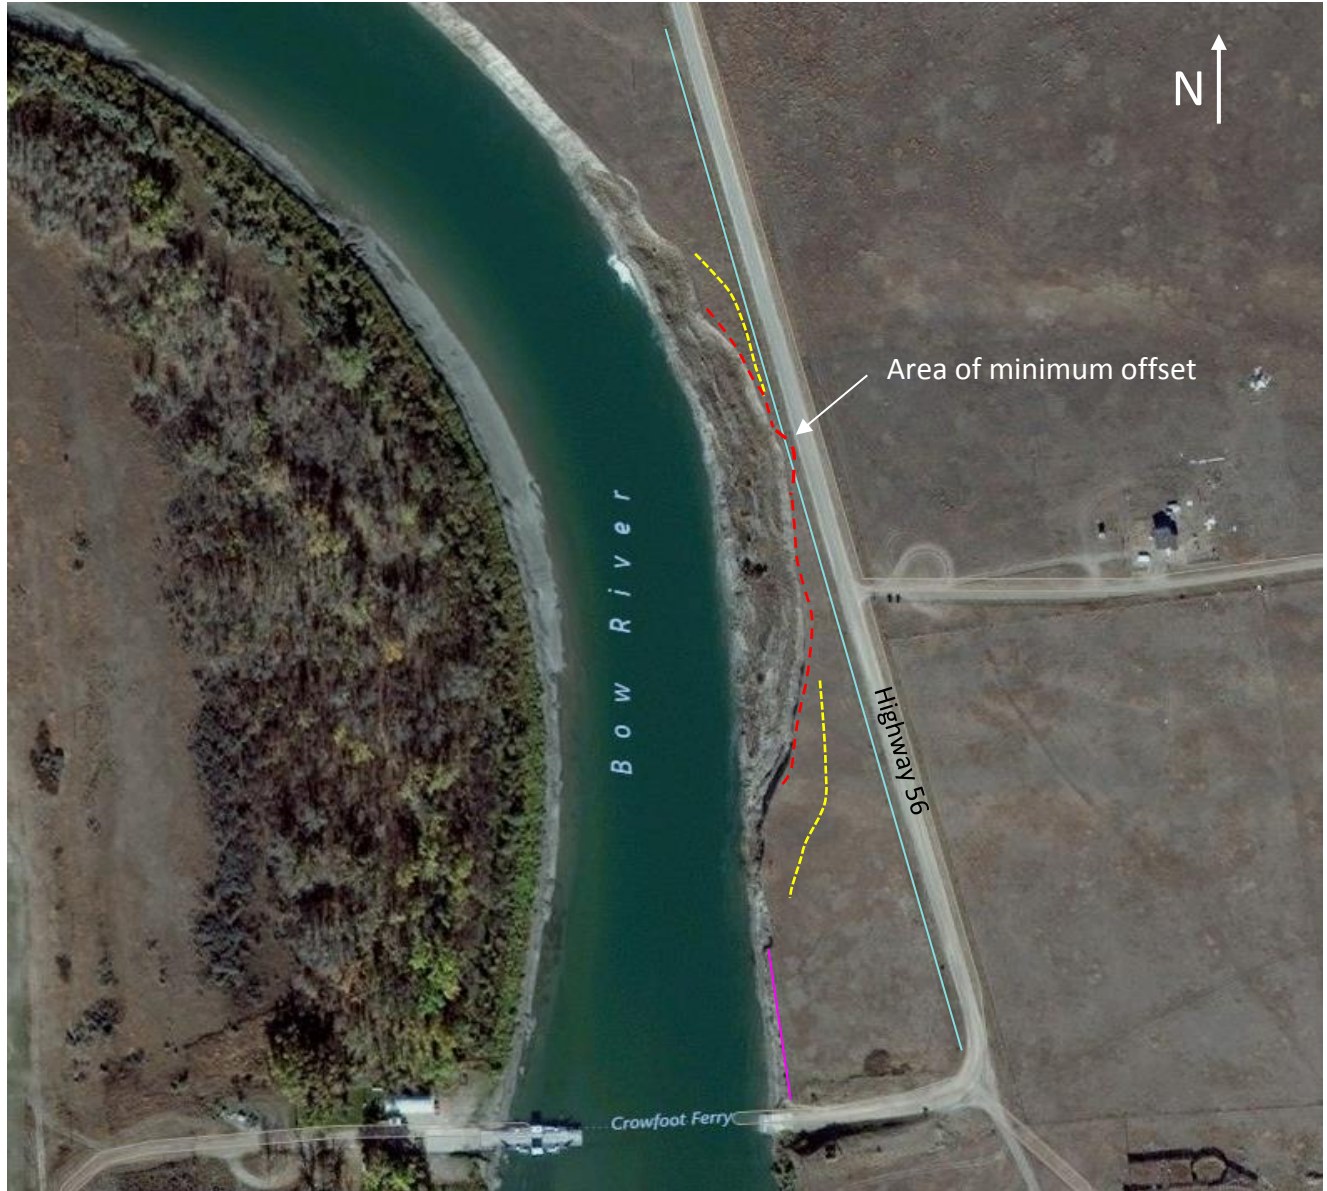
2

Retrogression of the scarp at the main slide area has continued since the previous inspection in May 2014. In 2014, the headscarp was measured to be 1.6 m offset from the fence line and has since undermined the fence and continued into the highway right-of-way. This indicates over 2.5 m of eastward retrogression since May 2014.

New cracks were observed north of the area of minimum offset. These cracks were not observed during previous inspections. Formation of the cracks indicate bank instability extends several hundred metres northward. Although these cracks are approximately 12 m west of the road edge, retrogression is expected to continue. Cracks to the south of the area of minimum offset appear unchanged since the previous inspection.

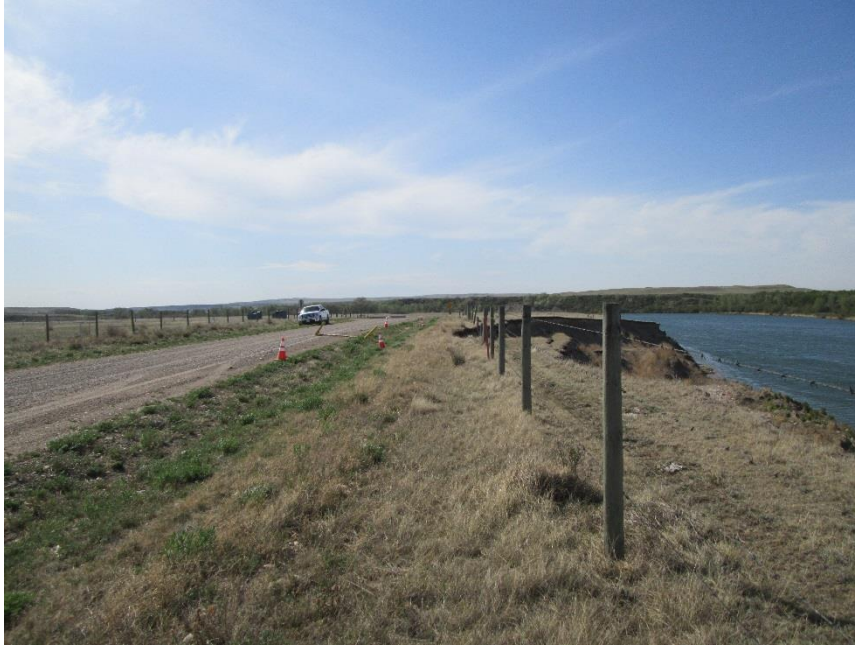
Photo 1 - (May 2016) –
Standing north of the area of
minimum offset, facing south
towards the ferry crossing.

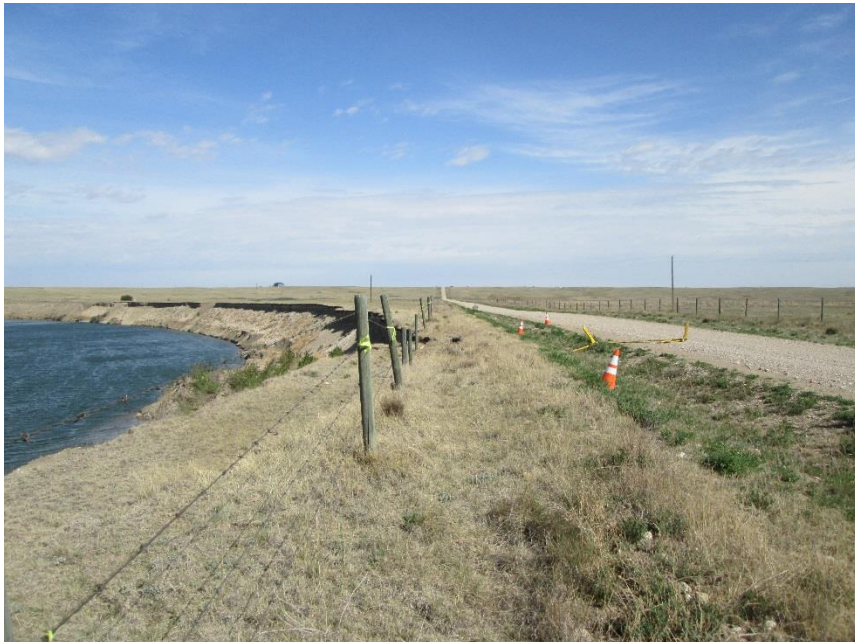
Photo 2 - (May 2016) –
Standing south of the area of
minimum offset, facing north.

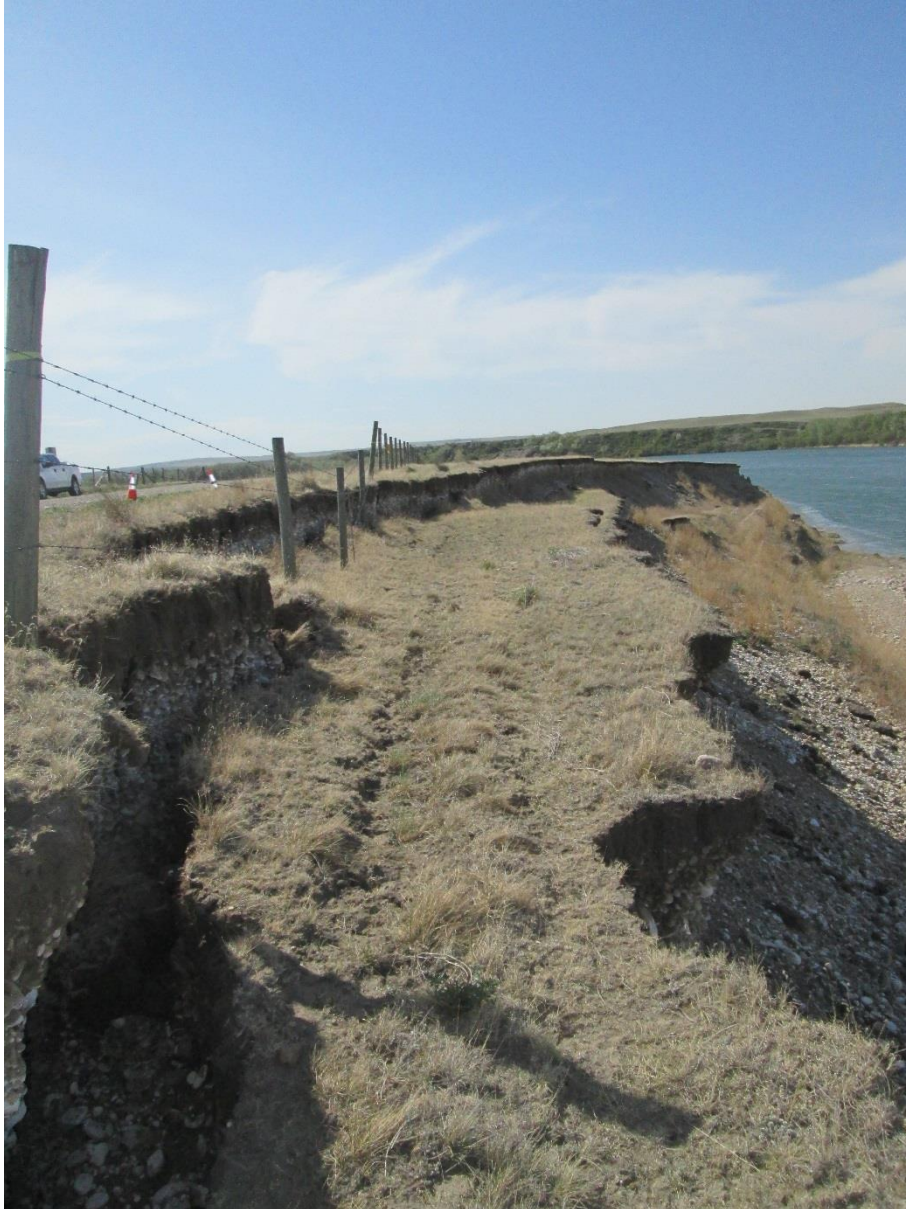
- ▶ The scarp of the landslide had undermined the fence for approximately 20 m. The affected fence posts had been marked with yellow flagging tape, possibly by the MCI. Refer to Photo 3.

- ▶ The slide block at the area of minimum offset had dropped 1.4 m from the road surface elevation. Cracks towards the north extent of the block had an aperture of 50 cm, and depth of 1.3 m. The minimum offset between the scarp of the landslide and the shoulder of the highway was 4.3 m. Refer to Photo 3.

The over-steepened upper area of the landslide will retrogress eastwards. An approximately 60 to 70 m long segment of the highway may become directly undermined by the landsliding. The risk of this occurring over the short term is judged to be moderate to high.

Photo 3 - (May 2016) –
Standing at north end of slump
block facing south towards ferry
crossing.

- ▶ The MCI should continue to monitor this site frequently and alert Alberta Transportation if any changes are observed.
- ▶ More permeant barriers such as Jersey barriers should be placed along the shoulder of the affected roadway to protect motorists.

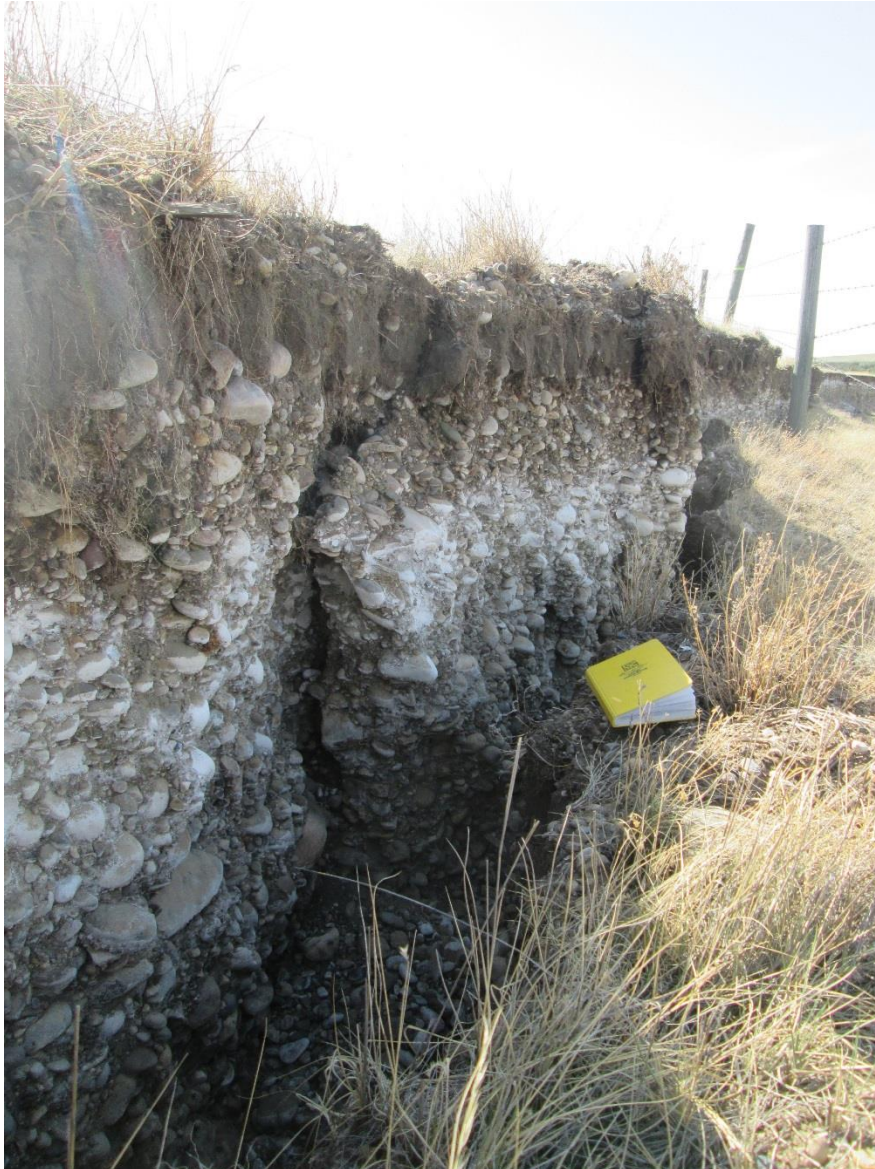
- ▶ Exposed sediment in the scarp face was subrounded gravel and cobbles within a silty sand matrix with occasional to numerous boulders. Refer to Photo 4.

Photo 4 - (May 2016) –
Close up of exposed soils.

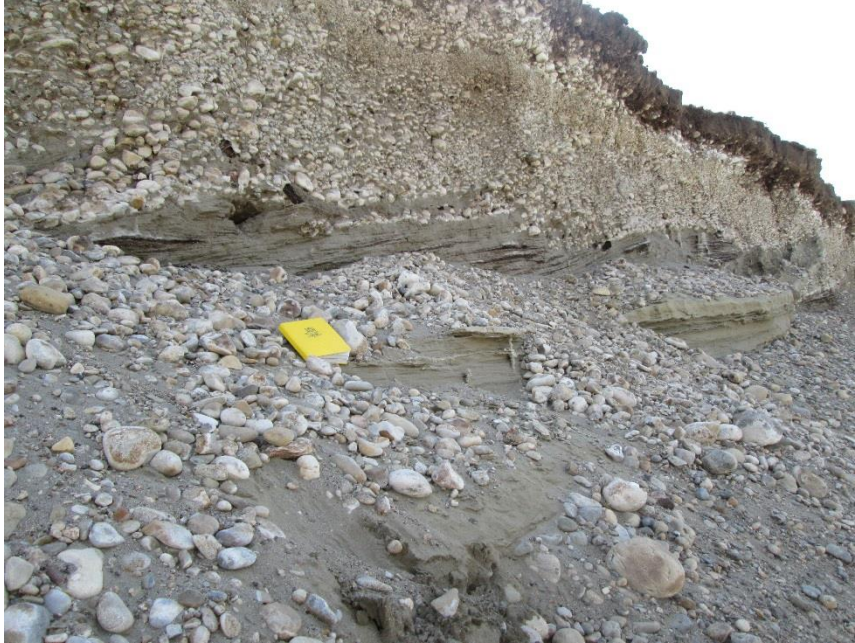
- ▶ Sandstone bedrock exposures were observed along the bank south of the area of minimum offset and was fine grained, well sorted, brown, laminated sands with occasional carbonaceous fragments and pockets. Refer to Photos 5 and 6.

Photo 5 - (March 2016) –
Bedrock exposure along left
(east) bank approximately 100 m
south of main headscarp
location.

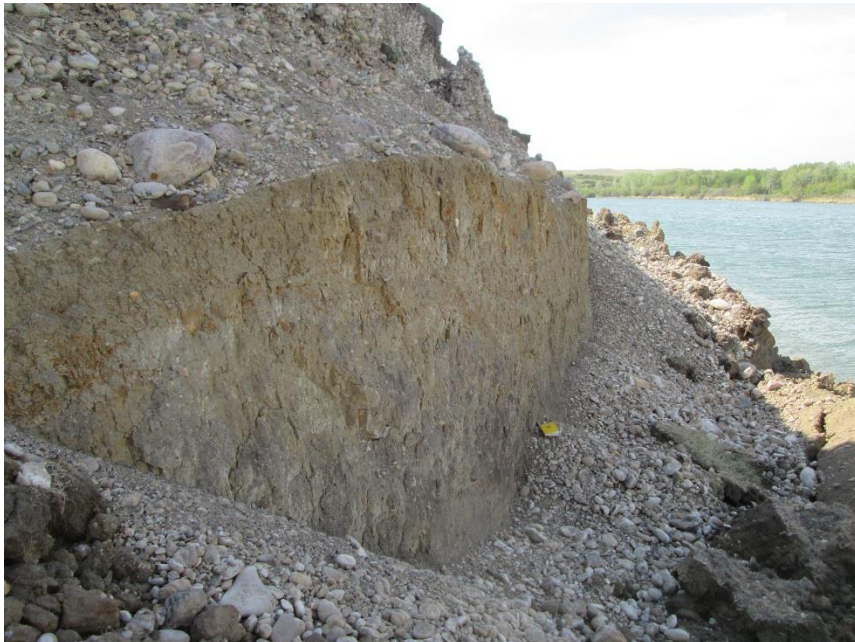
Photo 6 - (March 2016) –
Bedrock exposure along left
(east) bank approximately 100 m
upstream of ferry terminal.

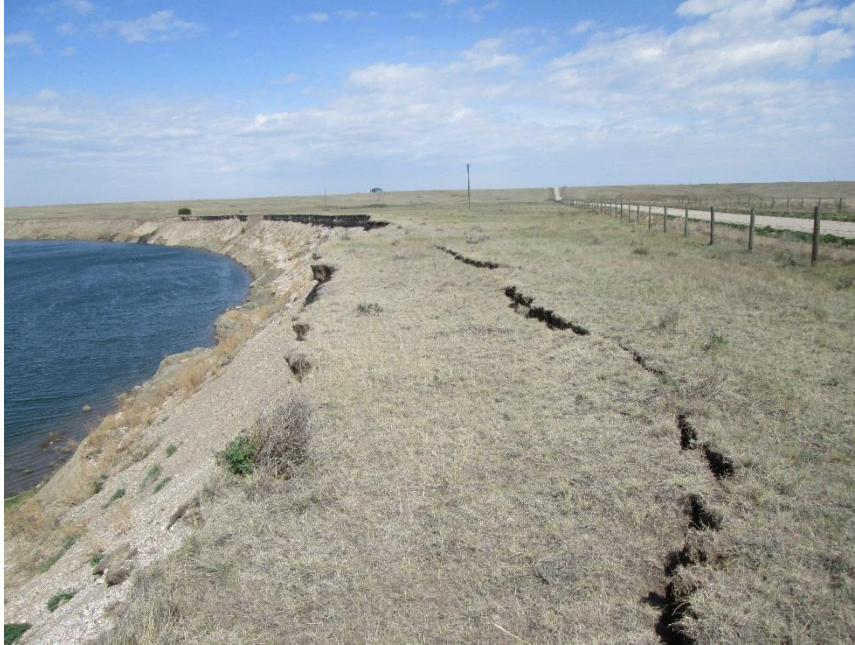
- ▶ New cracks were observed continuing northward from the area of minimum offset and extended for approximately 90 m. Minimum offset from the highway was 12 m (measured approximately 50 m north of main headscarp location). Cracks were 30 cm deep with an aperture of up to 20 cm. Refer to Photos 7 and 8.

Photo 7 - (May 2016) –
New cracks observed north of
area of minimum offset. Facing
north.

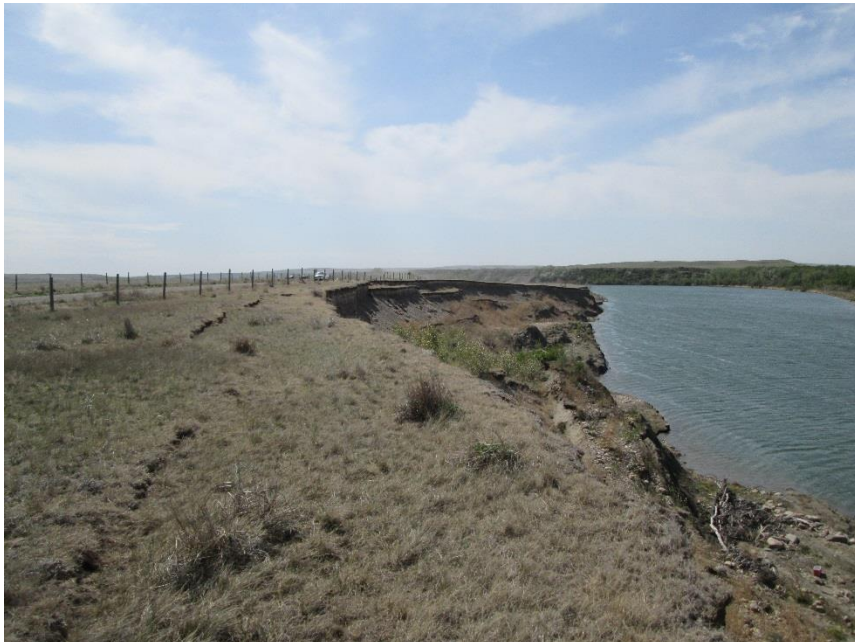
Photo 8 - (March 2016) –
New cracks observed north of
area of minimum offset. Facing
south.

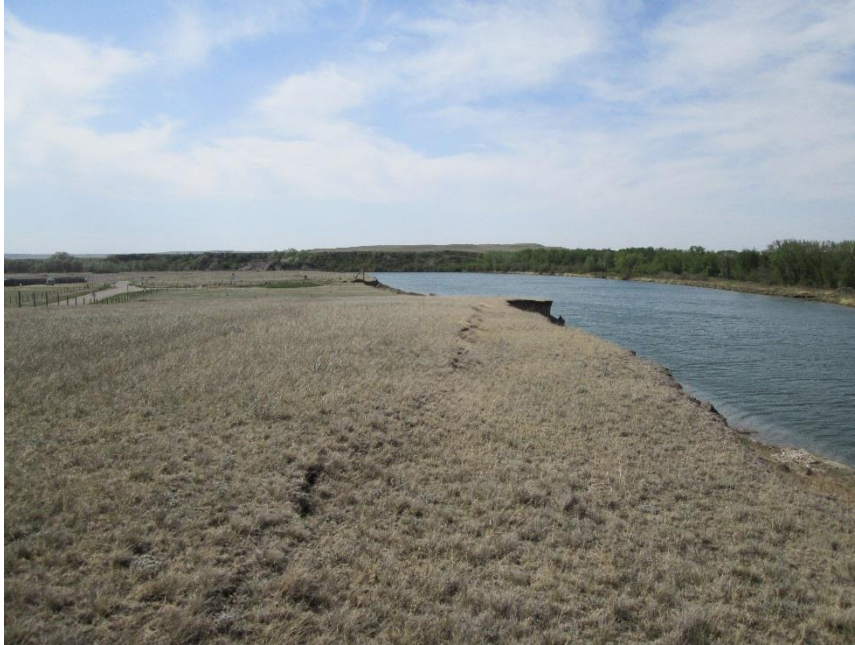
- ▶ Approximately 80 m south of the area of minimum offset, additional cracking was observed and extended 60 m. The crack was measured to be up to 30 cm in depth with an aperture of up to 20 cm. Refer to Photo 9.

Photo 9 - (May 2016) –
Cracks observed south of the
main landslide location. Facing
south towards ferry terminal.

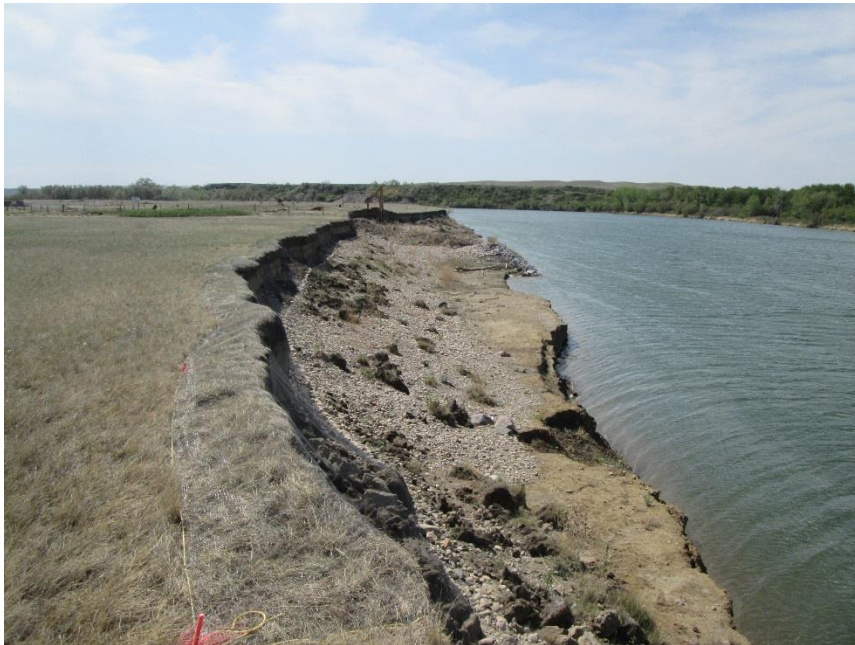
- ▶ Erosion netting had been placed along the bank for approximately 100 m north of the ferry crossing. Refer to Photo 10.
- ▶ The left bank of the river directly north of the ferry crossing was armored with large boulders and geotextile fabric. The fabric was damaged in numerous locations. Refer to Photos 11 and 12.

Photo 10 - (May 2016) –
Bank erosion on left (east) bank
upstream of ferry terminal.
Erosion netting placed over
scarp.

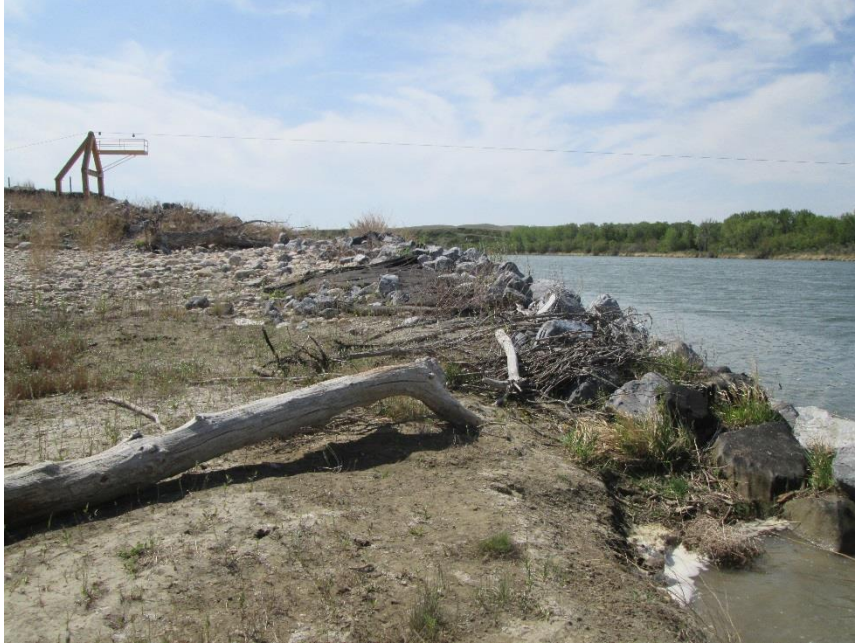
Photo 11 - (May 2016) –
Left bank armoring immediately
upstream of the ferry terminal.
Facing south.

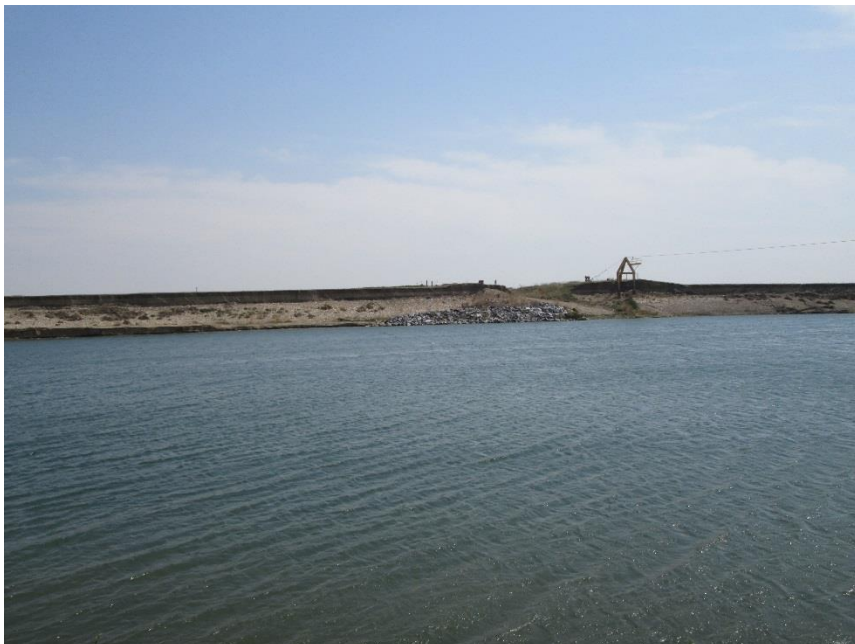
Photo 12 - (May 2016) –
On right bank, facing east.
Armoring of left bank
immediately upstream of ferry
terminal.
