GEOTECHNICAL ASPECTS OF THE KING STREET INTERCHANGE CONSTRUCTION, FORT McMURRAY, ALBERTA

Roger Skirrow, Alberta Transportation, Edmonton, Alberta, Canada
Don Proudfoot, Thurber Engineering Ltd., Edmonton, Alberta, Canada

Key words: interchange, embankments, colluvium, slope stability, wick drains, instrumentation, pile wall

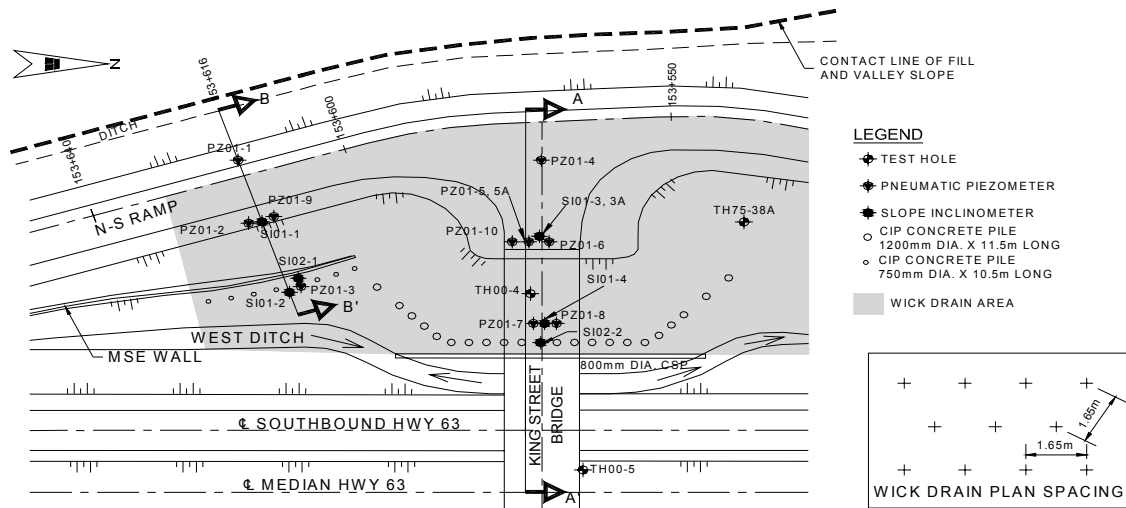
Figure 3. Plan of King Street west headslope area

The geotechnical investigation included a detailed airphoto review and engineering site reconnaissance. Test Hole drilling was also carried out by conventional solid stem auger drilling at the locations shown on Figure 3. Disturbed samples were retrieved using Standard Penetration Testing (SPT) and grab-sampling methods. The interpreted soil stratigraphy along cross-sections through the proposed west headslope of the King Street overpass and through the north-south ramp are shown on Figures 3 and 4, respectively. The drilling indicated that the colluvium layer beneath the west headslope and north-south ramp varied from about 3 to 6 m in thickness.

A subsurface pile wall was identified as the most practical and timely solution for providing additional support to the weak clay colluvium foundation soil underlying the embankment fills. The plan and cross-section arrangements of the piles are shown on Figures 3, 4 and 5. The piles consisted of cast-in-place bored reinforced concrete piles. The piles installed around the nose of the headslope fill consisted of 1200 mm diameter piles, 11.5 m in length, designed to provide an additional 175 kN/m (unfactored) of lateral support to the slope.

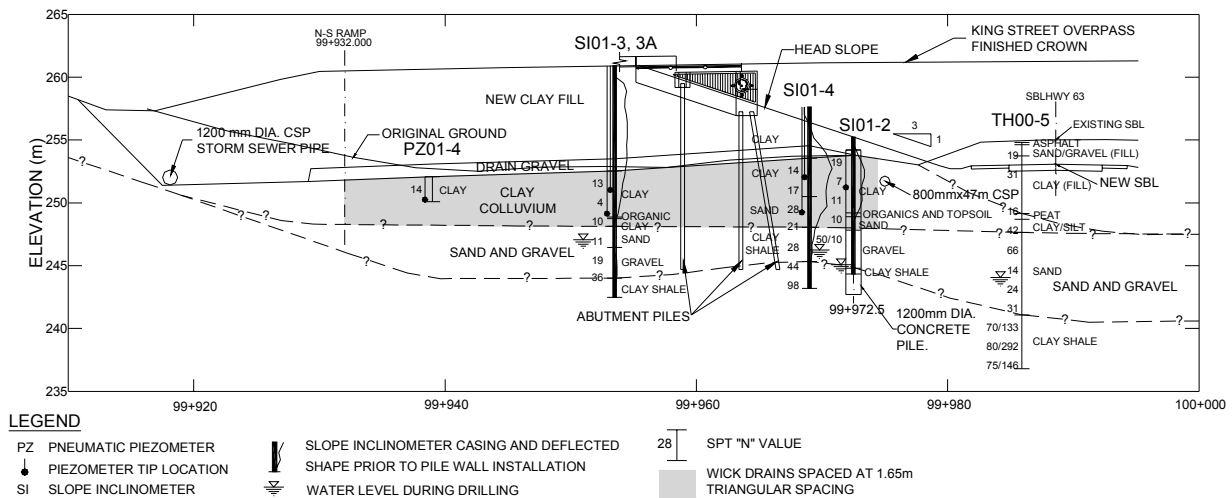
Figure 4. Stratigraphic cross-section A-A' through king street west headslope

The deflected shapes of the slope inclinometers at the end of fill placement at the two instrumentation cross-sections are shown on Figures 4 and 5.

The slope inclinometers (SI's) indicated that the clay colluvium was squeezing laterally in an eastward direction in response to the fill loading. A plot of ground displacement versus time for SI01-3A located behind the crest of the west headslope fill is shown on Figure 7. During the embankment construction, fill placement was paused after each meter of fill height to allow the creep rate to diminish before the next meter of fill was placed. However, after the fill reached the design maximum height, a steady rate of about 25 mm/year was noted in the clay colluvium layer which did not diminish with time. Ongoing creeping of the headslope was considered unacceptable due to the potential impact that long term movements could have on the bridge structure.

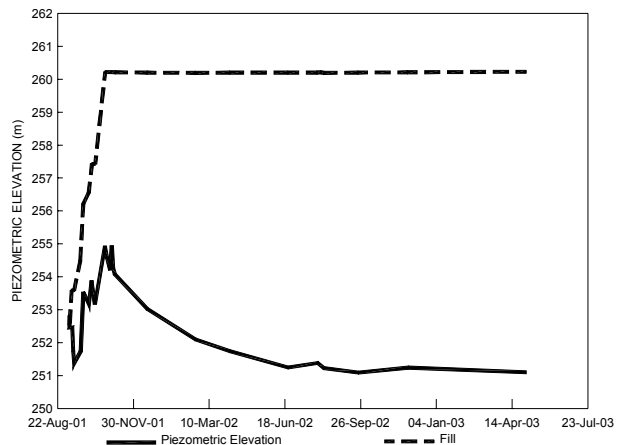
A plot of piezometric elevation versus time for P01-6, located under the crest of the west headslope with the tip installed in the clay colluvium, is shown on Figure 6. The corresponding elevation of the fill placed at this location is also shown on Figure 6. The pore pressure response to fill loading in this piezometer corresponded to an equivalent B_{bar} value of 0.25. Based on Figure 6, it took approximately 150 days for the wick drains to achieve 80% dissipation of the construction induced pore pressure from the clay colluvium.

Figure 6. Porewater pressure dissipation in piezometer P01-6 with tip in clay @ EL 251.03m

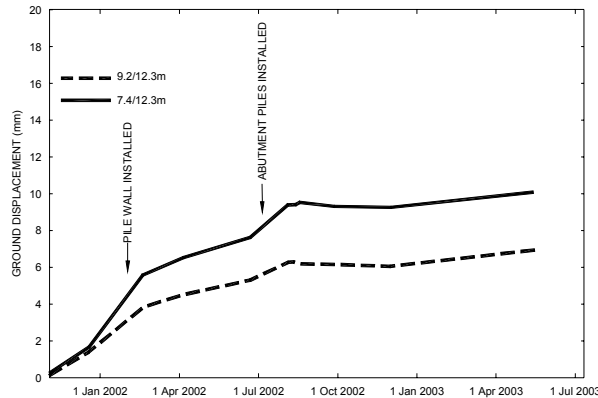
The noted creep rate corresponded to a strain rate of 6.5×10^{-3} when taken over the thickness of the clay layer. Based on previous work by Crooks et al (1986) it was assessed that this strain rate corresponding to an overall slope stability factor of safety (FOS) of about 1.15 and effective friction angle of 10 degrees for the slickensided clay colluvium. Since this FOS was less than the desired minimum value of 1.3, it was decided that further stabilizing measures would be required to increase the FOS and stop the lateral creep movements before bridge construction could be carried out.

Figure 7. Ground displacement versus time in SI01-3A

A pile wall, as described in the following section, was installed in February 2002. Additional SI's (SI02-1 and SI02-2) were installed in two of the piles to monitor the response of the piles to loading. As shown Figure 7, the

piles were successful in significantly reducing the creep rate of the colluvium to the point where the abutment piles (driven steel H piles) could be installed. The slope experienced some additional lateral movements during installation of the abutment H piles in July 2002, however the movements halted immediately after pile installation which allowed bridge abutment and deck construction to proceed.
