Bi-Annual GRMP Review Meeting Peace Region: Swan Hills District March 7, 2018

Area Summary

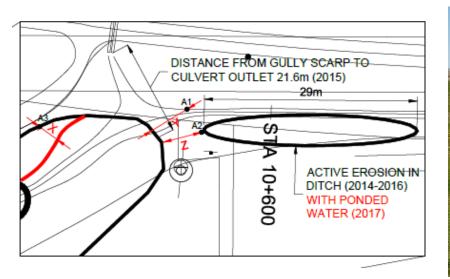
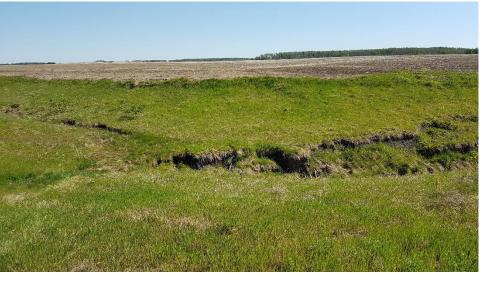
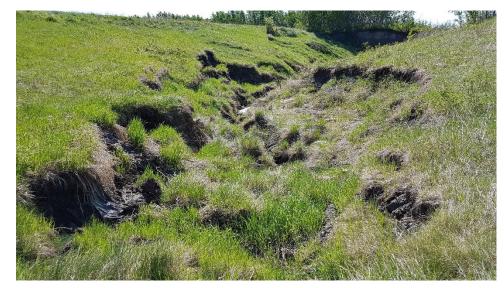
Site 12

DIMENSION	LENGTH (m)			
LABEL	2017	2016	2015	2014
X * (WIDTH)	5.0	-		-
Y (A1 TO CREST)	3.9	4.4	5.6	6.0
Z (A2 TO CREST)	6.9	7.55	8.6	8.7

^{*} LOCATION RESET IN 2017
